Detailed Visual Inspection

Concrete was the principal material used in the construction of the Bonner Bridge. Concrete elements include the following:

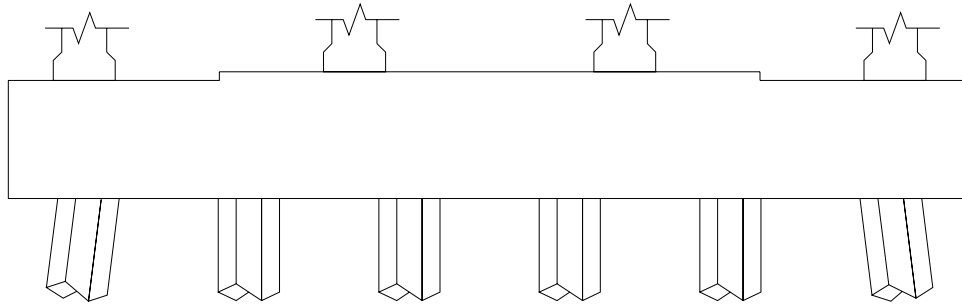
Bent configuration A: Bents 21, 31 and 117

A moderate amount of patching was observed on faces and top of the pile cap. The majority of the patched areas were sound, although there were many delaminated areas detected on the pile cap. A fairly large spall and exposed reinforcing steel existed on the lower edge of the pile cap on the north elevation. Bent 21 is a type A configuration (see Appendix D.2C, pg. D.2C-5).

A significant amount of patching was observed on the north face and soffit of the pile cap, with slightly less patching occurring on the south face. Two sizable delaminations were detected on the south face and one fairly large delamination existed on the pile cap soffit. Except for the patch on the pile cap soffit, all of the delaminations occurred in original concrete and not in patched areas. Bent 31 is a type A configuration (see Appendix D.2C, pg. D.2C-7).

One medium size patch (approximately 2-4 sq. ft.) was observed on both the north and south elevations and a smaller patch was observed on the lower east end of the pile cap. A few delaminated areas were detected on the north and south elevations, all approximately 1 sq. ft. or less. Several horizontal cracks were found in the pile cap - on the north and south faces and the top of the pile cap. One measured crack width on the south face was 0.04" and one crack on the top of the pile cap measured 0.05" in width. Bent 117 is a type A configuration (see Appendix D.2C, pg. D.2C-11).

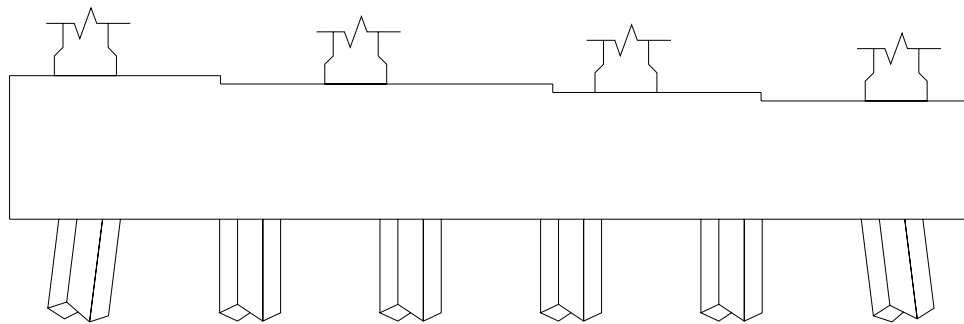
Bent configuration B: Bents 53, 75, 93, 102, 103, 176, 177 and 178

Significant patching was observed on the south face of the pile cap and more extensive patching exists on the north face. Several large delaminated areas were detected on both the north and south faces at the

upper edge and wrap up onto the top surface of the pile cap. One fairly small spall with exposed reinforcing steel was observed on the south face, at midspan, at the upper edge. Bent 53 is a type B configuration.

Significant patching was observed on the north elevation and slightly less patching on the south elevation. Several small delaminated areas were detected on the north face, one larger delaminated area was detected on the south face and several small areas were delaminated on the top of the pile cap. One spall (approximately 1 sq. ft.) with exposed reinforcing steel was observed on both the north and south elevations and two larger spalls were found on the top and soffit of the pile cap. Bent 75 is a type B configuration (see Appendix D.2C, pg. D.2C-8).

Relatively minor patching existed on the pile cap, with one patch observed on both the north and south faces. Several delaminated areas were detected in the north elevation, ranging in size from approximately 1 to 2 sq. ft., and a couple smaller delaminated areas were detected on the south face. A fairly small spall with exposed reinforcing steel was found on the north face at the top edge. Bent 93 is a type B configuration (see Appendix D.2C, pg. D.2C-10).

Several patches were observed on the north elevation of the pile cap, with the largest patch containing many vertical hairline cracks. A couple of small patches were found on the south face of the pile cap. Several relatively small (approximately 1-1.5 sq. ft.) delaminated areas were detected in both the north and south face of the pile cap, as well as in the pile cap soffit. Several cracks were found in the pile cap, with a length of 2' or less, with two measured crack widths equal to approximately 0.01". A small spall with exposed reinforcing steel was observed in the south face towards the east end, at the bottom edge. Bent 102 is a type B configuration (see Appendix D.2C, pp. D.2C-10, 11).

Moderate patching was observed on both the north and south elevations of the pile cap, with patch sizes ranging from approximately 1 sq. ft. to 5 sq. ft. Many small to medium size delaminated areas were detected in the north and south faces of the pile cap, as well as the pile cap top and soffit. Several spalls were found in the pile cap, along the lower edge of both the north and south faces, with four locations of exposed reinforcing steel. A crack with a measured width of 0.05" was observed in the north face at the lower west end. Bent 103 is a type B configuration (see Appendix D.2C, pg. D.2C-11).

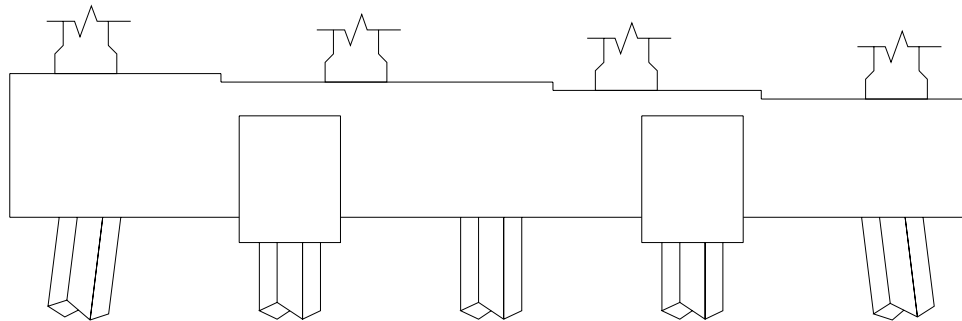
Bent configuration C: Bents 88, 116, 167 and 175

Several large patched areas (approximately 2-4 sq. ft.) were observed on the north face of the pile cap and one medium size patch existed on the south face. All of the patched areas were sound. Several relatively small delaminated areas were detected on the north and south faces and the pile cap soffit. A large spall with exposed reinforcing steel was observed on the south face, along the lower edge, as well as along the lower edges of the short beams atop the north-south battered piles. Bent 88 is a type C configuration (see Appendix D.2C, pp. D.2C-9, 10).

Medium sized patches (approximately 2-4 sq. ft.) were observed on both the north and south elevations. A moderate number of delaminated areas were detected on both the north and south faces and the pile cap top; all in the original concrete. Several of the delaminations contained horizontal cracks; a few with measured widths of 0.04". One delamination on the north face, when sounded, spalled off and released trapped water. Other cracks were observed in the original concrete of both the north and south faces and the top of the pile cap. Some of these cracks had measured widths of 0.04". Bent 116 is a type C configuration.

Several fairly small delaminated areas were detected on the pile cap south elevation and the south faces of the cross-pile caps. A couple small delaminated areas were also detected on the north face and the pile cap top. Several short cracks were observed on the top of the pile cap, the north elevation, the north and south faces of the cross-pile caps and on the east end of the pile cap. The range of measured crack widths was 0.015" to 0.075". Two spalls were observed on the south faces of both of the southern cross-pile caps, one of which had exposed reinforcing steel. Bent 175 is a type C configuration and was retrofit with concrete transfer girders.

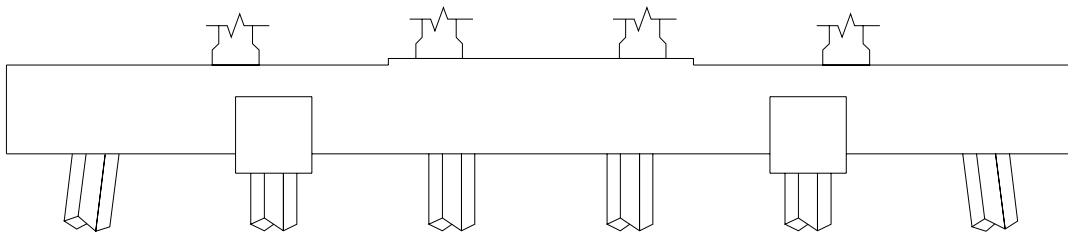
Bent configuration F: Bent 12

Approximately 60 percent of the north face contained shotcrete repair, with relatively small shotcrete repairs on the south face and pile cap soffit. The shotcrete repair on the north face contained map cracking throughout. Patching existed along three north-south lower edges of the battered pile caps. A few small delaminated areas were detected on the pile cap. A large crack (~ 3/16") was observed on the south face, and one location of spalled concrete with exposed reinforcing steel was observed on the north face of a battered pile cap. Bent 12 is a type F configuration (see Appendix D.2C, pg. D.2C-3).

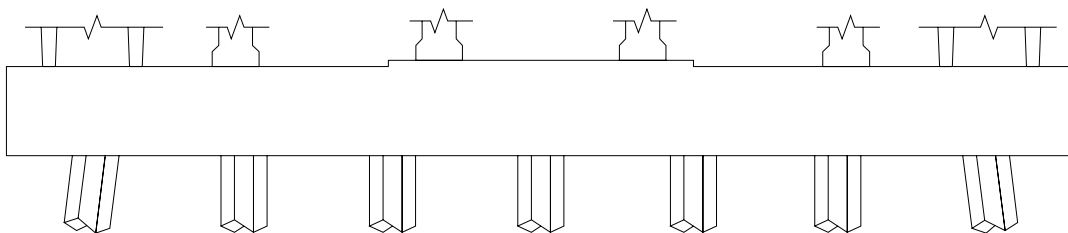
Bent configuration G: Bents 7, 13 and 201

Eight relatively small patches were observed on the pile cap, the majority of which were sound. Two patches on the south face contain map cracking. Two small delaminated areas were detected on the pile cap, at the lower edges and wrapping under to the cap soffit. A rather large spall with exposed reinforcing steel was observed on the lower edge of the south face. Bent 7 is a type G configuration (see Appendix D.2C, pp. D.2C-1, 2).

Moderate to light patching was observed on the pile cap, with more patching occurring on the north face. The majority of the patches observed seemed sound. A few small delaminated areas were detected on each face and the pile cap soffit, and a minor spall was observed on the north face. Bent 13 is a type G configuration (see Appendix D.2C, pg. D.2C-3).

Several small to medium size delaminated areas were detected in both the north and south faces of the pile cap. Moderate patching was observed on the pile cap. Several cracks were observed on the north,

south, and west faces of the pile cap, with one measured crack width approximately 0.05". Bent 201 was a type G configuration (see Appendix D.2C, pg. D.2C-15, 16)
