UNDERWATER BRIDGE INSPECTION REPORT

TYPE INSPECTION SUPPLEMENTAL (FENDER ONLY)

COUNTY BRUNSWICK BRIDGE NO. 090014 ROUTE N.C. 133

INSP. DATE 6/18/07 INSP. CYCLE 2 YR. ACROSS INTRACOASTAL WATERWAY
 (FENDER) (@ OAK ISLAND)

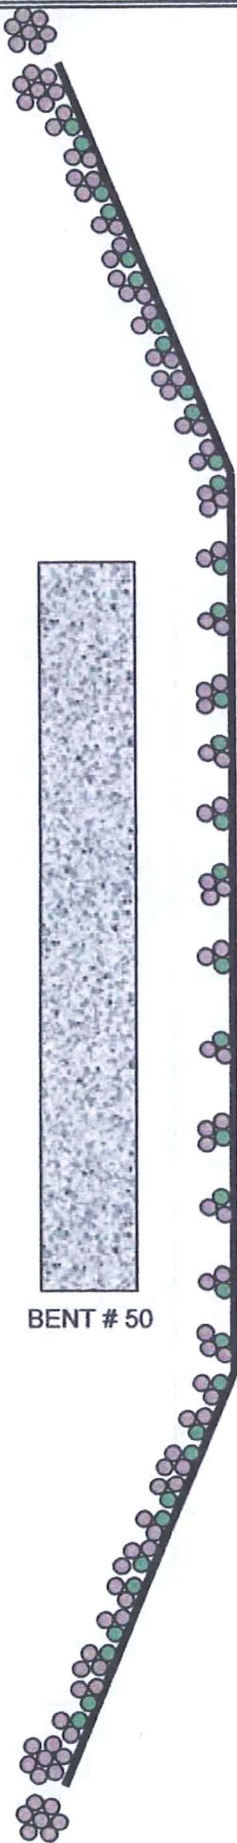
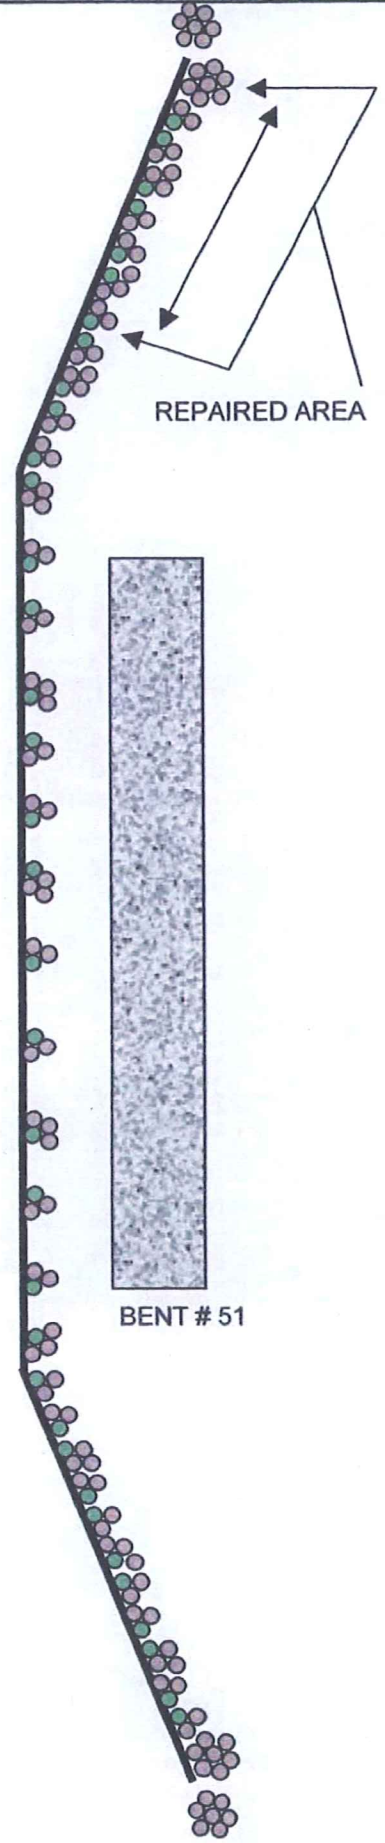
FENDER PLAN VIEW

REPAIRED AREA

- DENOTES OLDER CREOSOTE PILES
- DENOTES ADDED C.C.A. PILES

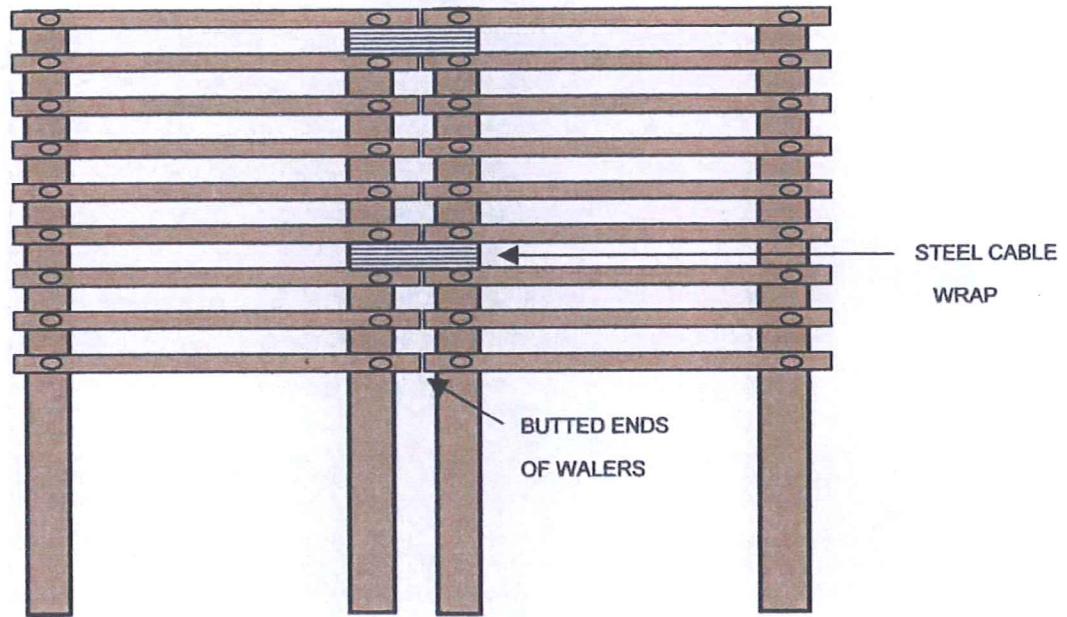
ORIGINAL DESIGN

12" AVERAGE DIAMETER CREOSOTE TIMBER PILES

9 ROWS OF 10" x 10" CREOSOTE TIMBER WALERS

(WALERS WERE NOT LAPPED WHICH ALLOWED INDEPENDENT MOVEMENT OF FENDER SECTIONS)

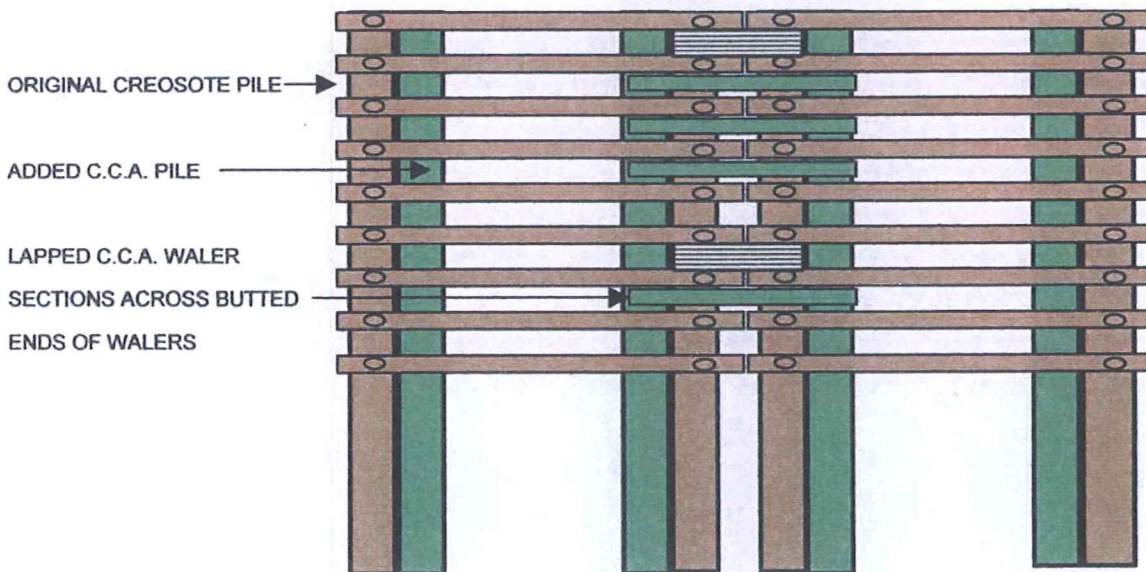
REPAIR DETAIL

REPAIRS WERE MADE TO STIFFEN FENDER SYSTEM CONSISTING OF DRIVING ADDITIONAL PILES AT EACH CLUSTER AND BY LAPPING ADDED WALER SECTIONS ACROSS ORIGINAL BUTTED ENDS OF WALERS

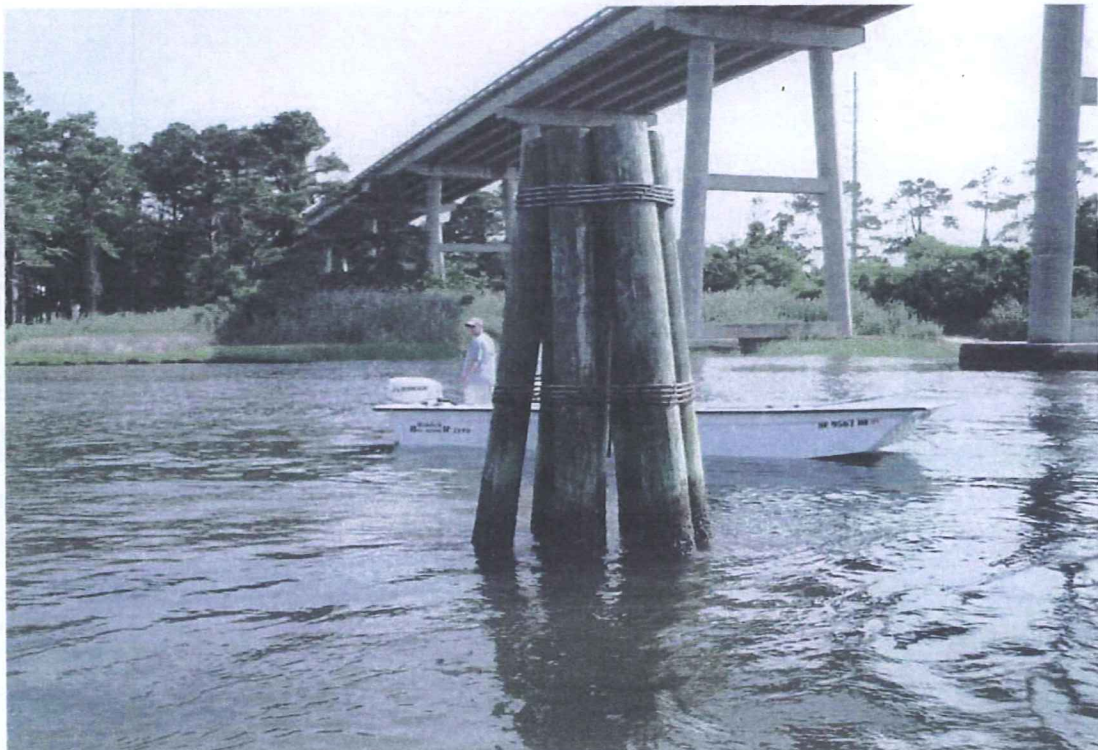
NORTHWEST DOLPHIN REPLACED WITH CCA TIMBER PILES.

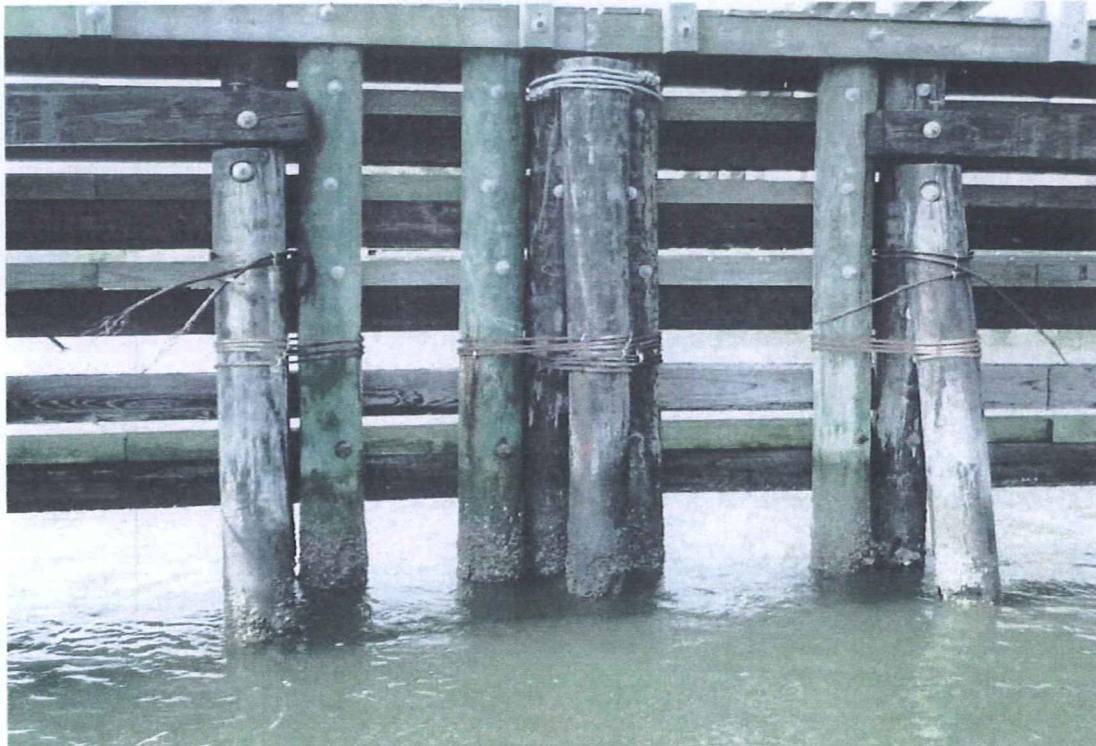
MODERATE RUST ON CABLE WRAPS WITH MOST UPPER CABLES COMPLETELY SEPARATED DUE TO RUST

RUSTED BROKEN CABLE WRAPS

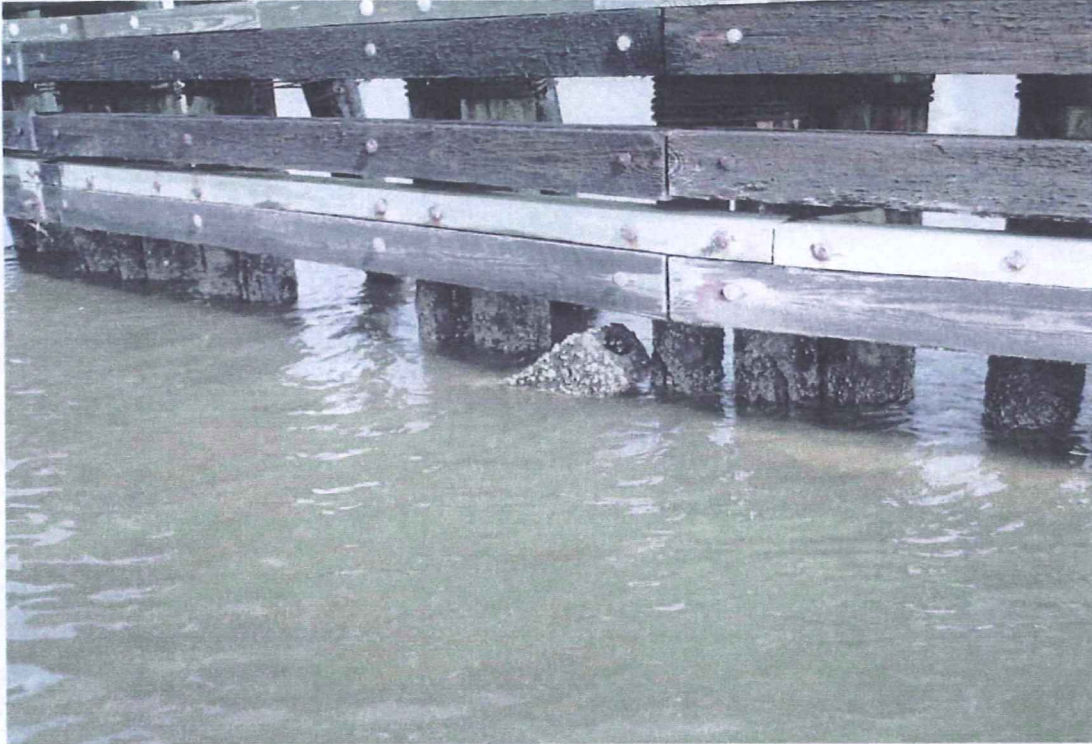
BROKEN HANGING WALER, N.FENDER

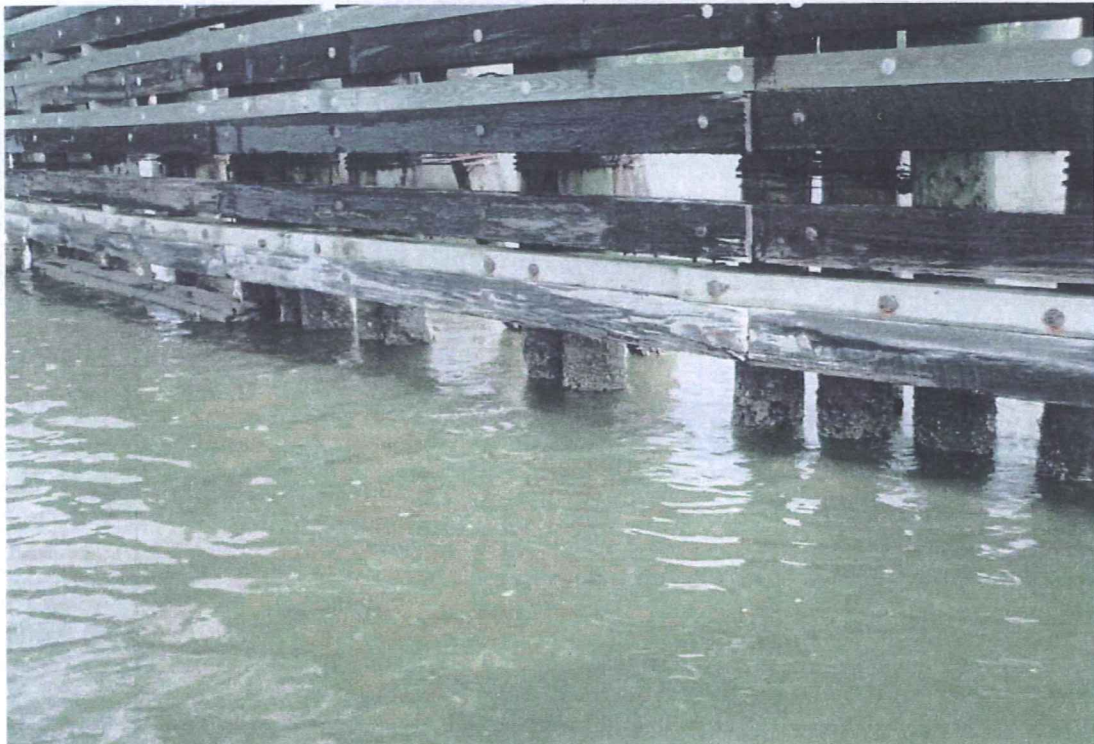
LOWER ROWS OF WALERS ARE MISSING AT RANDOM LOCATIONS

MISSING WALERS

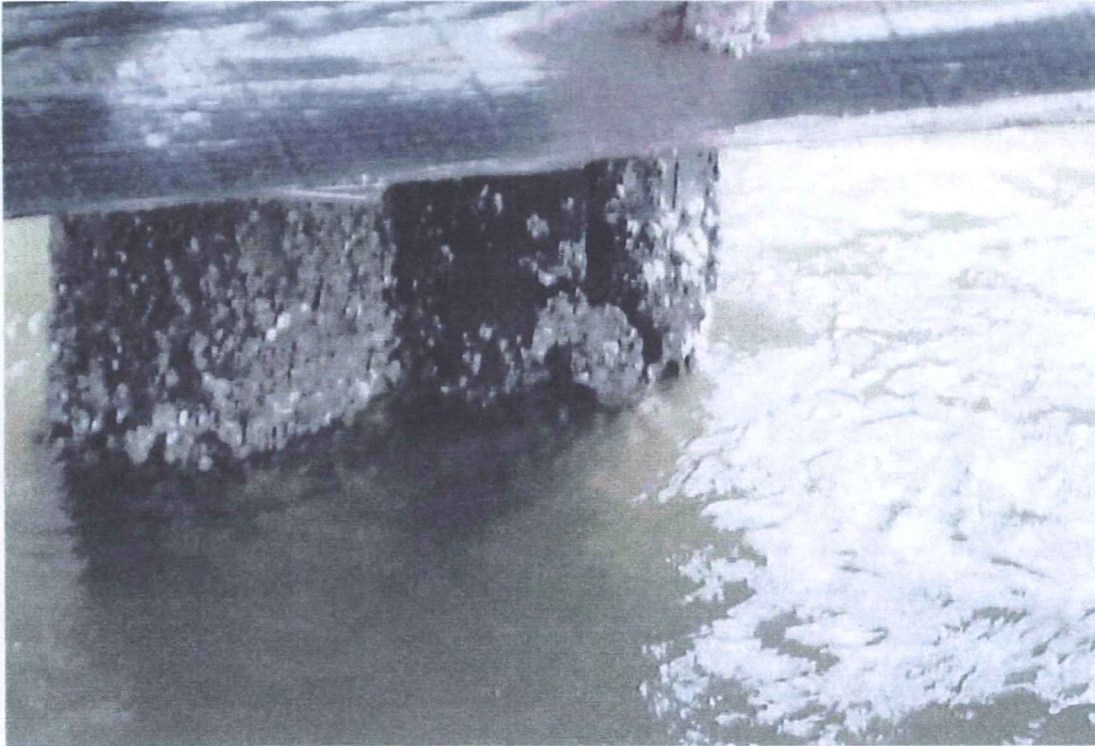
DECAYED PILE, N.FENDER

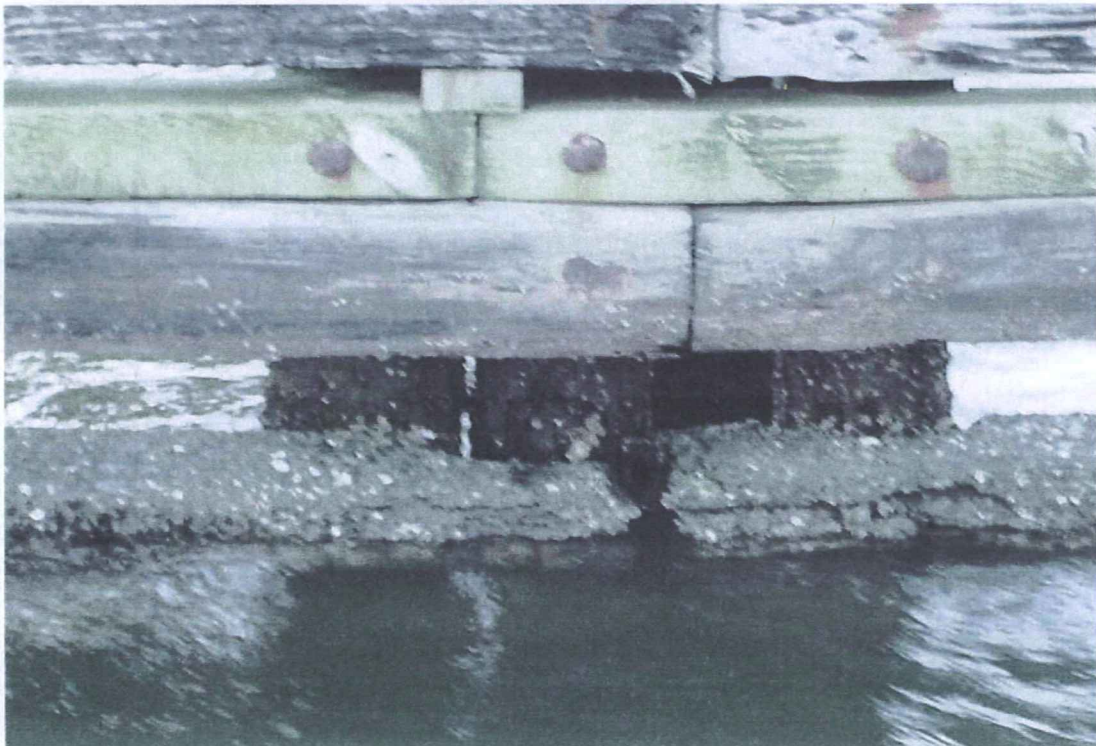
NUMEROUS WALERS ARE HOLLOW AND SEVERELY DETERIORATED AT ENDS (UP TO 4' DEEP) DUE TO MARINE BORERS

WALER DECAY, S.FENDER

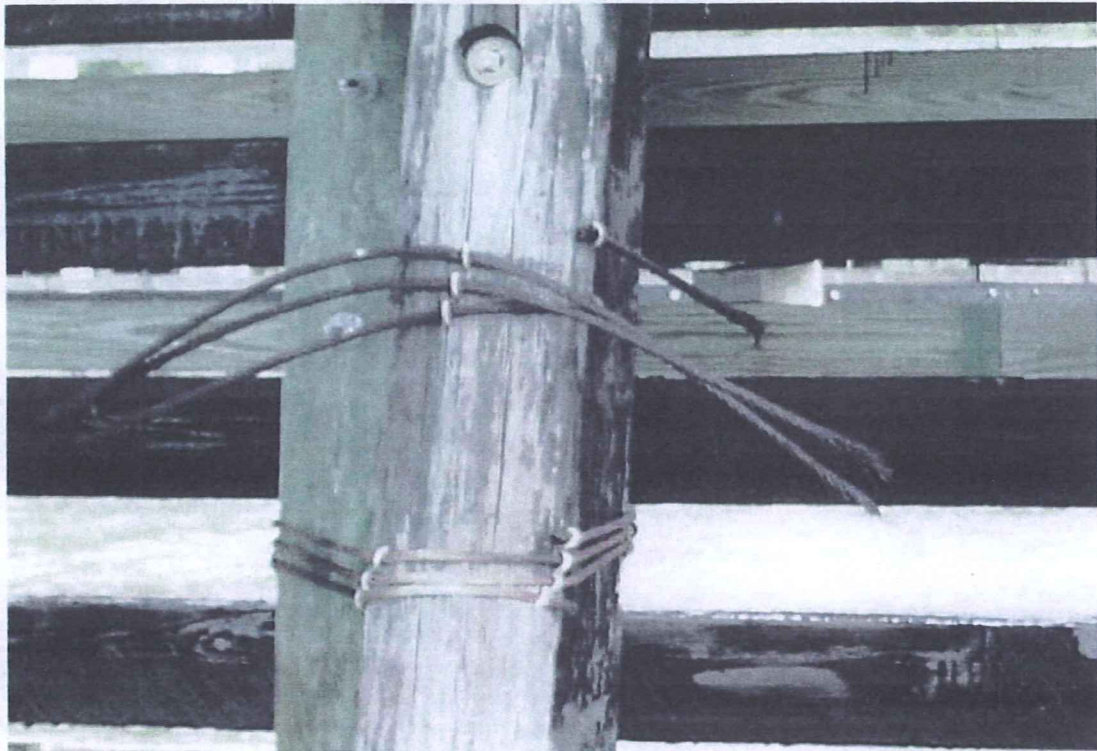
BROKEN RUSTED CABLE WRAPS, S.FENDER

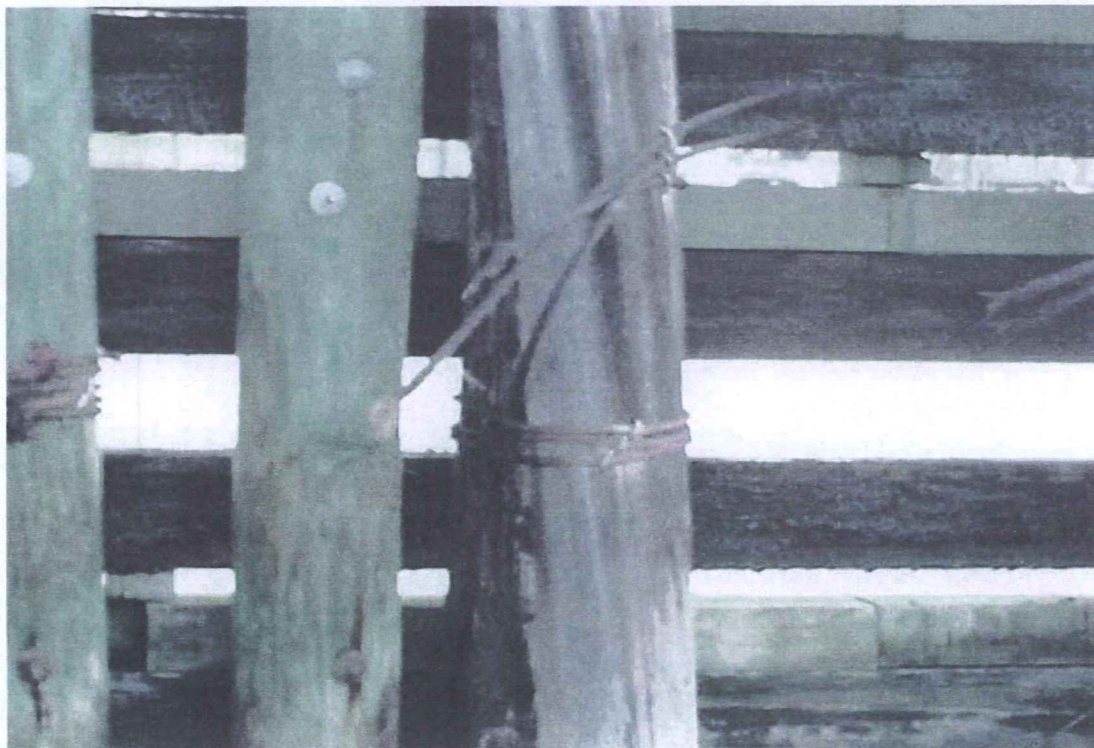
BROKEN RUSTED CABLE WRAPS, S.FENDER

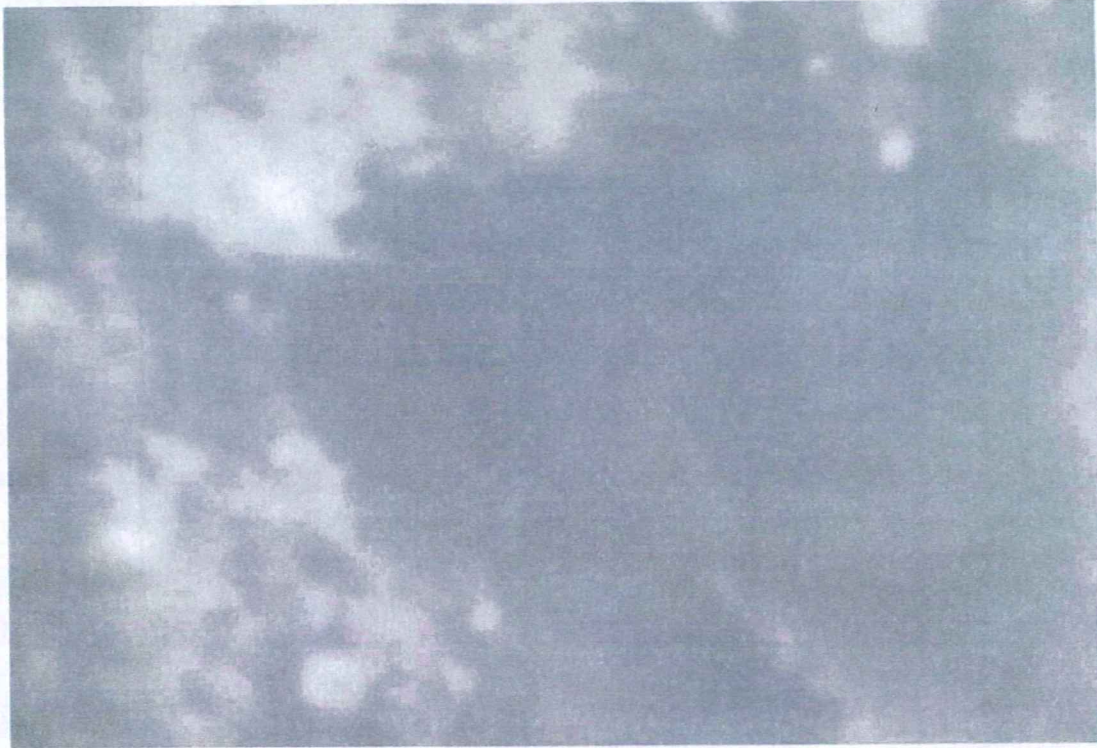
3" DEEP X 3" DIAMETER BORER HOLE IN PILE, S.FENDER

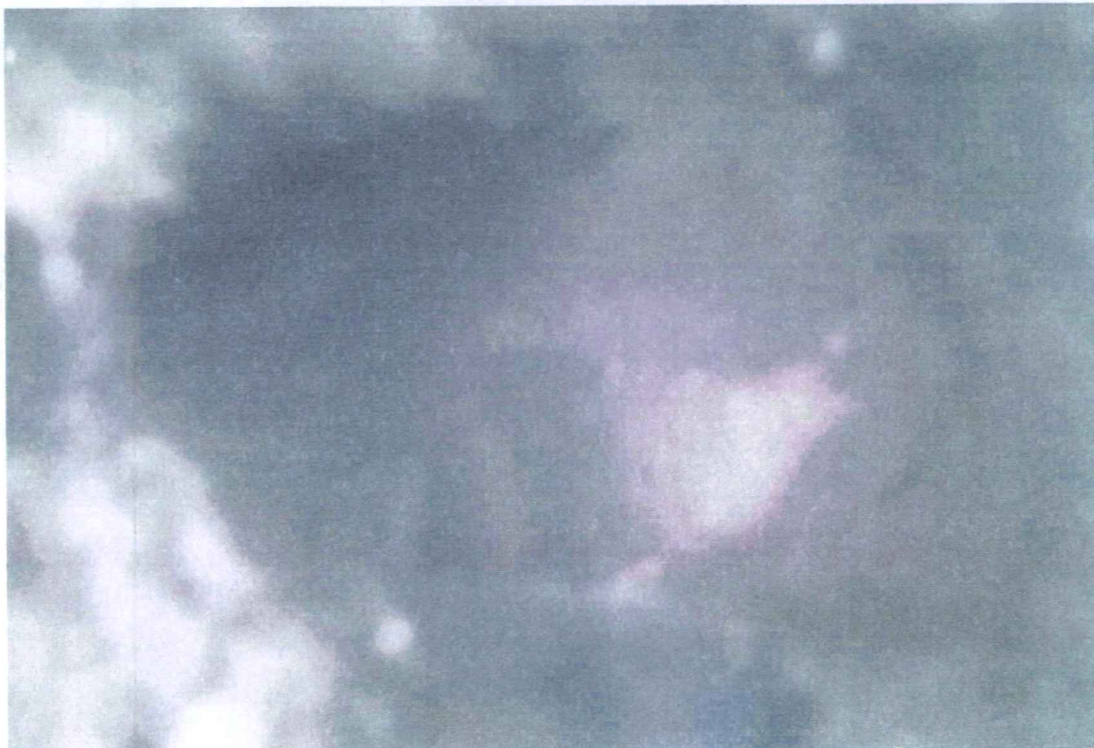
SAME HOLE WITH VIEW OF CRAB INSIDE

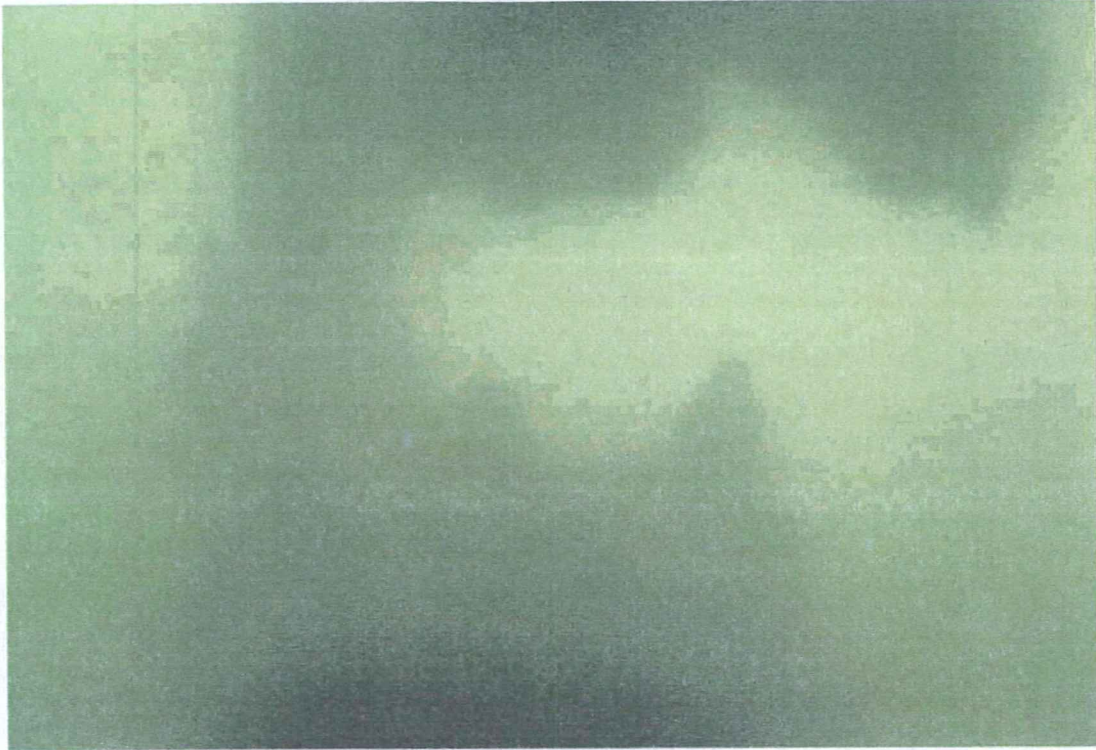
U/W PHOTO OF SEVERED PILE, S.FENDER

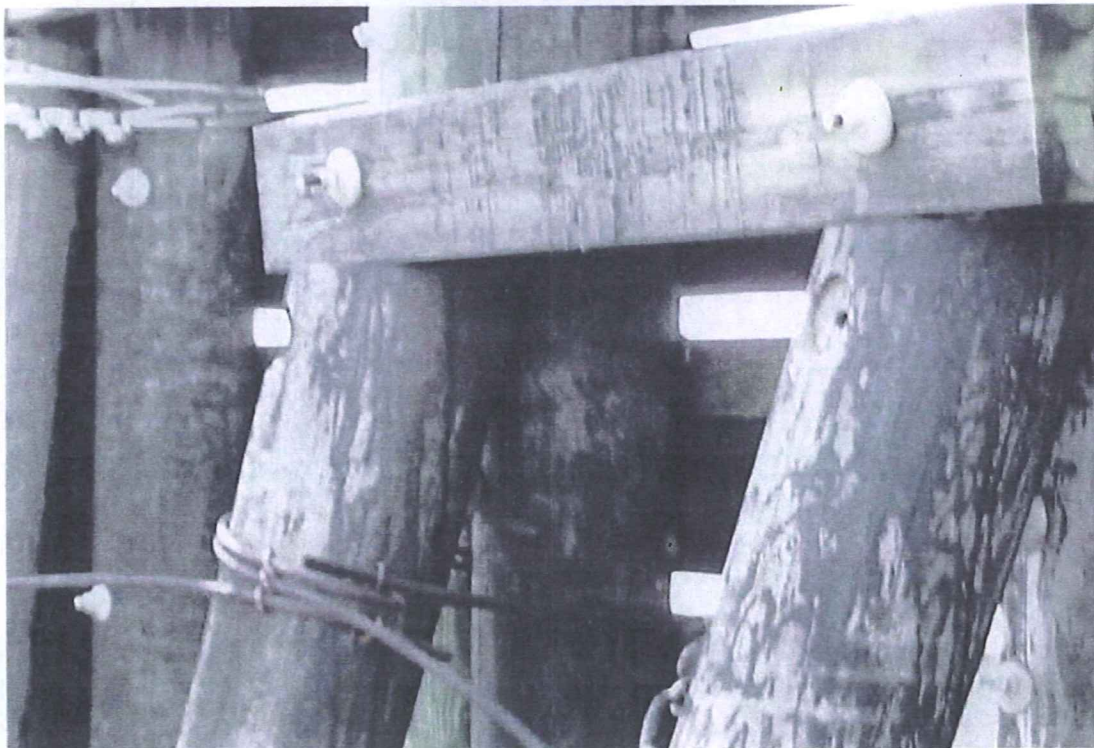
RANDOM BATTER PILES MISSING BOLTS
