N.C. DEPARTMENT OF TRANSPORTATION
DIVISION OF HIGHWAYS
BRIDGE MAINTENANCE UNIT

BRIDGE INSPECTION REPORT

COUNTY PASQUOTANK BRIDGE NUMBER 690019 INSPECTION CYCLE 2 YRS

ROUTE US158 ACROSS PASQUOTANK RIVER M.P. 000+000

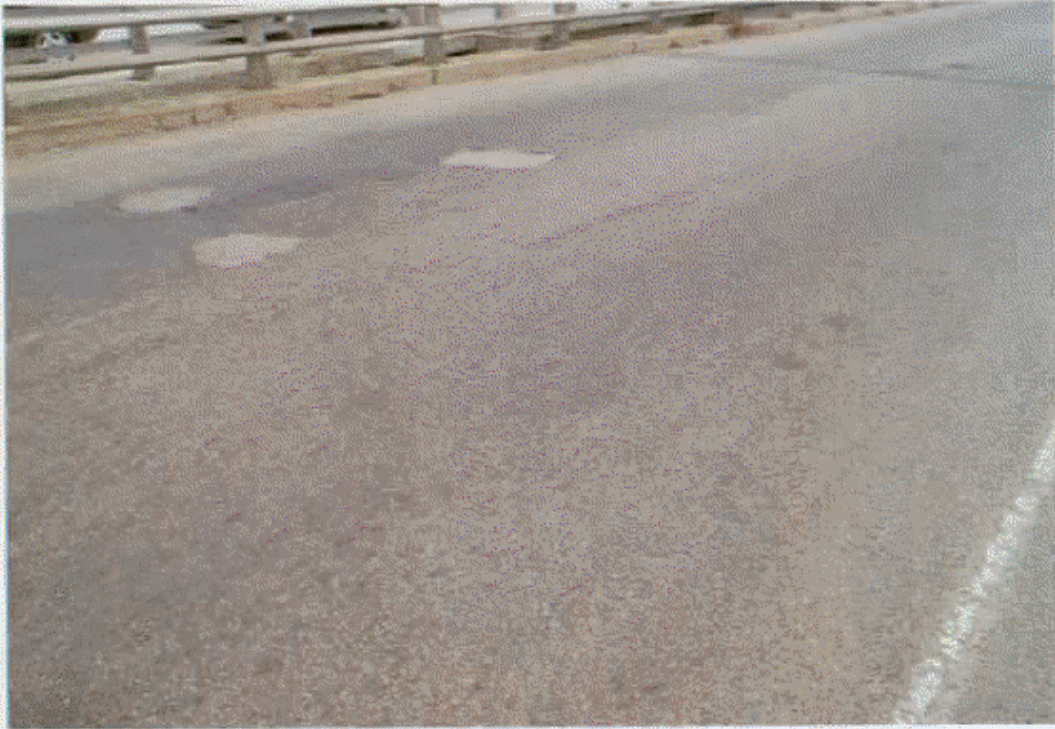
WEARING SURFACE

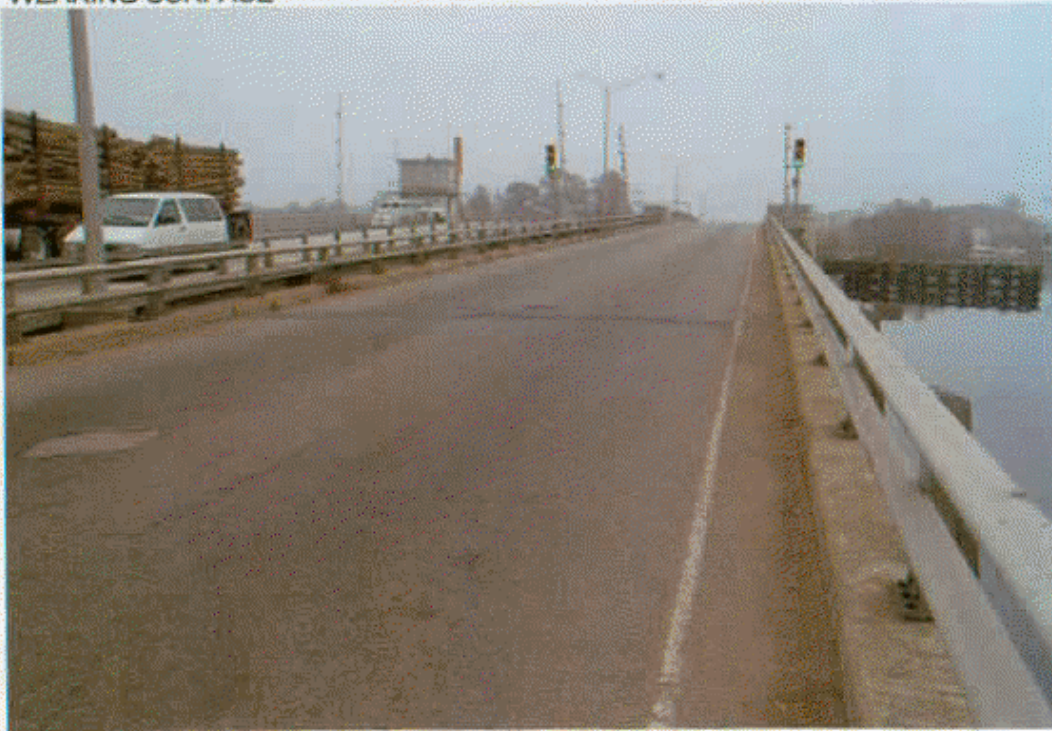
WEARING SURFACE

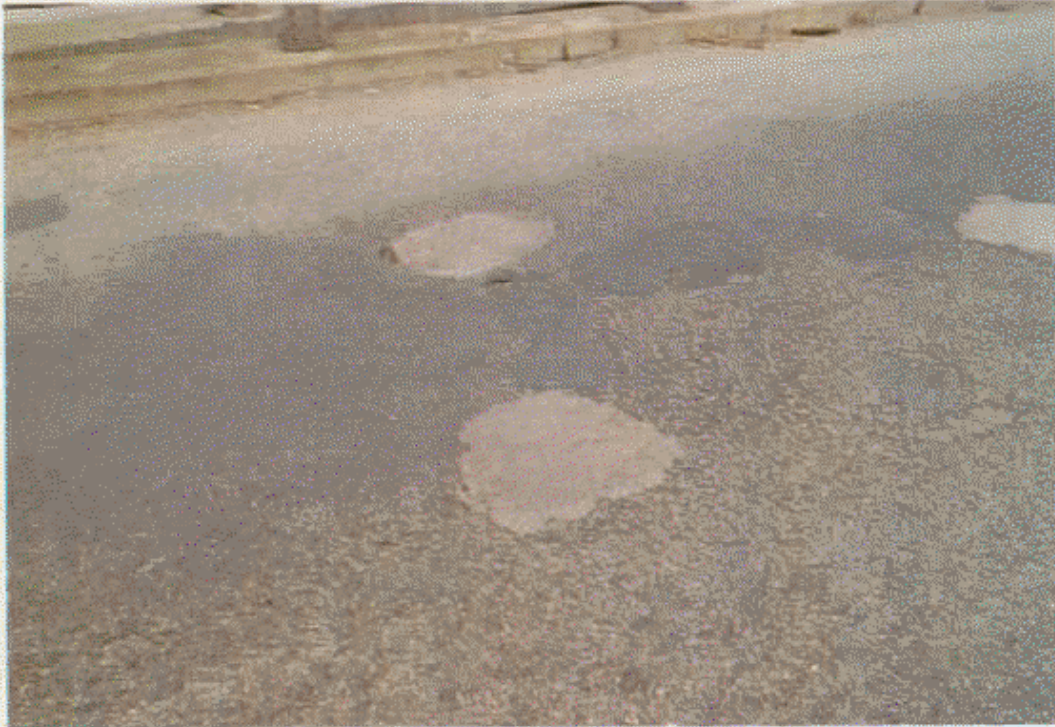
WEARING SURFACE

PATCHED AREAS

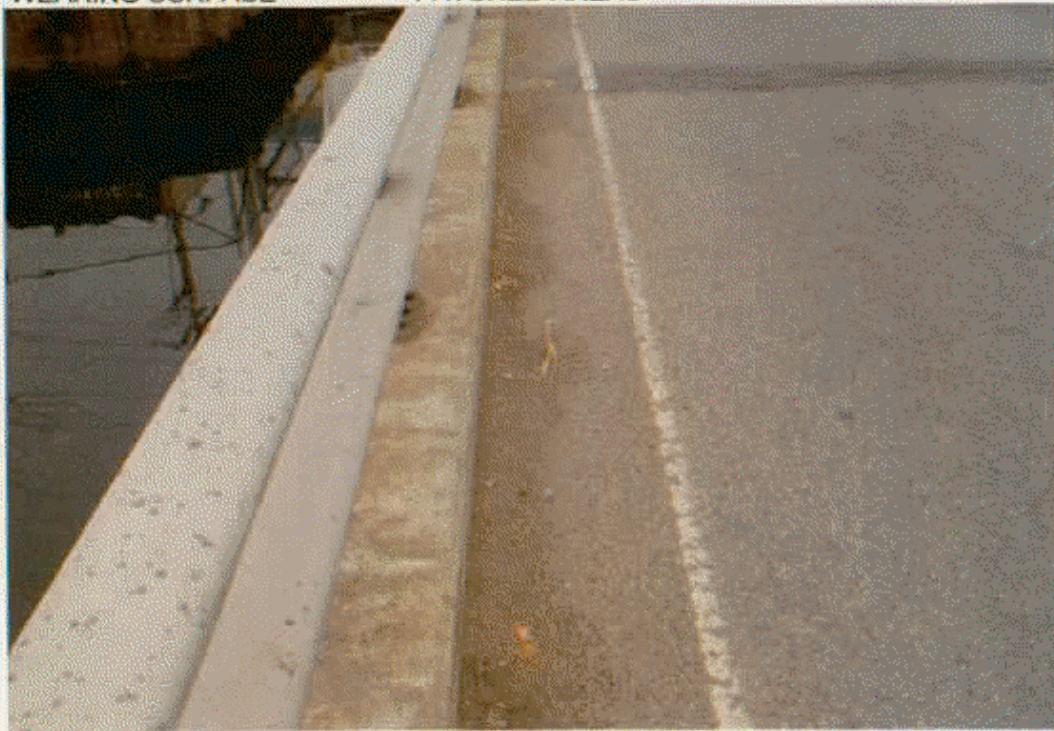
DRAIN HOLES STOPPED UP

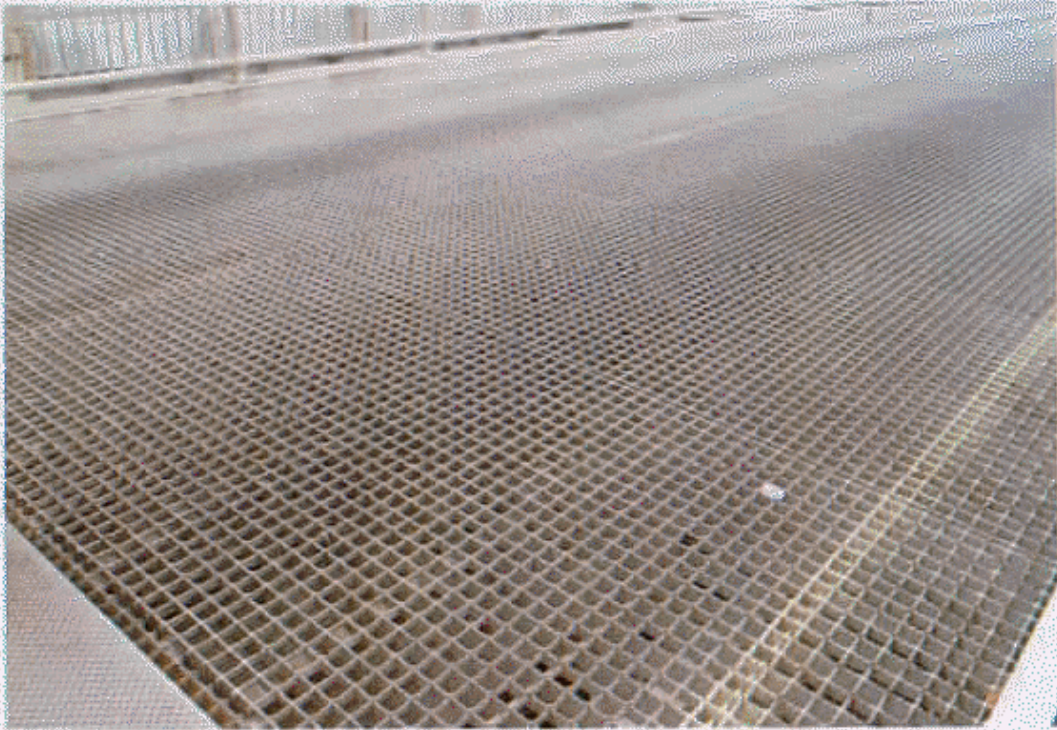
TOP OF STEEL GRID WEST LIFT

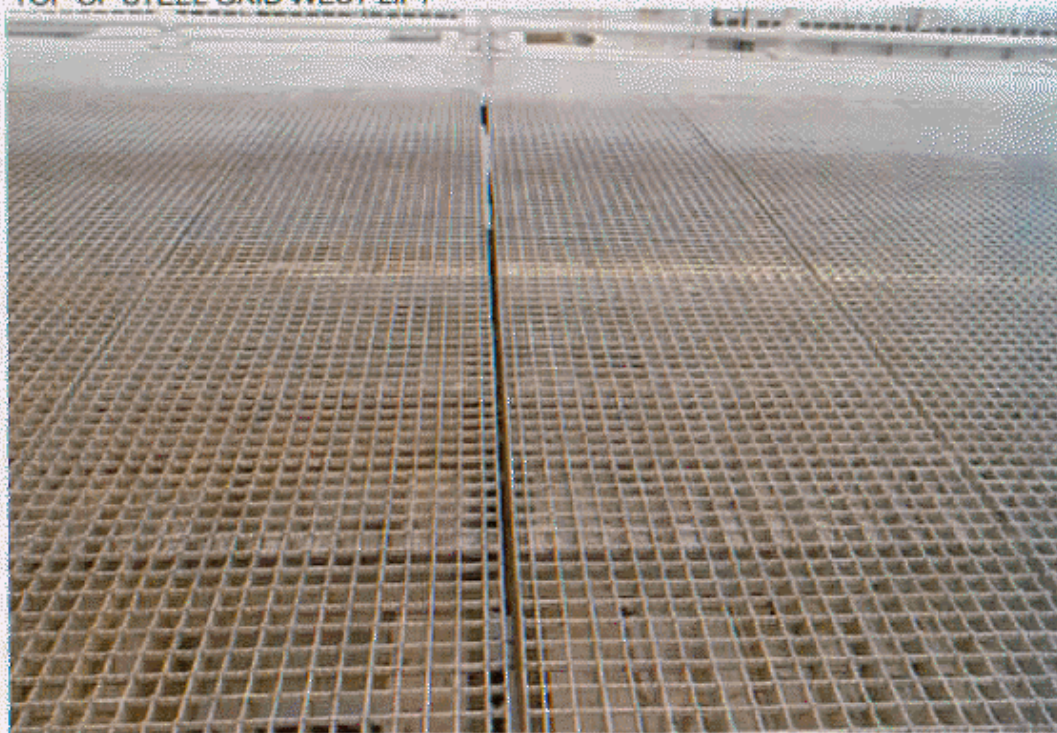
CENTER JOINT BETWEEN STEEL GRIDS

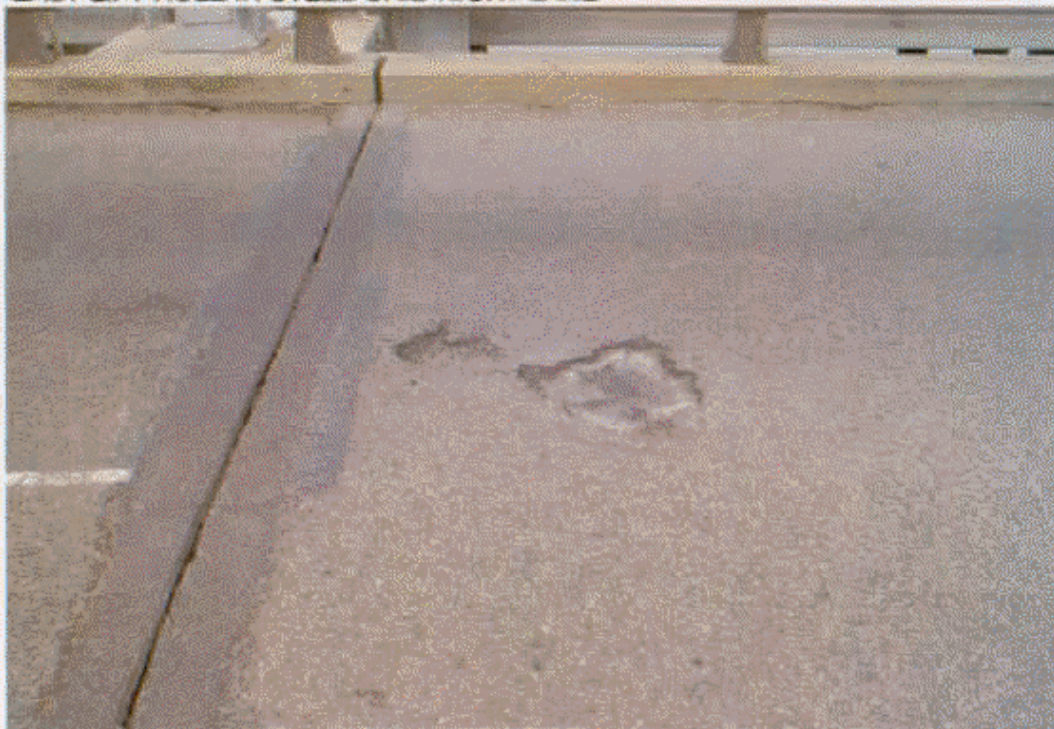
WEARING SURFACE SPALLED LEFT LANE SPAN #7 AT BENT#6

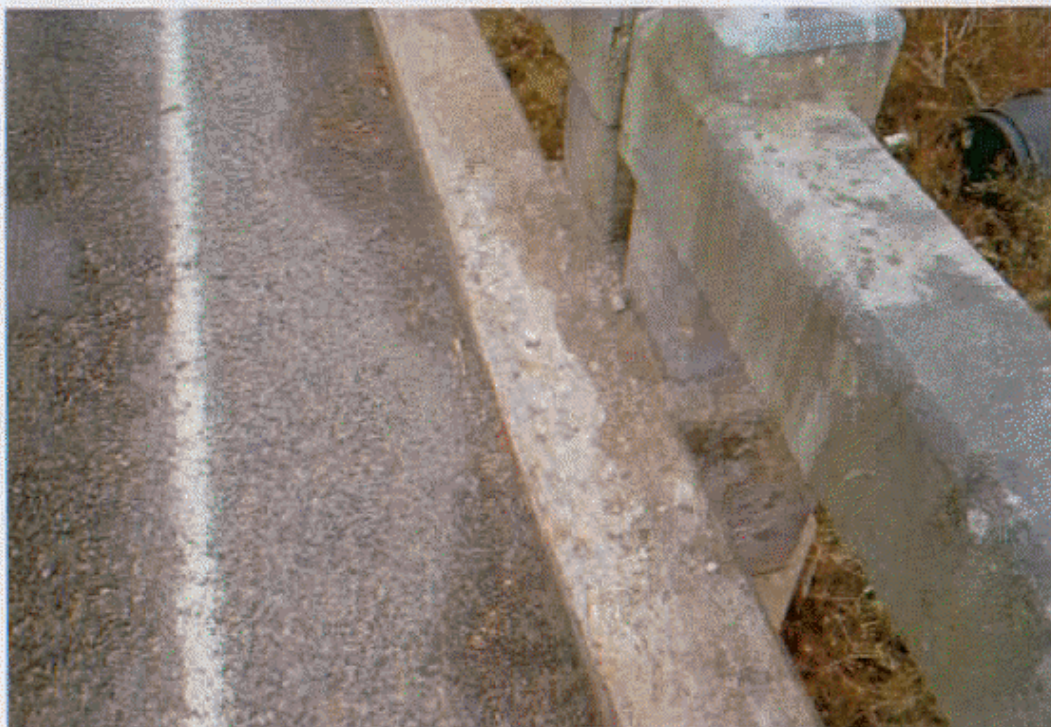
| Item No. | Description |
|---|--|
| 4 | CURBS - 6- SPALLS WITH SOME CONCRETE DETERIORATION AT PLACES. SEE PHOTO - THIS IS ON RC THICK SLAB SECTION ON EAST END ONLY.. |

CURB DETERIORATION RIGHT SIDE AT BENT#16 (SIMILAR AT BENT#18)

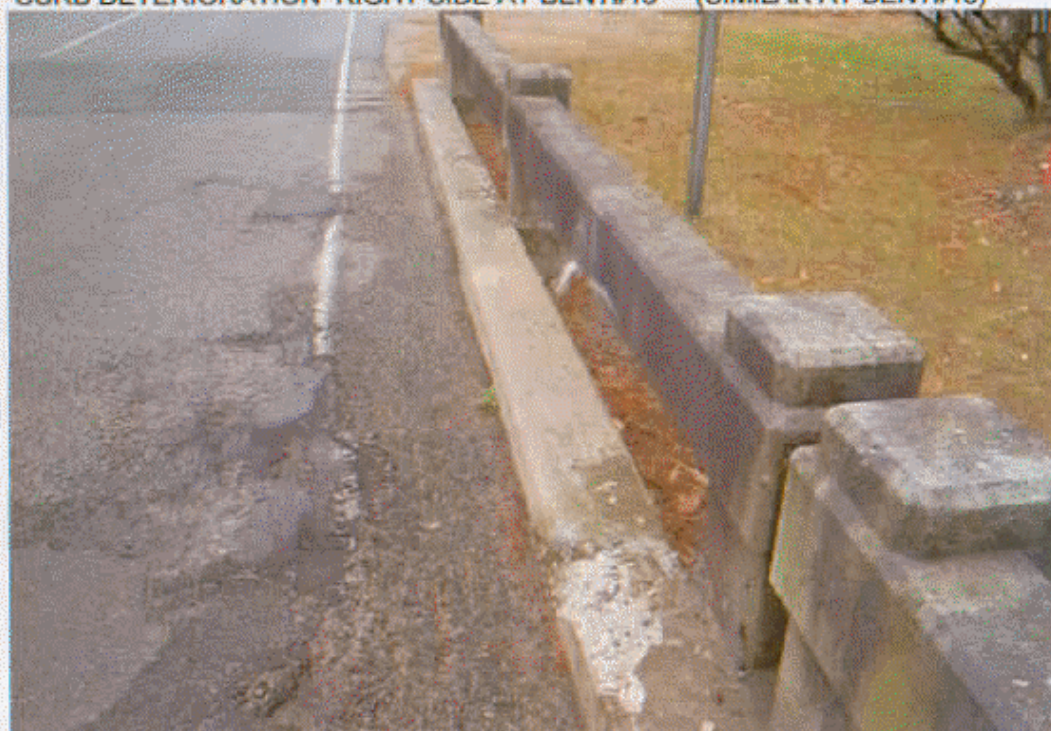
CURB DETERIORATION AT RIGHT SIDE LAST THREE SPANS

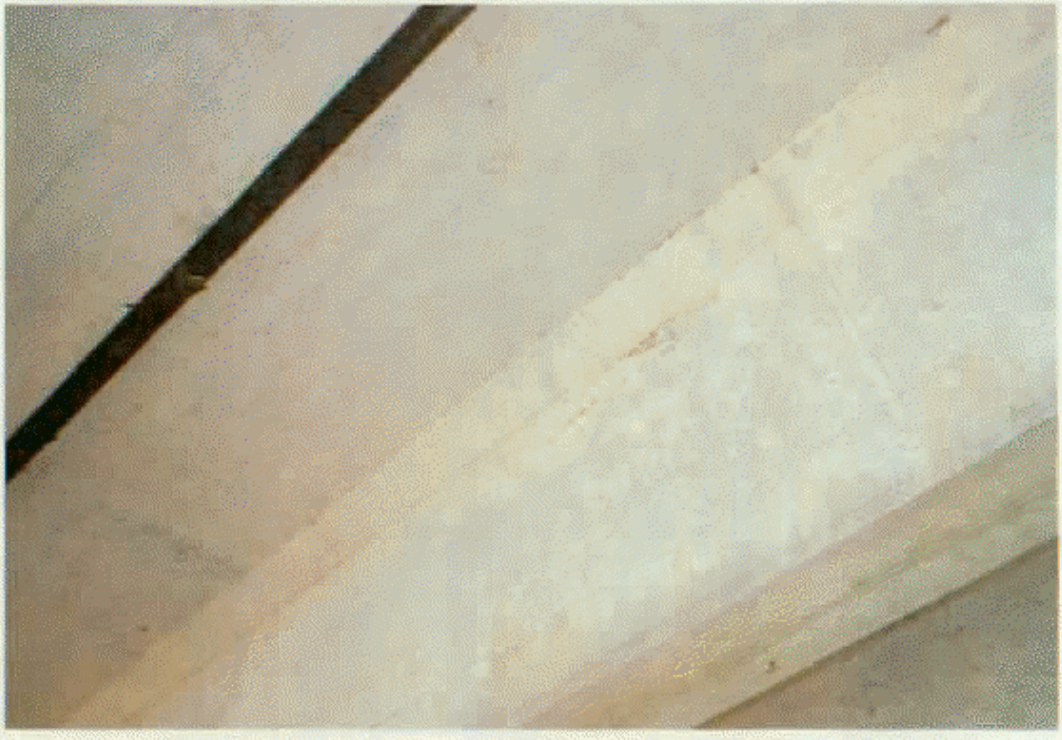
BOTTOM OF DECK

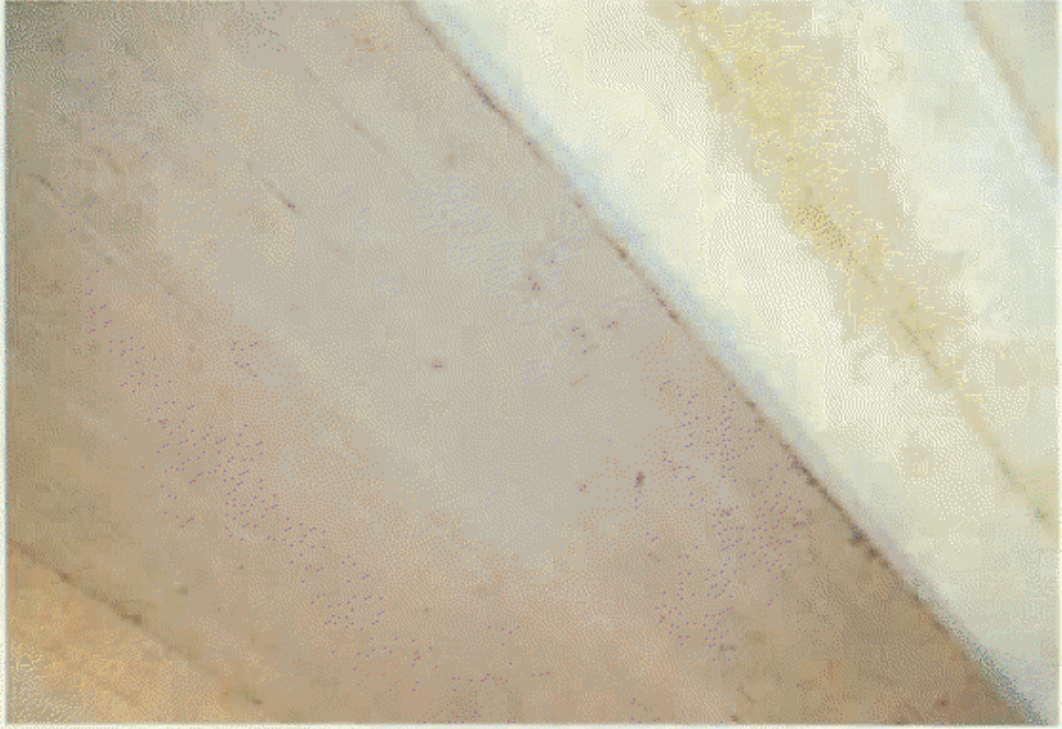
BOTTOM OF DECK

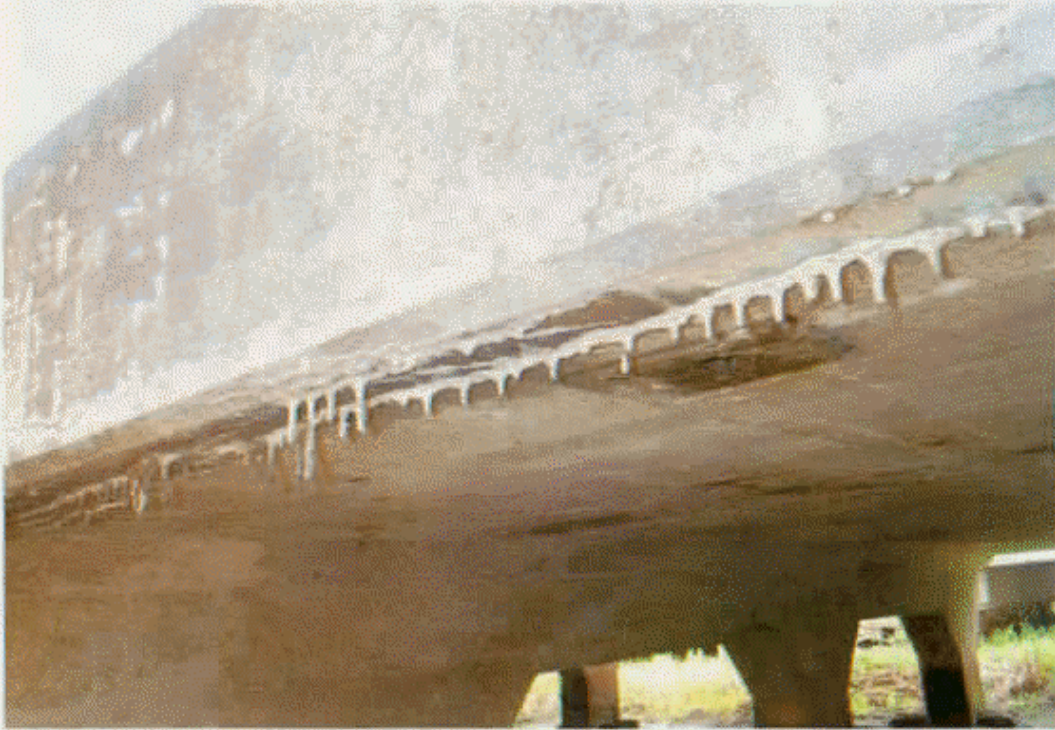
BOTTOM OF DECK (EFFLO)

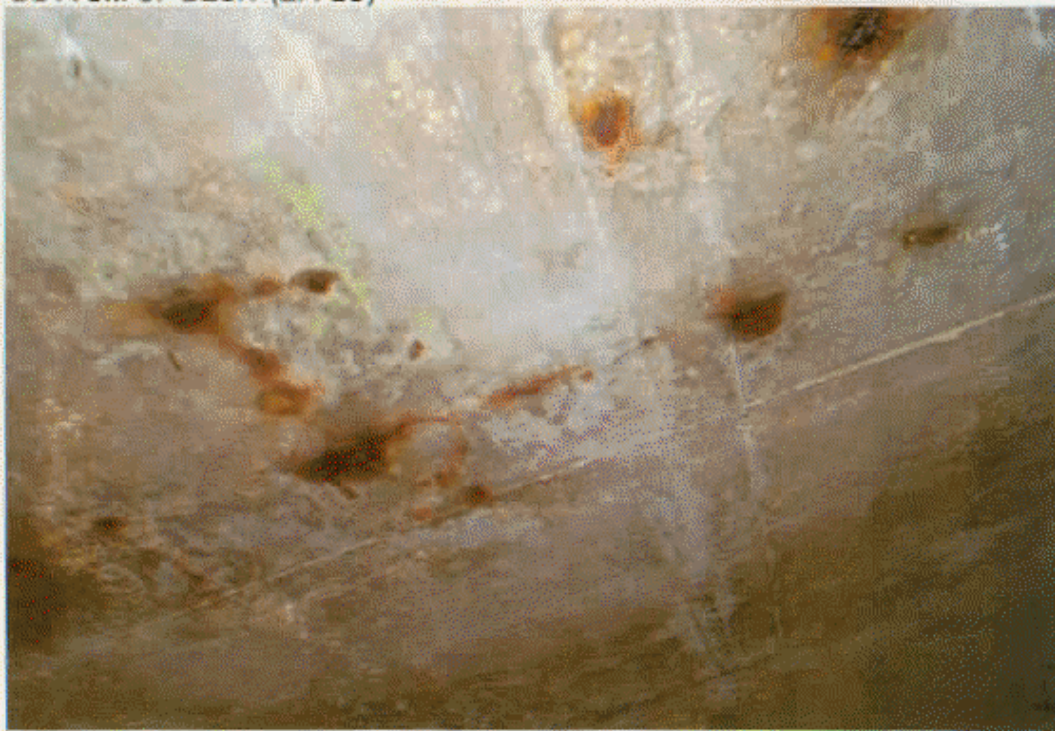
BOTTOM OF DECK

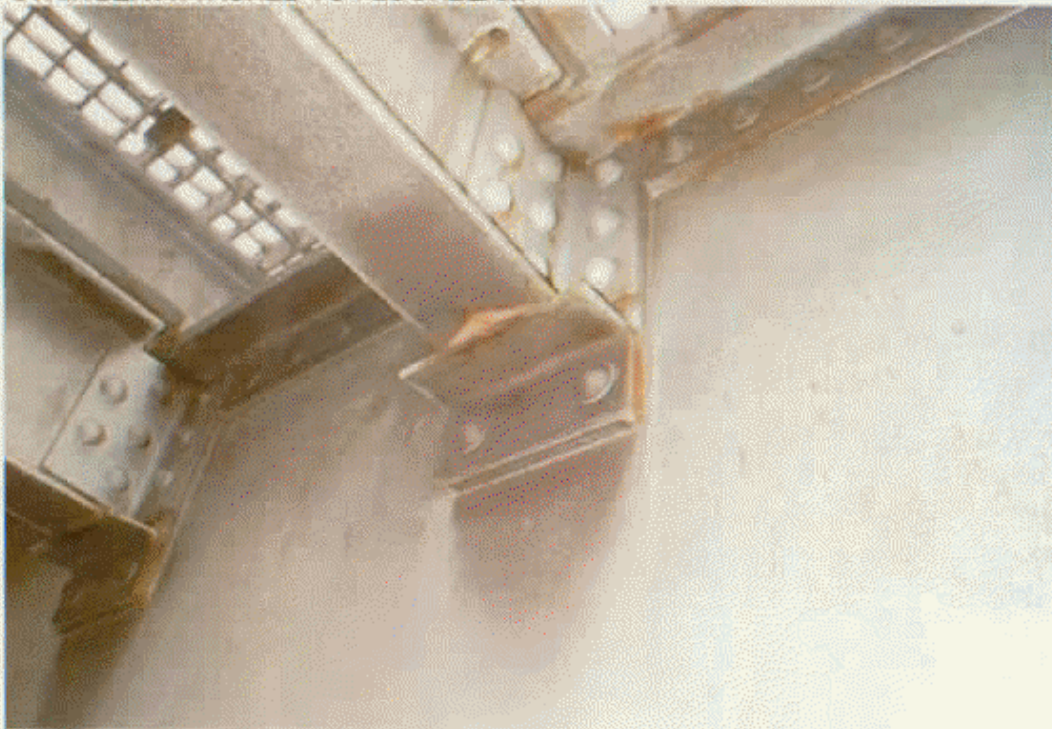
STRINGER ATTACHED TO FLOORBEAM

SAME AS ABOVE

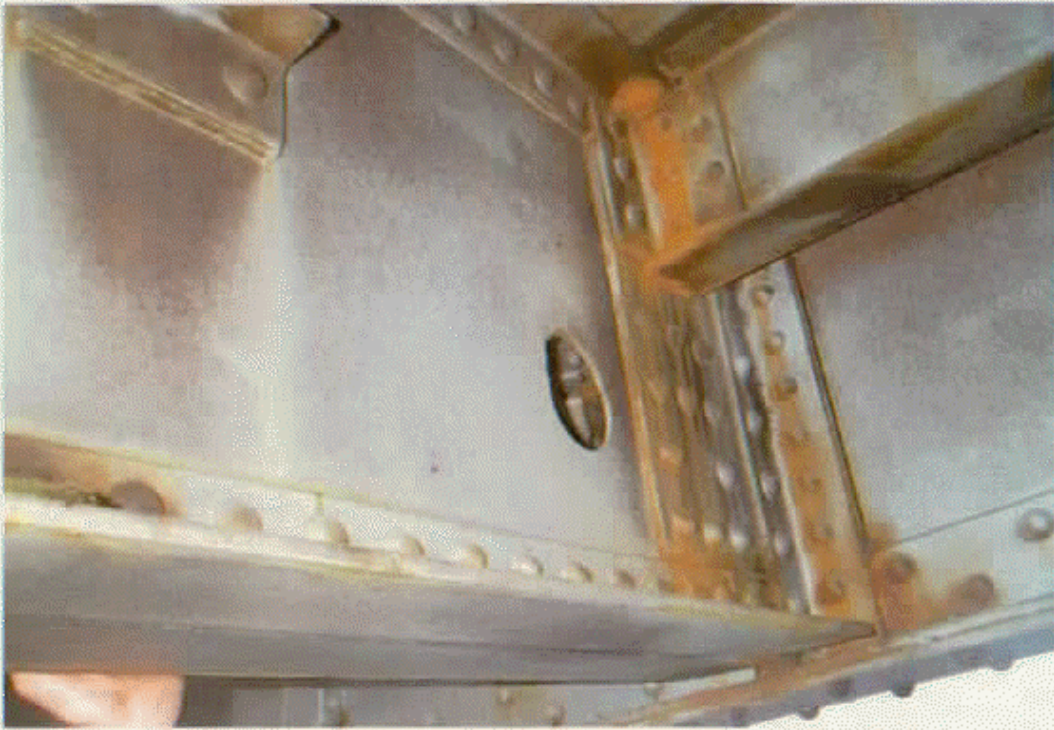
HOLE IN FLOORBEAM WHERE ARM WENT THRU

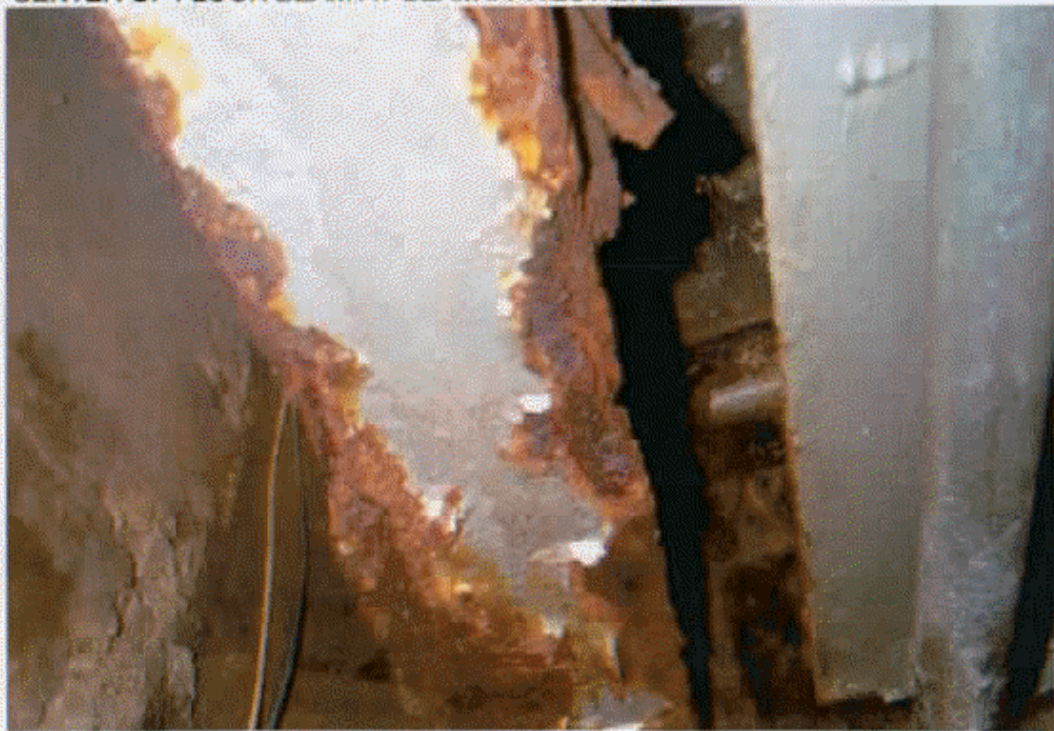
CENTER OF FLOOR BEAM AT BEAM #4 WEST END

SAME AS ABOVE

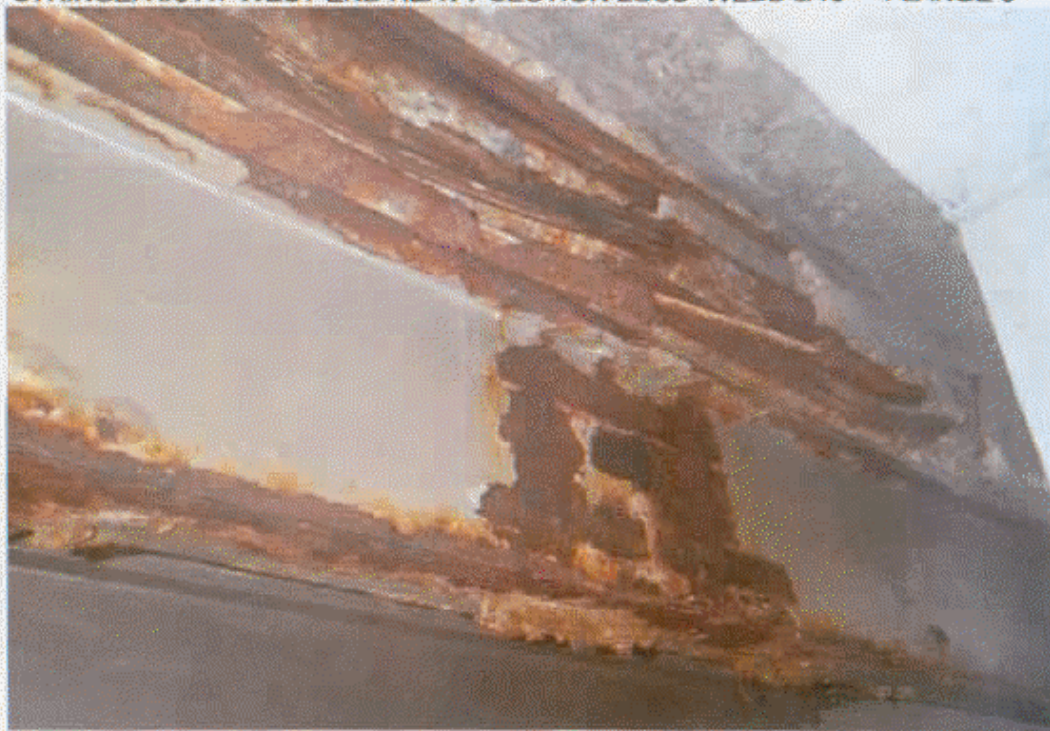
| Item No. | Description |
|---|--|
| 11 | STRINGERS - BASCULE LIFT SPAN - 5 - RUSTY WITH HEAVY SECTION LOSS AT FLOOR BEAM CONNECTIONS. SEE PHOTOS. BEAM #4 HAS HEAVY SECTION LOSS AT WEST END AND HAS TWO HOLES AT CONCRETE . HOLES ARE 2" ROUND 4" FROM TOP FLANG AND ONE HOLE IS 5" FROM BOTTOM FLANGE. PROMPT ACTION ISSUED |

STRINGER #6 AT WEST END HEAVY SECTION LOSS WEBB 3/16" FLANGE 5"

SAME AS ABOVE

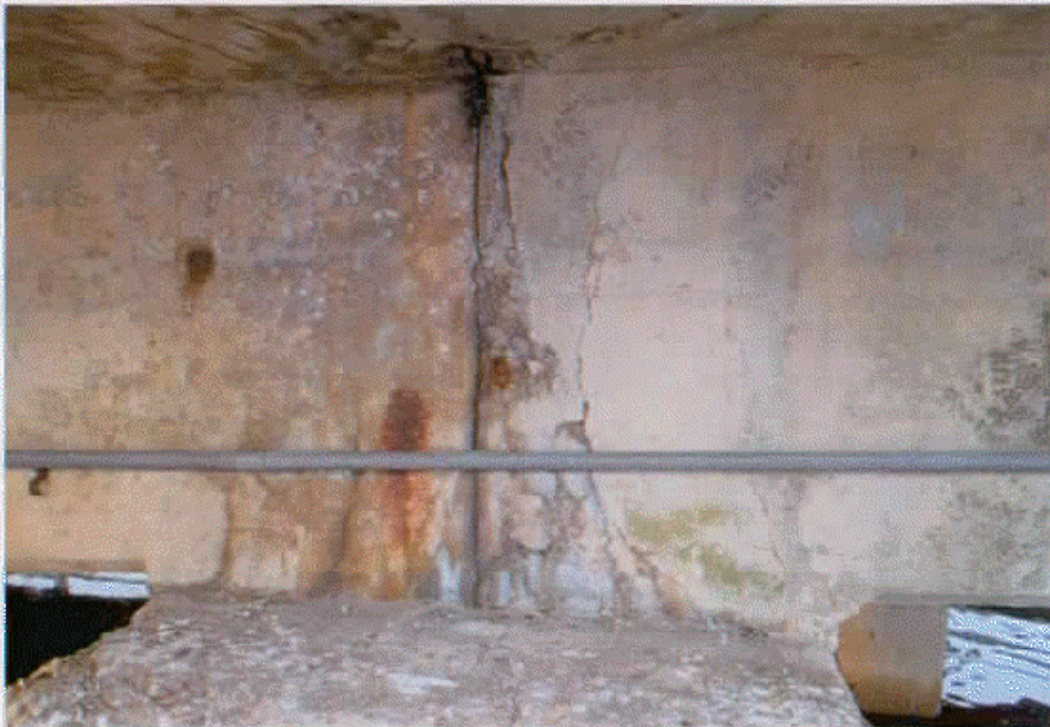
RIGHT SIDE GIRDER #4 AT BENT #2 SPAN #3
CRACKED, SPALLED AND DELMINATED

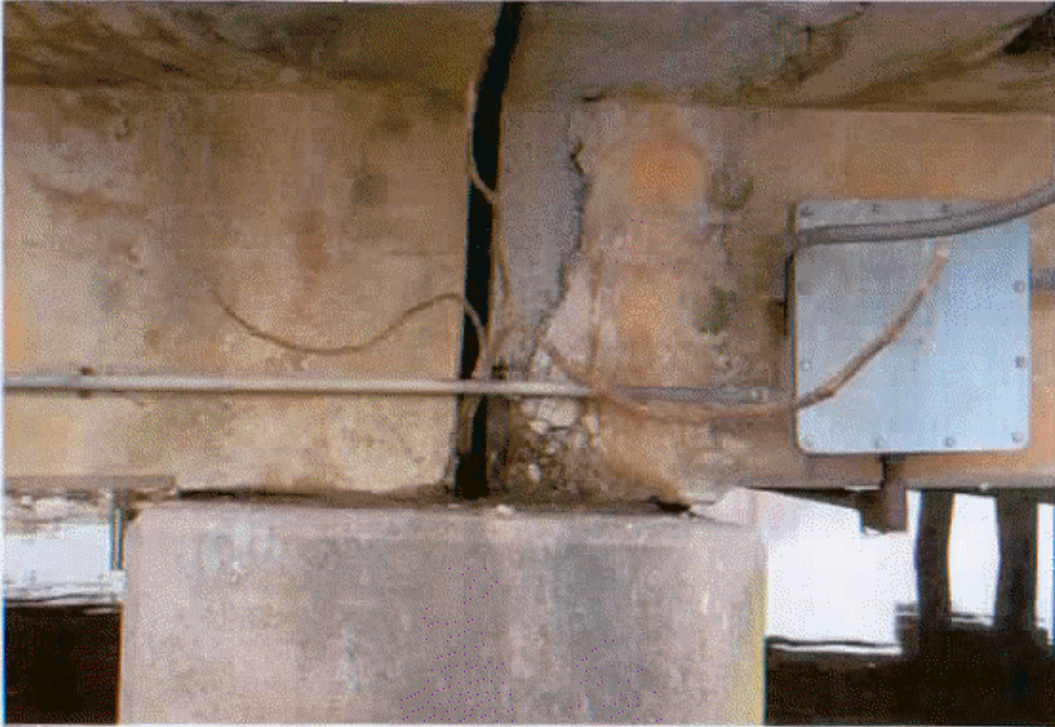
RIGHT SIDE OF BENT #3 (GIRDER #4 AT BENT #3 SPAN #4 DETERIORATION)

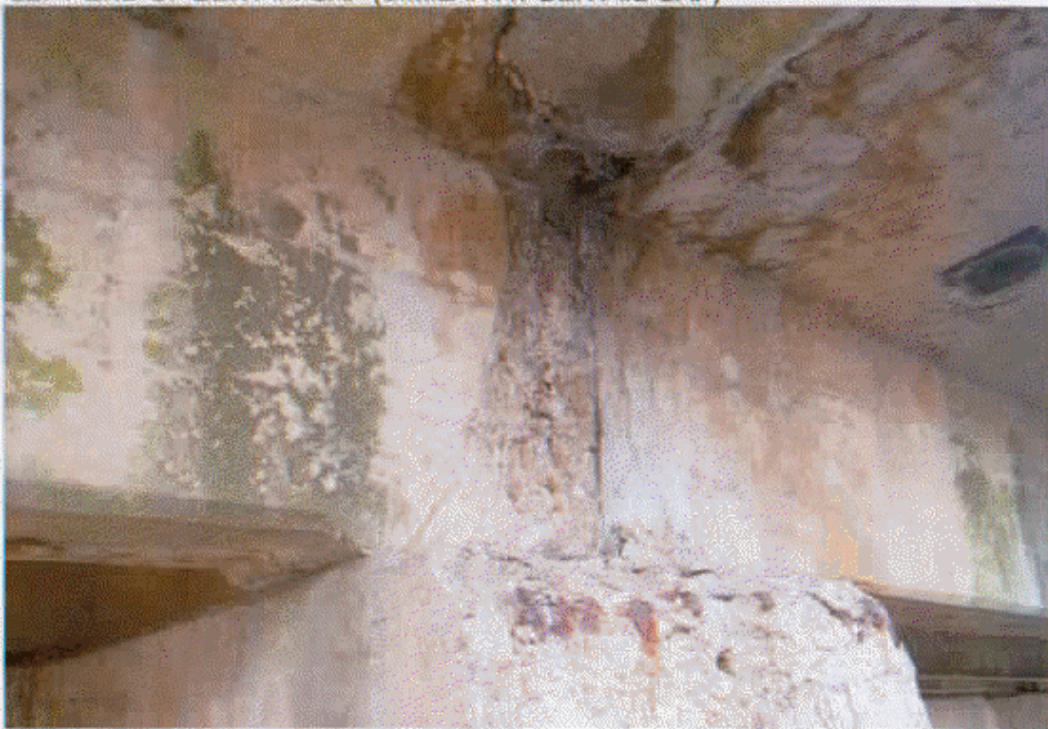
LEFT SIDE OF GIRDER #1 AT BENT #4 (DETERIORATION)

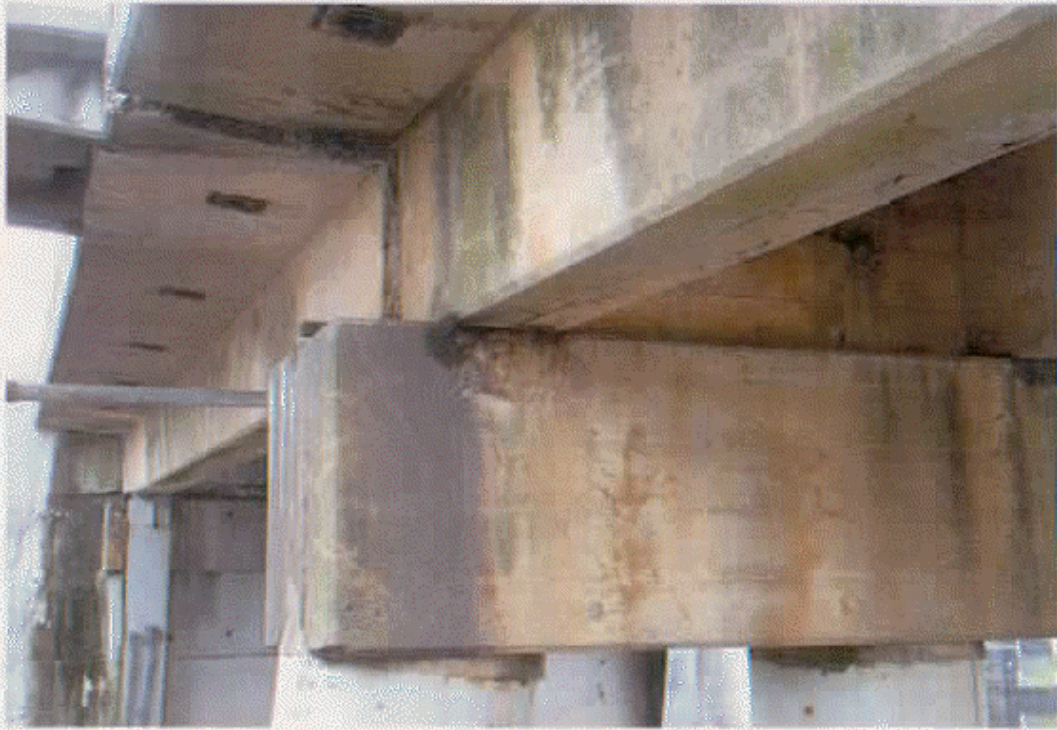
BENT #5 CAP SPALLED UNDER GIRDER #1

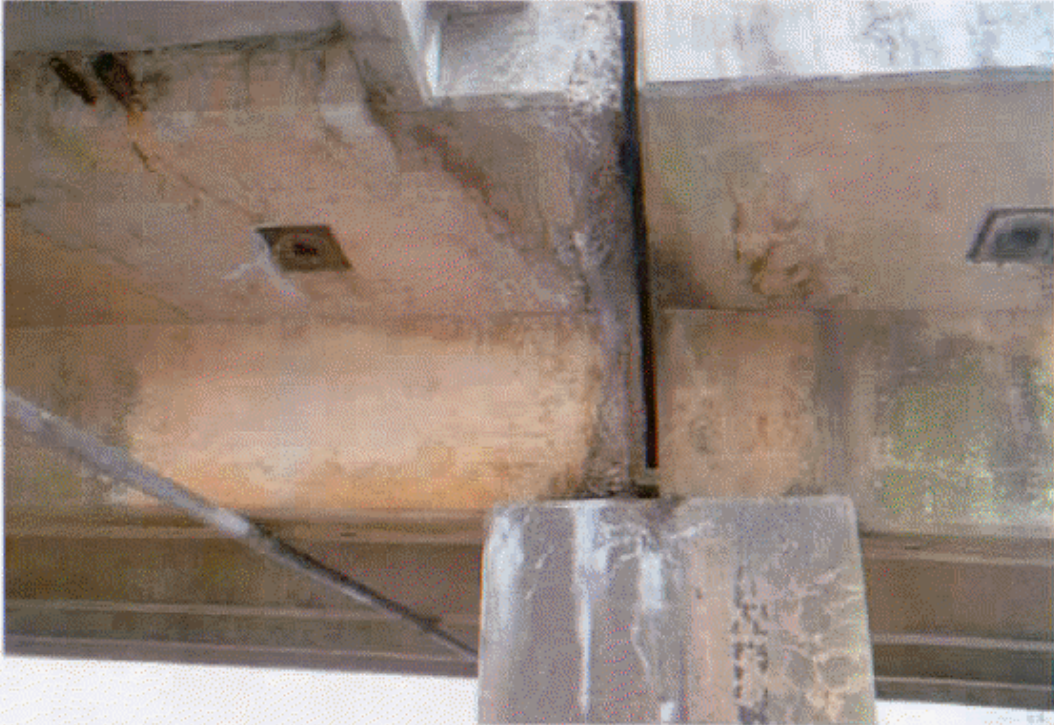
LEFT END OF BENT #5 (GIRDER #1 CRACKED, SPALLED AND DELMINATED)

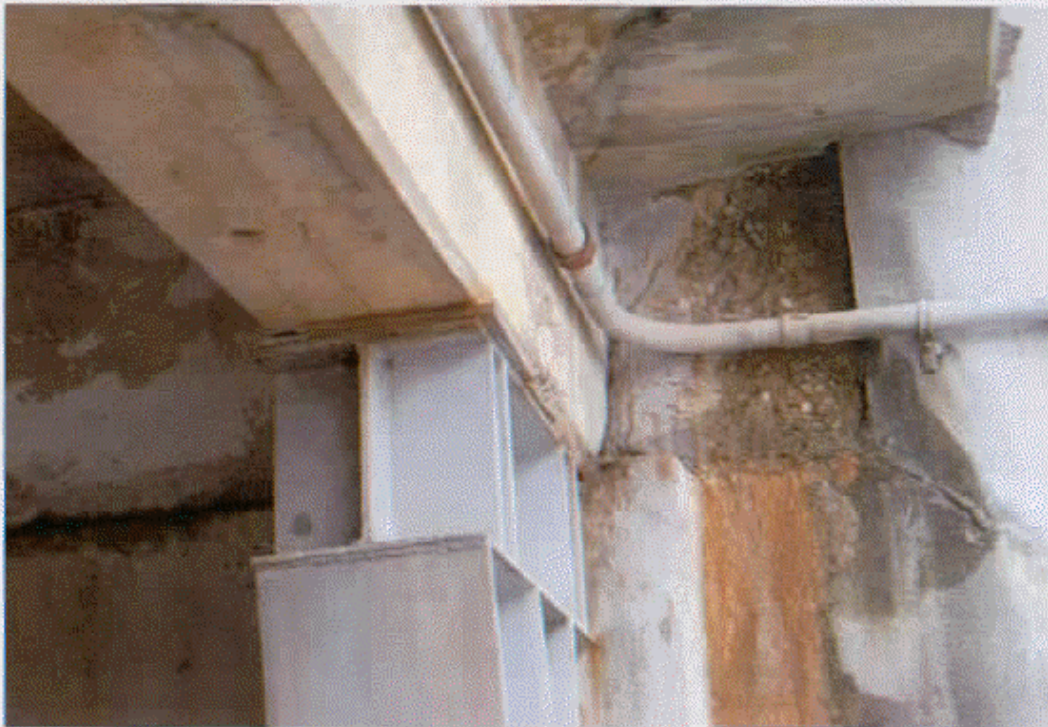
REST PIER #1 RIGHT SIDE OF GIRDER #1 CRACKED, SPALLED AND DELMINATED

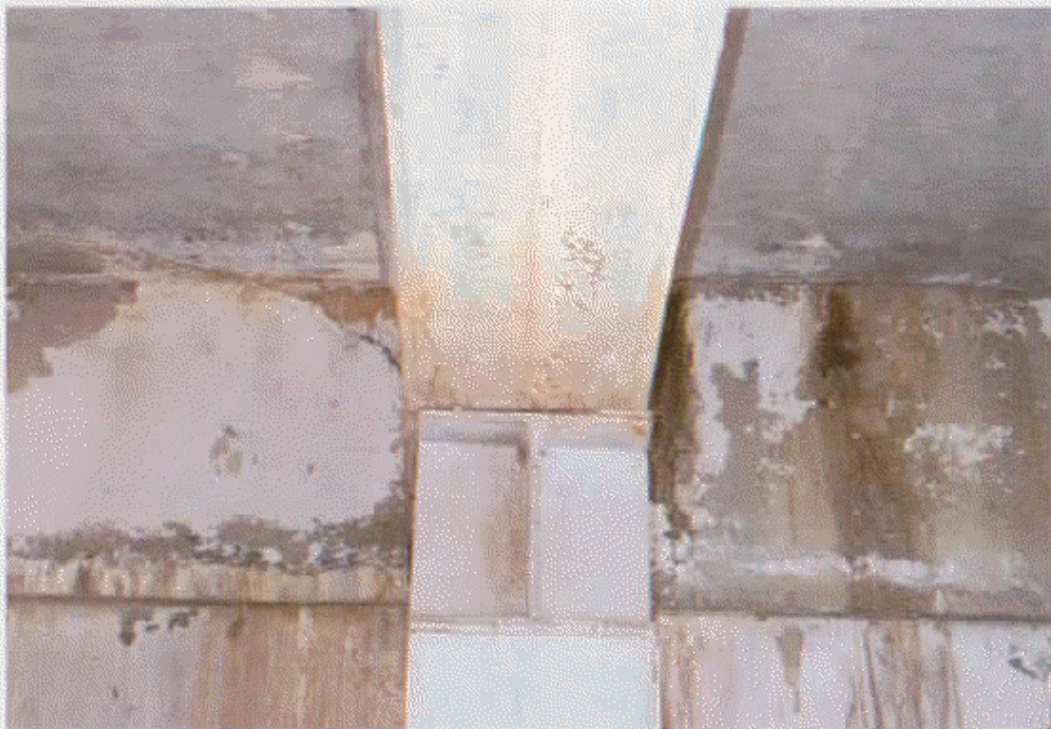
BOTTOM OF GIRDER #2 SPAN #6 AT REST PIER#1 AT SUPPORT BEAM PLATE
AND CRACK AT BOTTOM OF GIRDER

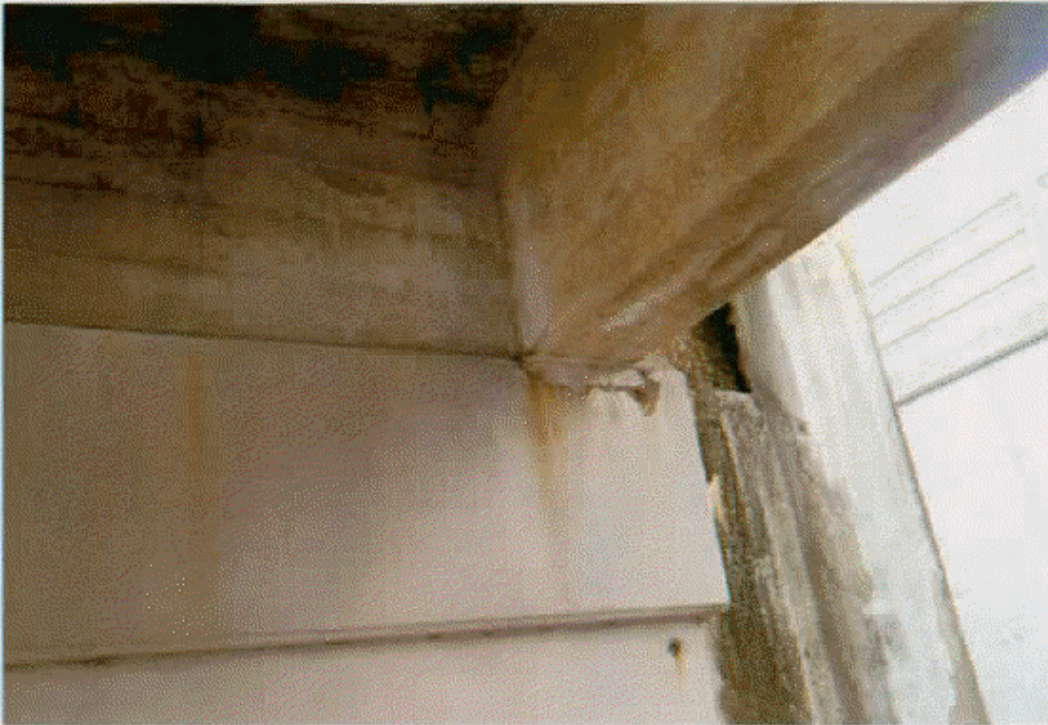
AT REST PIER #2 UNDER GIRDER #1 CRACKED, SPALLED AND DELMINATED

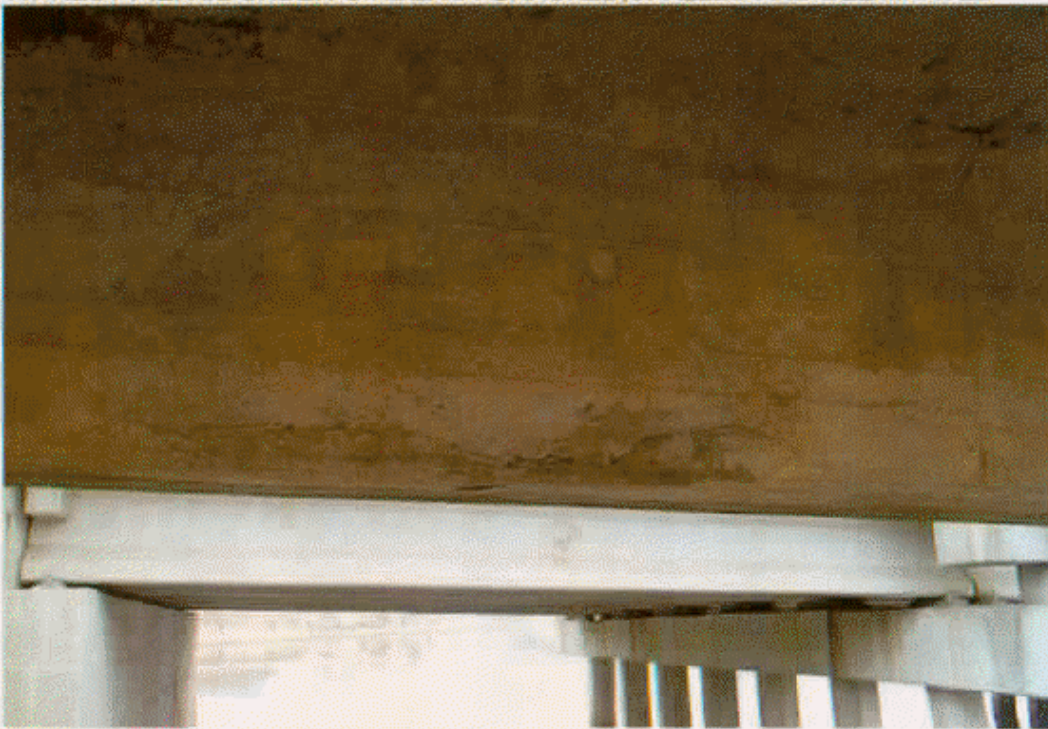
RIGHT BOTTOM EDGE OF GIRDER #1 SPAN #7 CRACKED & DELMINATED
FROM REST PIER #2 TO MID SPAN

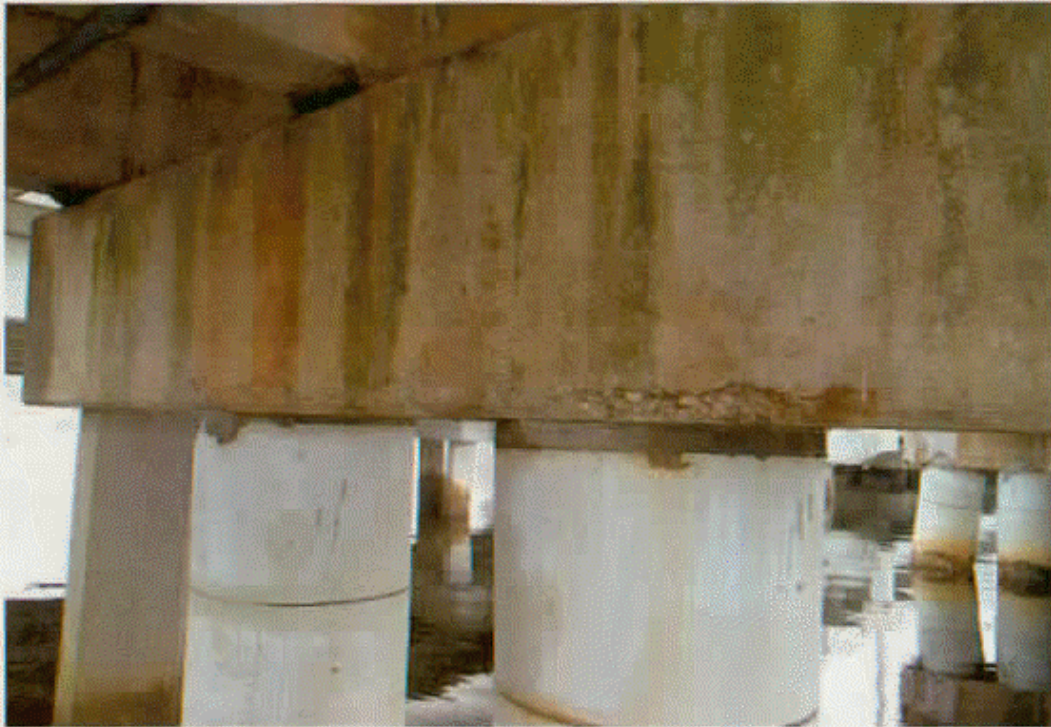
BENT #6 CAP BOTTOM EDGE OVER PILE #2 AND #3
CRACKED, SPALLED AND DELMINATED

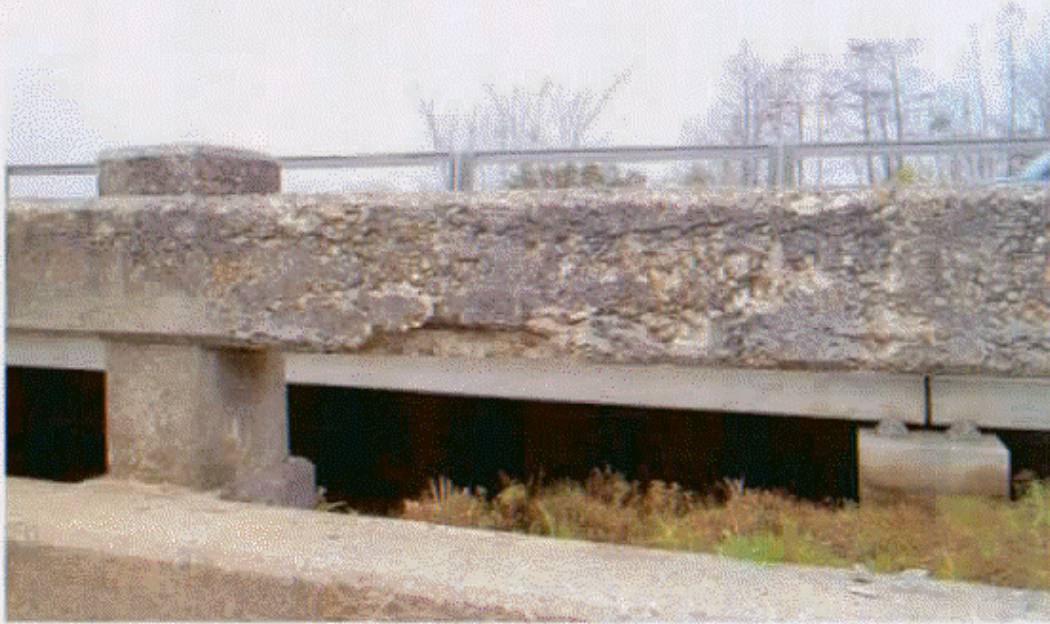
EXTERIOR OF LEFT CURB BETWEEN BENT #14 AND BENT #15
HEAVY DETERIORATION WITH RE-STEEL EXPOSED

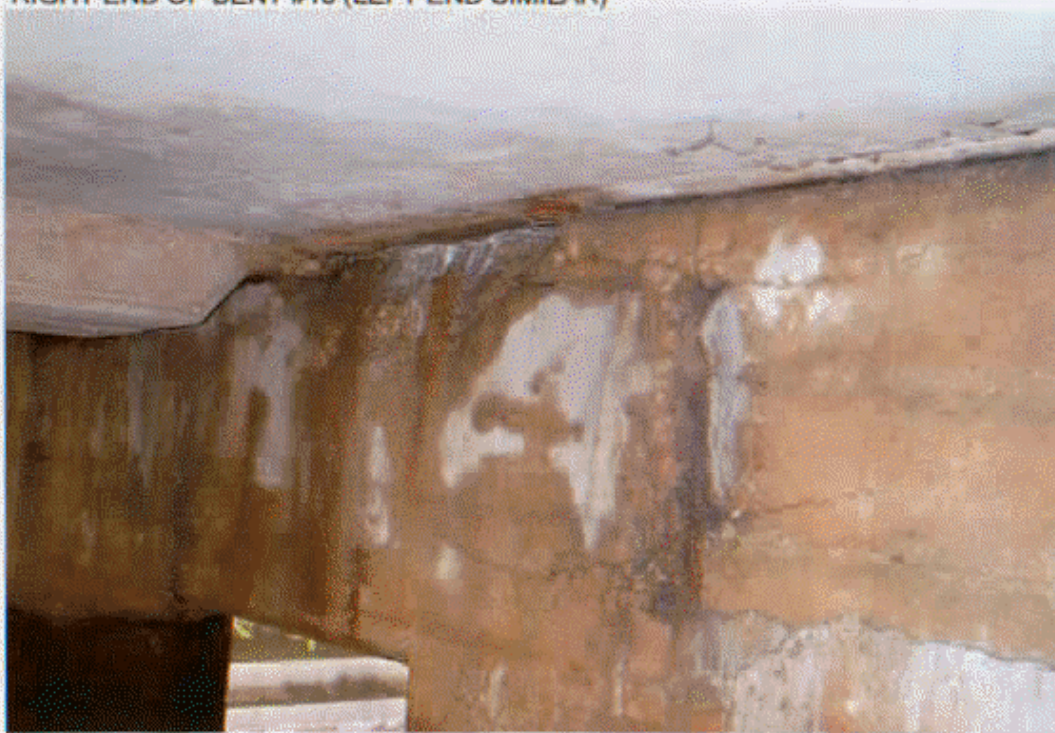
WEST FACE OF BENT#18 CAP (CRACKED, SPALLED AND DELMINATED AND WITH RE-STEEL EXPOSED)
