N.C. DEPARTMENT OF TRANSPORTATION
DIVISION OF HIGHWAYS
BRIDGE MAINTENANCE UNIT

BRIDGE INSPECTION REPORT

COUNTY PASQUOTANK BRIDGE NUMBER 690019 INSPECTION CYCLE 2 YRS

ROUTE US158 ACROSS PASQUOTANK RIVER M.P. 000+000

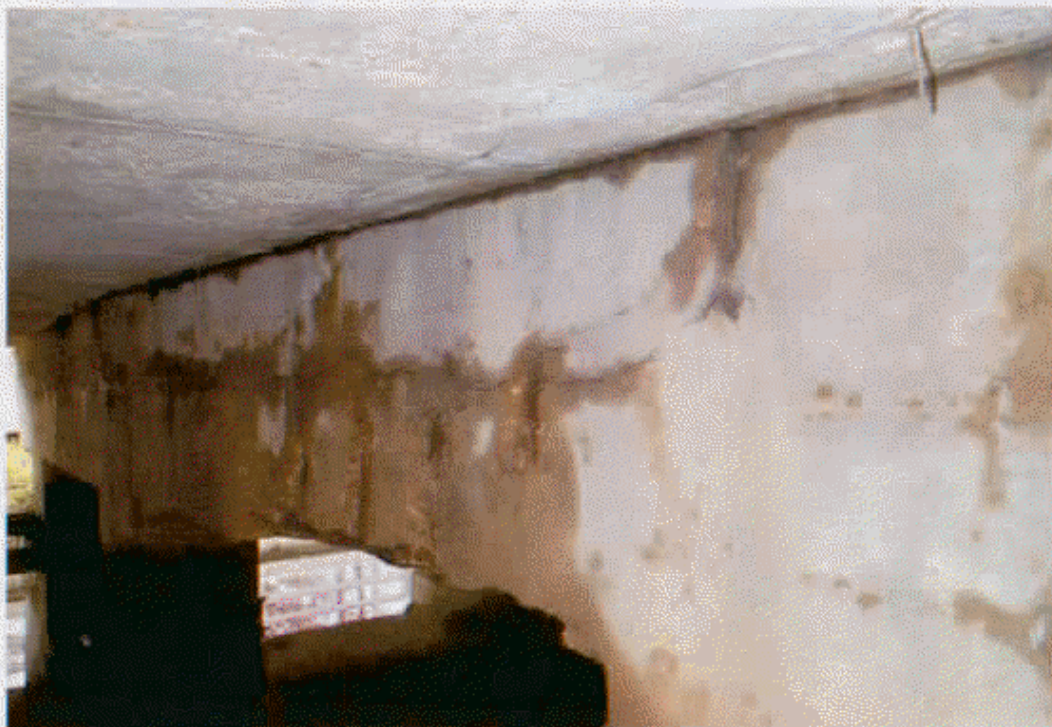
WEST FACE OF BENT #25 CAP (CRACKED, SPALLED AND DELMINATED WITH RE-STEEL EXPOSED)

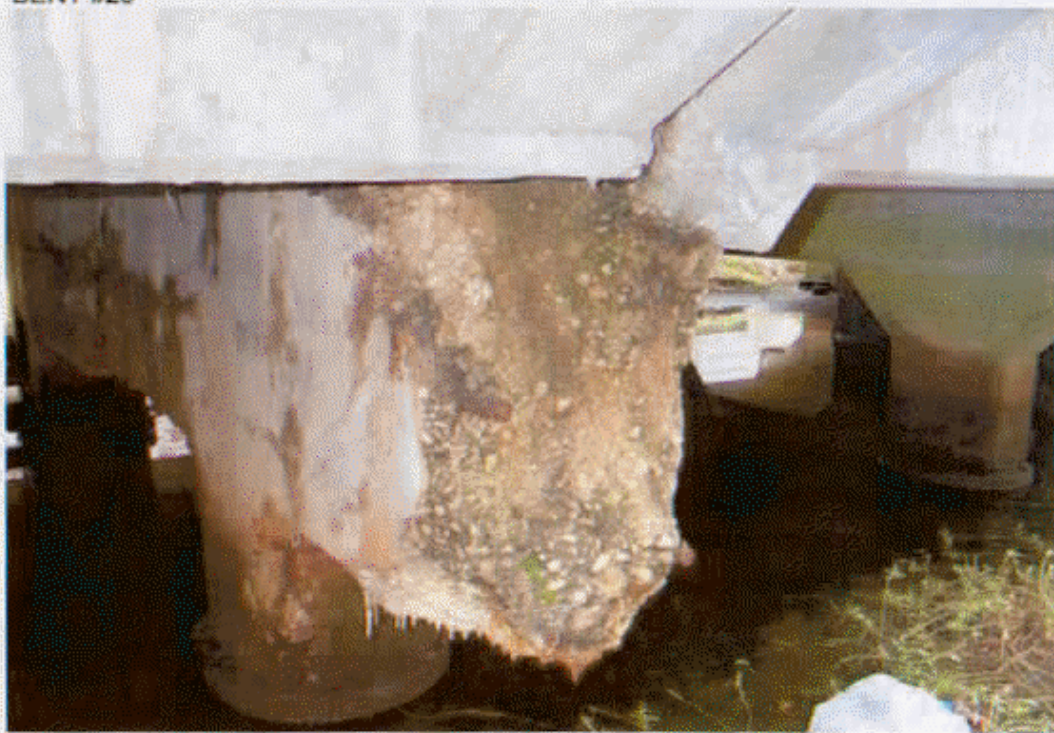
RIGHT END OF BENT #25 (HEAVY DETERIORATION)
