NC DEPARTMENT OF TRANSPORTATION
 DIVISION OF HIGHWAYS
 BRIDGE MANAGEMENT UNIT

BRIDGE INSPECTION REPORT

INSPECTION TYPE: Routine Inspection

COUNTY GUILFORD BRIDGE NUMBER 400317 INSPECTION CYCLE 2 YRS
 ROUTE US220 ACROSS HAW RIVER M.P. 0

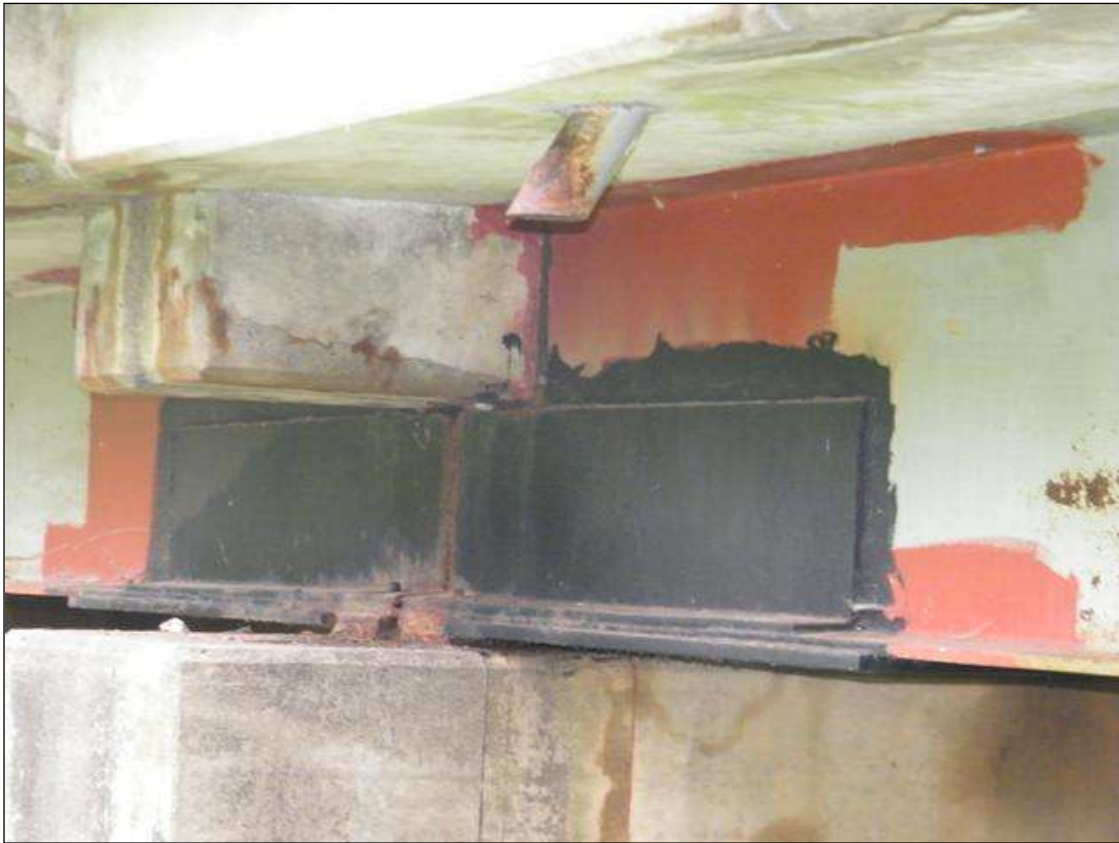
TEMP. REPAIRS, BEAM 4 IN SPANS 2,3 IS PLATED ALONG THE WEB AND BOTTOM AT PIER 2

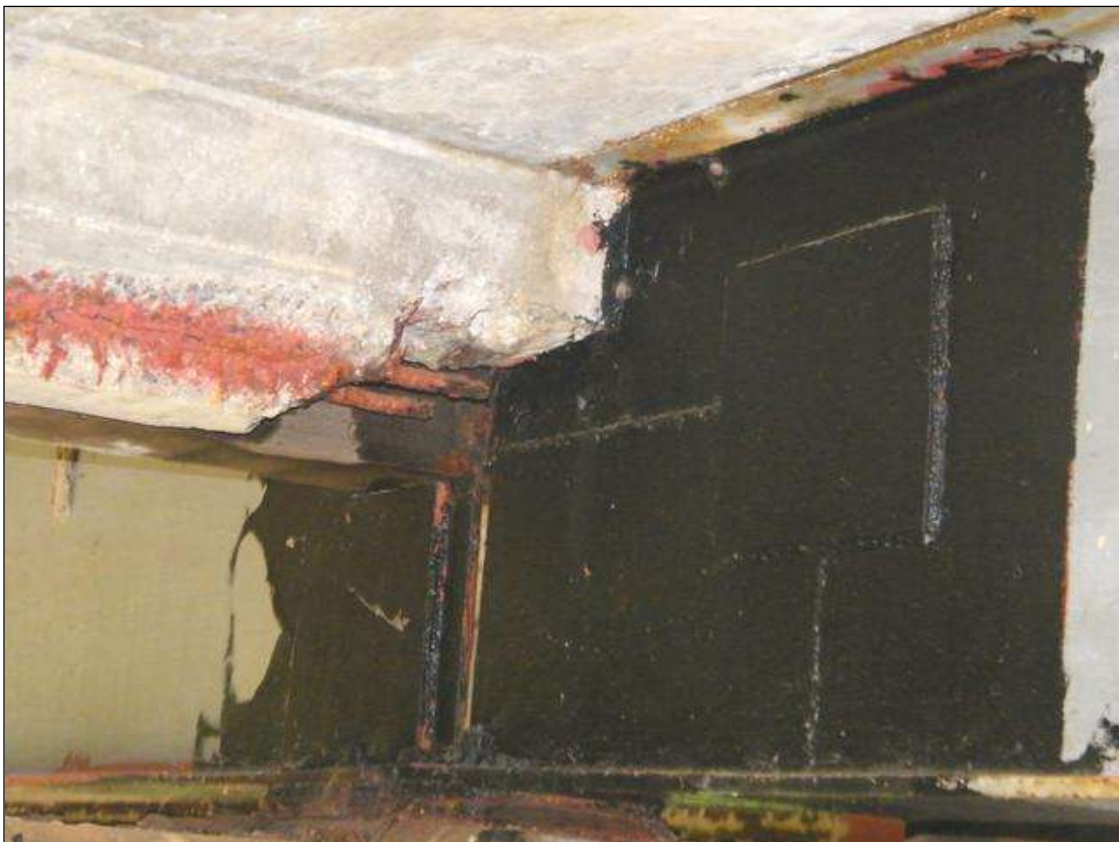
TEMP. REPAIRS, BEAM 3 IN SPANS 2,3 IS PLATED ALONG THE WEB AT PIER 2

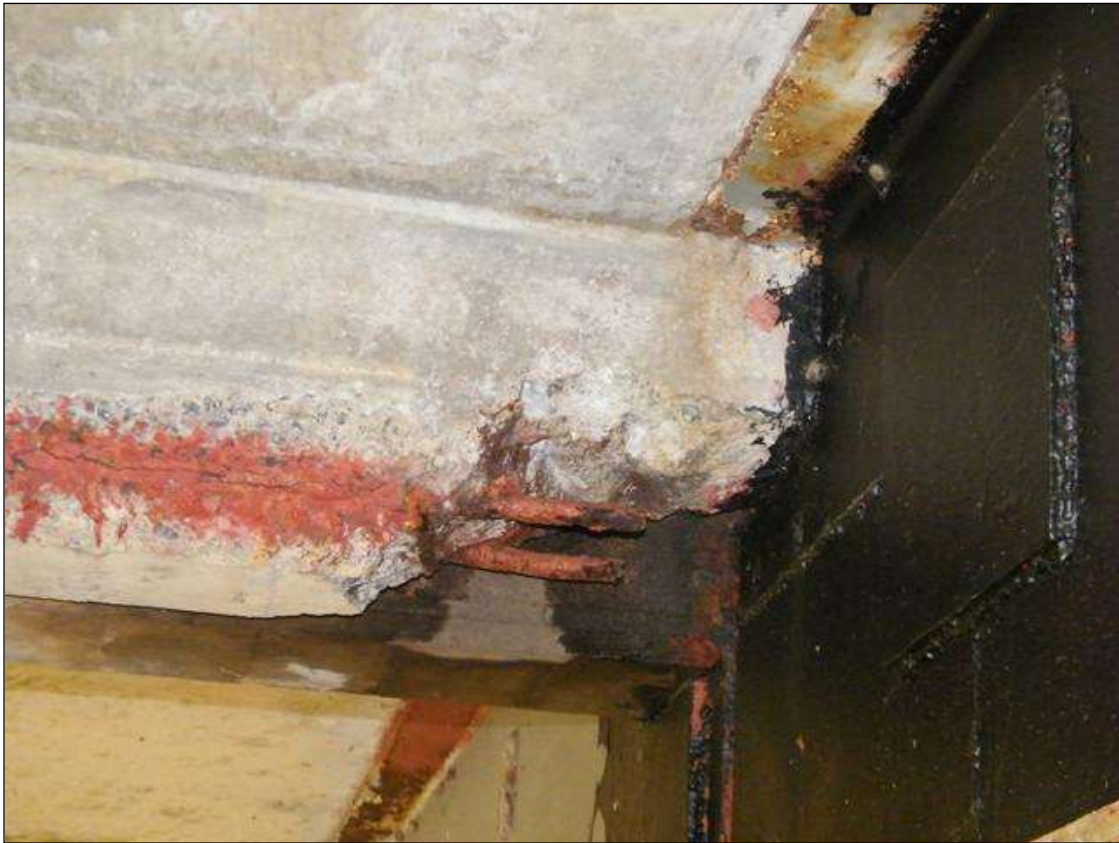
END DIAPHRAGMS HAVE BEEN CUT TO REPAIR BEAMS AT PIER 2

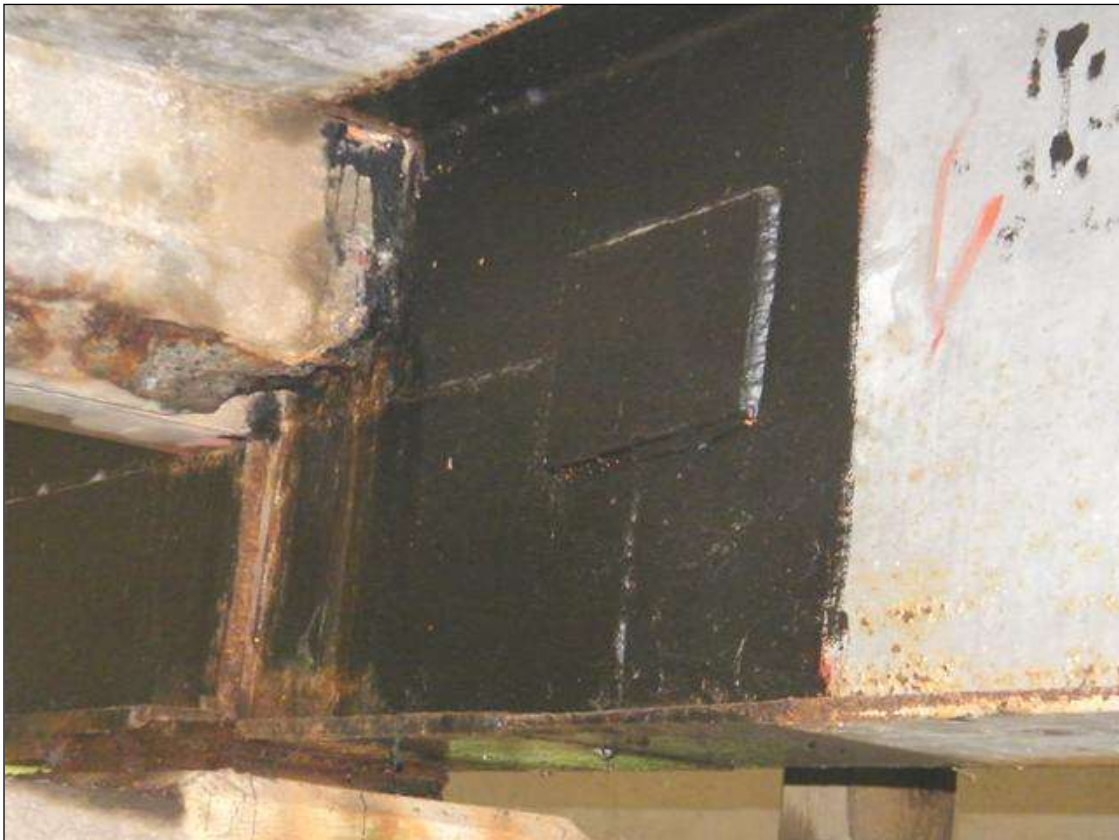
TEMP. REPAIR, BEAM 2, SPAN 3 @ PIER 2 HAS BEEN PLATED ALONG THE WEB

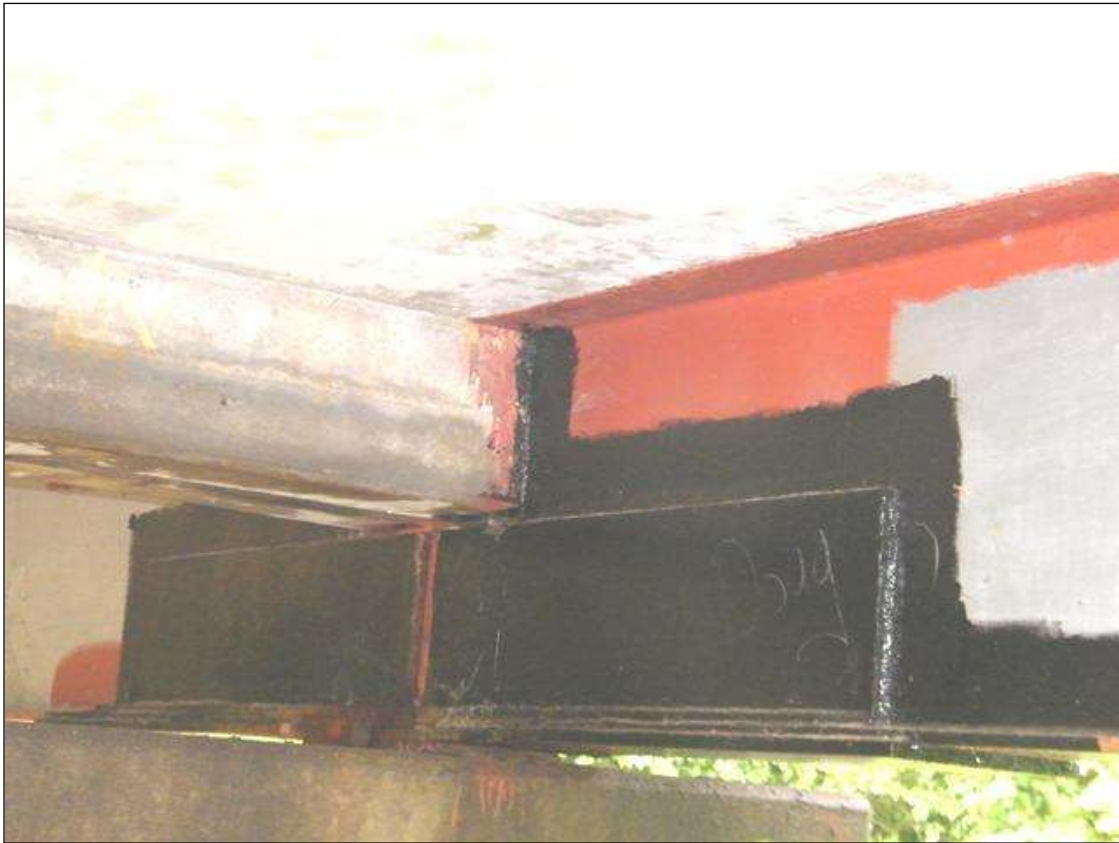
TEMP. REPAIRS, BEAM 1 IN SPANS 2,3 IS PLATED ALONG THE WEB AND BOTTOM AT PIER 2

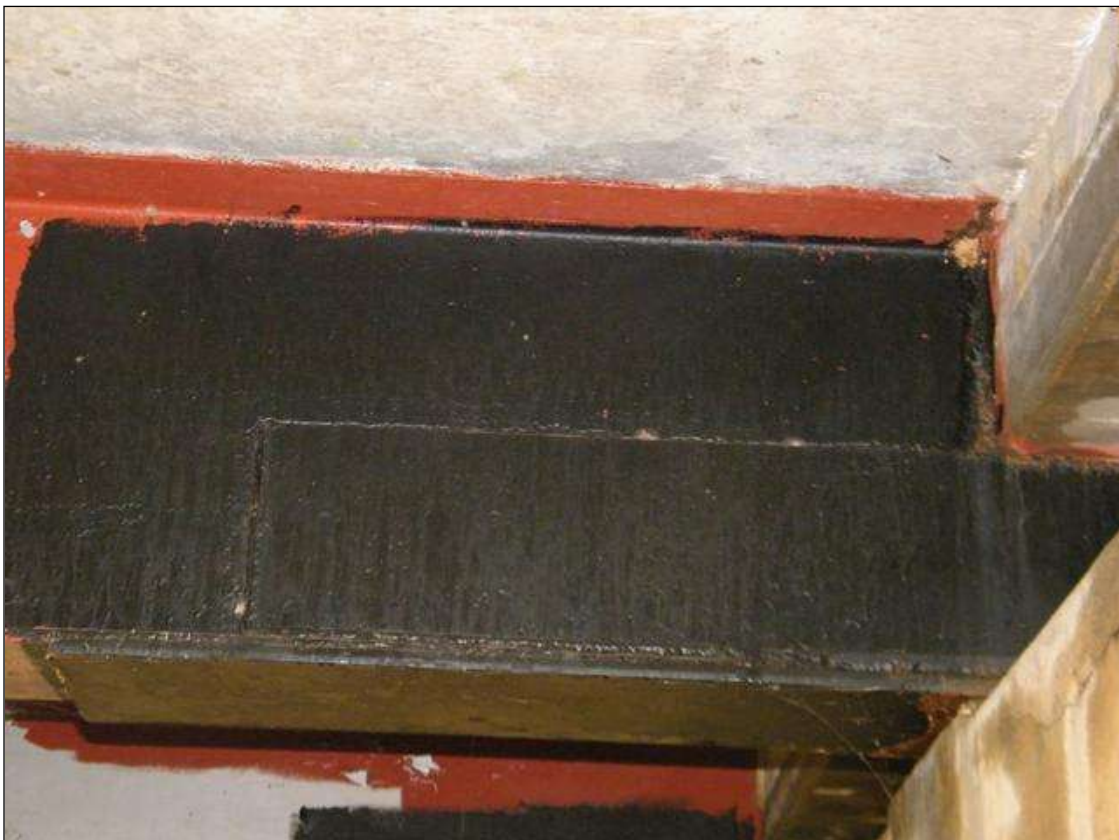
TEMP. REPAIR, BEAM 2, SPAN 2 HAS BEEN PLATED ALONG THE WEB AT PIER 2

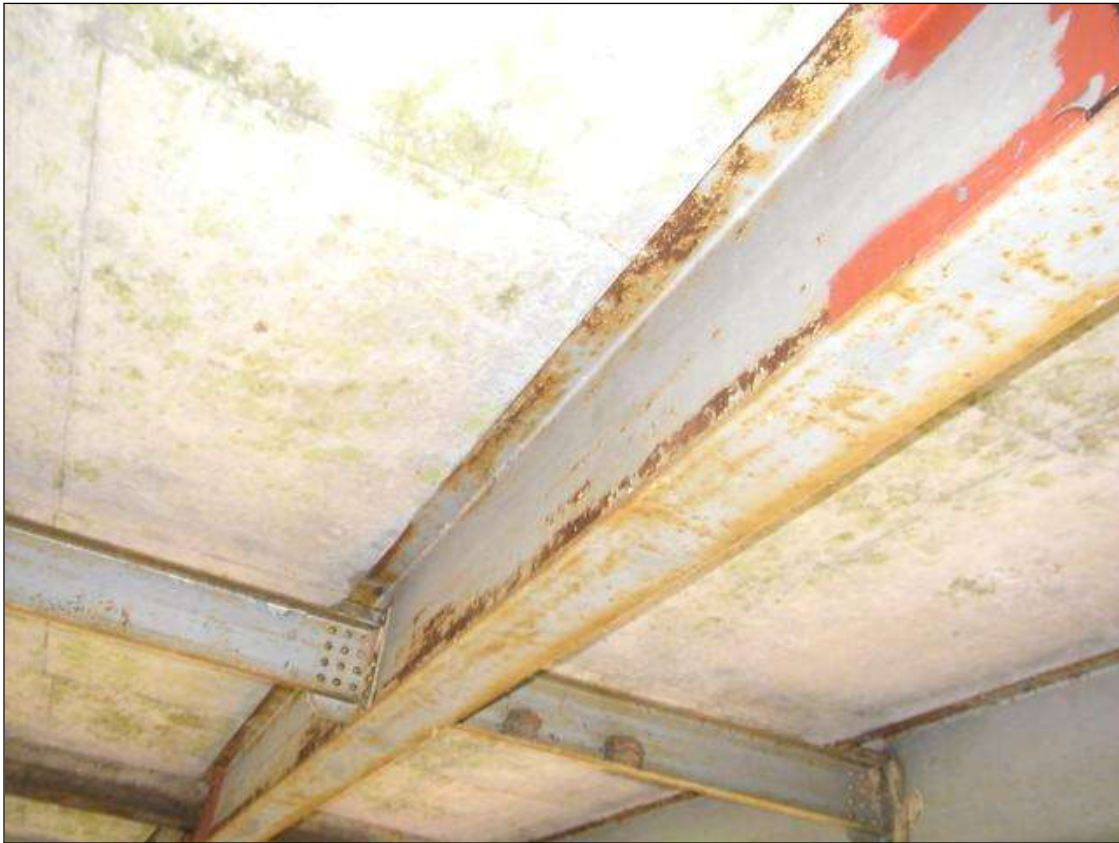
BEAM 2, SPAN 2 HAS SURFACE RUST IN SPOTS ALONG LENGTH

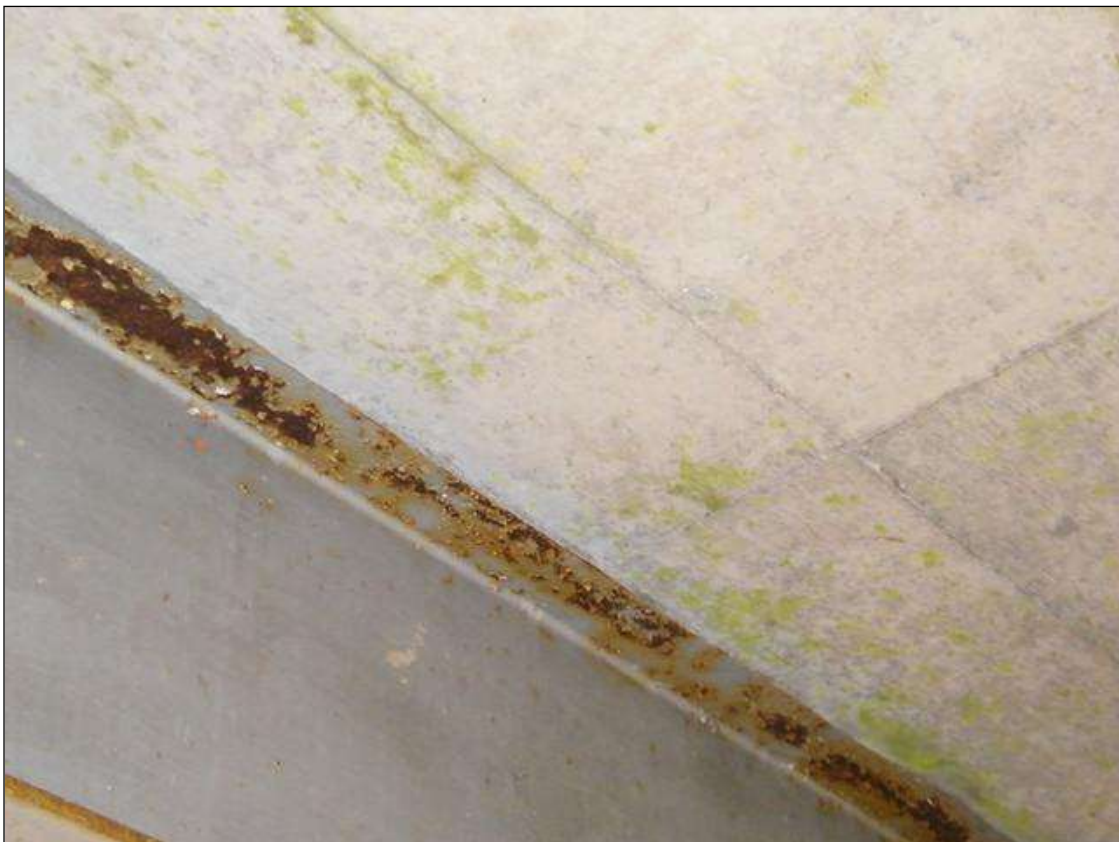
BEAM 3, SPAN 2 HAS SURFACE RUST IN SPOTS ALONG LENGTH

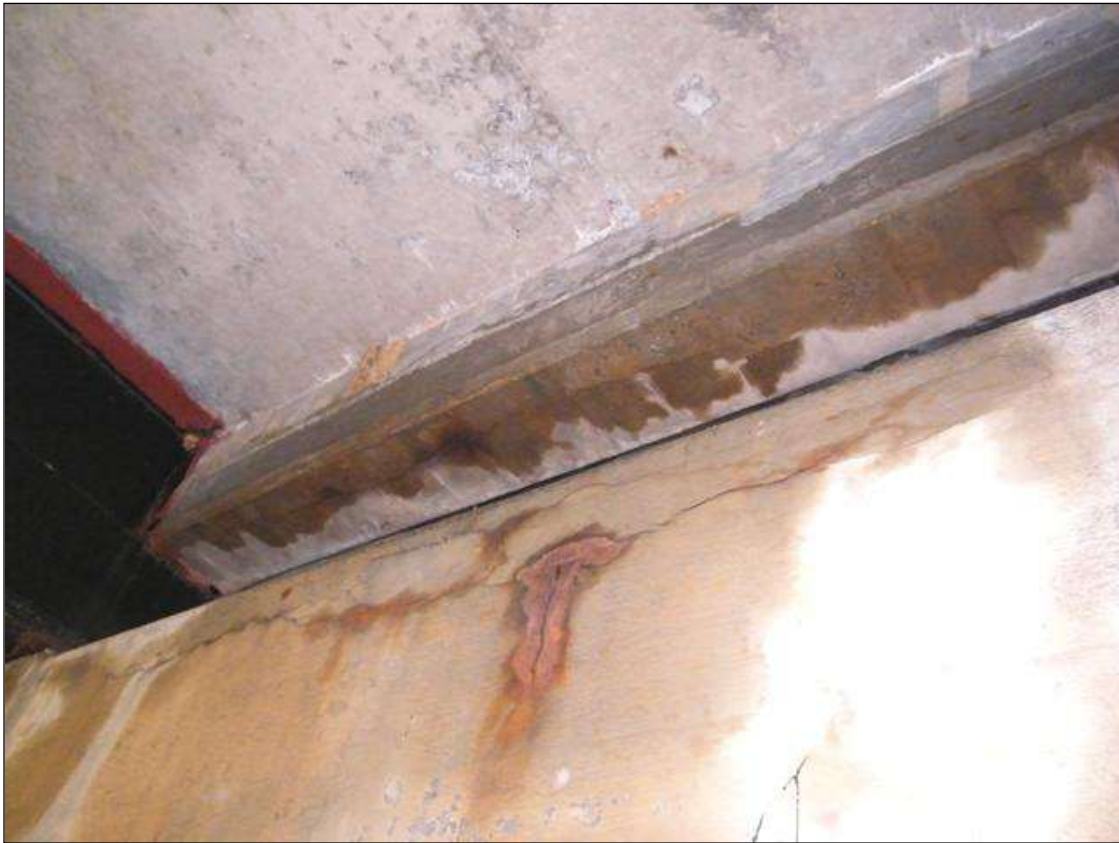
Item No.	Grade		
36a	6	CAPS ...6... PIER 2 CAP HAS HORIZONTAL H/L CRACKS NEAR TOP EDGE UNDER BAY 2 ON SOUTH FACE PIER 1 CAP HAS A HORIZONTAL H/L CRACK BETWEEN PILES 2 THRU 4 ,AND NORTH FACE OVER PILE 1. 1 INCH DEEP POP-OFF SPALL UNDER BEAM 2 .	
36b	5	ABUTMENT CAPS GOOD . COLUMNS ...5... PIER PILE ENCASEMENTS HAVE 1 INCH SURFACE PITTING ALONG WATERLINE .	
39	4	SLOPE PROTECTION ...4... SOUTH SLOPE PROTECTION HAS SECTION MISSING ON RIGHT SIDE AND BOTTOM , ALSO SHIFTING OUT 1 INCH FROM ABUTMENT ,RIP-RAP HAS BEEN ADDED AT MISSING SECTION .	
45c	5	...7... NORTH SLOPE PROTECTION GOOD . SCOUR ...5... 4 FEET SCOUR ALONG SOUTH SLOPE PROTECTION AND PIER 2 .	
50	6	APPROACHES ...6... BOTH CRACKED

PIER 2 CAP HAS A HORIZ. H/L CRACK ON THE SOUTH FACE AT BAY 2

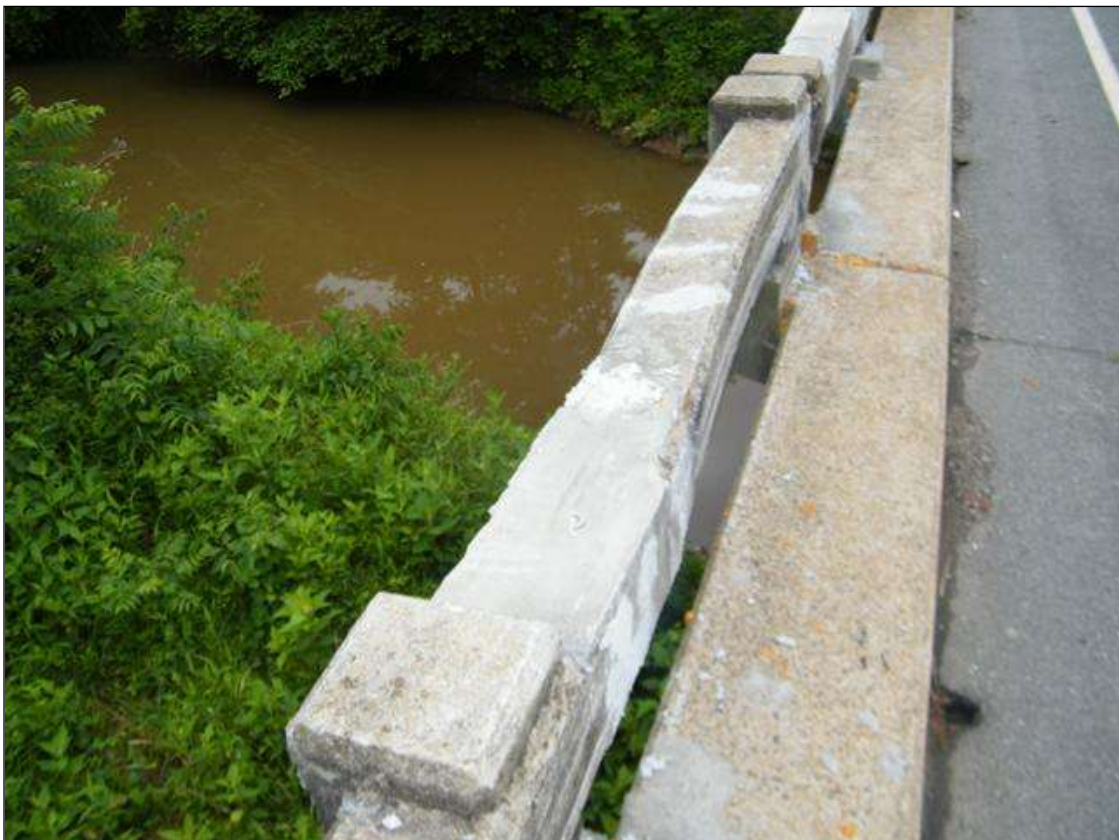
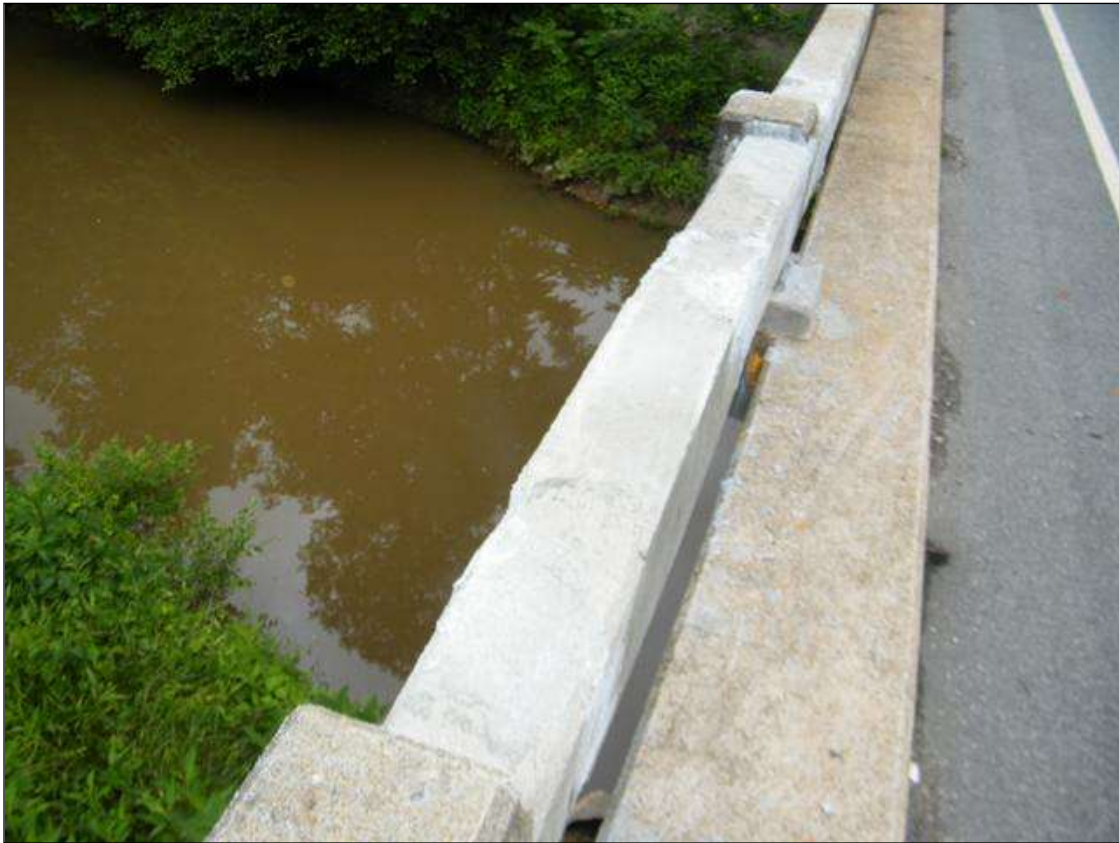
RIGHT RAIL HAS BEEN REPAIRED

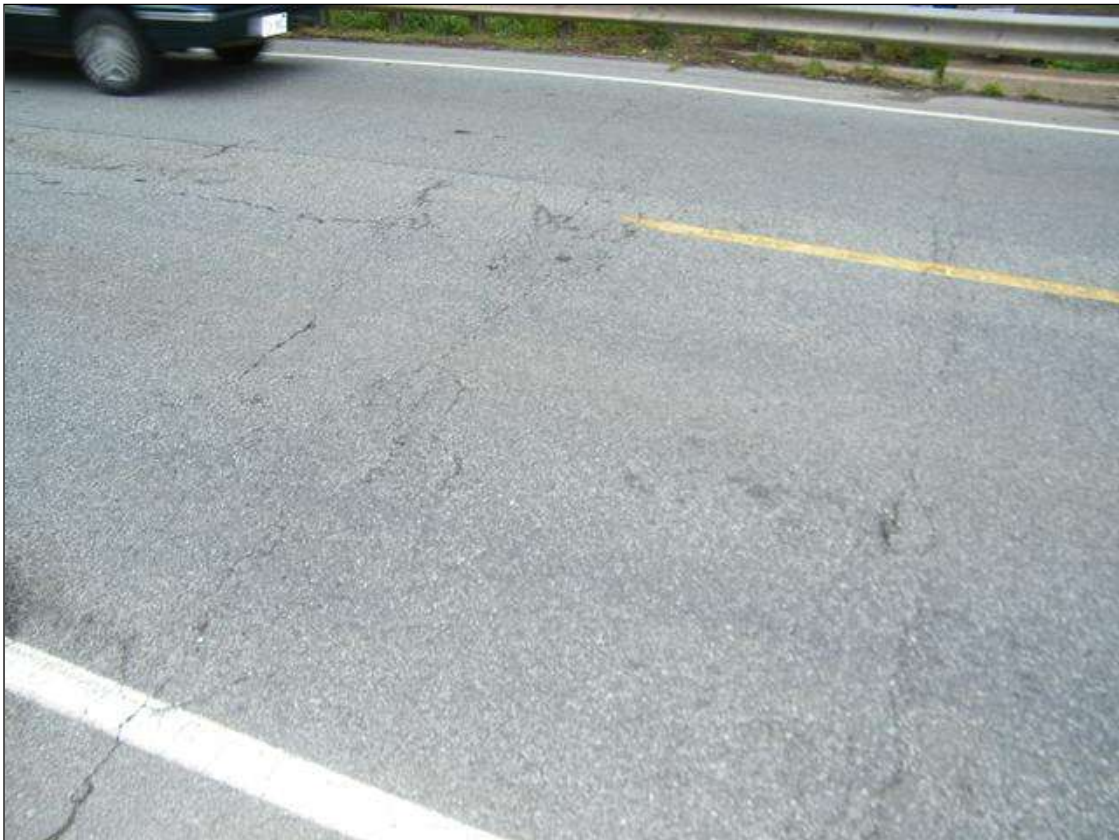
SOUTH APPROACH ROADWAY IS CRACKED

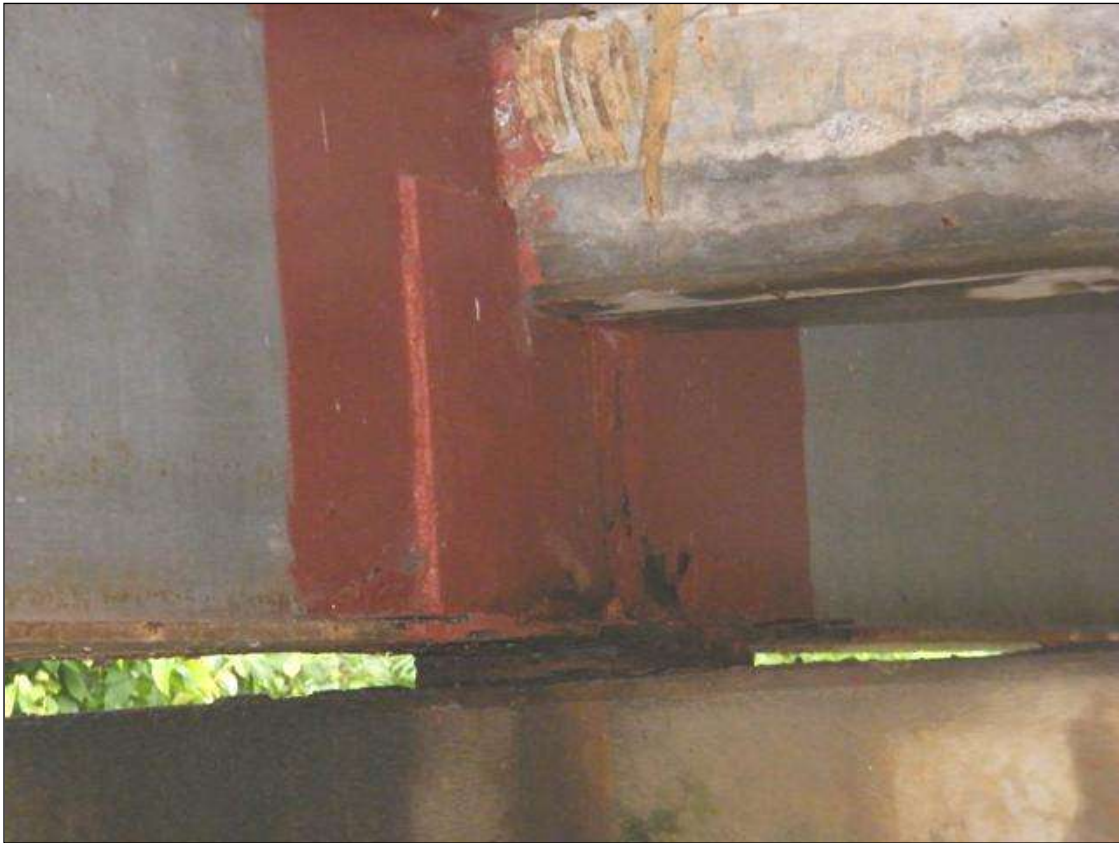
TEMP. REPAIR, BEAM 1, SPAN 1 HAS BEEN PLATED ALONG THE WEB AT PIER 1

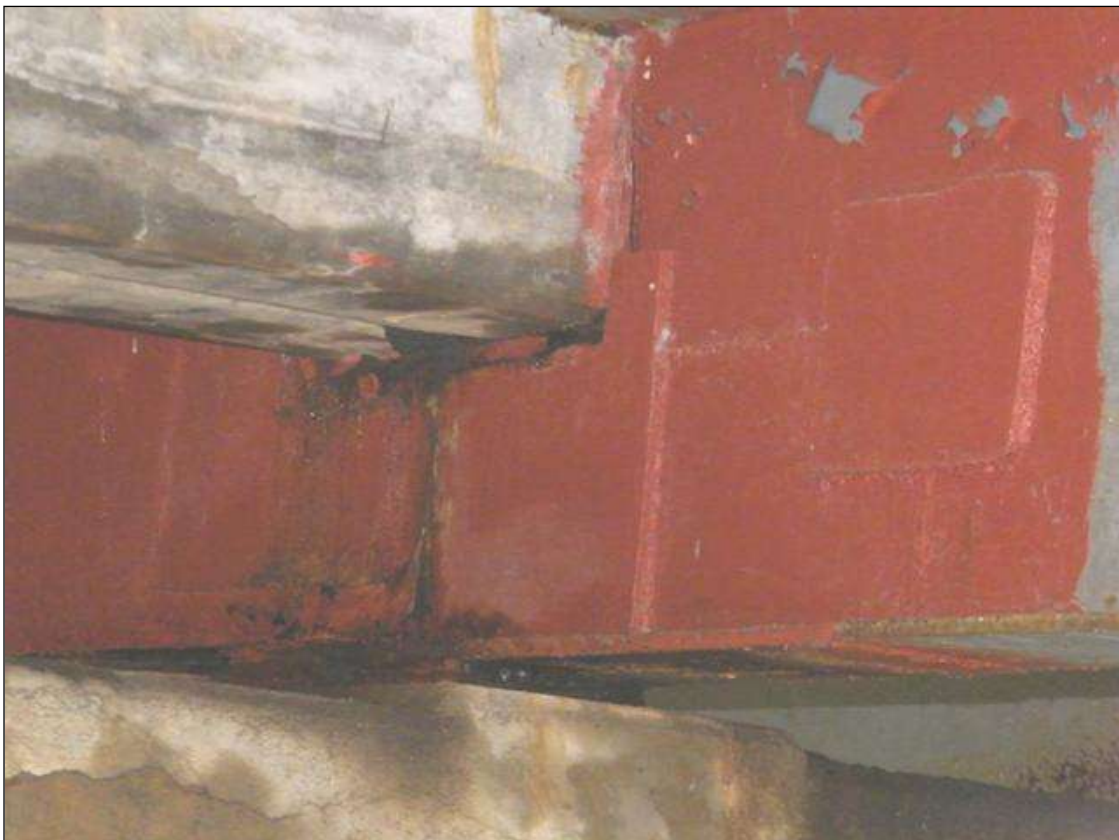
TEMP. REPAIRS, BEAM 2, SPANS 1,2 HAS BEEN PLATED ALONG THE WEB AT PIER 1

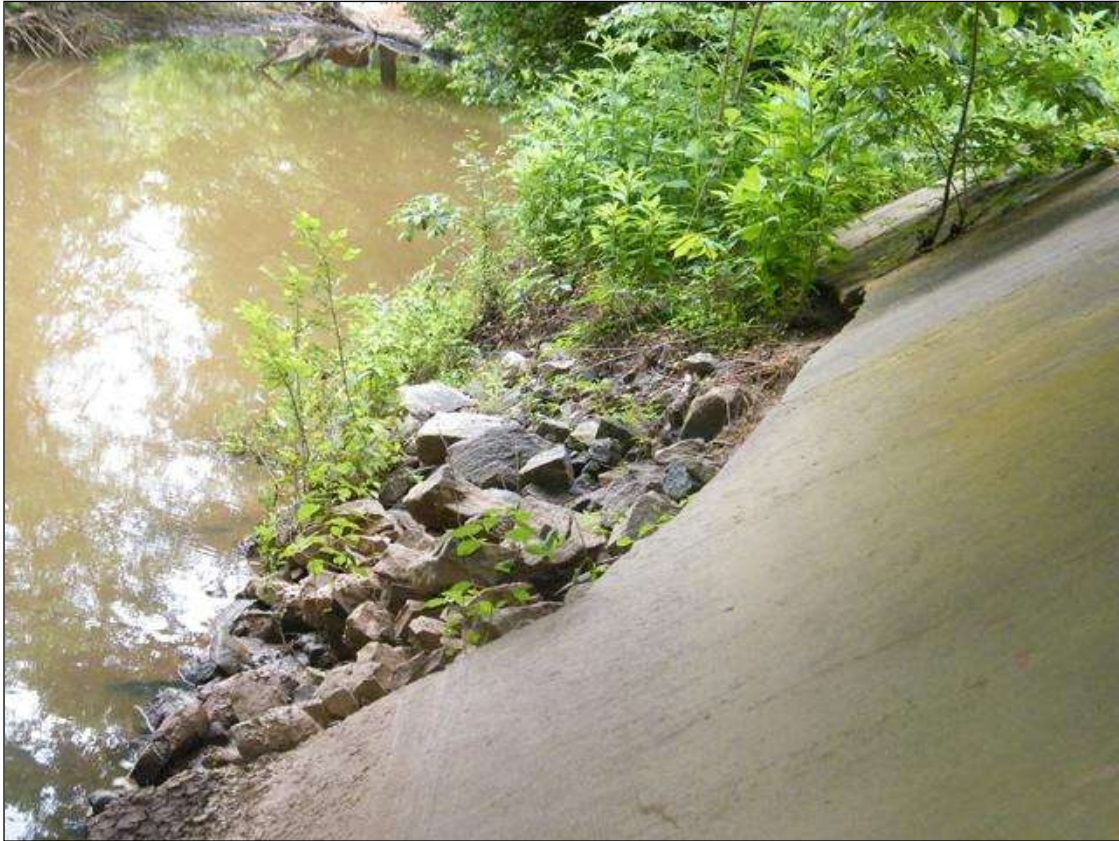
SOUTH SLOPE PROTECTION HAS SECTION MISSING ON RIGHT SIDE AND BOTTOM , RIP-RAP HAS BEEN ADDED AT MISSING SECT .

MMS Code	Description of Function	Unit	Quantity	Remarks	Est. Cost
3310	Maintenance/Repair/Replacement of Standard Bridge Expansion Joints	LF	60	JOINT MATERIAL HAS FALLEN OUT AND HAVE BEEN PAVED OVER .	
3342	Clean and Paint Structural Steel	SF	500	AREAS OF BEAMS OVER PIERS THAT HAVE BEEN PAINTED ARE PEELING OFF, AREAS OF SURFACE RUST ON BEAMS AND BEARINGS .	
3348	Maintain Concrete Substructure Components	LF	30	PIER PILE ENCASEMENTS HAVE 1 INCH SURFACE PITTING ALONG WATERLINE .	
3352	Maint Slope Protection	SF	100	SOUTH SLOPE PROTECTION HAS AREA ON RIGHT SIDE MISSING .

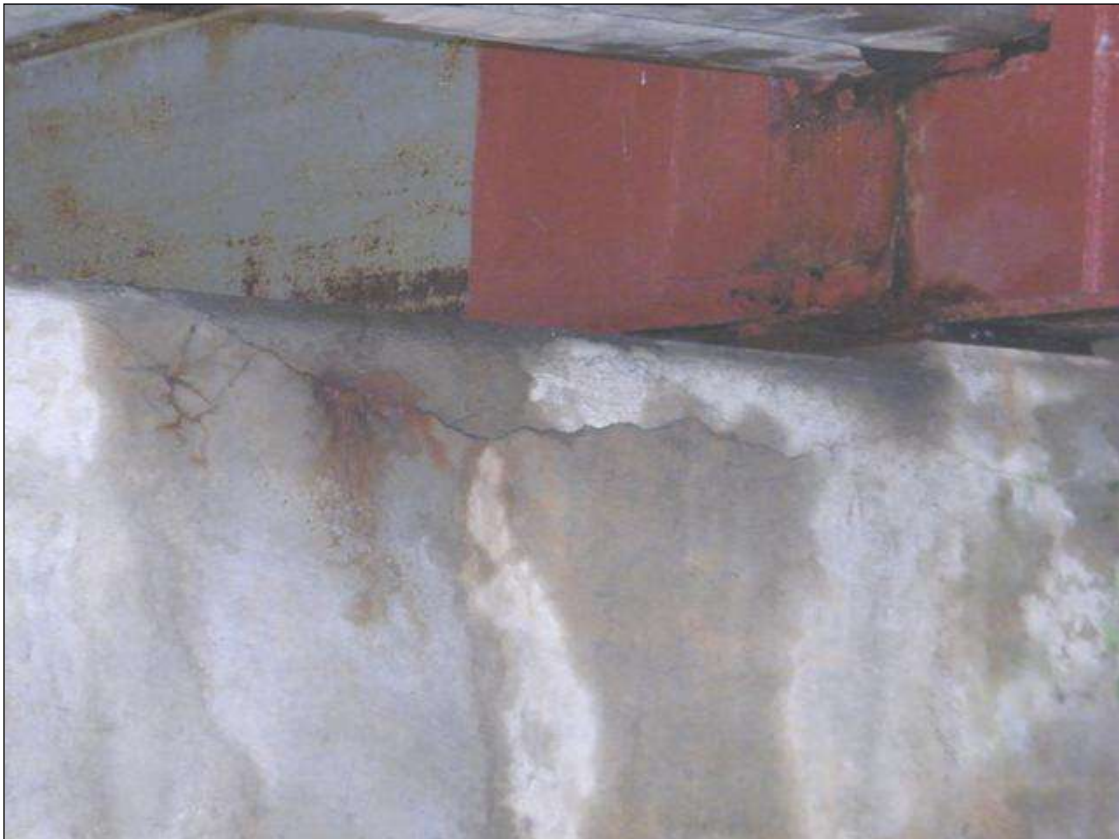
PIER 1 CAP HAS H/L HORIZONTAL CRACKING BETWEEN PILES 2 THRU 4

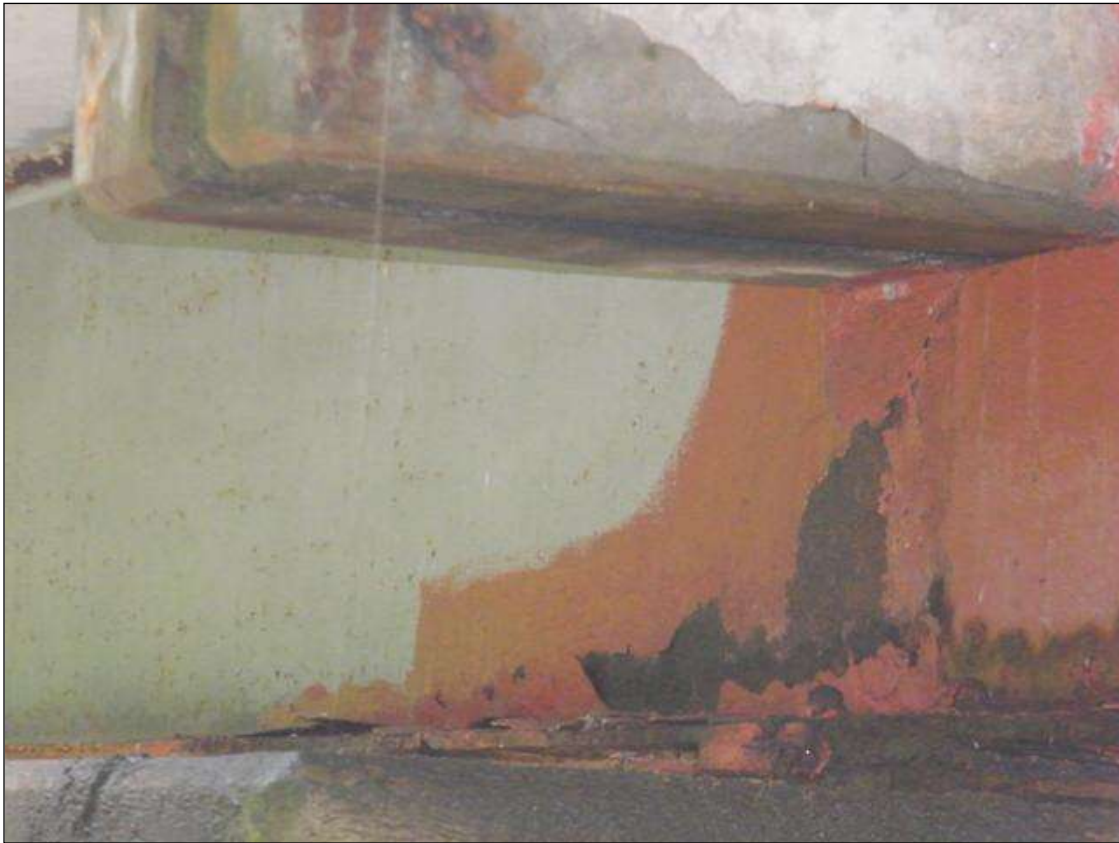
BEAM 1, SPAN 2 HAS AREAS OF PAINT PEELING WHERE SCALED AREA WAS PAINTED OVER

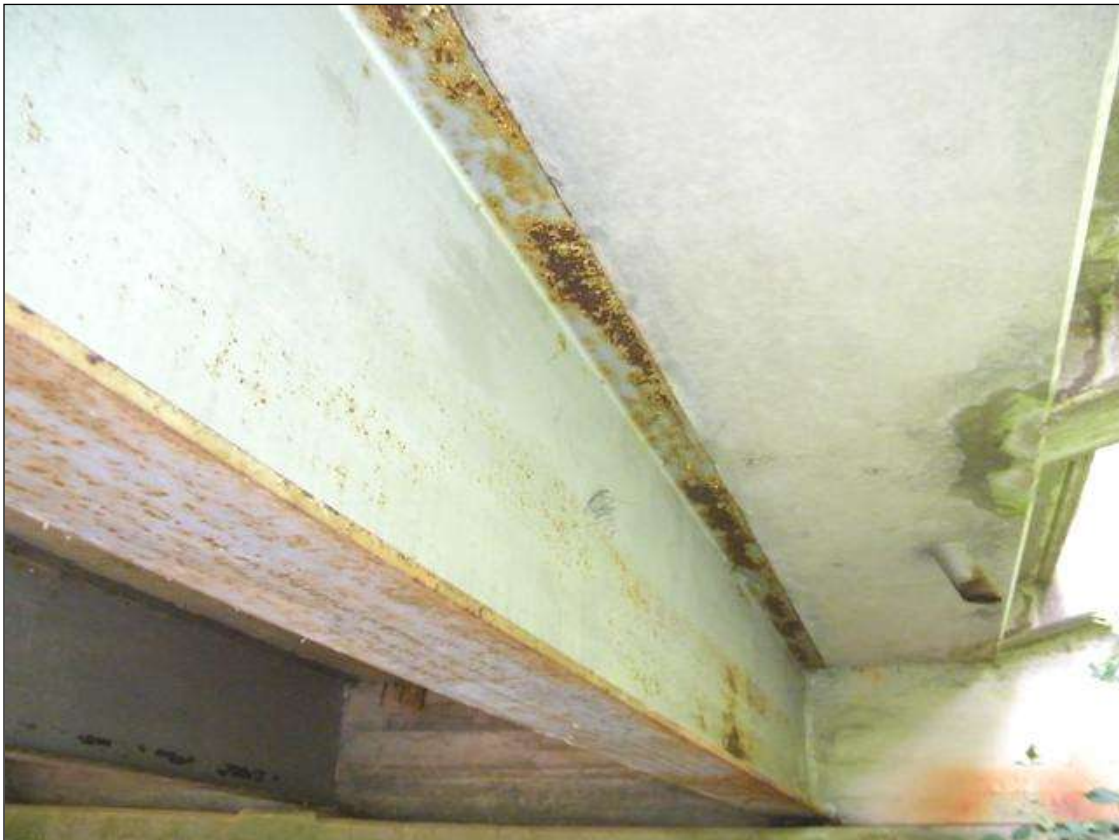
BEAM 1, SPAN 1 HAS SURFACE RUST ALONG LENGTH

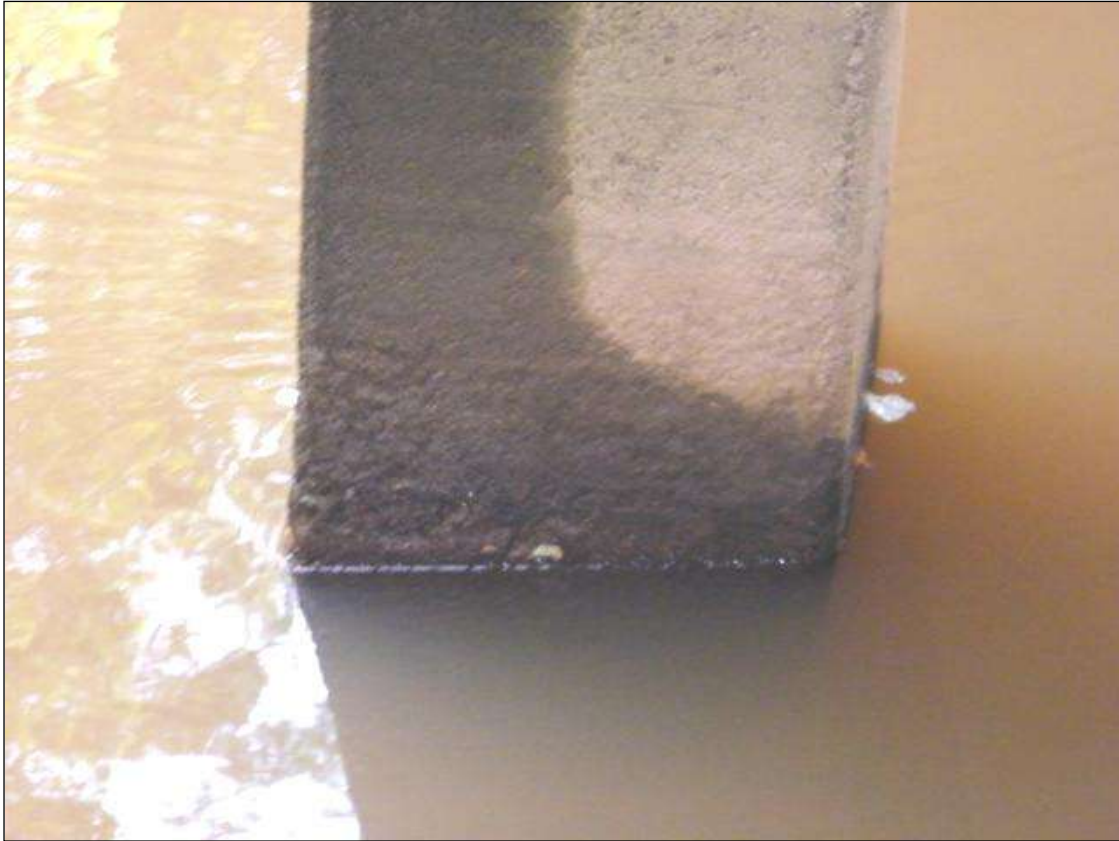
PILE ENCASEMENTS HAVE UP TO 1" DEEP SURFACE PITTING ALONG THE W/L
