PROJECT NO. <u>I-5788</u>						
CUMBERLAND COUNTY						
BRIDGE NO. 157						
SHEET 5 OF 5						
STATE OF NORTH CAROLINA DEPARTMENT OF TRANSPORTATION RALEIGH						
SUPERSTRUCTURE REPAIR SPAN E						
NBL						
		SIONS		SHEET NO. S-29		
NO. ВҮ: 1	DATE:	NO. BY:	DATE:	TOTAL SHEETS		
2		4		72

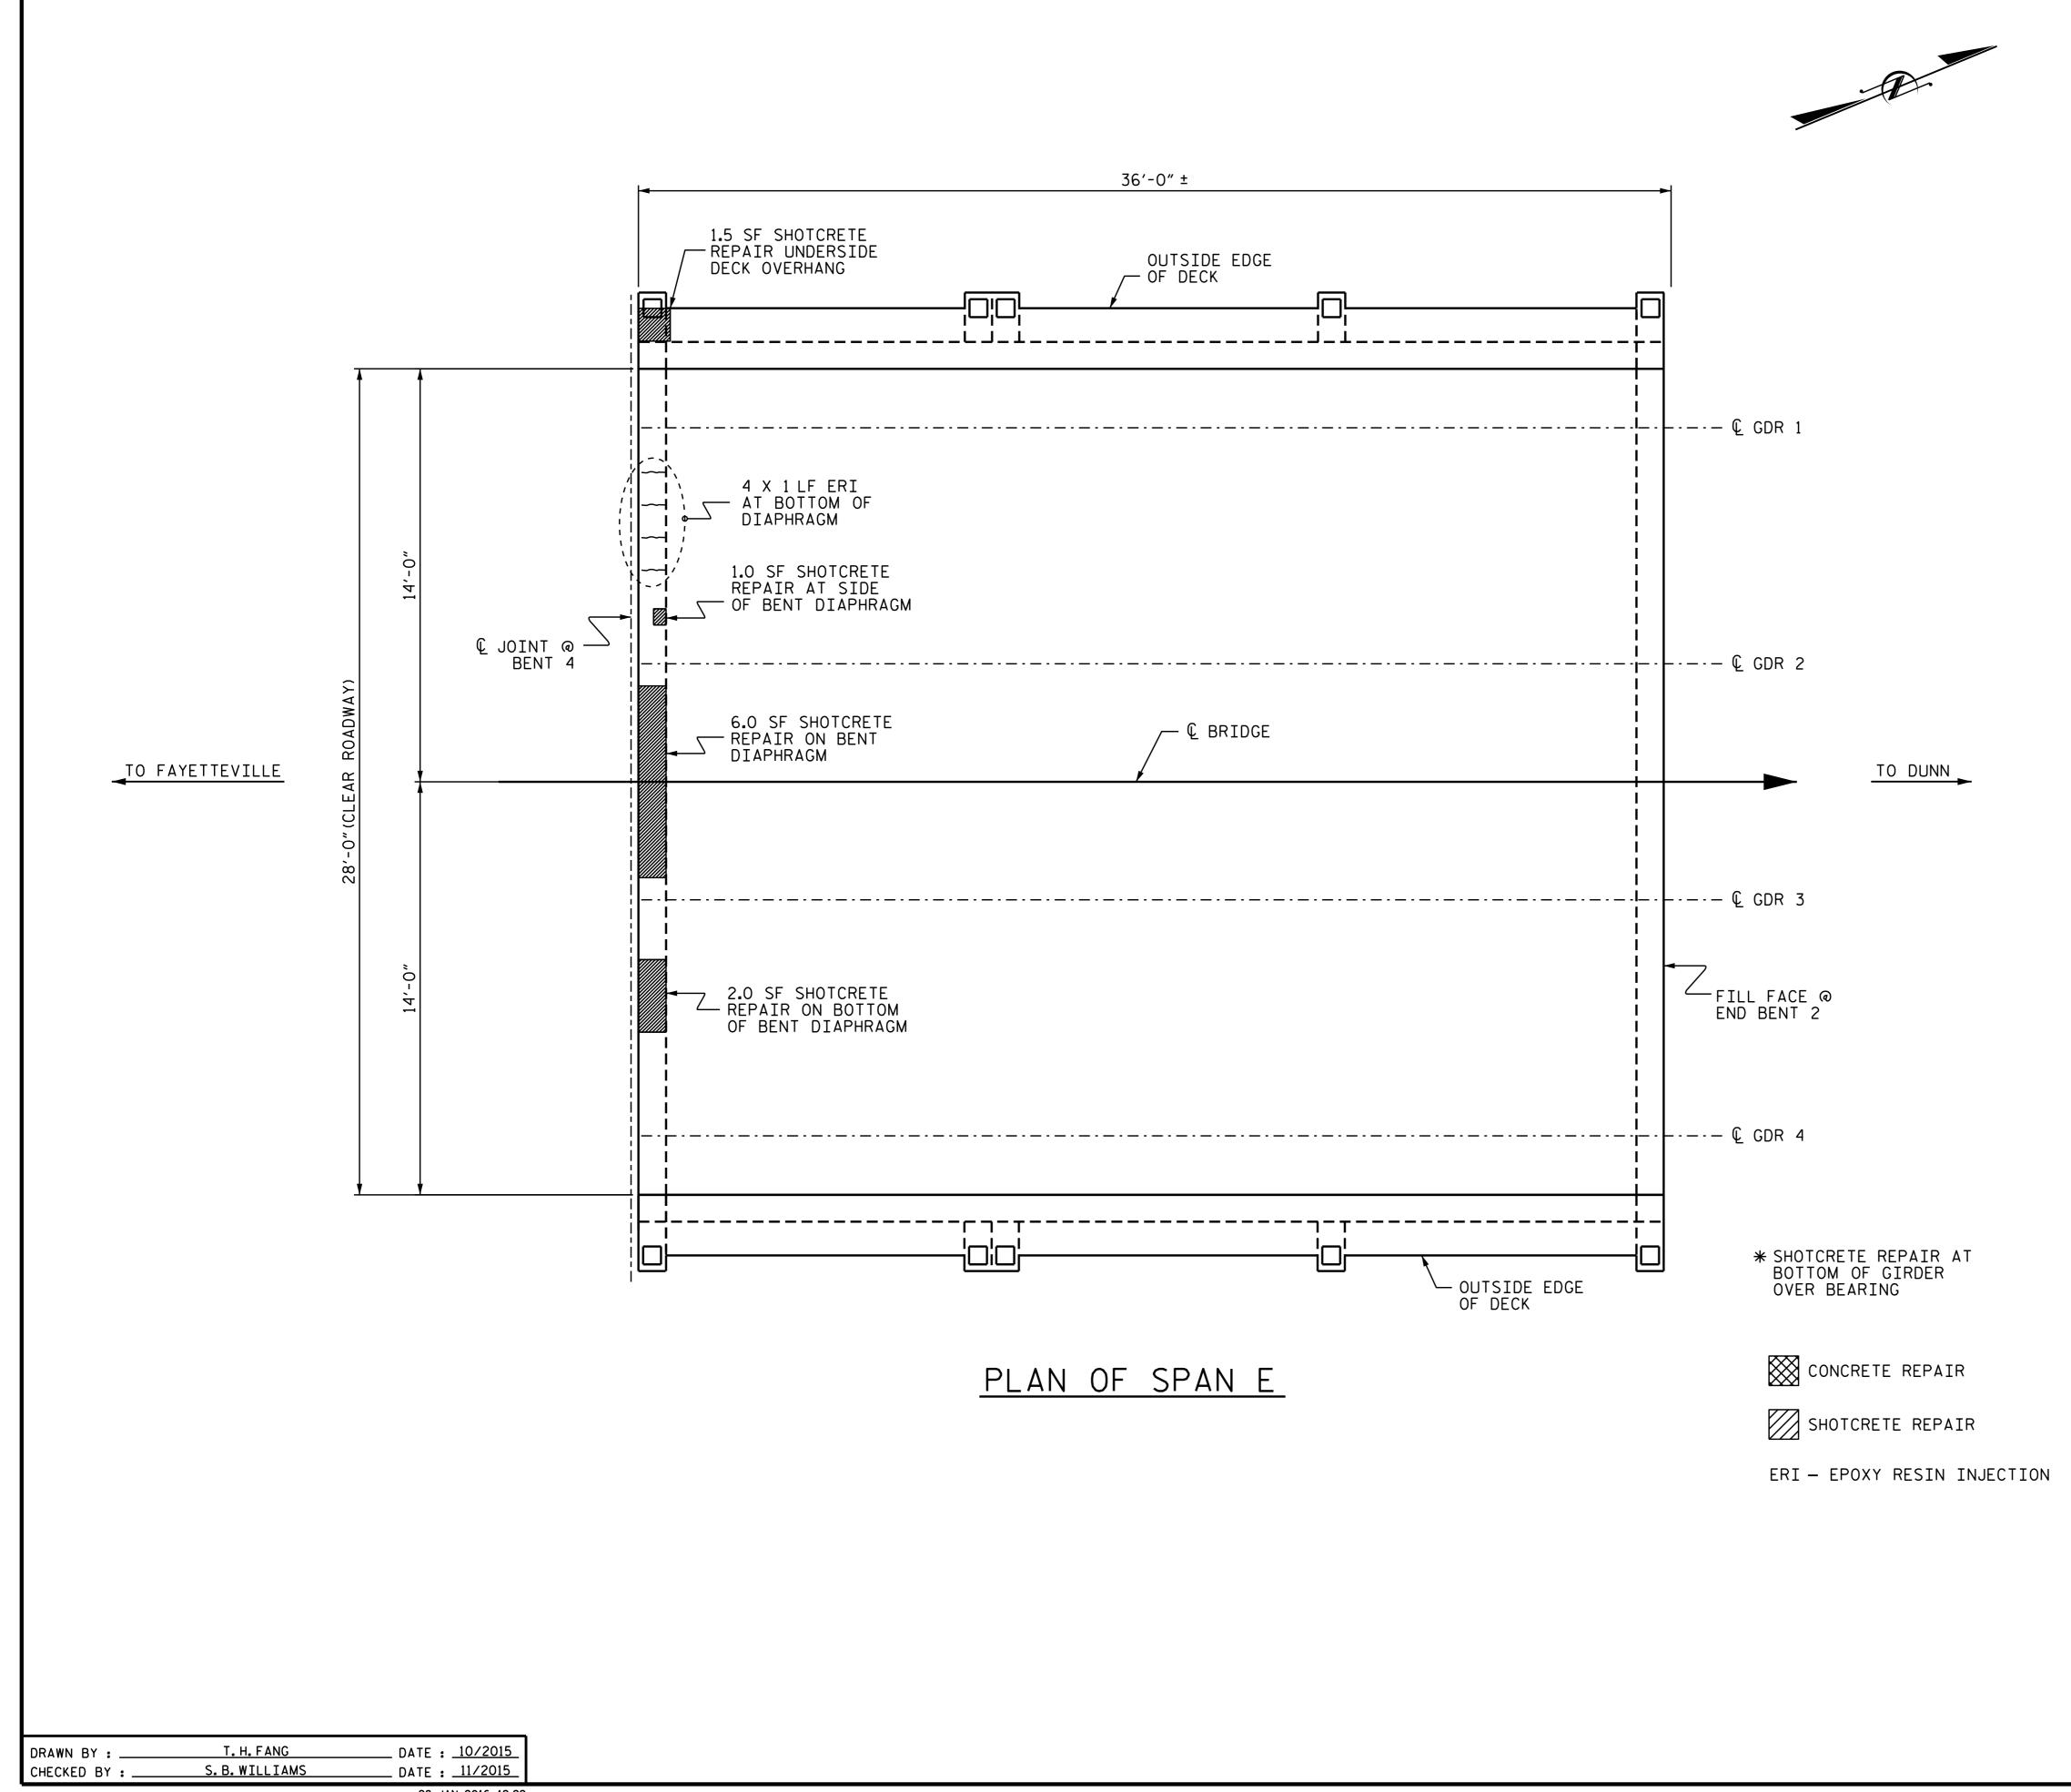
REPAIR QUANTITY TABLE							
UNDERSIDE OF DECK REPAIRS							
	ESTIMATE		ACTUAL				
SHOTCRETE REPAIRS	AREA SF	VOLUME CF	AREA SF	VOLUME CF			
UNDERSIDE OF DECK & OVERHANGS	1.5	0.4					
BENT DIAPHRAGMS	9.0	2.3					
RC DECK GIRDERS							
	ESTIMATE		ACTUAL				
EPOXY RESIN INJECTION	4.0 LF

VALUES IN CHARTS REPRESENT ESTIMATED UNDERSIDE OF DECK REPAIR TOTALS AFTER REMOVAL OF UNSOUND CONCRETE, MIN.OF 1" BEHIND REBAR AND MIN.1" CLEAR TO SAWCUT. SEE REPAIR DETAILS.

REPAIR LOCATIONS AND ESTIMATE OF QUANTITIES ARE GIVEN WITH THE BEST INFORMATION AVAILABLE. IF ADDITIONAL REPAIRS NOT SHOWN ON THE DRAWINGS ARE DEEMED NECESSARY BY THE ENGINEER, THE ENGINEER SHALL NOTE ON THE DRAWINGS THE APPROXIMATE LOCATION AND DESCRIPTION OF THE REPAIRS AND ADJUST THE ACTUAL QUANTITIES ENTERED INTO THE REPAIR QUANTITY TABLE. FOR BENT DIAPHRAGM AND RC DECK GIRDER REPAIR DETAILS SEE SHEET S-24. REPAIR CONCRETE BENT DIAPHRAGMS AS DIRECTED BY THE ENGINEER.
