PROJECT NO. I-5788
CUMBERLAND COUNTY
 BRIDGE NO. 157

STATE OF NORTH CAROLINA
 DEPARTMENT OF TRANSPORTATION
 RALEIGH
SUBSTRUCTURE REPAIR
 END BENTS 1 & 2
 NBL

REVISIONS						SHEET NO. S-30
NO.	BY:	DATE:	NO.	BY:	DATE:	
1			3			TOTAL SHEETS
2			4			72

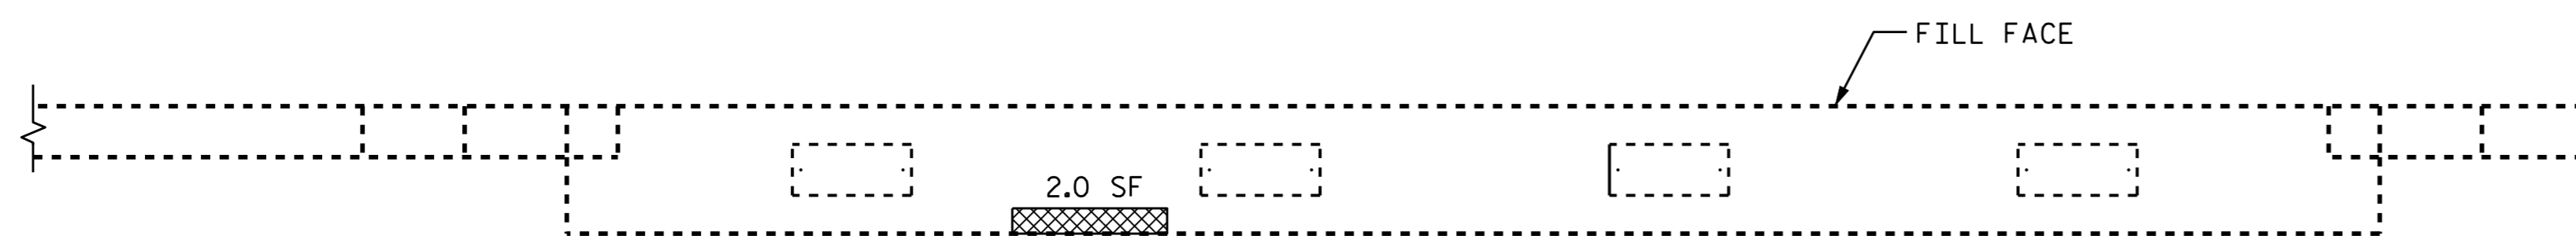
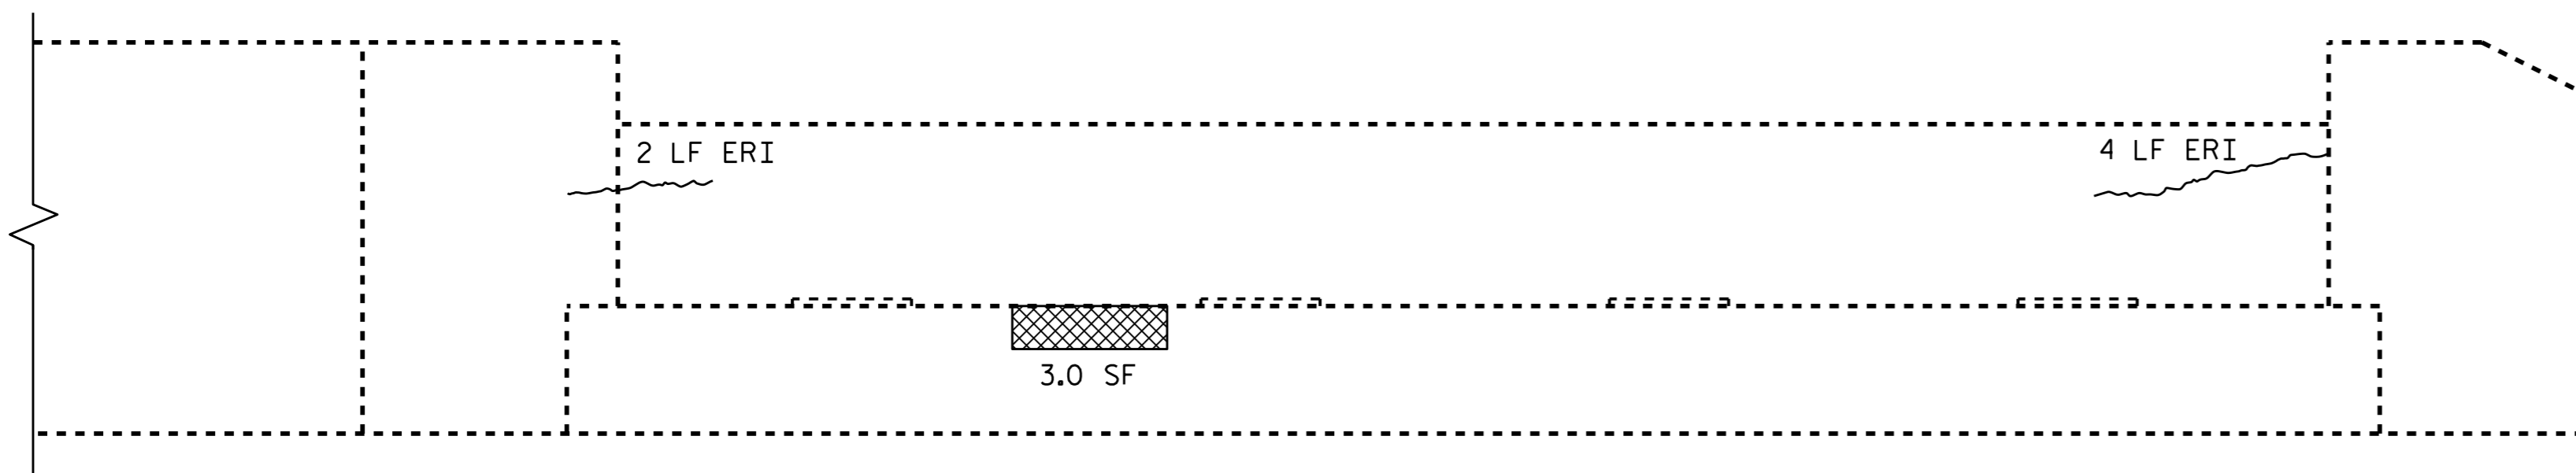
REPAIR QUANTITY TABLE				
REPAIRS END BENT 1	QUANTITIES			
	ESTIMATE		ACTUAL	
SHOTCRETE REPAIRS	AREA SF.	VOLUME CF.	AREA SF.	VOLUME CF.
CAP (VERTICAL FACE)				
CAP (HORIZONTAL FACE)				
CURTAIN WALL				
CONCRETE REPAIRS	5.0	1.3		
EPOXY RESIN INJECTION		LN. FT.		LN. FT.
CAP				
CURTAIN WALL		6.0		
EPOXY COATING		SO. FT.		SO. FT.
TOP OF CAP		43.9

- CONCRETE REPAIR
- SHOTCRETE REPAIR
- ERI - EPOXY RESIN INJECTION

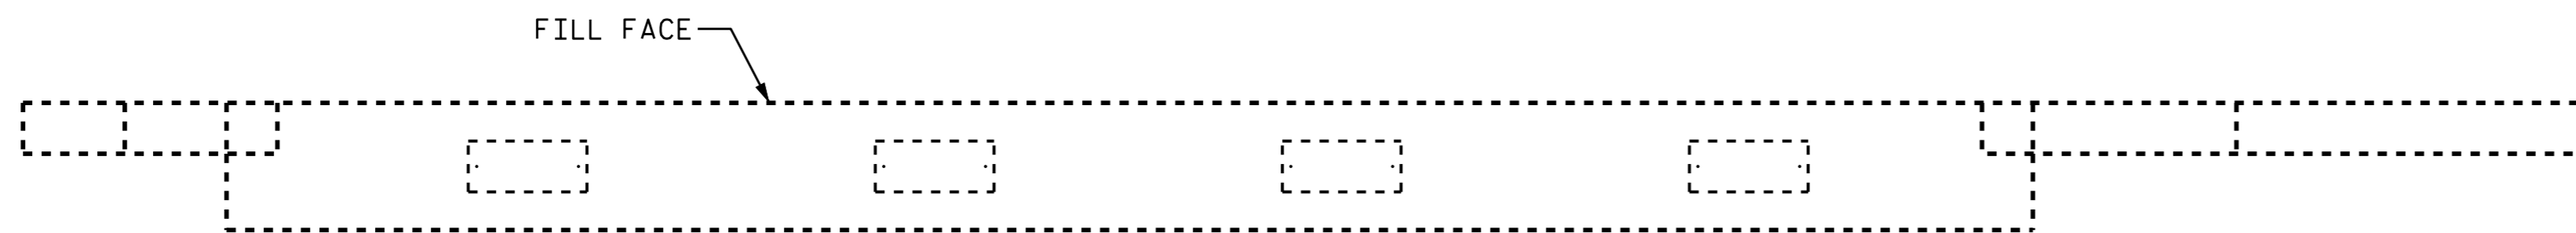
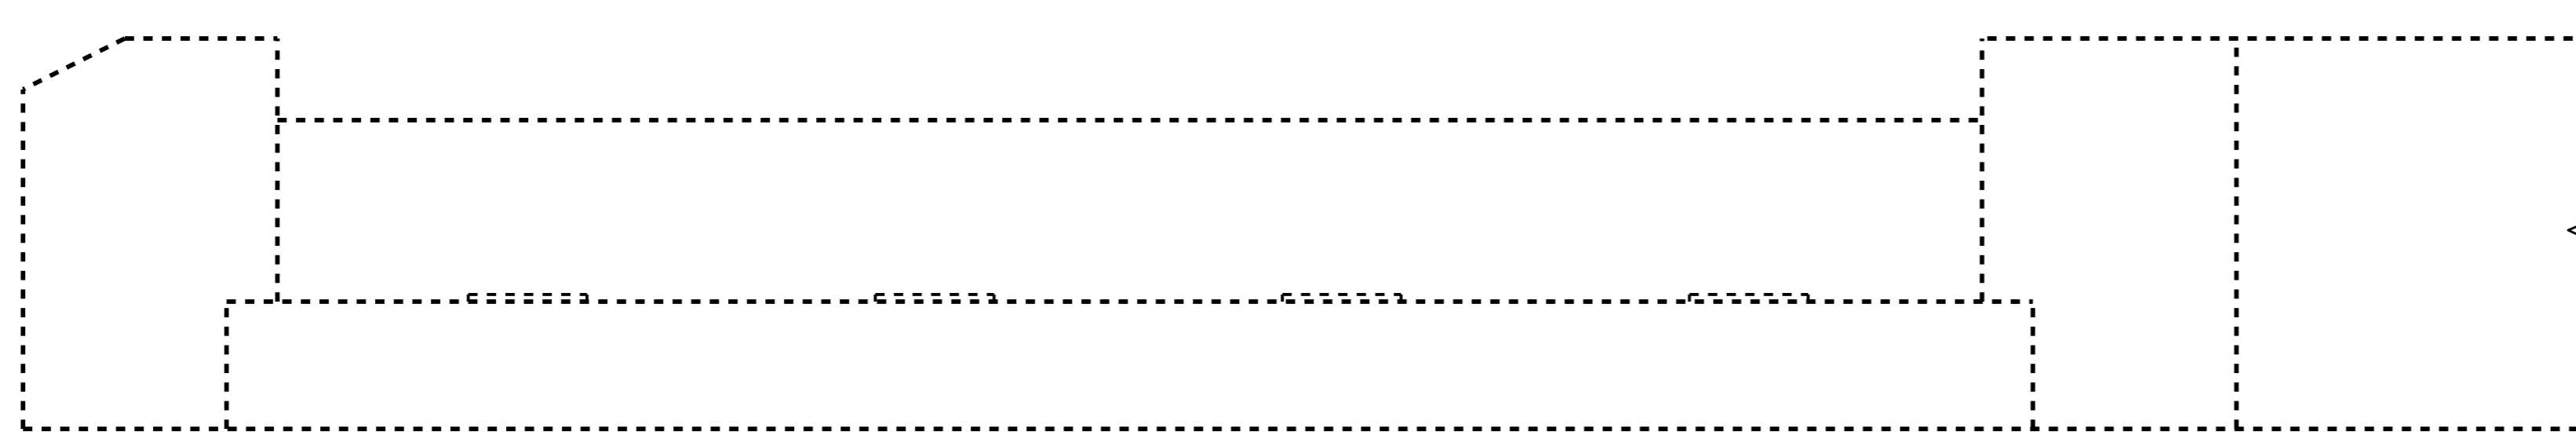
REPAIRS END BENT 2	QUANTITIES			
	ESTIMATE		ACTUAL	
SHOTCRETE REPAIRS	AREA SF.	VOLUME CF.	AREA SF.	VOLUME CF.
CAP (VERTICAL FACE)				
CAP (HORIZONTAL FACE)				
CURTAIN WALL				
CONCRETE REPAIRS				
EPOXY RESIN INJECTION		LN. FT.		LN. FT.
CAP				
CURTAIN WALL				
EPOXY COATING		SO. FT.		SO. FT.
TOP OF CAP		43.9

EPOXY COATING SHALL BE APPLIED TO THE TOP FACE OF THE END BENT CAP.
