PROJECT NO. I-5788
CUMBERLAND COUNTY
STATION: 157

STATE OF NORTH CAROLINA
DEPARTMENT OF TRANSPORTATION
RALEIGH
SUBSTRUCTURE REPAIR
BENT 2
NBL

REVISIONS						SHEET NO. S-32
NO.	BY:	DATE:	NO.	BY:	DATE:	
1			3			TOTAL SHEETS 72
2			4

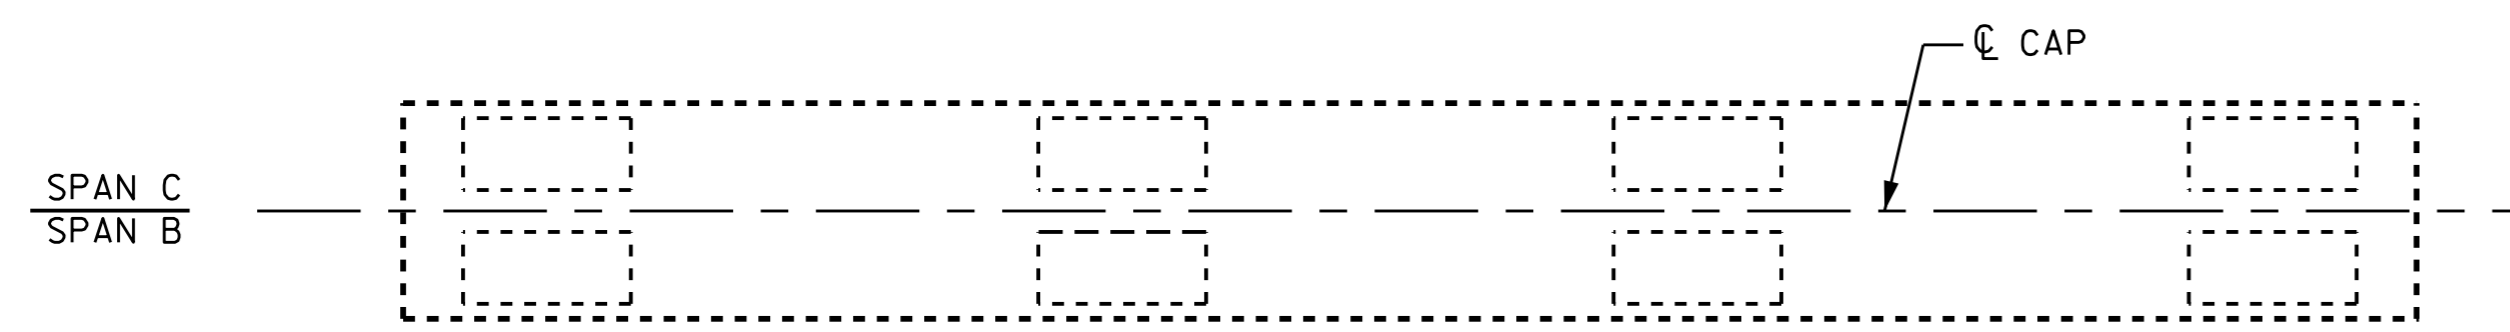
TOP OF CAP

EPOXY COATING SHALL BE APPLIED TO THE TOP FACE OF THE BENT CAP.
