PROJECT NO. I-5788  
CUMBERLAND COUNTY  
STATION: 157

STATE OF NORTH CAROLINA  
DEPARTMENT OF TRANSPORTATION  
RALEIGH  
**SUBSTRUCTURE REPAIR**  
**BENT 3**  
**NBL**

REVISIONS						SHEET NO. S-33
NO.	BY:	DATE:	NO.	BY:	DATE:	
1			3			TOTAL SHEETS 72
2			4

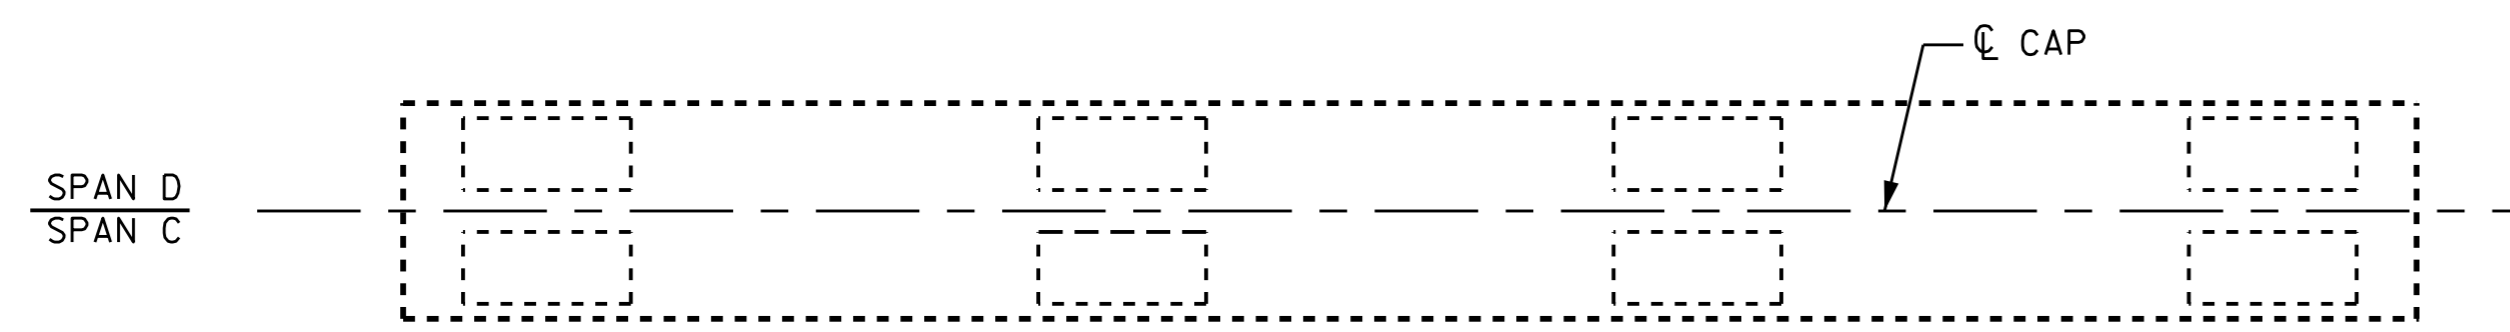
TOP OF CAP

EPOXY COATING SHALL BE APPLIED TO THE TOP FACE OF THE BENT CAP.
