PROJECT NO. <u>I-5788</u> <u>CUMBERLAND</u> COUNTY					
BRIDGE NO. 158					
SHEET 2 OF 5 STATE OF NORTH CAROLINA DEPARTMENT OF TRANSPORTATION RALEIGH SUPERSTRUCTURE REPAIR SPAN B SBL					
REVISIONS	SHEET NO. S-38				
NO. BY: DATE: NO. BY: DATE: 1 3 4 3 4	TOTAL SHEETS 72

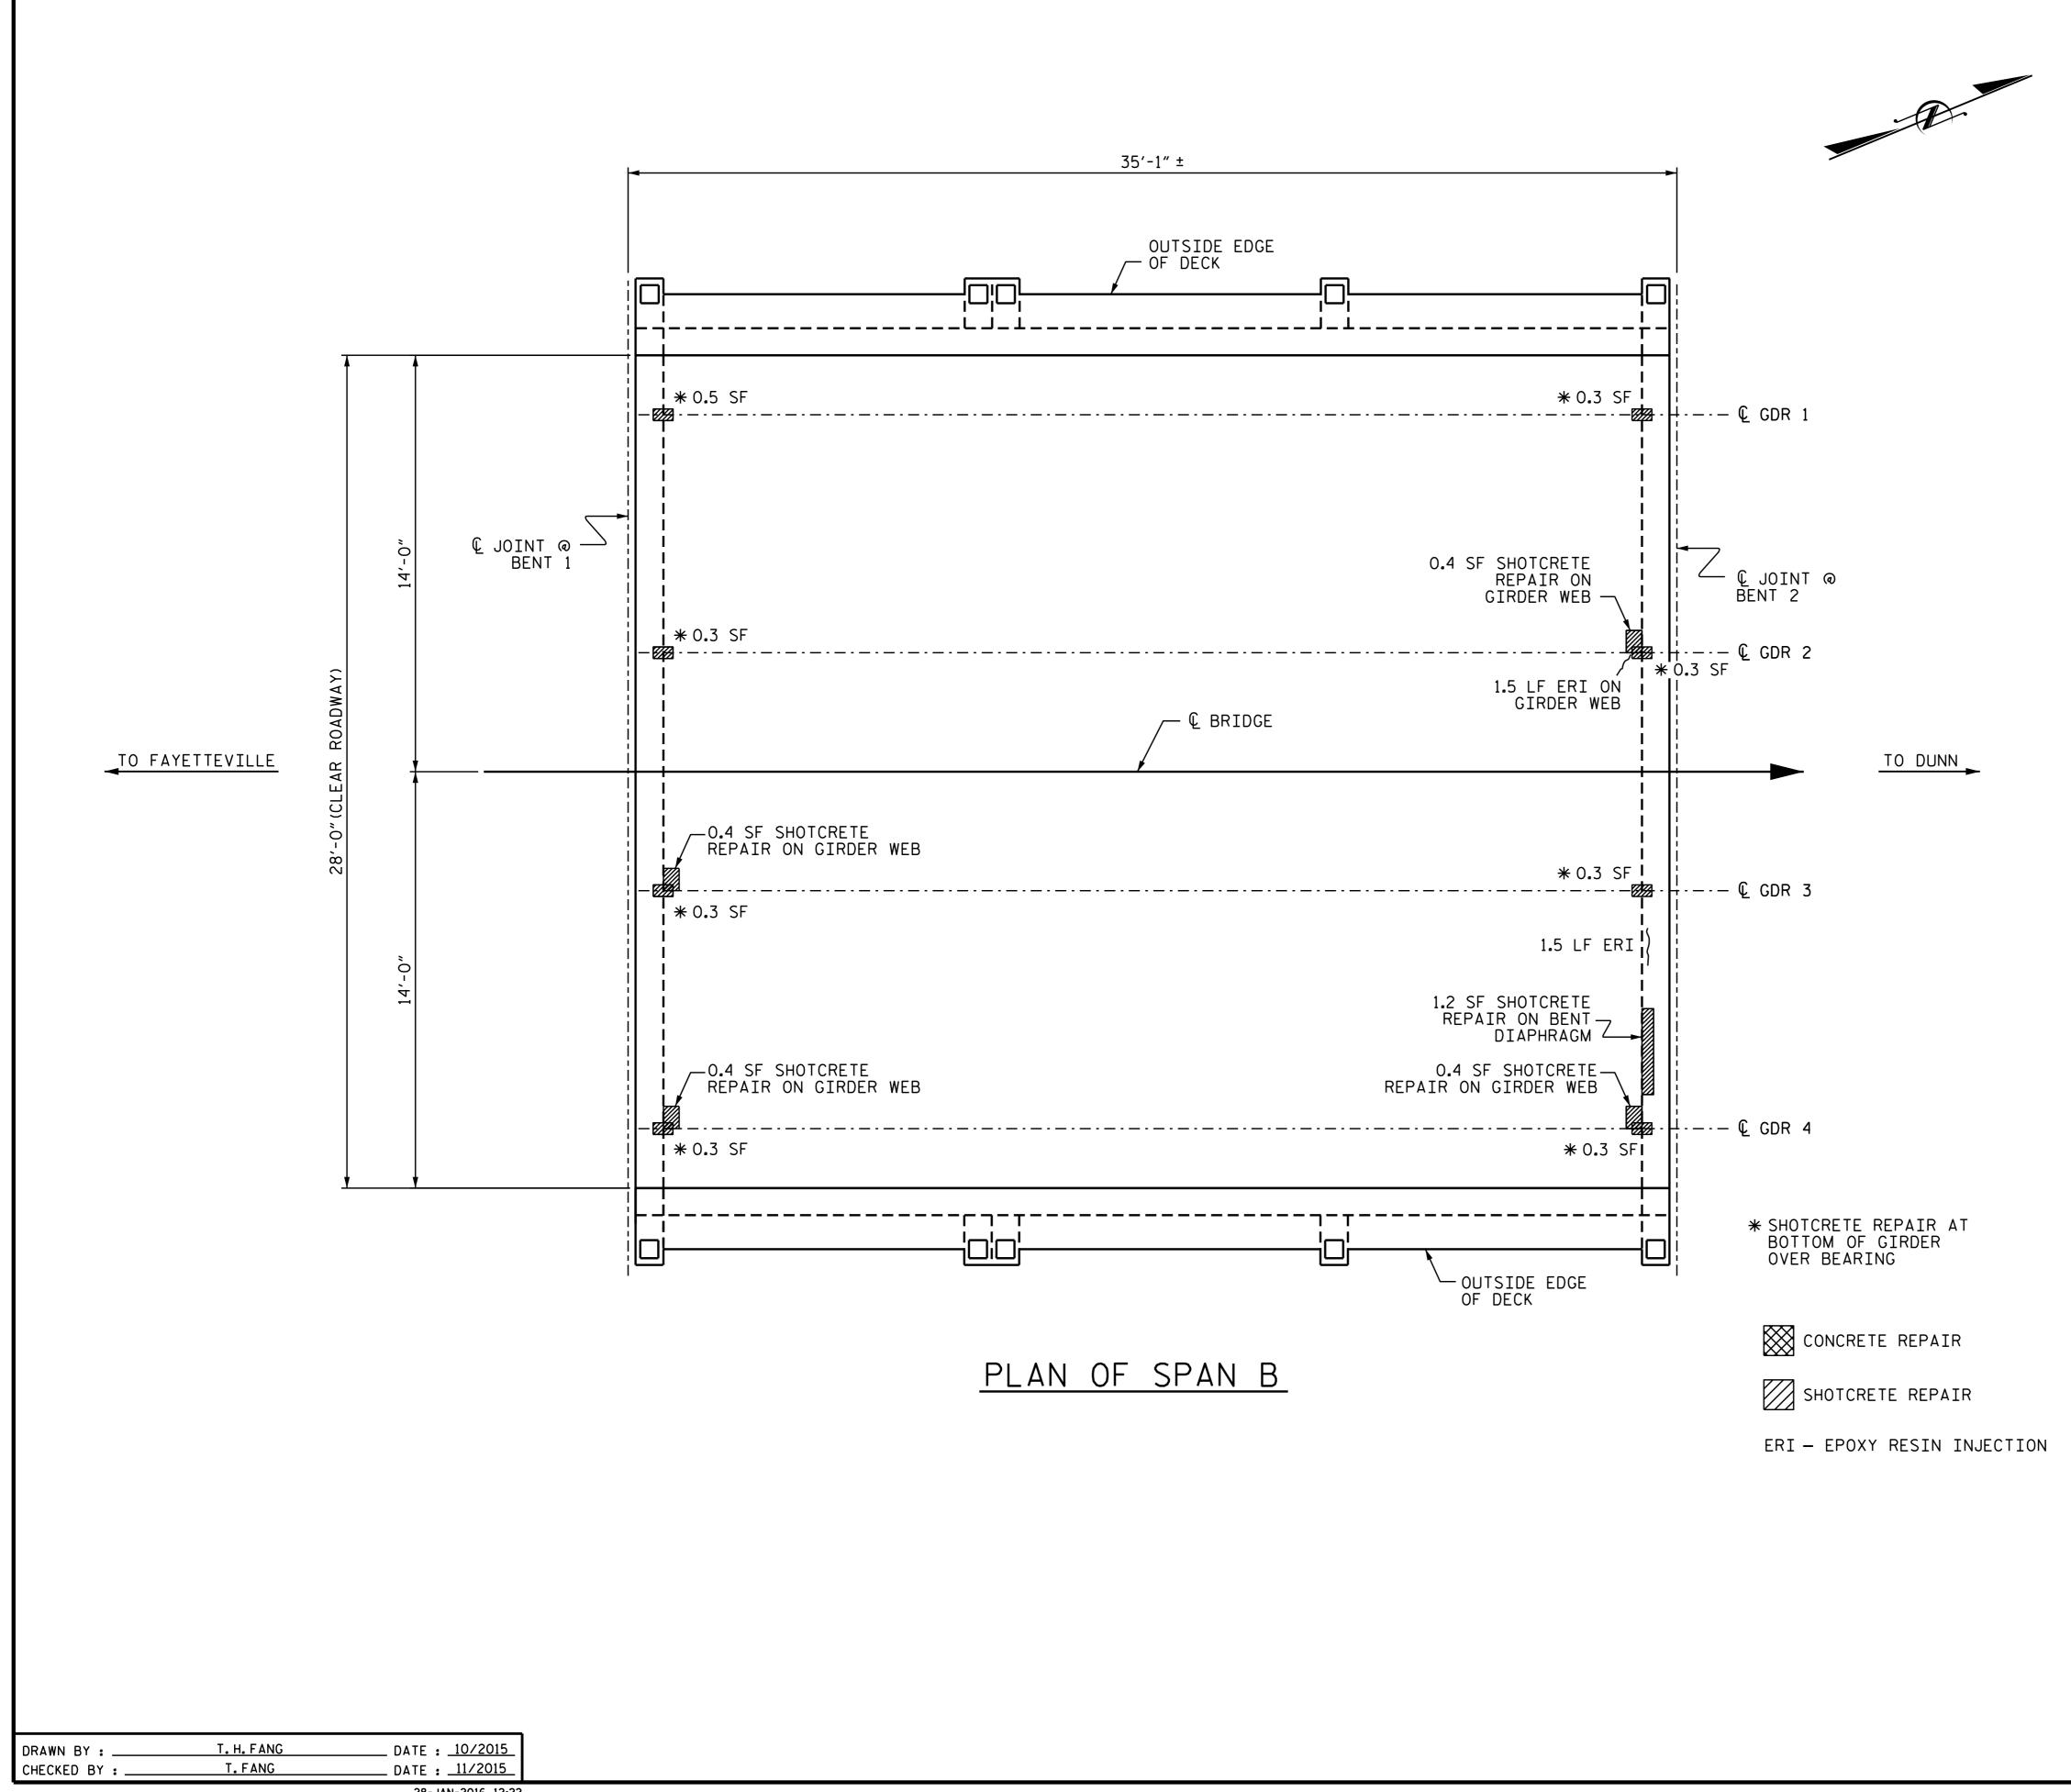
REPAIR QUANTITY TABLE						
UNDERSIDE OF DECK REPAIRS						
		ESTIMATE		ACTUAL		
SHOTCRETE REPAIRS	AREA SF	VOLUME CF	AREA SF	VOLUME CF		
UNDERSIDE OF DECK & OVERHANGS						
BENT DIAPHRAGMS	1.2	0.3				
RC DECK GIRDERS	4.2	1.1				
	ESTIMATE		AC	ACTUAL		
EPOXY RESIN INJECTION	3.0 LF

VALUES IN CHARTS REPRESENT ESTIMATED UNDERSIDE OF DECK REPAIR TOTALS AFTER REMOVAL OF UNSOUND CONCRETE, MIN.OF 1" BEHIND REBAR AND MIN.1" CLEAR TO SAWCUT. SEE REPAIR DETAILS.

REPAIR LOCATIONS AND ESTIMATE OF QUANTITIES ARE GIVEN WITH THE BEST INFORMATION AVAILABLE. IF ADDITIONAL REPAIRS NOT SHOWN ON THE DRAWINGS ARE DEEMED NECESSARY BY THE ENGINEER, THE ENGINEER SHALL NOTE ON THE DRAWINGS THE APPROXIMATE LOCATION AND DESCRIPTION OF THE REPAIRS AND ADJUST THE ACTUAL QUANTITIES ENTERED INTO THE REPAIR QUANTITY TABLE. FOR BENT DIAPHRAGM AND RC DECK GIRDER REPAIR DETAILS SEE SHEET S-24. REPAIR CONCRETE BENT DIAPHRAGMS AS DIRECTED BY THE ENGINEER.
