PROJECT NO. I-5788
CUMBERLAND COUNTY
 BRIDGE NO. 158

STATE OF NORTH CAROLINA
 DEPARTMENT OF TRANSPORTATION
 RALEIGH
 SUPERSTRUCTURE
 REPAIR
 SPAN D
 SBL

REVISIONS						SHEET NO. S-40
NO.	BY:	DATE:	NO.	BY:	DATE:	
1			3			TOTAL SHEETS 72
2			4

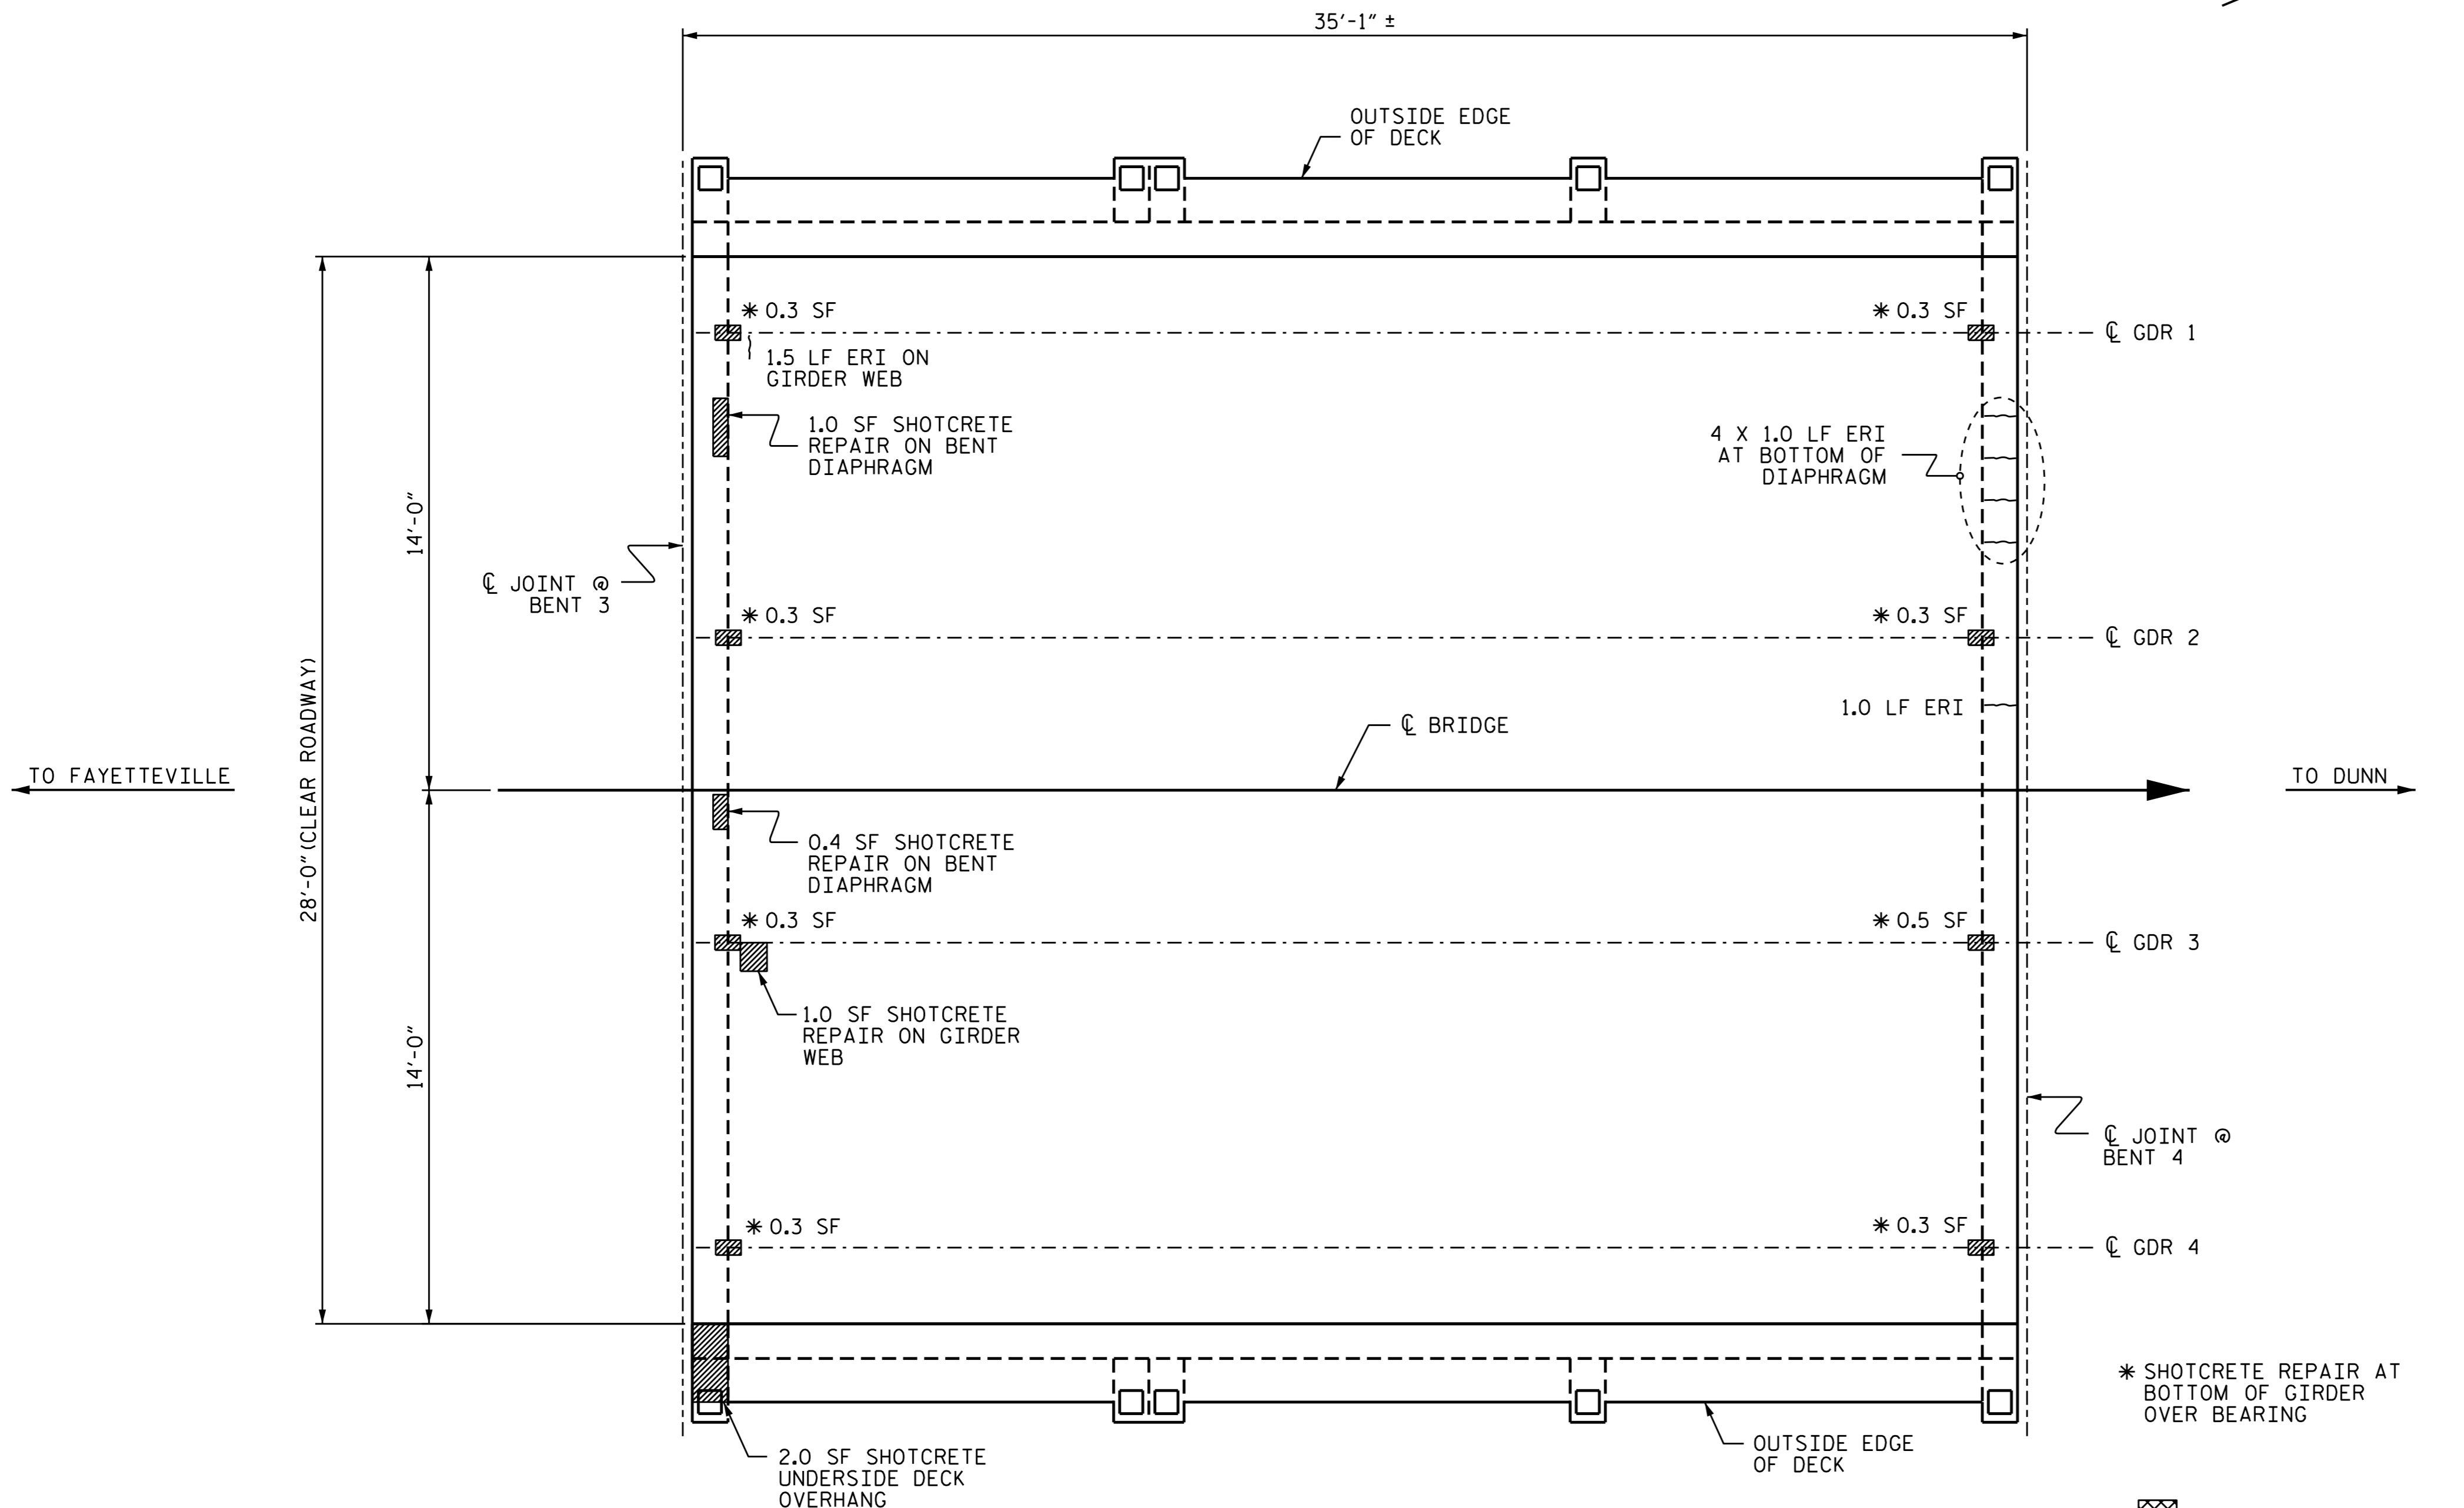
PLAN OF SPAN D

* SHOTCRETE REPAIR AT BOTTOM OF GIRDER OVER BEARING

CONCRETE REPAIR

SHOTCRETE REPAIR

ERI - EPOXY RESIN INJECTION

REPAIR CONCRETE BENT DIAPHRAGMS AS DIRECTED BY THE ENGINEER.
