PROJECT NO. I-5788
HARNETT COUNTY
 BRIDGE NO.: 73

STATE OF NORTH CAROLINA
 DEPARTMENT OF TRANSPORTATION
 RALEIGH
SUBSTRUCTURE REPAIR
BENT 1
NBL

REVISIONS						SHEET NO. S-59 TOTAL SHEETS 72
NO.	BY:	DATE:	NO.	BY:	DATE:	
1			3			
2			4

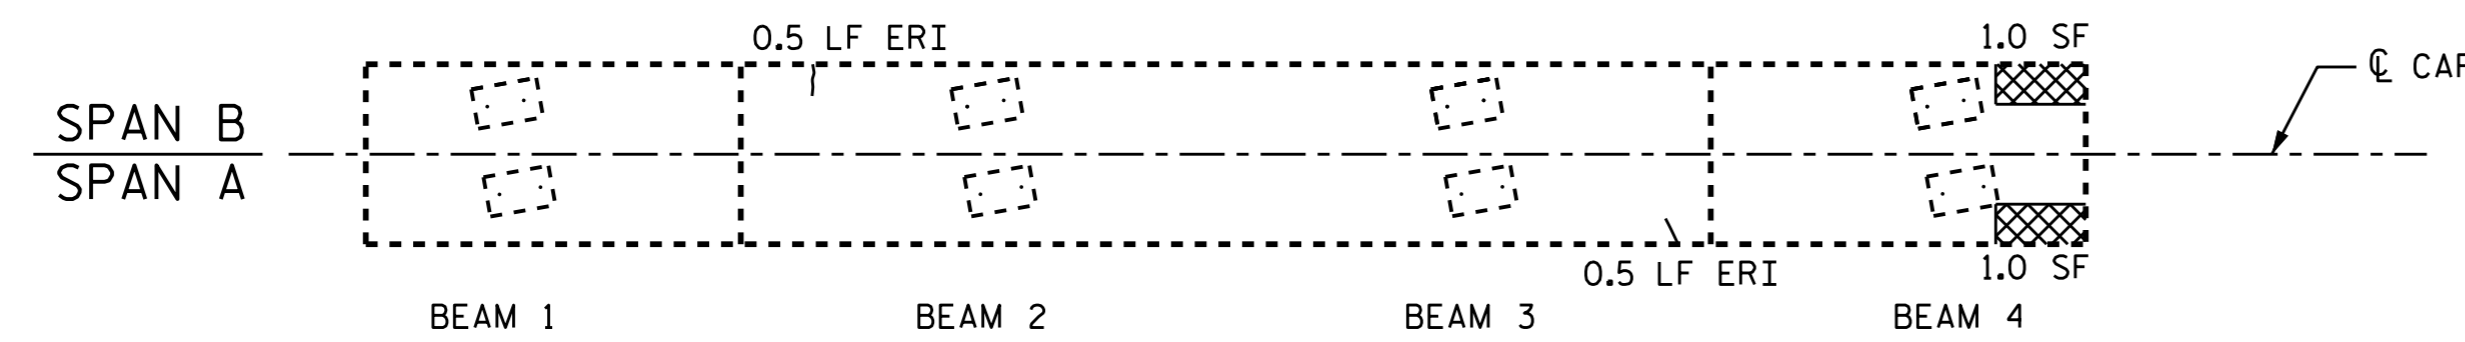
TOP OF CAP

EPOXY COATING SHALL BE APPLIED TO THE TOP FACE OF THE BENT CAP.

FOR STRUCTURE REPAIRS, SEE "TYPICAL CAP AND COLUMN REPAIR DETAILS" SHEET S-72.
