PROJECT NO. I-5788
HARNETT COUNTY
 BRIDGE NO.: 77

STATE OF NORTH CAROLINA
 DEPARTMENT OF TRANSPORTATION
 RALEIGH
SUBSTRUCTURE REPAIR
BENT 1
SBL

REVISIONS						SHEET NO. S-69 TOTAL SHEETS 72
NO.	BY:	DATE:	NO.	BY:	DATE:	
1			3			
2			4

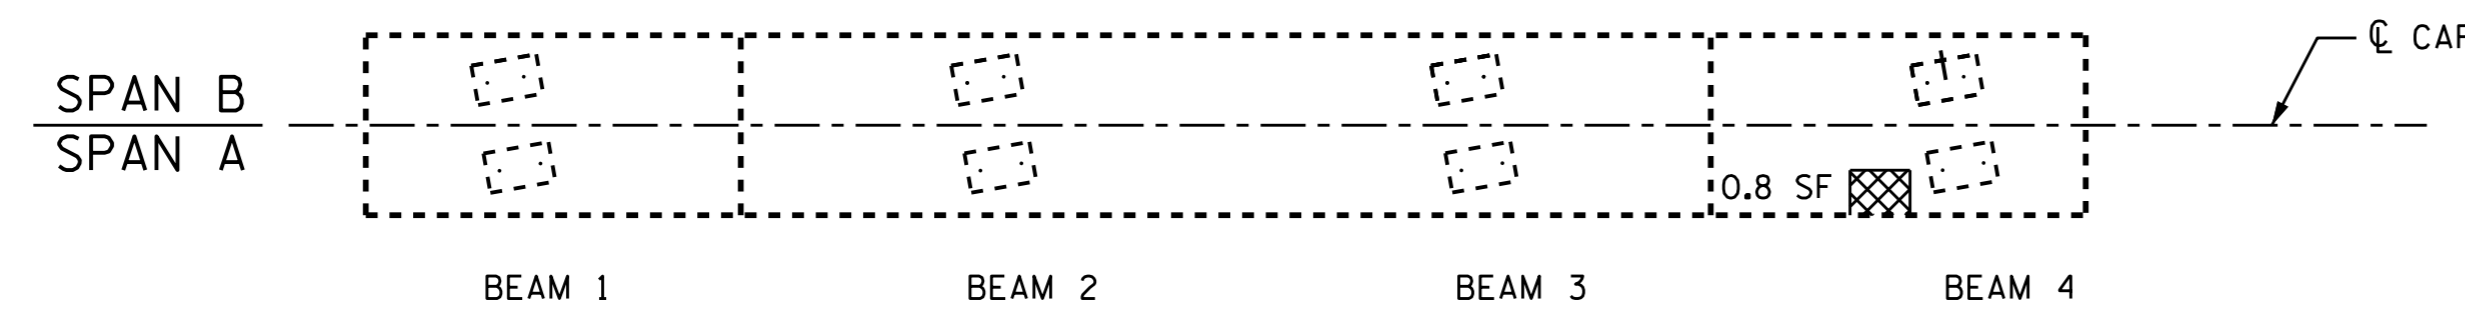
TOP OF CAP

EPOXY COATING SHALL BE APPLIED TO THE TOP FACE OF THE BENT CAP.
