AS-BUILT REPAIR QUANTITY TABLE

PROJECT NO. I-5756 HAYWOOD COUNTY 208 BRIDGE NO.

STATE OF NORTH CAROLINA DEPARTMENT OF TRANSPORTATION

BENT 2

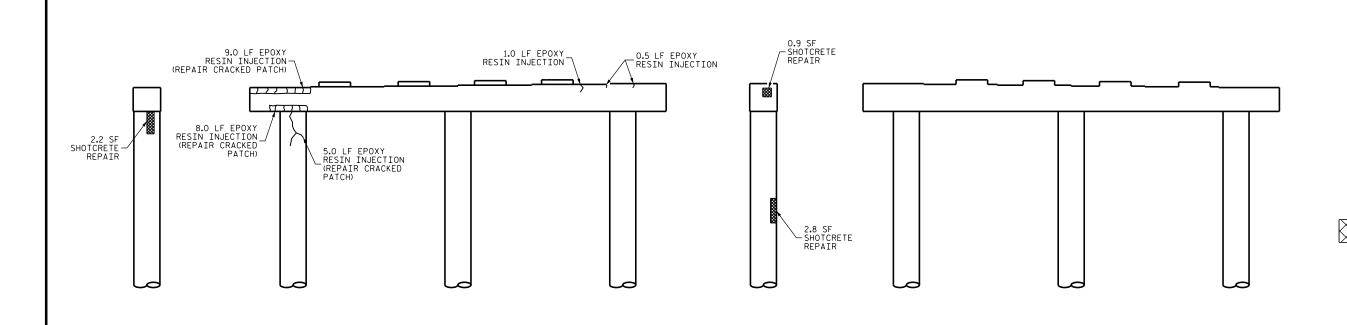
DAMAGED AREA

DRAWN BY : CHECKED BY : 0.6 LF EPOXY RESIN-INJECTION

REPAIRS BENT 2	QUANTITIES			
	ESTIMATE		ACTUAL	
SHOTCRETE REPAIRS	AREA SF	VOLUME CF	AREA SF	VOLUME CF
CAP	0.9	0.8 *		
COLUMN	5.0	4.2 *		
	•			
EPOXY RESIN INJECTION		LN. FT		LN. FT
CAP		20.1		
COLUMN		5.0		
EPOXY COATING		SQ. FT		SQ. FT
TOP OF BENT CAP		0

VALUES IN CHARTS REPRESENT ESTIMATED REPAIR TOTALS AFTER REMOVAL OF UNSOUND CONCRETE, MIN. OF 1" BEHIND REBAR AND MIN.1" CLEAR TO SAWCUT.
