PROJECT NO. I-5756

222

BRIDGE NO.

BENT 1

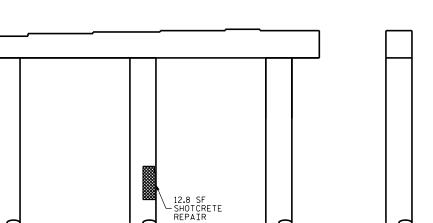
* QUANTITY HAS BEEN INCREASED DUE TO THE POTENTIAL FOR FURTHER DETERIORATION SINCE THE FIELD INSPECTION BY STRUCTURES MANAGEMENT UNIT.

REPAIRS BENT 1	QUANTITIES			
	ESTIMATE		ACTUAL	
SHOTCRETE REPAIRS	AREA SF	VOLUME CF	AREA SF	VOLUME CF
CAP	0.0	0.0		
COLUMN	16.0	12.0 *		
EPOXY RESIN INJECTION		LN. FT		LN. FT
CAP		0.0		
COLUMN		0.0		
EPOXY COATING		SQ. FT		SQ. FT
TOP OF BENT CAP		0

FOR CAP REPAIRS, SEE "TYPICAL CAP AND COLUMN REPAIR DETAILS" SHEET.

VALUES IN CHARTS REPRESENT ESTIMATED REPAIR TOTALS AFTER REMOVAL OF UNSOUND CONCRETE, MIN. OF 1" BEHIND REBAR AND MIN. 1" CLEAR TO SAWCUT.
