PROJECT NO. I-5756 HAYWOOD COUNTY 224 BRIDGE NO.

STATE OF NORTH CAROLINA

BENT 2

S-65

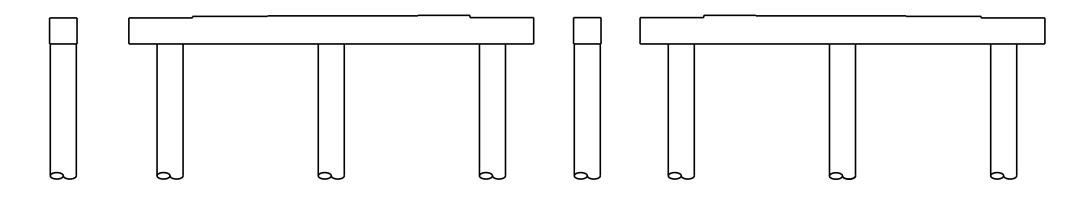
NO REPAIRS NOTED FOR BENT 2 DURING INSPECTION BY STRUCTURES MANAGEMENT UNIT. THE CONTRACTOR AND ENGINEER SHALL INSPECT THE BENT PRIOR TO BEGINNING WORK.
