PROJECT NO. I-5756  
HAYWOOD COUNTY  
 BRIDGE NO. 228

SHEET 3 OF 4

**BENT 3**

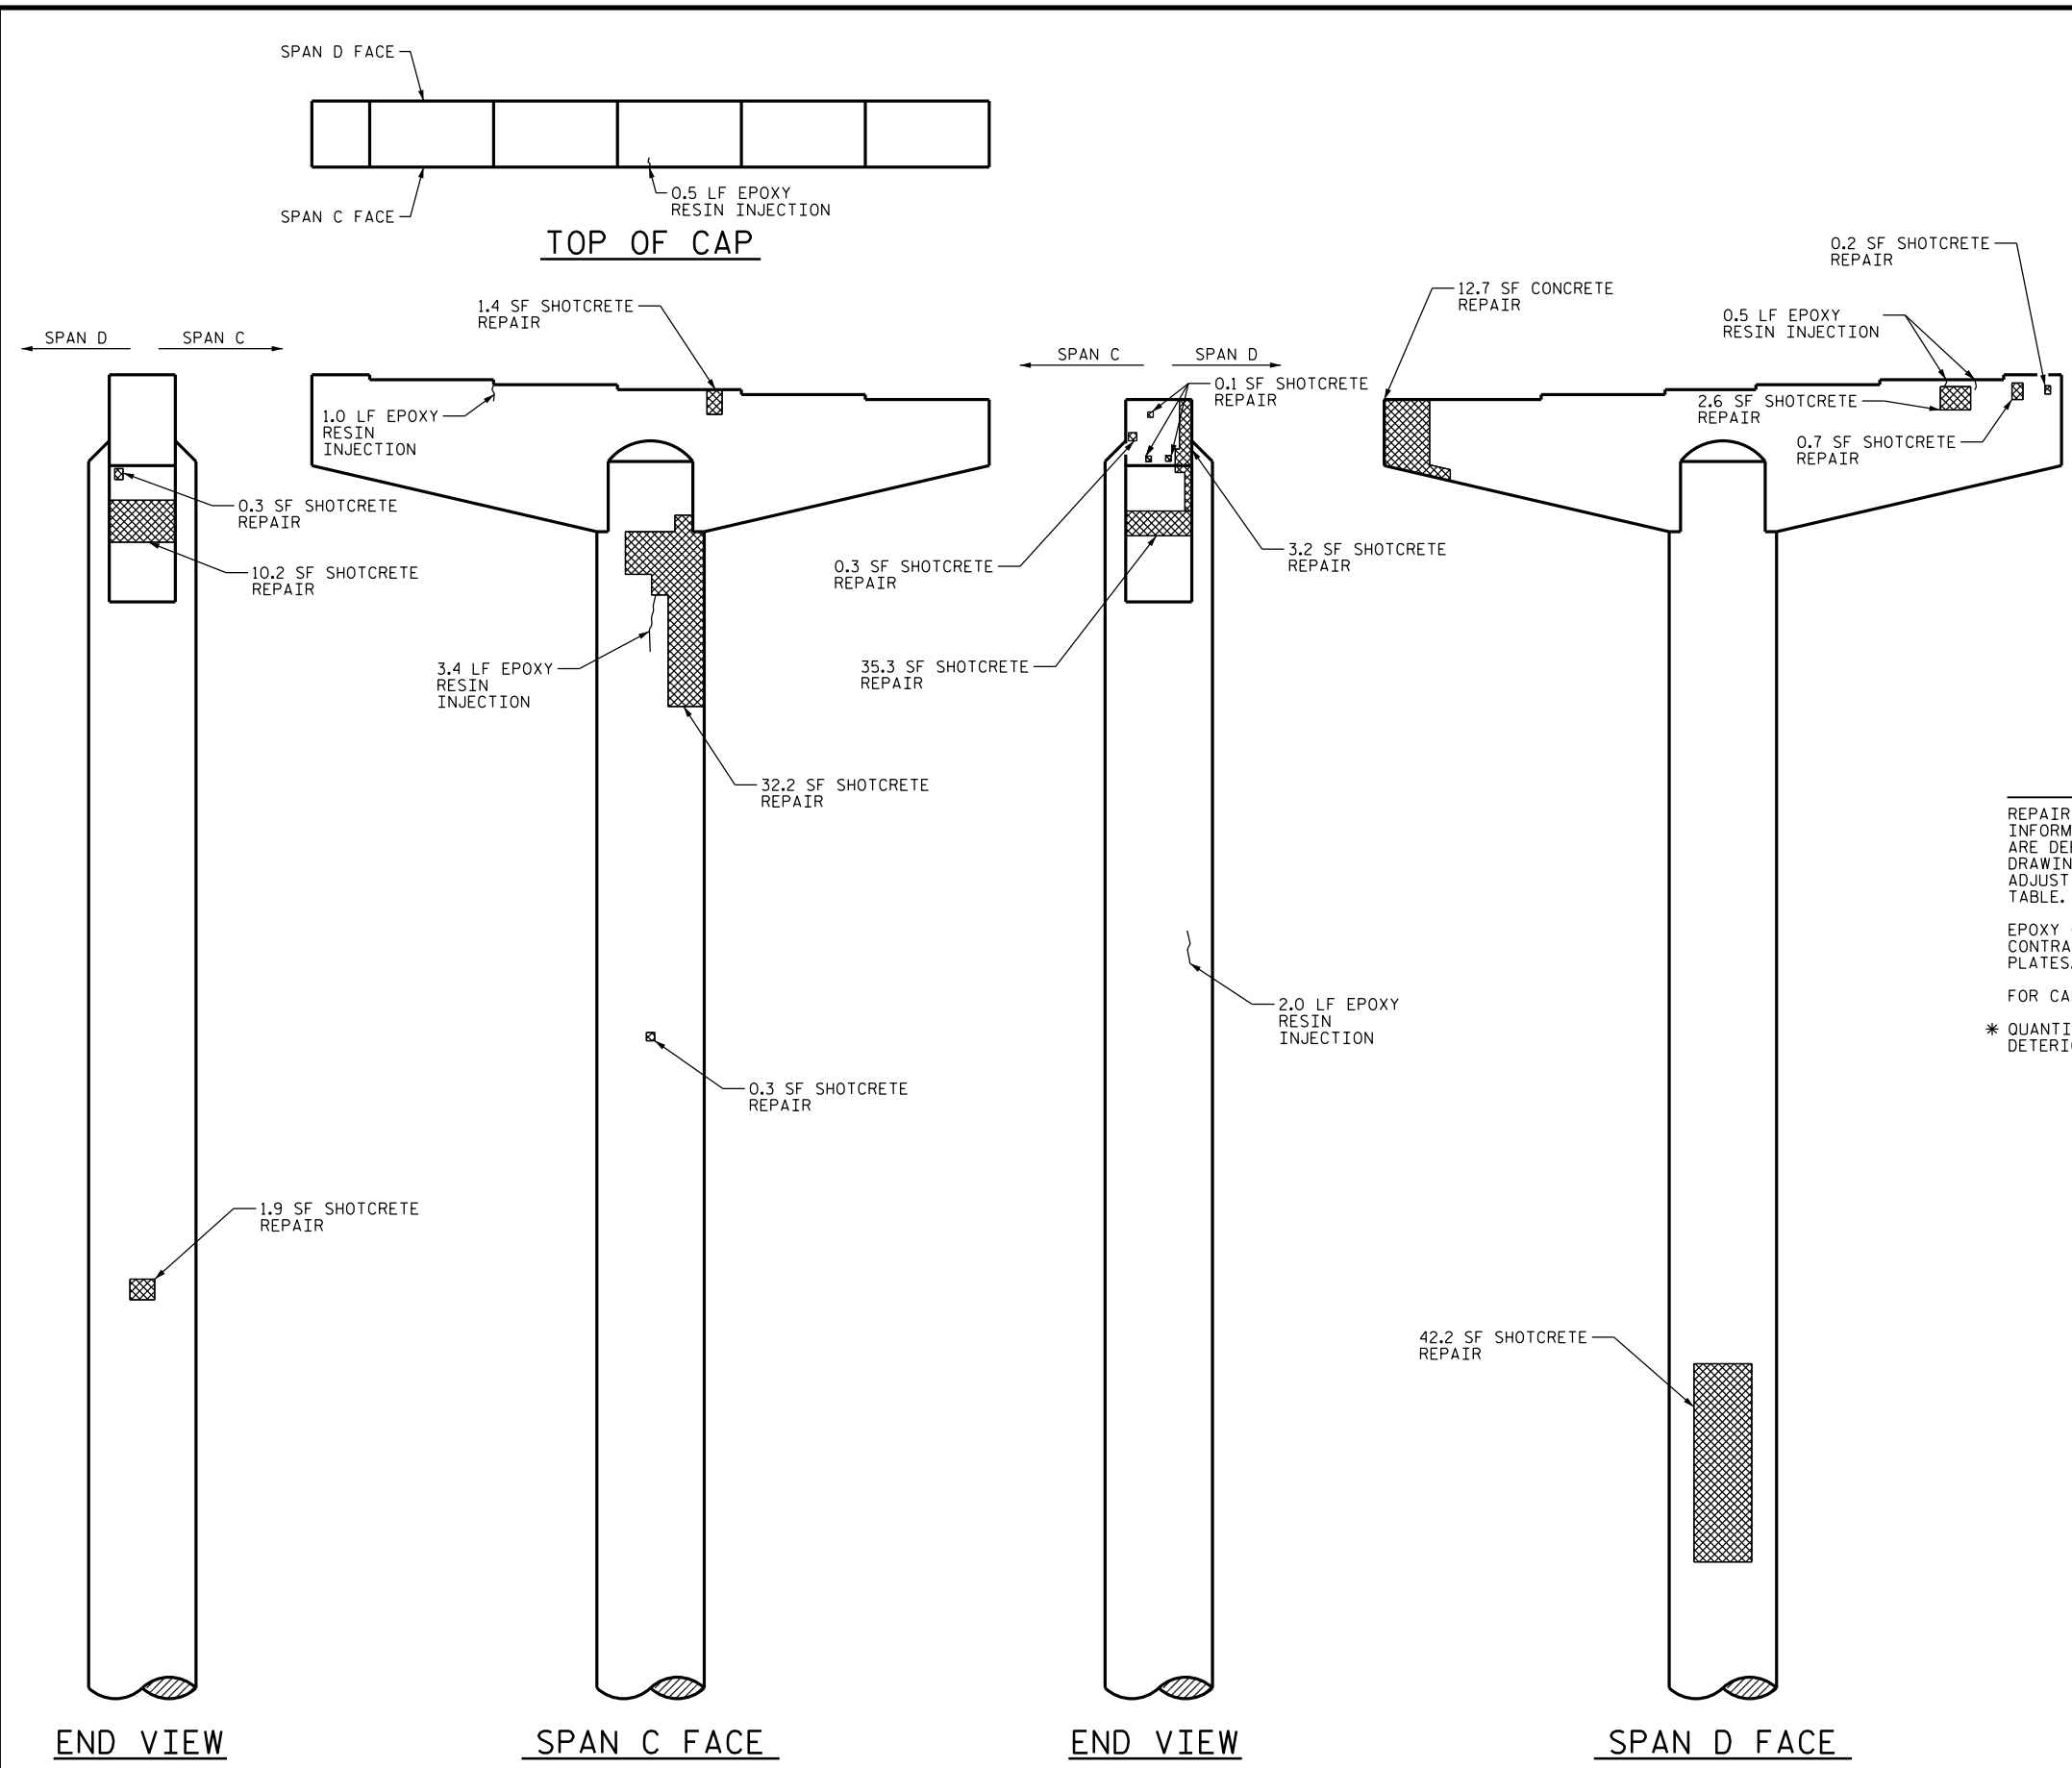
AS-BUILT REPAIR QUANTITY TABLE				
REPAIRS BENT 3	QUANTITIES			
	ESTIMATE		ACTUAL	
SHOTCRETE REPAIRS	AREA SF	VOLUME CF	AREA SF	VOLUME CF
CAP	54.5	48.3*		
COLUMN	76.6	64.6*		
CONCRETE REPAIRS	AREA SF	VOLUME CF	AREA SF	VOLUME CF
CAP	12.7	11.9*		
COLUMN	0.0	0.0		
EPOXY RESIN INJECTION			LN. FT	LN. FT
CAP			2.5	
COLUMN			5.4	
EPOXY COATING			SQ. FT	SQ. FT
TOP OF BENT CAP			164

\* QUANTITY HAS BEEN INCREASED DUE TO THE POTENTIAL FOR FURTHER DETERIORATION SINCE THE FIELD INSPECTION BY STRUCTURES MANAGEMENT UNIT.

EPOXY COATING SHALL BE APPLIED TO THE TOP FACE OF THE CAP. THE CONTRACTOR SHALL NOT COAT THE AREA OF THE CAP BENEATH THE MASONRY PLATES. FOR EPOXY COATING, SEE SPECIAL PROVISIONS.

FOR CAP REPAIRS, SEE "TYPICAL CAP AND COLUMN REPAIR DETAILS" SHEET.
