PROJECT NO. I-5809 McDOWELL COUNTY 138 BRIDGE NO. SHEET 1 OF 2 -DocuSigned by: STATE OF NORTH CAROLINA SEAL 32492 DEPARTMENT OF TRANSPORTATION . NOINEE? BENT 1 9/27/2016 REVISIONS DATE: BY: DATE: S-8 DOCUMENT NOT CONSIDERED FINAL UNLESS ALL SIGNATURES COMPLETED TOTAL SHEETS 68

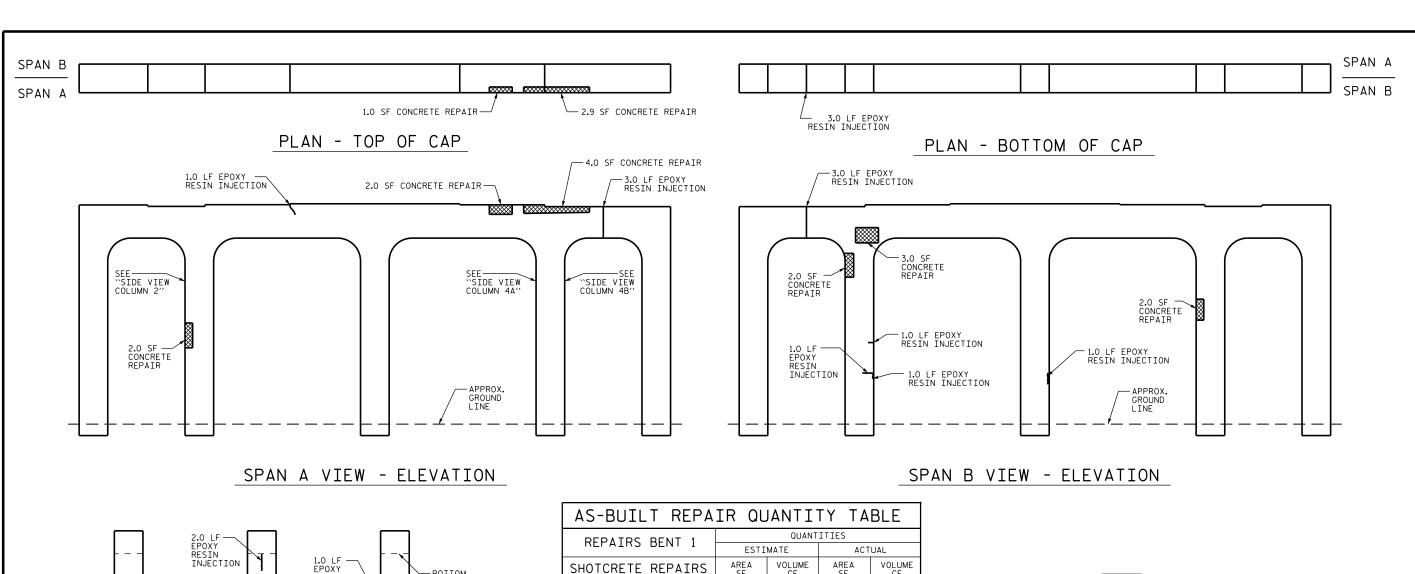
\* QUANTITY HAS BEEN INCREASED DUE TO THE POTENTIAL FOR FURTHER DETERIORATION SINCE THE FIELD INSPECTION BY STRUCTURES MANAGEMENT UNIT.

VALUES IN CHART REPRESENT ESTIMATED REPAIR TOTALS AFTER REMOVAL OF UNSOUND CONCRETE, MINIMUM OF 1" BEHIND REBAR AND MINIMUM 2" CLEAR TO SAWCUT. SEE REPAIR DETAILS.

CLEAN AND REMOVE DEBRIS FROM TOP OF CAP AND APPLY EPOXY PROTECTIVE COATING.EPOXY COATING SHALL BE APPLIED TO THE TOP FACE OF THE CAP. THE CONTRACTOR SHALL NOT COAT THE AREA OF THE CAP BENEATH THE MASONRY PLATES. FOR EPOXY COATING, SEE SPECIAL PROVISIONS.

FOR REPAIR DETAILS, SEE "TYPICAL CAP AND COLUMN REPAIR DETAILS" SHEET.
