PLAN - BOTTOM OF CAP

AS-BUILT REPAIR QUANTITY TABLE				
REPAIRS BENT 1	QUANTITIES			
REPAIRS BENT I	ESTIMATE		ACTUAL	
SHOTCRETE REPAIRS	AREA SF	VOLUME CF	AREA SF	VOLUME CF
CAP	0.0	0.0		
COLUMN	0.0	0.0		
CONCRETE REPAIRS	AREA SF	VOLUME CF	AREA SF	VOLUME CF
CAP	15.7	9.8 *		
COLUMN	0.0	0.0		
EPOXY RESIN INJECTION		LN. FT		LN. FT
CAP		2.0		
COLUMN		0.0		
EPOXY COATING		SQ. FT		SQ. FT
TOP OF BENT CAP		192

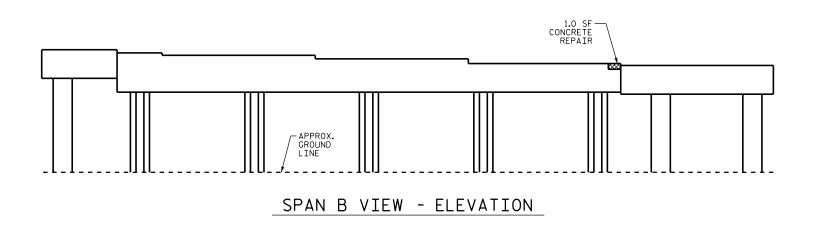
DAMAGED AREA

EPOXY RESIN INJECTION

CLEAN AND REMOVE DEBRIS FROM TOP OF CAP AND APPLY EPOXY PROTECTIVE COATING.EPOXY COATING SHALL BE APPLIED TO THE TOP FACE OF THE CAP. THE CONTRACTOR SHALL NOT COAT THE AREA OF THE CAP BENEATH THE MASONRY PLATES. FOR EPOXY COATING.SEE SPECIAL PROVISIONS.
