AS-BUILT REPA	IR QU	JANTI	ΓΥ ΤΔ	BLE		
REPAIRS BENT 2		QUANT				
SHOTCRETE REPAIRS	AREA	IMATE VOLUME	AREA	VOLUME		
САР	SF 0.0	CF 0.0	SF	CF		
COLUMN	0.0	0.0				
CONCRETE REPAIRS	AREA SF	VOLUME CF	AREA SF	VOLUME CF		
CAP COLUMN	8.4 21.5	5.3 * 14.0 *				
EPOXY RESIN INJECT	ION	LN. FT		LN. FT

1.0 SF CONCRETE REPAIR		EPOXY R	ESIN INJE	CTION		
CONCRETE REPAIR		F	ROJEC	T NO	I-580	9
		_			<u> </u>	
		F		NO	1 - 1	
SIDE VIEW COLUMN 1	Signed by:	_	HEET 2 OF			
John	SEAL 32492 16	nnaccou	ı	STATE OF N RTMENT OF RA	ORTH CAROLINA TRANSPORTA LEIGH	TION
=,=:,=						
		ļ		REVISIONS		SHEET NO.

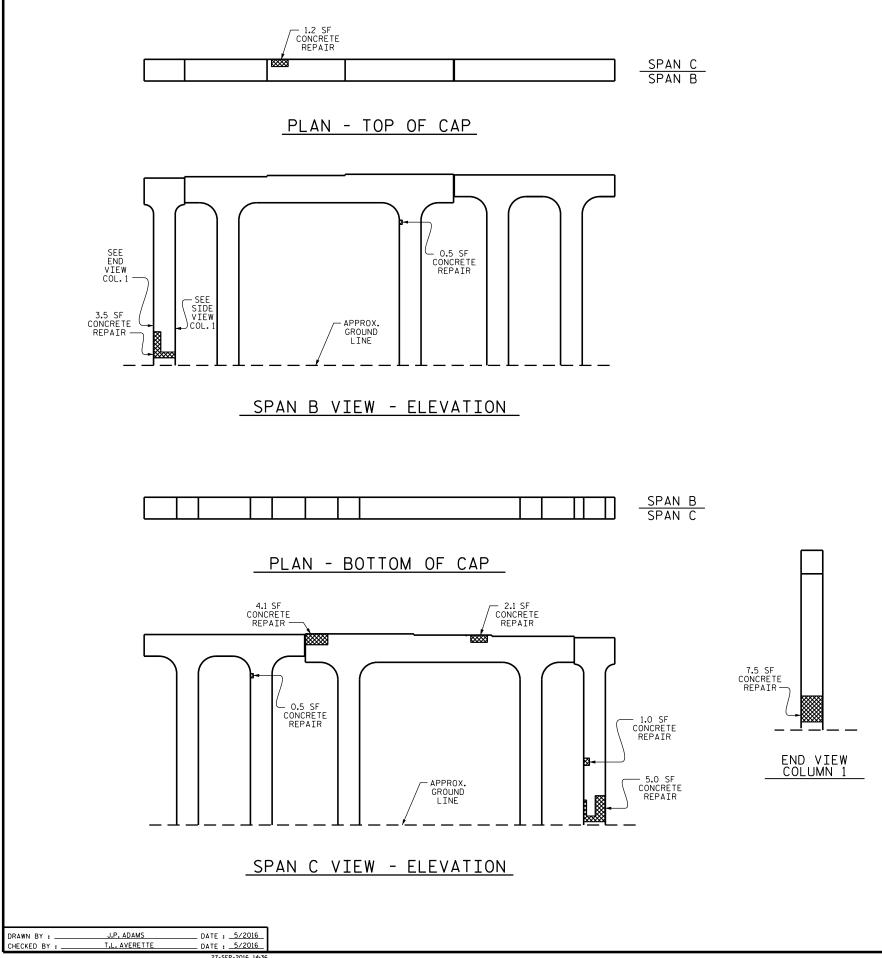
0.0				
		0.0				
EPOXY COATING	EPOXY COATING			SQ. FT		
TOP OF BENT CAP		125	C 15755			
VALUES IN CHART REPRESENT ES REMOVAL OF UNSOUND CONCRETE, MINIMUM 2" CLEAR TO SAWCUT.	MINIMUM (OF 1" BEHIND	LS AFIER REBAR AN	ID		
NOTES:

* QUANTITY HAS BEEN INCREASED FIELD INSPECTION BY STRUCTUF FOR REPAIR DETAILS, SEE ``TYPI FOR BRIDGE JACKING DETAILS, S	RES MANAGE ICAL CAP A	MENT UNIT.	REPAIR DE			E THE
		DAMAGED	AREA
