* QUANTITY HAS BEEN INCREASED DUE TO THE POTENTIAL FOR FURTHER DETERIORATION SINCE THE FIELD INSPECTION BY STRUCTURES MANAGEMENT UNIT.					
FOR REPAIR DETAILS, SEE ``TYPICAL CAP AND COLUMN REPAIR DETAILS' SHEET.					
DAMAGED AREA					
EPOXY RESIN INJECTION					
PROJECT NO. <u>I-5809</u> <u>McDOWELL</u> COUNTY BRIDGE NO. <u>152</u> SHEET 1 OF 3					
John Multiple Martine Department of TRANSPORTATION TOCING SEAL SEAL TOCHES OF MORTH CAROLINA DEPARTMENT OF TRANSPORTATION RALEIGH BENT 1					
9/27/2016					
F	IENT NOT INAL UNLE NATURES C	CONSIDERED SS ALL OMPLETED	№. ву: 1 2	REVISIO DATE: NO 3	BY: DATE: S-54

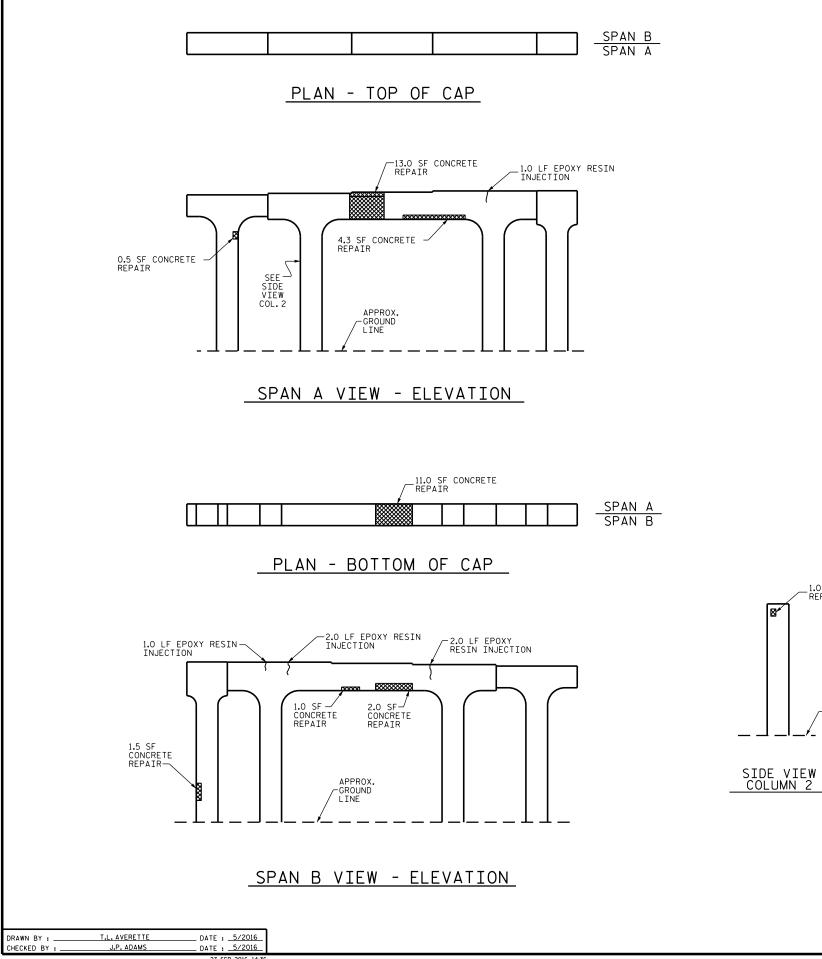
1
	IR QUANTITY TABLE				-
REPAIRS BENT 1	EST	ESTIMATE ACTUAL		TUAL	
SHOTCRETE REPAIRS	AREA SF	VOLUME CF	AREA SF	VOLUME CF	
САР	0.0	0.0			-
COLUMN	0.0	0.0			-
CONCRETE REPAIRS	AREA SF	VOLUME CF	AREA SF	VOLUME CF	
CAP	31.3	20.0 *			-
COLUMN	3.0	2.0 *			-
EPOXY RESIN INJECTION		LN. FT		LN. FT	
CAP COLUMN		6.0 0.0			-
					-
EPOXY COATING		SQ. FT		SQ. FT	
TOP OF BENT CAP		113			-
NOTES: REPAIR LOCATIONS AND ESTIMATE OF QUANTITIES ARE GIVEN WITH THE BEST INFORMATION AVAILABLE. IF ADDITIONAL REPAIRS NOT SHOWN ON THE DRAWINGS ARE DEEMED NECESSARY BY THE ENGINEER. THE ENGINEER WILL NOTE ON THE DRAWINGS THE APPROXIMATE LOCATION AND DESCRIPTION OF THE REPAIRS AND ADJUST THE ACTUAL QUANTITIES ENTERED INTO THE REPAIR QUANTITY TABLE.					
CLEAN AND REMOVE DEBRIS FROM TOP OF CAP AND APPLY EPOXY PROTECTIVE COATING.EPOXY COATING SHALL BE APPLIED TO THE TOP FACE OF THE CAP. THE CONTRACTOR SHALL NOT COAT THE AREA OF THE CAP BENEATH THE MASONRY PLATES. FOR EPOXY COATING,SEE SPECIAL PROVISIONS.

_1.0 SF CONCRETE REPAIR
