PROJECT NO. I-5000  
GASTON COUNTY  
 BRIDGE NO. 120

SHEET 1 OF 3

STATE OF NORTH CAROLINA  
 DEPARTMENT OF TRANSPORTATION  
 RALEIGH

**BENT 2**  
 (LEFT SECTION)

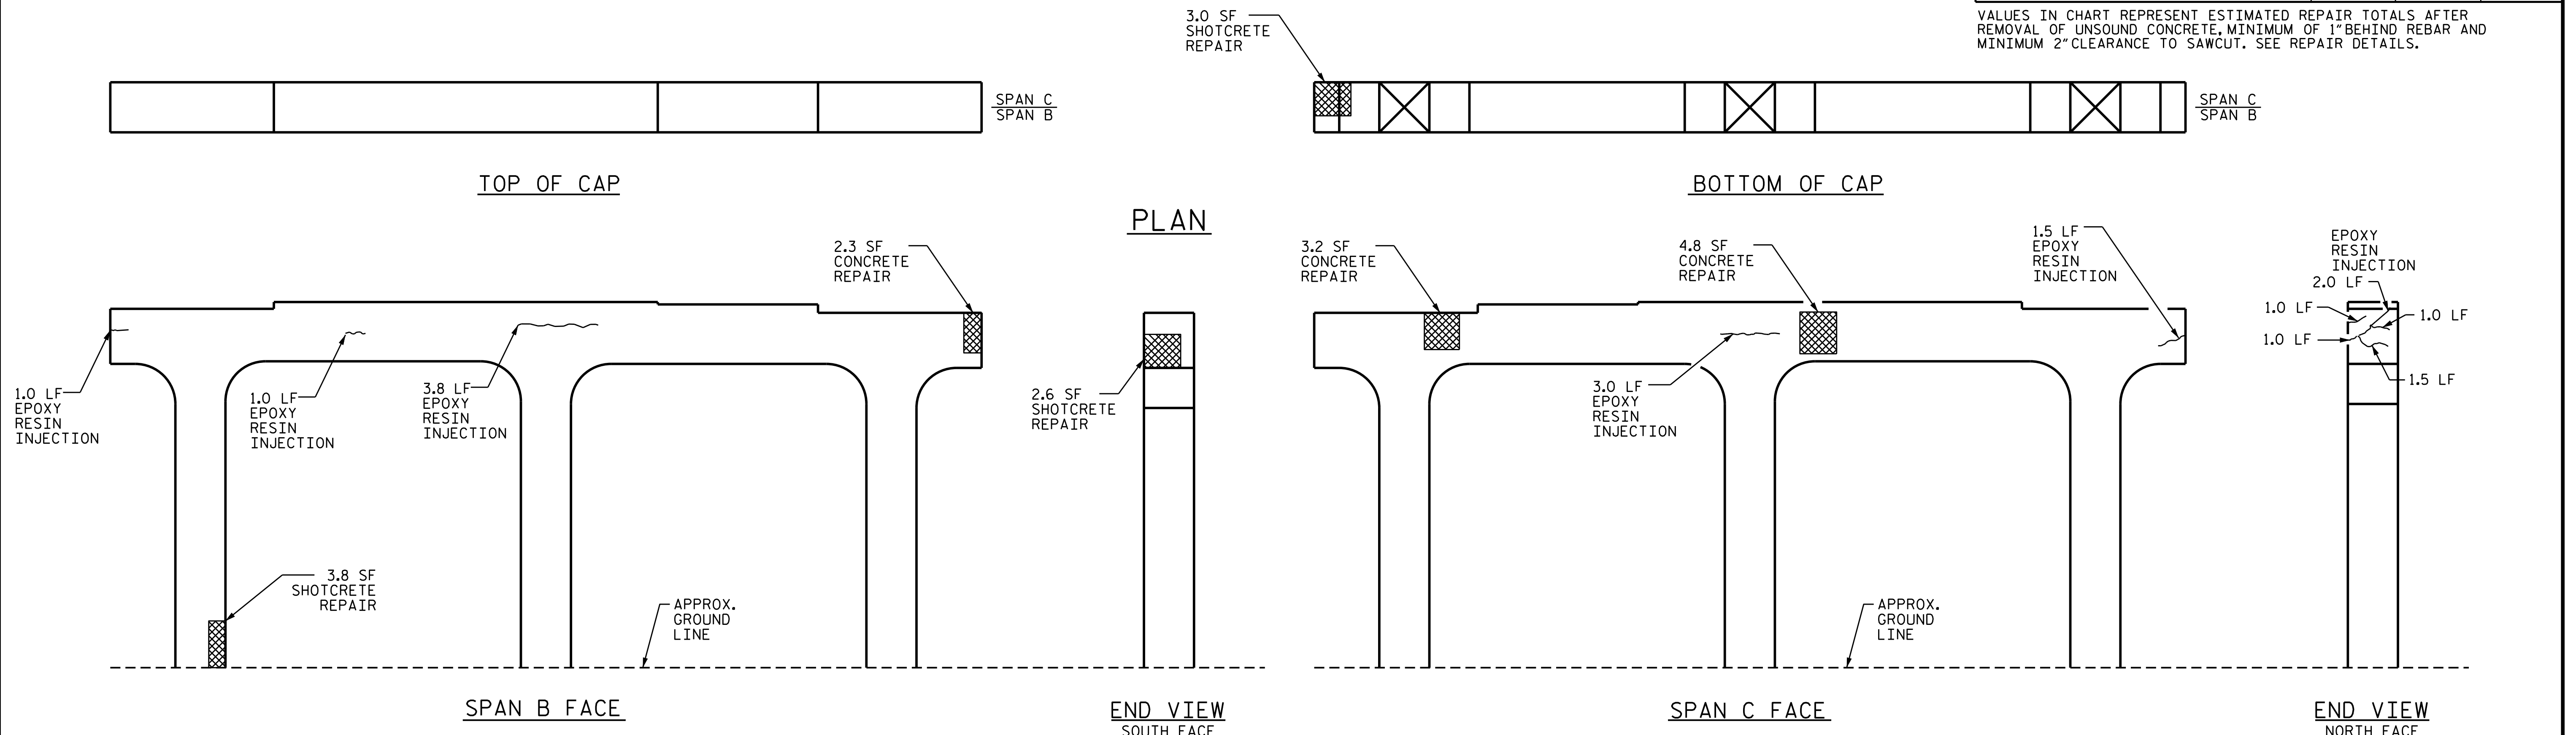
ELEVATION

\* QUANTITY HAS BEEN INCREASED DUE TO THE POTENTIAL FOR FURTHER DETERIORATION SINCE THE FIELD INSPECTION BY STRUCTURES MANAGEMENT UNIT.

VALUES IN CHART REPRESENT ESTIMATED REPAIR TOTALS AFTER REMOVAL OF UNSOUND CONCRETE, MINIMUM OF 1" BEHIND REBAR AND MINIMUM 2" CLEARANCE TO SAWCUT. SEE REPAIR DETAILS.

SHOTCRETE REPAIRS MAY BE SUBSTITUTED IN LIEU OF CONCRETE REPAIRS WITH THE APPROVAL OF THE ENGINEER.

FOR CAP REPAIR DETAILS, SEE "TYPICAL CAP AND COLUMN REPAIR DETAILS" SHEET.

EPOXY COATING SHALL BE APPLIED TO THE TOP FACE OF THE CAP. THE CONTRACTOR SHALL NOT COAT THE AREA OF THE CAP BENEATH THE MASONRY PLATES. FOR EPOXY COATING, SEE SPECIAL PROVISIONS.
