PROJECT NO. I-5000
GASTON COUNTY
 BRIDGE NO. 120

SHEET 4 OF 6

STATE OF NORTH CAROLINA
 DEPARTMENT OF TRANSPORTATION
 RALEIGH

**BENT 4
 SPAN E FACE
 (CENTER SECTION)**

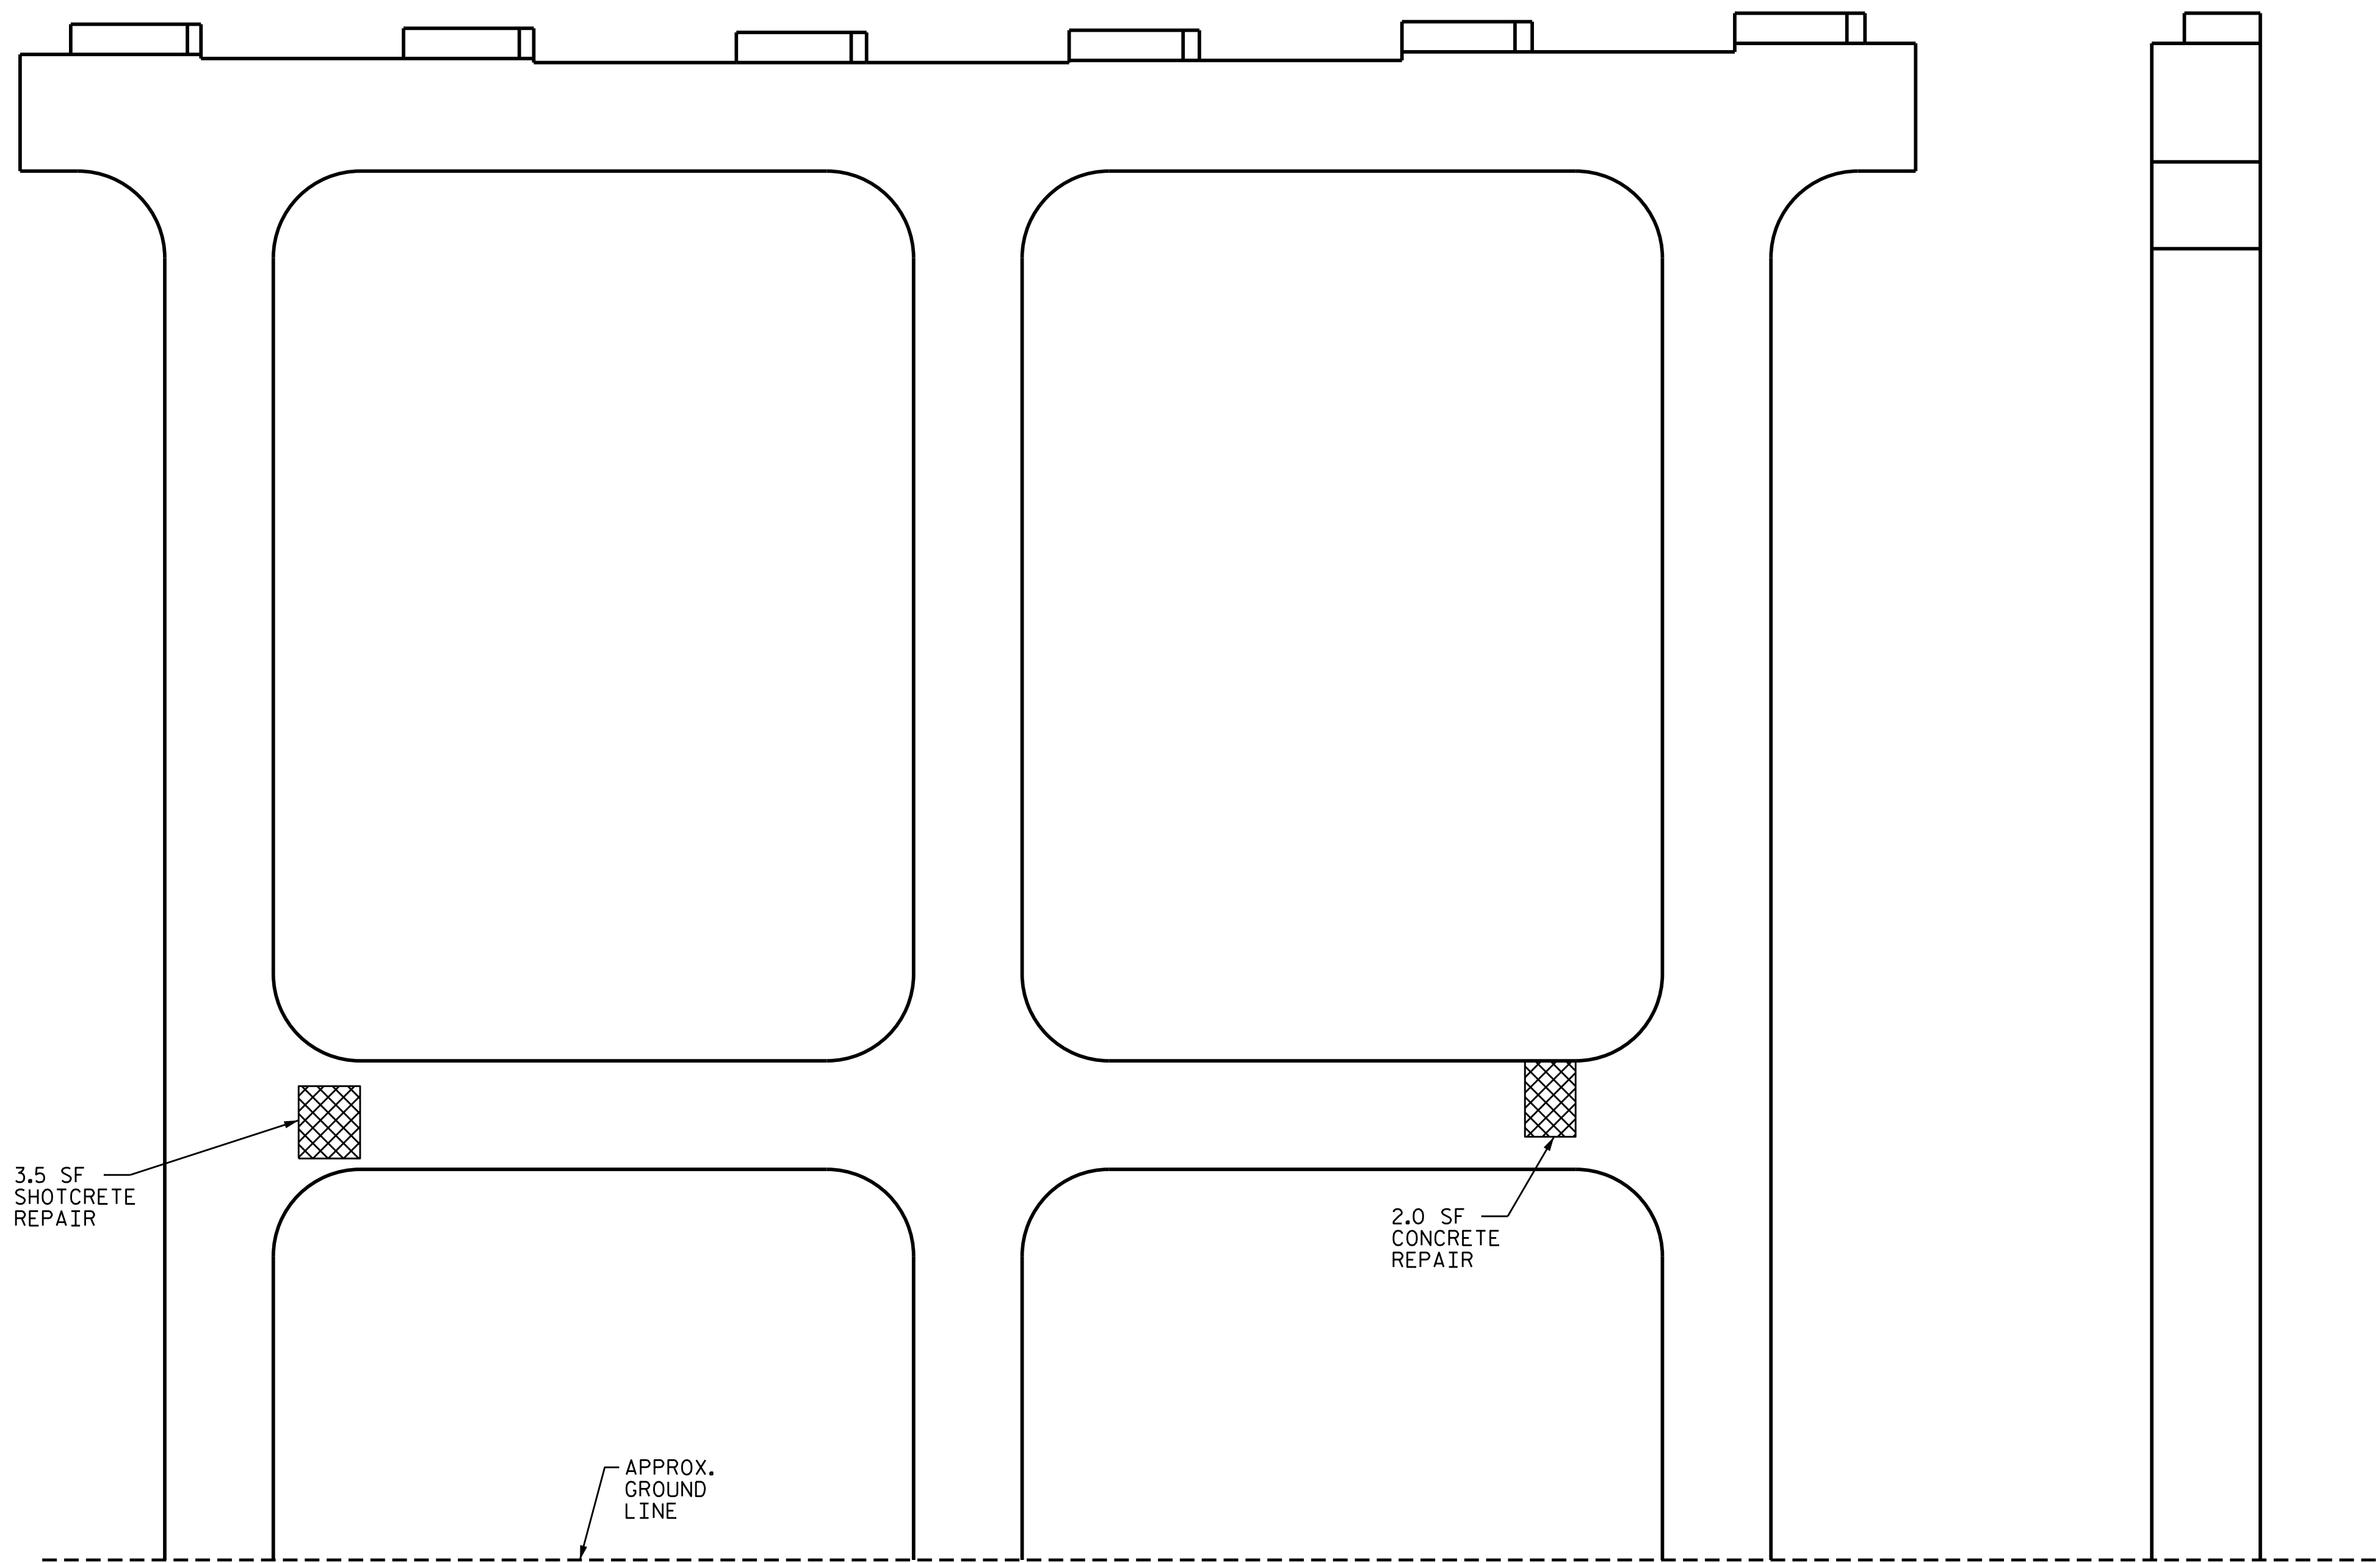
* QUANTITY HAS BEEN INCREASED DUE TO THE POTENTIAL FOR FURTHER DETERIORATION SINCE THE FIELD INSPECTION BY STRUCTURES MANAGEMENT UNIT.

CONCRETE REPAIRS TO THE BENT CAP MAY REQUIRE BRIDGE JACKING. FOR BRIDGE JACKING, SEE "JACKING DETAILS" SHEET.

EPOXY COATING SHALL BE APPLIED TO THE TOP FACE OF THE CAP. THE CONTRACTOR SHALL NOT COAT THE AREA OF THE CAP BENEATH THE MASONRY PLATES. FOR EPOXY COATING, SEE SPECIAL PROVISIONS.
