PROJECT NO. I-5781  
JOHNSTON COUNTY  
 BRIDGE NO. 497

STATE OF NORTH CAROLINA  
 DEPARTMENT OF TRANSPORTATION  
 RALEIGH  
**SUBSTRUCTURE**  
 REPAIR  
 BENT 1

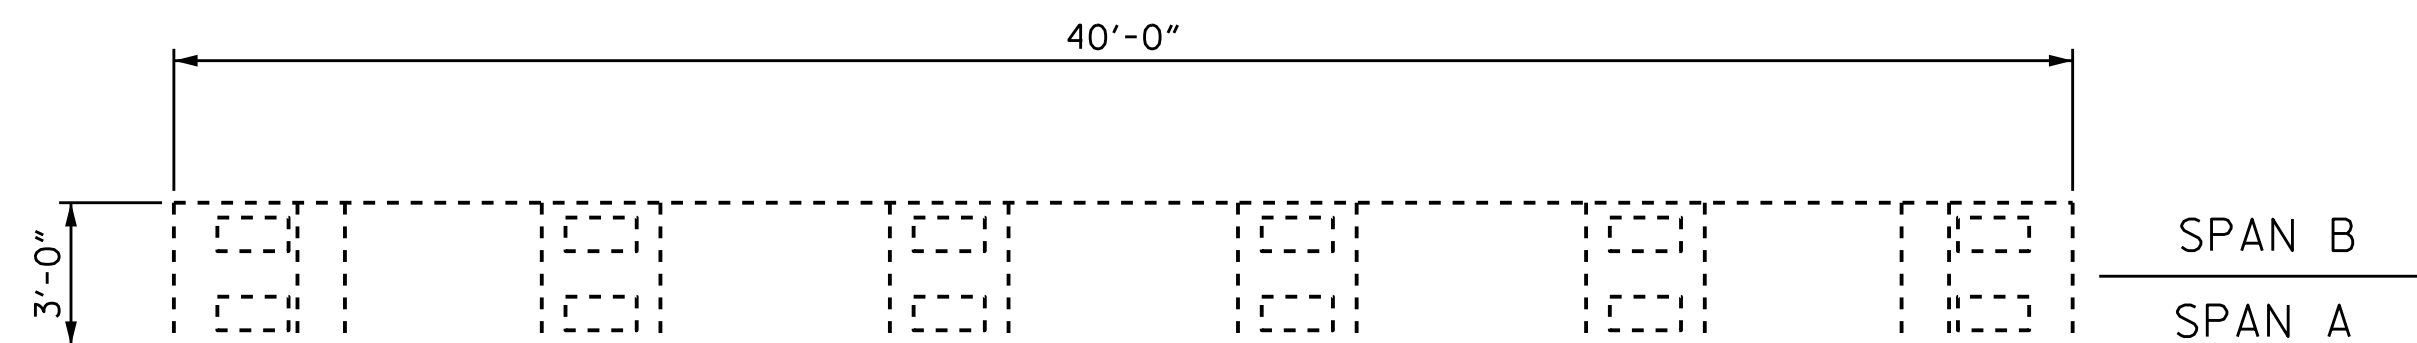
PLAN  
TOP OF CAP

BENT 1	QUANTITIES			
	ESTIMATE		ACTUAL	
SHOTCRETE REPAIRS	AREA SF	VOLUME CF	AREA SF	VOLUME CF
CAP (VERTICAL FACE)	0.0	0.0		
CAP (HORIZONTAL, CORNER)	0.0	0.0		
COLUMN	0.0	0.0		
EPOXY RESIN INJECTION		LN. FT.		LN. FT.
CAP		0.0		
COLUMN		0.0		
EPOXY COATING	AREA SF			
TOP OF CAP	120.0
