NC DEPARTMENT OF TRANSPORTATION      ATTENTION:  
 DIVISION OF HIGHWAYS  
 STRUCTURE MANAGEMENT UNIT

# Structure Safety Report

## 4 Year Underwater Element Inspection

COUNTY: NEW HANOVER      STRUCTURE NUMBER: 640013      FREQUENCY: 48 MONTHS

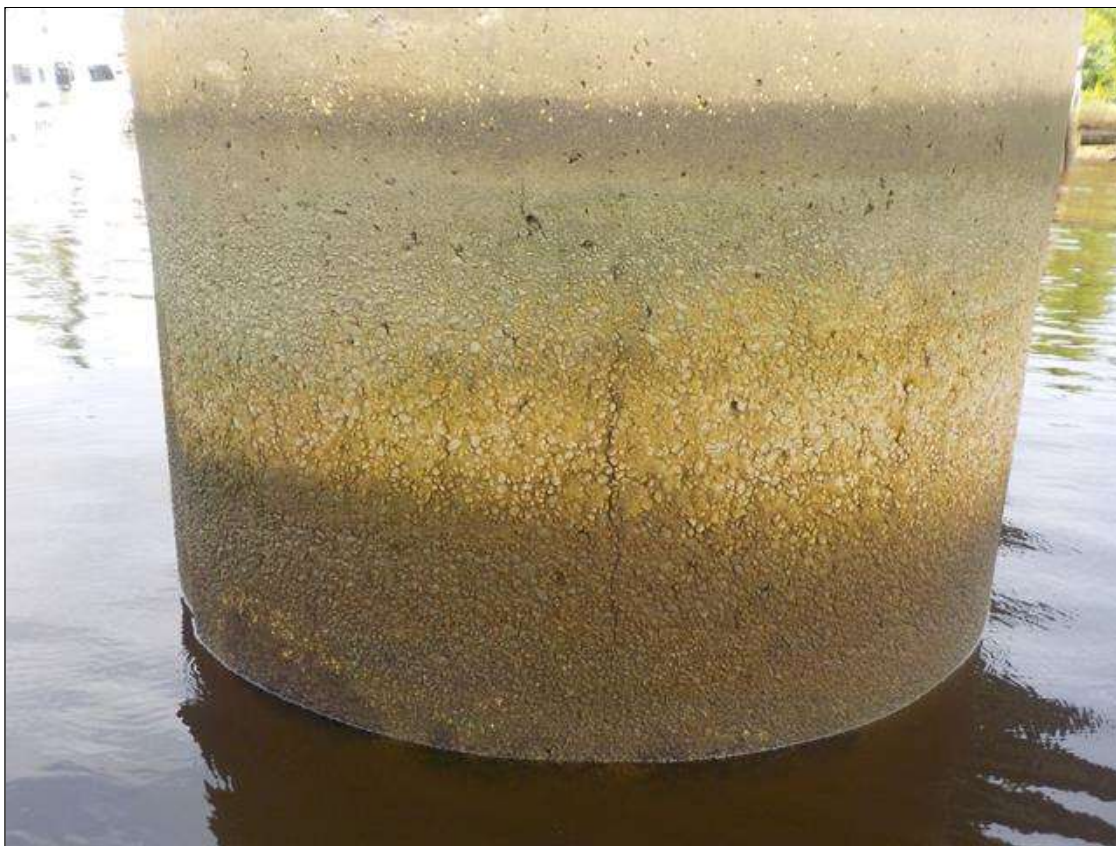
BENT 13, C-2, COARSE AGG

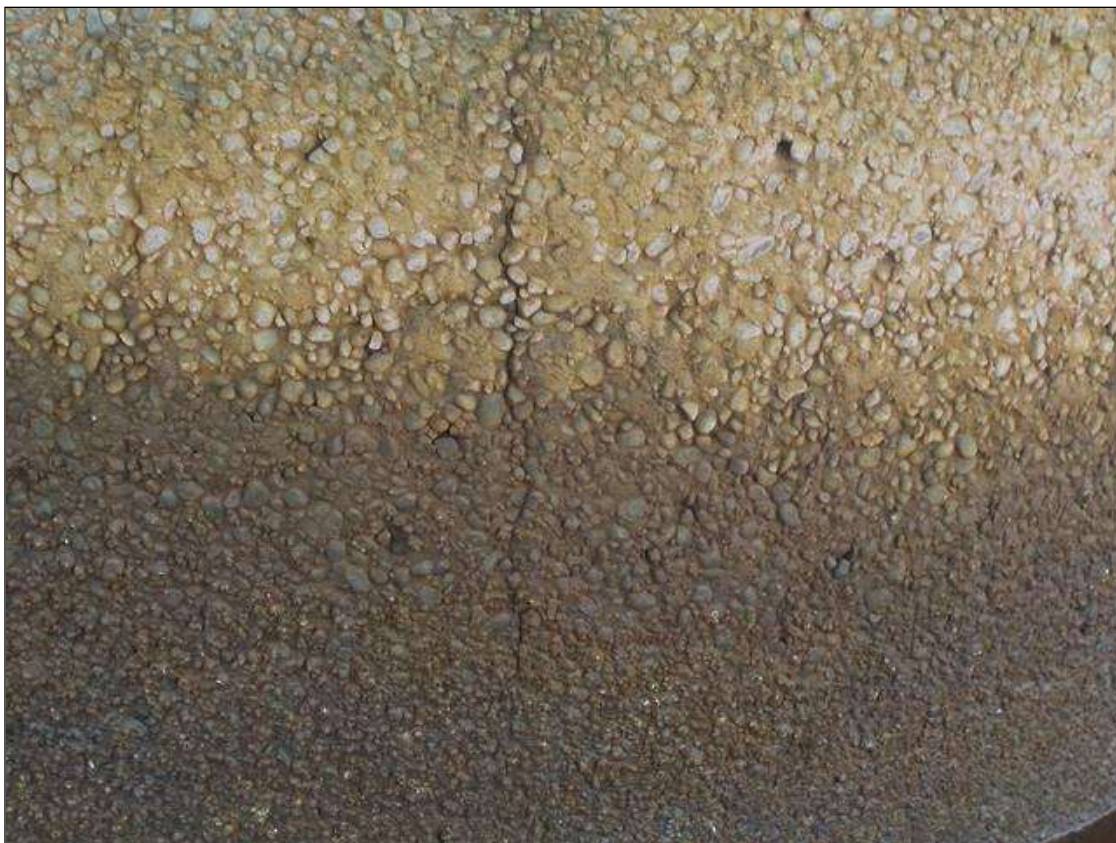
BENT 13, C-2, CRACK-1/16" SPALLED TO 1/8", EAST FACE. NORTH AND SOUTH SIMILAR-3 CRACKS.

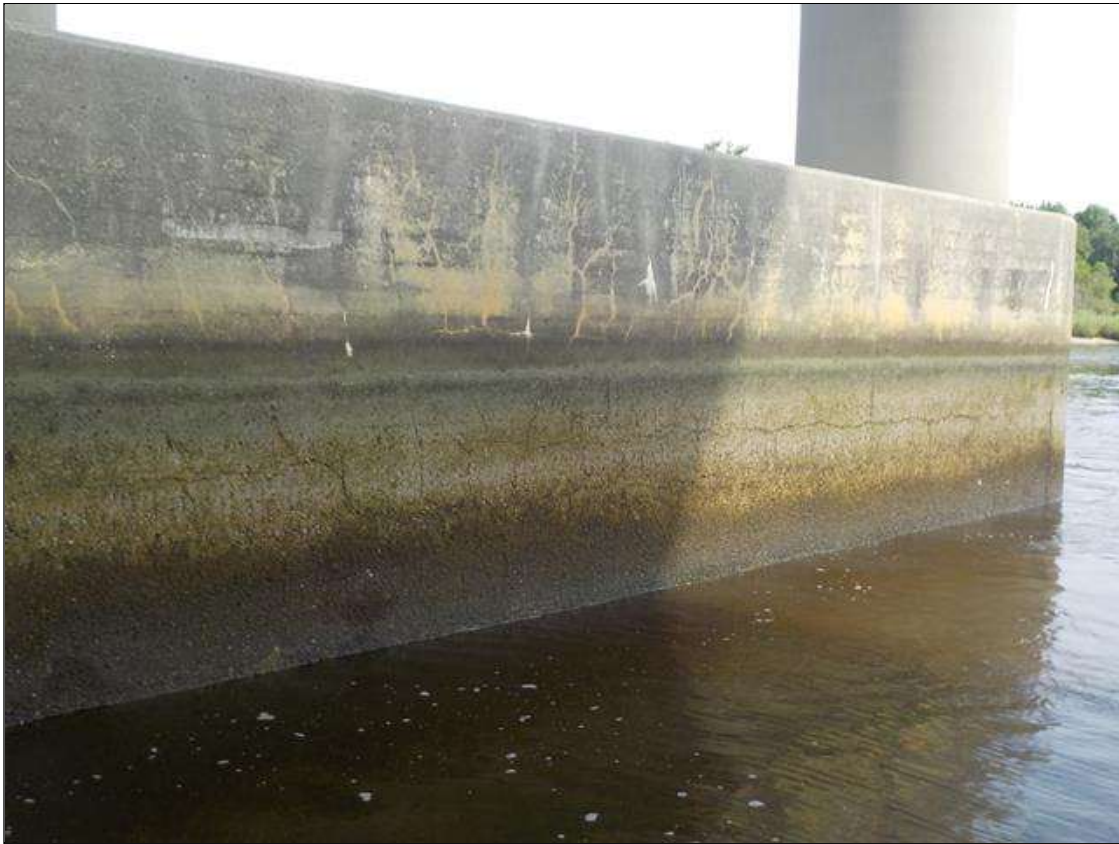
BENT 14, HORZ. CRACK 1/8", WITH VERTICAL CRACK 1/16" FULL LENGTH TZ

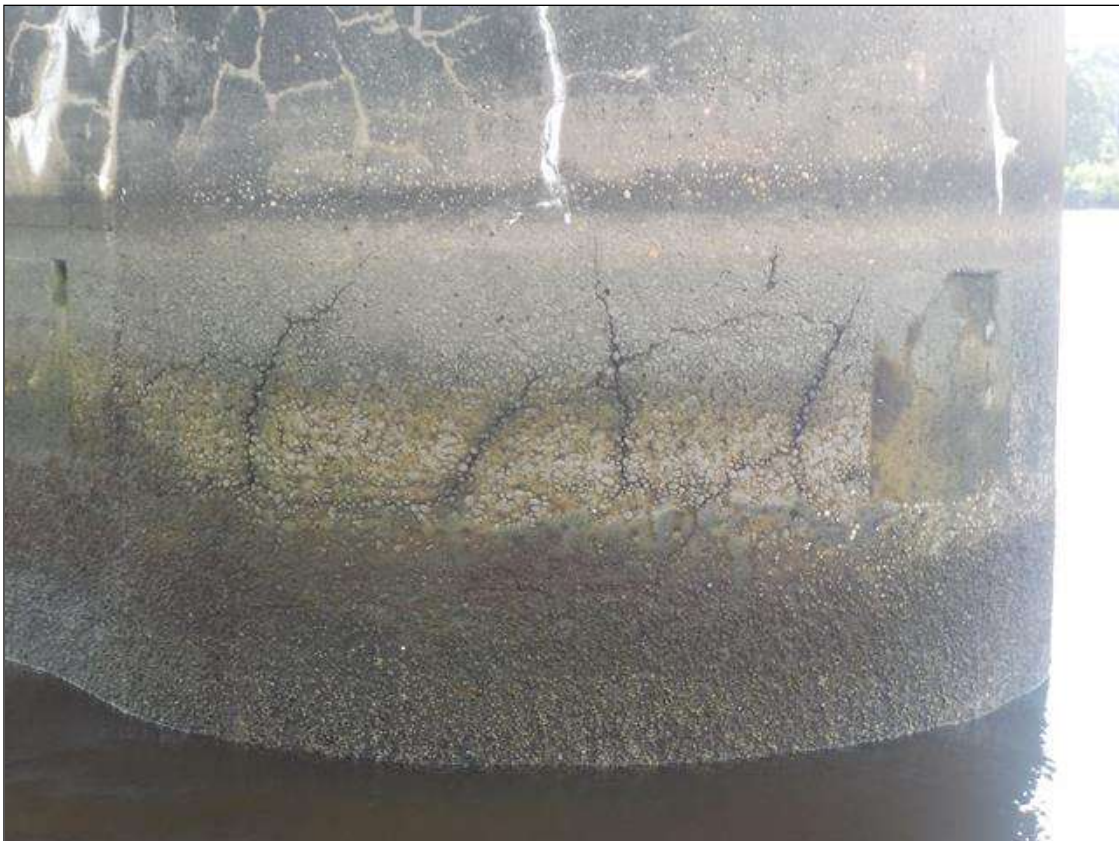
BENT 15, HORZ. /VERTICAL CRACKING TO 1/8" FULL LENGTH TZ

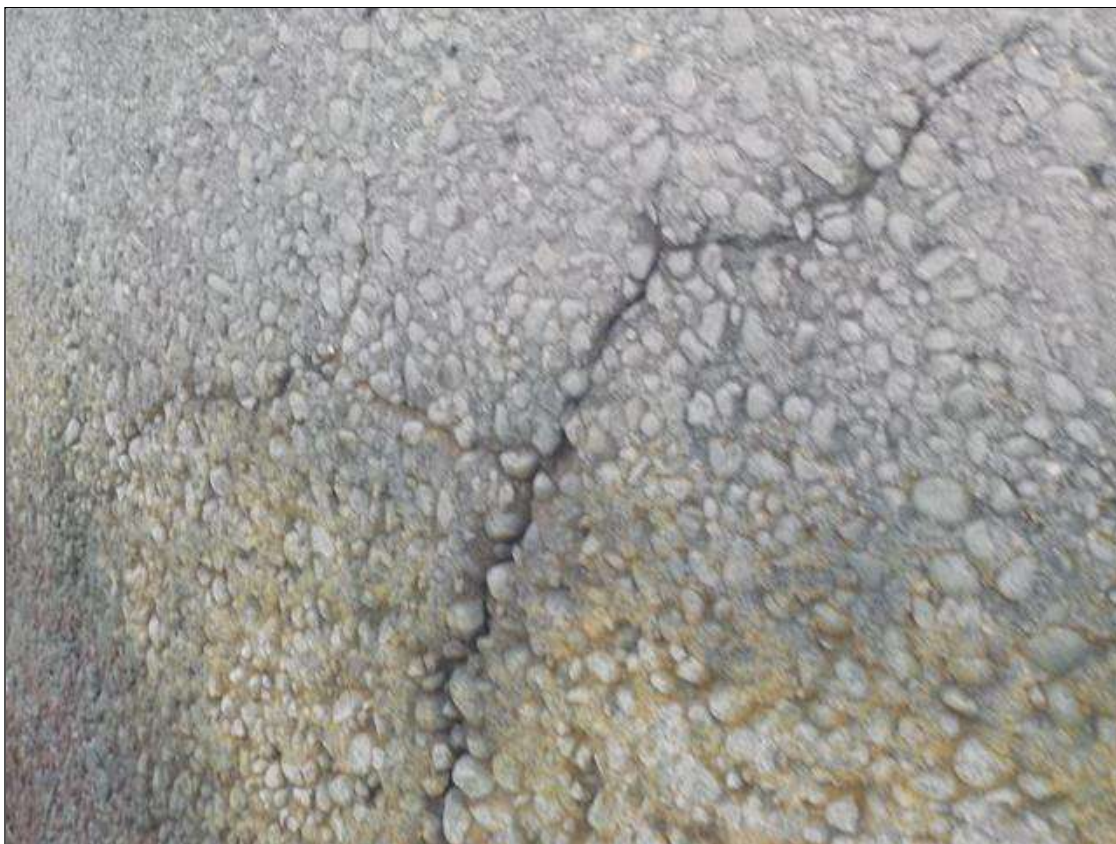
BENT 15, COARSE AGG EXPOSED TO 1/2"

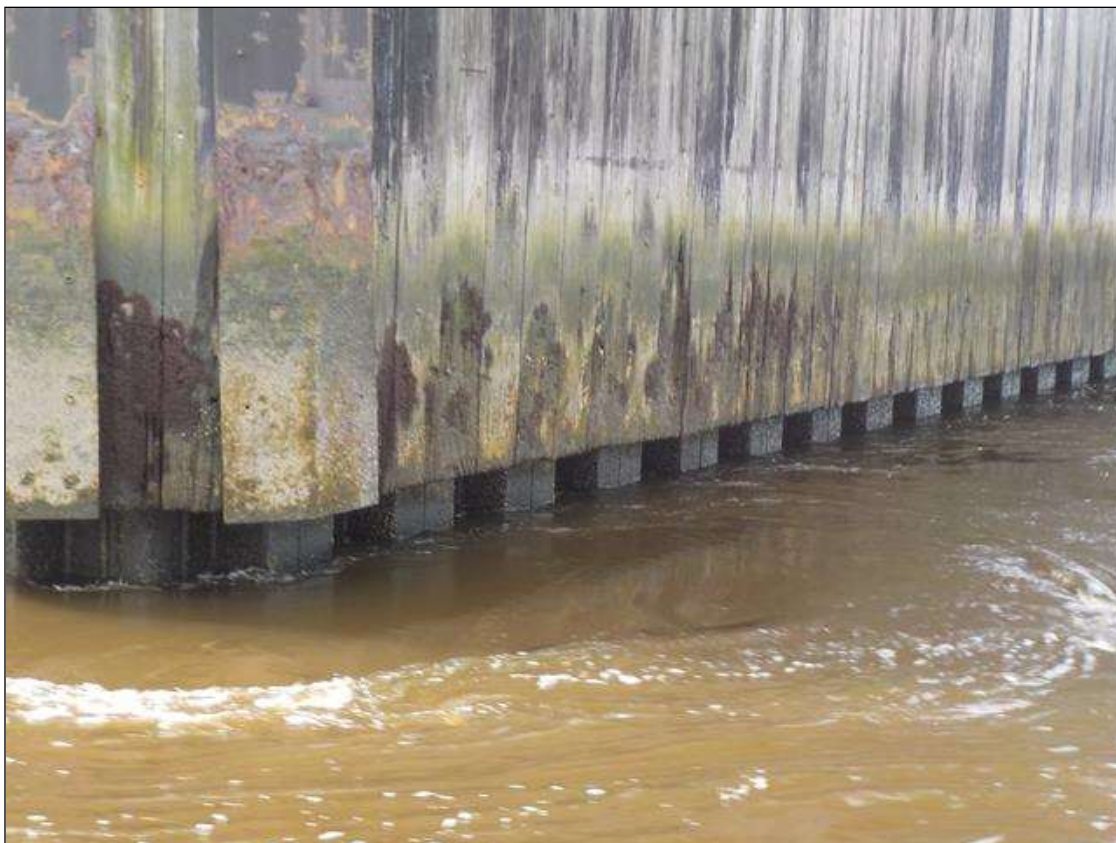
DECAYING TIMBERS BENT 17- VERTICALS

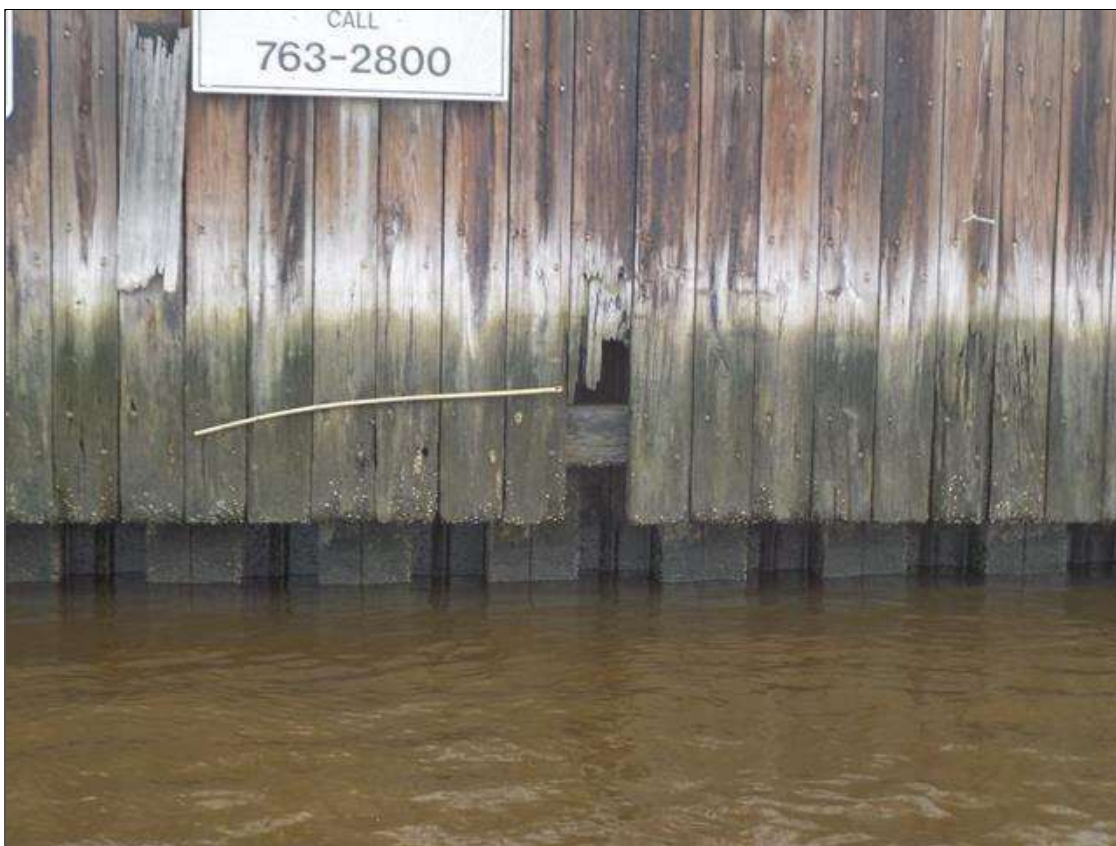
BENT 17 DECAY ON TIMBER- VERTICAL

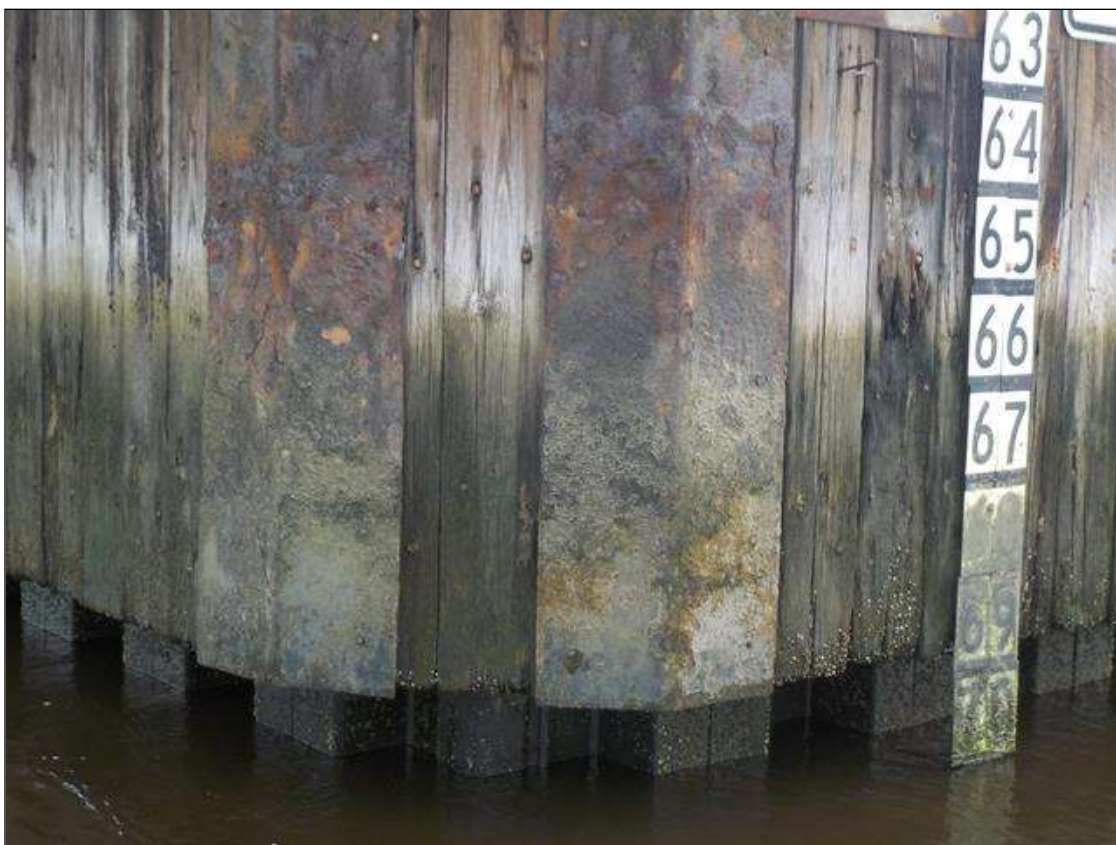
BENT 17, RUST ON COVER PLATES

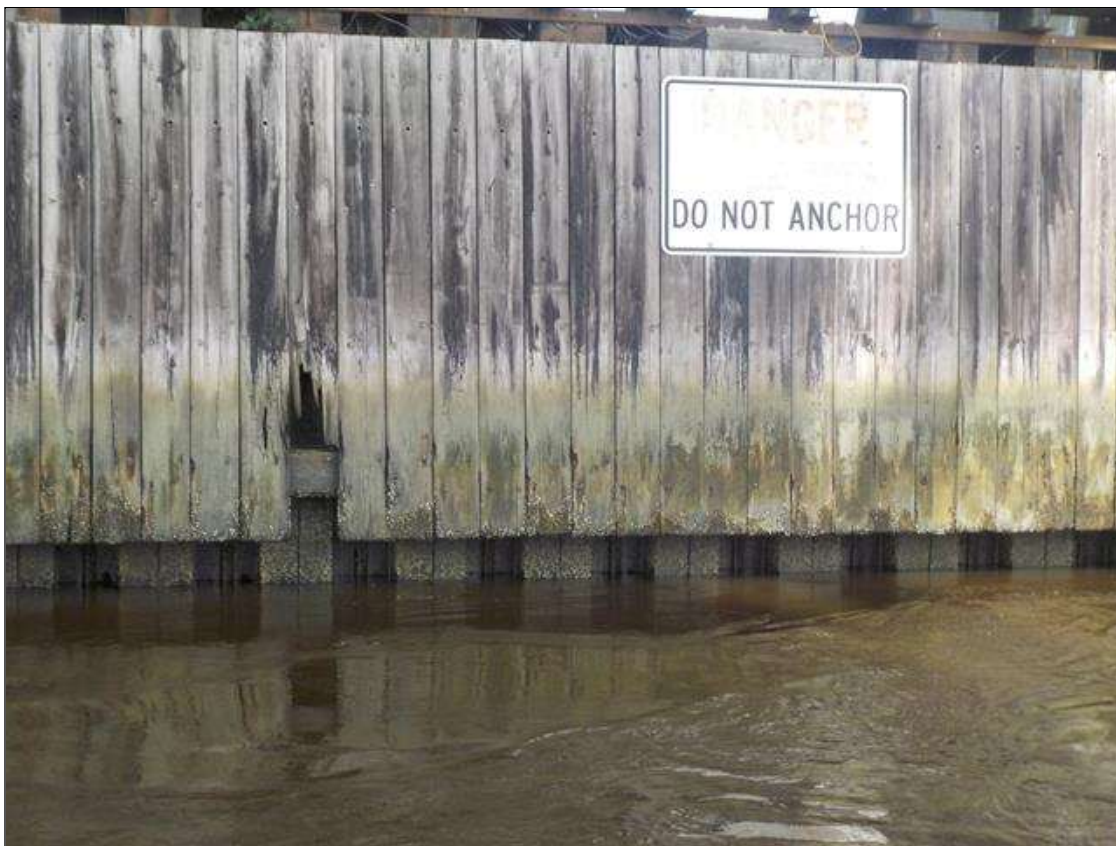
BENT 16, DECAY ON TIMBER- VERTICALS

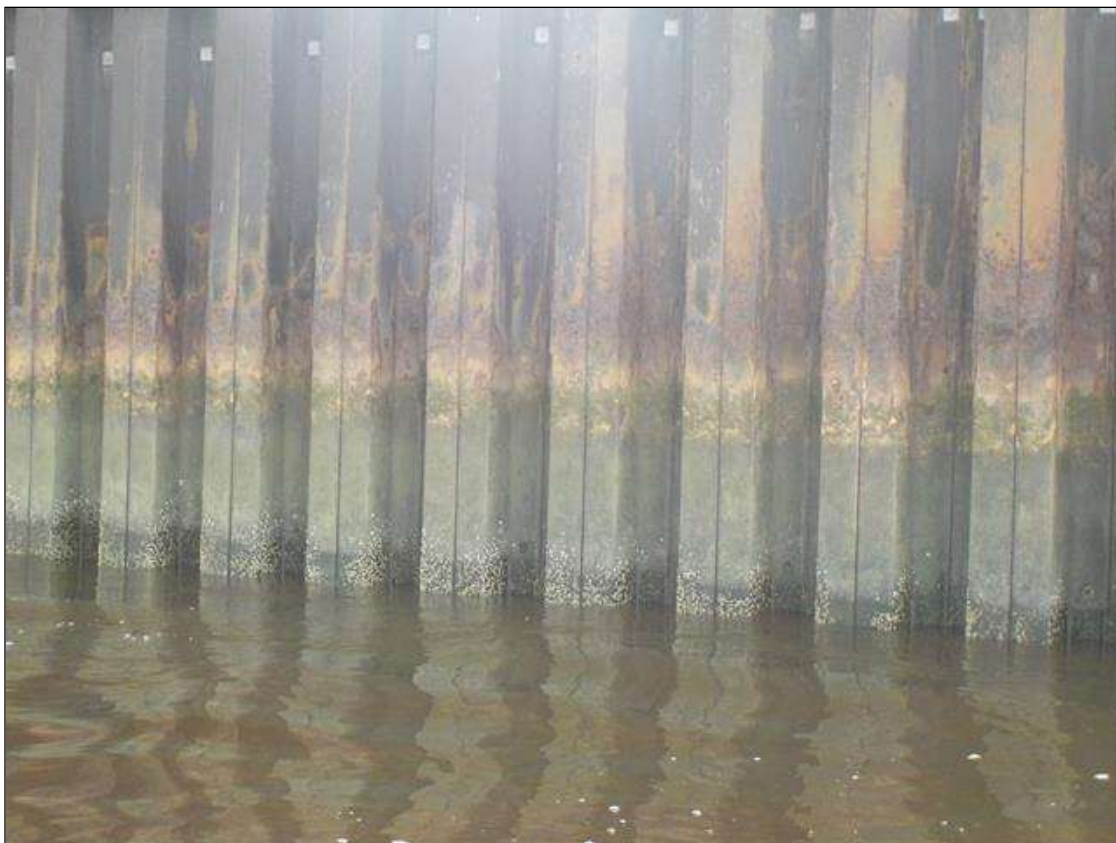
BENT 16, RUST BLISTERS ON SHEET PILE

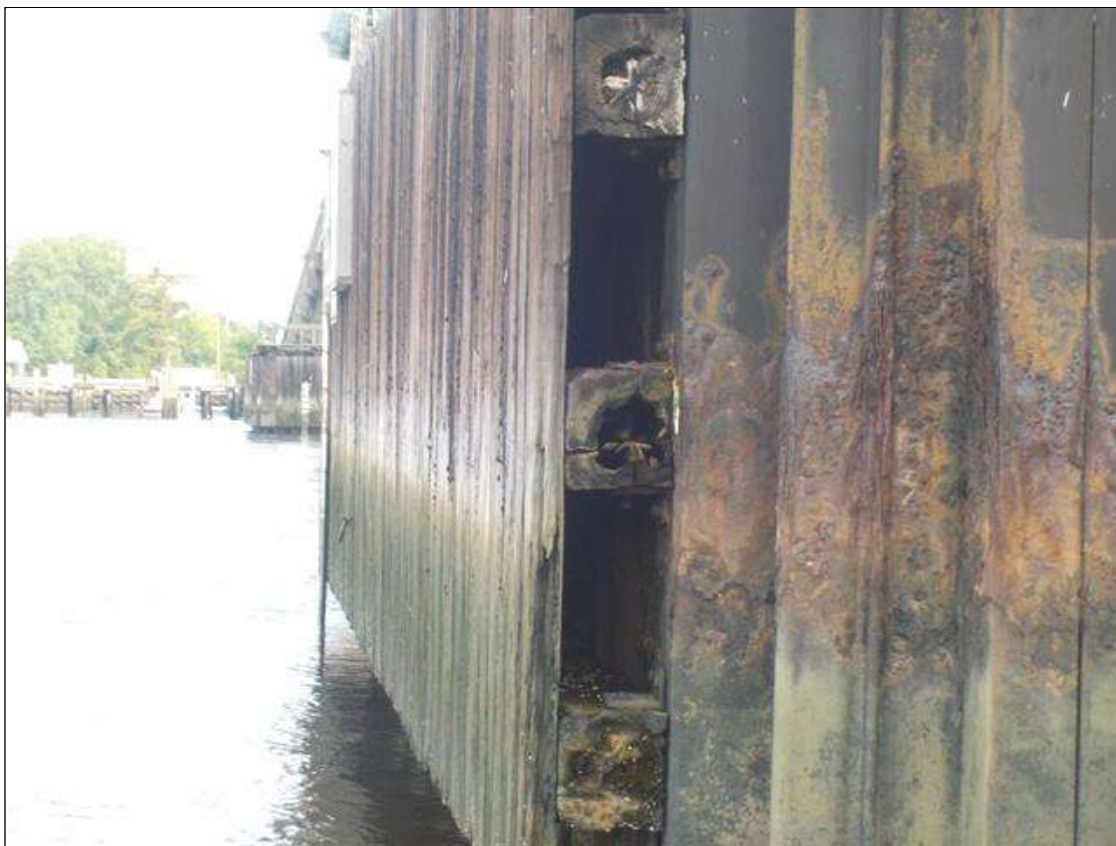
BENT 19, TIMBER DECAY ON WHALERS
