NC DEPARTMENT OF TRANSPORTATION
 DIVISION OF HIGHWAYS
 STRUCTURE MANAGEMENT UNIT

Structure Safety Report

Fracture Critical and Machinery Element Inspection

COUNTY: NEW HANOVER STRUCTURE NUMBER: 640013 FREQUENCY: 24 MONTHS

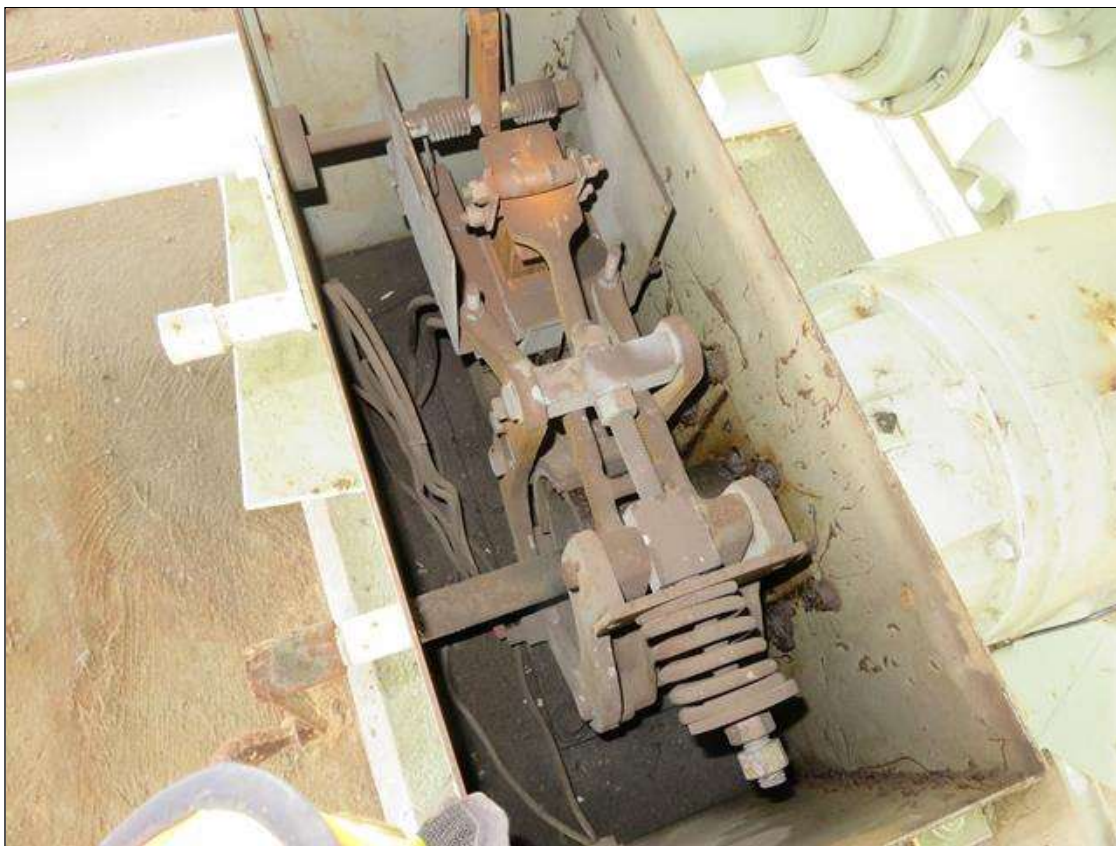
WEST END SPEED REDUCER BRAKE (FAIR)

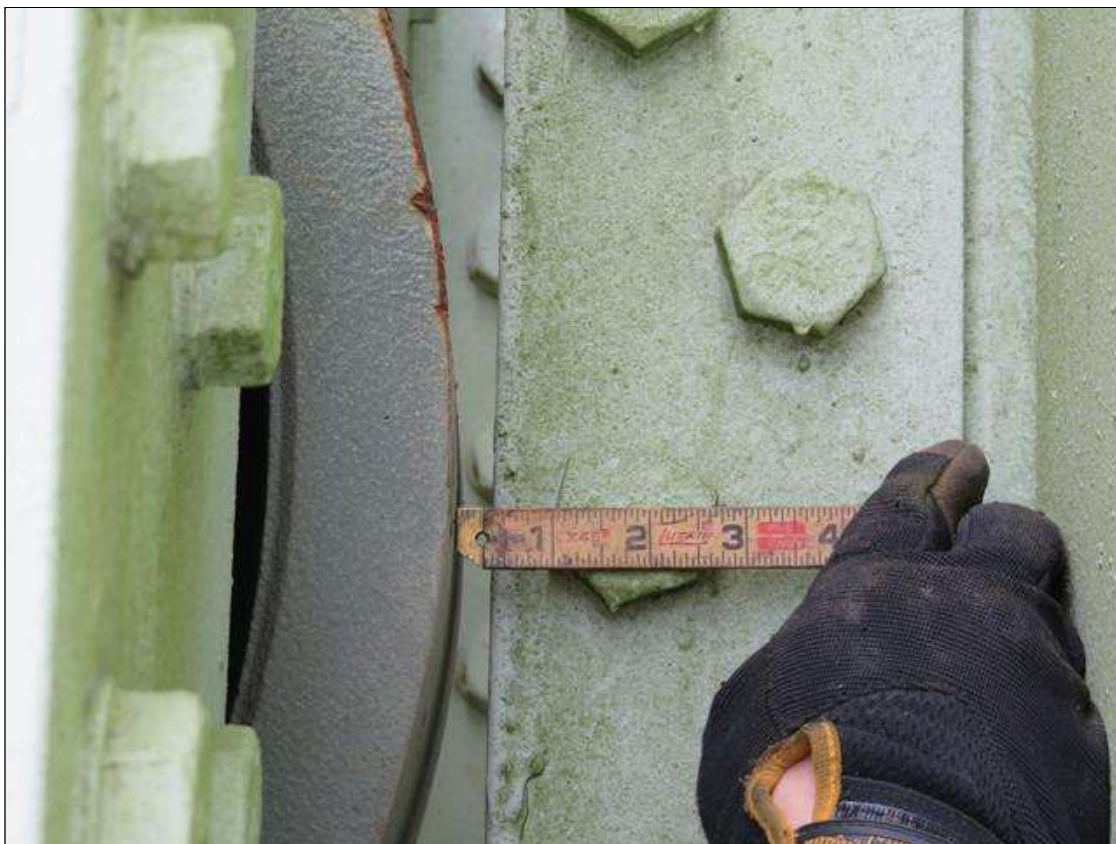
GUIDE ROLLER HAS 3/8" GAP NORTH WEST SIDE

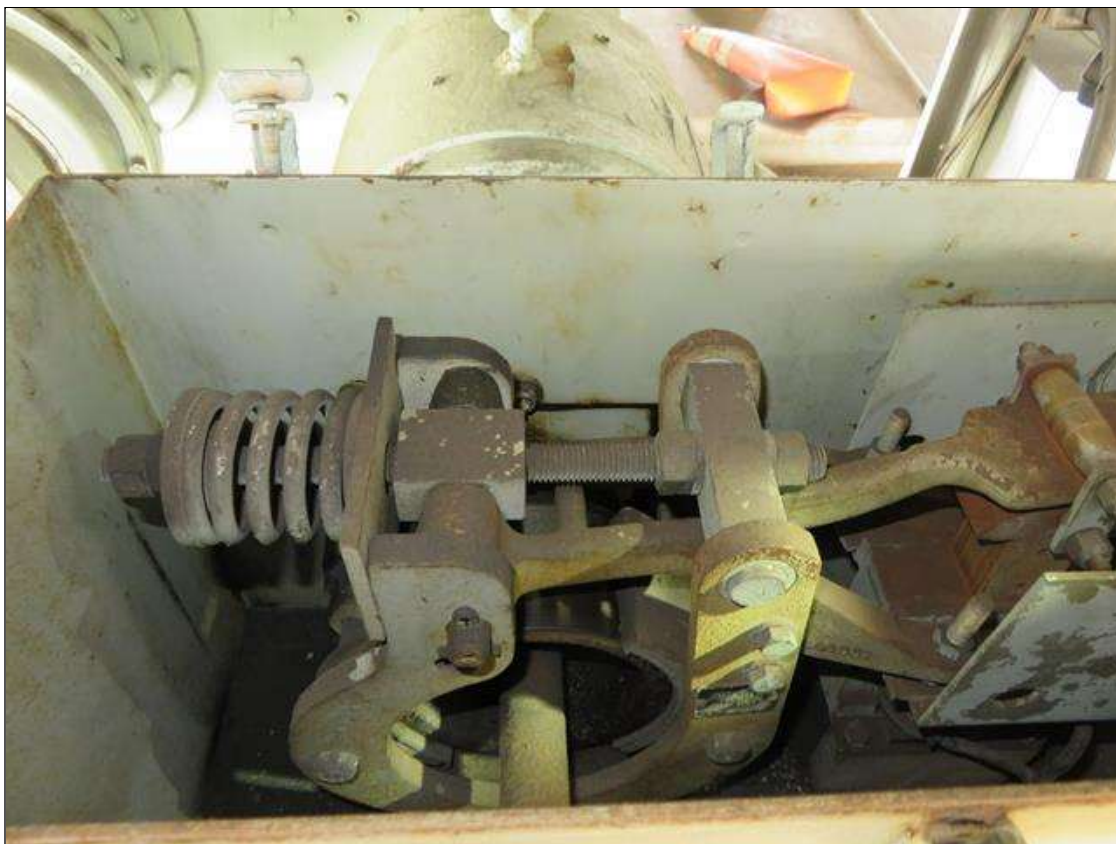
EAST TOWER SPEED REDUCER BRAKE (FAIR) PADS FAIR

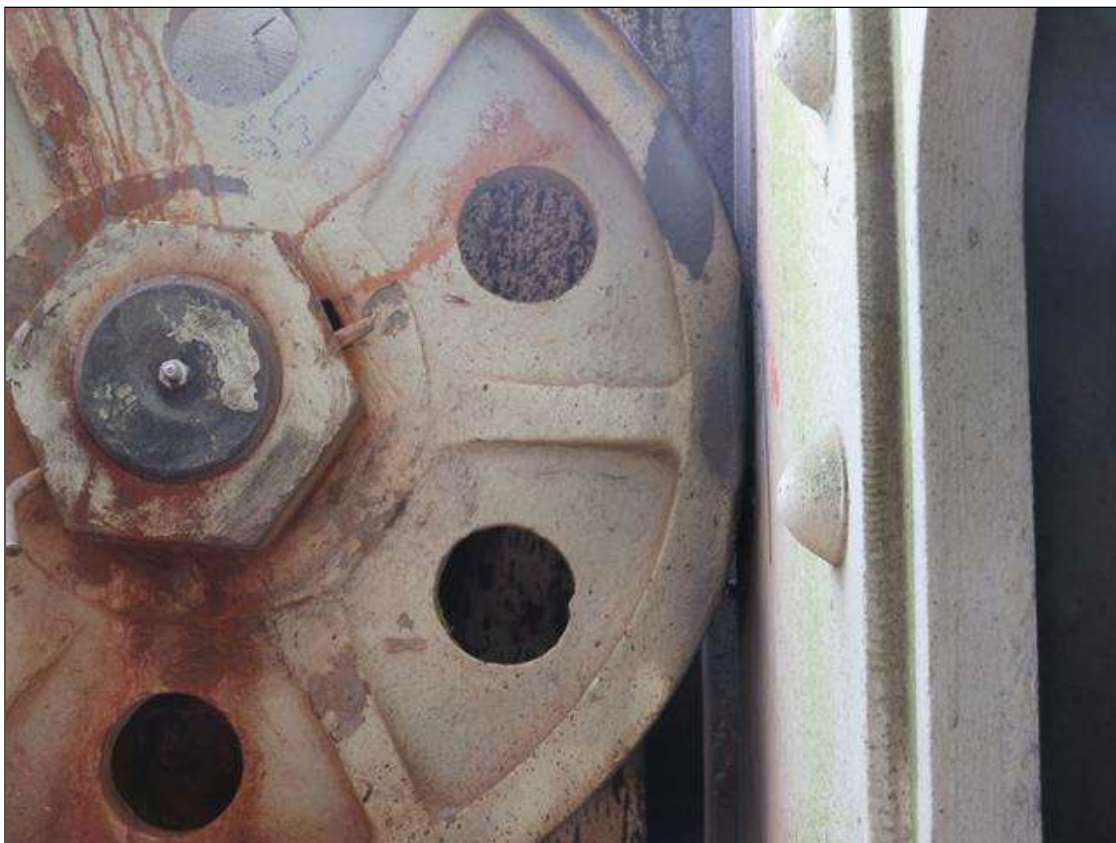
FLAT SPOT WORN ON WHEEL NORTH EAST LOWER TOWER ROLLER #54

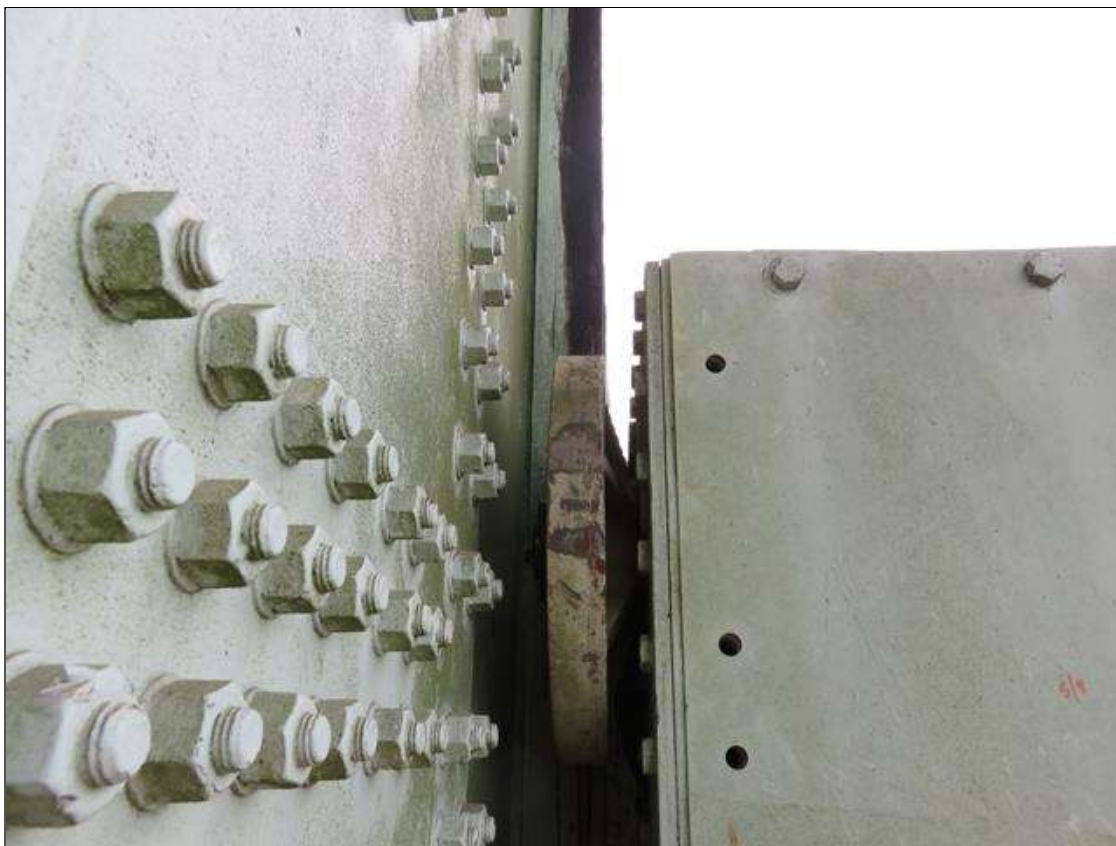
GUIDE WHEEL ON NORTH EAST SIDE FROZEN.

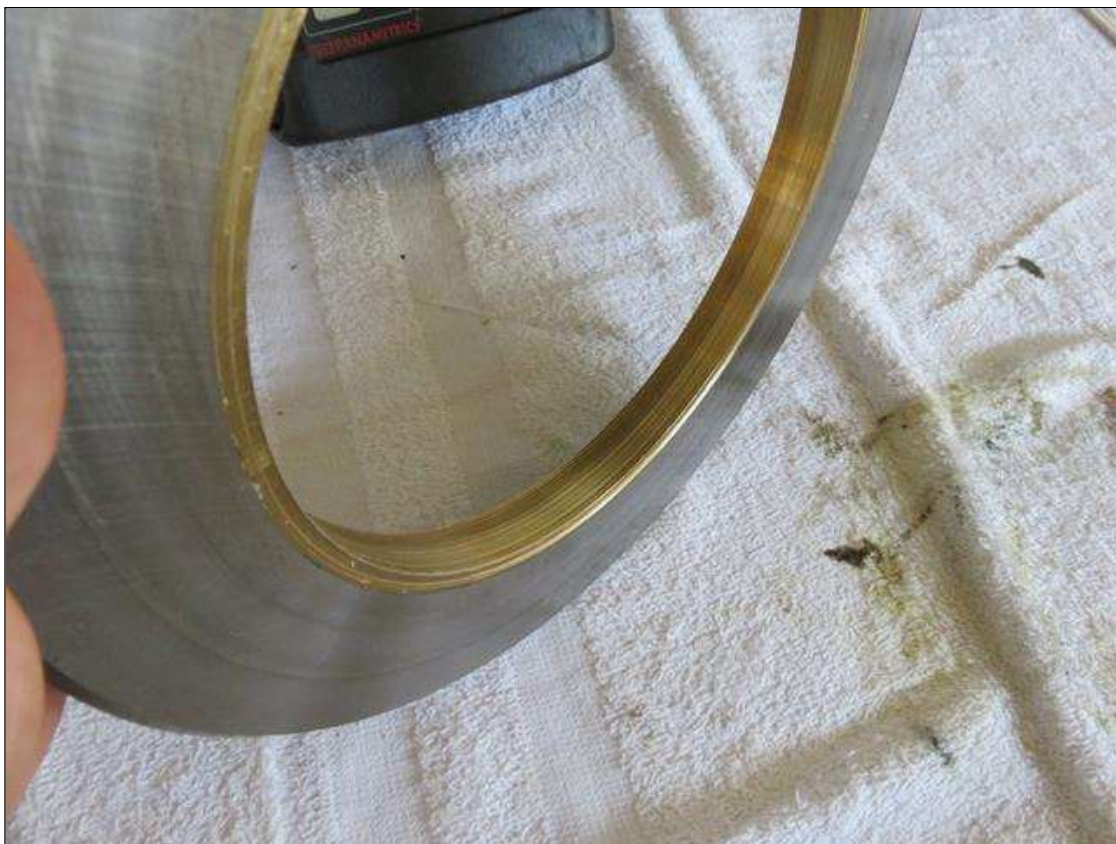
NORTH EAST ROOM INNER SOUTH SIDE BRONZE BUSHING HAS 1/32" GROOVES IN BRONZE RING.

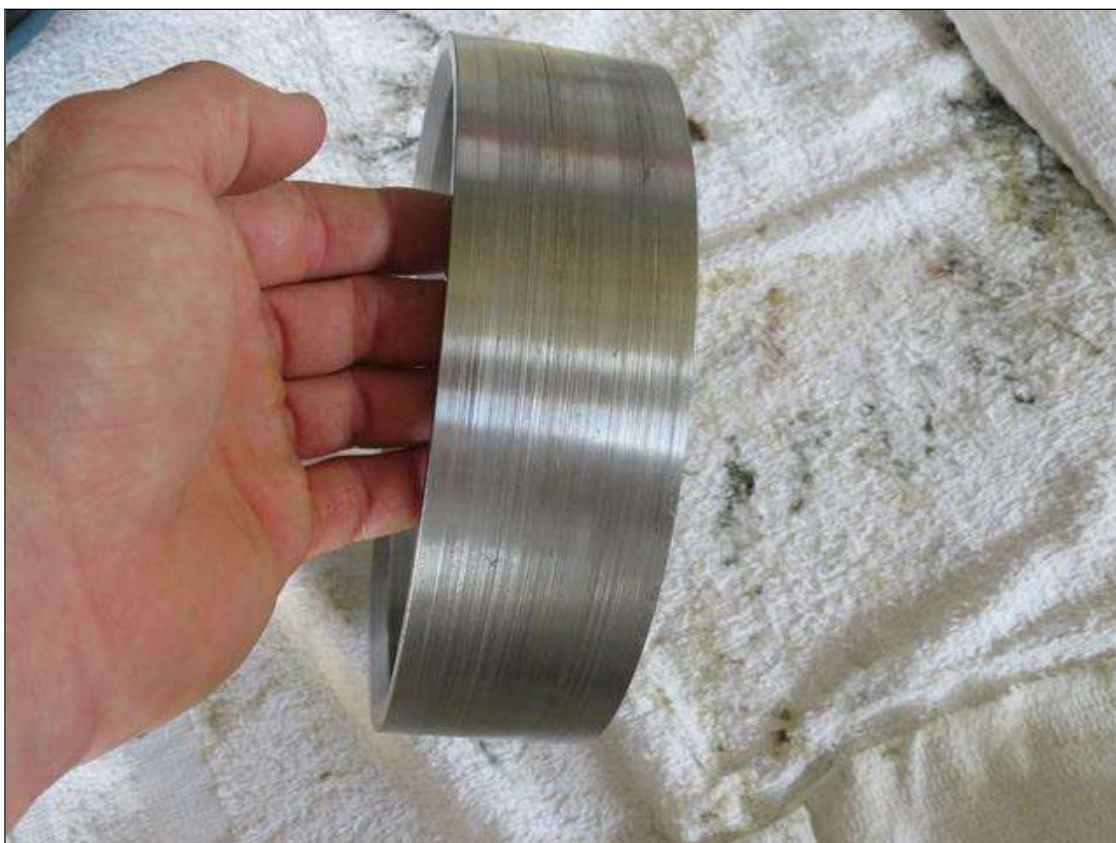
NORTH EAST ROOM INNER SOUTH SIDE RACE BUSHING HAS SEVERAL DEEP GROOVES AND IS BEING REPLACED WITH NEW DURING THE 2017 INSPECTION.

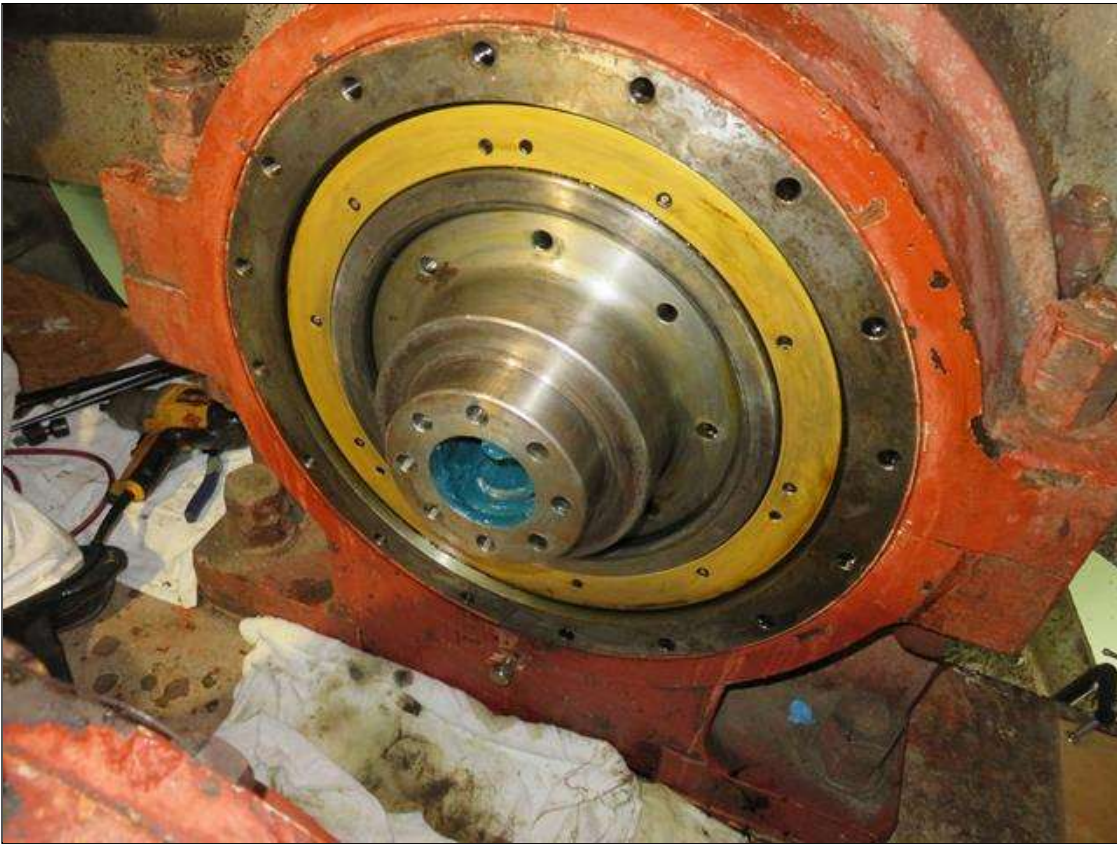
NORTH EAST ROOM SOUTH SIDE INNER PLATE HAS A SERIES OF 1/16" KNICKS ALONG EDGE FOR A LENGTH OF 9"

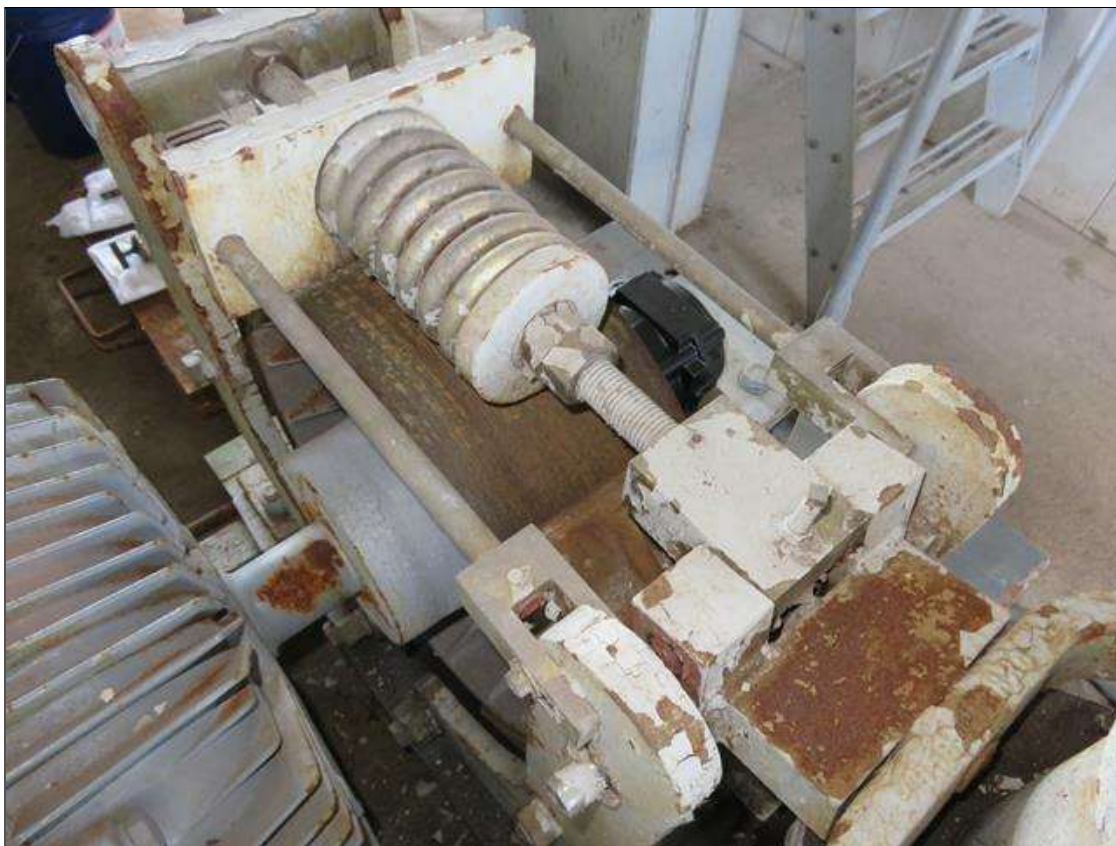
BRAKE #1 EAST OPERATING MACHINERY HAS 1/32" SURFACE RUST ON DRUM (PADS GOOD)

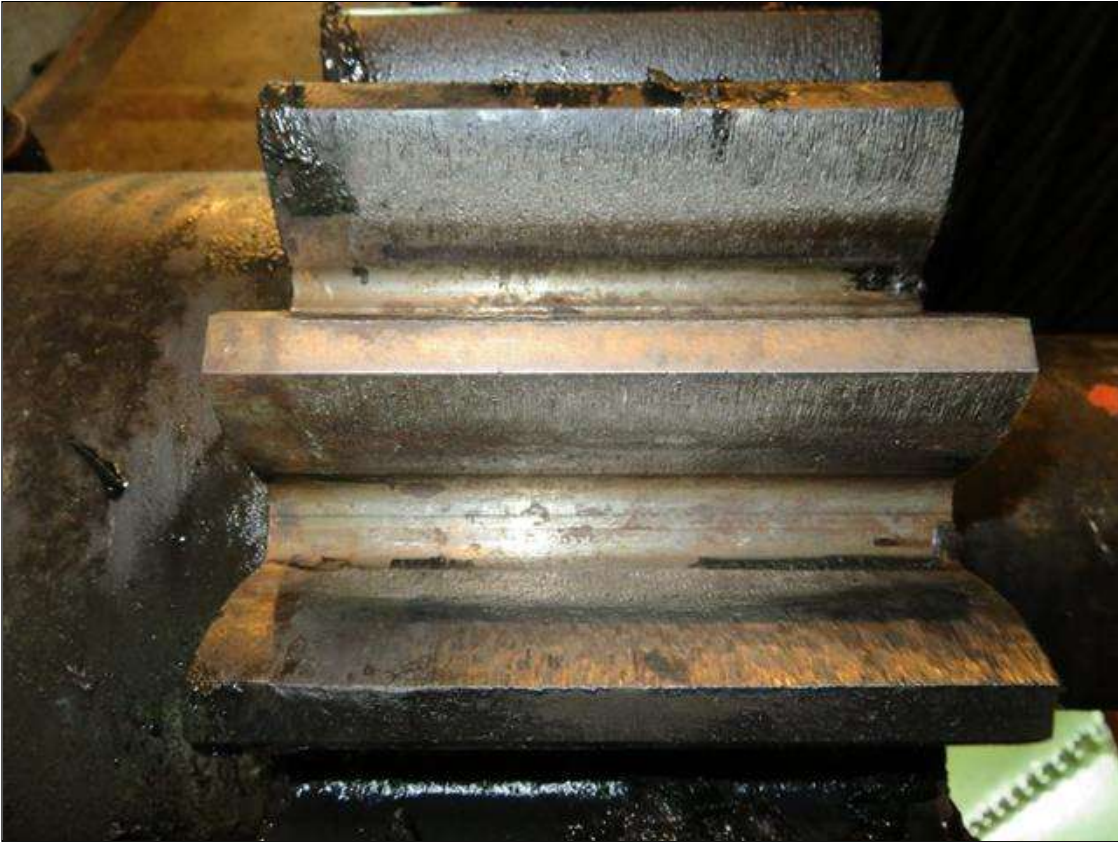
SOUTH EAST ROOM GEAR # 276 HAS 1/32" GROOVES ON OPEN AND CLOSING SIDE FACE OF TOOTH. (ALL SHOW THIS CONDITION #277 IN SOUTH EAST ROOM ALSO.)

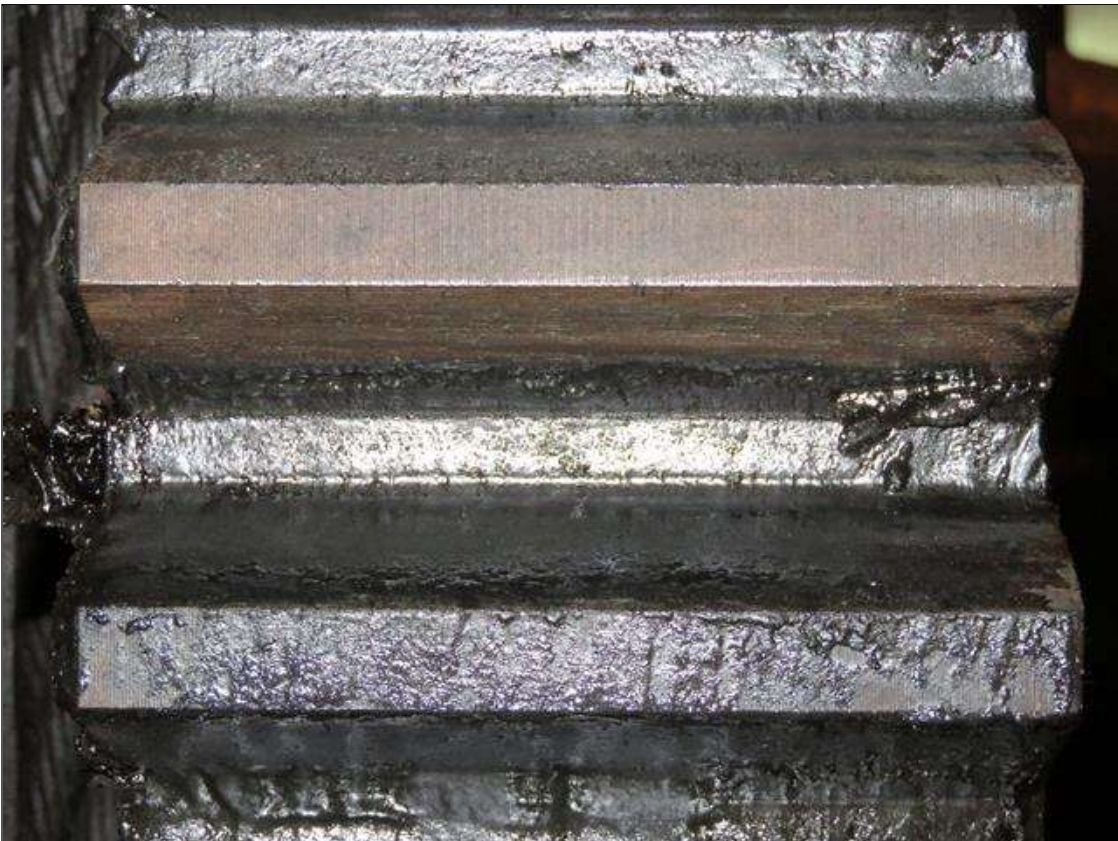
SOUTH EAST ROOM GEAR 271-1 HAS 1/32" GROOVES ON OPEN AND CLOSING SIDE OF TEETH. (271-2 SHOWS SAME CONDITION)

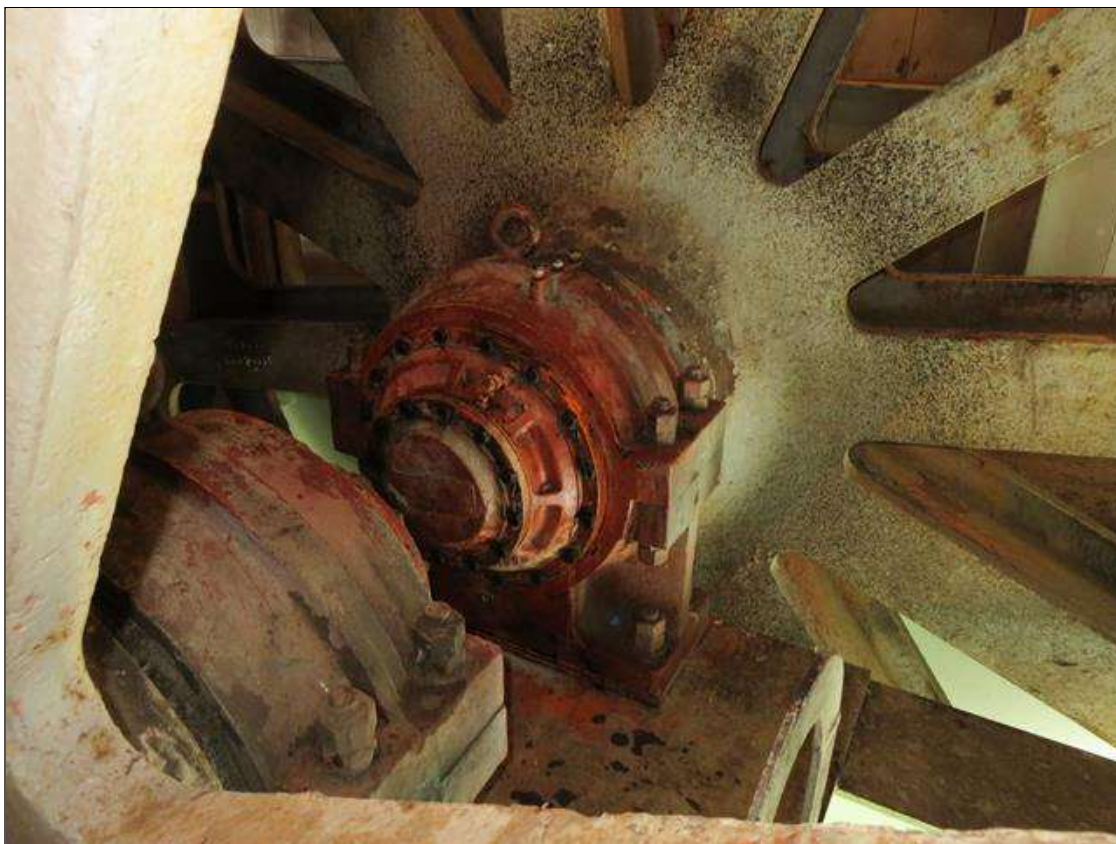
GEAR 278 IN SOUTH EAST ROOM HAS SEVERAL SMALL 1/16" GOUGES ON FACE OF TEETH.

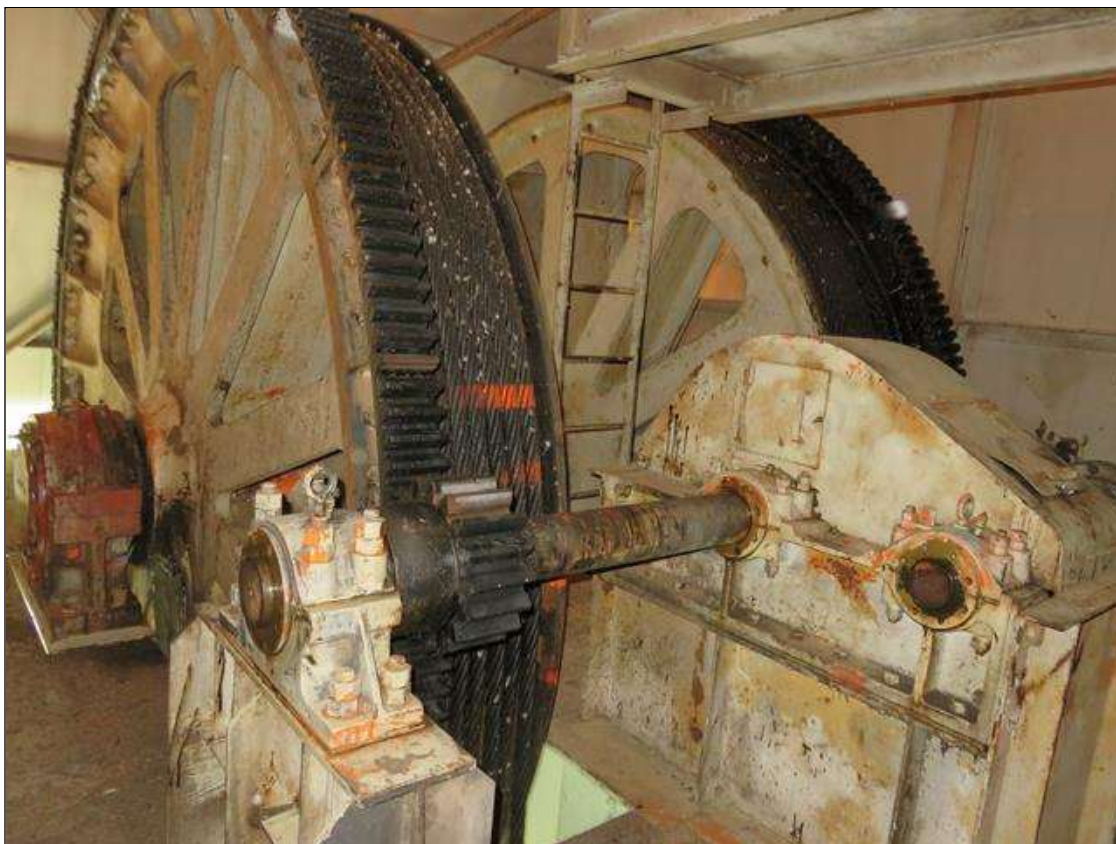
NORTH EAST ROOM GEAR 276 HAS 1/32" GROOVES ON OPEN AND CLOSING SIDE OF TEETH.

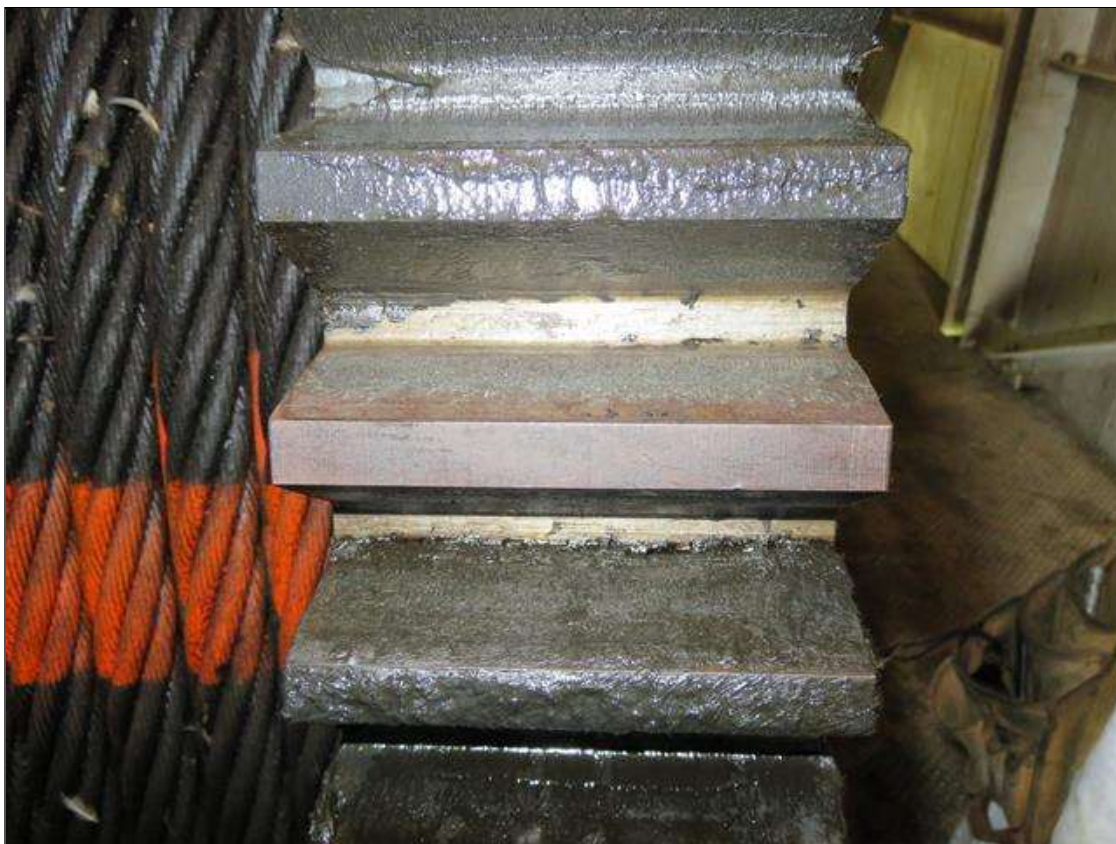
NORTH EAST ROOM GEAR 271-2 HAS MINOR SCORING TO OPEN AND CLOSING SIDE OF TEETH.

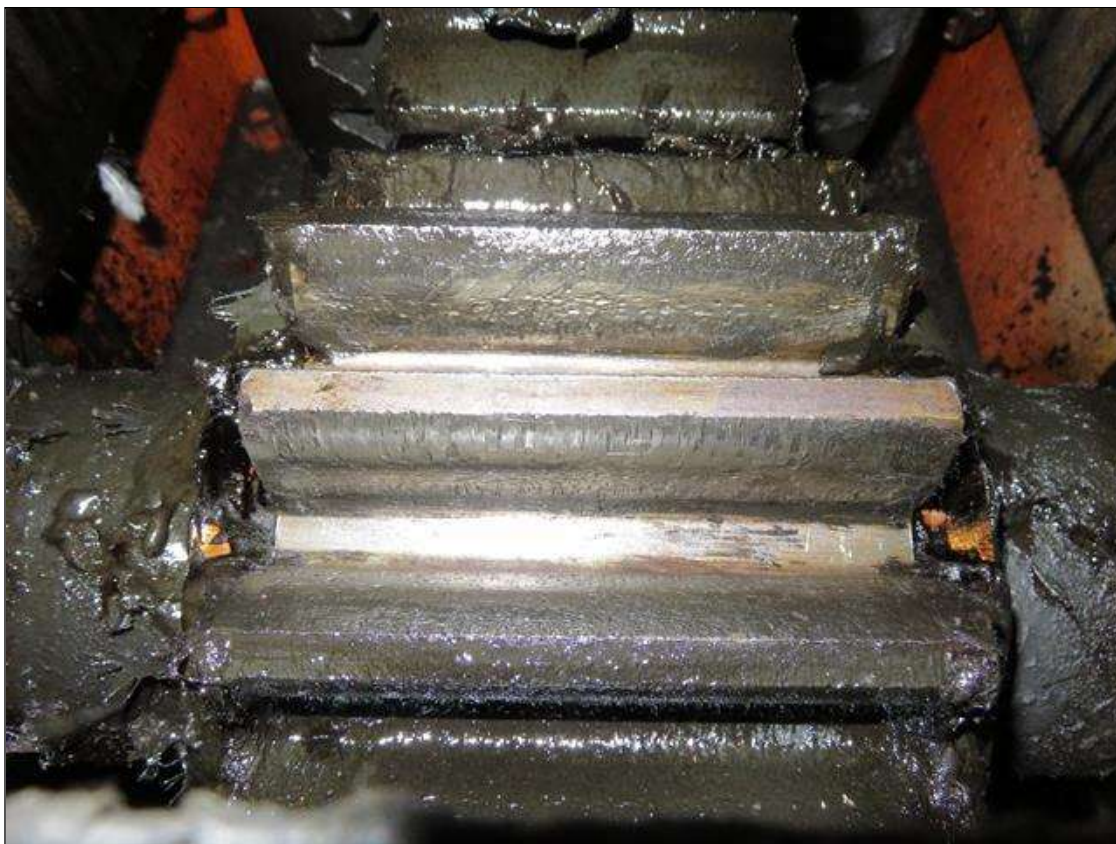
GEARS 278 HAS 1/16" DEEP GOUGES IN OPEN AND CLOSING SIDES OF TEETH.

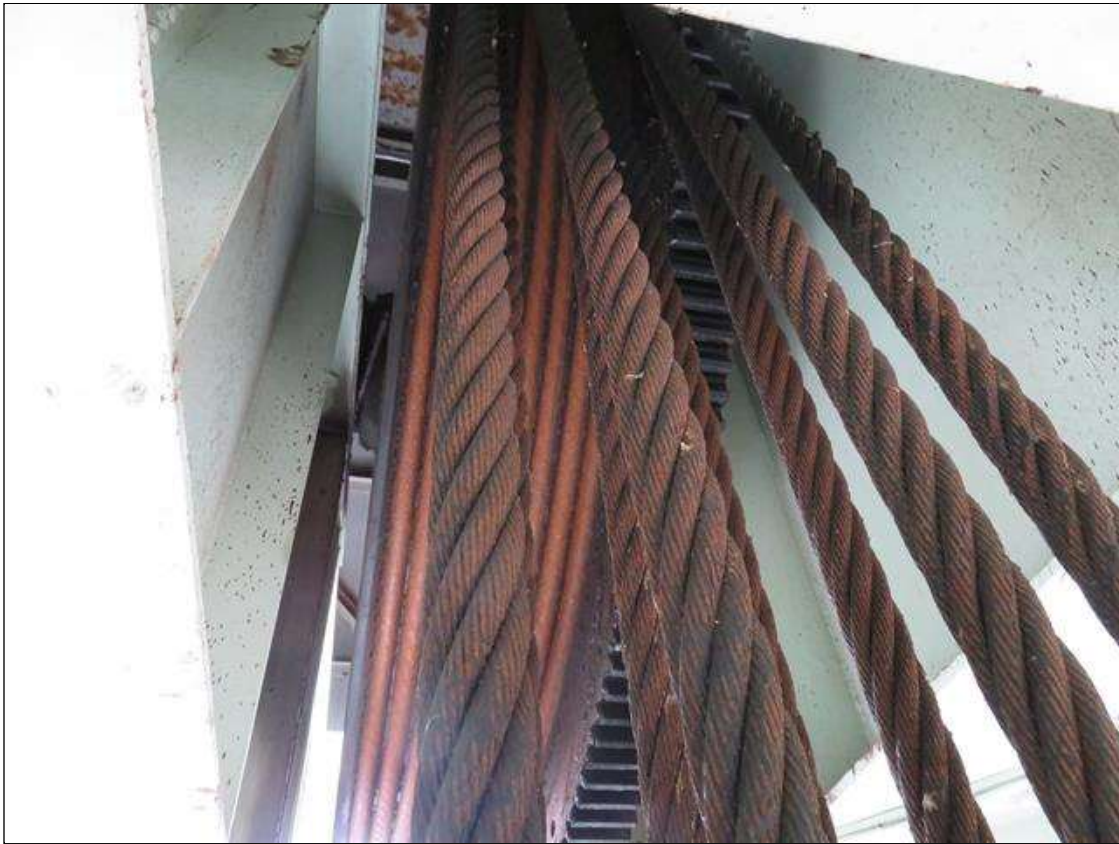
COUNTER WEIGHT CABLES SHOW EARLY STAGES OF SURFACE RUST AND NEED GREASING SOUTH EAST TOWER PICTURED ALL CABLES NEED TO BE GREASED.

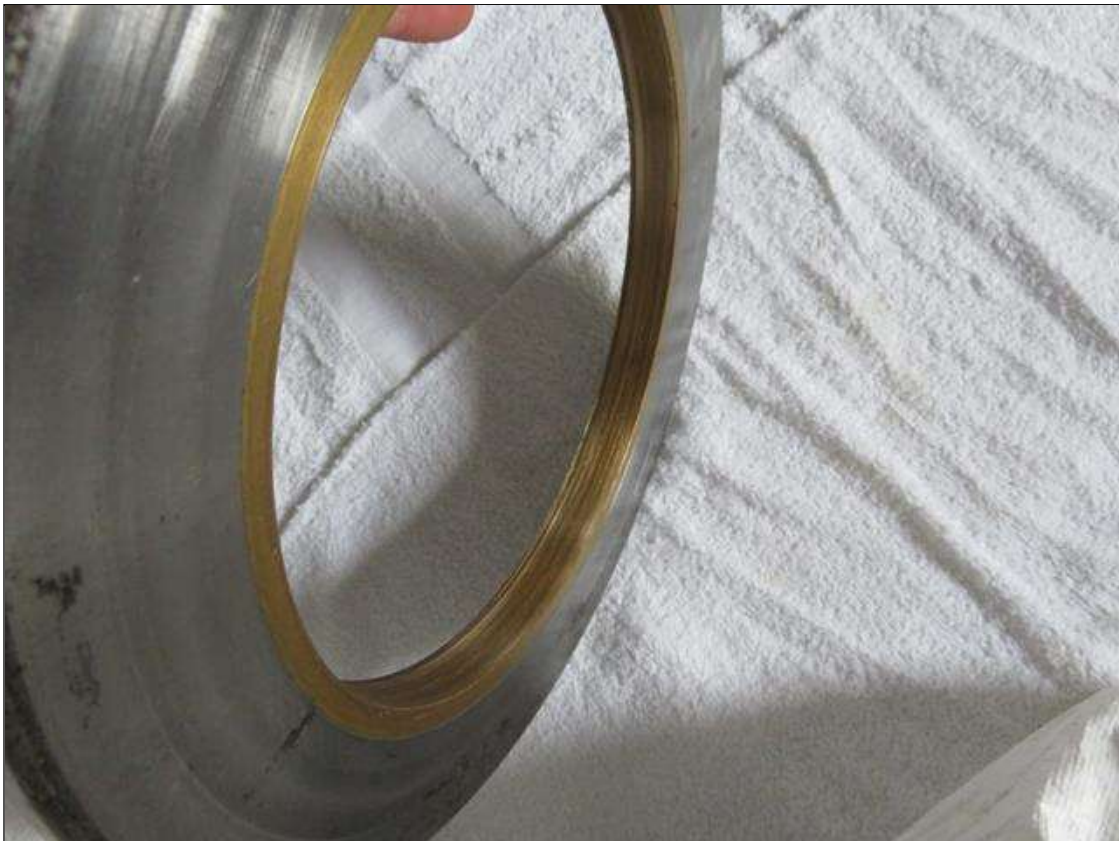
BRONZE BUSHING FROM SOUTH WEST ROOM INNER SOUTH TRUNNION HAS 1/8" DEEP GROOVES IN BRONZE RING AND WAS REPLACED WITH NEW DURING OUR 2017 INSPECTION.

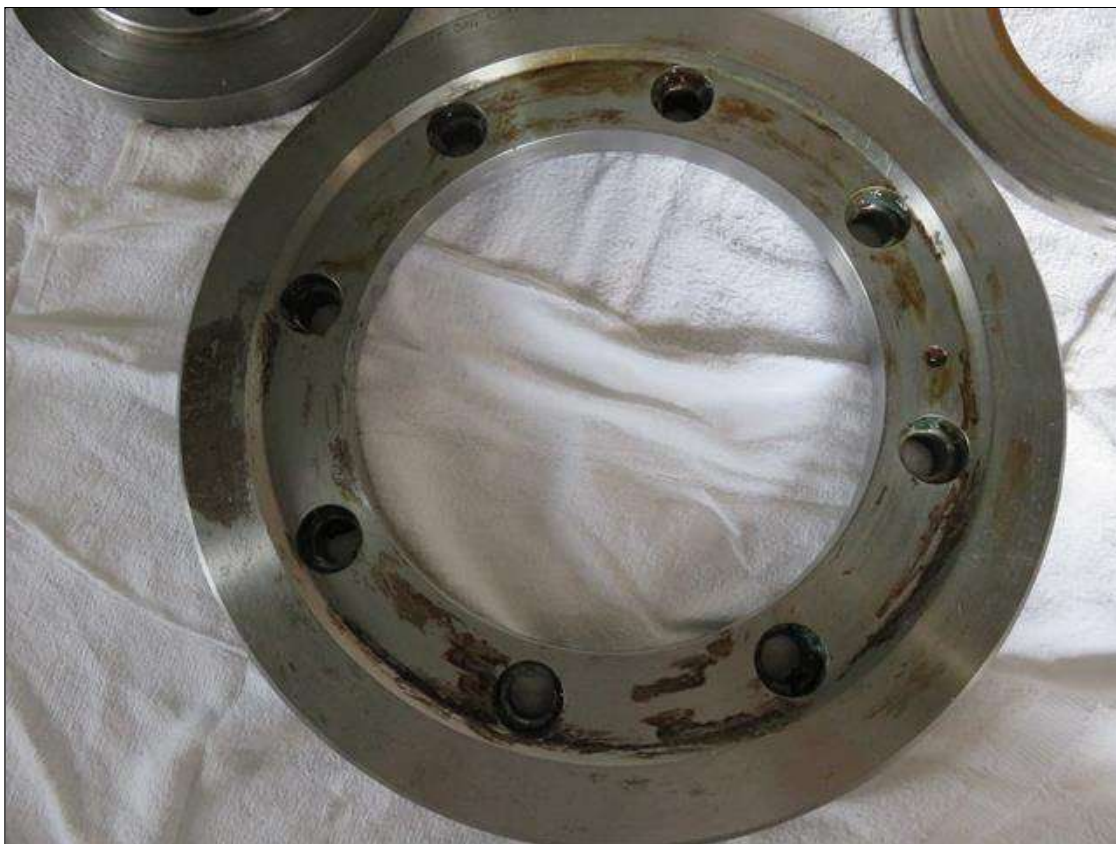
SOUTH WEST ROOM SOUTH SIDE TRUNNION INNER PLATE HAS AREAS OF SURFACE RUST ON FACE. (NO SECTION LOSS PRESENT)

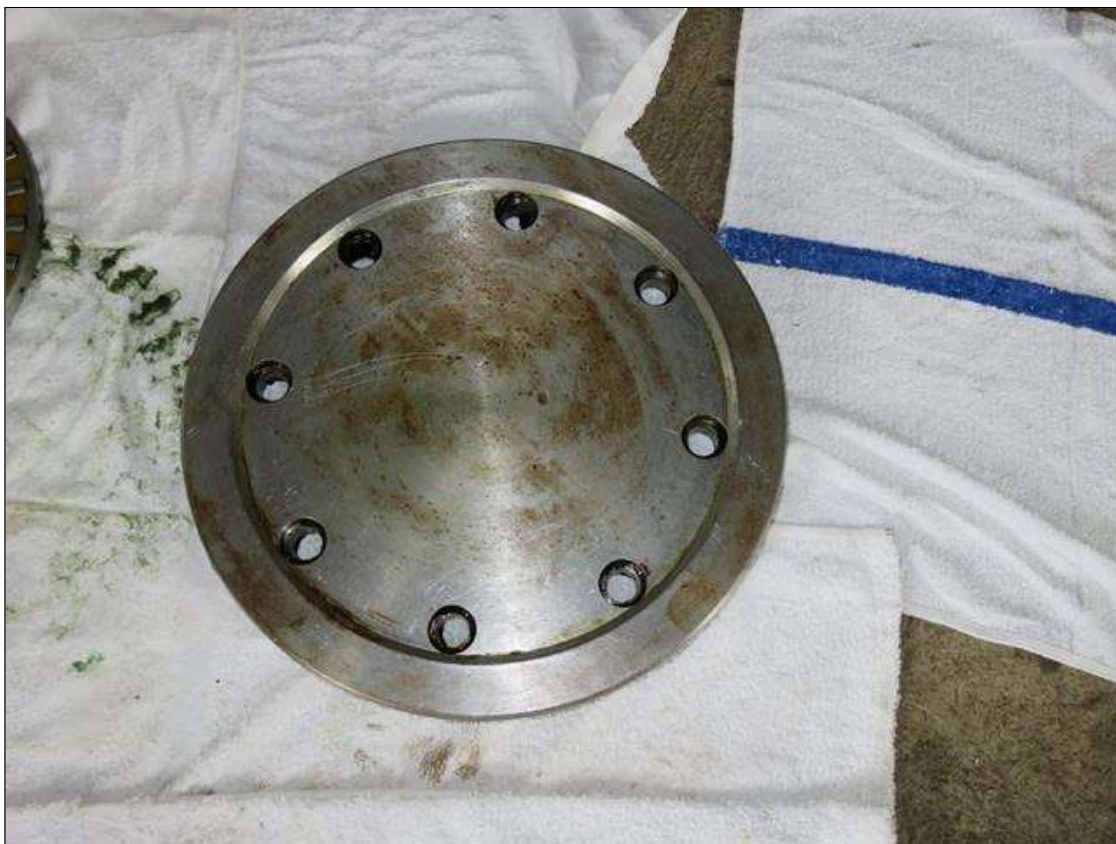
NORTH WEST ROOM OUTSIDE SOUTH TRUNNION INNER PLATE. (FAIR MINOR SURFACE STAINING/
SURFACE RUSTING WITH NO SECTION LOSS.)

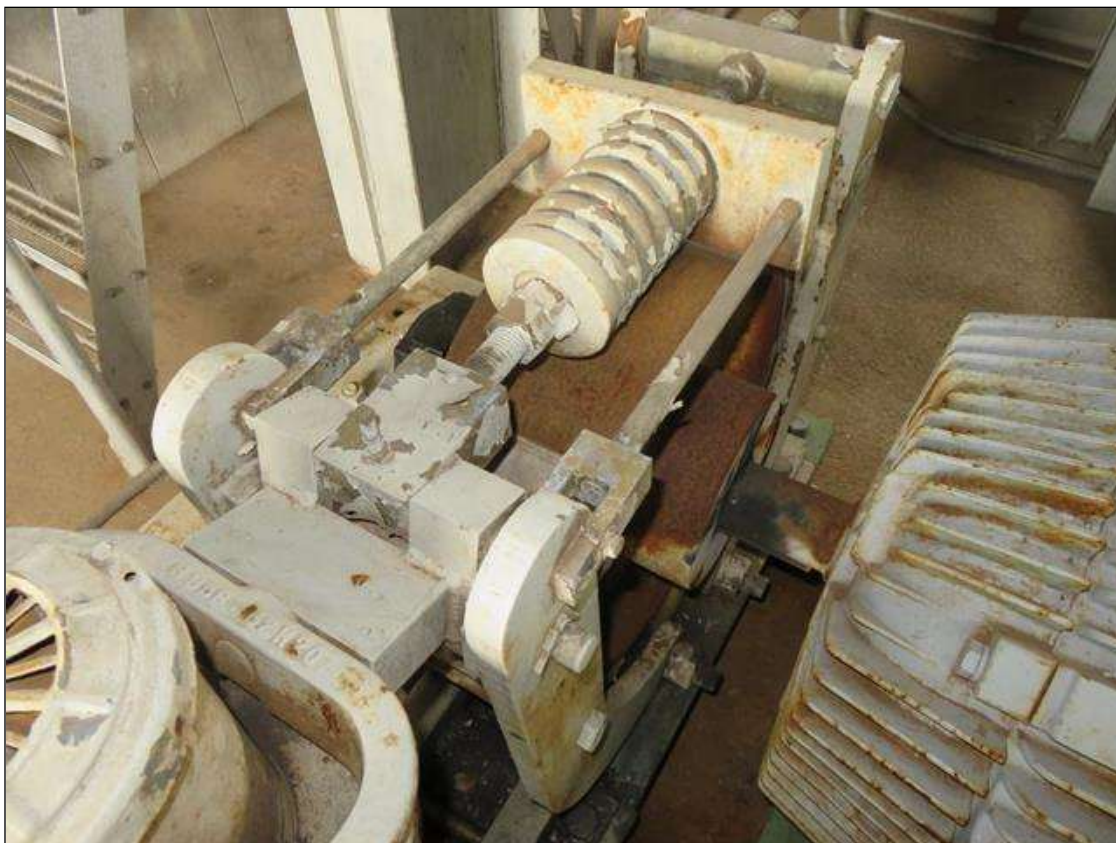
BRAKE #3 OPERATING MACHINERY WEST TOWER HA 1/32" SURFACE RUST TO DRUM.

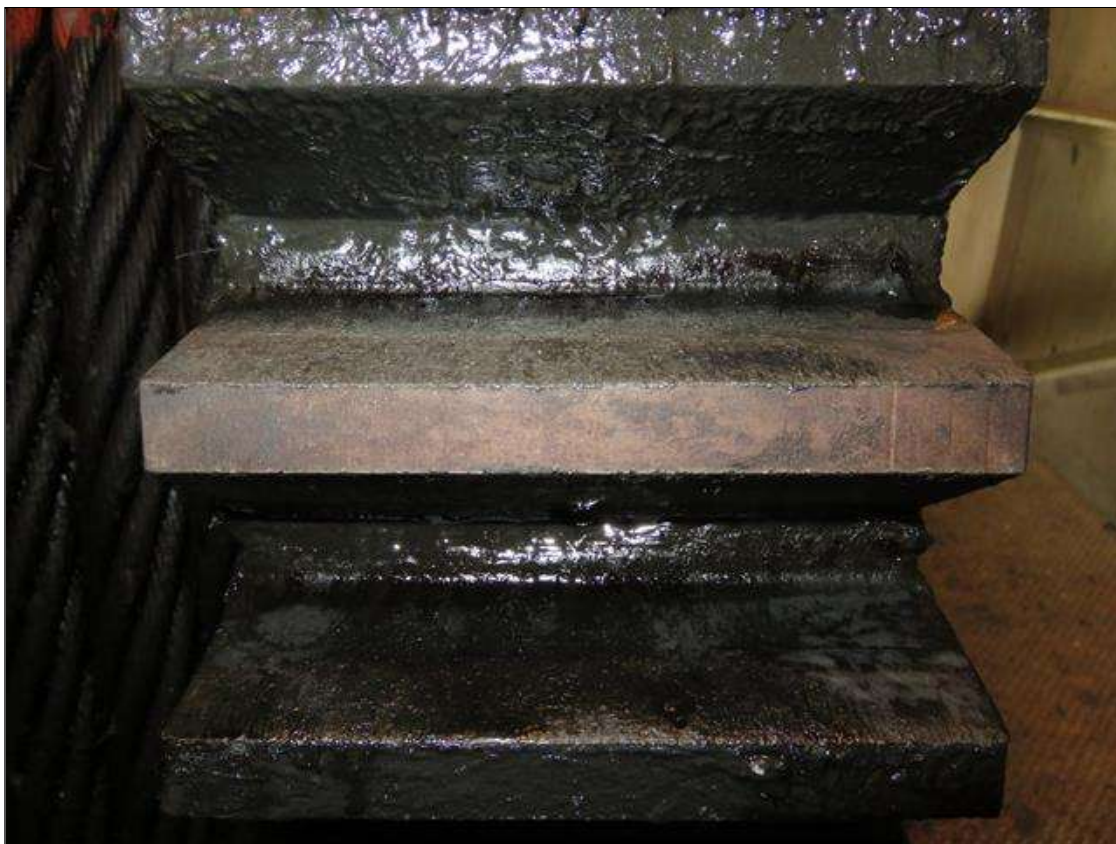
GEAR 271-1 IS IN FAIR CONDITION (MINOR GROOVES ON OPEN AND CLOSING SIDE OF TEETH. (SOUTH WEST ROOM WEST TOWER)

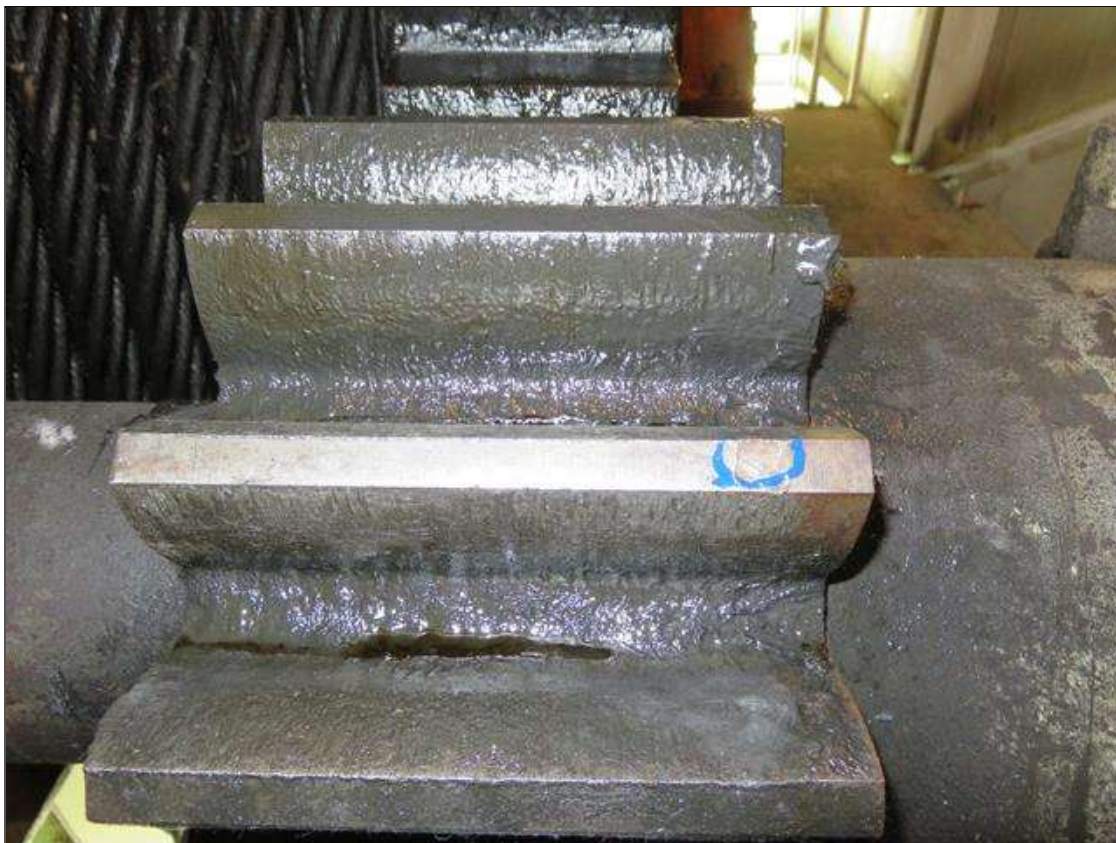
GEAR 277 TOOTH HAS SMALL 1/8" GOUGE IN TOP RIGHT SIDE OF TOOTH SOUTH WEST ROOM (WEST TOWER)

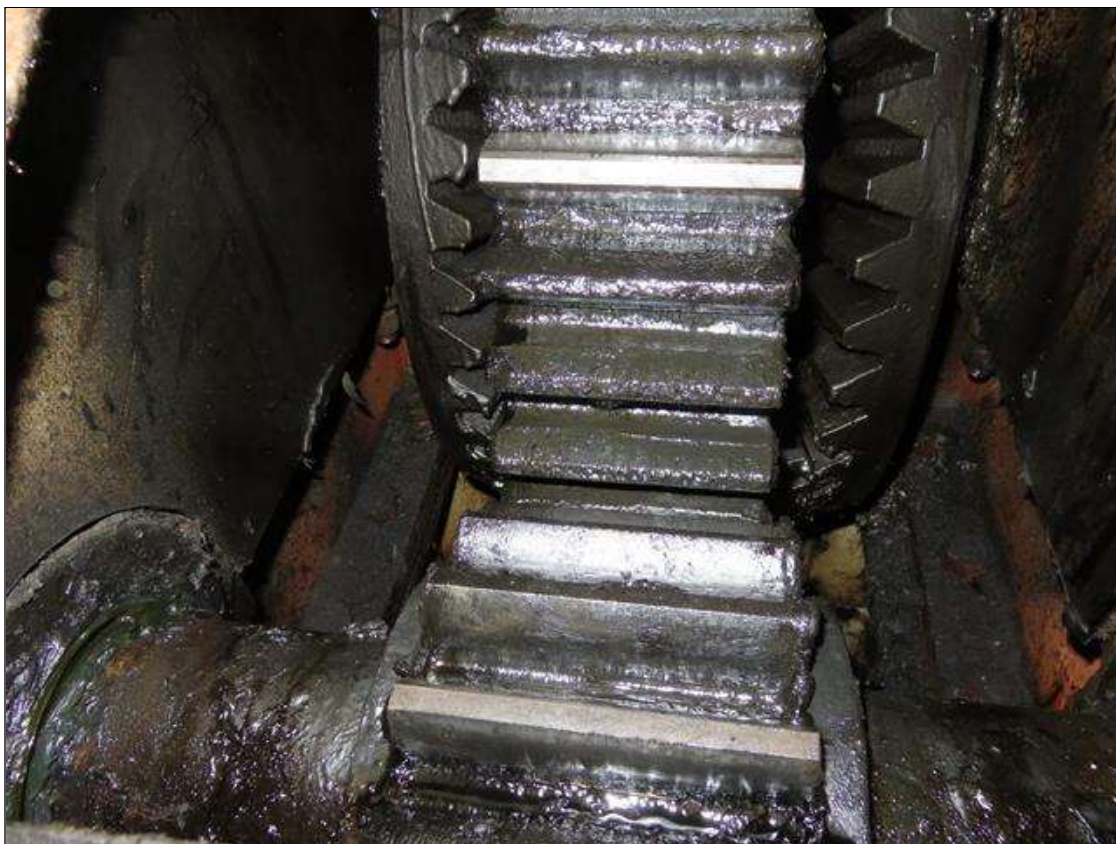
GEAR 276 HAS 1/32" GROOVES IN OPEN AND CLOSING SIDE OF TOOTH SOUTH WEST ROOM (WEST TOWER)

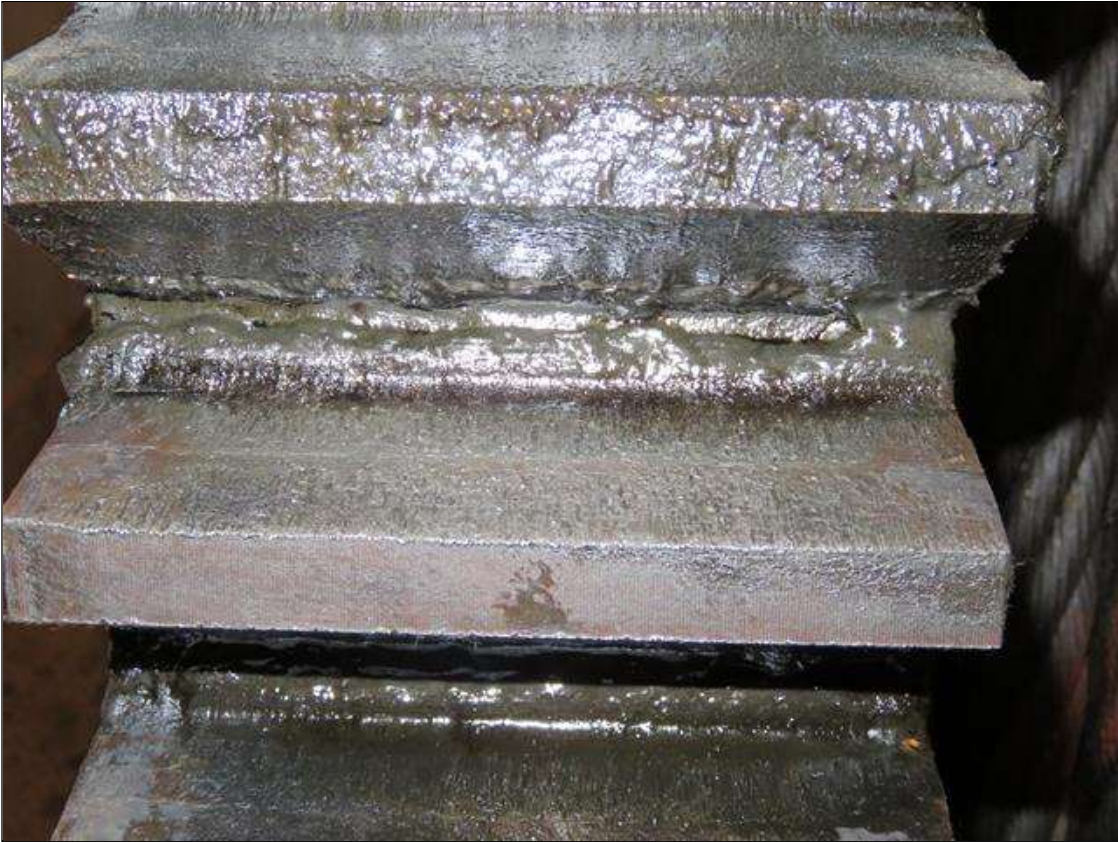
SOCRING & 1/32" GROOVES IN OPEN AND CLOSING SIDE OF 271-1 SOUTH WEST ROOM (WEST TOWER)
