NC DEPARTMENT OF TRANSPORTATION
 DIVISION OF HIGHWAYS
 STRUCTURE MANAGEMENT UNIT

Structure Safety Report

Fracture Critical and Machinery Element Inspection

COUNTY: NEW HANOVER STRUCTURE NUMBER: 640013 FREQUENCY: 24 MONTHS

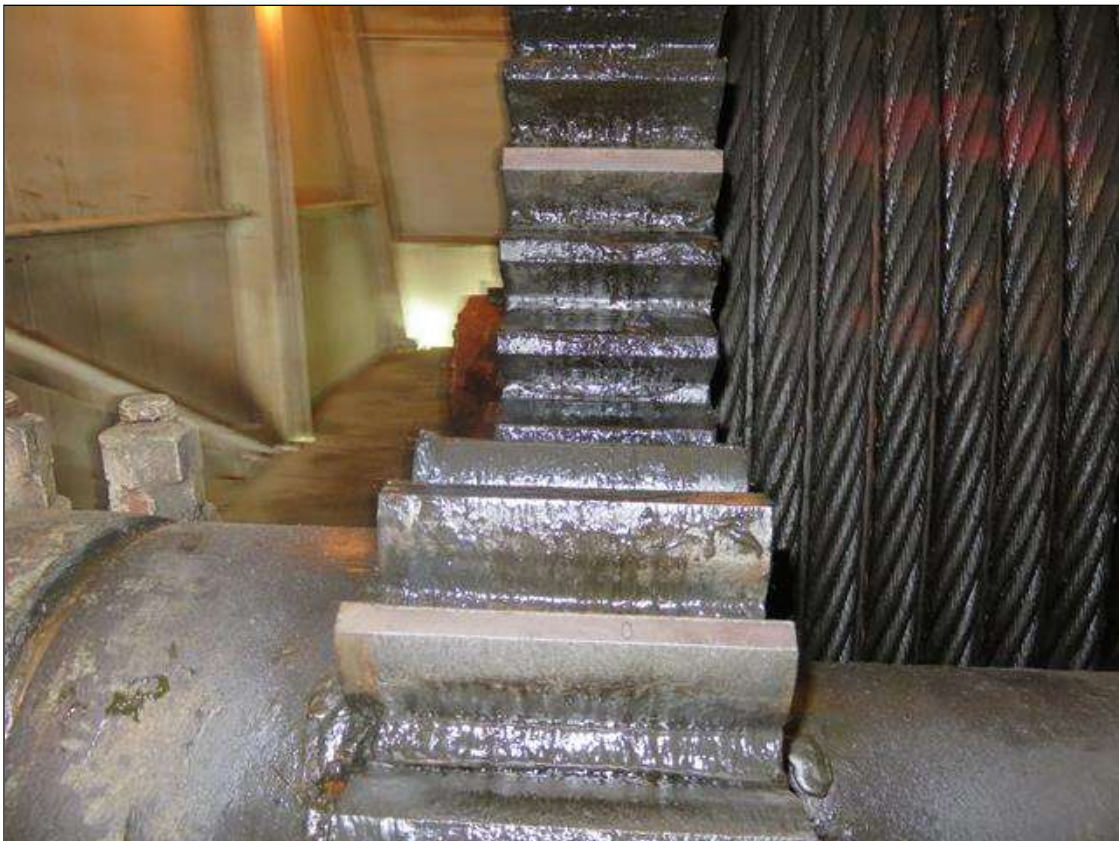
GEARS 271-1 & 276 NORTH WEST ROOM BOTH HAVE SCORING AND 1/32" GROOVES ON OPEN AND CLOSING SIDE OF TEETH.

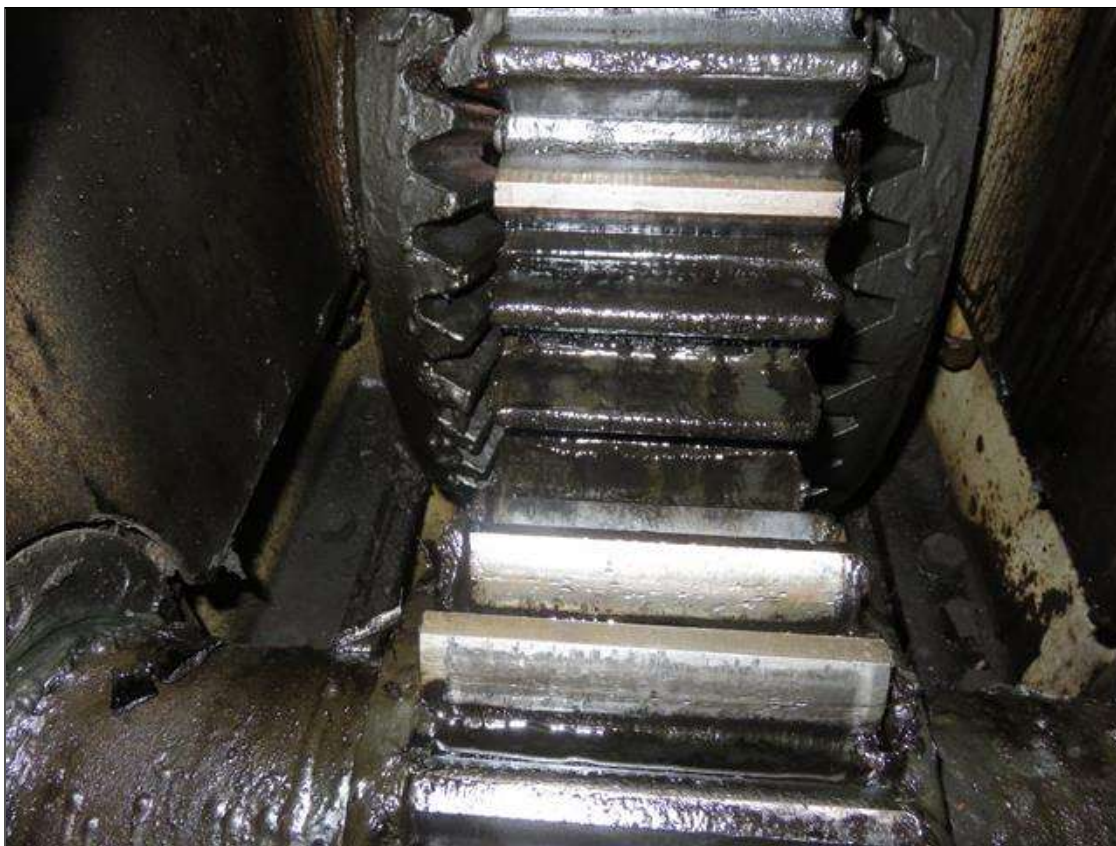
GEARS 278 HAVE SEVERAL SMALL 1/8" KNICKS AND GOUGES ON FACE OF TEETH NORTH WEST ROOM.

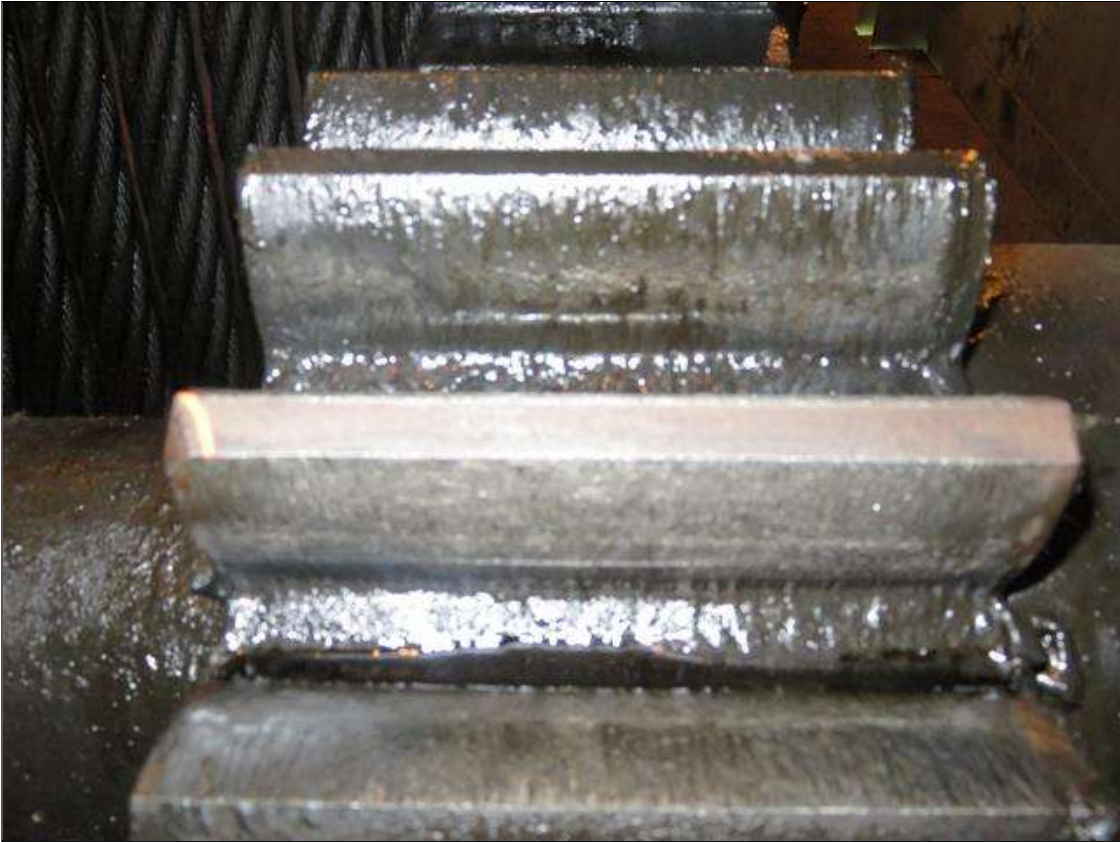
GEAR #277 IN WEST TOWER HAS 1/32" GROOVES ON OPEN AND CLOSING SIDE OF TOOTH & 1/16" CHIP TO LEFT CORNER OF TOOTH. (NORTH WEST ROOM)

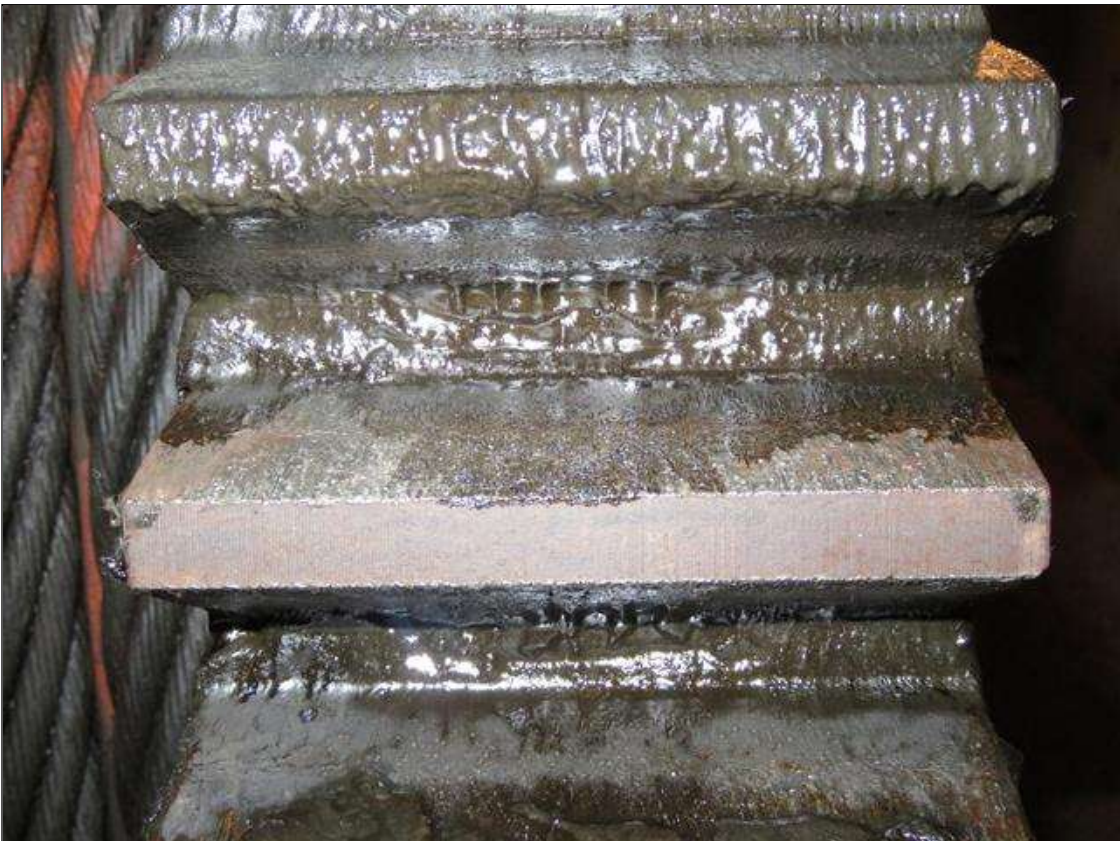
GEAR 271-2 IN WEST TOWER HAS 1/32" GROOVES ON OPEN AND CLOSING SIDE OF TOOTH (NORTH WEST ROOM)
