PROJECT NO. 15BPR.15

NEW HANOVER COUNTY

APPROACH SPANS
STRUCTURAL STEEL

REPAIR DETAILS

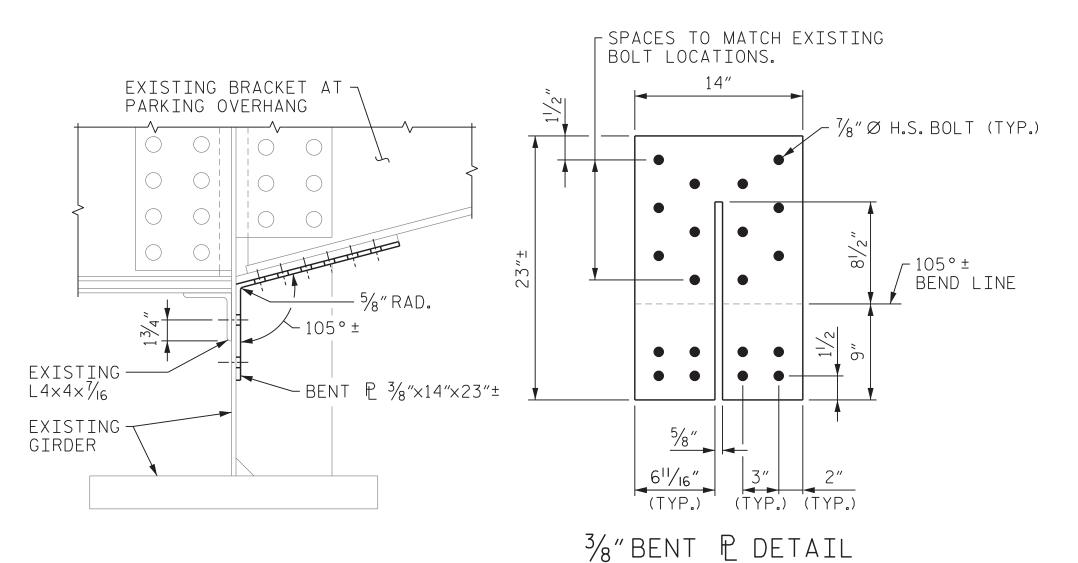
REPAIR(3

LOCATED AT PARKING AREAS

CLOSE PARKING AREA TO TRAFFIC WHILE PERFORMING REPAIR (3).

REPAIR ONE BRACKET AT A TIME.

BEFORE PAINTING, APPLY SEALANT AROUND BENT PLATE.

(4 REQUIRED)
