PROJECT NO. 15BPR.25

BRUNSWICK _ COUNTY

SUBSTRUCTURE CONCRETE REPAIRS BENT 50

| | ⊢ | | SHEET NO. | | | | |
|---|---|---|---|---|---|---|---|
| DOCUMENT NOT CONSIDERED | NO. | BY: | DATE: | NO. | BY: | DATE: | S-88 |

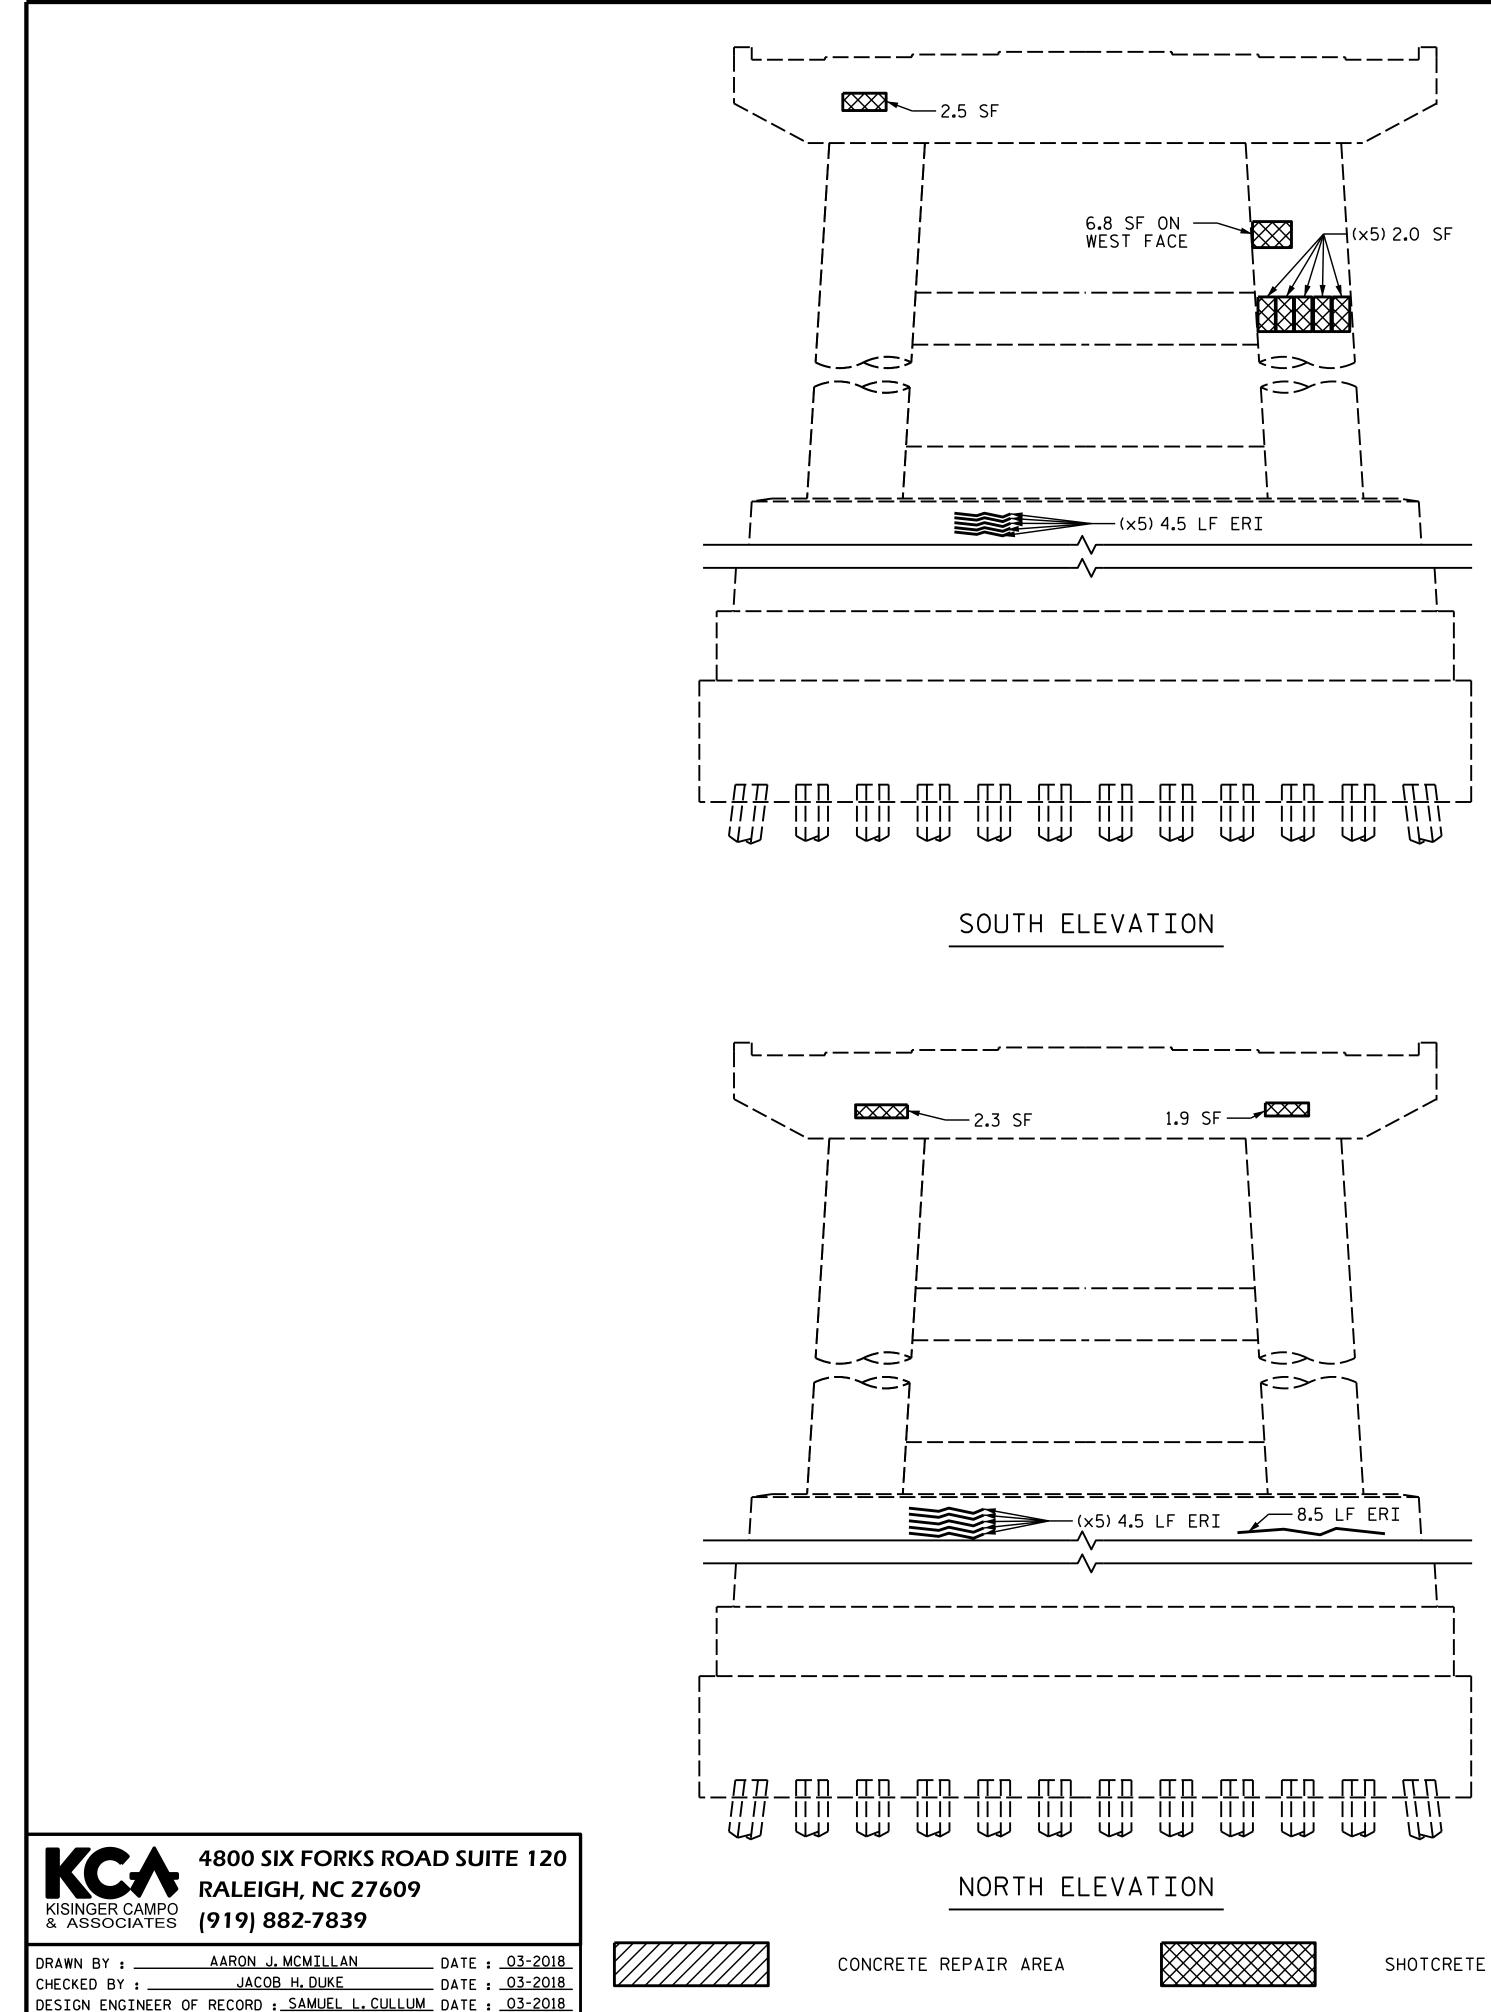
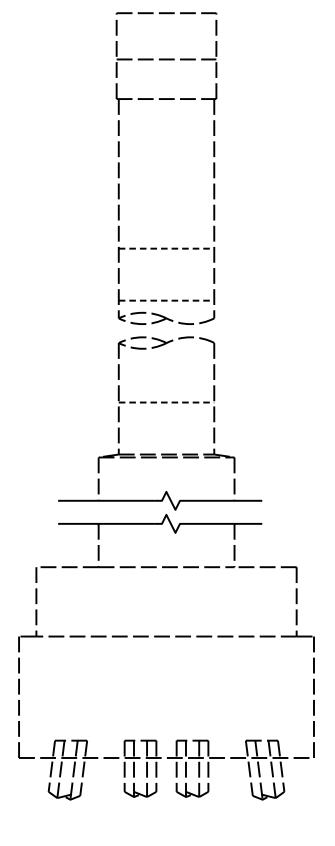
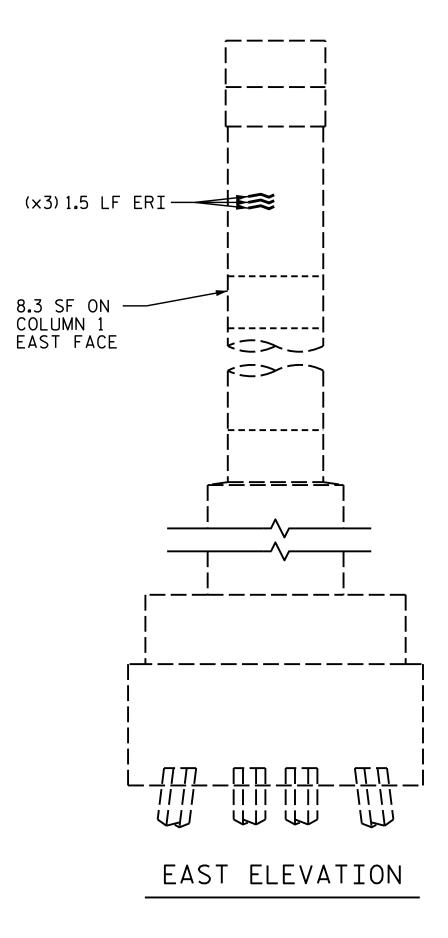
WEST ELEVATION

SHOTCRETE REPAIR AREA

EPOXY RESIN INJECTION (ERI)

VALUES IN CHART REPRESENT ESTIMATED REPAIR TOTALS AFTER REMOVAL OF UNSOUND CONCRETE.MINIMUM OF 1"BEHIND REBAR AND MINIMUM 2"CLEARANCE TO SAWCUT.FOR REPAIR DETAILS, SEE "CONCRETE RESTORATION DETAILS - SUBSTRUCTURE" SHEET.

FOR CONCRETE AND SHOTCRETE REPAIRS, SEE CONCRETE RESTORATION DETAILS - SUBSTRUCTURE SHEET.
