PROJECT NO. I-5825
MECKLENBURG COUNTY
 BRIDGE NO. 215

SHEET 1 OF 2

BENT 1
 SPAN A FACE

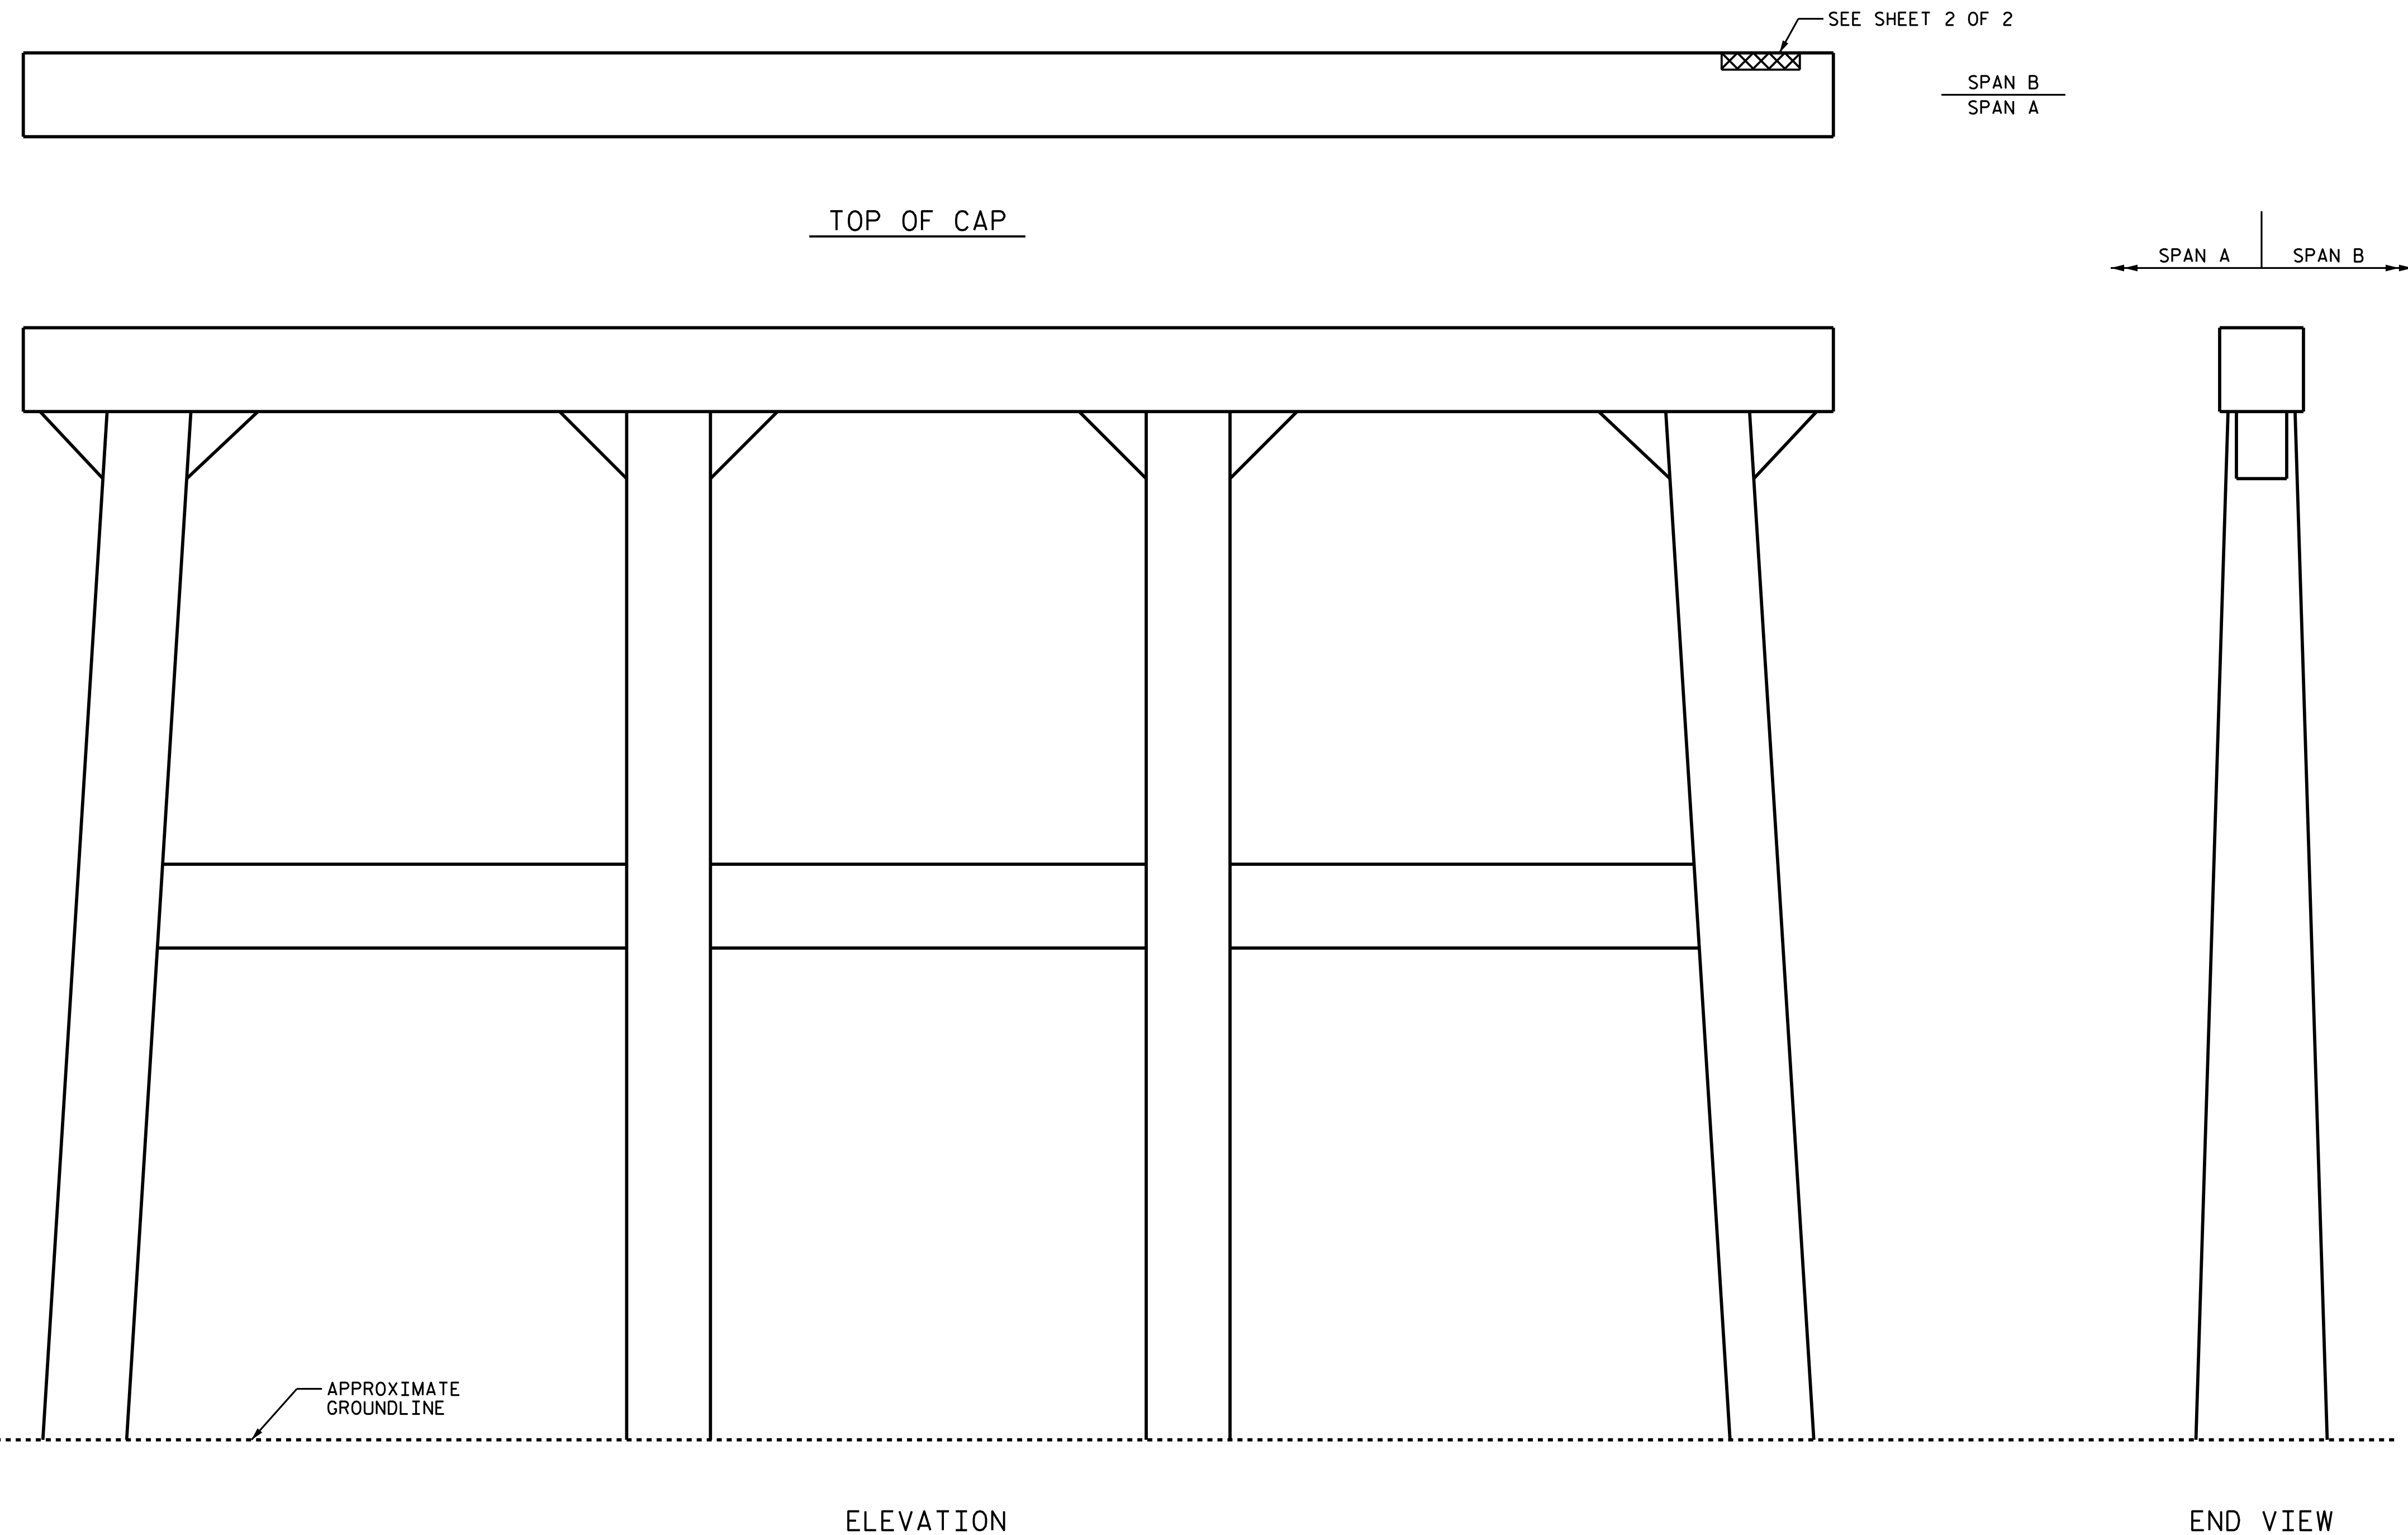
VALUES IN CHART REPRESENT ESTIMATED REPAIR TOTALS AFTER REMOVAL OF UNSOUND CONCRETE, MINIMUM OF 1" BEHIND REBAR AND MINIMUM 2" CLEARANCE TO SAWCUT. FOR REPAIR DETAILS, SEE "TYPICAL CAP AND COLUMN REPAIR DETAILS" SHEET.

CONCRETE REPAIR AREA

CLEAN AND REMOVE DEBRIS FROM THE TOP OF THE CAP AND APPLY EPOXY PROTECTIVE COATING. EPOXY COATING SHALL BE APPLIED TO THE TOP SURFACE OF THE CAP. THE CONTRACTOR SHALL NOT COAT THE AREA OF THE CAP BENEATH THE MASONRY PLATES. FOR EPOXY COATING, SEE SPECIAL PROVISIONS.

CONCRETE REPAIRS TO THE BENT CAP MAY REQUIRE BRIDGE JACKING. FOR BRIDGE JACKING, SEE "JACKING DETAILS" SHEET.
