PROJECT NO. I-5825
MECKLENBURG COUNTY
BRIDGE NO. 215

SHEET 1 OF 2

BENT 2
SPAN B FACE

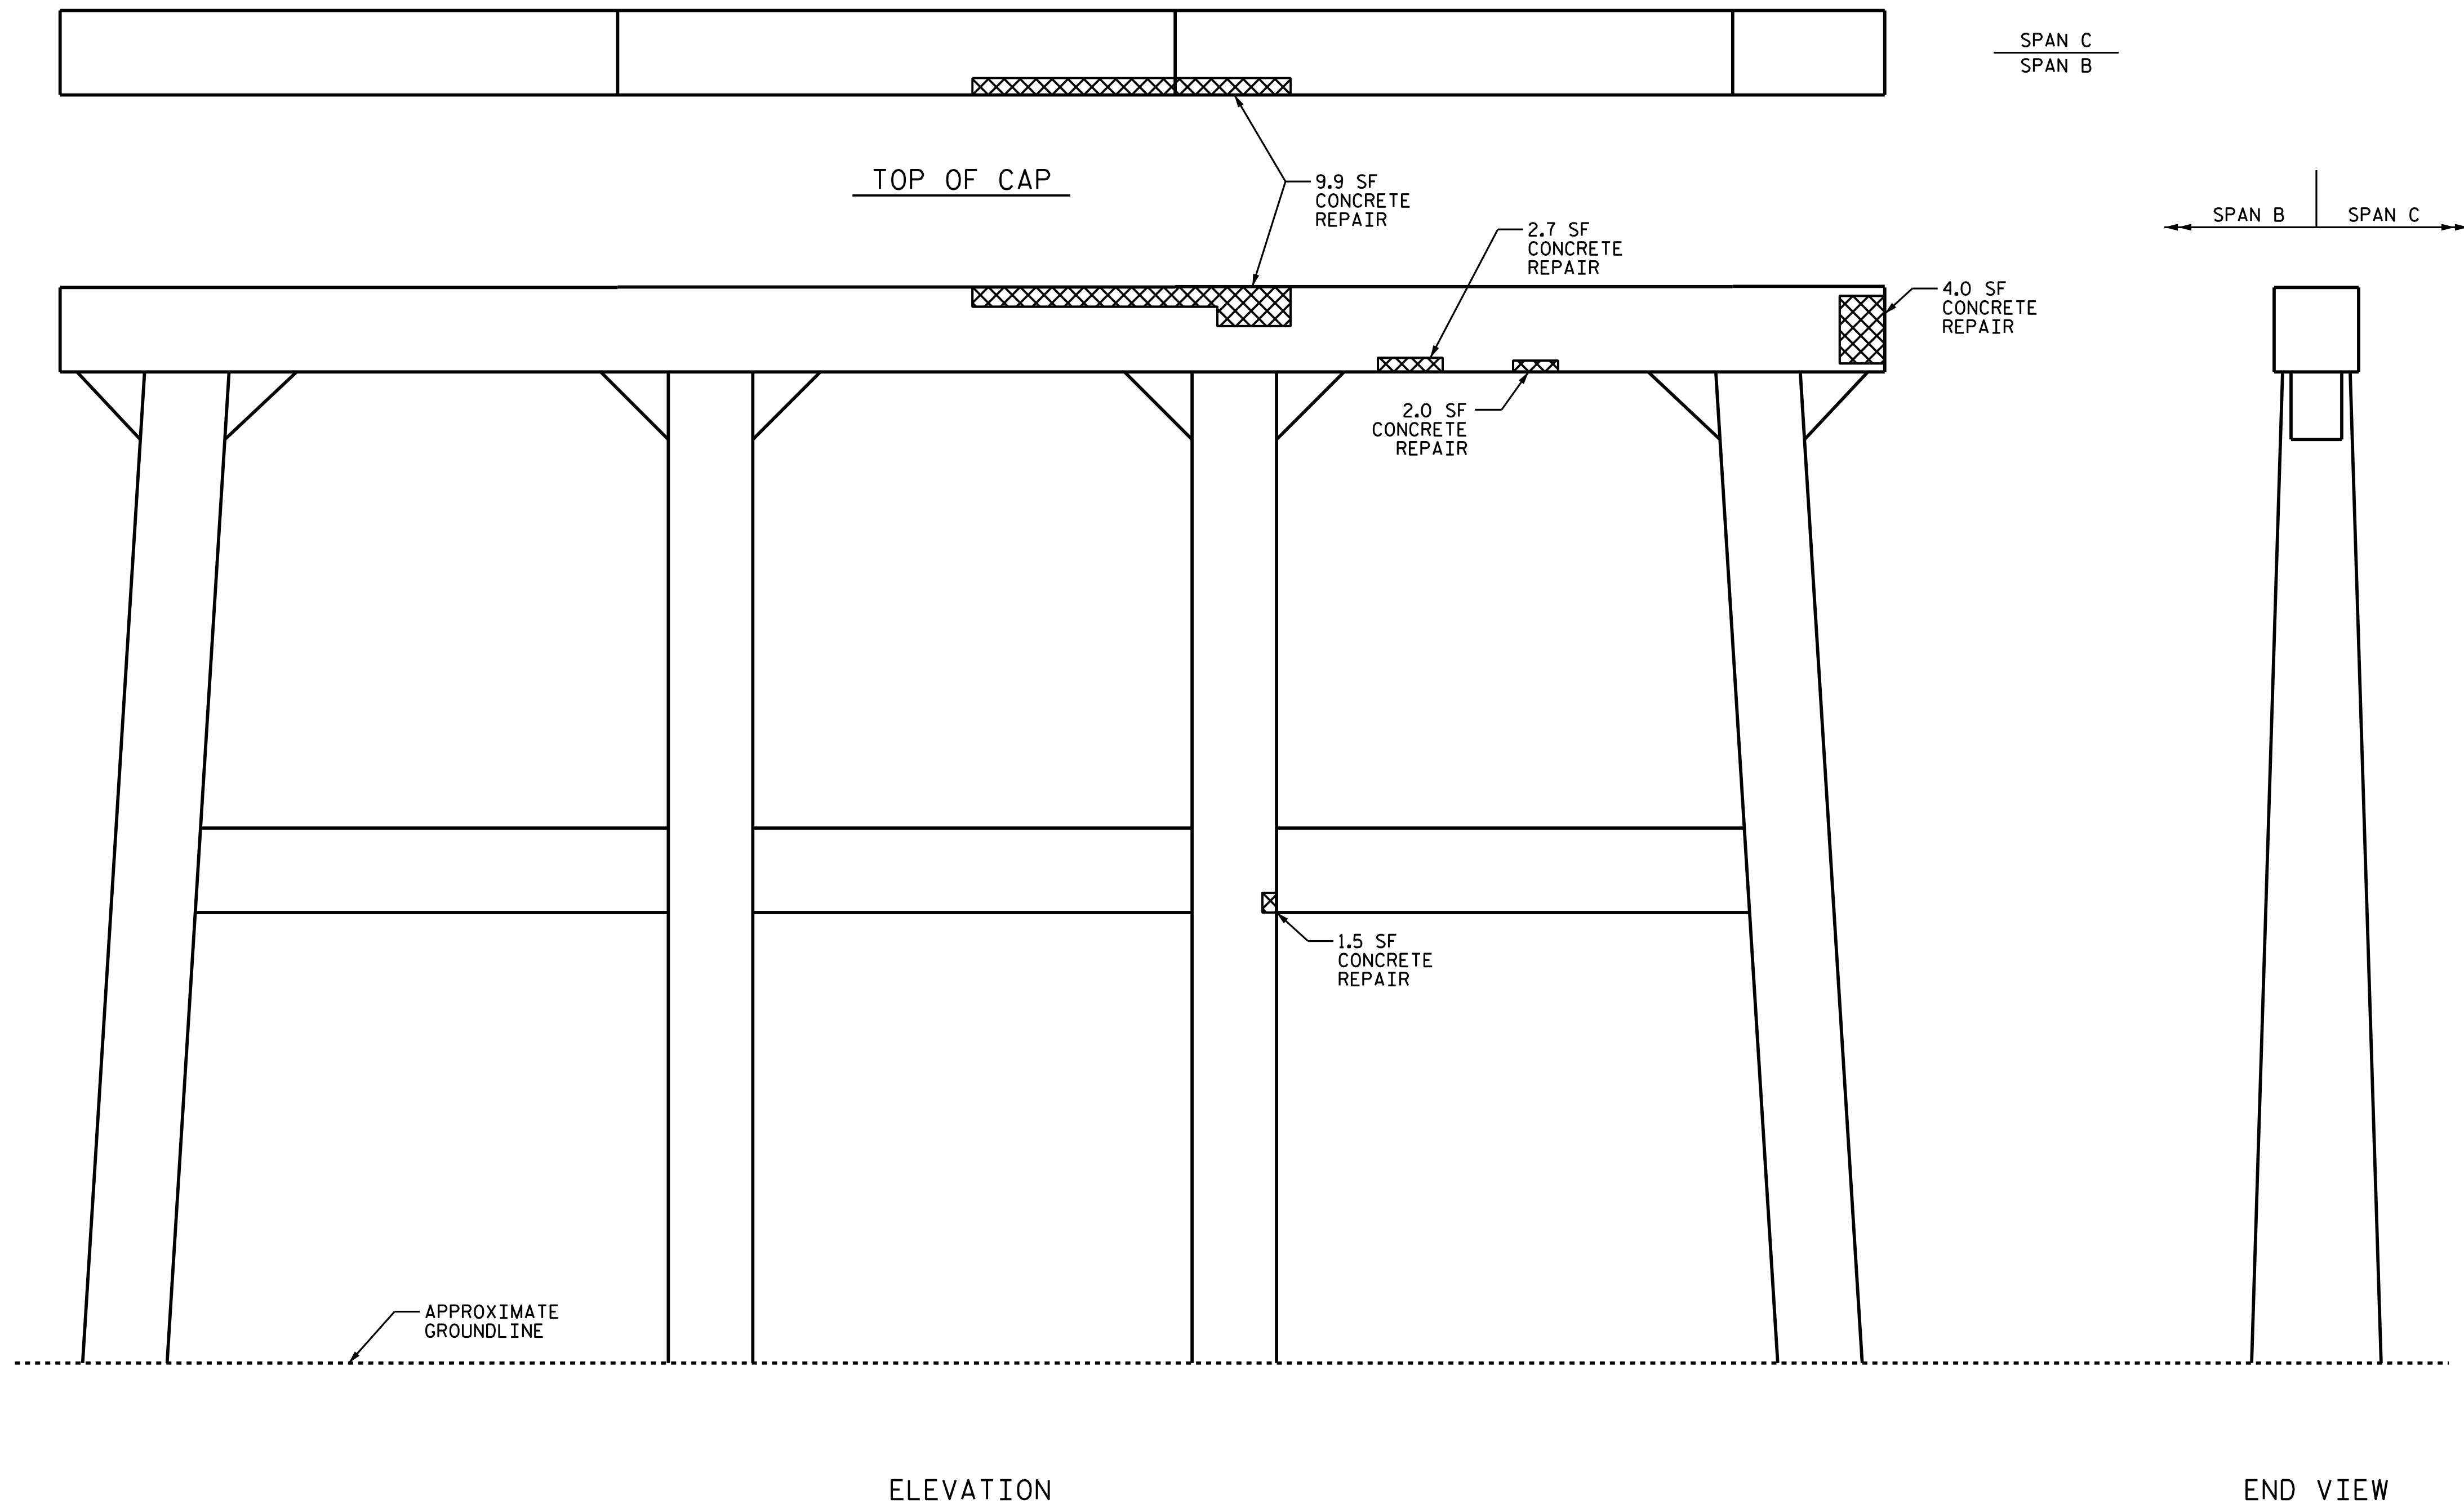
CONCRETE REPAIR AREA

CLEAN AND REMOVE DEBRIS FROM THE TOP OF THE CAP AND APPLY EPOXY PROTECTIVE COATING. EPOXY COATING SHALL BE APPLIED TO THE TOP SURFACE OF THE CAP. THE CONTRACTOR SHALL NOT COAT THE AREA OF THE CAP BENEATH THE MASONRY PLATES. FOR EPOXY COATING, SEE SPECIAL PROVISIONS.

CONCRETE REPAIRS TO THE BENT CAP MAY REQUIRE BRIDGE JACKING. FOR BRIDGE JACKING, SEE "JACKING DETAILS" SHEET.
