PROJECT NO. I-5825

MECKLENBURG

BENT 3

CONCRETE REPAIR AREA

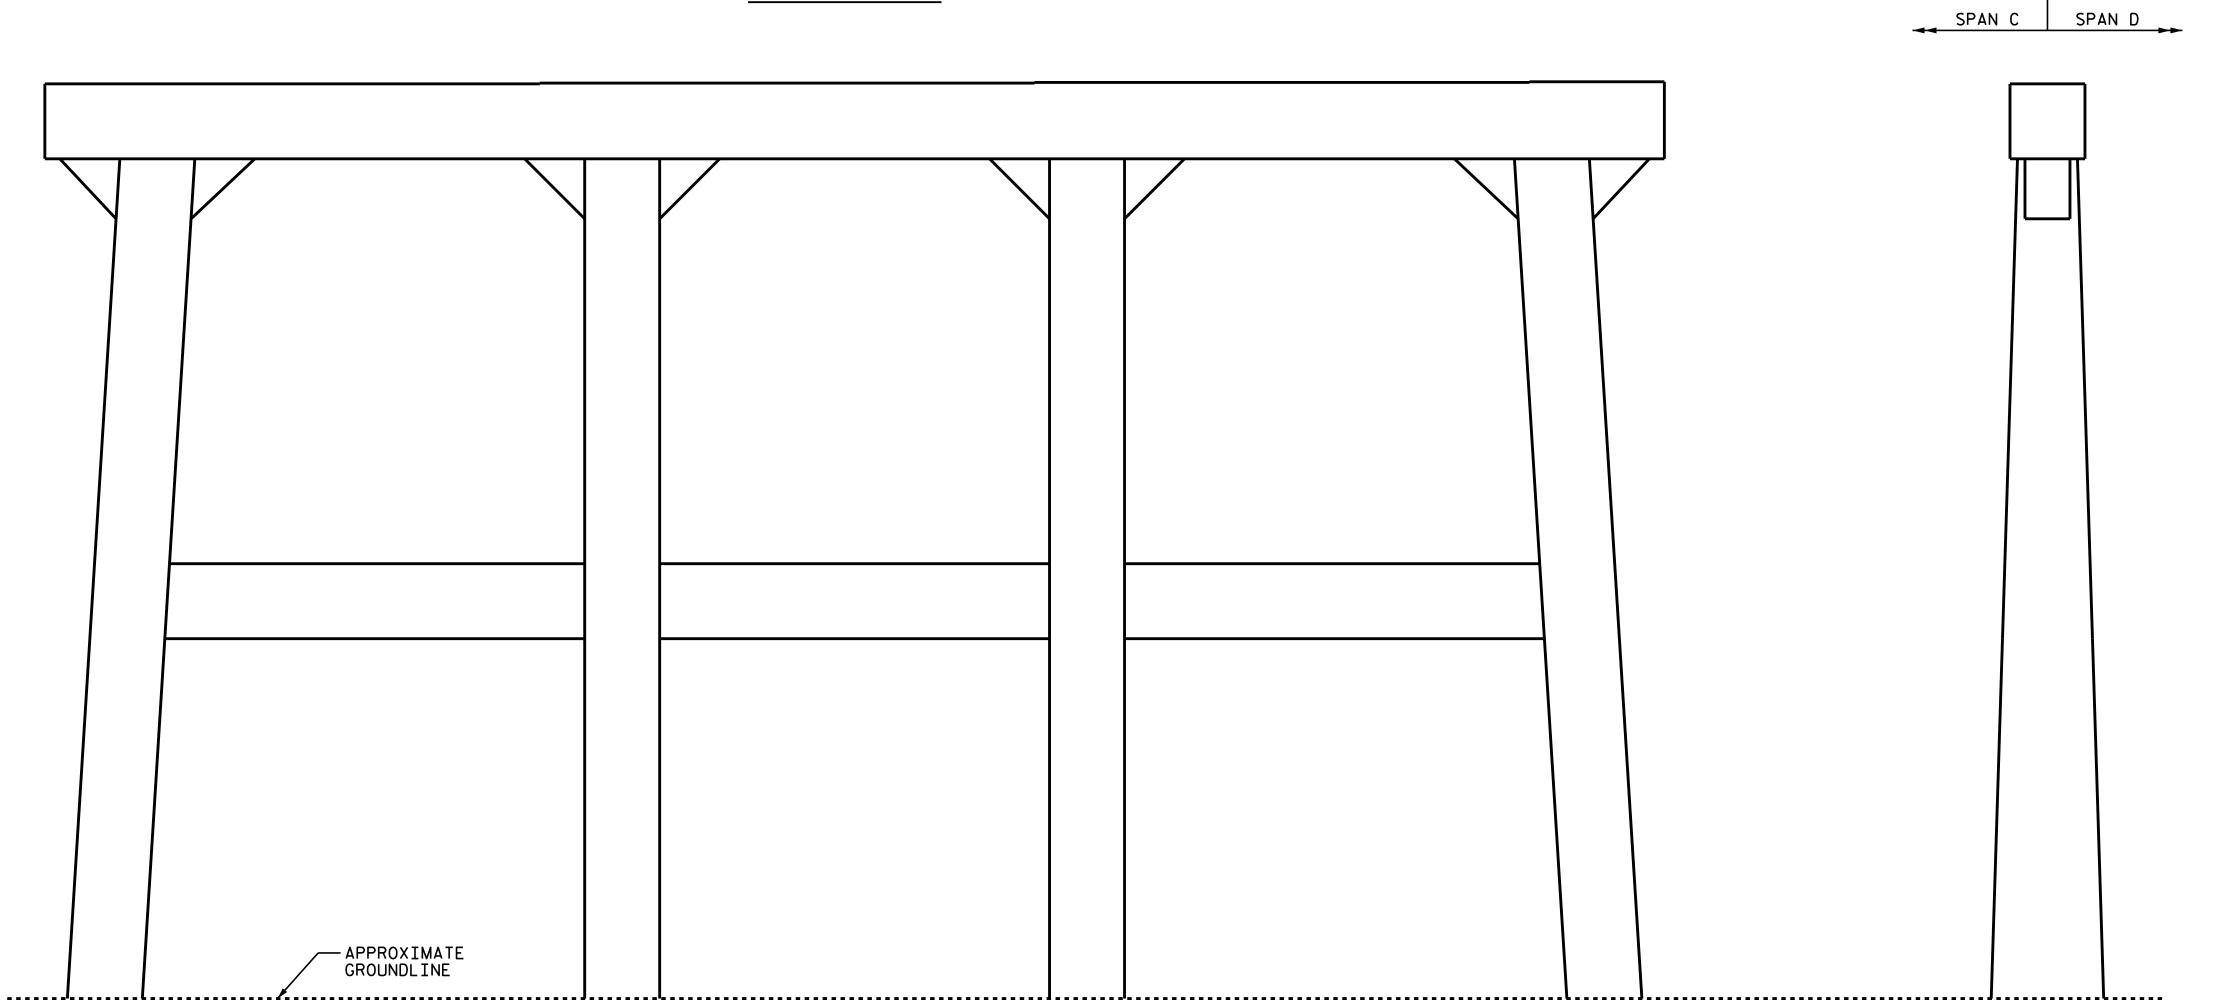
QUANTITIES BENT 3 ESTIMATE ACTUAL VOLUME CU.FT. CONCRETE REPAIRS VOLUME SO.FT. SQ.FT. CU.FT. CAP 5.3 2.7 COLUMNS 0.0 0.0

EPOXY COATING SQ.FT. SQ.FT. 135 TOP OF BENT CAP

VALUES IN CHART REPRESENT ESTIMATED REPAIR TOTALS AFTER REMOVAL OF UNSOUND CONCRETE, MINIMUM OF 1"BEHIND REBAR AND MINIMUM 2"CLEARANCE TO SAWCUT. FOR REPAIR DETAILS, SEE "TYPICAL CAP AND COLUMN REPAIR DETAILS" SHEET.

CLEAN AND REMOVE DEBRIS FROM THE TOP OF THE CAP AND APPLY EPOXY PROTECTIVE COATING. EPOXY COATING SHALL BE APPLIED TO THE TOP SURFACE OF THE CAP. THE CONTRACTOR SHALL NOT COAT THE AREA OF THE CAP BENEATH THE MASONRY PLATES. FOR EPOXY COATING, SEE SPECIAL PROVISIONS.

CONCRETE REPAIRS TO THE BENT CAP MAY REQUIRE BRIDGE JACKING. FOR BRIDGE JACKING, SEE "JACKING DETAILS" SHEET.
