PROJECT NO. I-5769  
MECKLENBURG COUNTY  
 BRIDGE NO. 590222

STATE OF NORTH CAROLINA  
 DEPARTMENT OF TRANSPORTATION  
 RALEIGH  
 SUBSTRUCTURE  
 END BENT 1

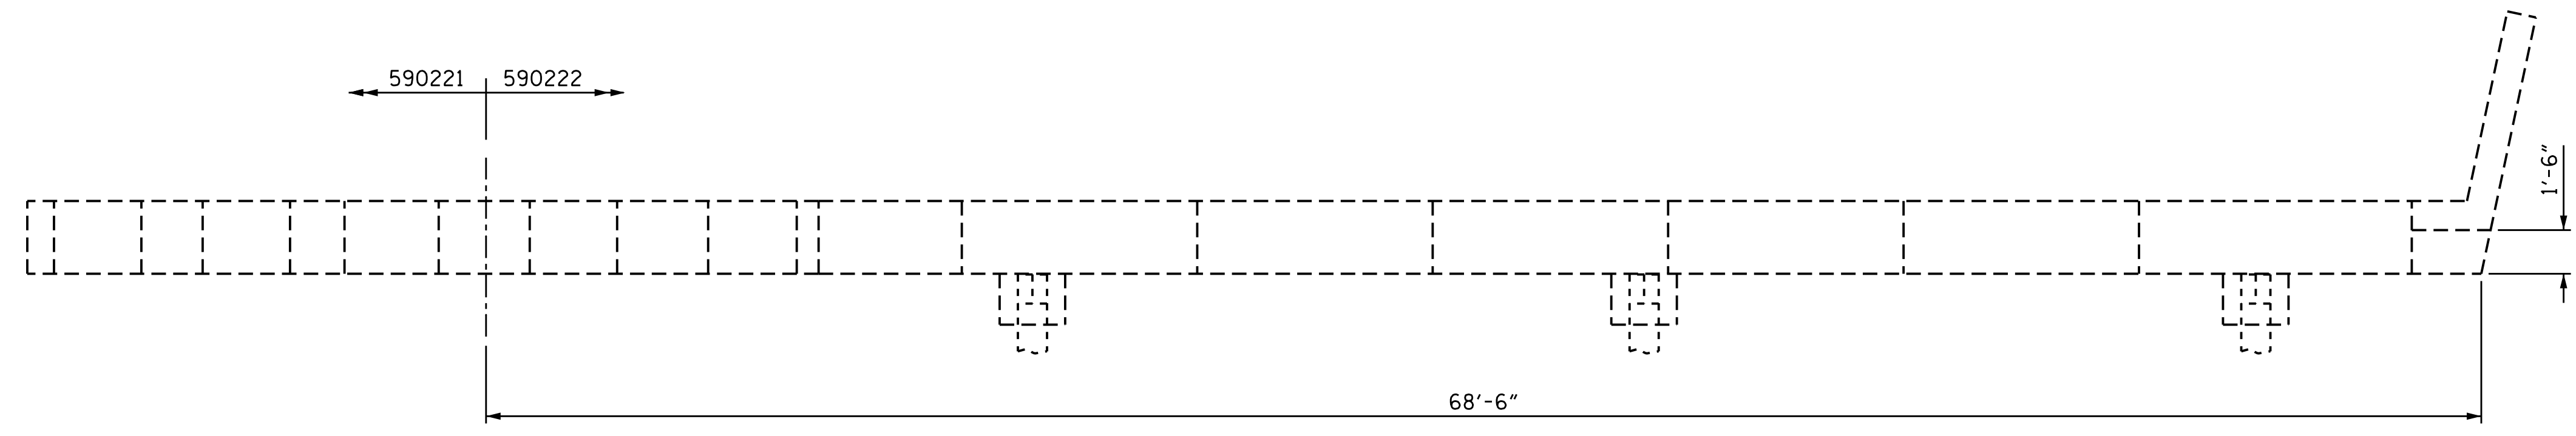
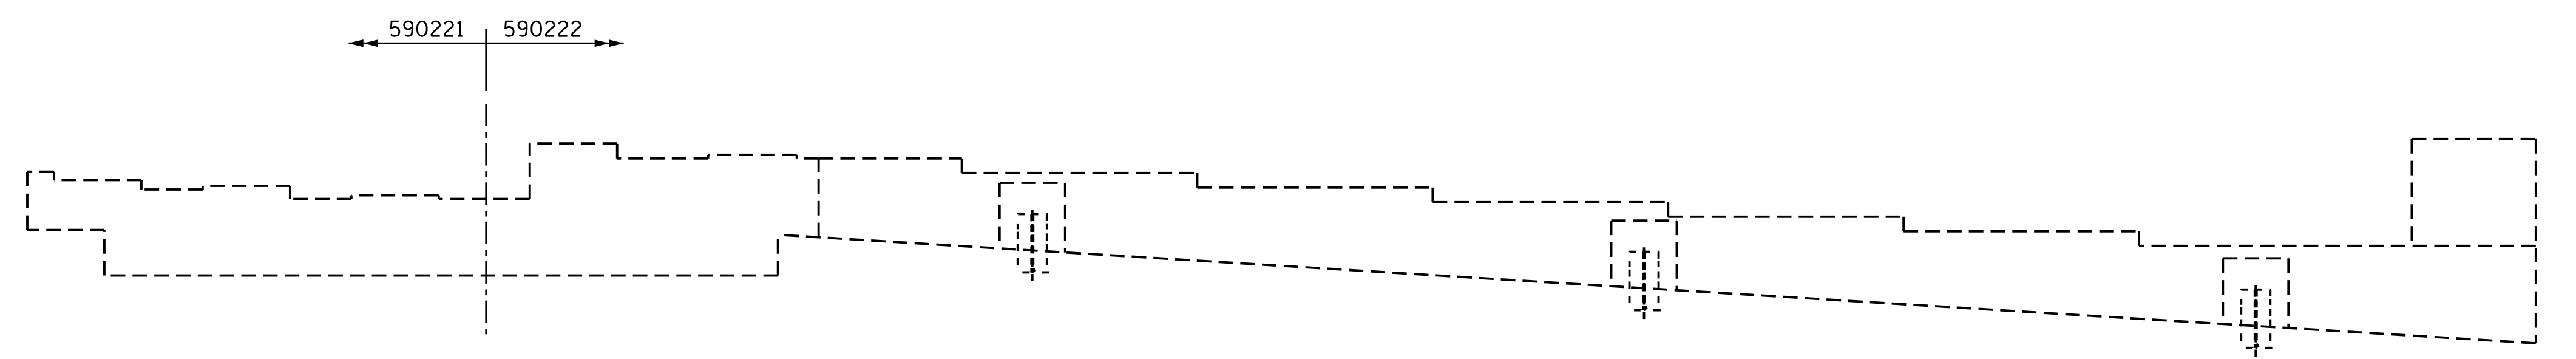
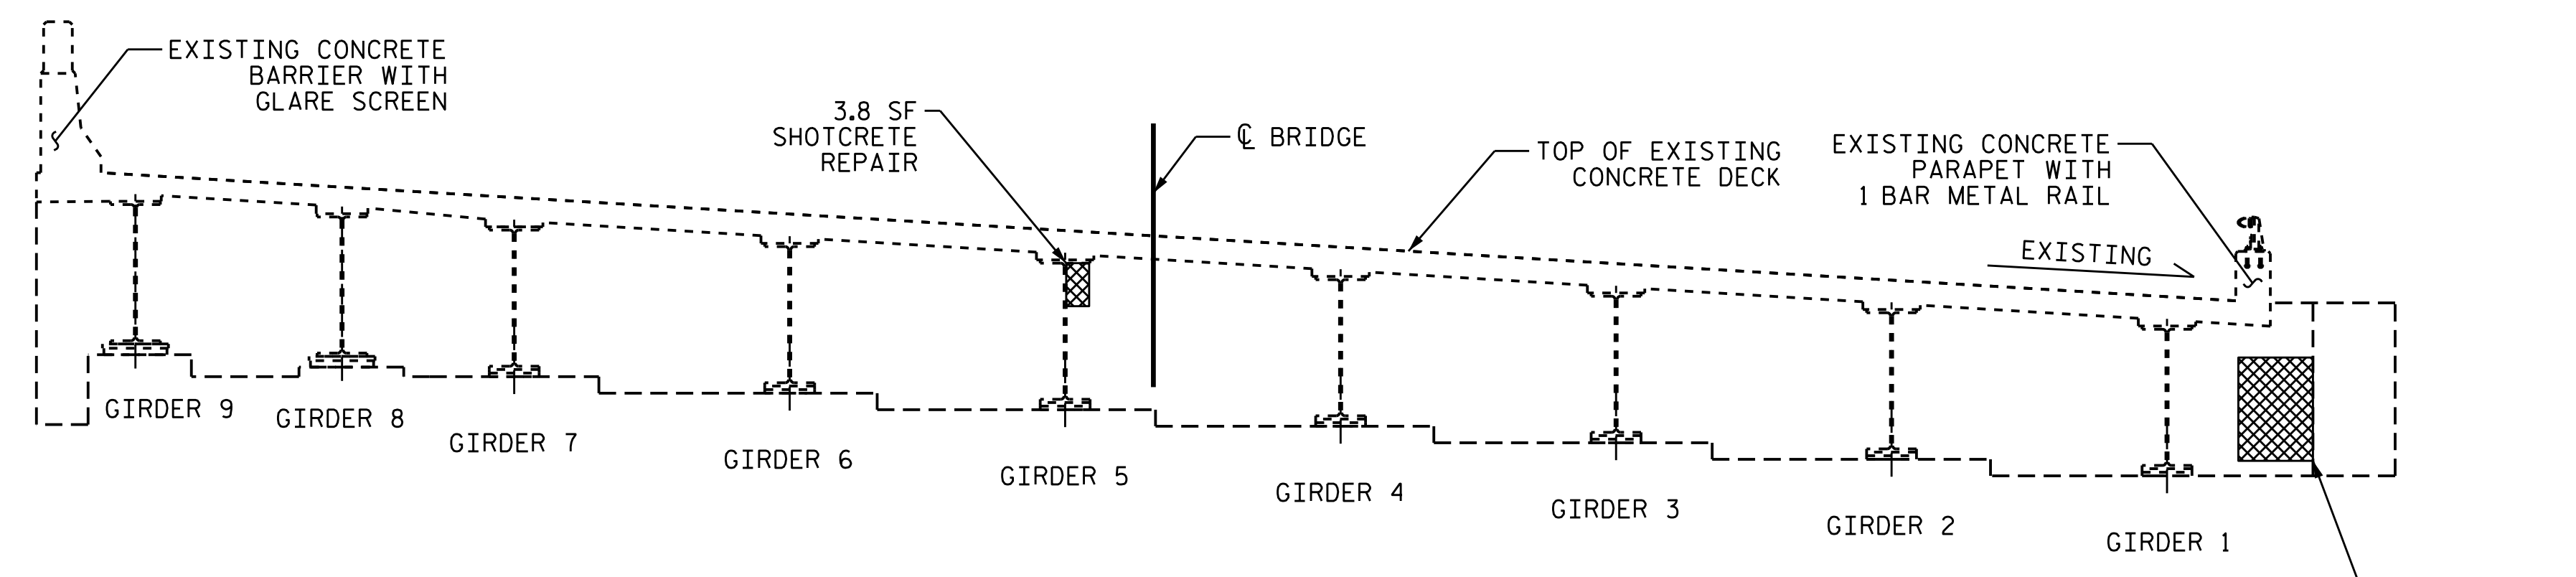
AS-BUILT REPAIR QUANTITY TABLE				
END BENT 1 REPAIRS	QUANTITIES			
	ESTIMATE		ACTUAL	
SHOTCRETE REPAIRS	AREA SF	VOLUME CF	AREA SF	VOLUME CF
CAP	0	0		
CURTAIN WALL	13.2	6.6		
CONCRETE REPAIRS	AREA SF	VOLUME CF	AREA SF	VOLUME CF
CAP	0	0		
CURTAIN WALL	0	0		
EPOXY COATING	AREA SF		AREA SF	
CAP	124

CLEAN AND REMOVE DEBRIS FROM THE TOP OF THE CAP AND APPLY EPOXY PROTECTIVE COATING. EPOXY COATING SHALL BE APPLIED TO THE TOP SURFACE OF THE CAP AND TO THE TOP SURFACE OF THE PILE CAPS. THE CONTRACTOR SHALL NOT COAT THE AREA OF THE CAP BENEATH THE MASONRY PLATES. FOR EPOXY COATING, SEE SPECIAL PROVISIONS.
