PROJECT NO. I-5769
 MECKLENBURG COUNTY
 BRIDGE NO. 590241

STATE OF NORTH CAROLINA
 DEPARTMENT OF TRANSPORTATION
 RALEIGH
 SUBSTRUCTURE
 BENT 1

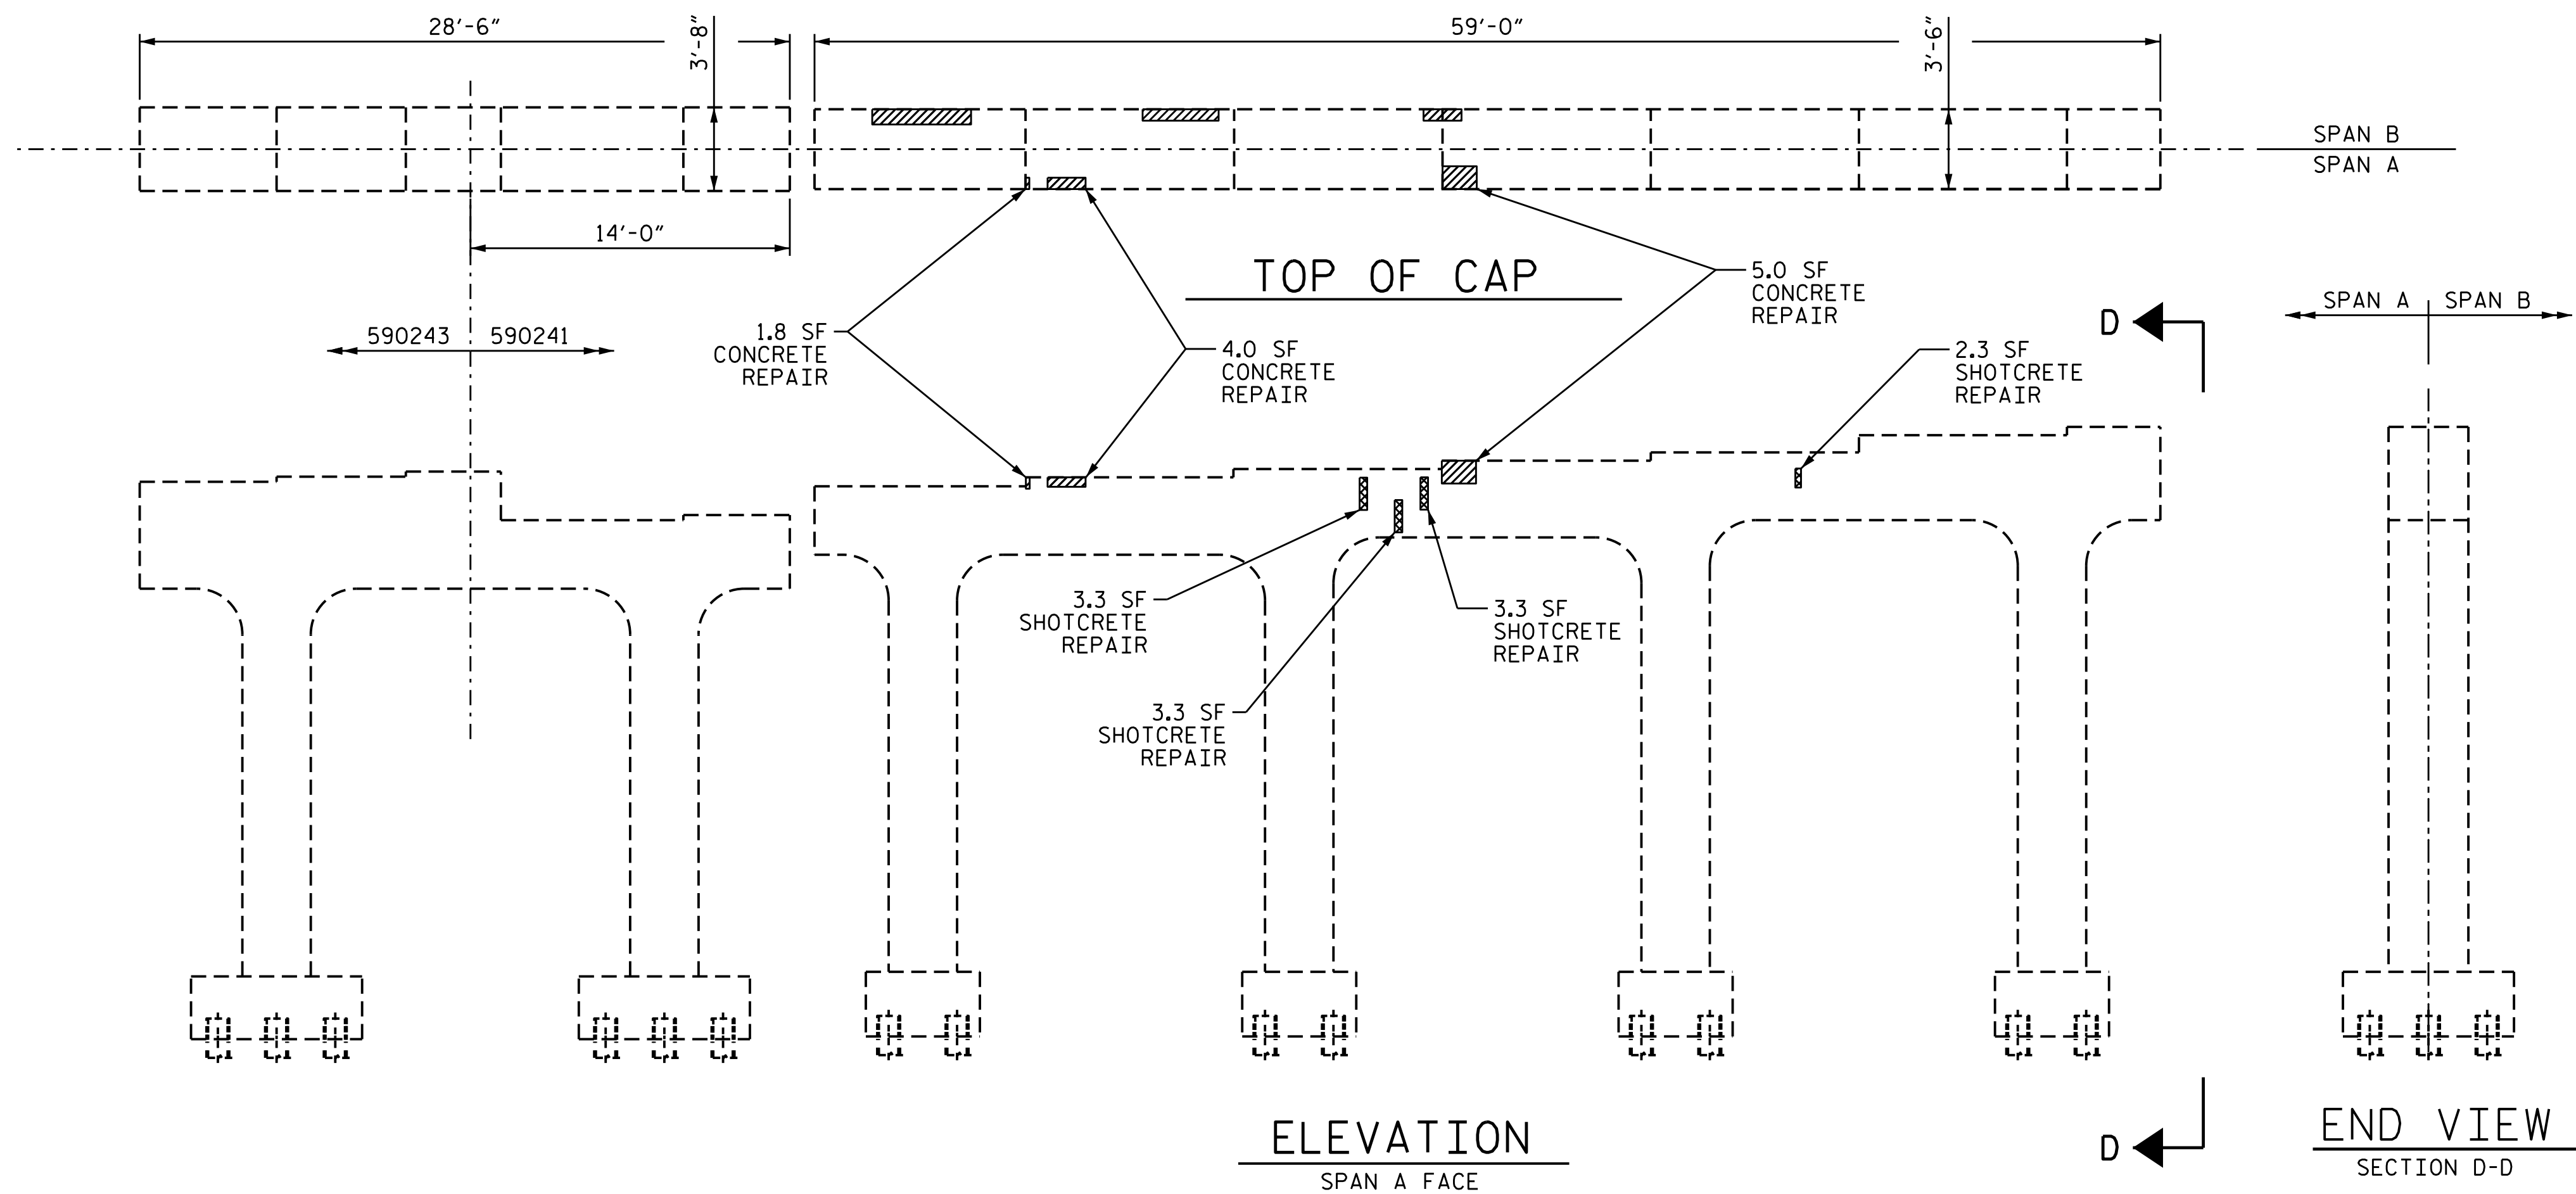
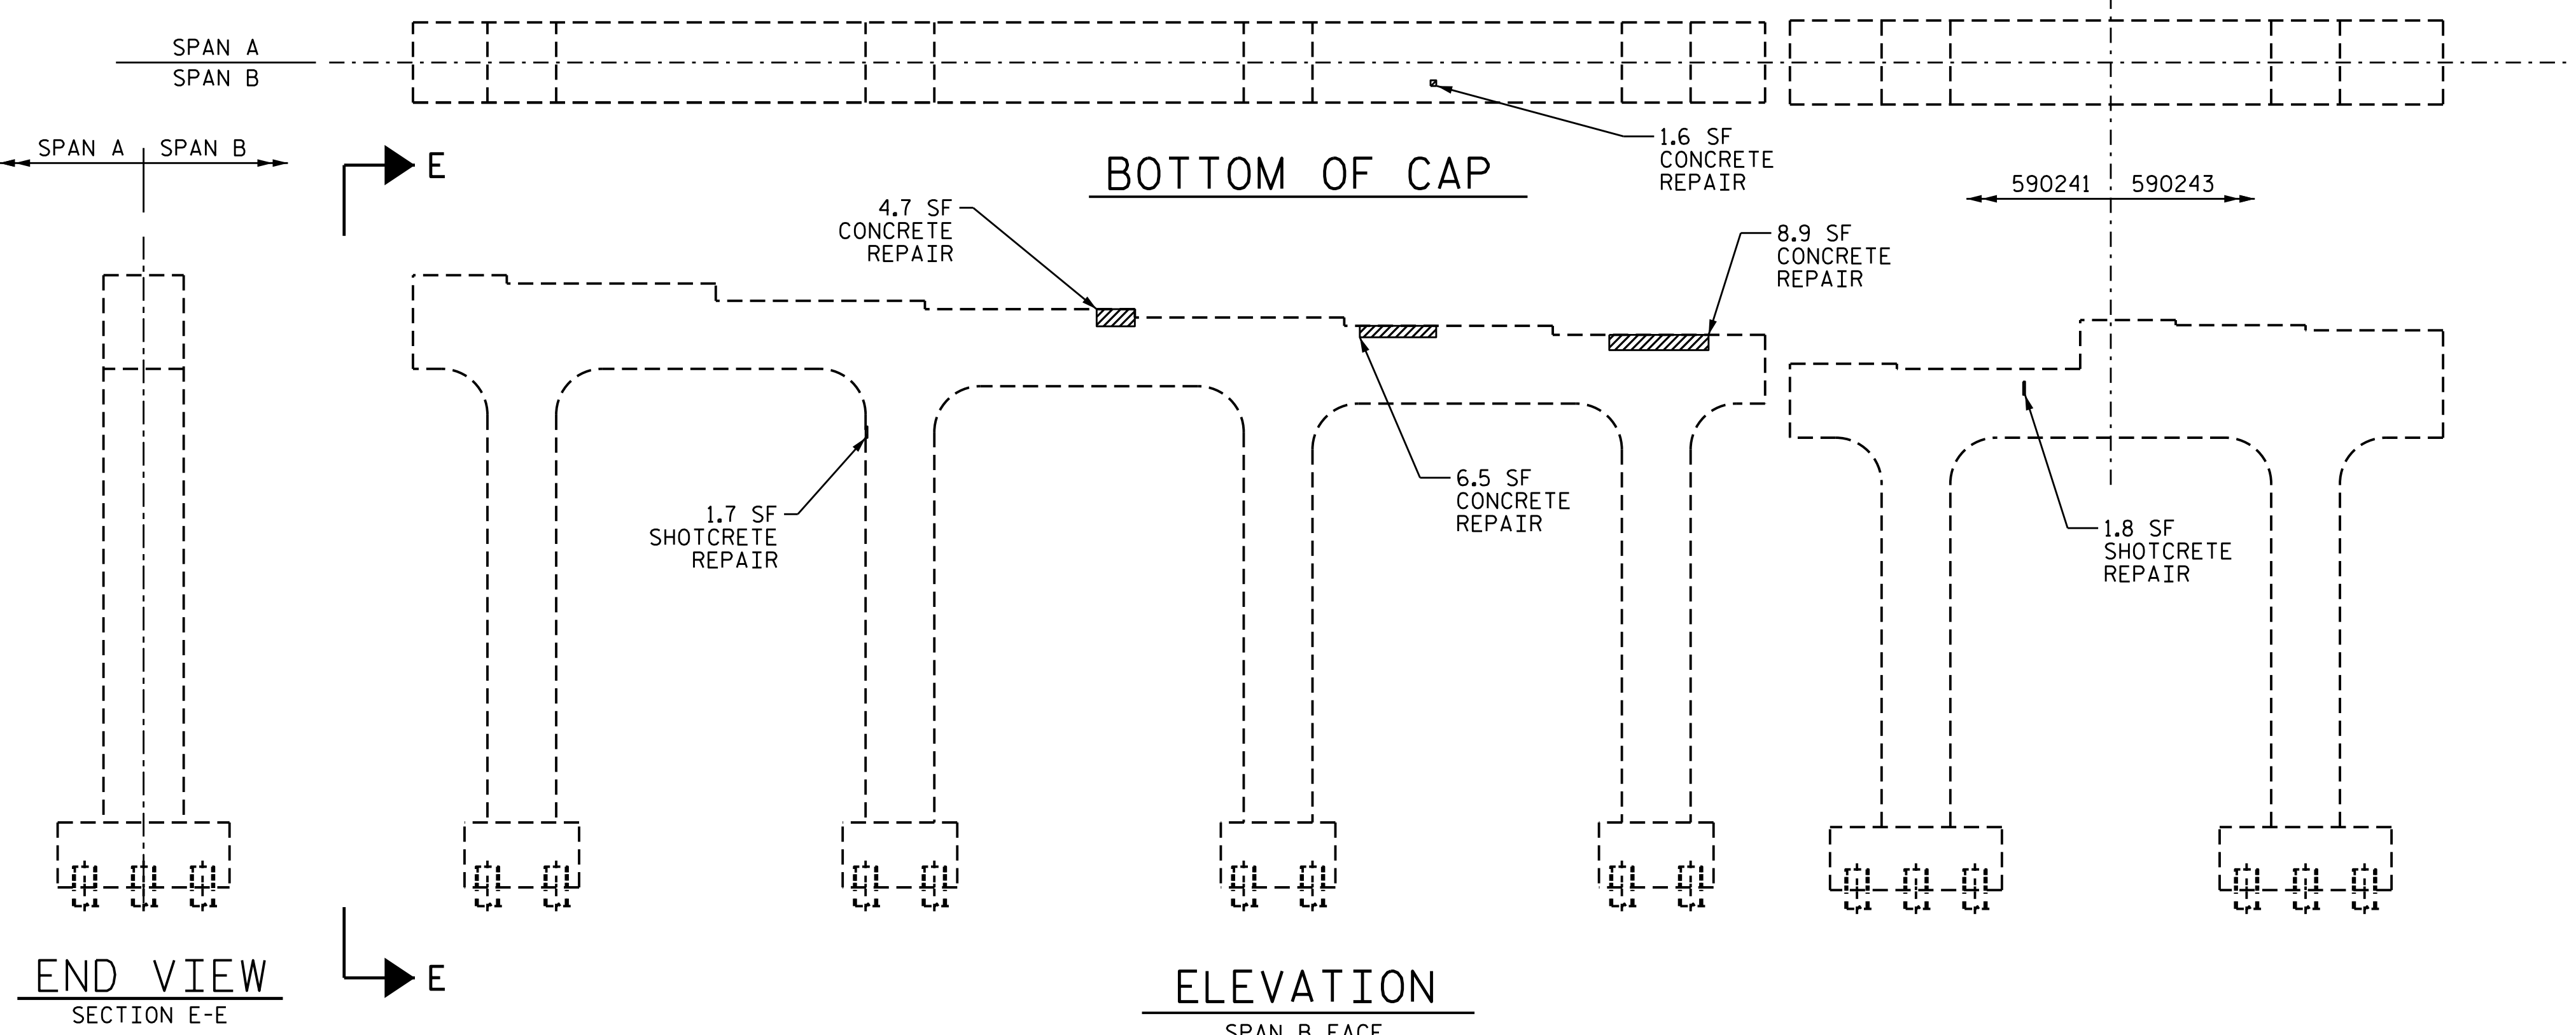
AS-BUILT REPAIR QUANTITY TABLE				
BENT 1 REPAIRS	QUANTITIES			
	ESTIMATE		ACTUAL	
SHOTCRETE REPAIRS	AREA SF	VOLUME CF	AREA SF	VOLUME CF
CAP	14.0	7.0		
COLUMN	1.7	0.9		
CONCRETE REPAIRS	AREA SF	VOLUME CF	AREA SF	VOLUME CF
CAP	32.5	20.3		
COLUMN	0	0		
EPOXY COATING	AREA SF		AREA SF	
CAP	277

CLEAN AND REMOVE DEBRIS FROM THE TOP OF THE CAP AND APPLY EPOXY PROTECTIVE COATING. EPOXY COATING SHALL BE APPLIED TO THE TOP SURFACE OF THE CAP. THE CONTRACTOR SHALL NOT COAT THE AREA OF THE CAP BENEATH THE MASONRY PLATES. FOR EPOXY COATING, SEE SPECIAL PROVISIONS.
