PROJECT NO.	<u> </u>	5769
MECKLEN	BURG	_ COUNTY
BRIDGE NO	5902	241

STATE OF NORTH CAROLINA DEPARTMENT OF TRANSPORTATION RALEIGH

SUBSTRUCTURE

END BENT 2

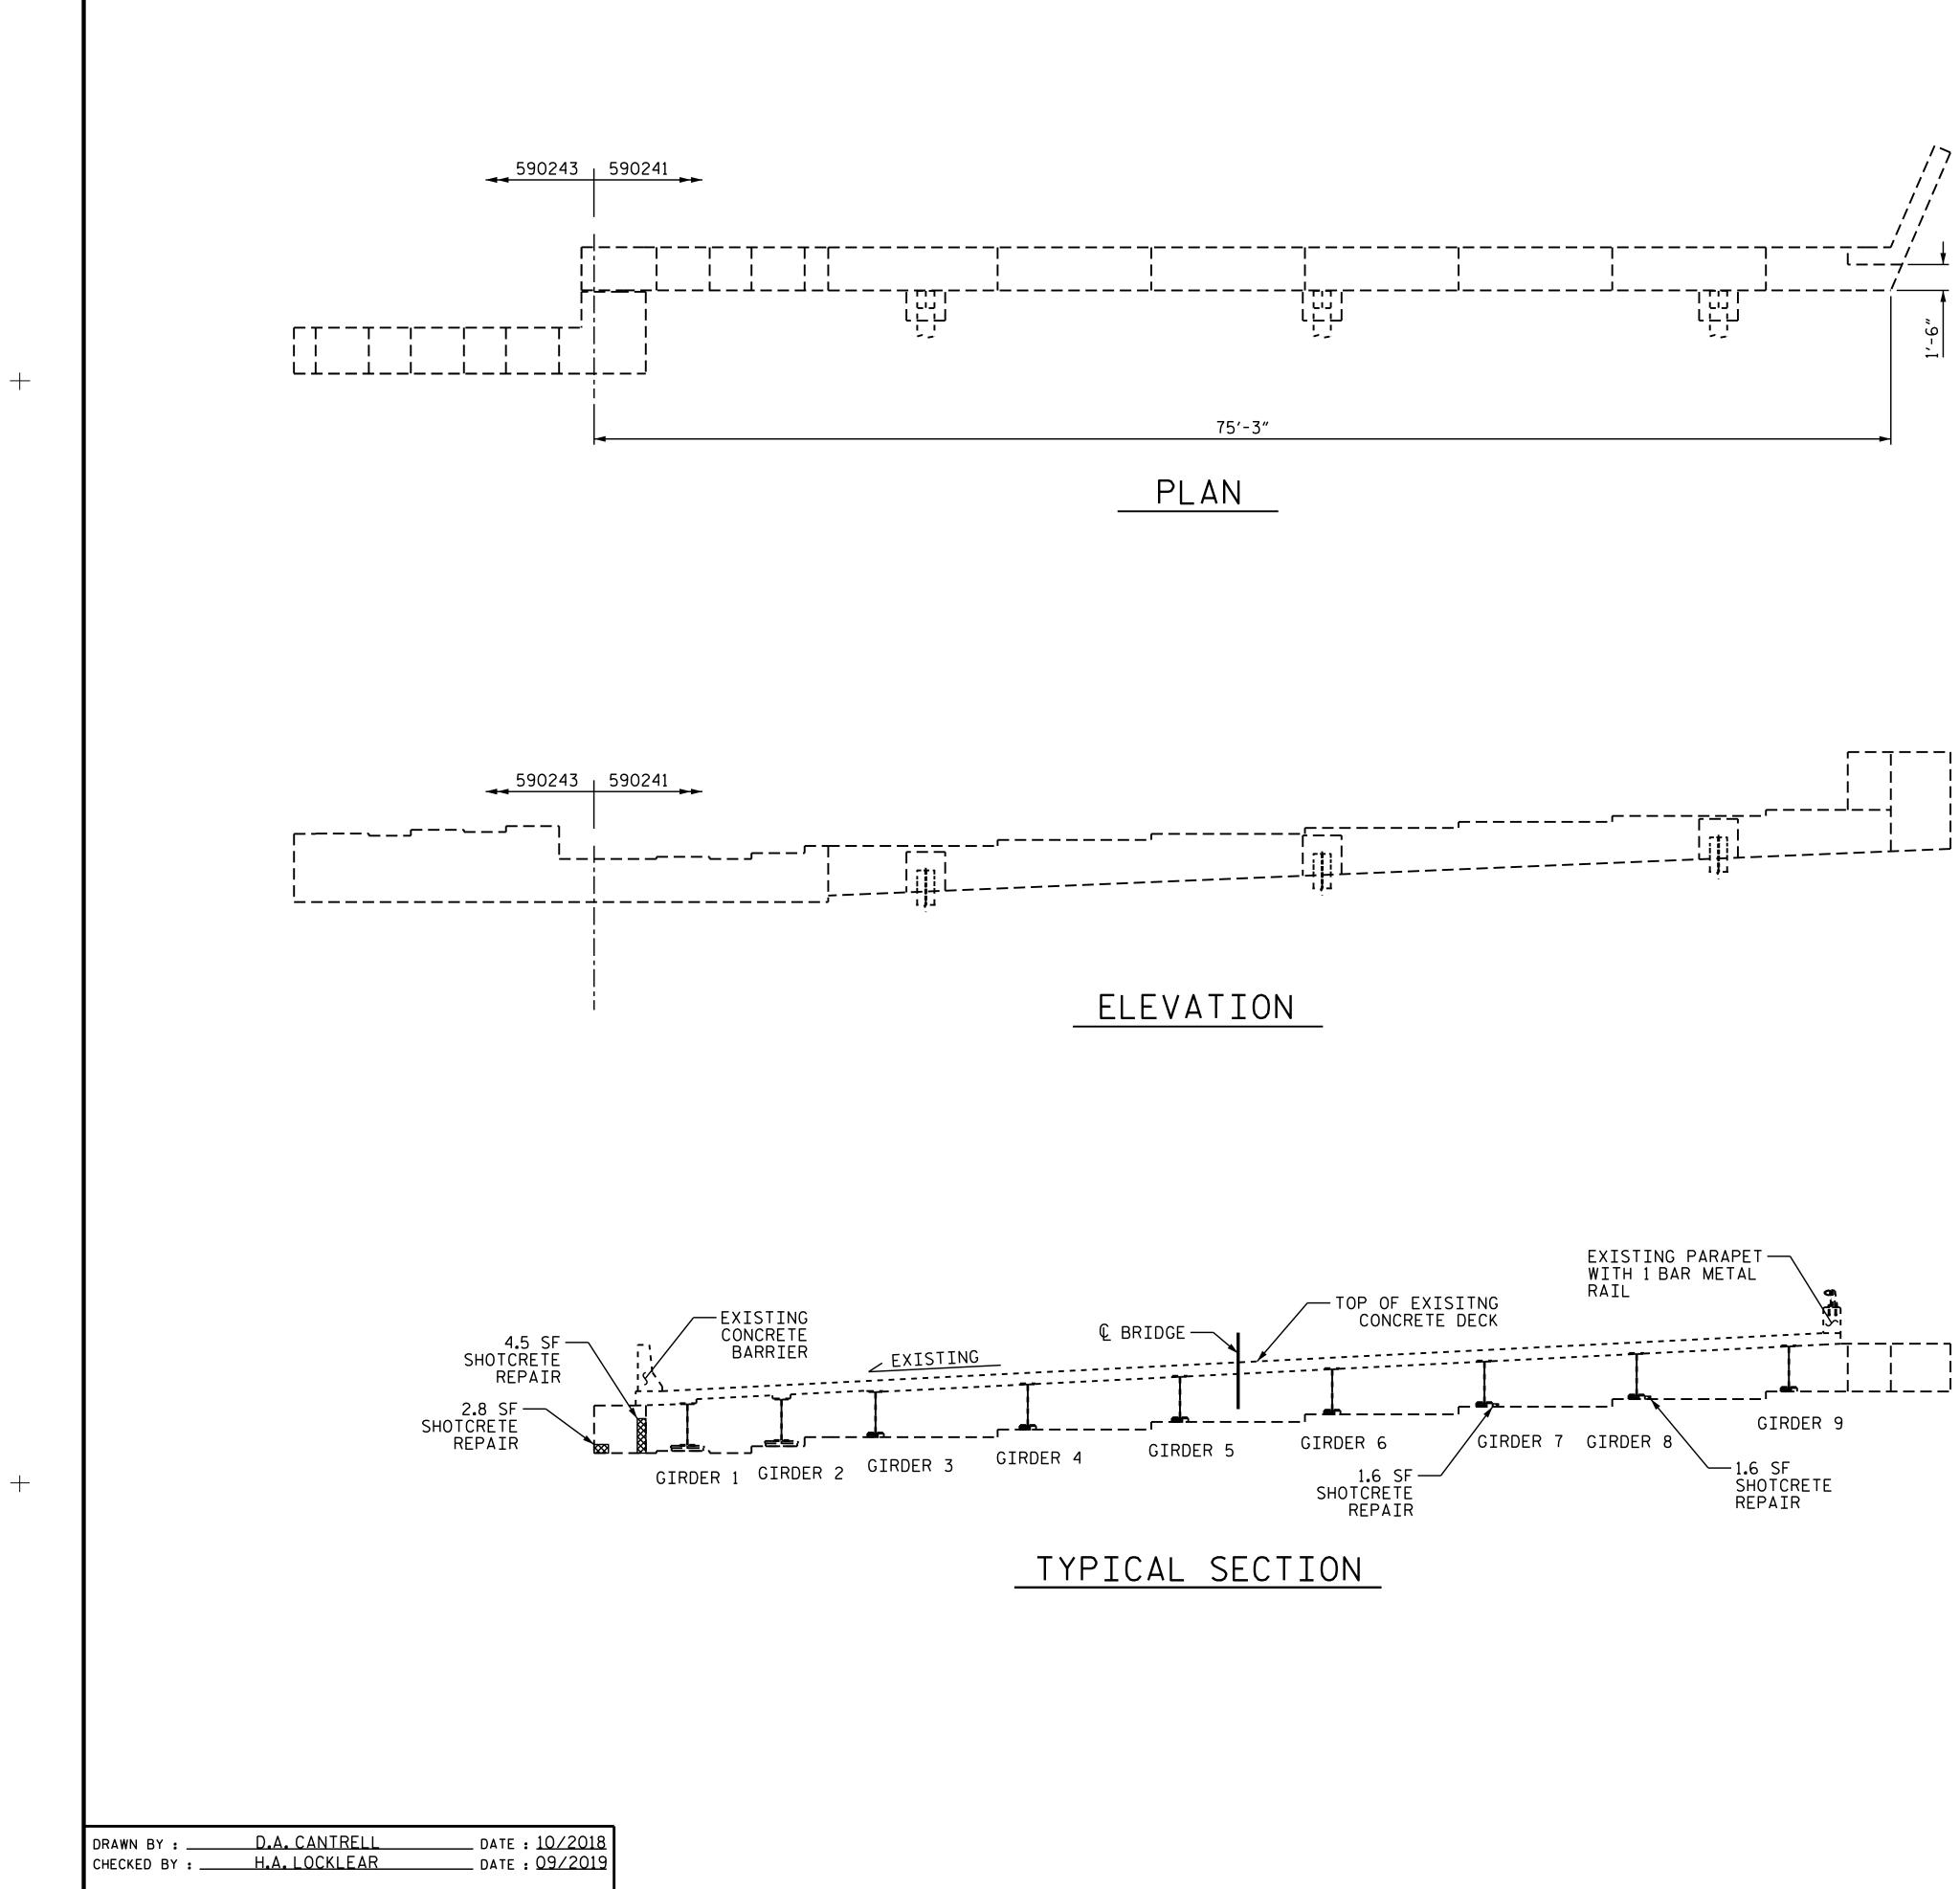
AS-BUILT REPAIR QUANTITY TABLE									
END BENT 2 REPAIRS	QUANTITIES								
ENU DENI Z REFAIRS	ESTI	ΜΑΤΕ	ACTUAL						
SHOTCRETE REPAIRS	AREA SF	VOLUME CF	AREA SF	VOLUME CF					
САР	0	0							
CURTAIN WALL	10.5	5.3							
CONCRETE REPAIRS	AREA SF	VOLUME CF	AREA SF	VOLUME CF					
САР	0	0							
CURTAIN WALL	0	0							
EPOXY COATING	AREA SF		AREA SF						
САР	13	33

VALUES IN CHART REPRESENT ESTIMATED REPAIR TOTALS AFTER REMOVAL OF UNSOUND CONCRETE, MINIMUM OF 1"BEHIND REBAR AND MINIMUM OF 2" CLEARANCE TO SAWCUT. FOR REPAIR DETAILS, SEE "TYPICAL CAP AND COLUMN REPAIR DETAILS" SHEET.

CLEAN AND REMOVE DEBRIS FROM THE TOP OF THE CAP AND APPLY EPOXY PROTECTIVE COATING. EPOXY COATING SHALL BE APPLIED TO THE TOP SURFACE OF THE CAP AND TO THE TOP SURFACE OF THE PILE CAPS. THE CONTRACTOR SHALL NOT COAT THE AREA OF THE CAP BENEATH THE MASONRY PLATES.FOR EPOXY COATING, SEE SPECIAL PROVISIONS.

CONCRETE REPAIRS MAY BE SUBSTITIUTED IN LIEU OF SHOTCRETE REPAIRS WITH THE APPROVAL OF THE ENGINEER.

FOR SHOTCRETE REPAIRS, SEE SPECIAL PROVISIONS.
