NC DEPARTMENT OF TRANSPORTATION
 DIVISION OF HIGHWAYS
 STRUCTURE MANAGEMENT UNIT

ATTENTION: **PRIORITY MAINTENANCE ISSUED**

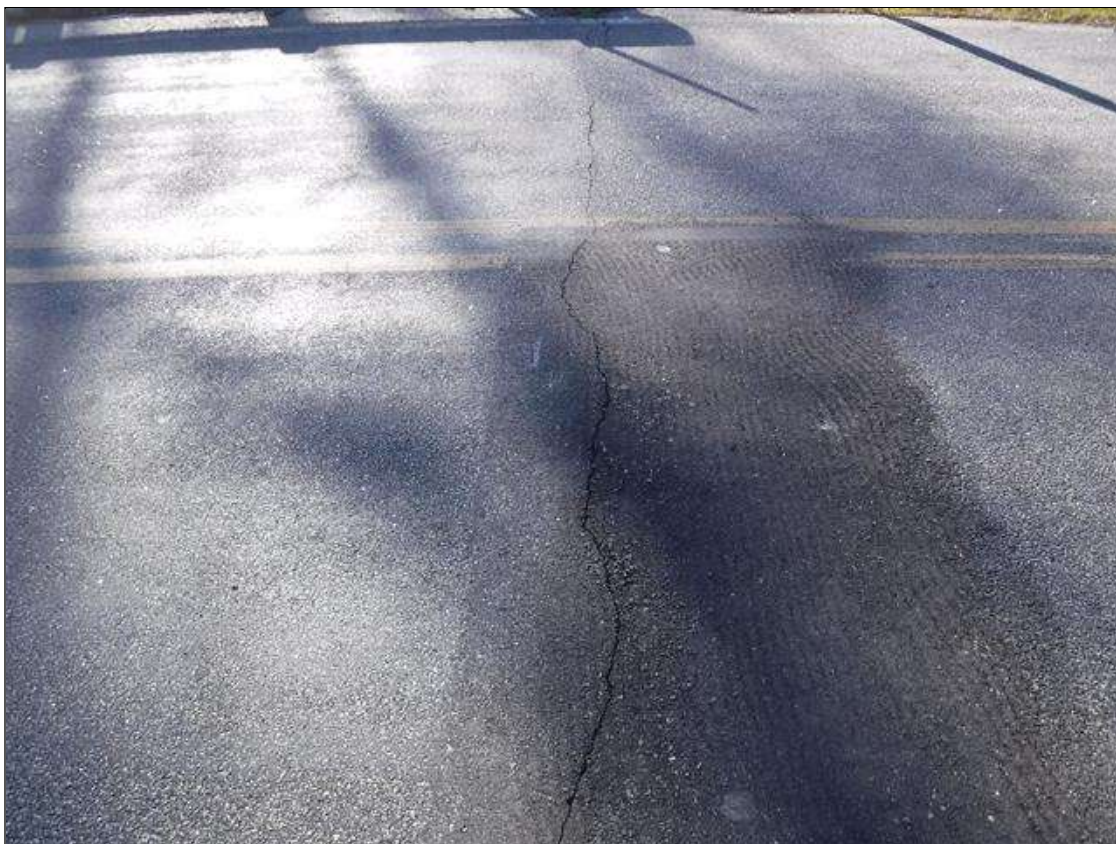
Span 1 Wearing Surface: TRANSVERSE CRACKING END BENT 1

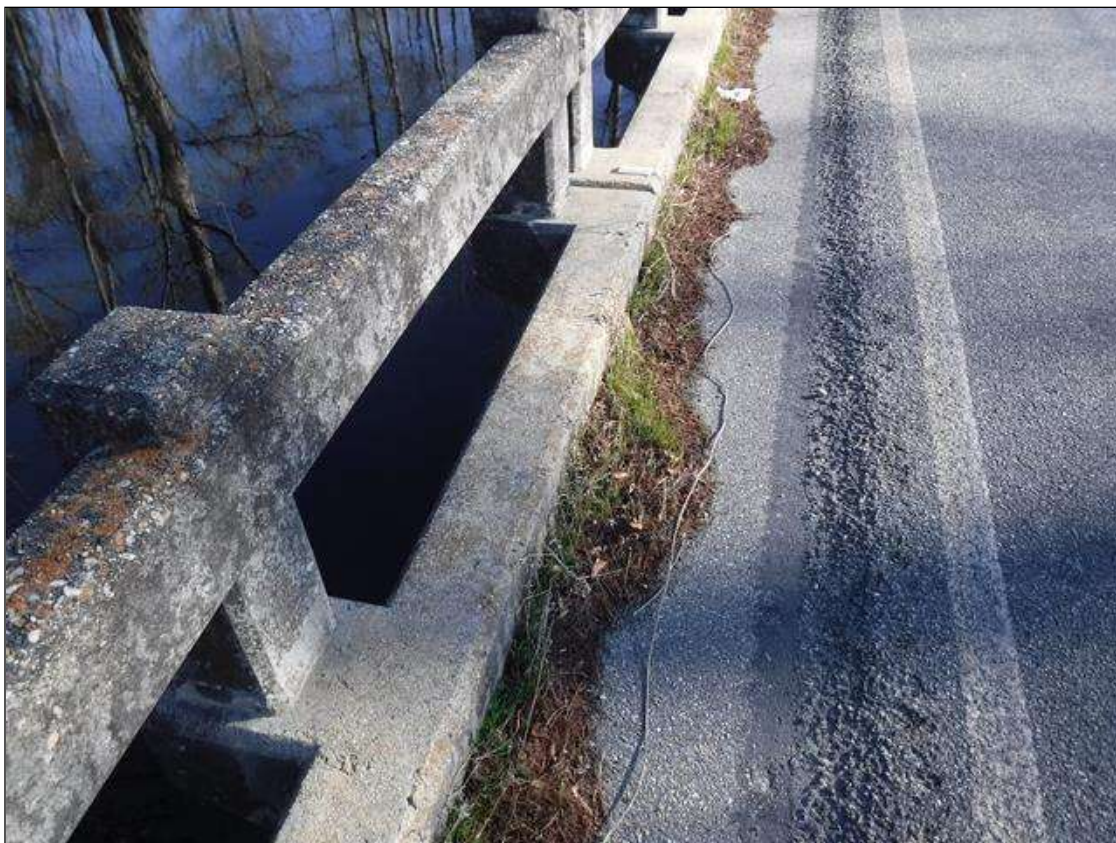
DEBRIS VEGETATION ALONG CURBS

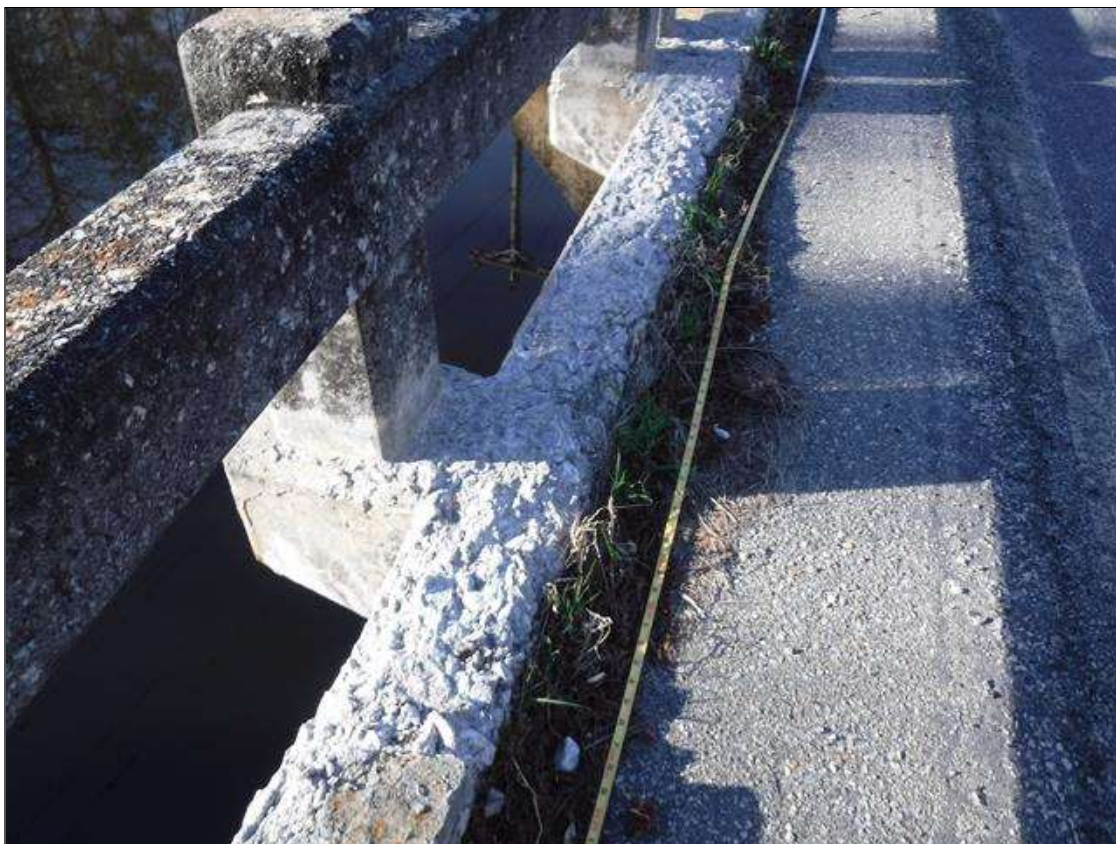
Span 1 Deck: SPALLING IN RIGHT CURB 3 INCH DEEP

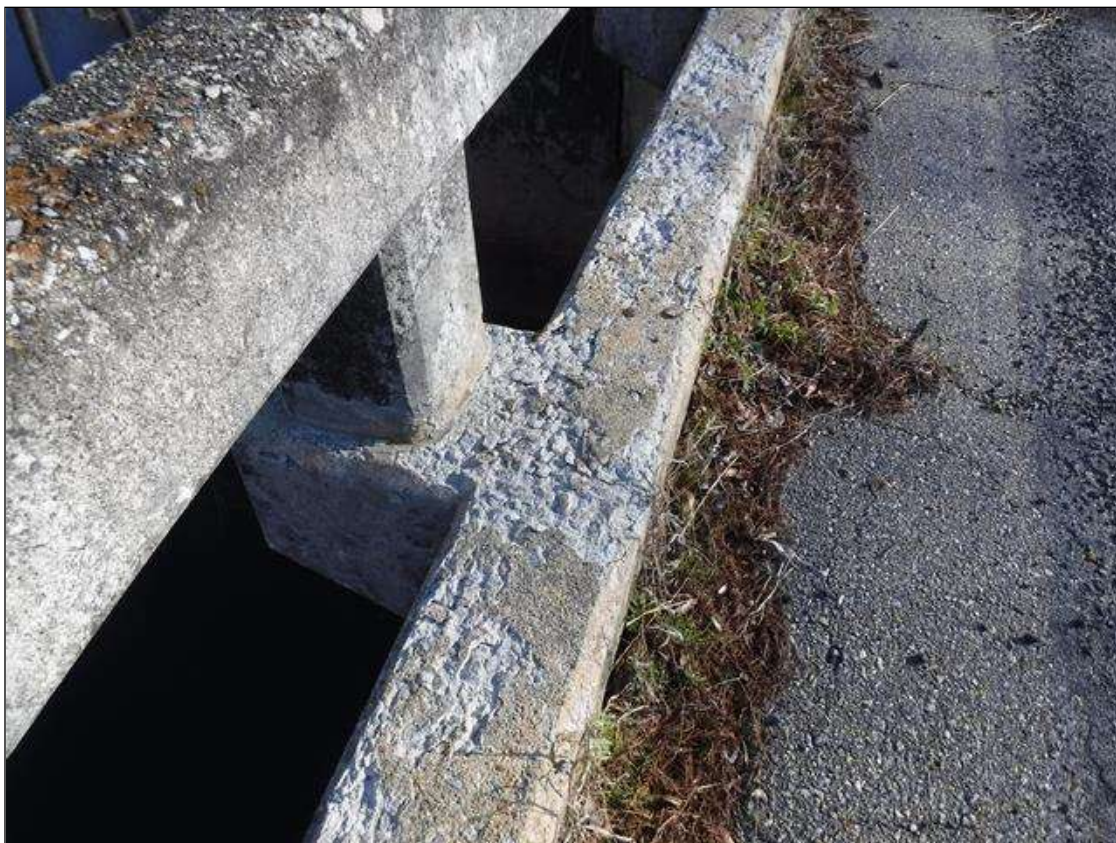
Span 2 Deck: SPALLING 1/2 IN DEEP TOP LEFT CURB

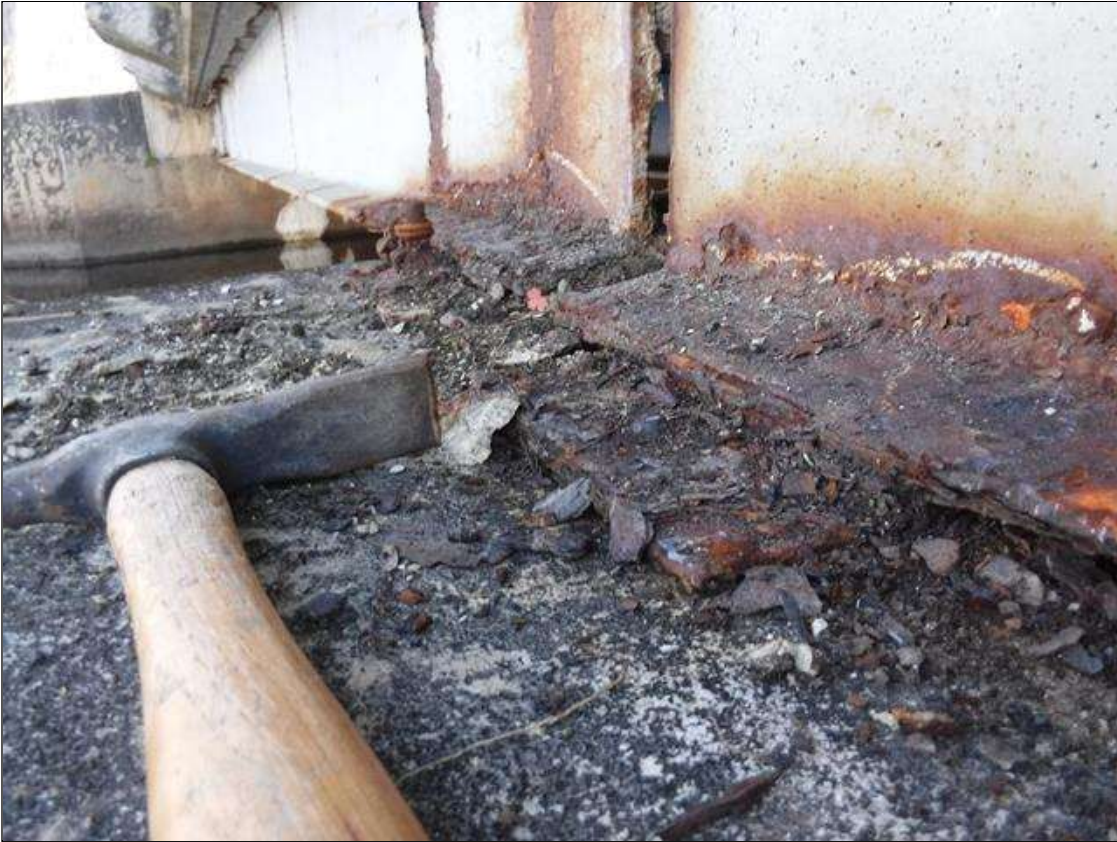
Span 1 Beam 1 Far Bearing: MISSING ANCHOR BOLT BEAM 1 BEARING OVER BENT 1 PRIORITY MAINTENANCE ISSUED

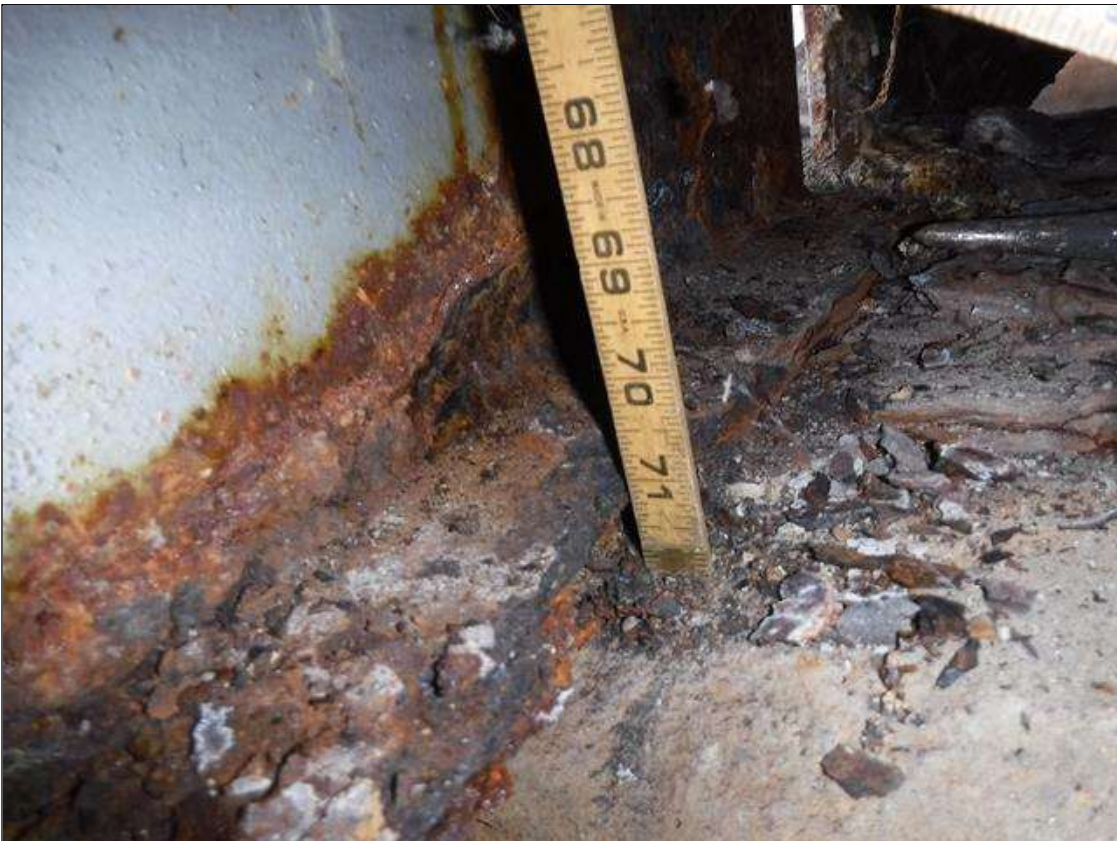
Span 1 Beam 1: SECTION LOSS 100 % 1/2 IN WIDE X 1 FOOT LONG BOTTOM FLANGE BENT 1 REAMINDER DOWN TO KNIFE EDGE, WEB 5/16 IN REMAINING 2 IN HIGH PRIORITY MAINTENANCE ISSUED

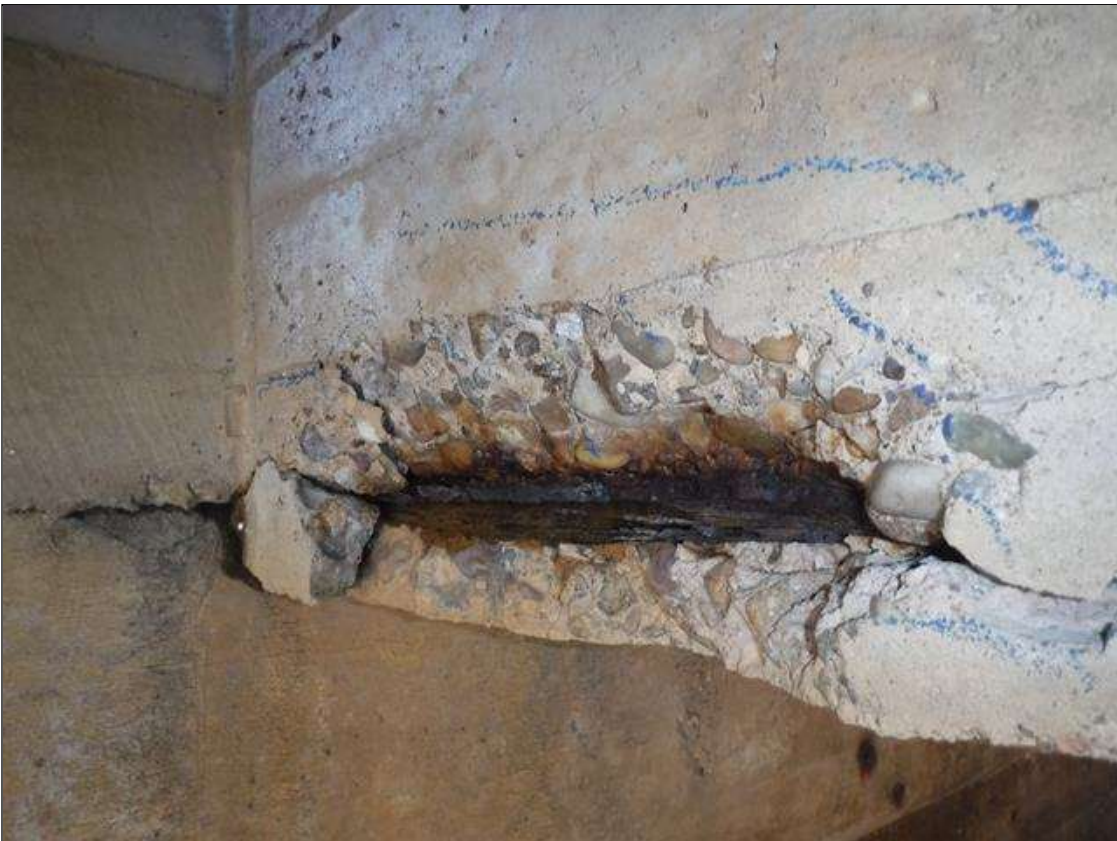
Span 1 Beam 5: SURFACE RUST ON EXPOSED BEAM AT SPALLED COATING

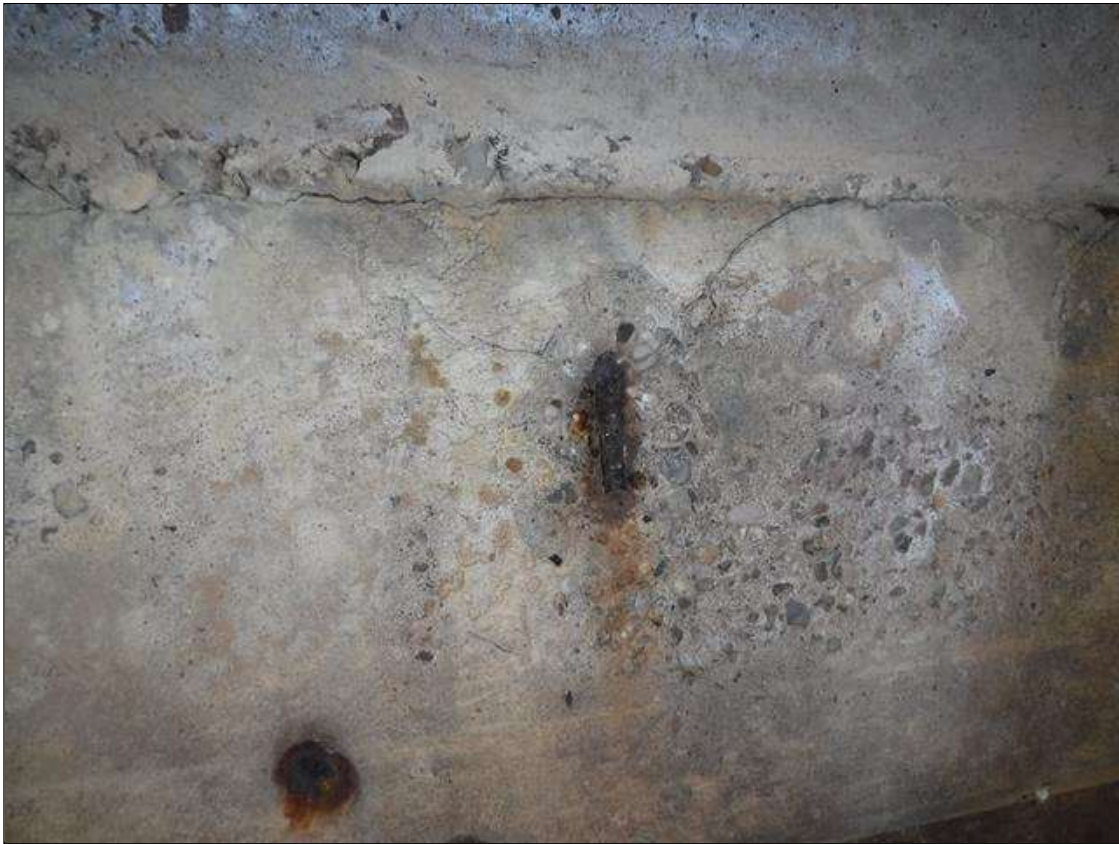
Bent 1 Cap 1: SURFACE SPALLS IN FACE OF CAP

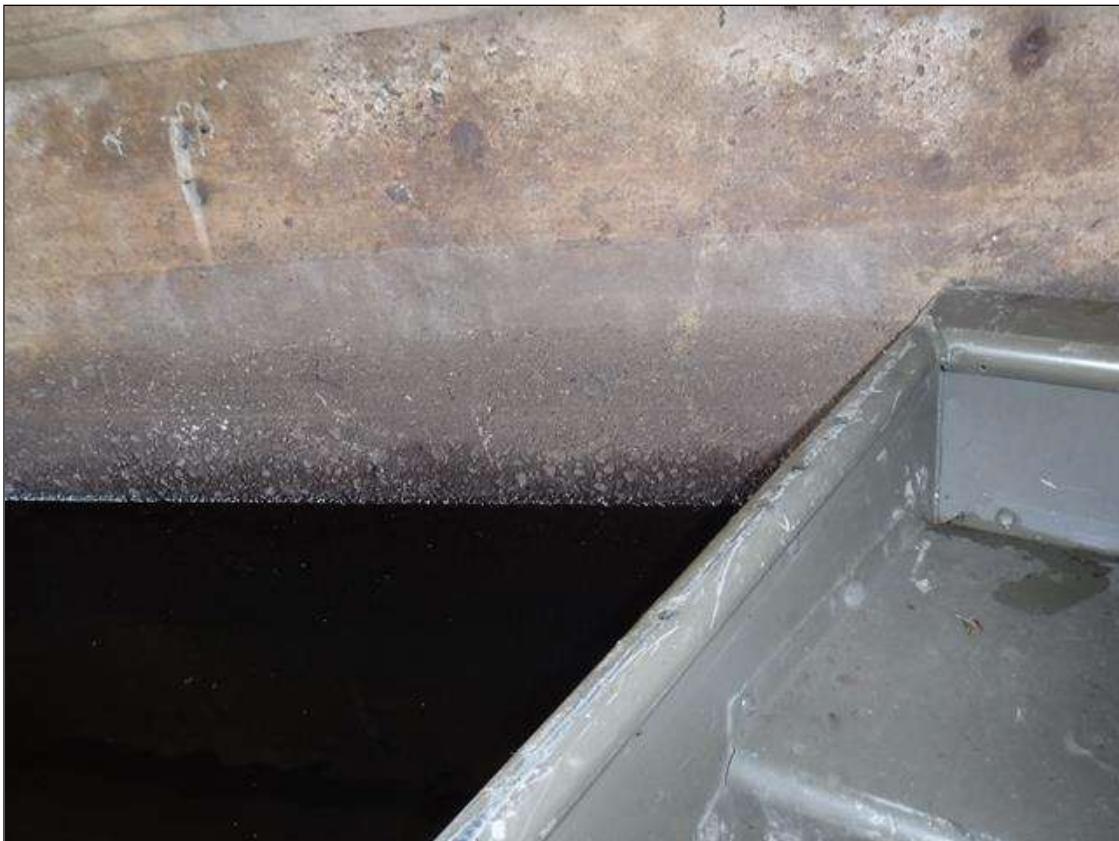
ABRASION IN FACE OF CAP BENT 1

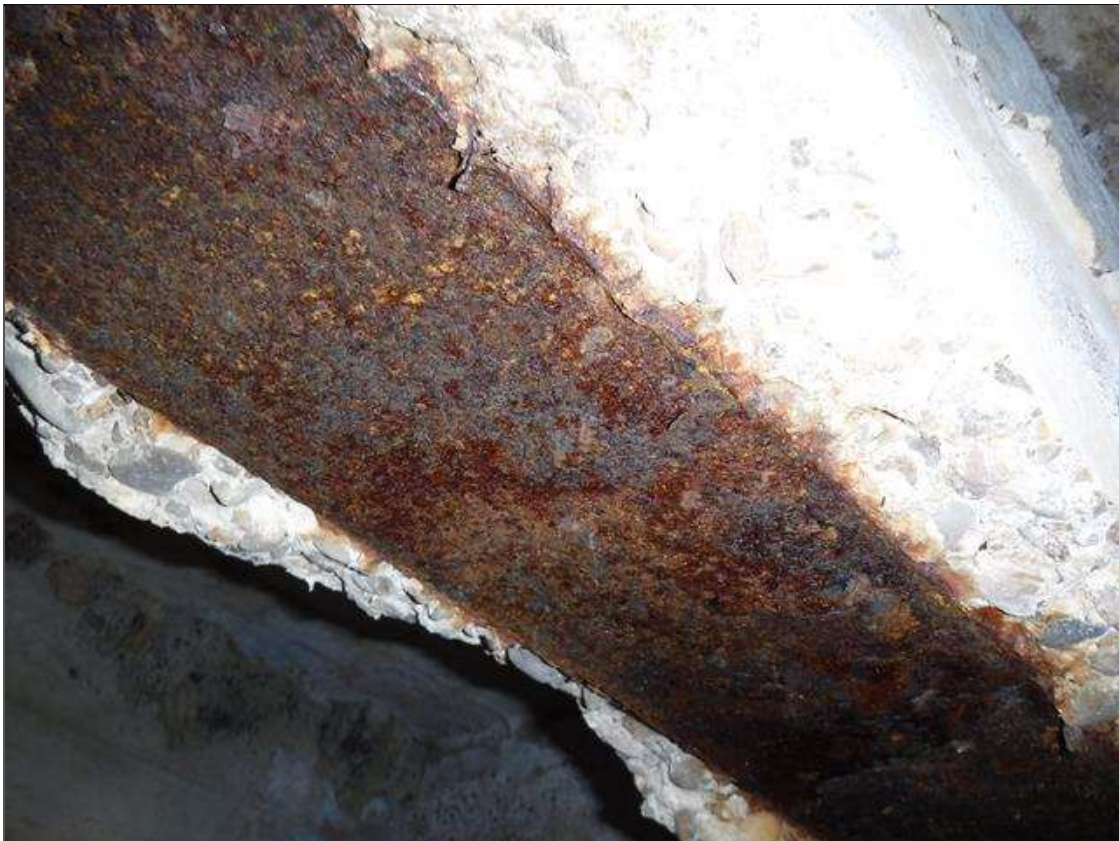
Span 2 Beam 4: RUSTY BOTTOM OF BEAM AT BENT 1

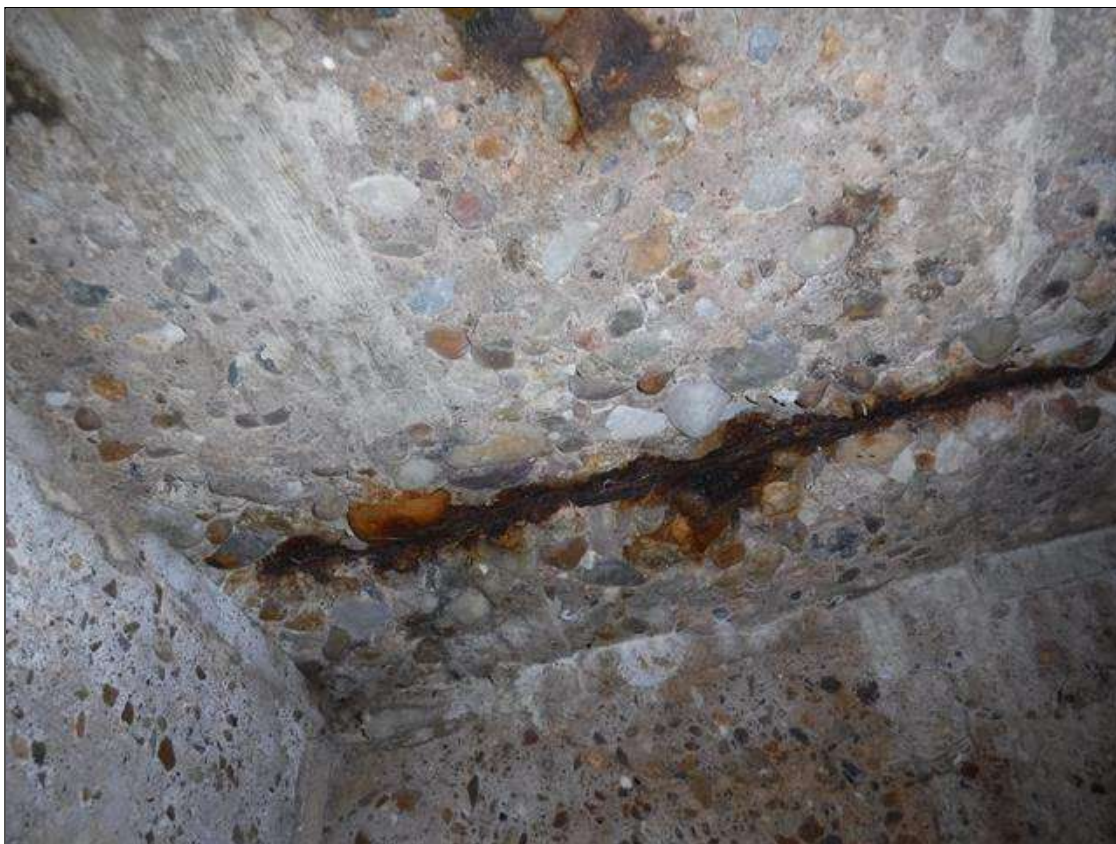
Span 2 Deck: SPALL IN BOTTOM OF DECK UNDER BAY 3 WITH EXPOSED STEEL

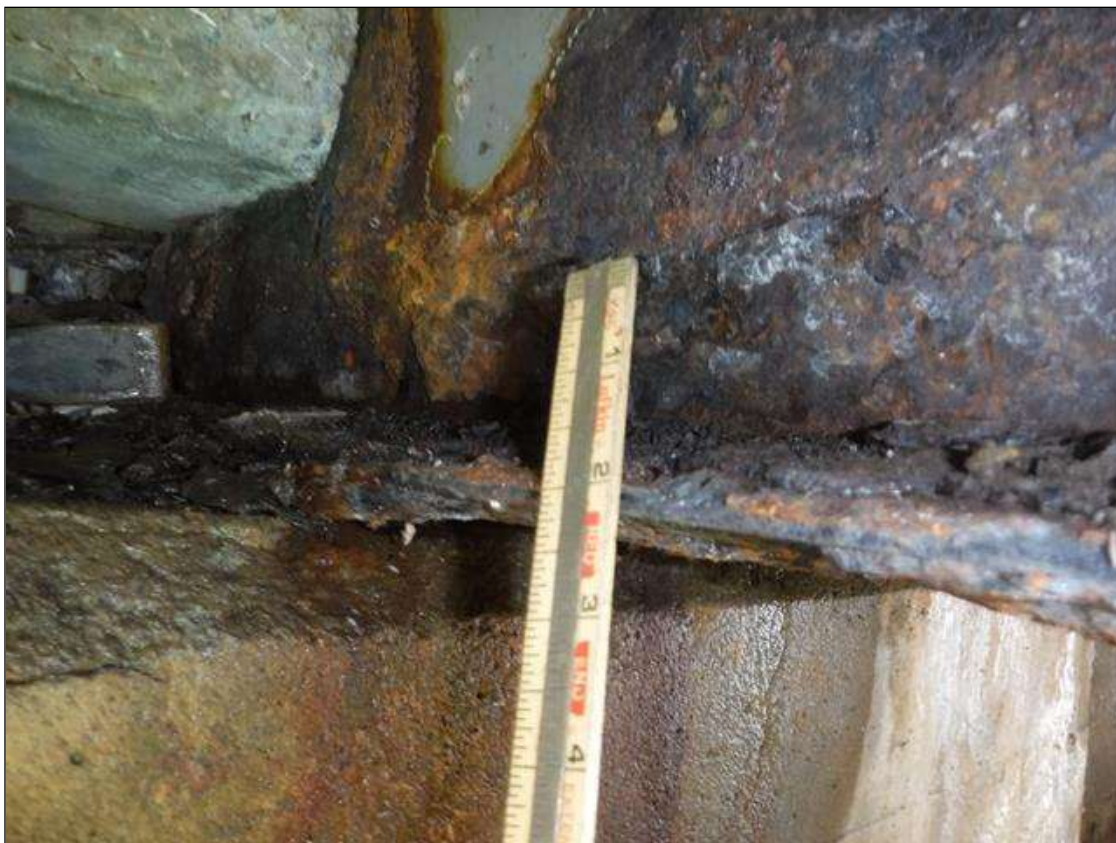
Span 2 Beam 9: SECTION LOSS 1/4 IN REMAINING BOTTOM FLANGE 4 FOOT LONG AT BENT 1, 5/16 IN REMAINING WEB 8 IN HIGH X 3 FOOT PRIORITY MAINTENANCE ISSUED

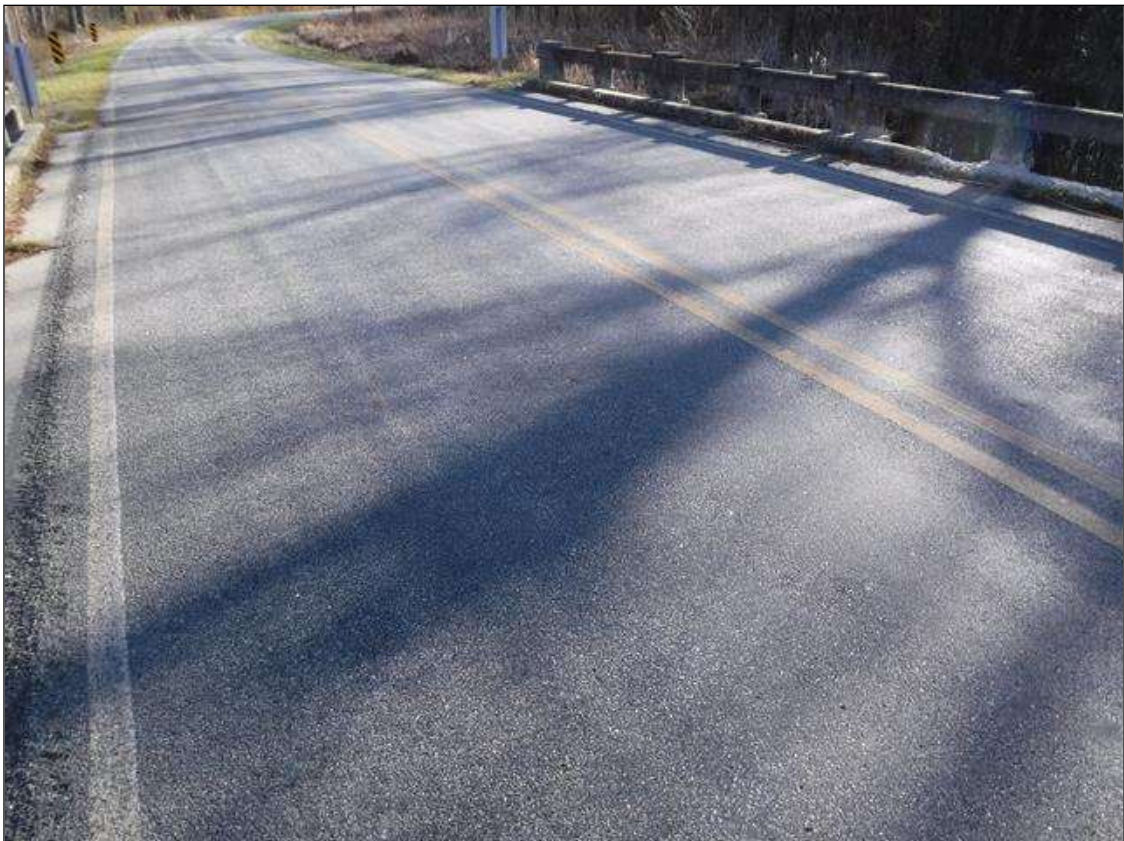
ASPHALT WEARING SURFACE

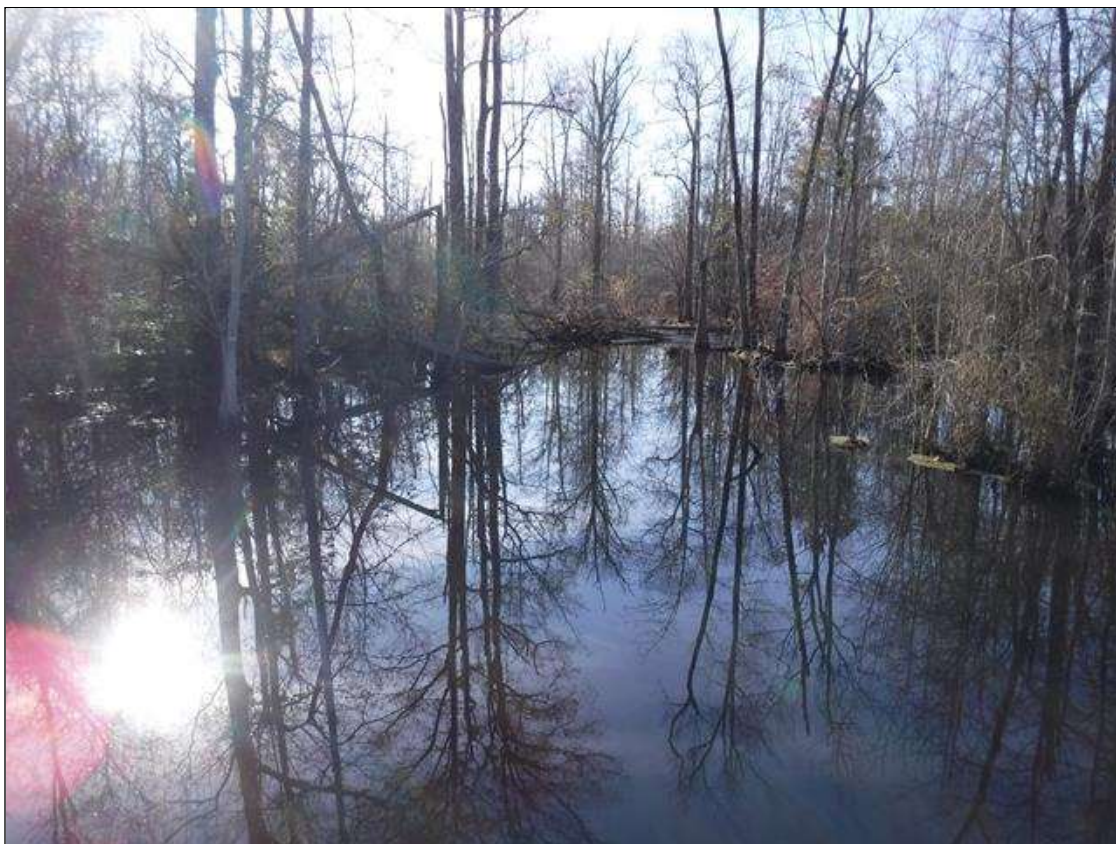
LOOKING EAST DOWNSTREAM

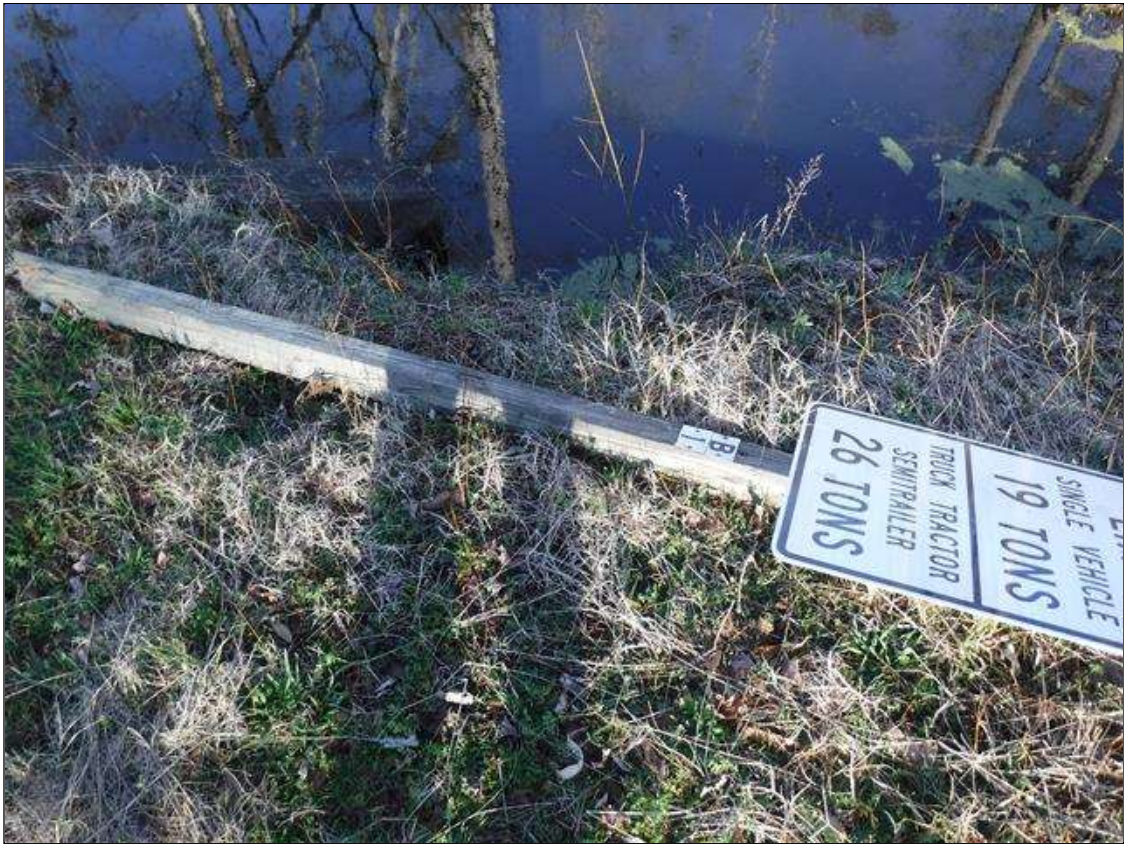
POSTING SIGN DOWN NORTH END MISSING AT SOUTH END PRIORITY MAINTENANCE ISSUED

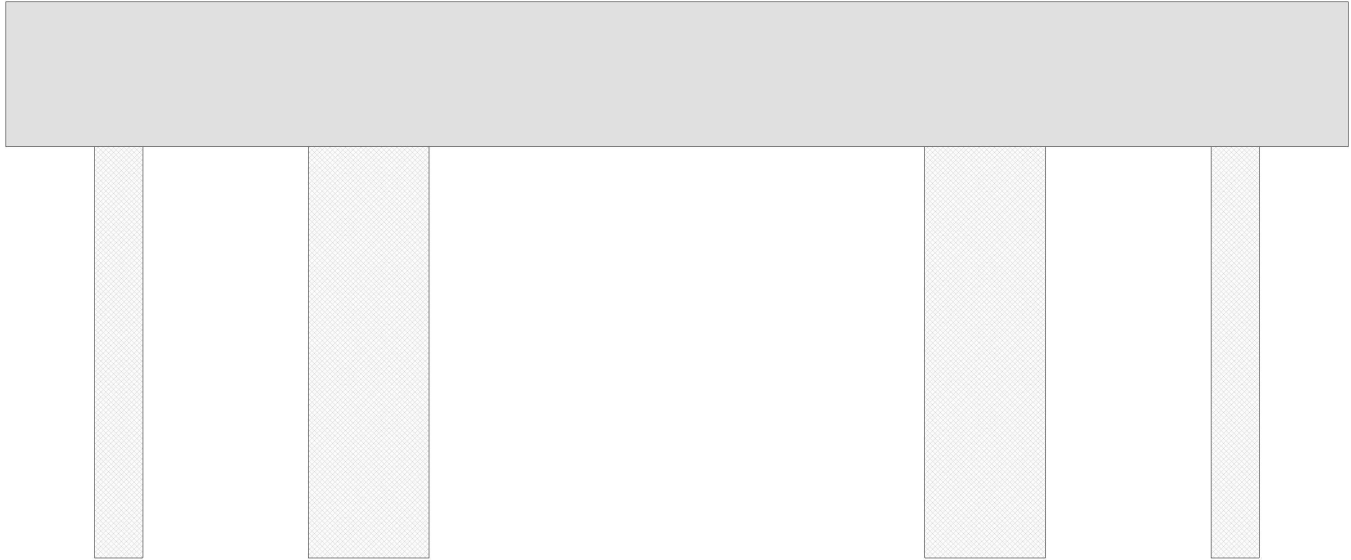
Cap Information			Material Cast-in-Place Concrete							
Length	Width	Height	Left Overhang	Right Overhang	Left Beam to End of Cap.	Right Beam to End of Cap.				
27.750 ft.	2.500 ft.	2.833 ft.	2.330 ft.	2.333 ft.	1.833 ft.	1.833 ft.				
Subcap Information			Material							
Length	Width	Height	Left Overhang	Right Overhang	Left Pile to Splice.					
Sill Information			Material							
Length	Width	Height								
Pile #	Material	Spacing	Width/Dia.	Height	Length	Orientation	Driven?	Replacement?	Removed?	Collar?
1	Concrete	5.167 ft.	1 ft.			Vertical	No	No	No	No
2	Concrete	12.75 ft.	2.5 ft.			Vertical	No	No	No	No
3	Concrete	5.167 ft.	2.5 ft.			Vertical	No	No	No	No
4	Concrete		1 ft.			Vertical	No	No	No	No
Bent/Abutment #: 1			Similar Bents:
