> PROJECT NO. 15BPR.24 BRUNSWICK ____ COUNTY

BRIDGE NO. 090013

SUBSTRUCTURE

BENT 13

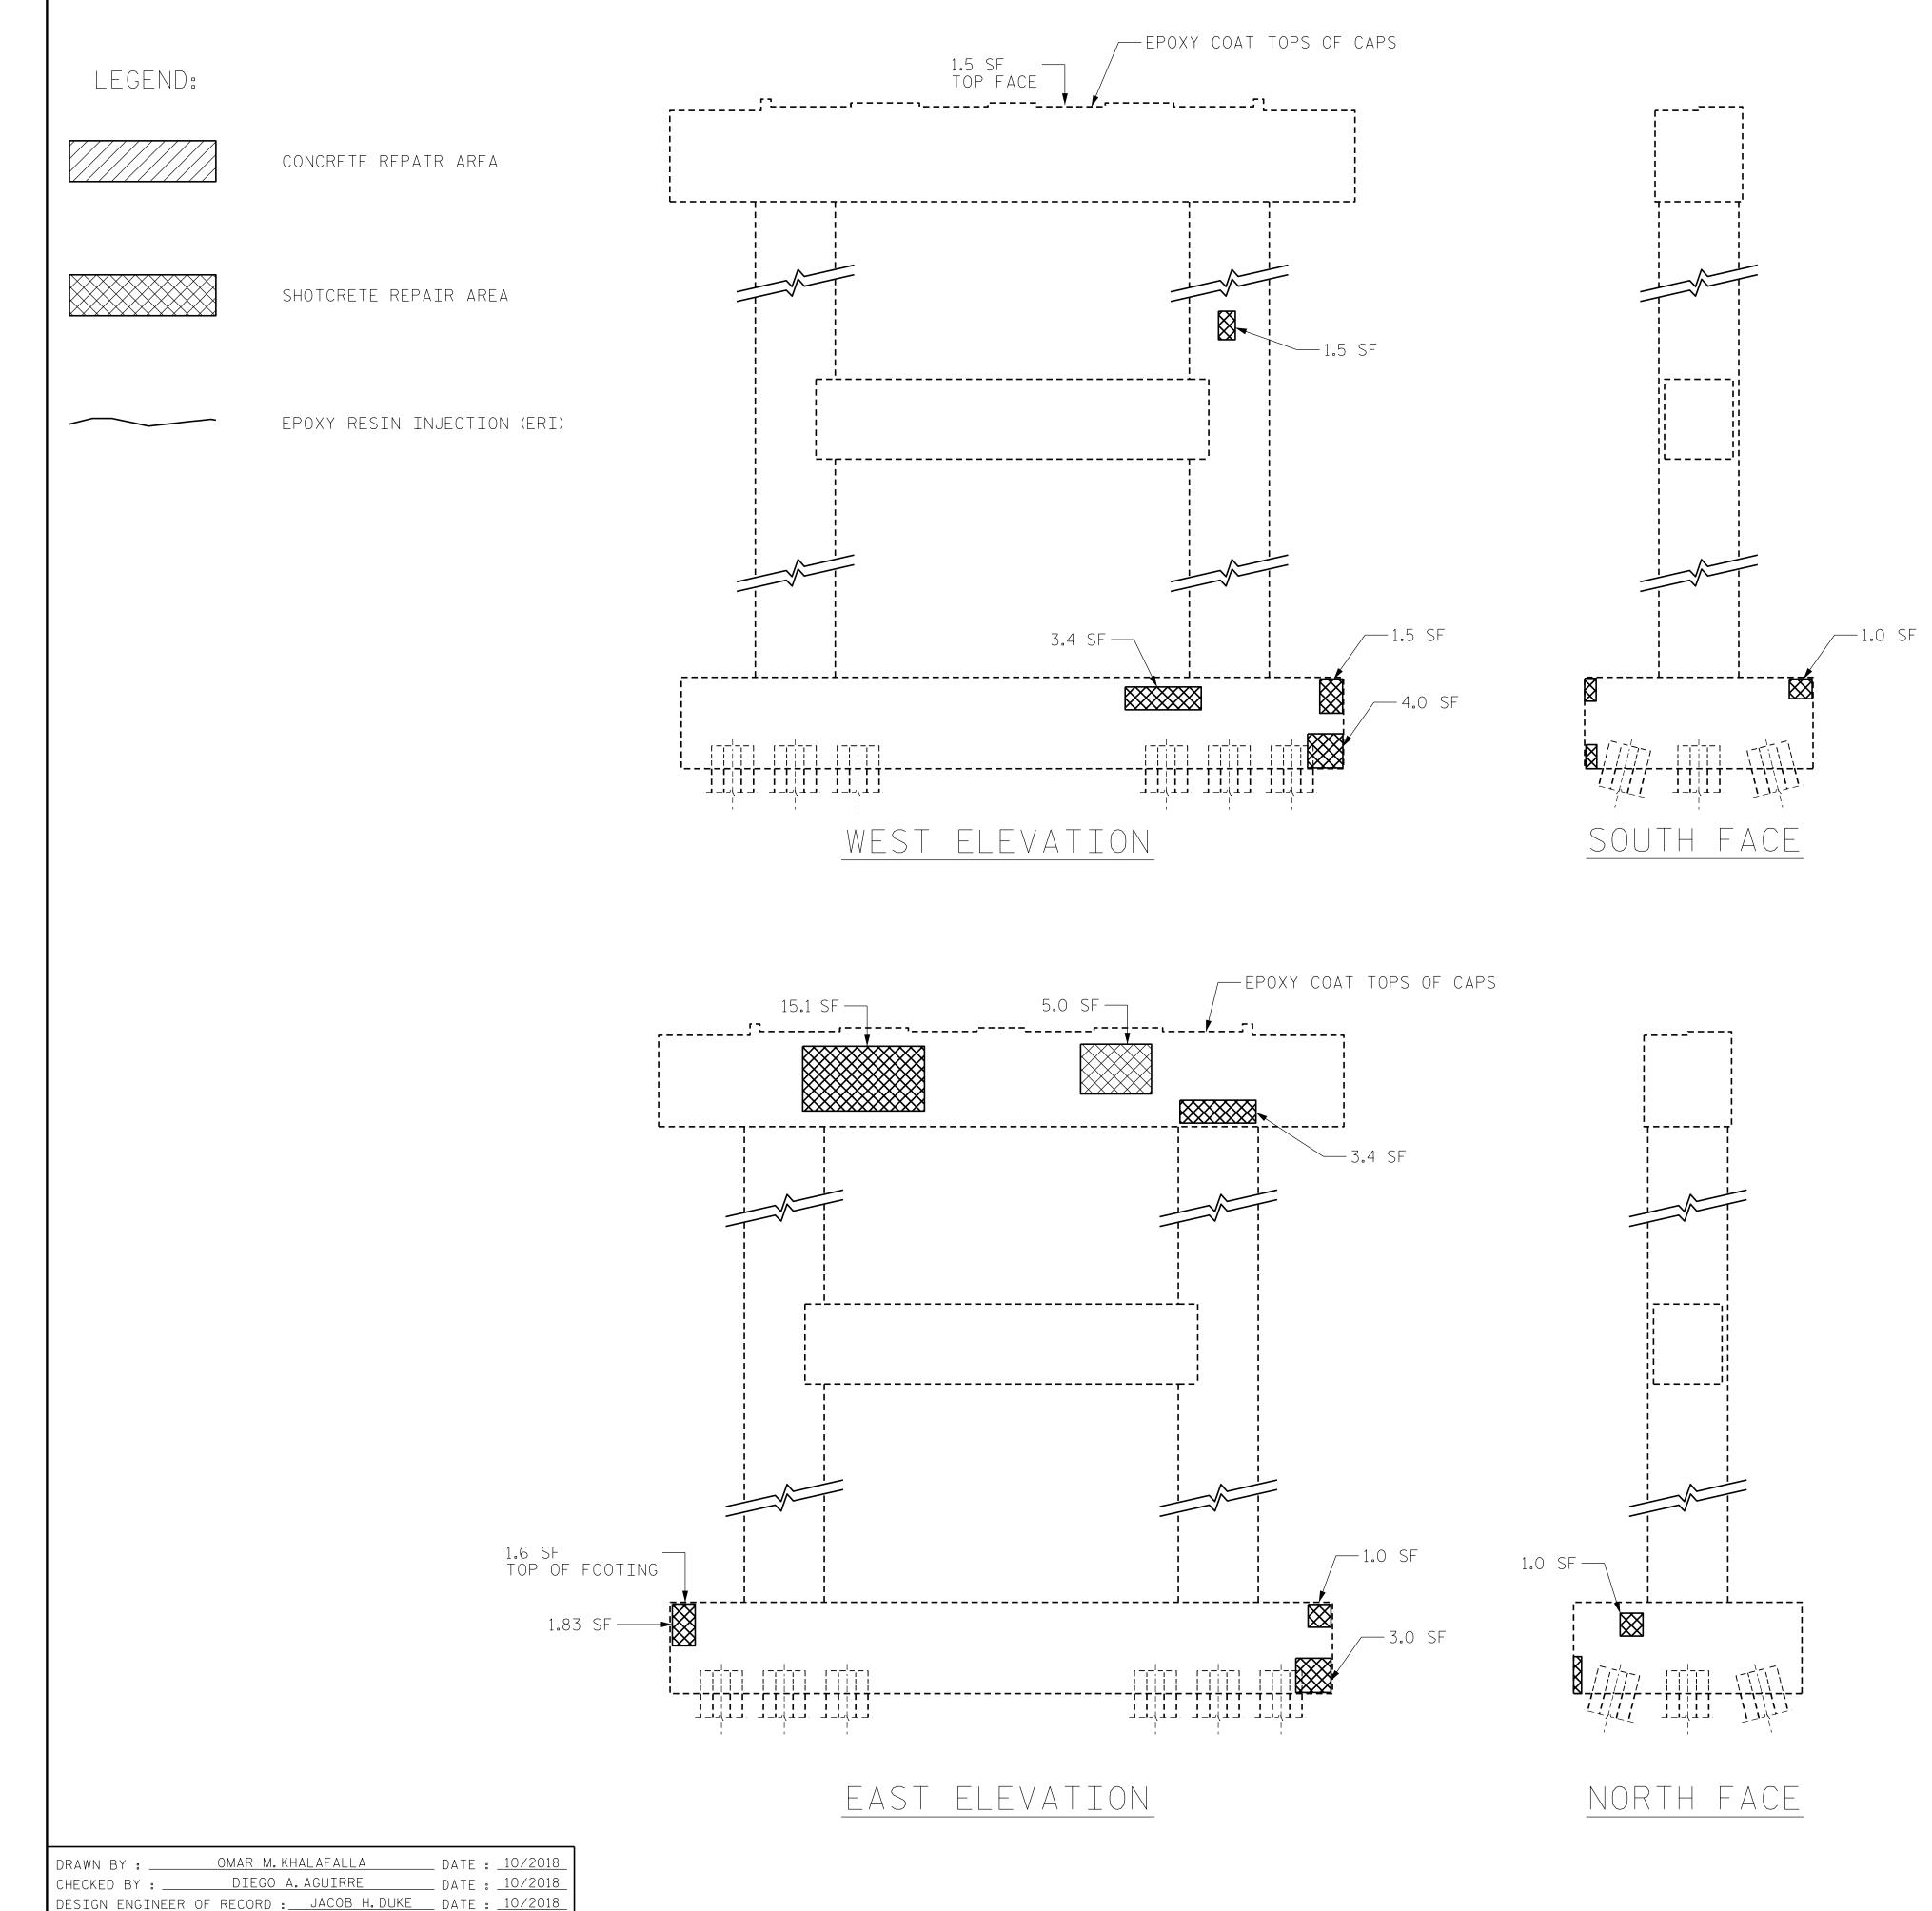
CURRENT AVERAGE COVER IS EXPECTED TO BE FROM 2"TO 3" ON THE CAP AND FROM $1\frac{1}{2}$ " TO 2" ON THE COLUMNS BASED ON VISUAL INSPECTION.

ALL DEFECT QUANTITIES ON STRUTS AND COLUMN FOOTINGS ARE LISTED WITH THE QUANTITIES FOR THE CAP.

* QUANTITIES OF CONCRETE REPAIR AREAS ARE ANTICIPATED UNDER BEARING AREAS.DUE TO LACK OF INFORMATION, ALL AREAS ARE NOT KNOWN. QUANTITY INCLUDES CONTINGENCIES AND ARE ANTICIPATED TO BE SUFFICIENT FOR ACTUAL QUANTITIES ENCOUNTERED. FOR CONCRETE REPAIRS SEE "CONCRETE RESTORATION DETAILS" SHEETS.

FOR CONCRETE AND SHOTCRETE REPAIRS, SEE "CONCRETE RESTORATION DETAILS" SHEET 3 OF 3.

VALUES IN CHART REPRESENT ESTIMATED REPAIR TOTALS AFTER REMOVAL OF UNSOUND CONCRETE. MINIMUM OF 1"BEHIND REBAR AND MINIMUM 2"CLEARANCE TO SAWCUT. FOR REPAIR DETAILS, SEE "CONCRETE RESTORATION DETAILS - SUBSTRUCTURE" SHEET.

SHOTCRETE REPAIRS TO THE BENT CAP MAY REQUIRE BRIDGE JACKING.FOR BRDIGE JACKING, SEE SPECIAL PROVISIONS.
