NC DEPARTMENT OF TRANSPORTATION  
 DIVISION OF HIGHWAYS  
 STRUCTURE MANAGEMENT UNIT

ATTENTION: PRIORITY MAINTENANCE ISSUED; CHANGE TO APPROACH ROADWAY DATA

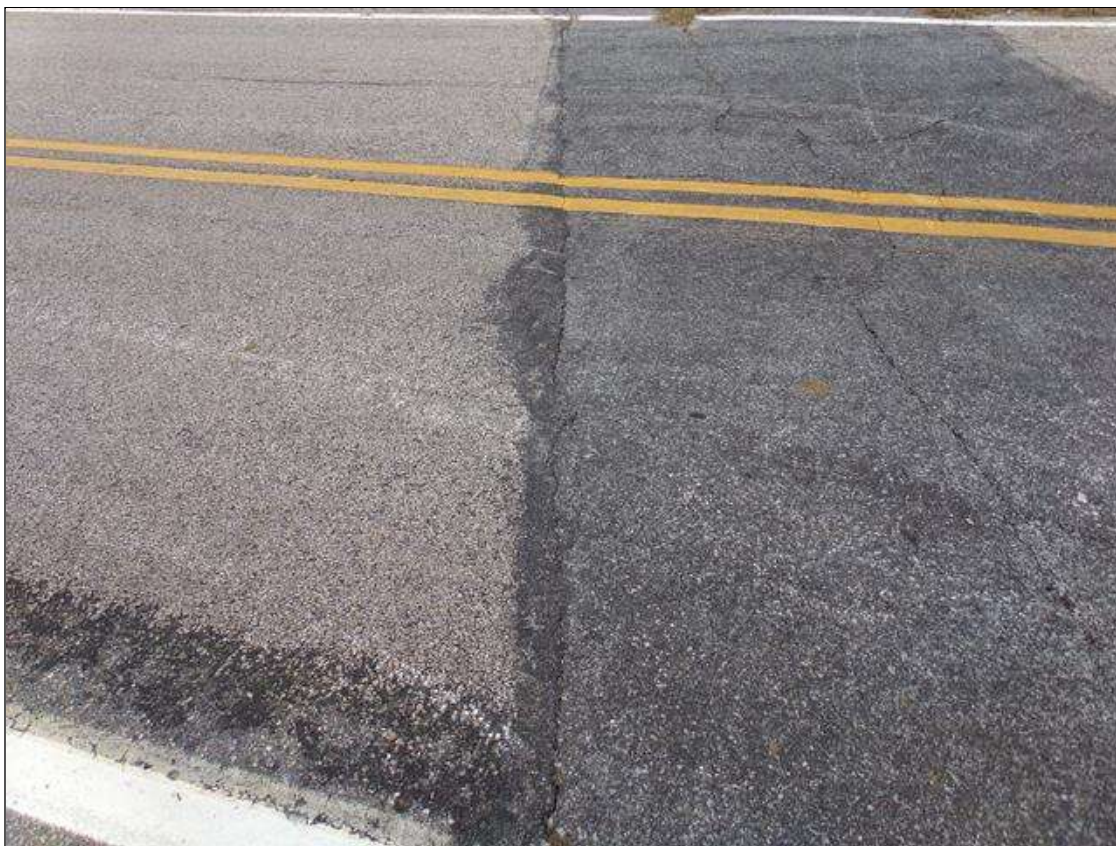
Span 3 Wearing Surface: Full width transverse crack up to 1/4" wide over abutment.

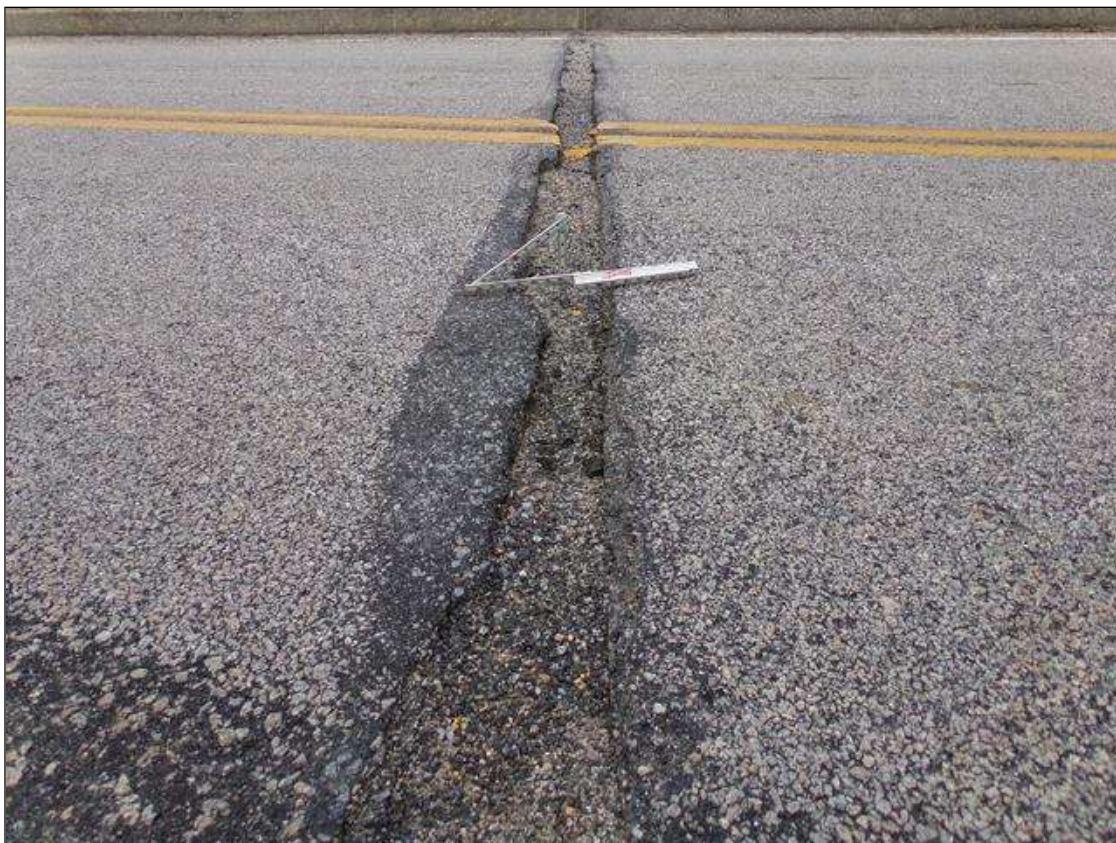
Span 2 Wearing Surface: PM--Full width pothole over pier 2 up to 6" wide x 2" deep full width of bridge. Pothole is full of gravel 1" deep.

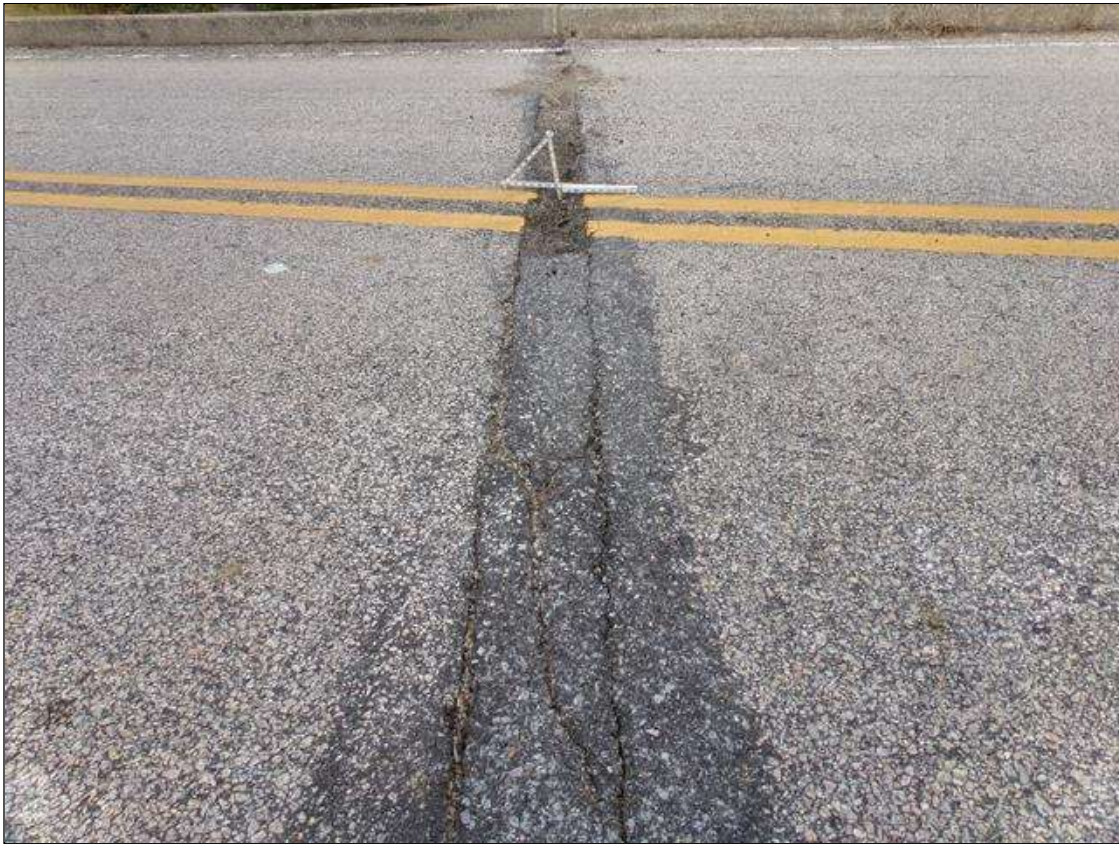
Span 1 Wearing Surface: PM--12' long pothole starting at center line out in westbound travel lane over pier 1 up to 6" wide x 2" deep full width of bridge. Pothole is full of gravel 1" deep.

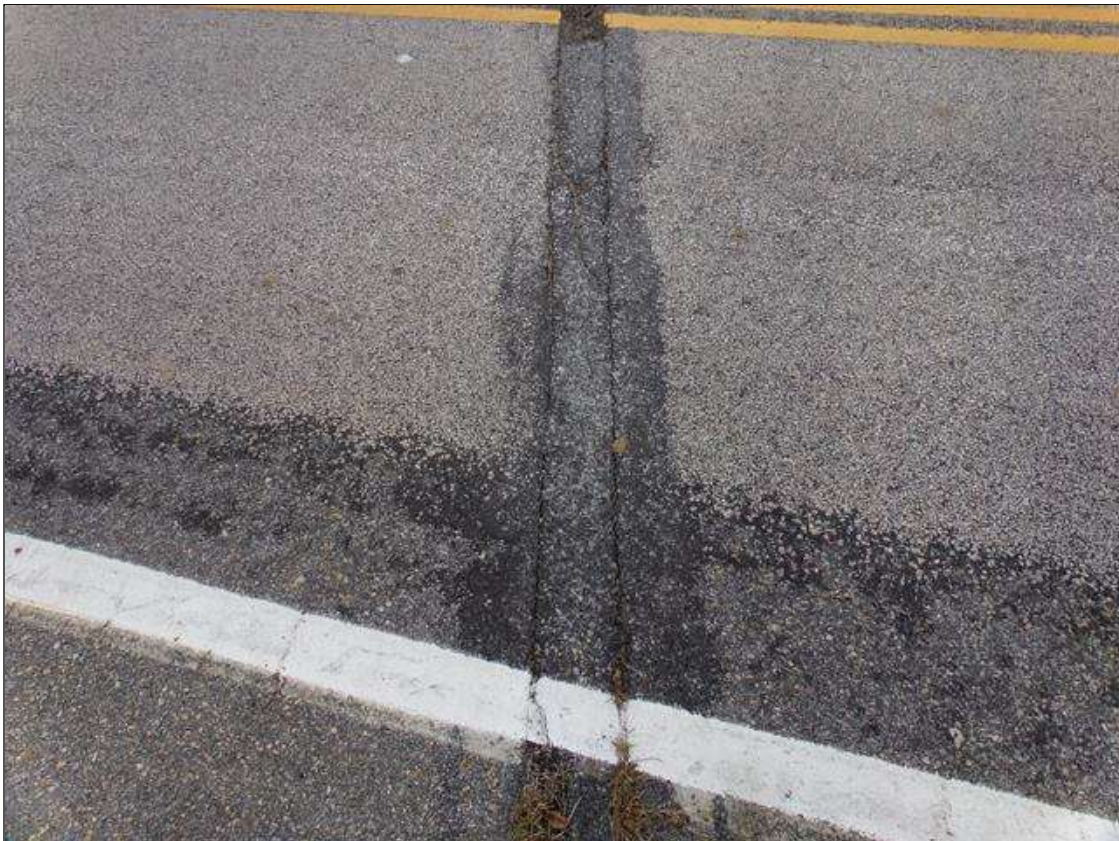
Span 1 Wearing Surface: Eastbound travel lane and both shoulders over end bent 1 have 2 transverse cracks up to 1/4" over pier 1.

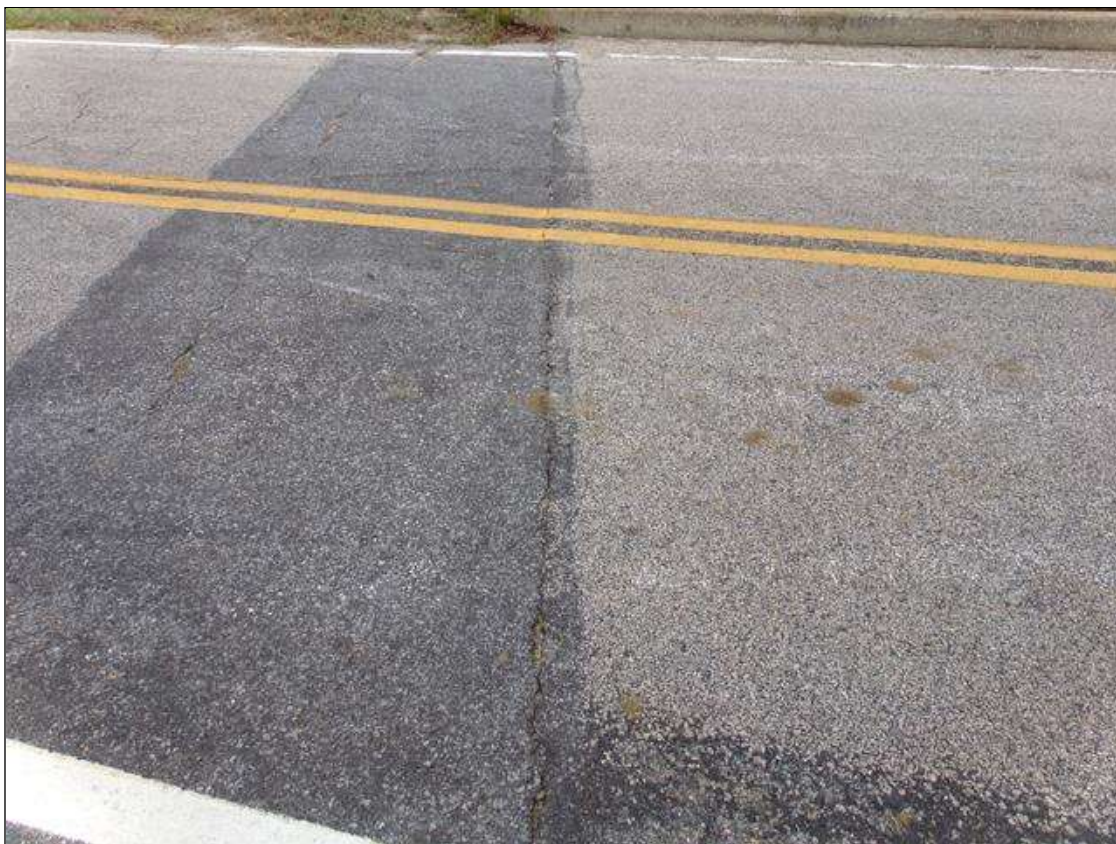
Span 1 Wearing Surface: Full width transverse crack up to 1/4" wide over abutment.

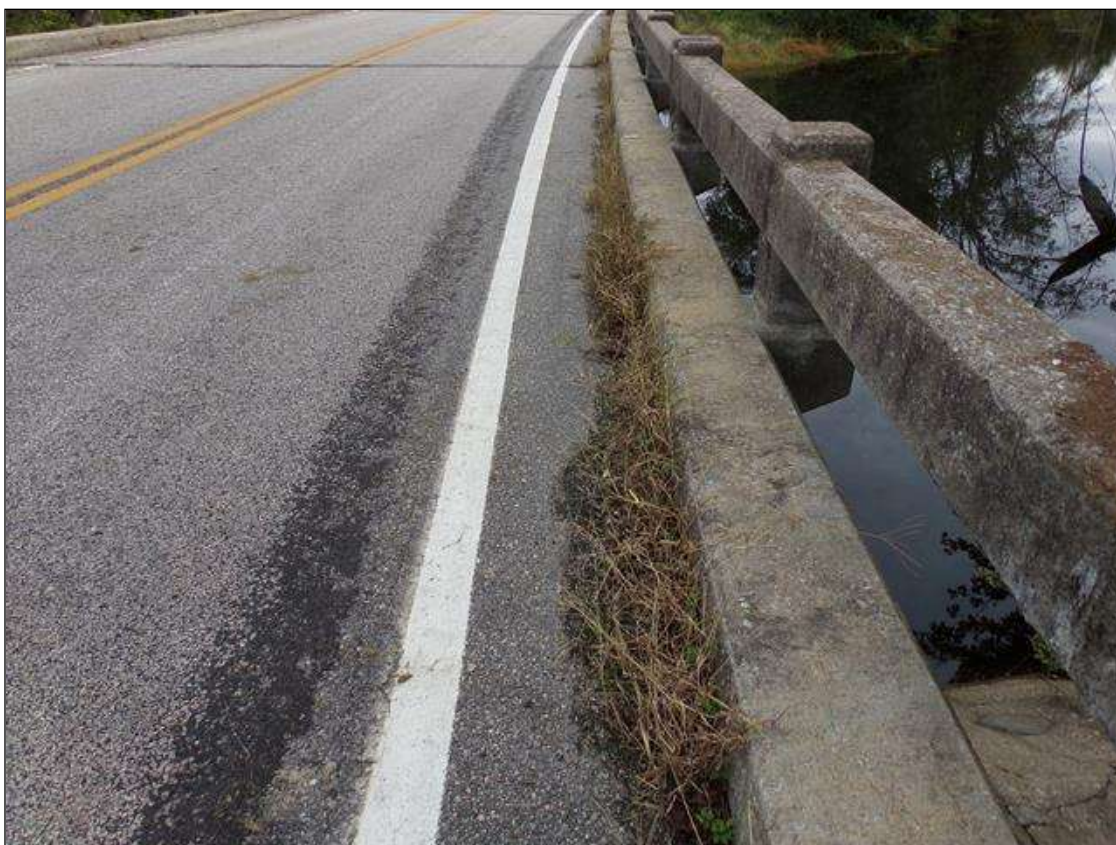
Debris accumulation with vegetation growth entire length of right rail 10" wide with a few drains partially blocked.

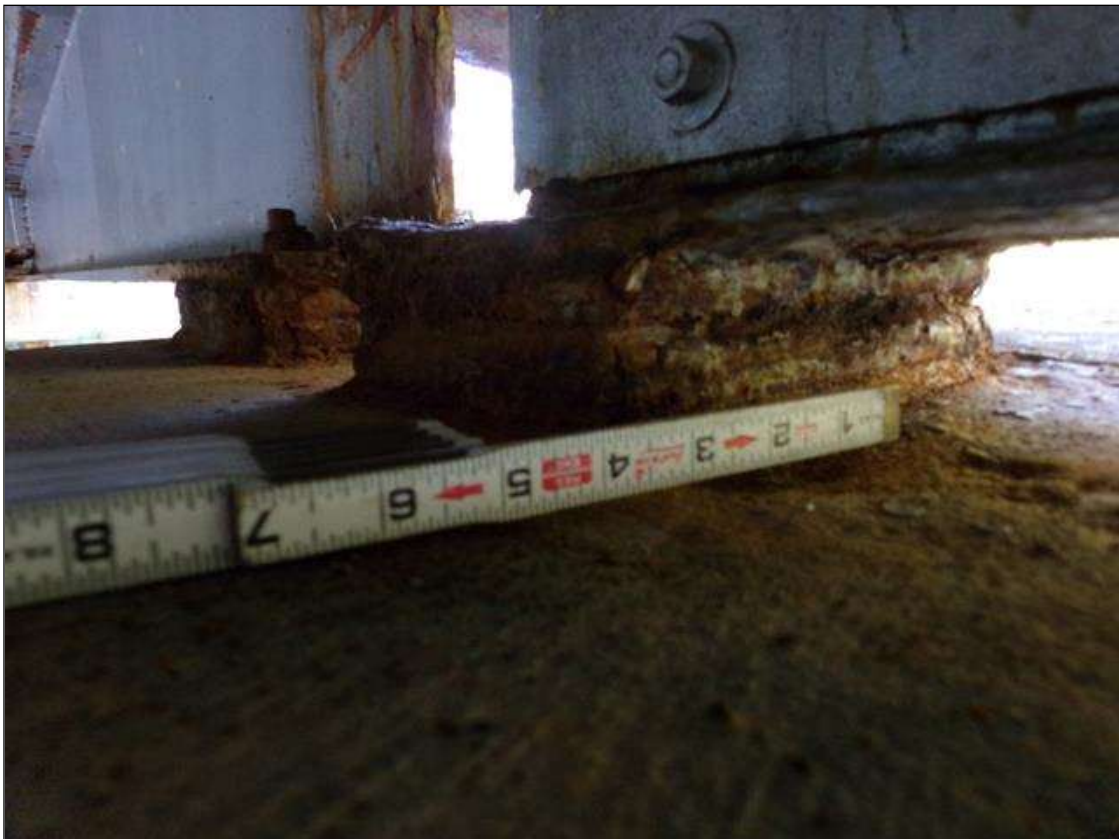
Span 1 Beam 4 Far Bearing: Previously cleaned and painted, but corrosion has reactivated with no additional section loss (up to 1/8") and anchor bolt nut corroded (100%)

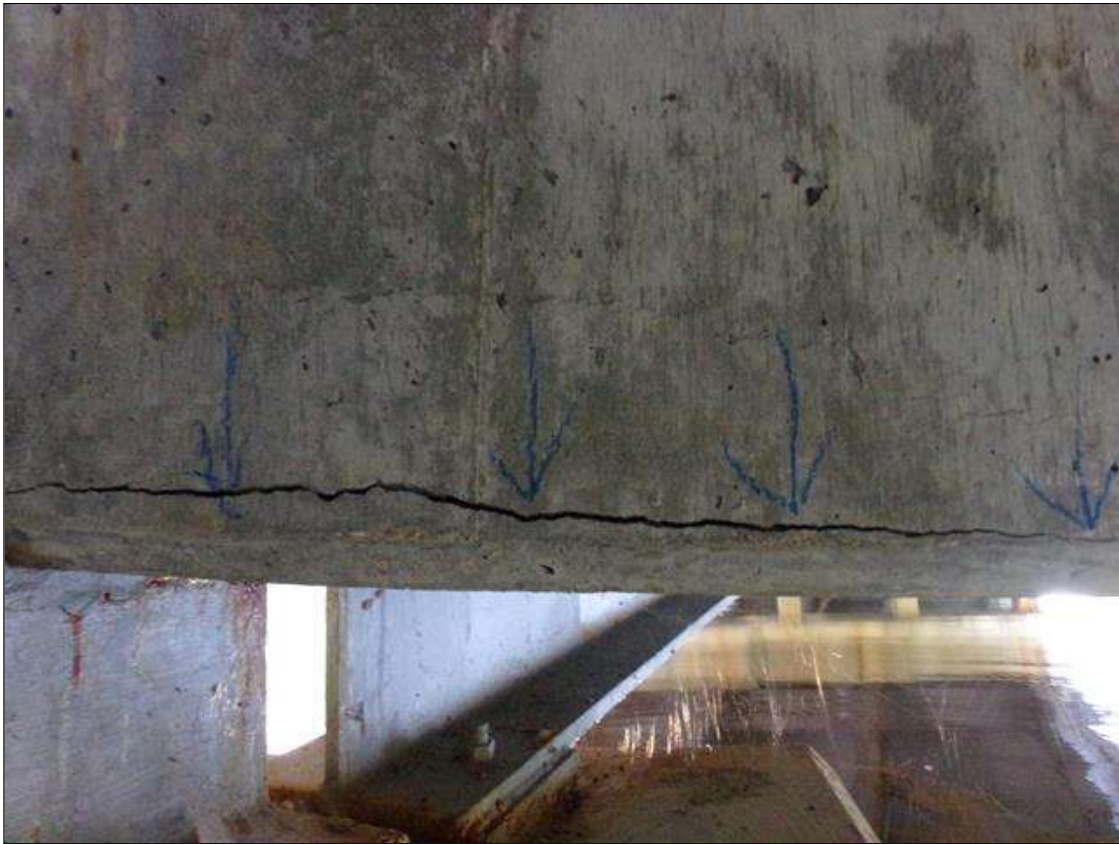
End Diaphragm at Pier: Typical cracking up to 1/8" wide on diaphragm (Span 1 in Bay 3 at Pier 1 shown; Others similar)

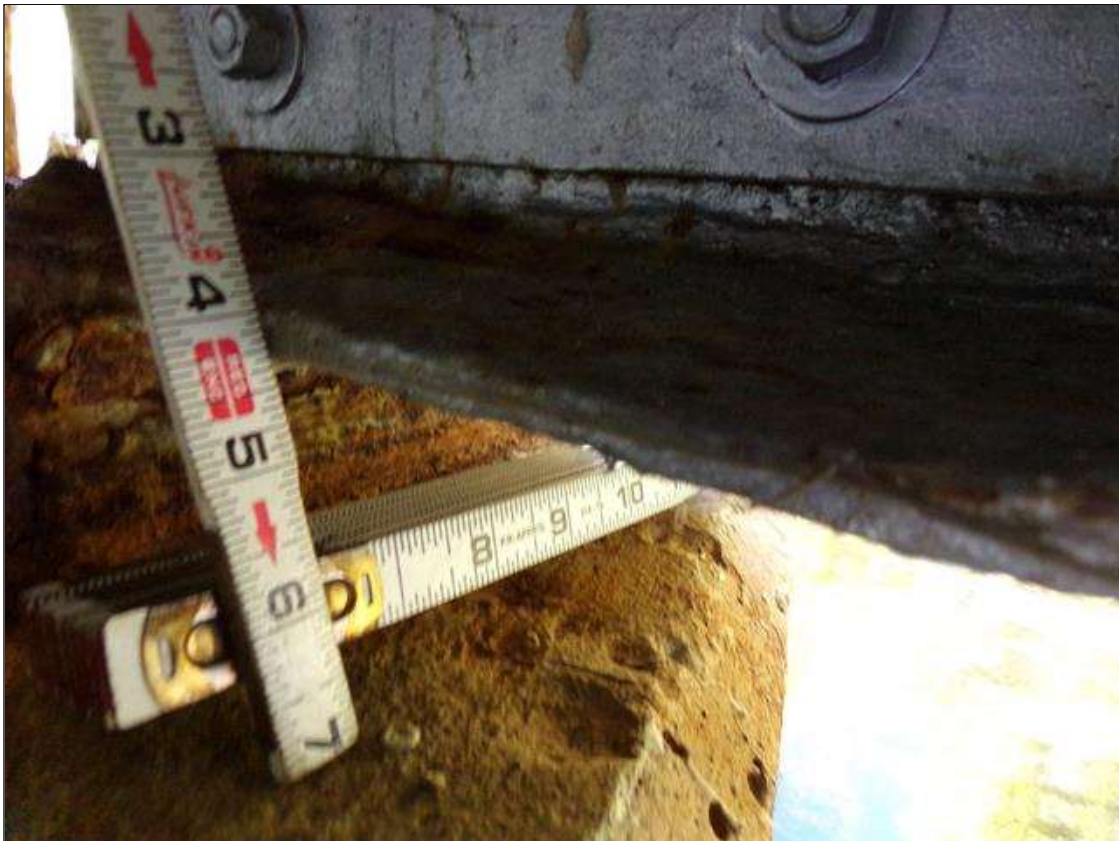
Span 1 Beam 4: 1' long painted over corrosion with section loss (3/8" remaining thickness) on outer edges (2") of bottom flange with 7/16" average remaining thickness across full width. 11/16" original thickness.

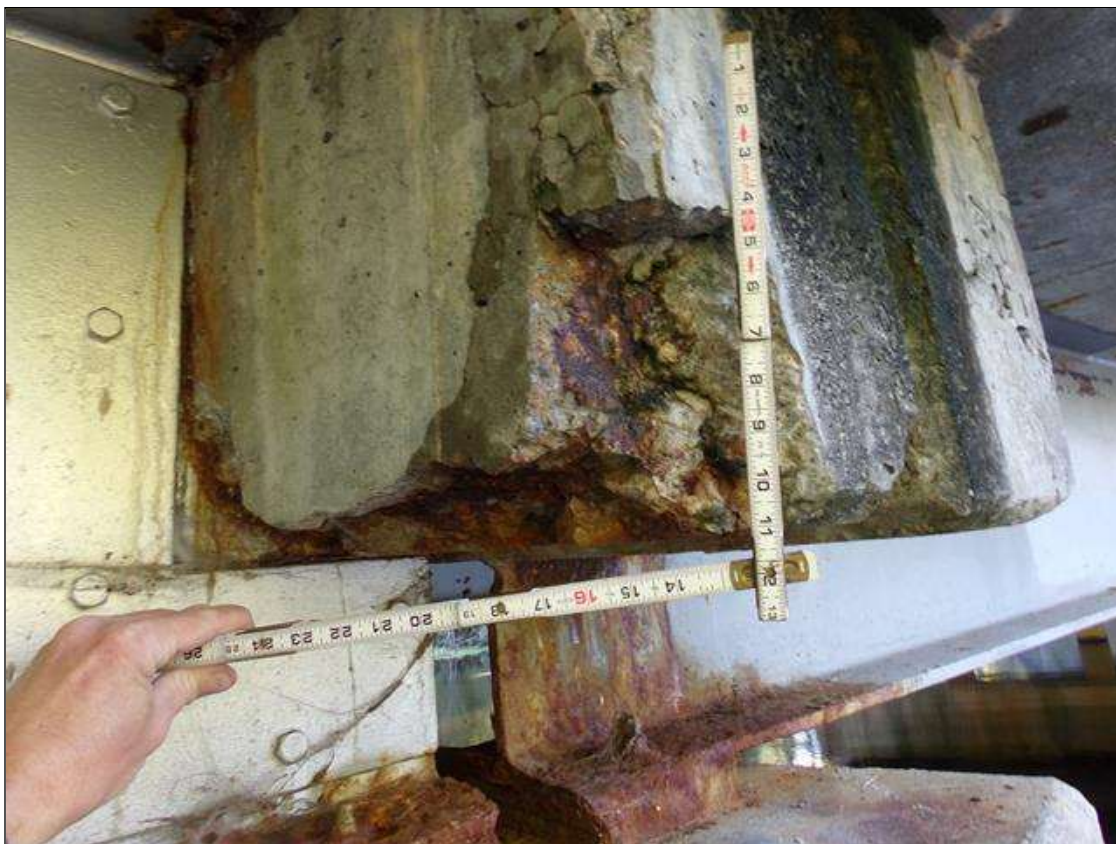
End Diaphragm: Full height x full width x up to 3" deep area of delamination/spall on southwest corner on south overhang in span 1

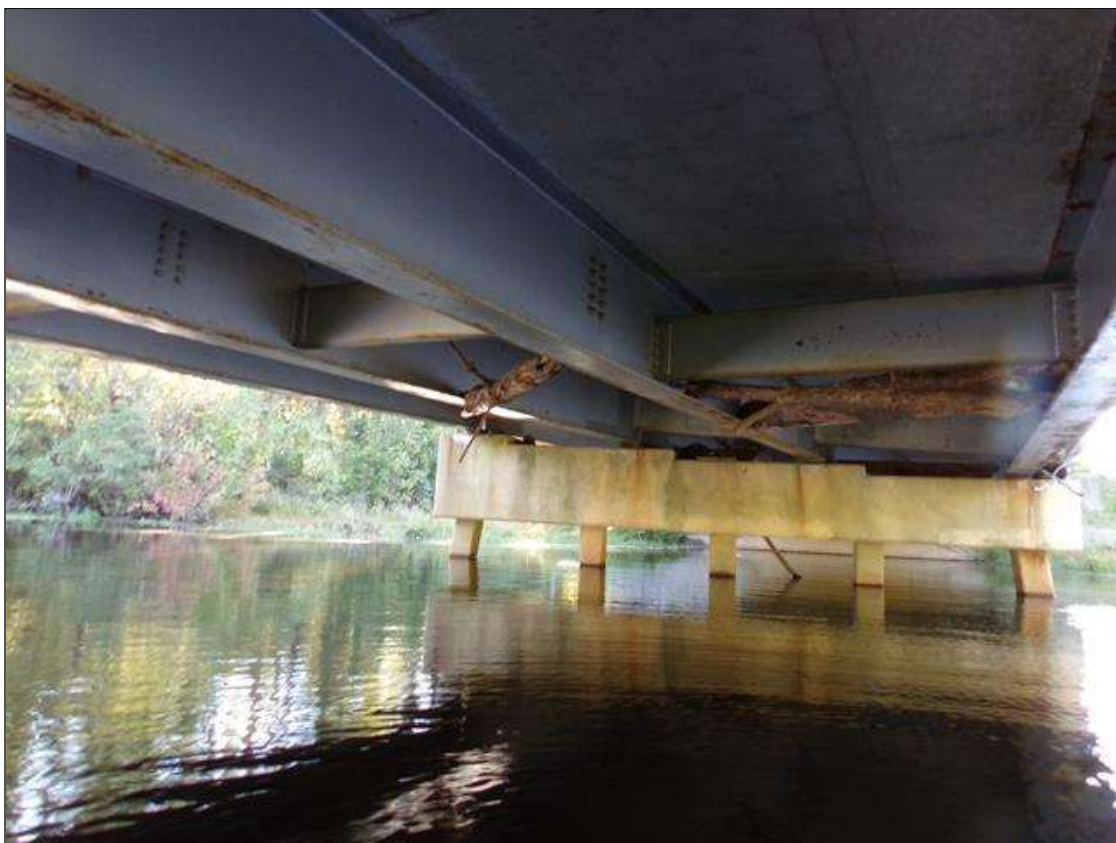
Drift accumulation between beams in bays 2 and 3 in span 2 and on top of pier 2 cap within all bays and south end

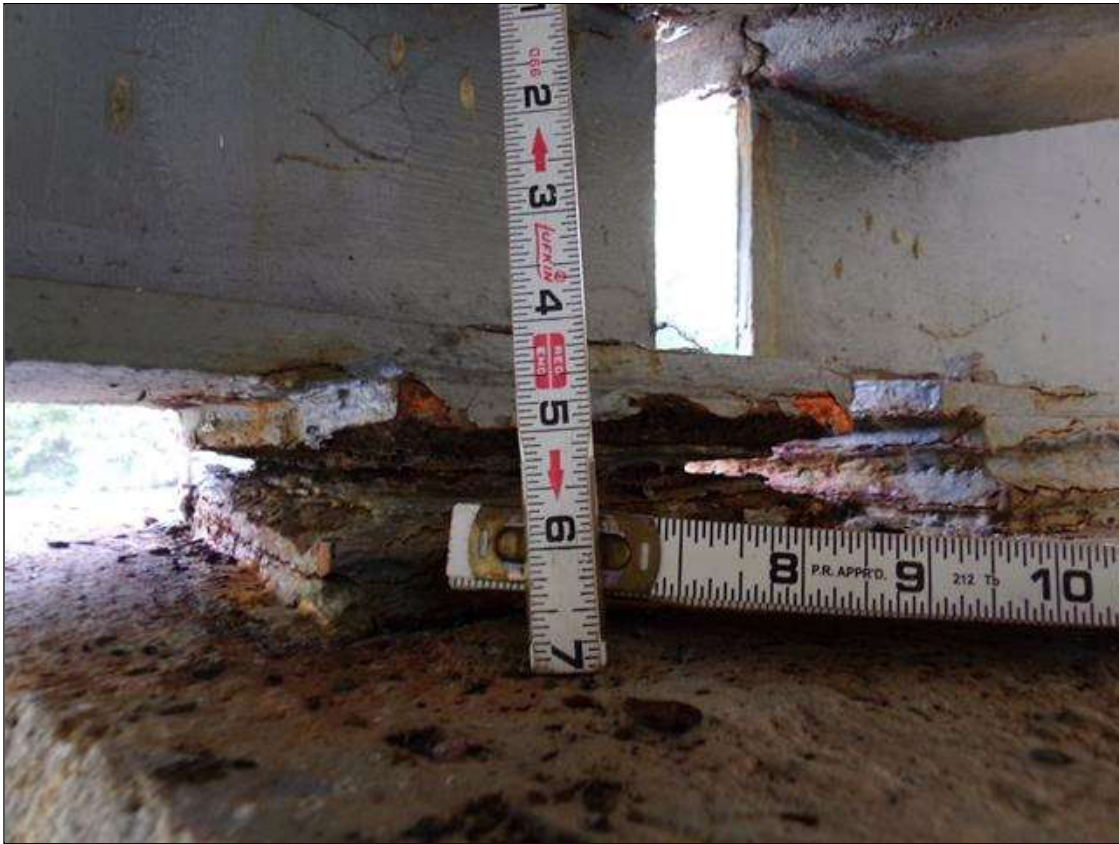
Span 2 Beam 1 Far Bearing: PM---Previously cleaned and painted over section loss (approximately 40%) with reactivated corrosion with nearly 60% section remaining.

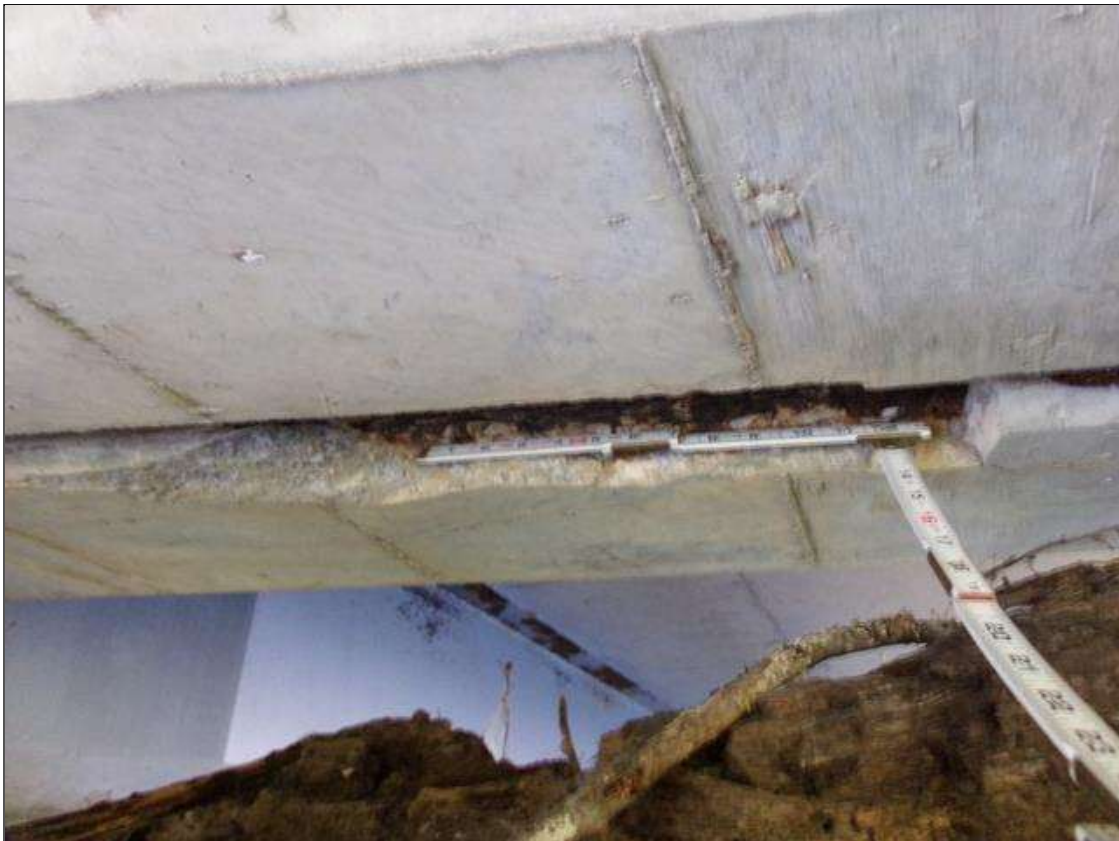
End Diaphragm: Span 3 2' long x 3" wide x 3" d spall with exposed rebar with no measurable section on bottom west face corner

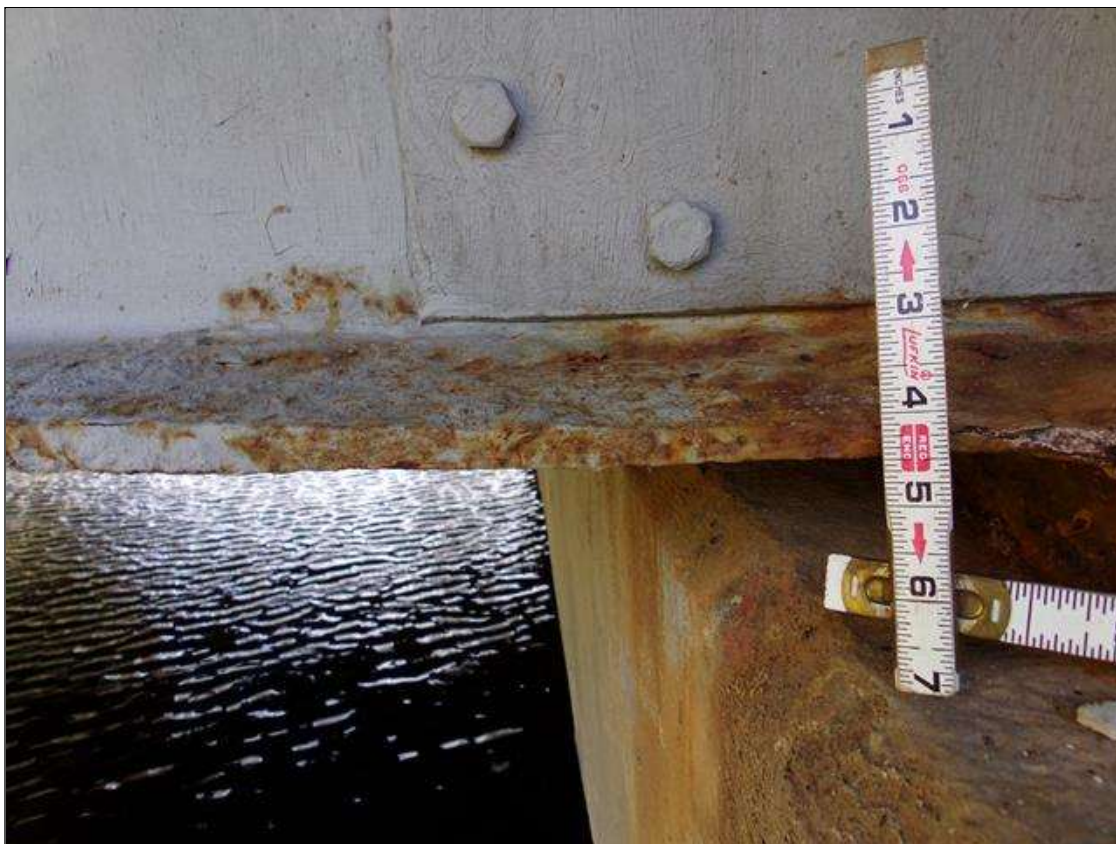
Span 2 Beam 4: bottom flange at bent 2, pitting (1ft x 5in) (0.30in avg rem) (recently cleaned and painted with rust staining)

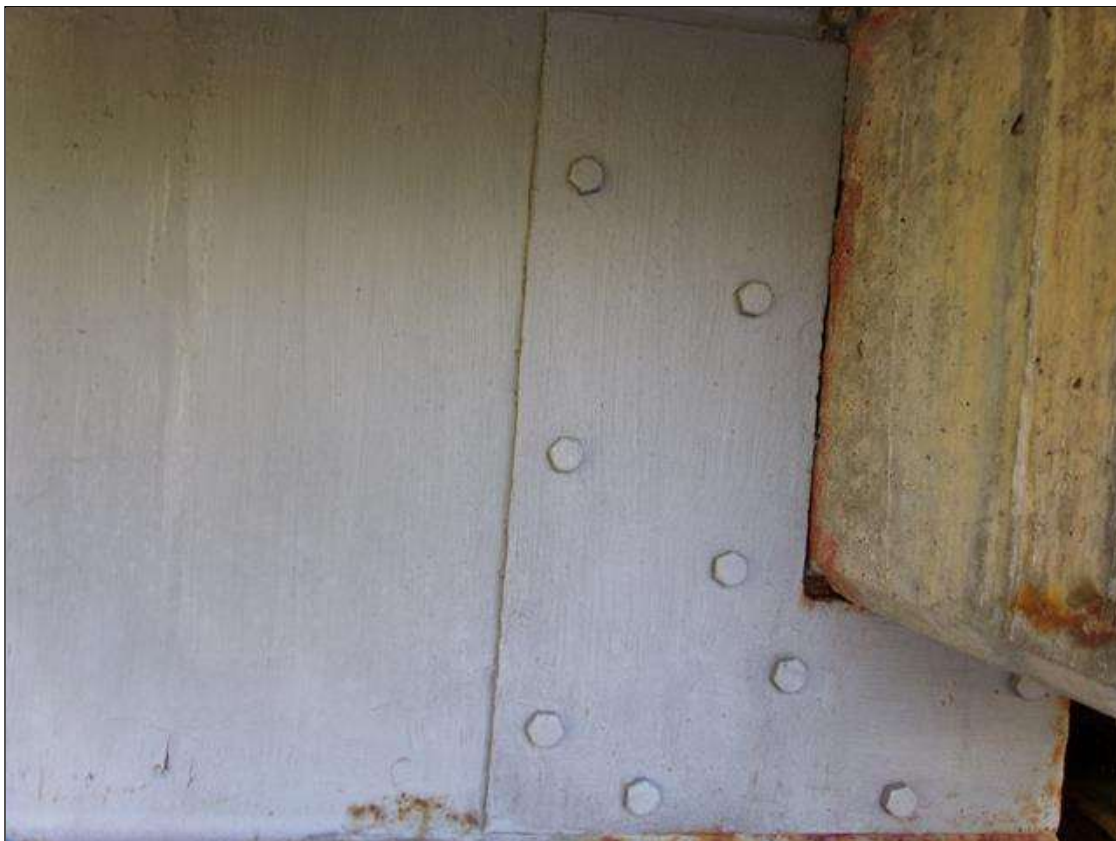
18" long x 20" long added at end of beam 4 at pier 2 span 2

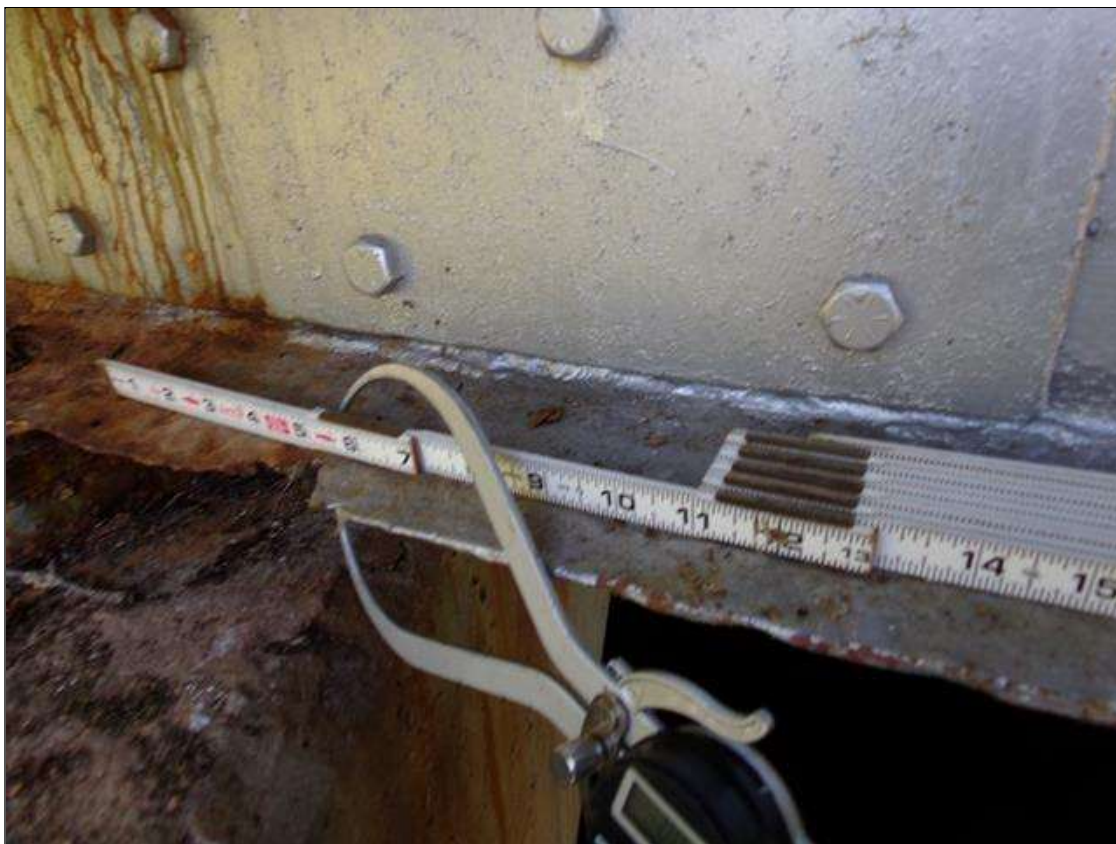
Span 3 Beam 4: PM---2' long x full width x down to knife edge area of advanced section loss (0.20" average thickness remaining) on bottom flange at pier 2. 5" long x 1" wide area of 100% section loss on north bottom flange. Previously cleaned and painted with rust staining reactivated.

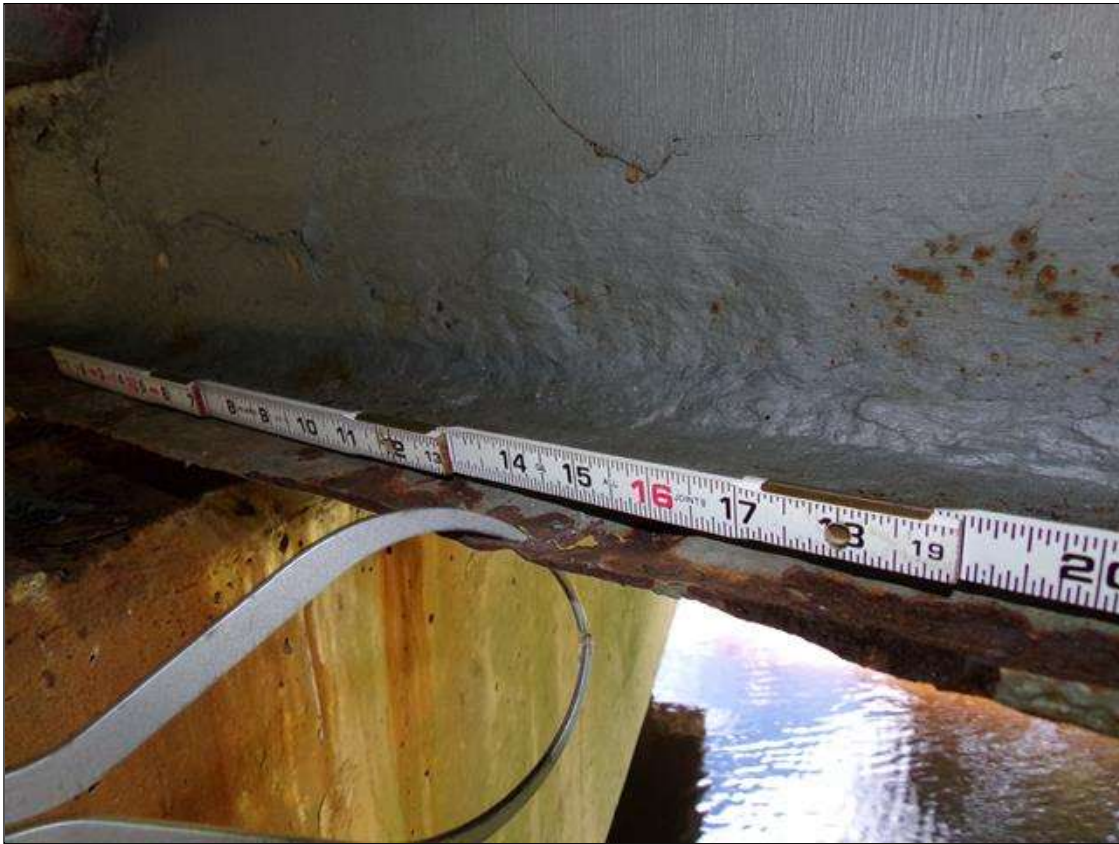
Span 3 Beam 2: PM---2' long x full width x down to knife edge area of advanced section loss (0.33" average thickness remaining) on bottom flange at pier 2. 1.5" long x 3/4" wide area of 100% section loss on south bottom flange at 16" from bearing. Previously cleaned and painted with rust staining reactivated.

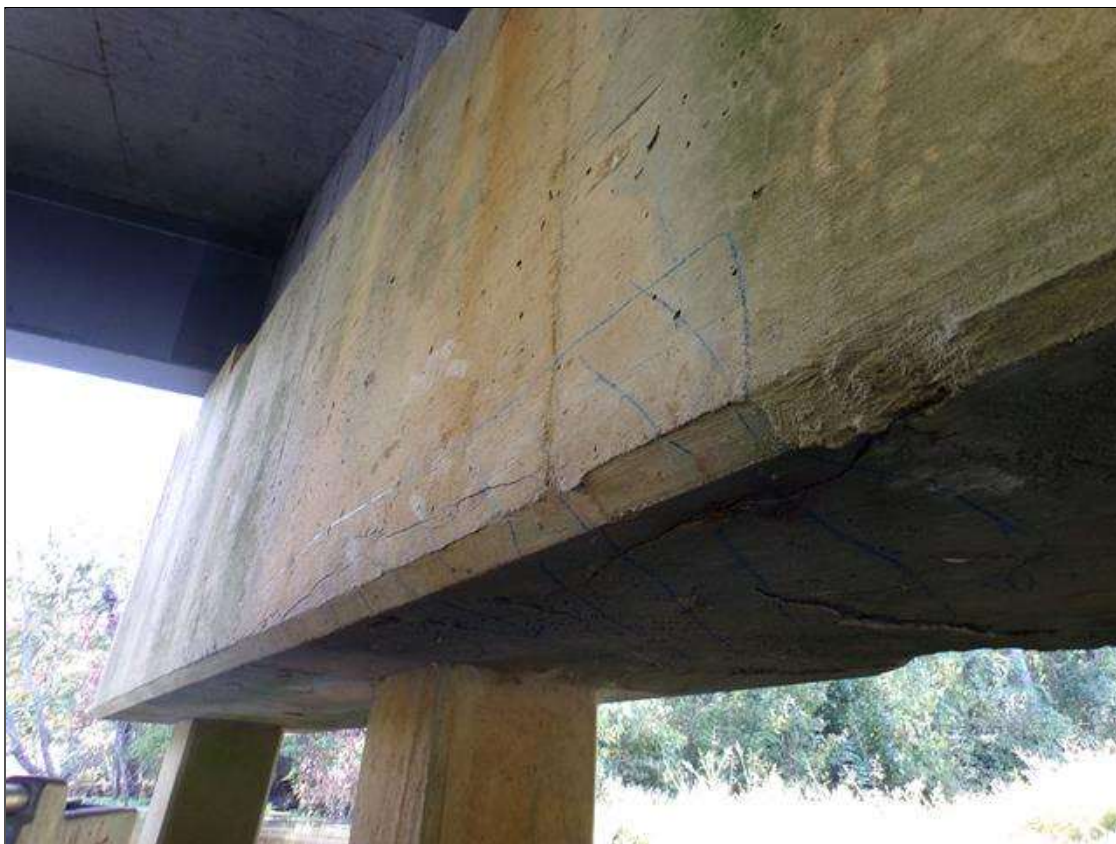
Bent 2 Cap 1: 3.5' long x 6" high x full width on bottom of cap on west face under beam 2

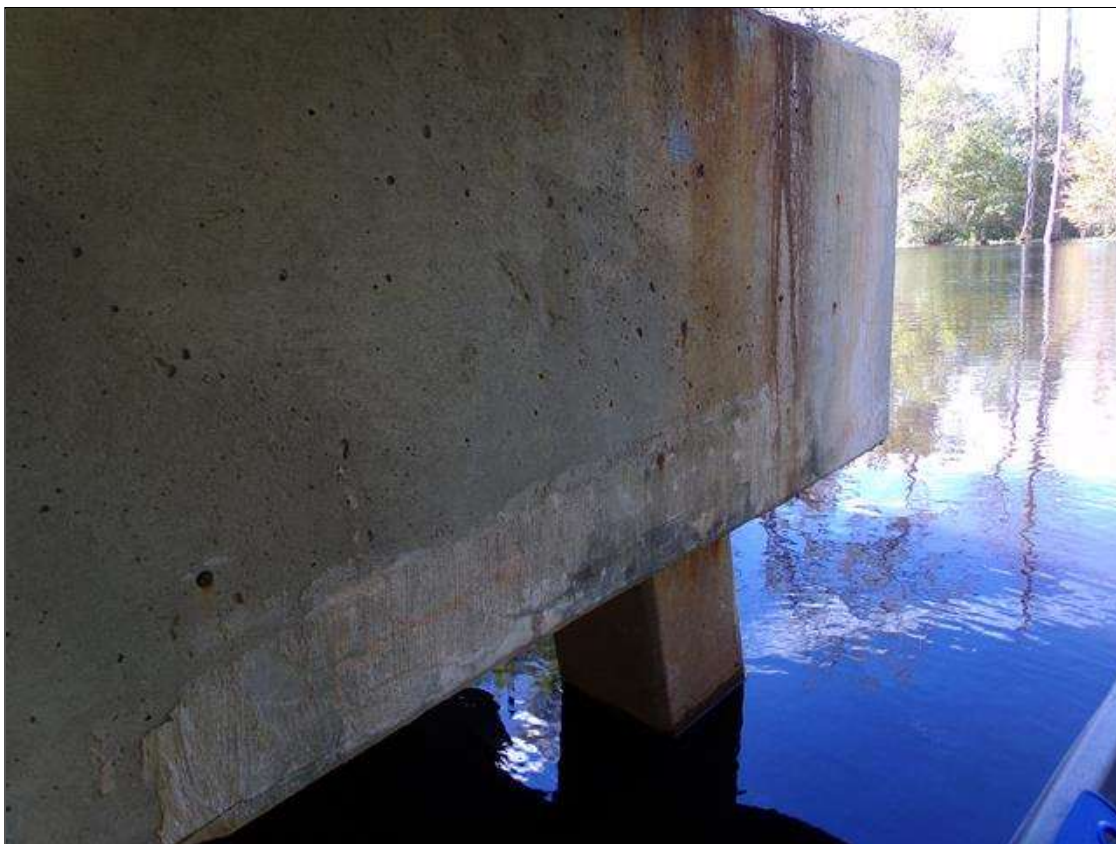
Bent 2 Cap 1: 5ft x up to full height sound patched area with hairline map cracking on west face at south end.

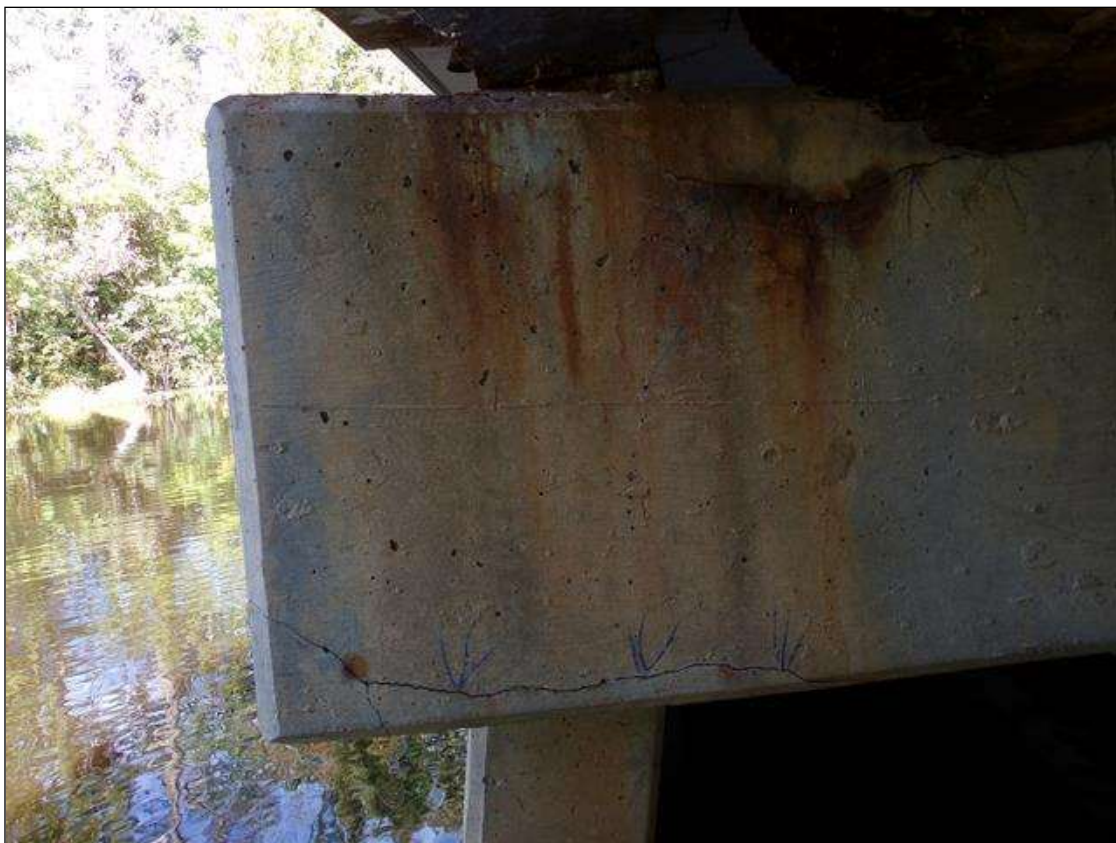
Bent 2 Cap 1: 3' long x up to 1/8" wide horizontal crack with rust staining on south end at bottom of cap that wraps around 3" on south end

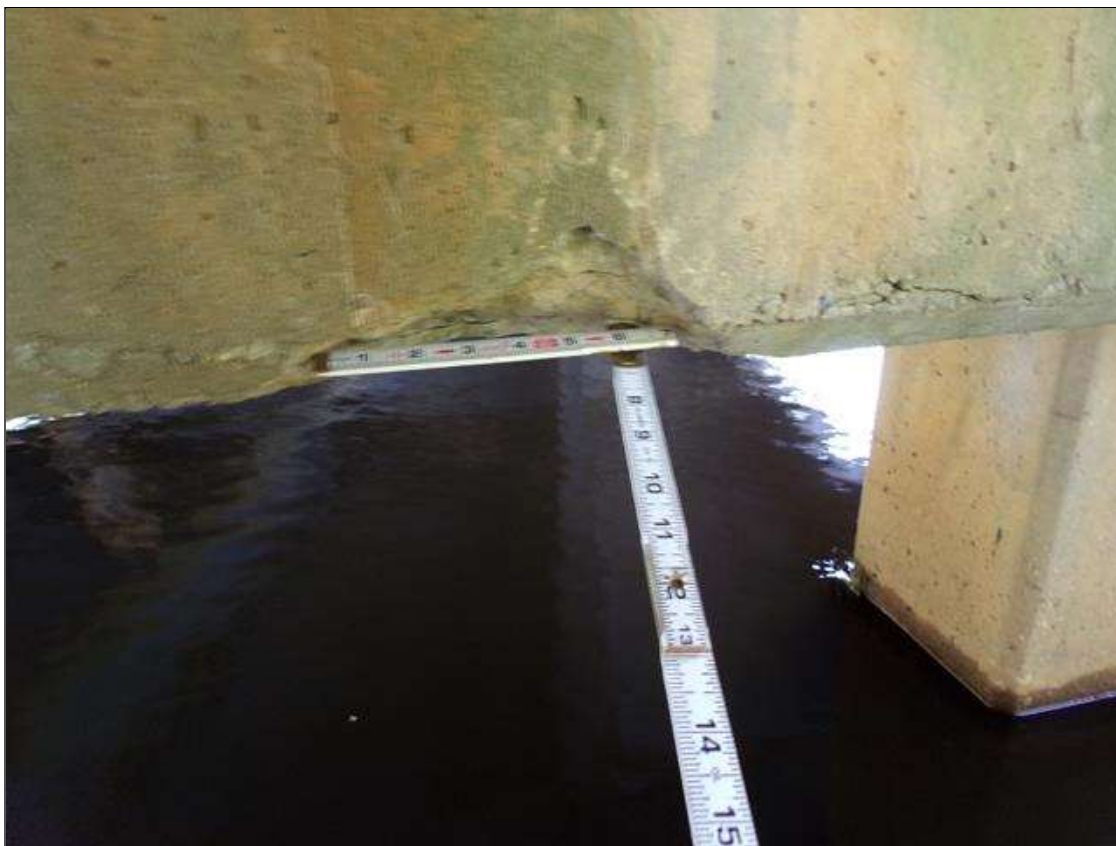
Bent 2 Cap 1: 8" long x 7" high x 3" deep spall with no exposed rebar between piles 2 and 3 on bottom of east face of cap

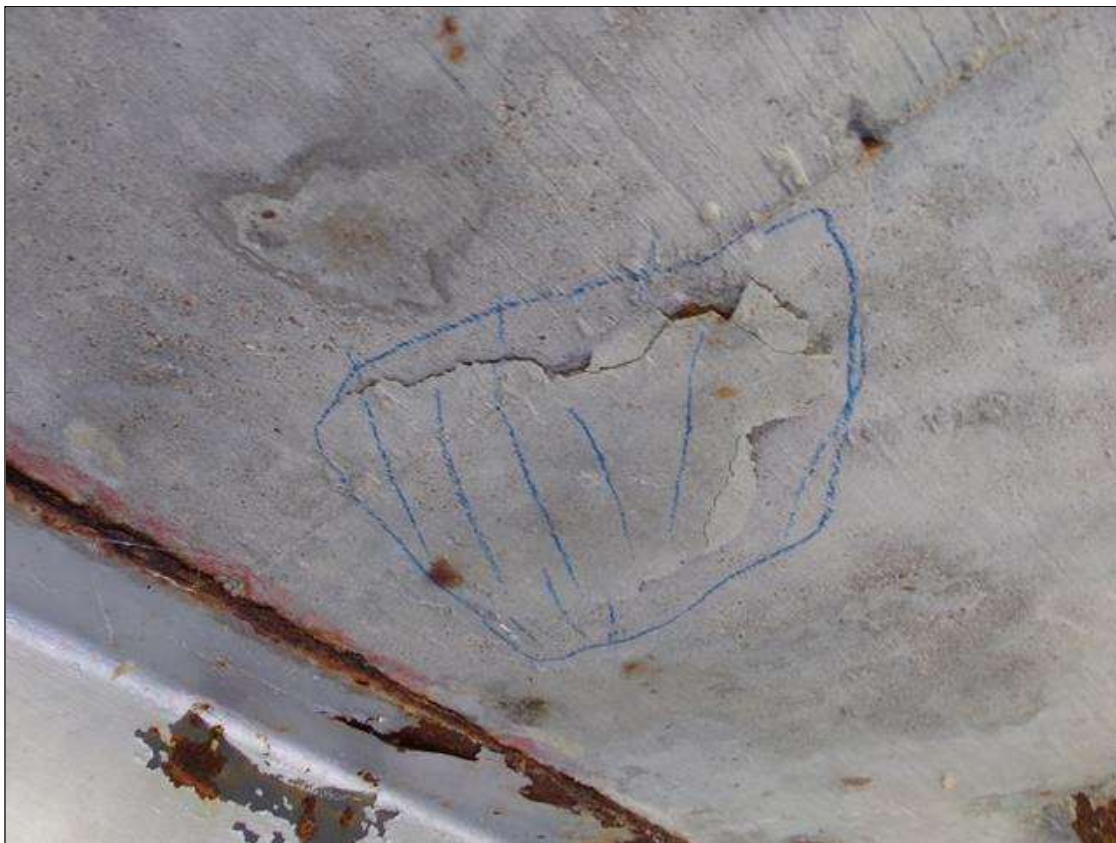
Span 3 Deck: 7" diameter area of delamination on south overhang at 2' from pier 2

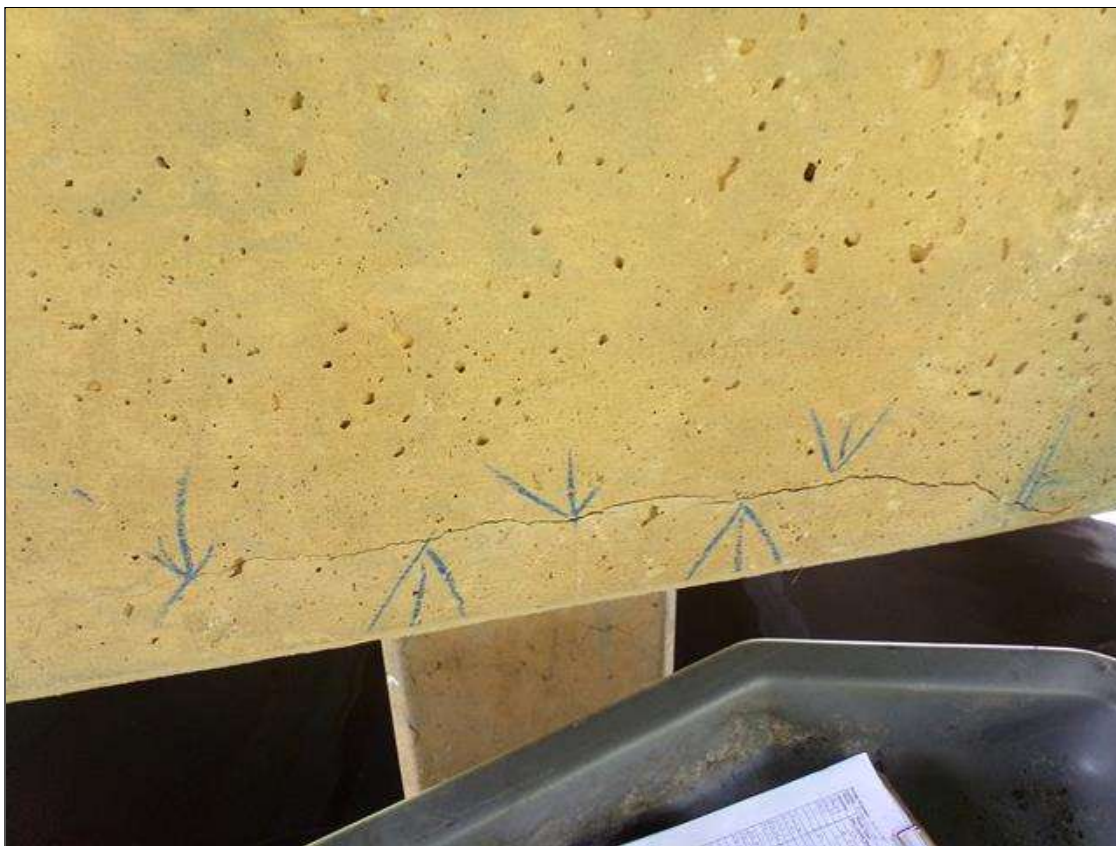
Bent 2 Cap 1: 3' long x up to 1/16" wide horizontal crack on bottom of east face of cap at pile 3
