NC DEPARTMENT OF TRANSPORTATION  
 DIVISION OF HIGHWAYS  
 STRUCTURE MANAGEMENT UNIT

ATTENTION: PRIORITY MAINTENANCE ISSUED; CHANGE TO APPROACH ROADWAY DATA

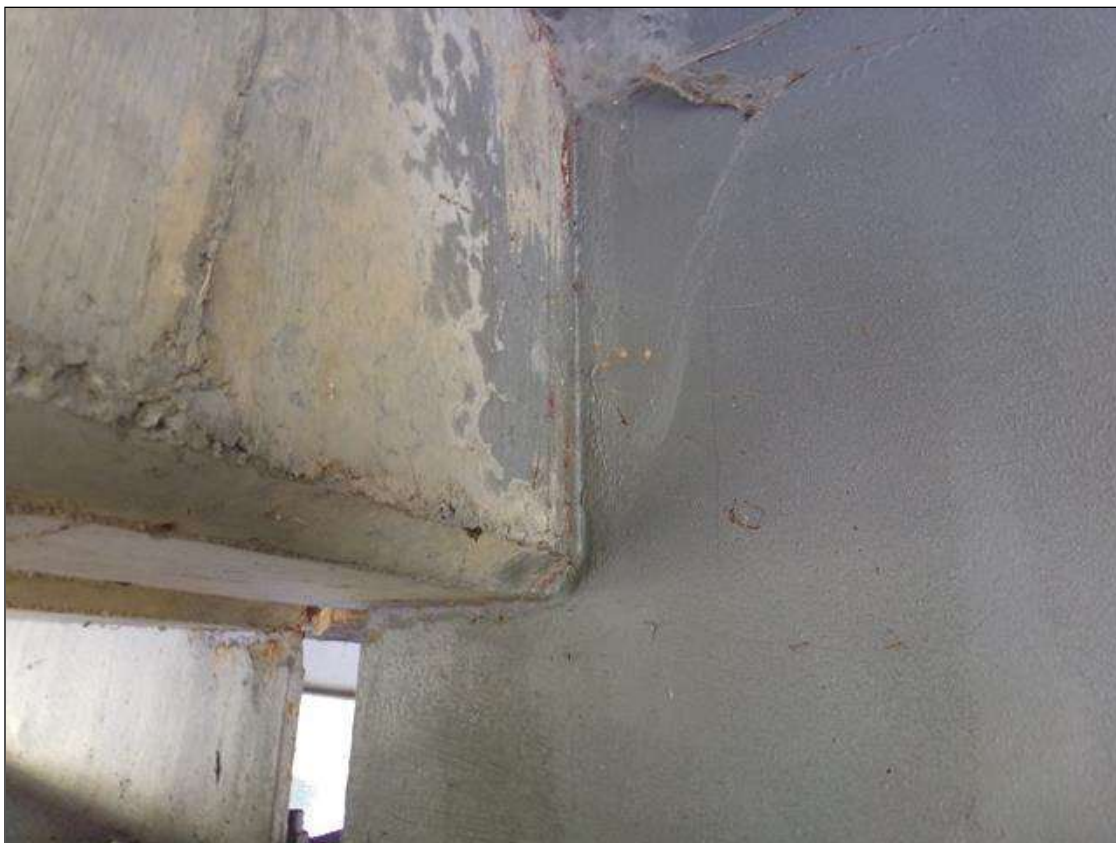
Span 1 Beam 2: Typical painted over pitting (1' long x 1" wide x up to 1/8" deep) at interface with concrete end diaphragms at piers.

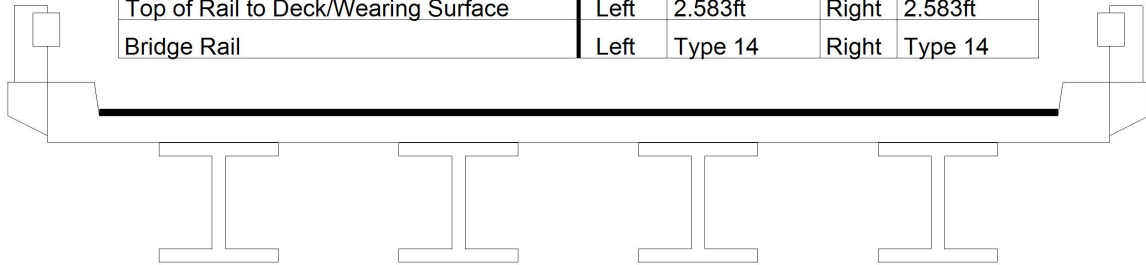
Measurements for Span #	1			
Deck Thickness	0.667	Left Overhang		*3.75
Top of Rail to Bottom of Beam	5.417	Right Overhang		*3.75

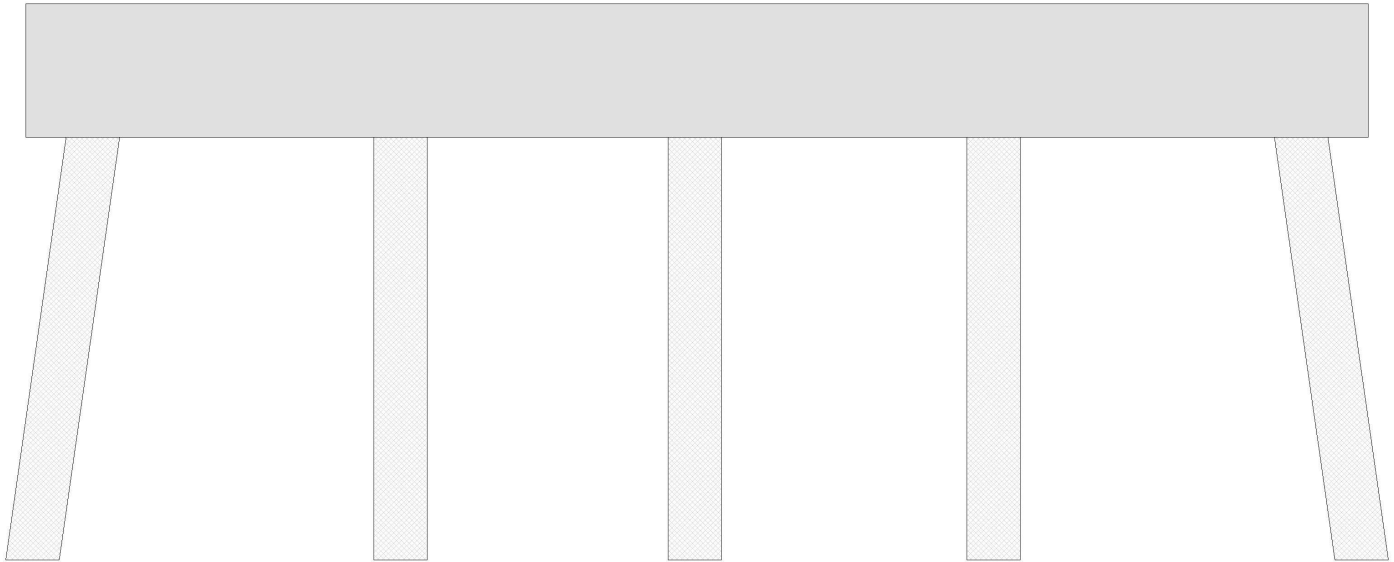
<b>Cap Information</b>			<b>Material</b> Cast-in-Place Concrete							
Length	Width	Height	Left Overhang	Right Overhang	Left Beam to End of Cap.	Right Beam to End of Cap.
