NC DEPARTMENT OF TRANSPORTATION  
 DIVISION OF HIGHWAYS  
 STRUCTURE MANAGEMENT UNIT

ATTENTION: PAR Submitted, Changes to Structure Data, Temporary Shoring

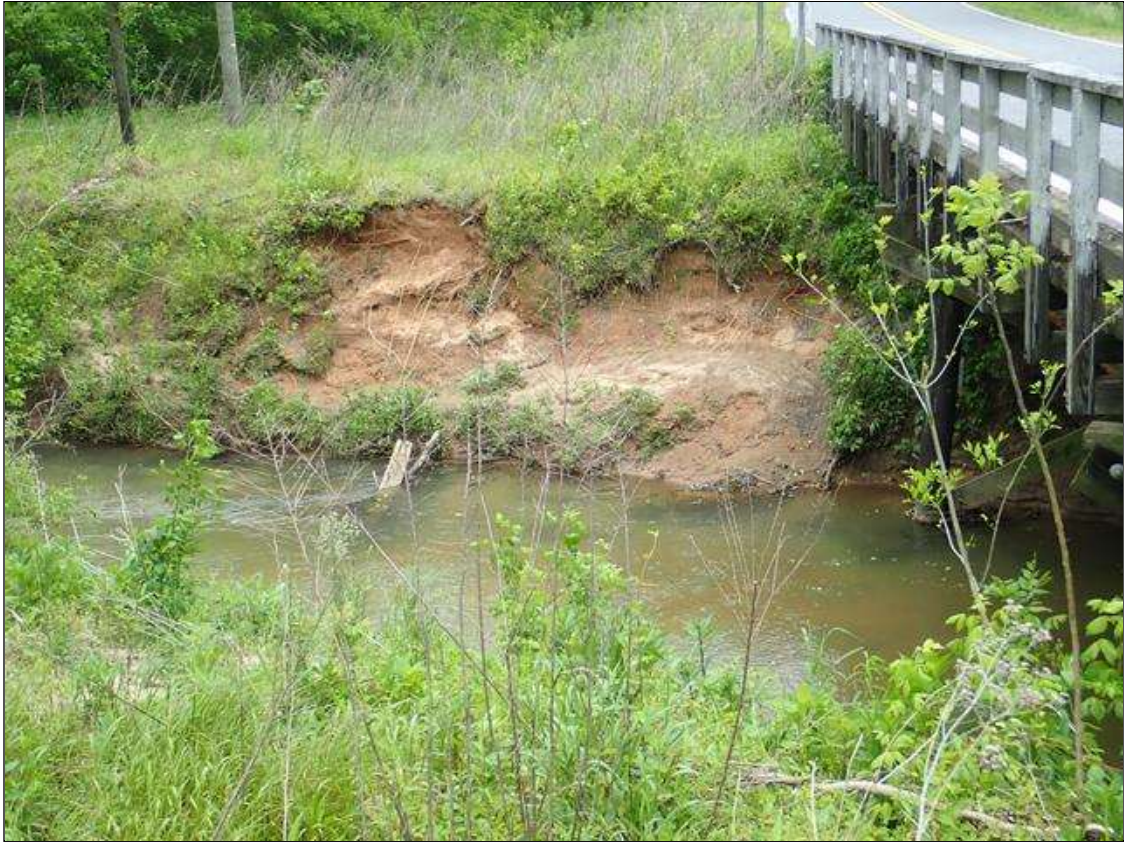
Scour: at both embankments, cut banks [8ft high]

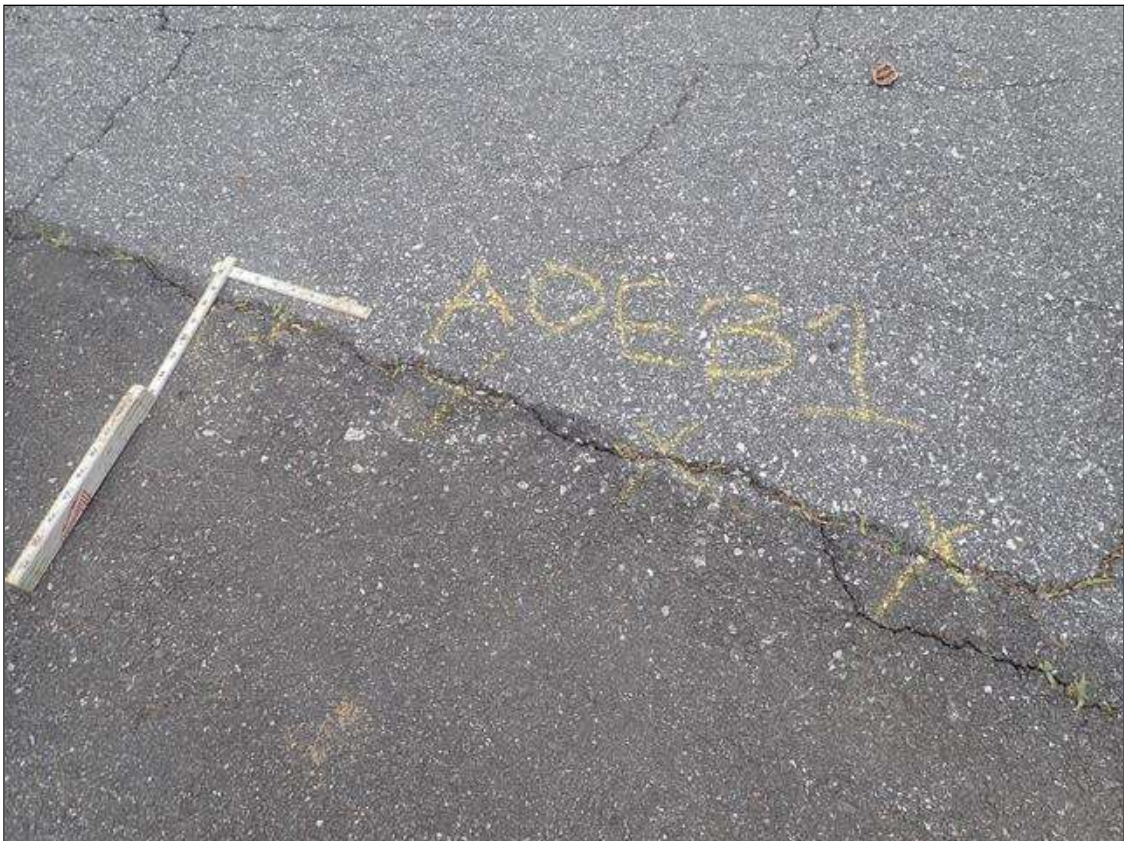
asphalt over end bent 1, transverse crack [full width x up to 3/16in]

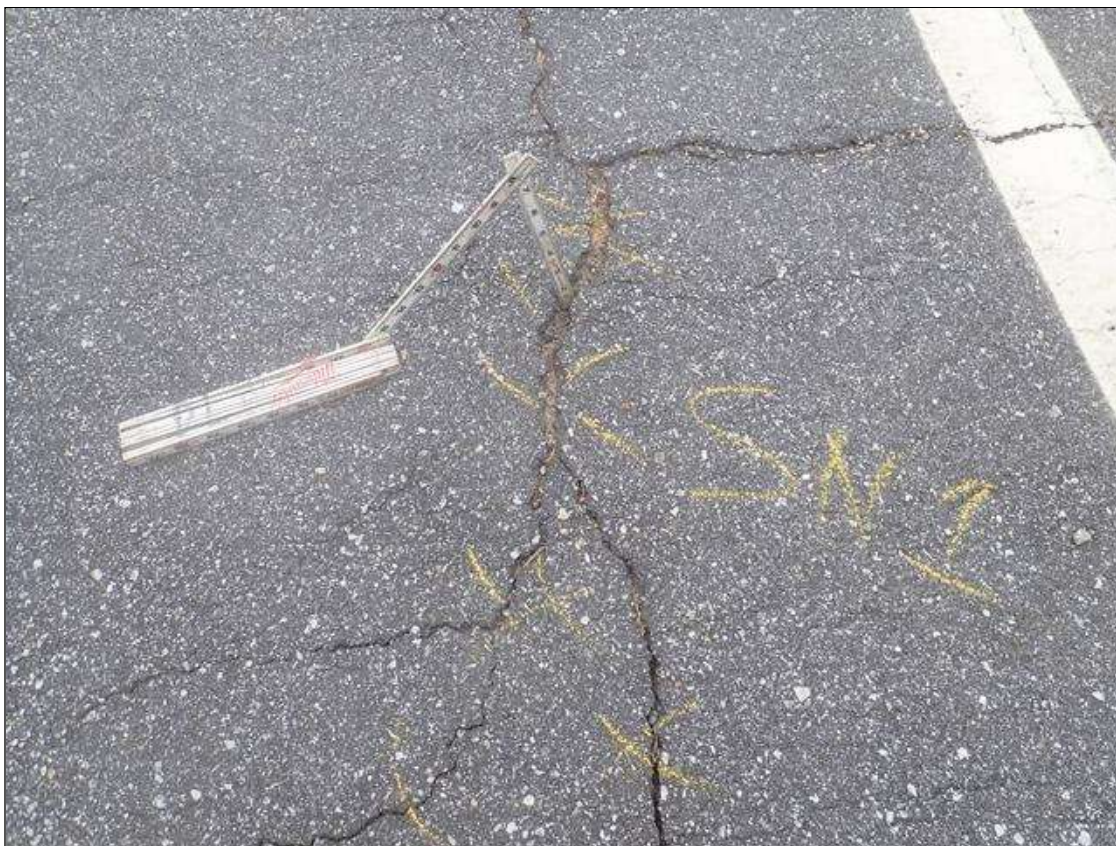
Span 1 Wearing Surface: throughout asphalt wearing surface, multiple transverse cracks and longitudinal cracks [up to full width x up to full length x up to 5/8in]

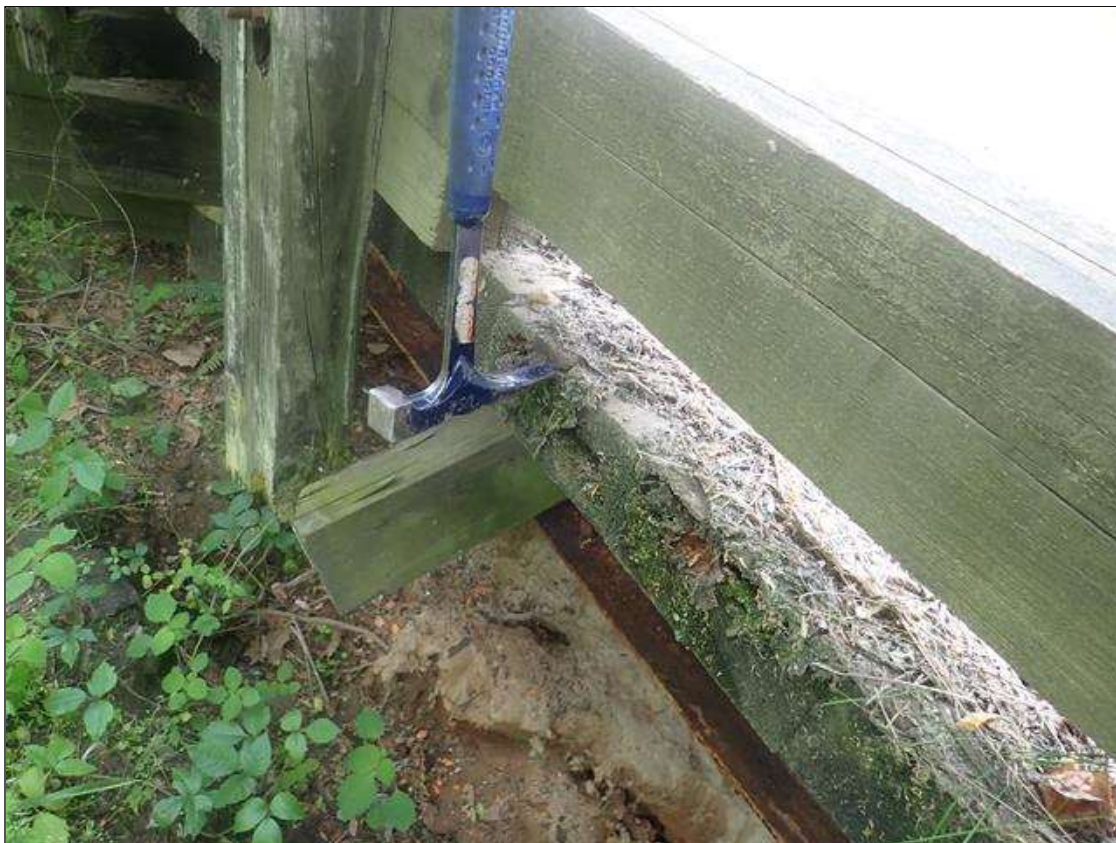
Span 3 Deck: along East and West ends of deck boards, areas of decay/soft timber [less than 10%]

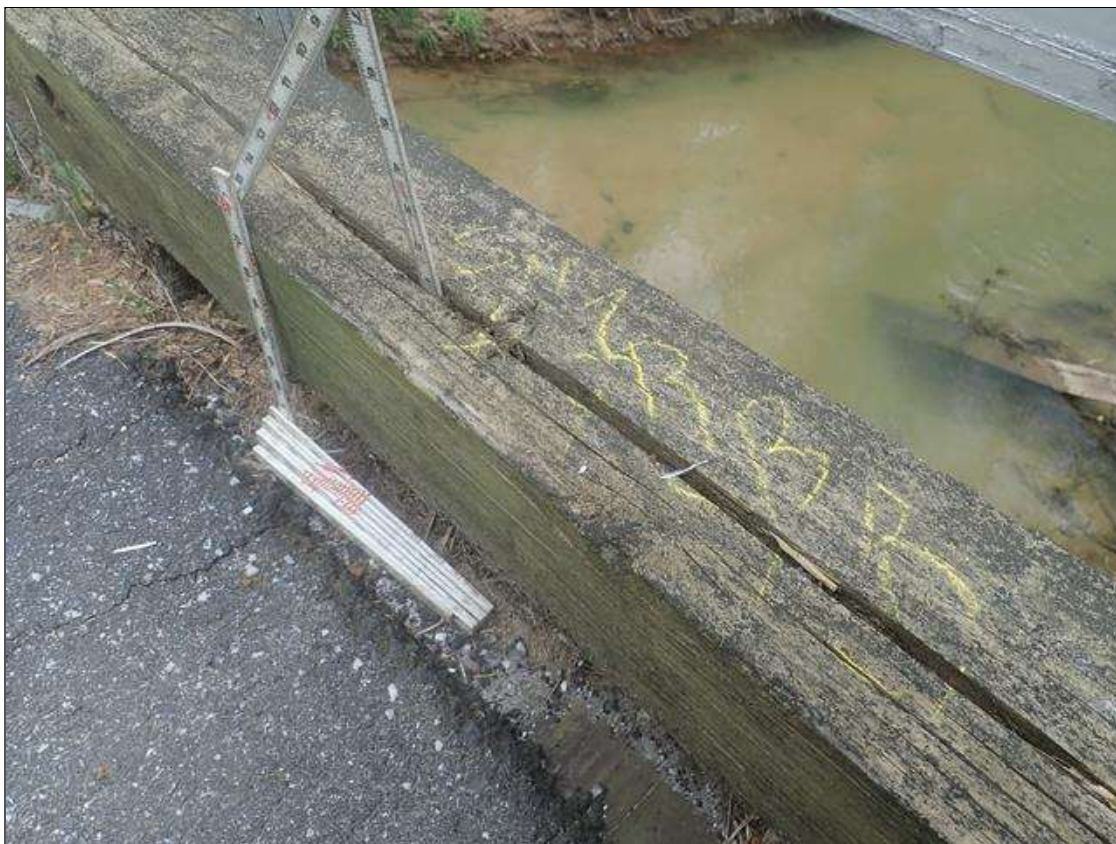
Span 1 Right Bridge Rail: along top of curb, multiple checks [up to 3/8in x up to 1.5in deep]

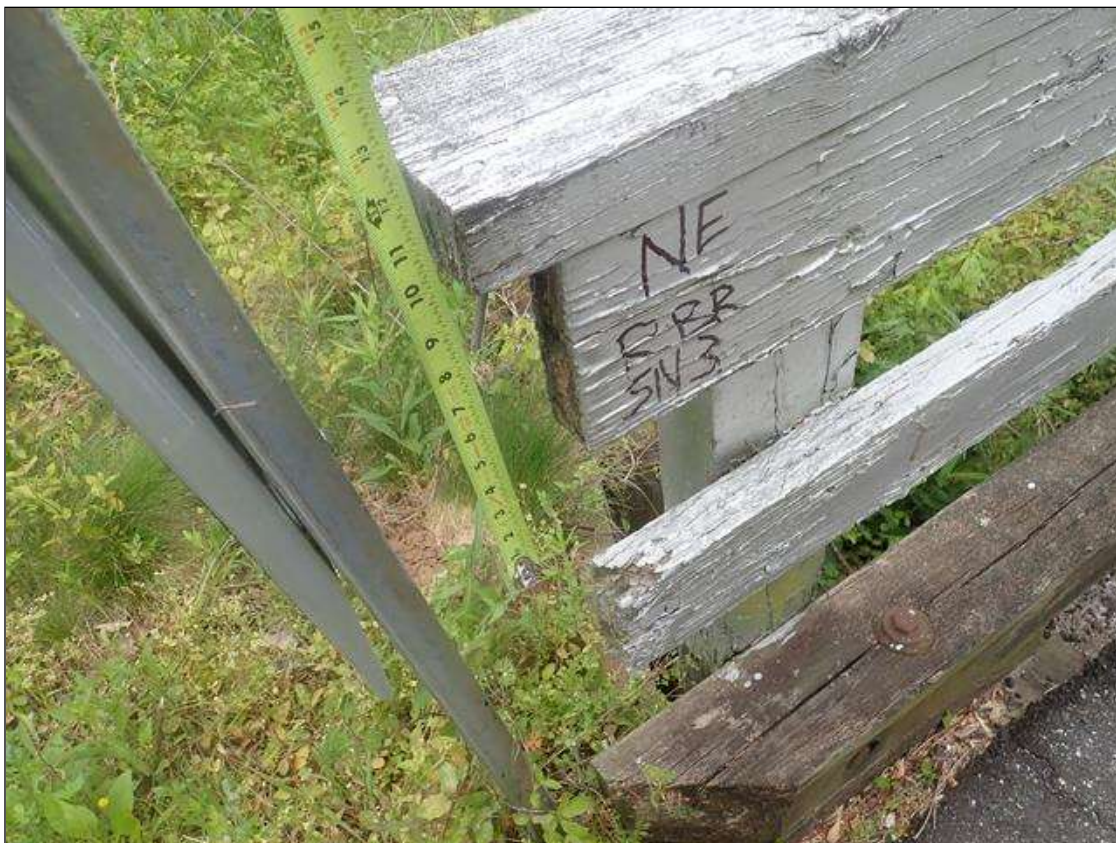
Span 3 Right Bridge Rail: [PAR] at End Bent 2, vertical end board missing

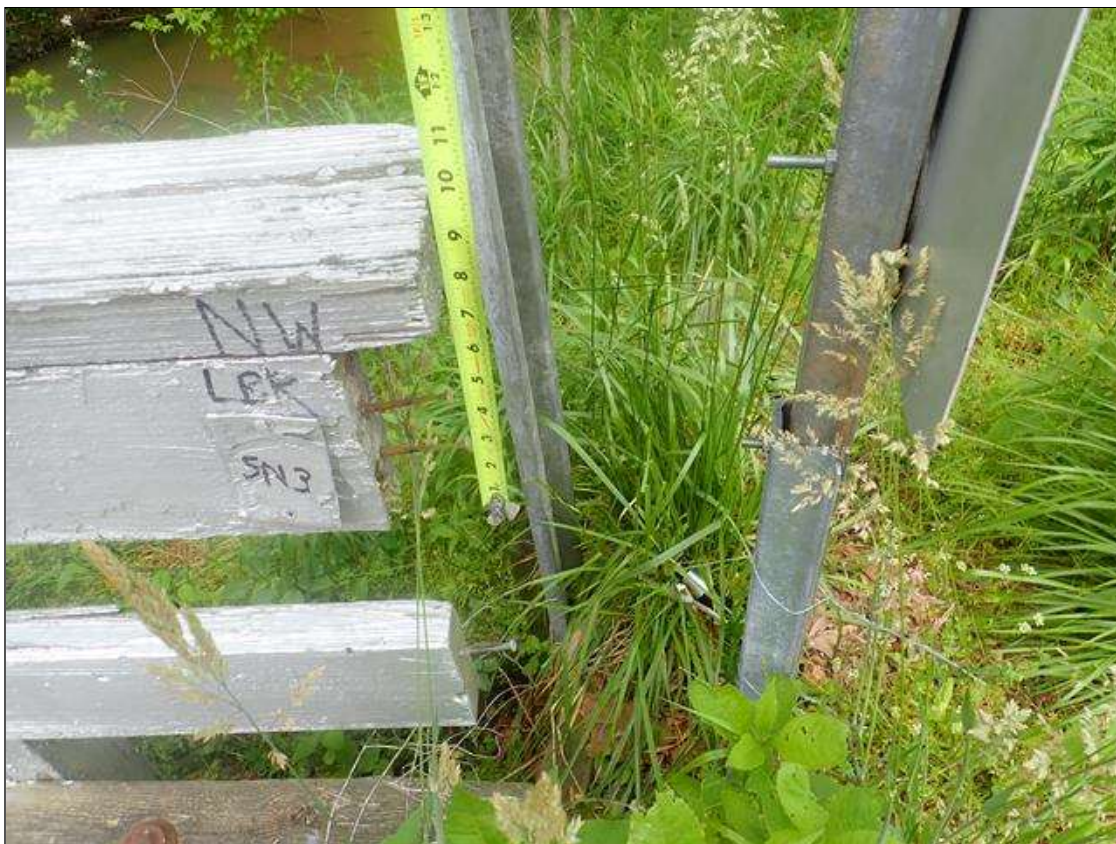
Span 3 Left Bridge Rail: [PAR] at End Bent 2, vertical end board missing

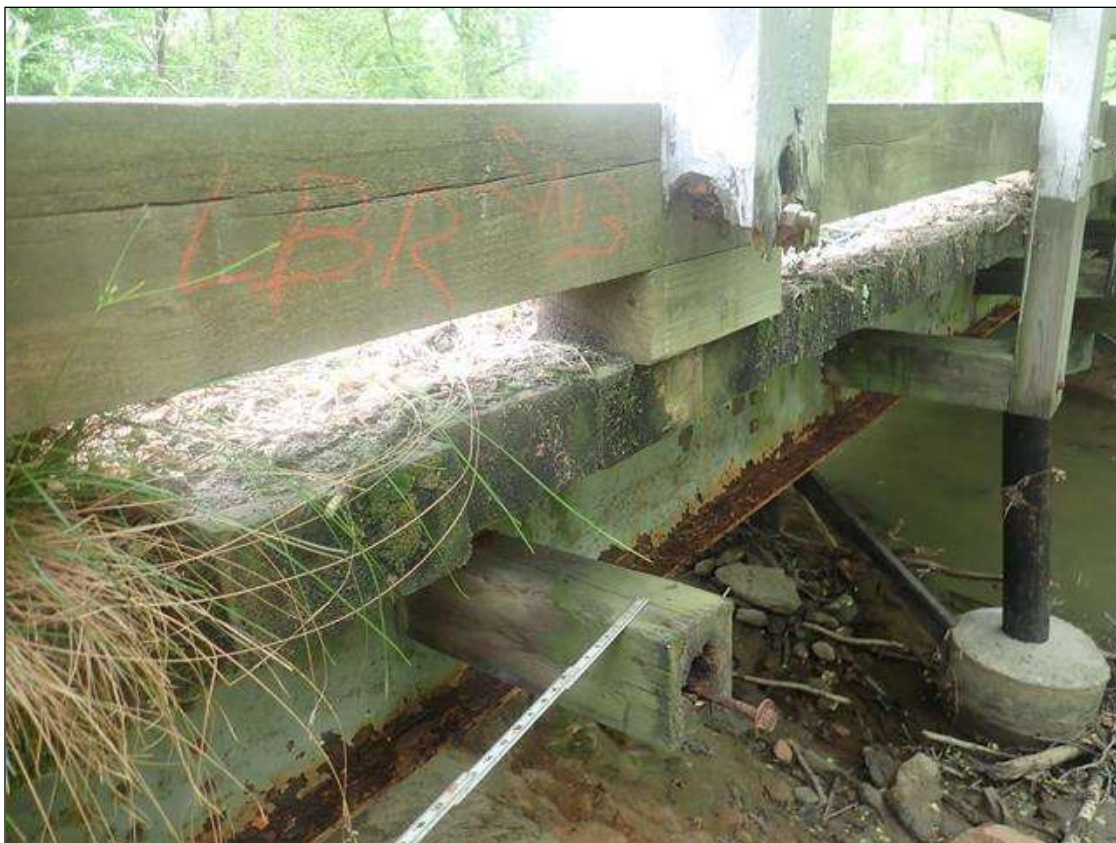
Span 3 Left Bridge Rail: [PAR] at 3rd post from End Bent 2, decay [30in x 100% loss] with missing standoff connection

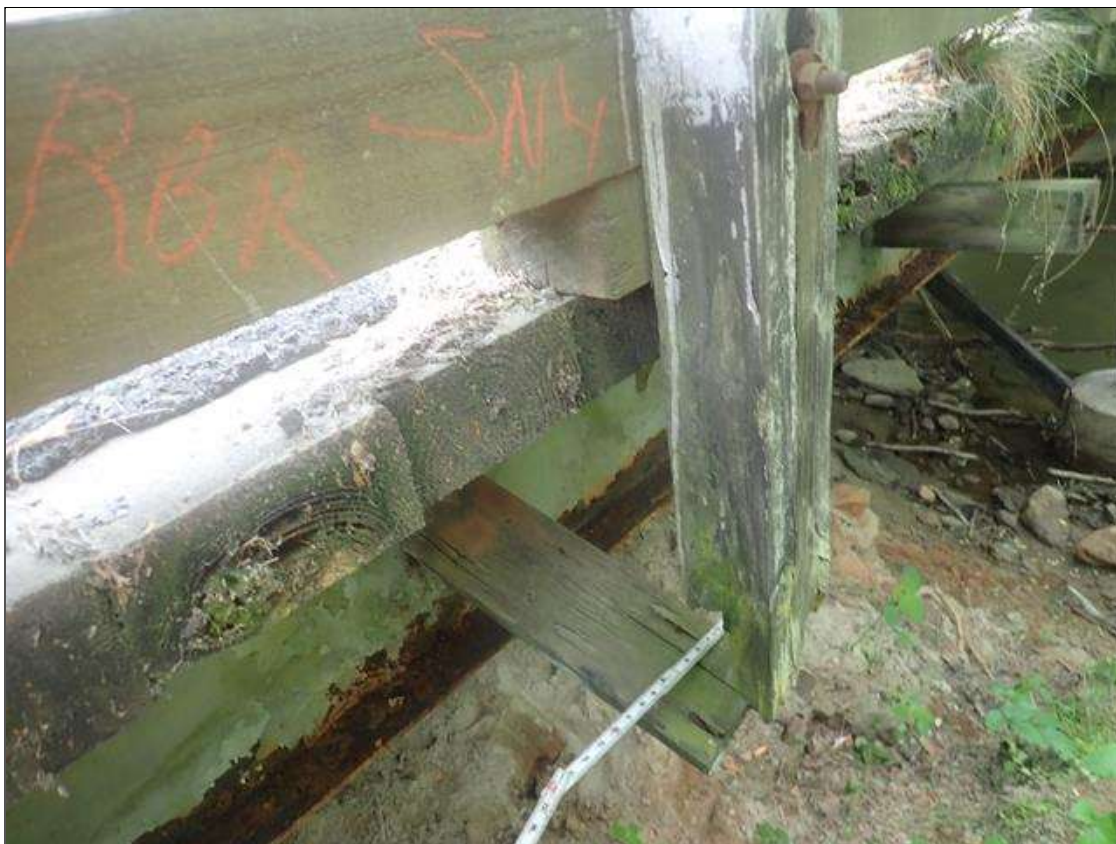
Span 3 Left Bridge Rail: [PAR] at 2rd post from End Bent 2, decay [30in x 100% loss] with missing standoff connection

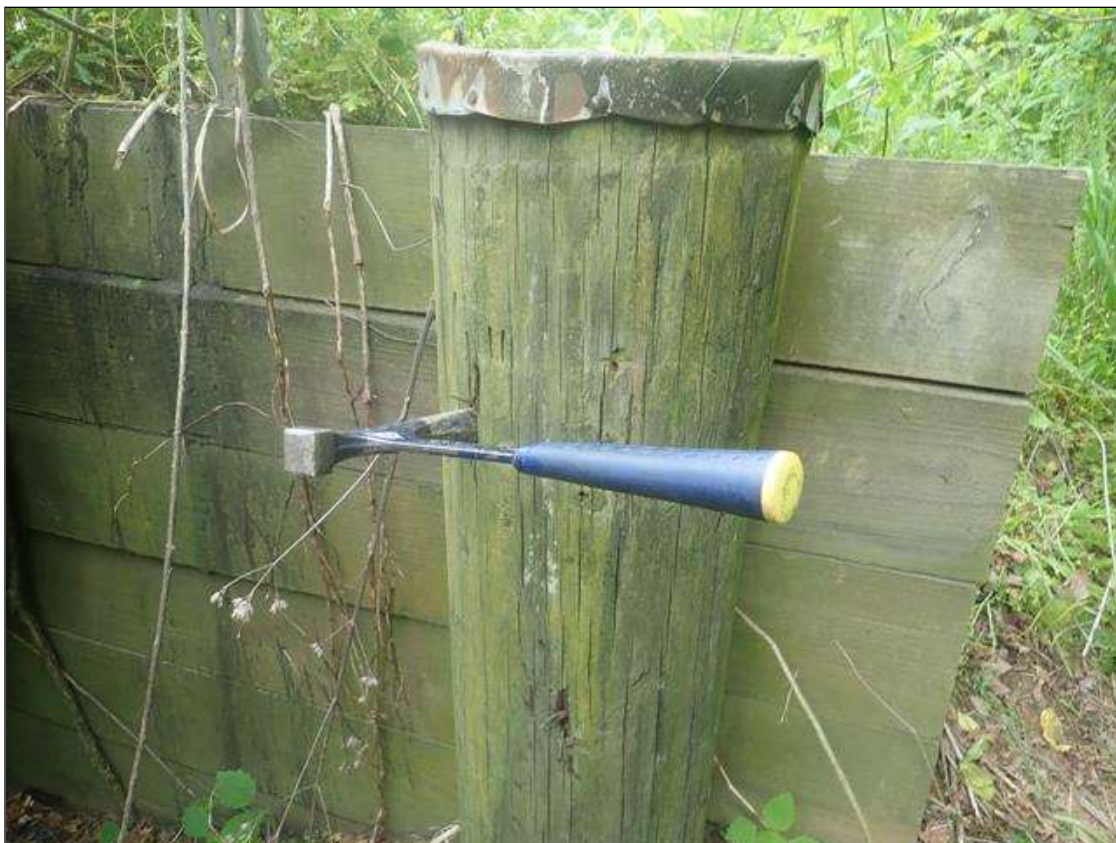
Southwest wingwall along soldier pile around exterior, decay [up to 2in deep] x full circumference

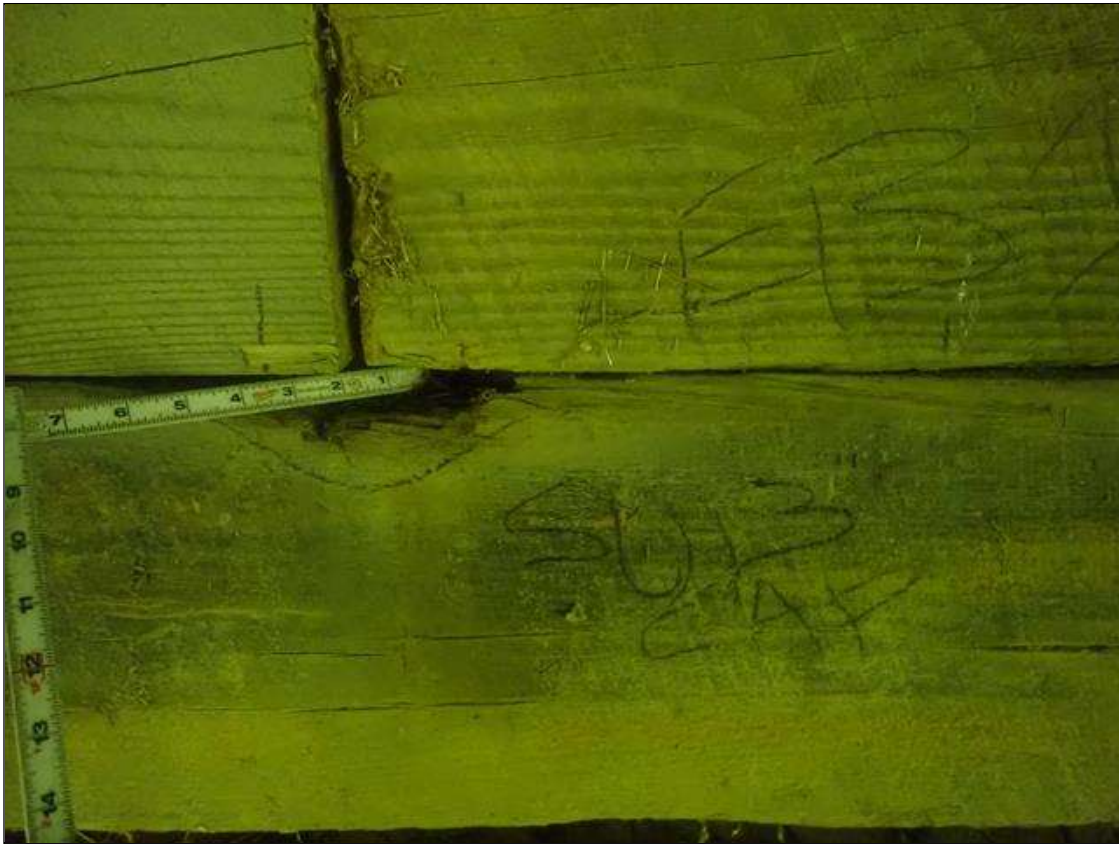
Bent 1 Cap 2: at 4ft from pile 2, decay [6in x 4in x up to 1.5in deep]

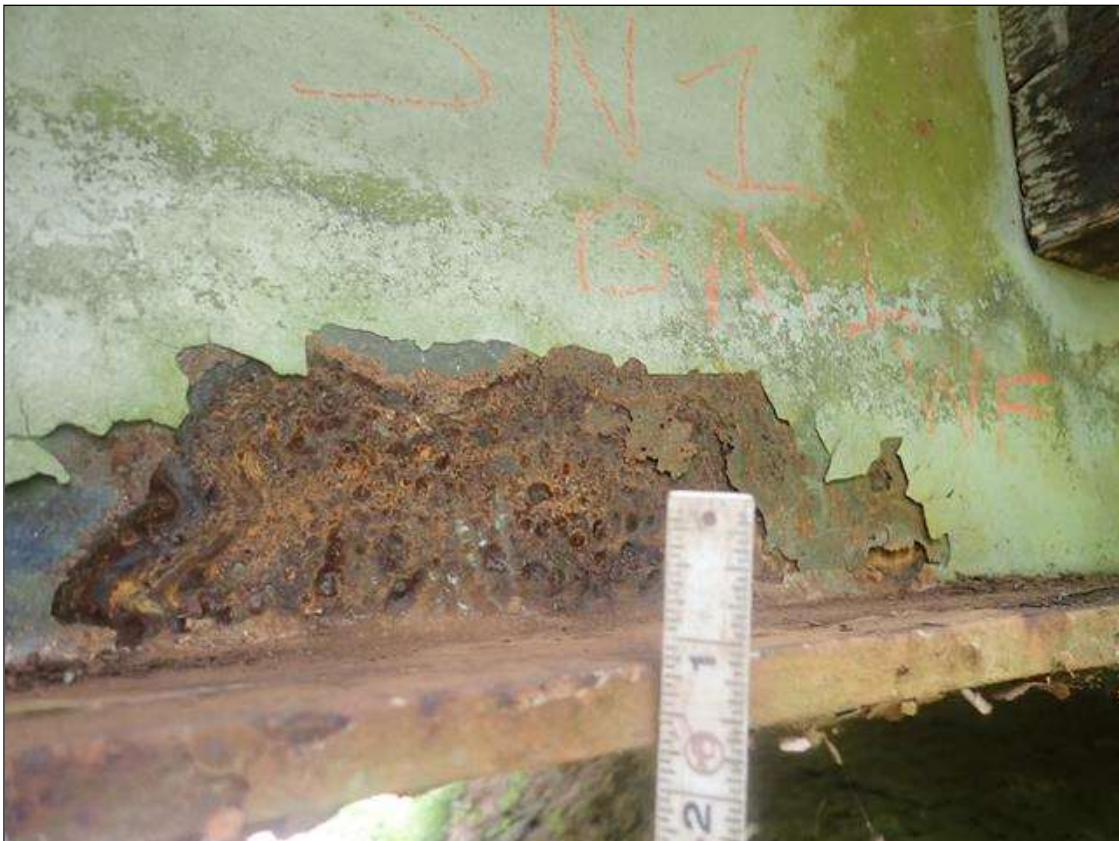
Span 1 Beam 1: along beam, active corrosion with section loss: top flange [full width x 17/32in avg rem], bottom flange [full width x 17/32in avg rem], and lower web [up to 5in high x 11/32in avg rem]

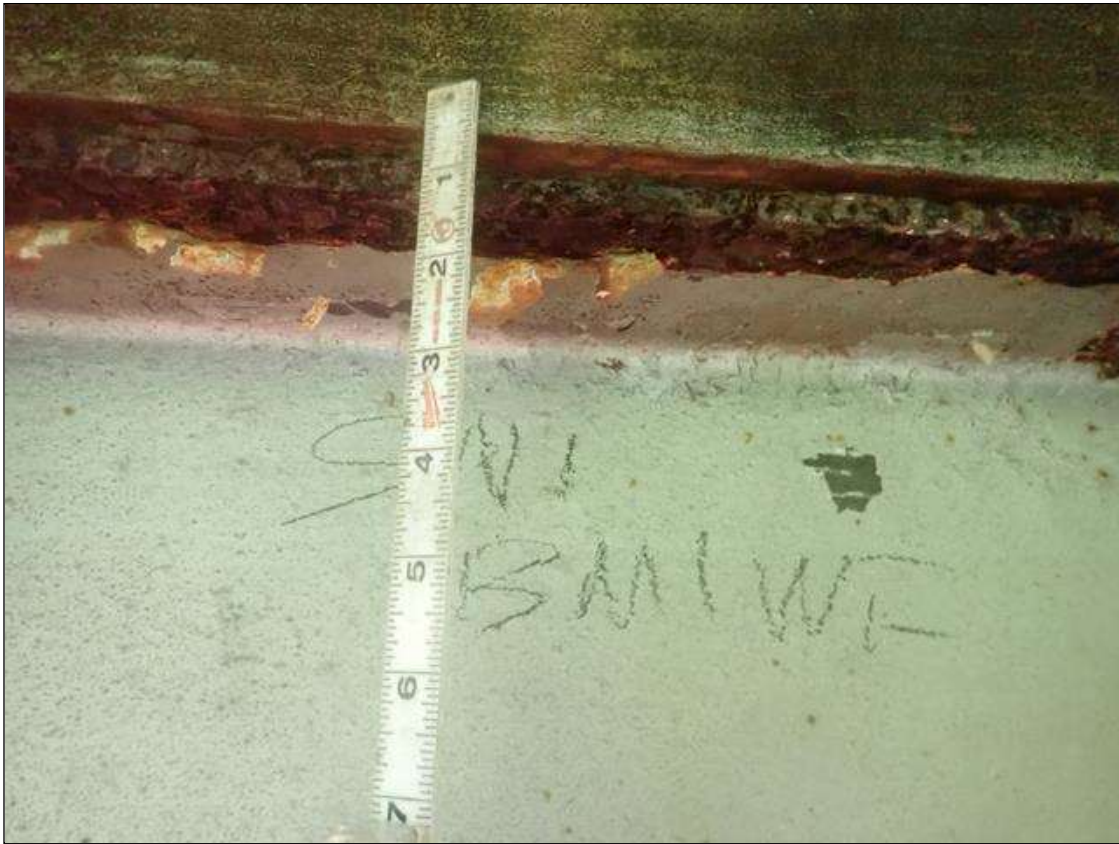
Span 1 Beam 1: along beam, active corrosion with section loss: top flange [full width x 17/32in avg rem], bottom flange [full width x 17/32in avg rem], and lower web [up to 5in high x 11/32in avg rem]

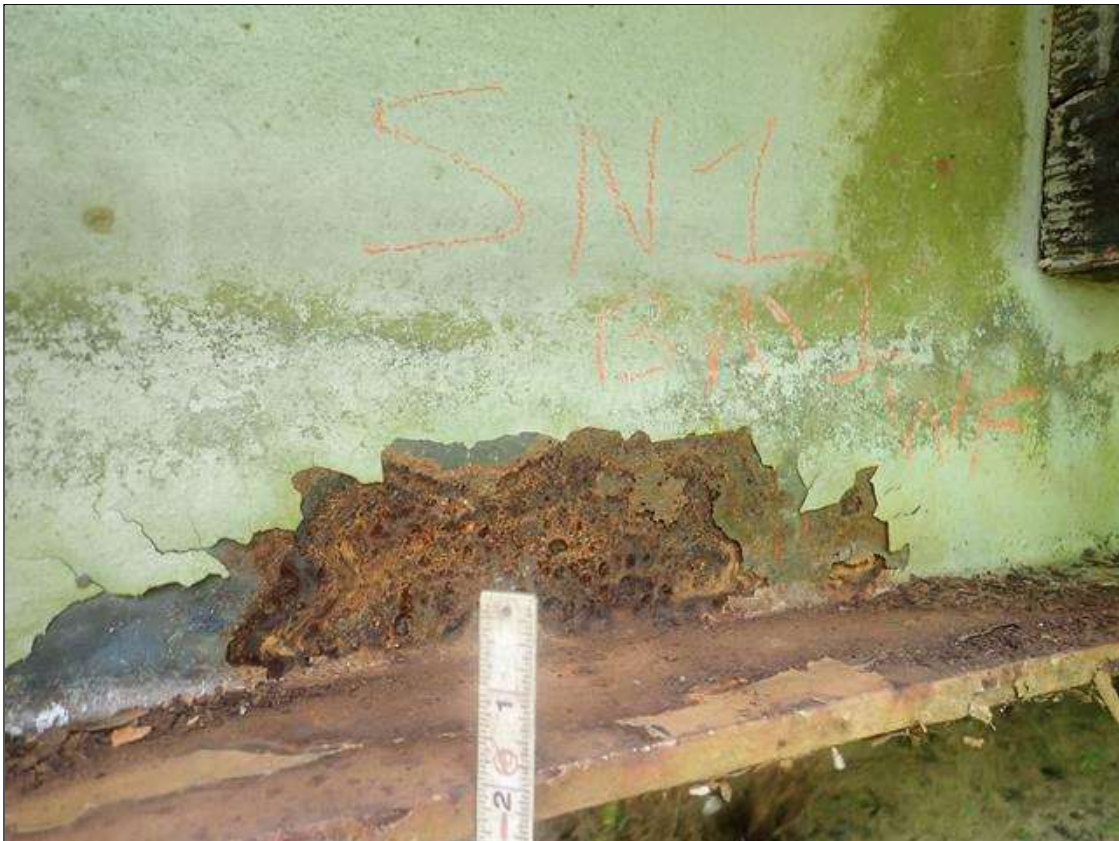
Span 1 Beam 1: along beam, active corrosion with section loss: top flange [full width x 17/32in avg rem], bottom flange [full width x 17/32in avg rem], and lower web [up to 5in high x 11/32in avg rem]

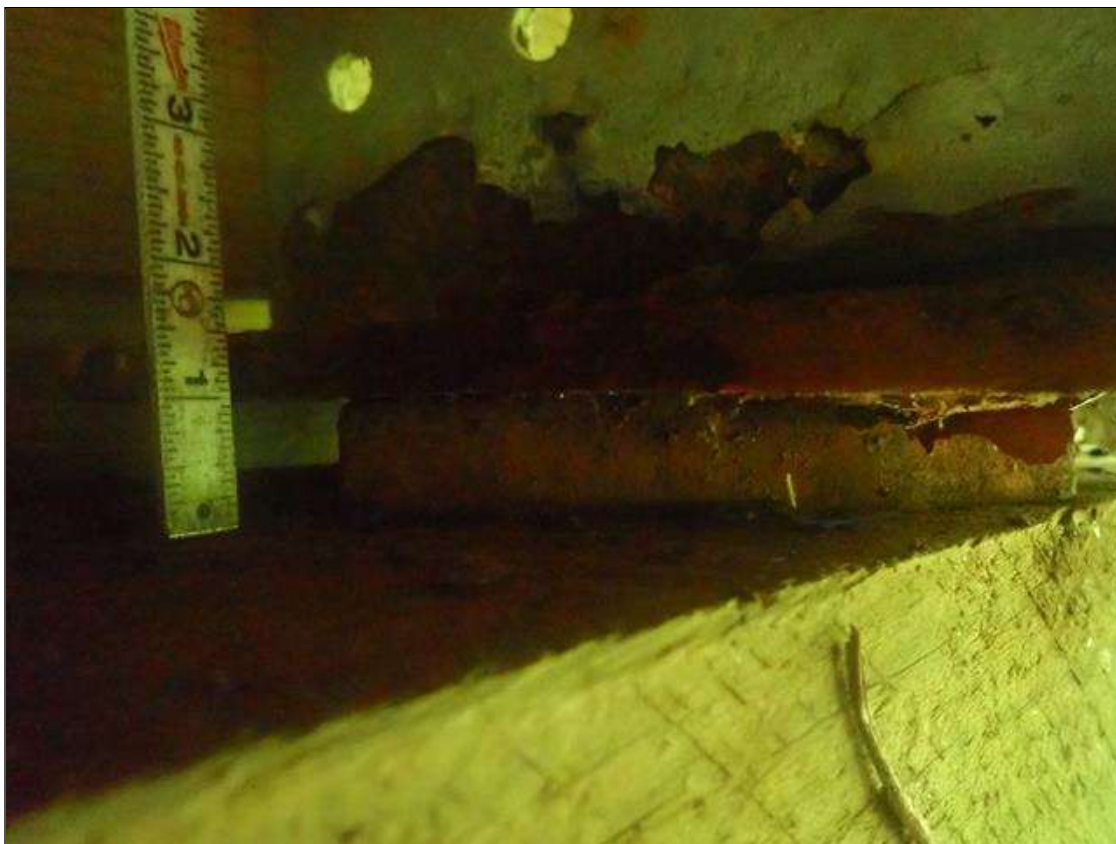
Span 1 Beam 1 Near Bearing: throughout bearing, active surface corrosion [no section loss]

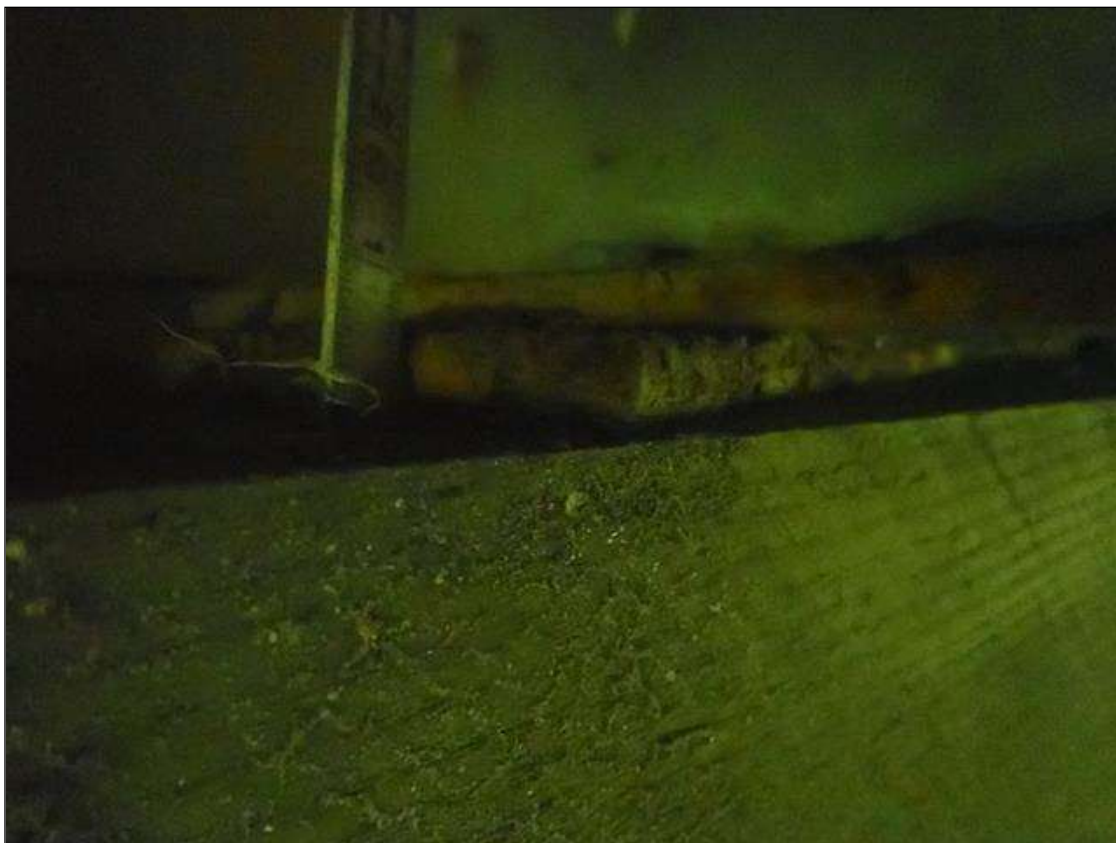
Span 1 Beam 4 Near Bearing: throughout bearing, active corrosion with section loss [up to 1/32in]

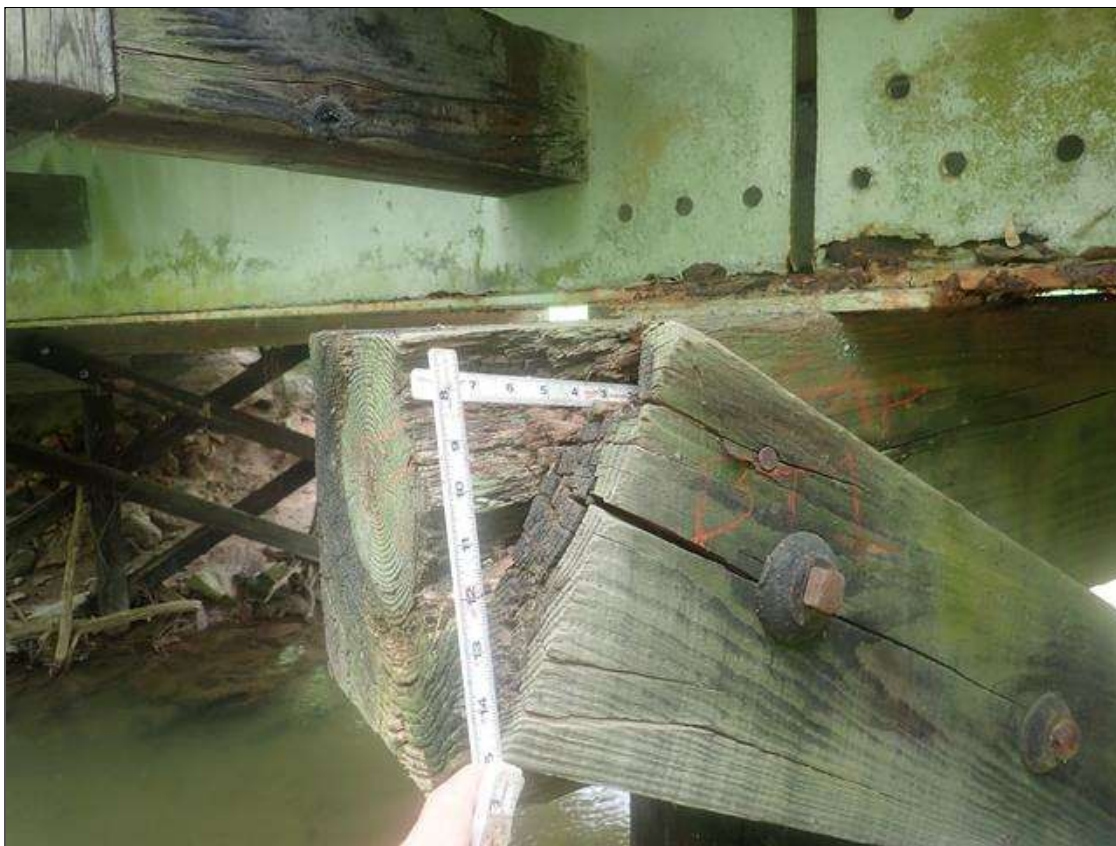
Bent 1 Cap 1: top left corner at West end, decay [9in x 7in x 2in]

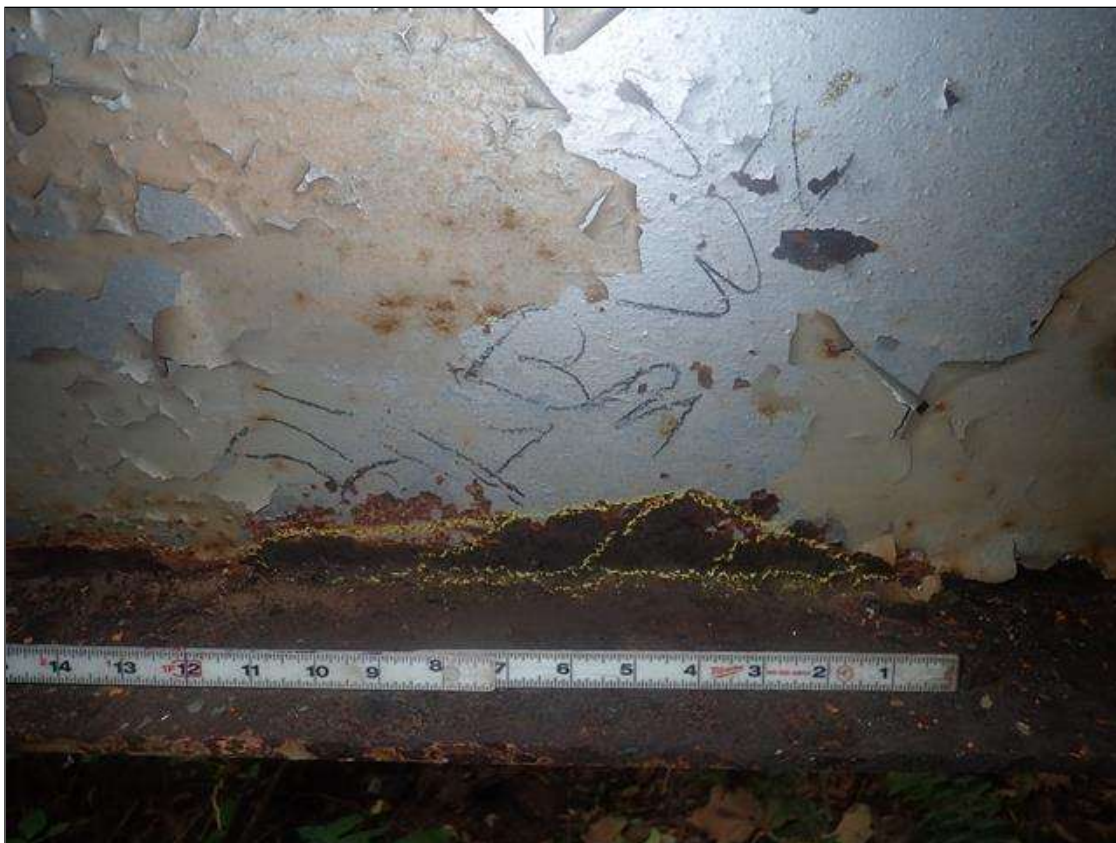
Span 3 Beam 1: [PAR] lower web at 3ft from End Bent 2, active corrosion with section loss [1in x up to 2in high x 3/16in avg rem]

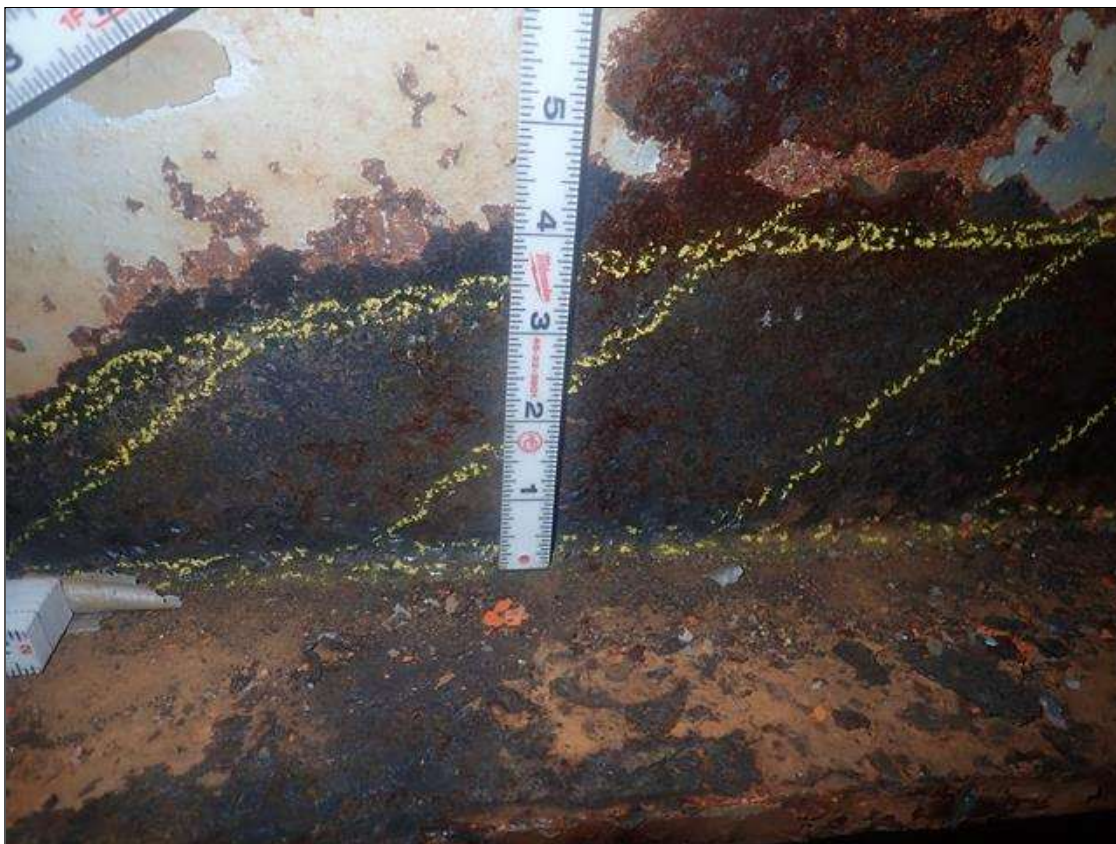
Span 3 Beam 3: [PAR] both sides of lower web 12ft from End Bent 2, active corrosion with section loss [4ft x up to 6in high x 1/4in avg rem]

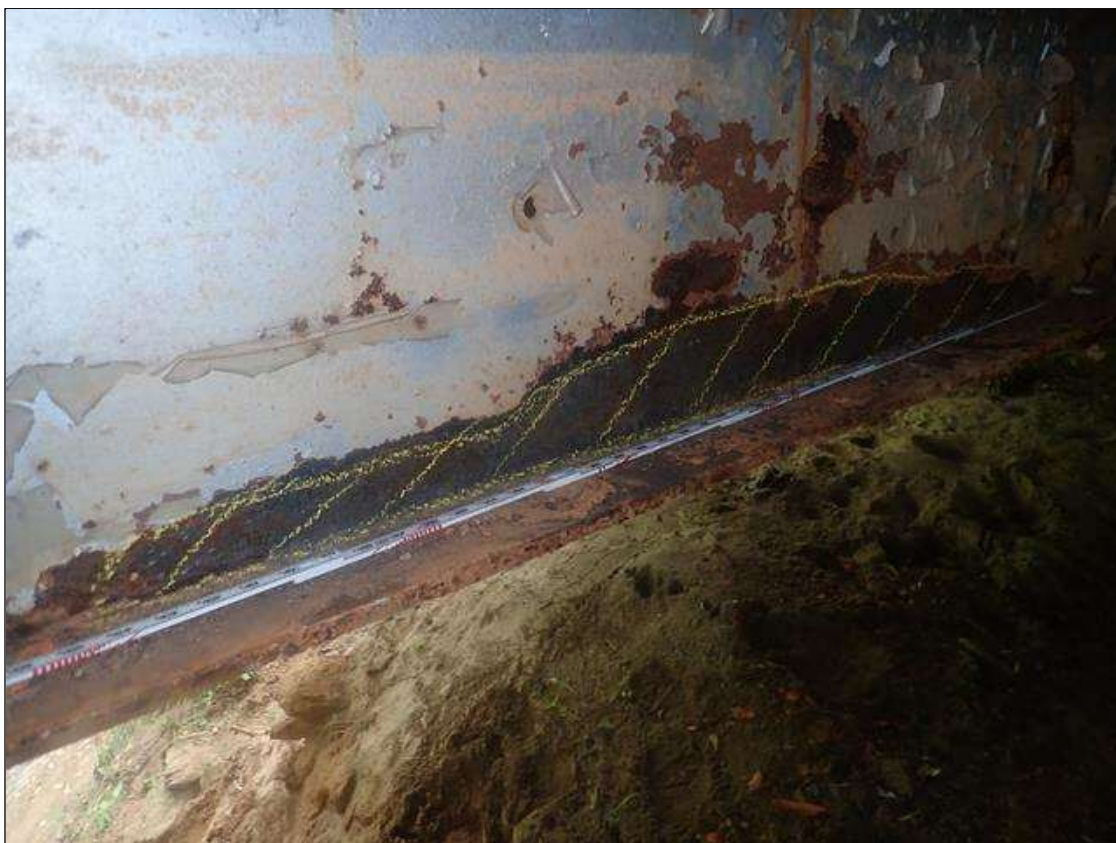
Span 3 Beam 3: [PAR] both sides of lower web 12ft from End Bent 2, active corrosion with section loss [4ft x up to 6in high x 1/4in avg rem]

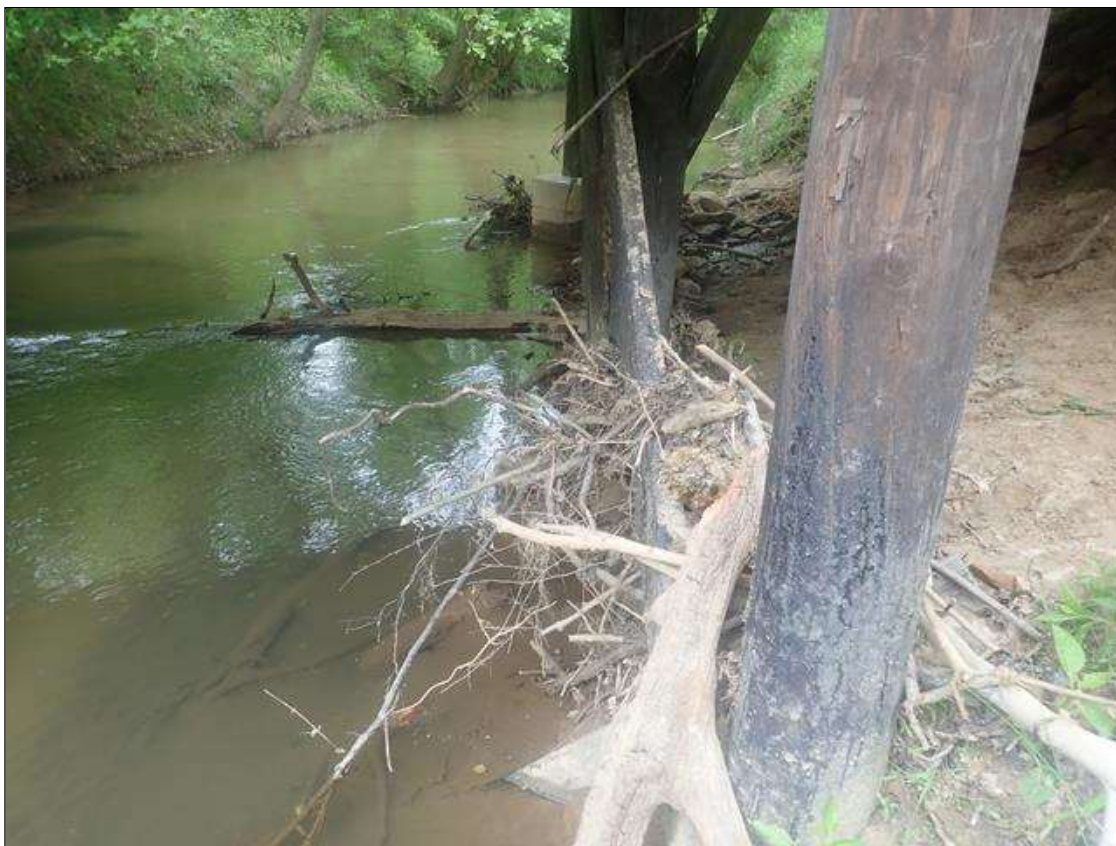
At bent 2 piles, drift accumulation [up to 6in]

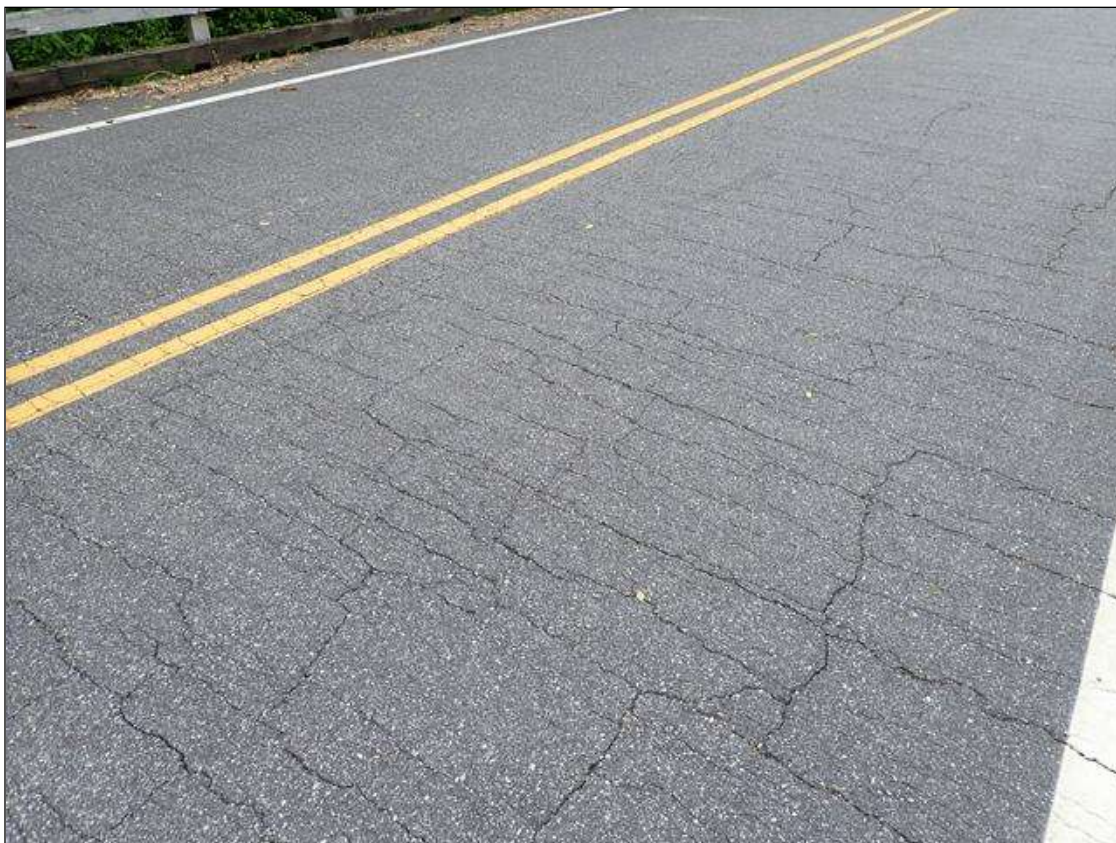
typical wearing surface

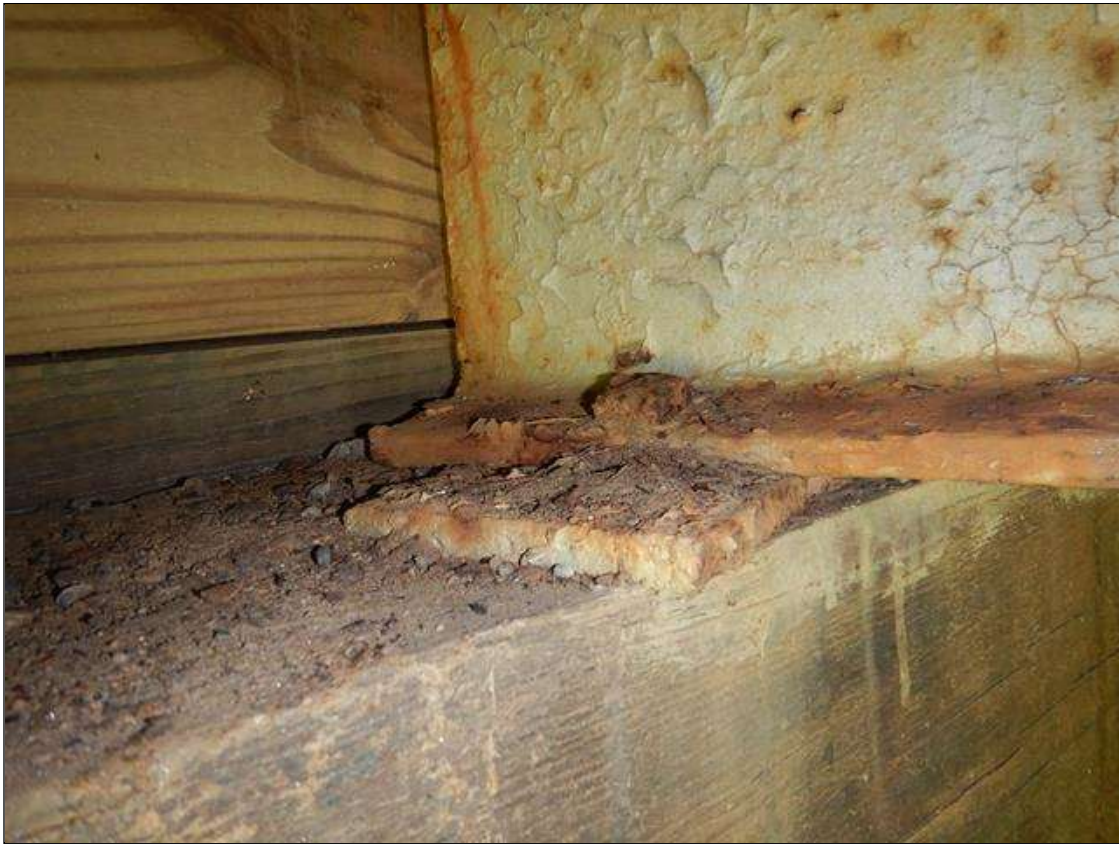
North approach looking South

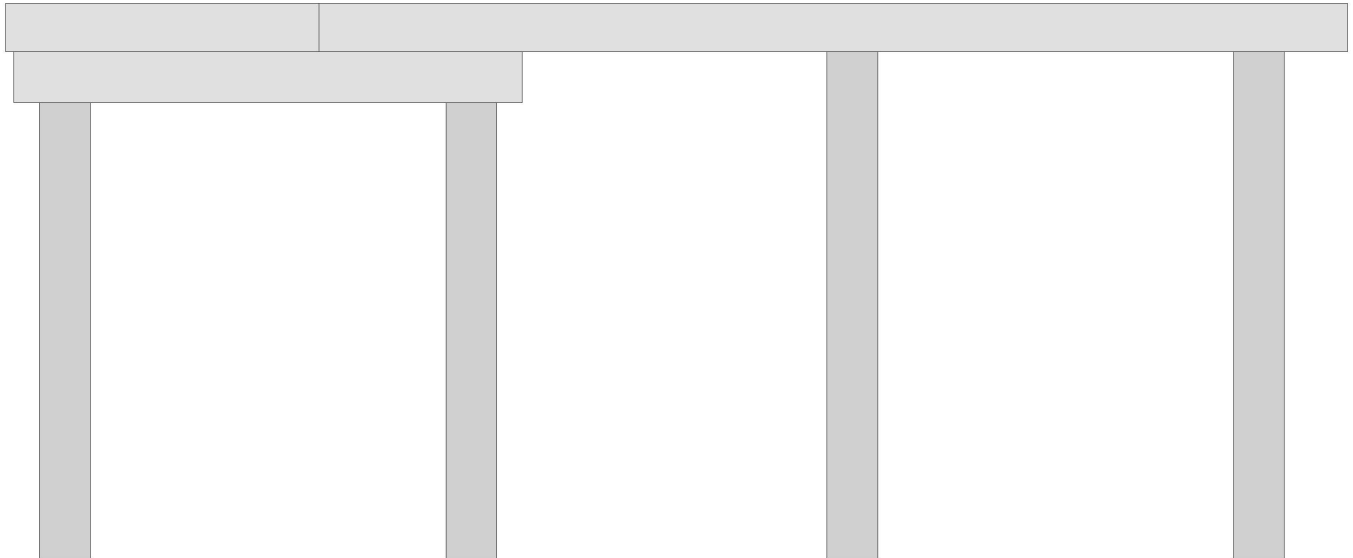
<b>Cap Information</b>			Material Timber							
Length	Width	Height	Left Overhang	Right Overhang	Left Beam to End of Cap.	Right Beam to End of Cap.				
26.416 ft.	.833 ft.	.958 ft.	1.167 ft.	1.750 ft.	1.000 ft.	1.916 ft.				
<b>Subcap Information</b>			Material Timber							
Length	Width	Height	Left Overhang	Right Overhang	Left Pile to Splice.					
10.000 ft.	.833 ft.	1.000 ft.	1.000 ft.	1.000 ft.	5 ft.					
<b>Sill Information</b>			Material							
Length	Width	Height								
Pile #	Material	Spacing	Width/Dia.	Height	Length	Orientation	Driven?	Replacement?	Removed?	Collar?
1	Timber	8 ft.	1 ft.			Vertical	Yes	No	No	No
2	Timber	7.5 ft.	1 ft.			Vertical	Yes	No	No	No
3	Timber	8 ft.	1 ft.			Vertical	Yes	No	No	No
4	Timber		1 ft.			Vertical	Yes	No	No	No
<b>End Bent/Abutment #: 1</b>
