NC DEPARTMENT OF TRANSPORTATION  
 DIVISION OF HIGHWAYS  
 STRUCTURE MANAGEMENT UNIT

ATTENTION: PAR Submitted, Changes to Structure Data, Temporary Shoring

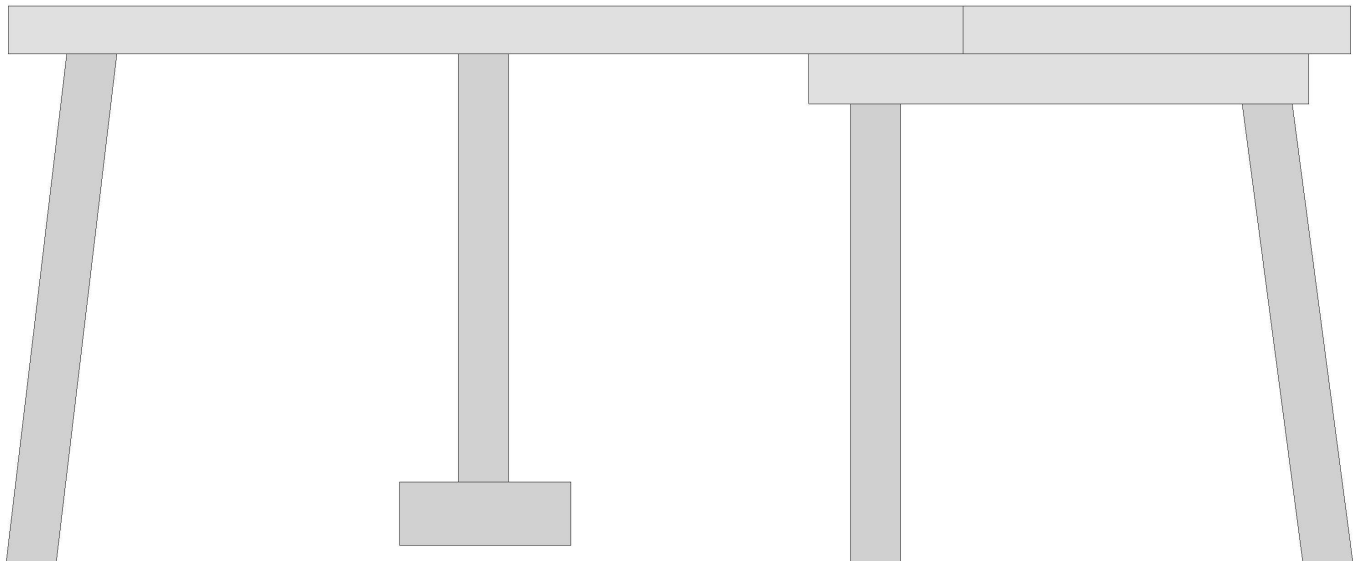
<b>Cap Information</b>			<b>Material Timber</b>							
Length	Width	Height	Left Overhang	Right Overhang	Left Beam to End of Cap.	Right Beam to End of Cap.				
26.833 ft.	.958 ft.	.958 ft.	1.667 ft.	1.667 ft.	1.333 ft.	1.500 ft.				
<b>Subcap Information</b>			<b>Material Timber</b>							
Length	Width	Height	Left Overhang	Right Overhang	Left Pile to Splice.					
10.000 ft.	1.000 ft.	1.000 ft.	1.083 ft.	1.083 ft.	1.75 ft.					
<b>Sill Information</b>			<b>Material</b>							
Length	Width	Height								
Pile #	Material	Spacing	Width/Dia.	Height	Length	Orientation	Driven?	Replacement?	Removed?	Collar?
1	Timber	7.833 ft.	1 ft.			Battered	Yes	No	No	No
2	Timber	7.833 ft.	1 ft.			Vertical	Yes	No	No	Yes
3	Timber	7.833 ft.	1 ft.			Vertical	Yes	No	No	No
4	Timber		1 ft.			Battered	Yes	No	No	No
<b>Bent #: 1</b>

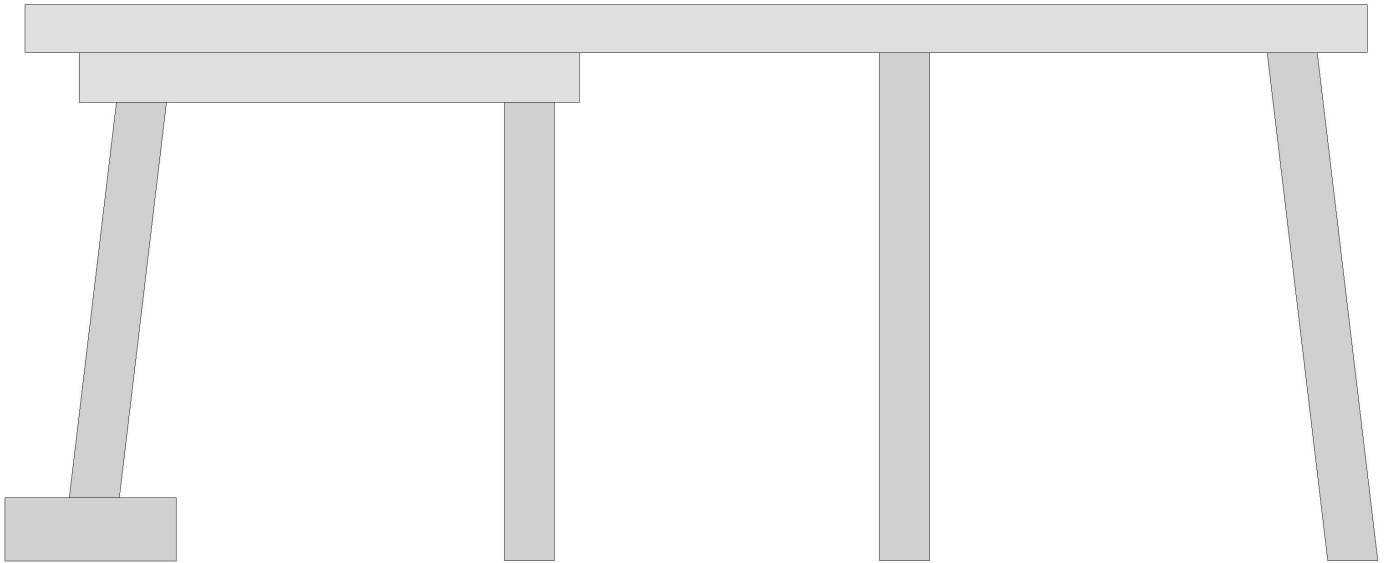
<b>Cap Information</b>			<b>Material</b> Timber							
Length	Width	Height	Left Overhang	Right Overhang	Left Beam to End of Cap.	Right Beam to End of Cap.				
26.833 ft.	.958 ft.	.958 ft.	2.083 ft.	1.500 ft.	1.667 ft.	1.750 ft.				
<b>Subcap Information</b>			<b>Material</b> Timber							
Length	Width	Height	Left Overhang	Right Overhang	Left Pile to Splice.					
10.000 ft.	1.000 ft.	1.000 ft.	1.000 ft.	1.000 ft.						
<b>Sill Information</b>			<b>Material</b>							
Length	Width	Height								
Pile #	Material	Spacing	Width/Dia.	Height	Length	Orientation	Driven?	Replacement?	Removed?	Collar?
1	Timber	8 ft.	1 ft.			Battered	Yes	No	No	*Yes
2	Timber	7.5 ft.	1 ft.			Vertical	Yes	No	No	No
3	Timber	7.75 ft.	1 ft.			Vertical	Yes	No	No	No
4	Timber		1 ft.			Battered	Yes	No	No	No
<b>Bent #: 2</b>

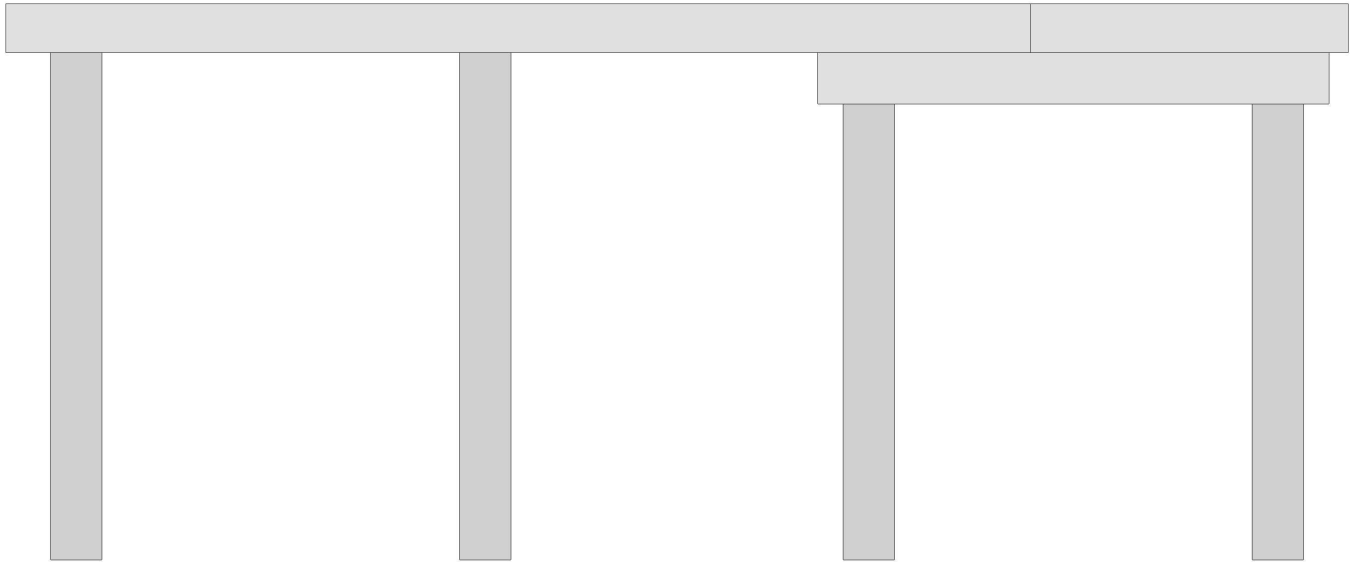
<b>Cap Information</b>			<b>Material</b> Timber							
Length	Width	Height	Left Overhang	Right Overhang	Left Beam to End of Cap.	Right Beam to End of Cap.				
26.250 ft.	.833 ft.	.958 ft.	1.375 ft.	1.375 ft.	1.5 ft.	1.333 ft.				
<b>Subcap Information</b>			<b>Material</b> Timber							
Length	Width	Height	Left Overhang	Right Overhang	Left Pile to Splice.					
10.000 ft.	.833 ft.	1.000 ft.	1.000 ft.	1.000 ft.	3.167 ft.					
<b>Sill Information</b>			<b>Material</b>							
Length	Width	Height								
Pile #	Material	Spacing	Width/Dia.	Height	Length	Orientation	Driven?	Replacement?	Removed?	Collar?
1	Timber	8 ft.	1 ft.			Vertical	Yes	No	No	No
2	Timber	7.5 ft.	1 ft.			Vertical	Yes	No	No	No
3	Timber	8 ft.	1 ft.			Vertical	Yes	No	No	No
4	Timber		1 ft.			Vertical	Yes	No	No	No
<b>End Bent#: 2</b>
