NC DEPARTMENT OF TRANSPORTATION
 DIVISION OF HIGHWAYS
 STRUCTURE MANAGEMENT UNIT

ATTENTION: PAR Submitted, Changes to Structure Data

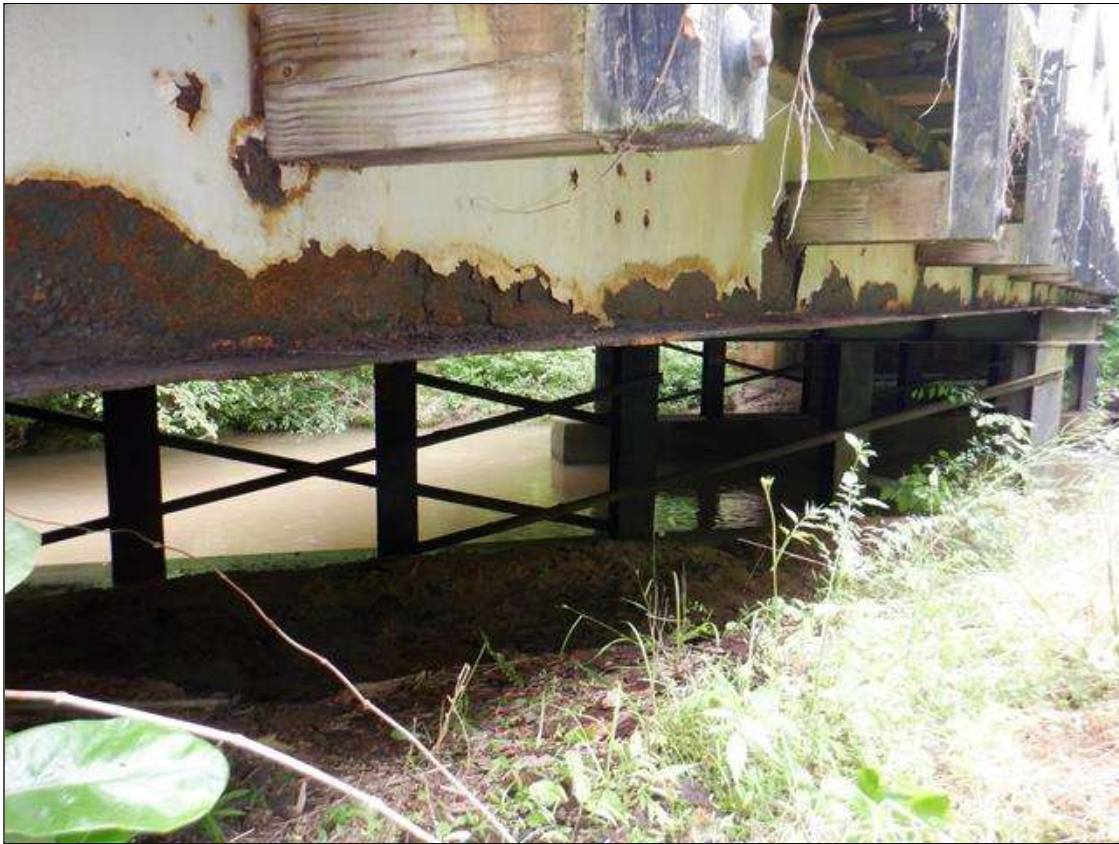
Span 1 Beam 10: [PAR] along length of beam, multiple areas of active corrosion with section loss; bottom flange [up to 68in x 6in - avg rem 1/4in], lower web & web at rail post connections [up to 10ft x 6in - avg rem 1/4in]

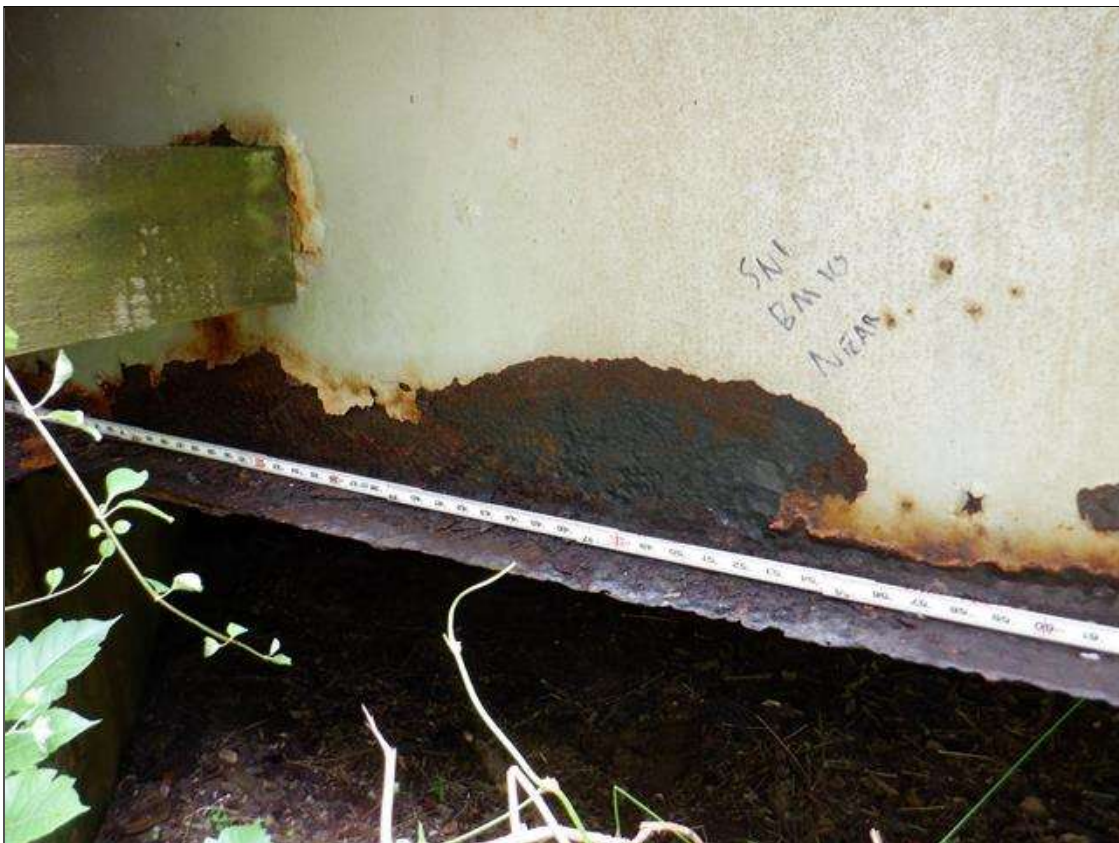
Span 1 Beam 10: [PAR] along length of beam, multiple areas of active corrosion with section loss; bottom flange [up to 68in x 6in - avg rem 1/4in], lower web & web at rail post connections [up to 10ft x 6in - avg rem 1/4in]

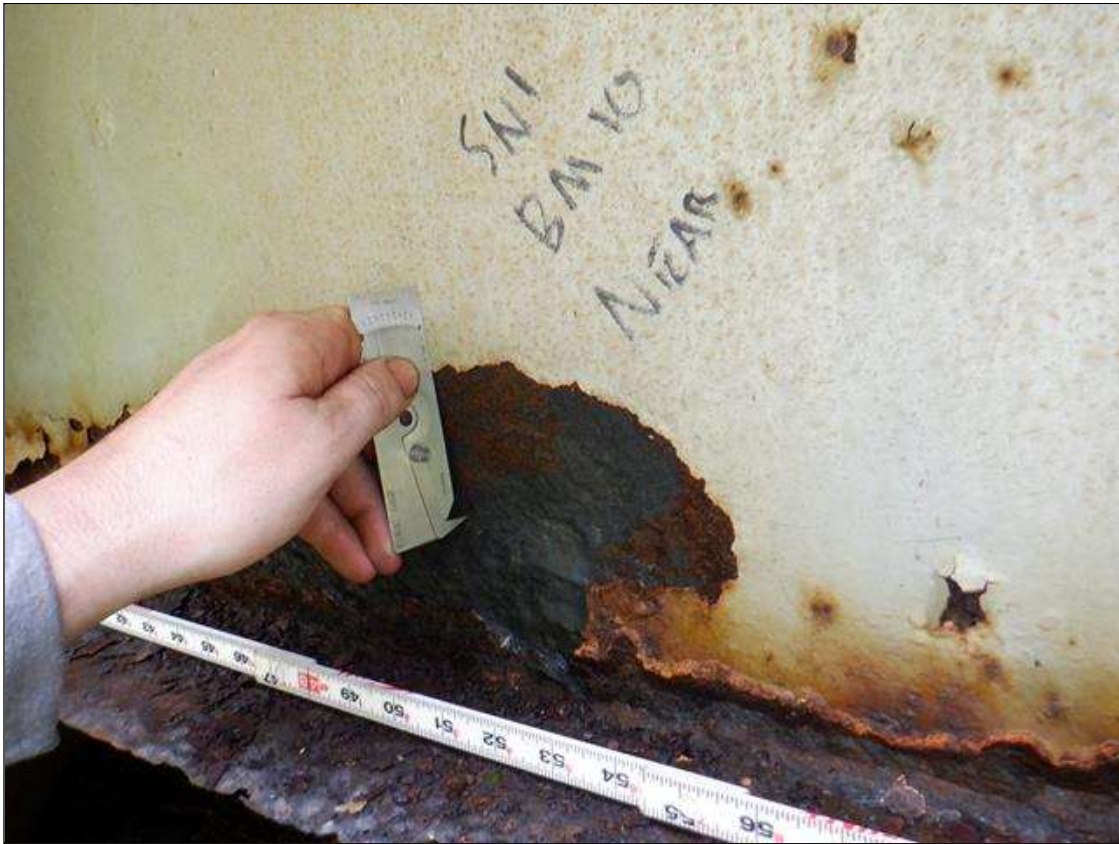
Span 1 Beam 10: [PAR] along length of beam, multiple areas of active corrosion with section loss; bottom flange [up to 68in x 6in - avg rem 1/4in], lower web & web at rail post connections [up to 10ft x 6in - avg rem 1/4in]

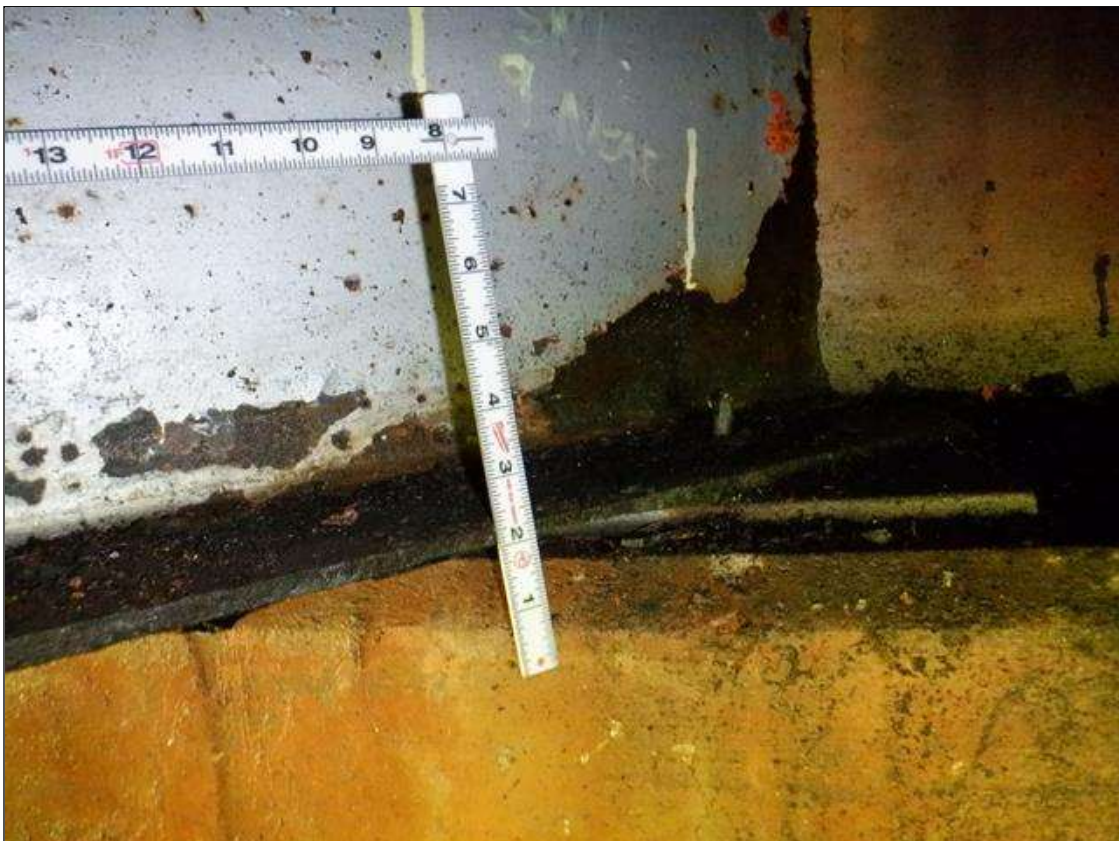
Span 1 Beam 9: [PAR] at near end, active corrosion with section loss; bottom flange [18in x full width - avg rem 0.35in], lower web [8in x up to 8in - avg rem 1/4in]

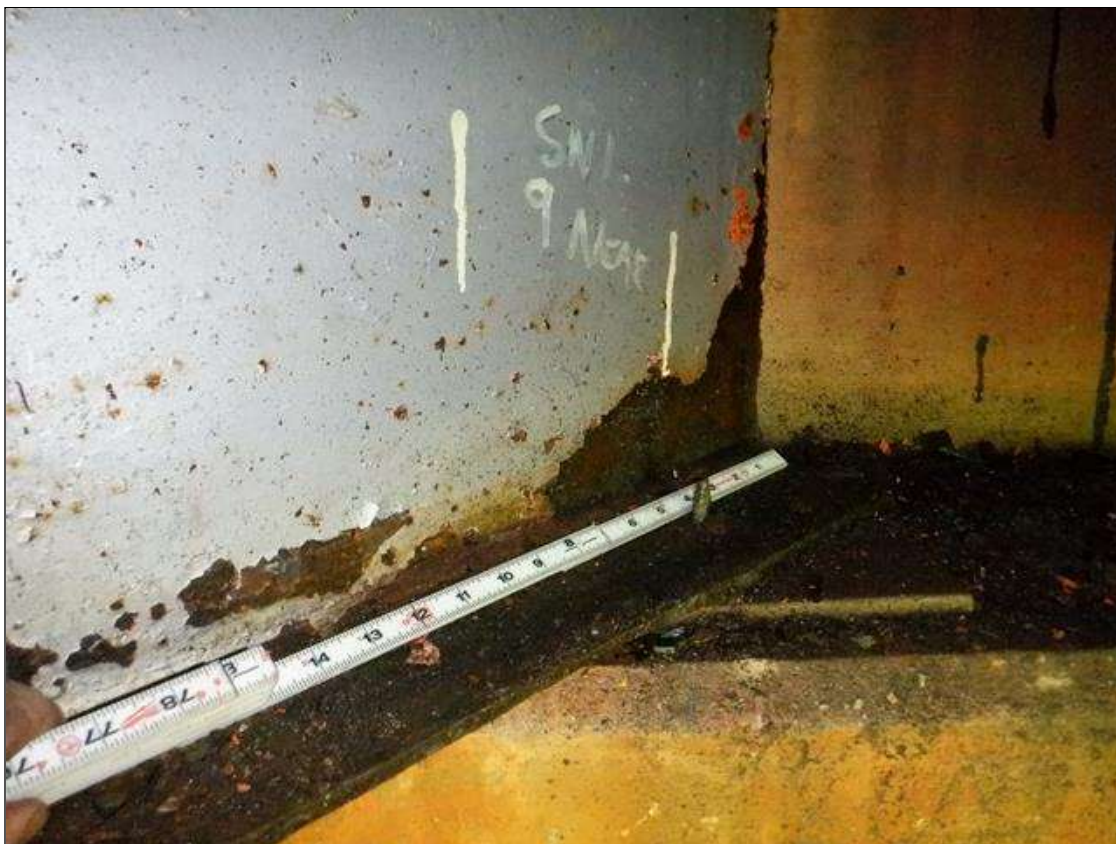
Span 1 Beam 9: [PAR] at near end, active corrosion with section loss; bottom flange [18in x full width - avg rem 0.35in], lower web [8in x up to 8in - avg rem 1/4in]

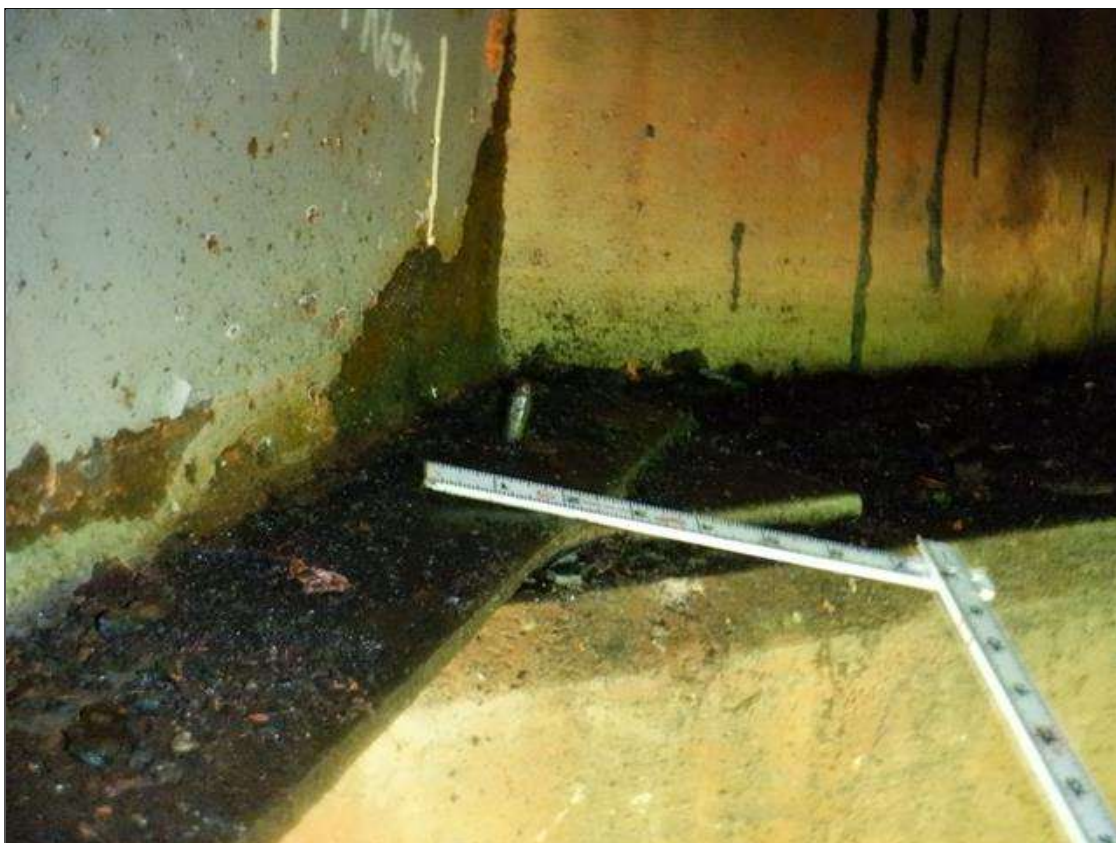
Span 1 Beam 9 Near Bearing: [PAR] North anchor bolt nut missing, [1/8in loss] on bolt and not fully embedded

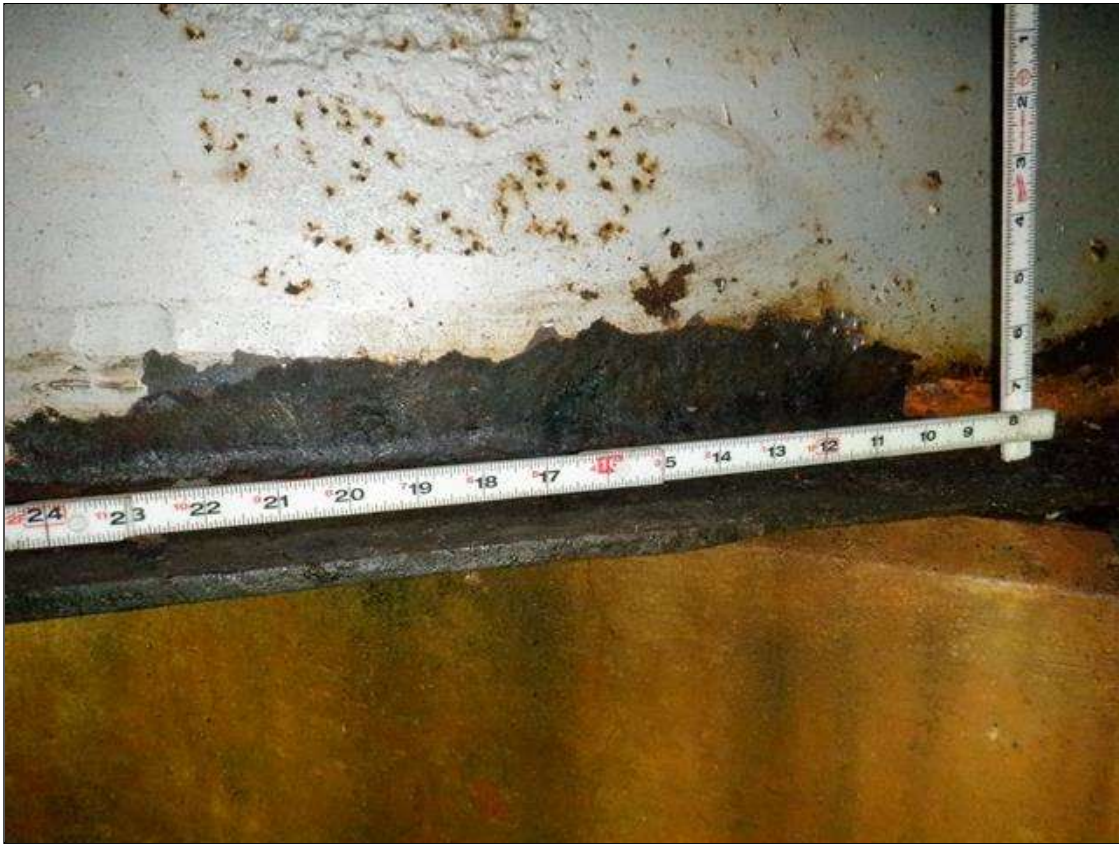
Span 1 Beam 8: [PAR] at near end, active corrosion with section loss; bottom flange [22in x full width - avg rem 1/4in], lower web [28in x up to 2-1/2in - avg rem 1/4in]

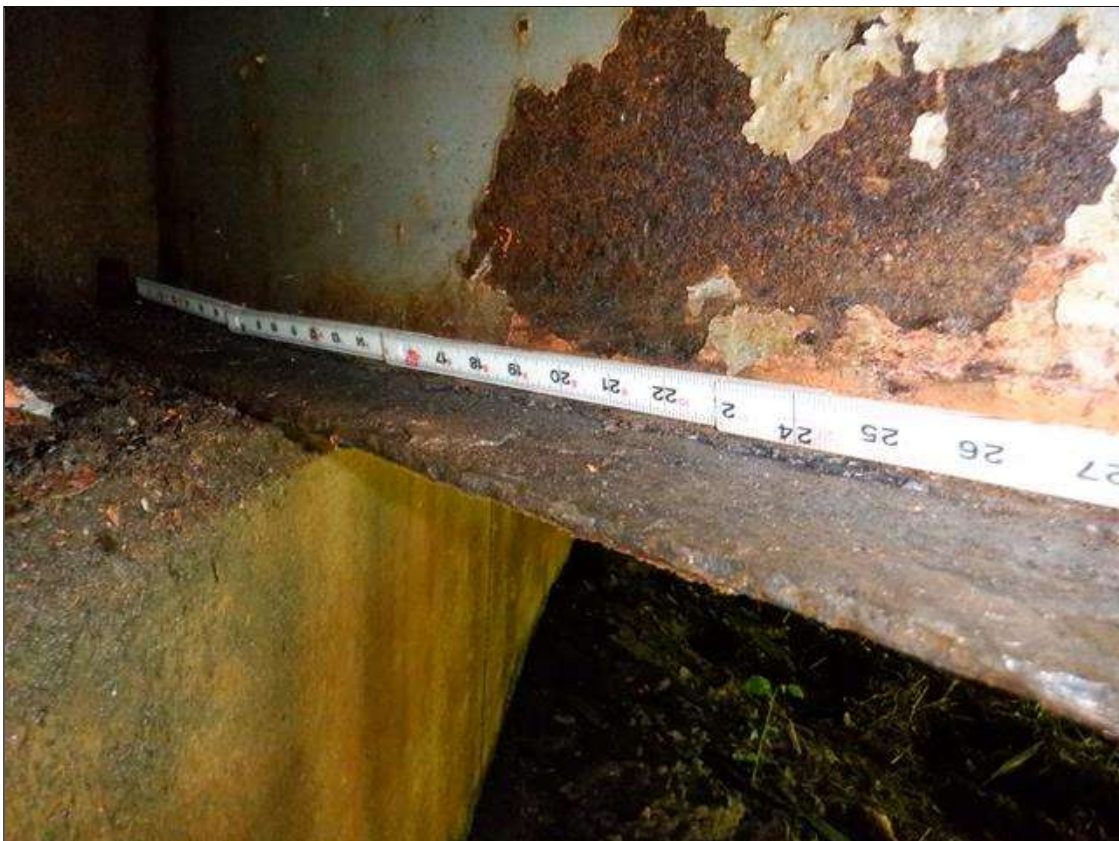
Span 1 Beam 8: [PAR] at near end, active corrosion with section loss; bottom flange [22in x full width - avg rem 1/4in], lower web [28in x up to 2-1/2in - avg rem 1/4in]

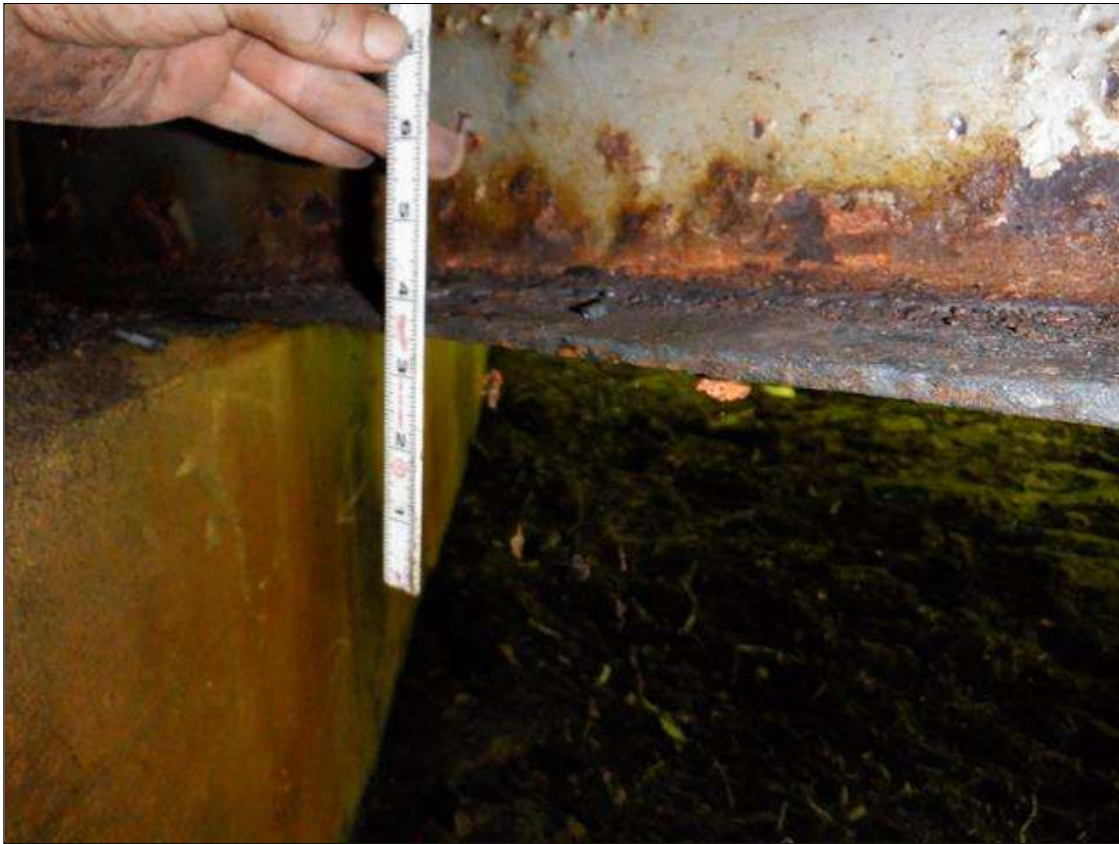
Span 1 Beam 7: [PAR] bottom flange at near end, active corrosion with section loss [up to 30in x up to full width - avg rem 3/8in, with areas down to 1/4in at edges]

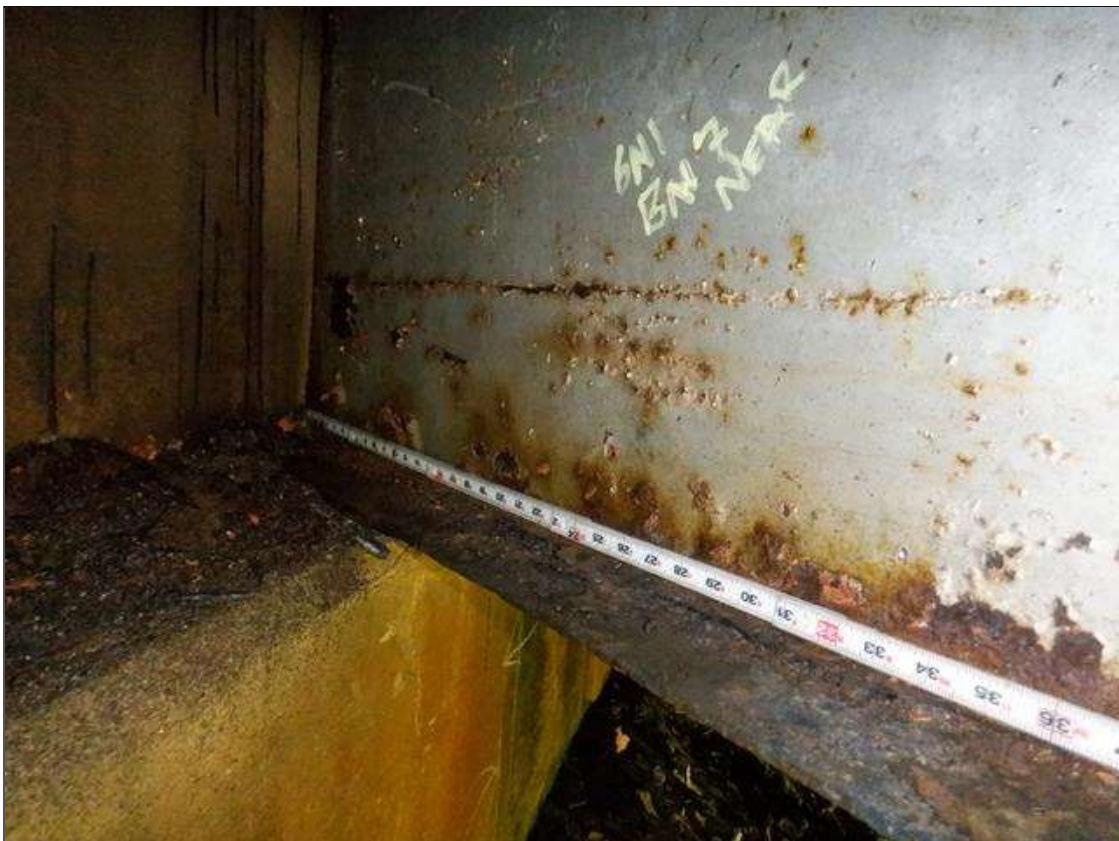
Span 1 Beam 7: [PAR] bottom flange at near end, active corrosion with section loss [up to 30in x up to full width - avg rem 3/8in, with areas down to 1/4in at edges]

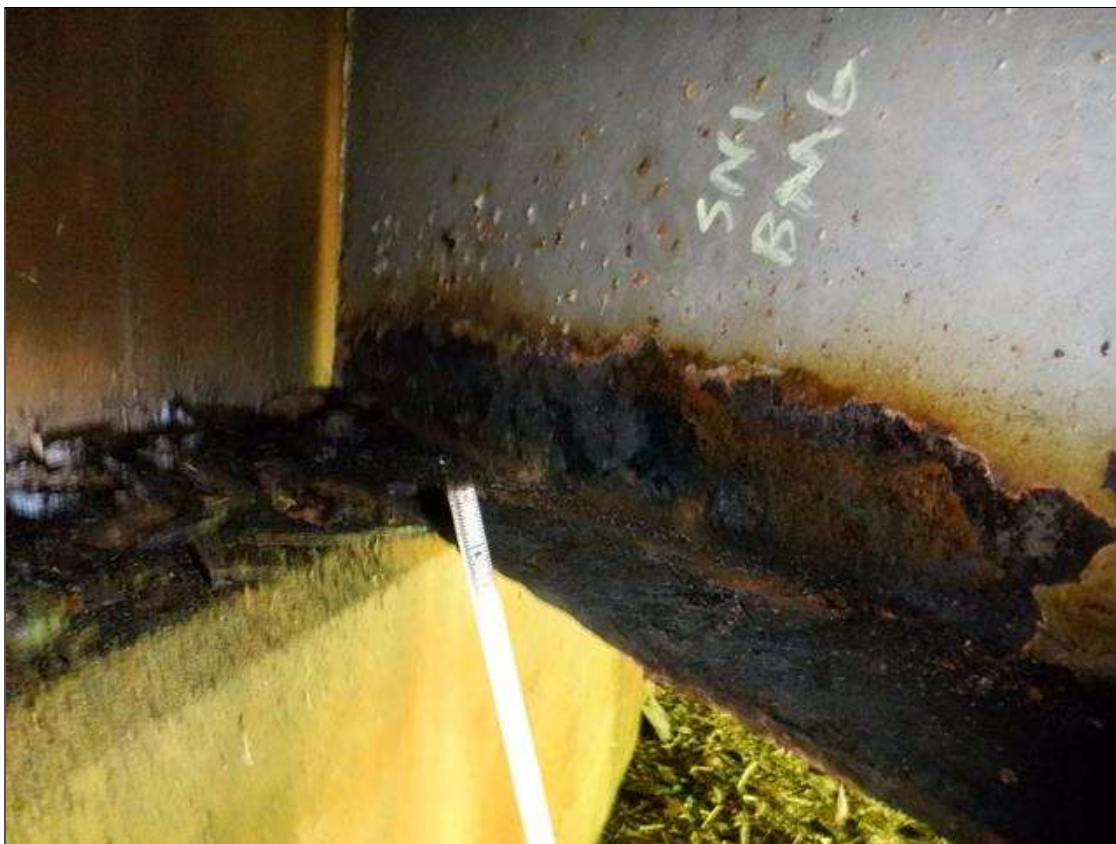
Span 1 Beam 6: [PAR] at near end, active corrosion with section loss, South bottom flange [up to 36in x up to 4in - avg rem 3/8in], lower web [30in x up to 3in - avg rem 1/4in]

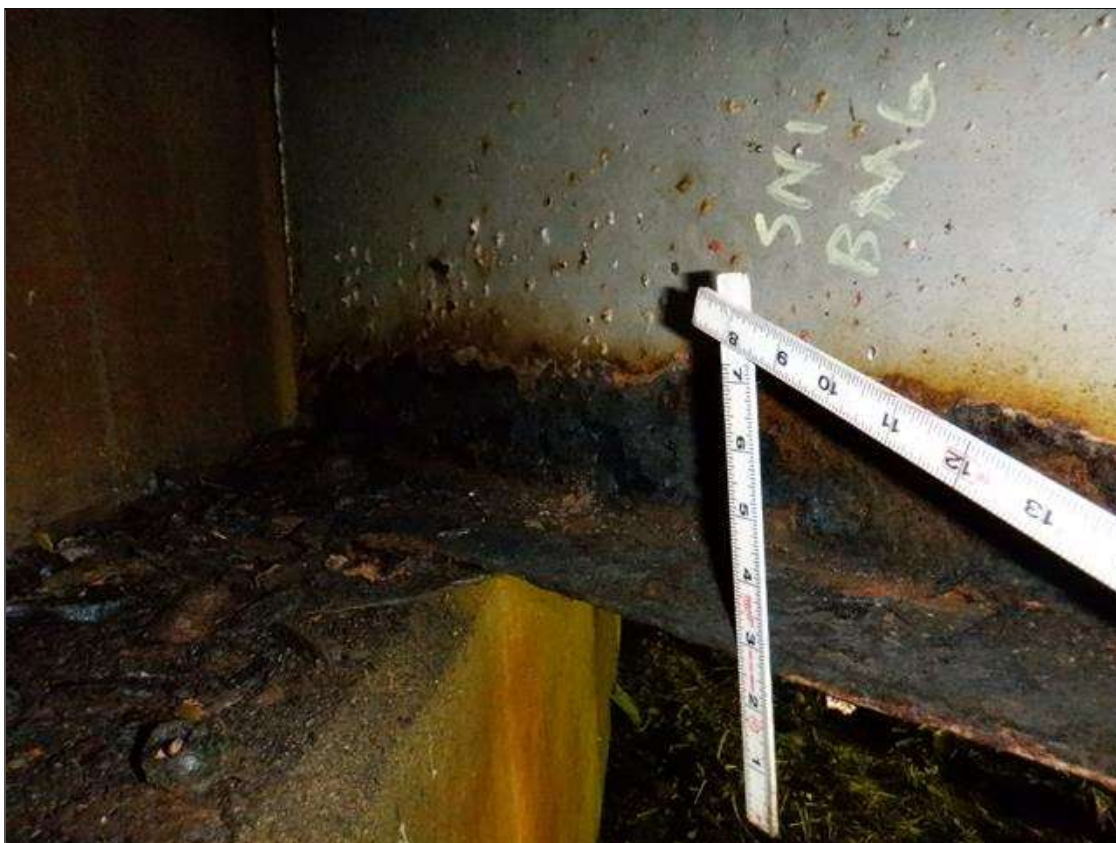
Span 1 Beam 6: [PAR] at near end, active corrosion with section loss, South bottom flange [up to 36in x up to 4in - avg rem 3/8in], lower web [30in x up to 3in - avg rem 1/4in]

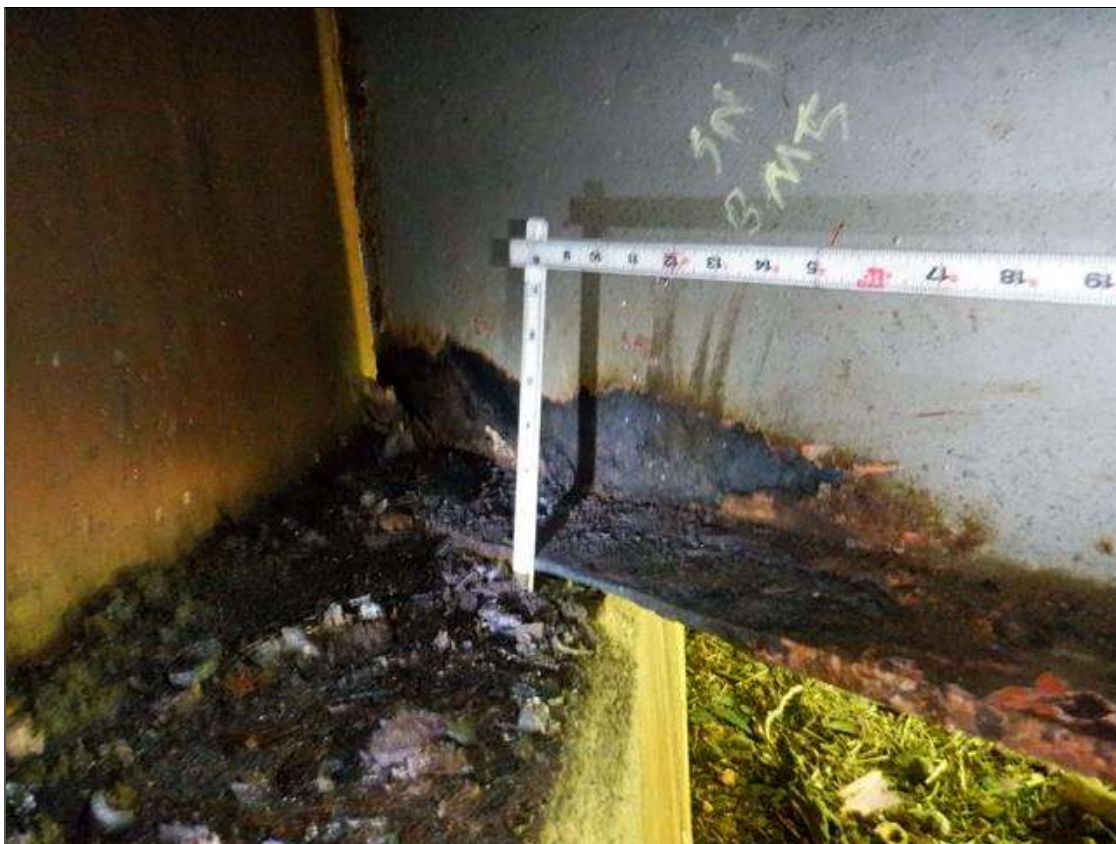
Span 1 Beam 5: [PAR] at near end, active corrosion with section loss; bottom flange [20in x full width - avg rem 3/8in], lower web [18in x 4in - avg rem 1/4in]

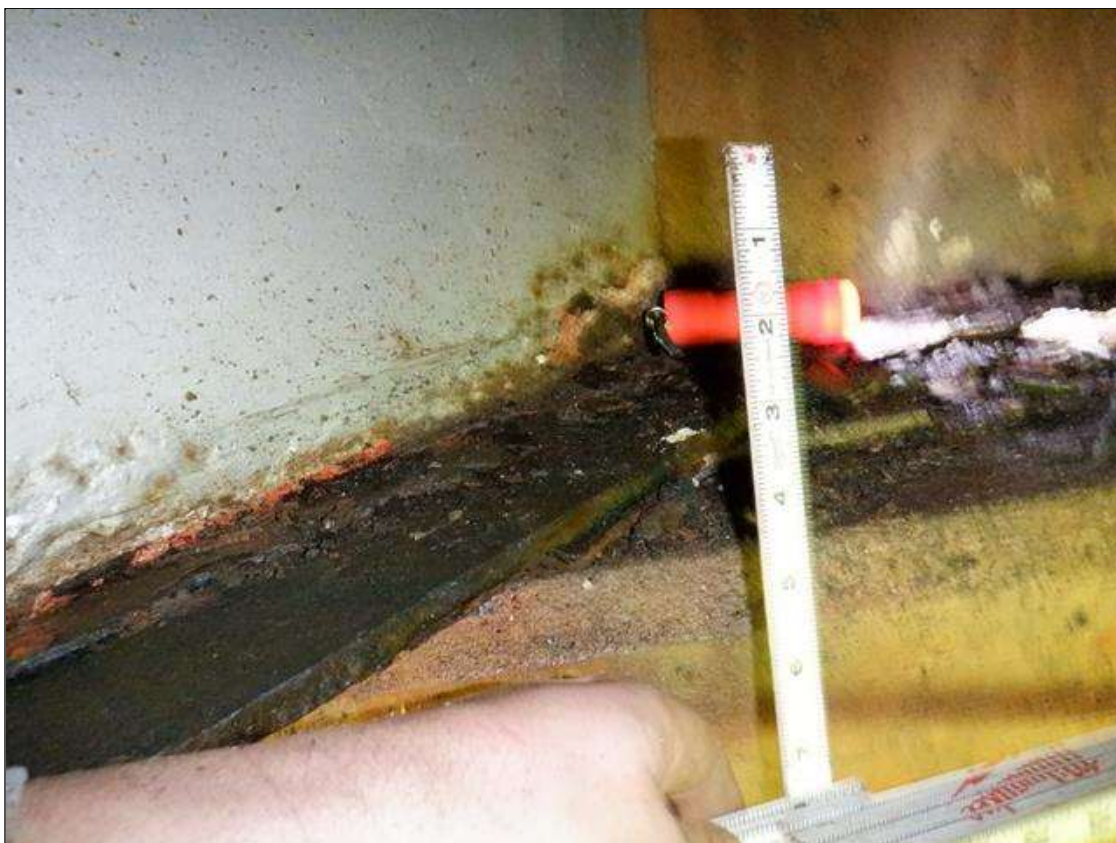
Span 1 Beam 6 Near Bearing: [PAR] North anchor bolt missing

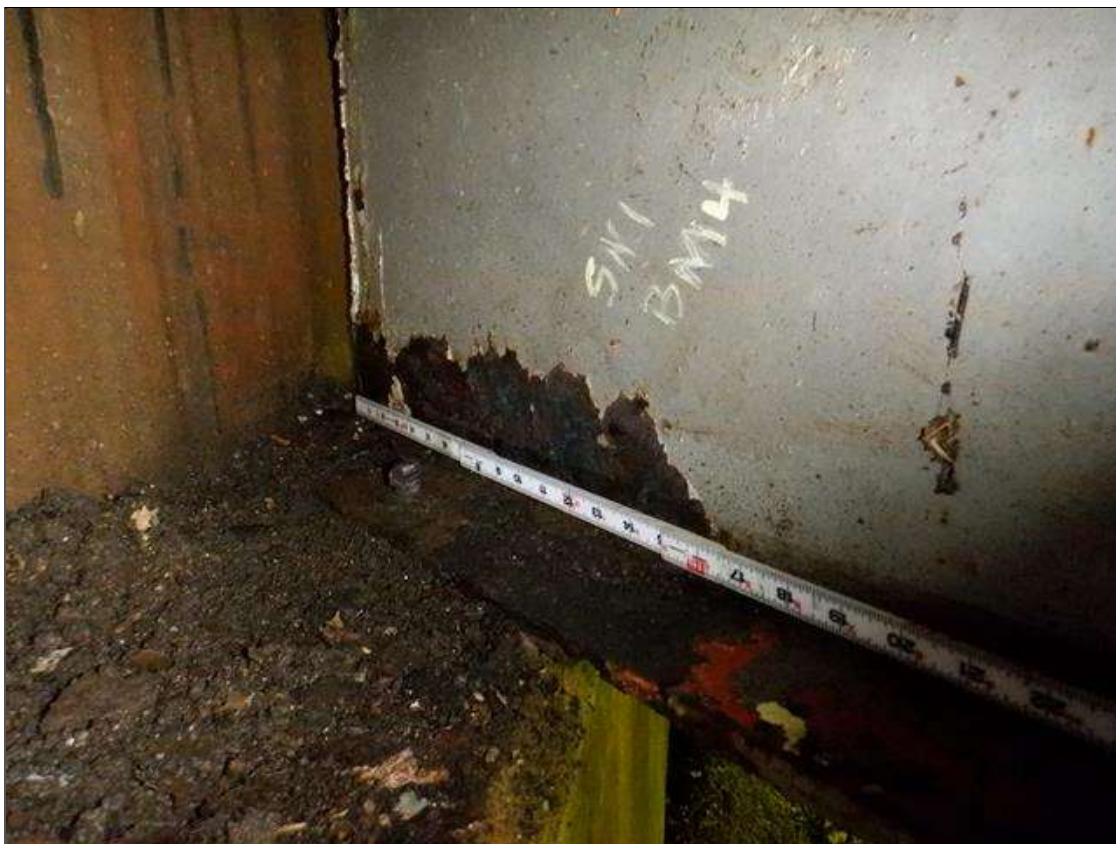
Span 1 Beam 4: [PAR] at near end, active corrosion with section loss; bottom flange [16in x full width - avg rem 1/2in], lower web [14in x 2in - avg rem 1/4in]

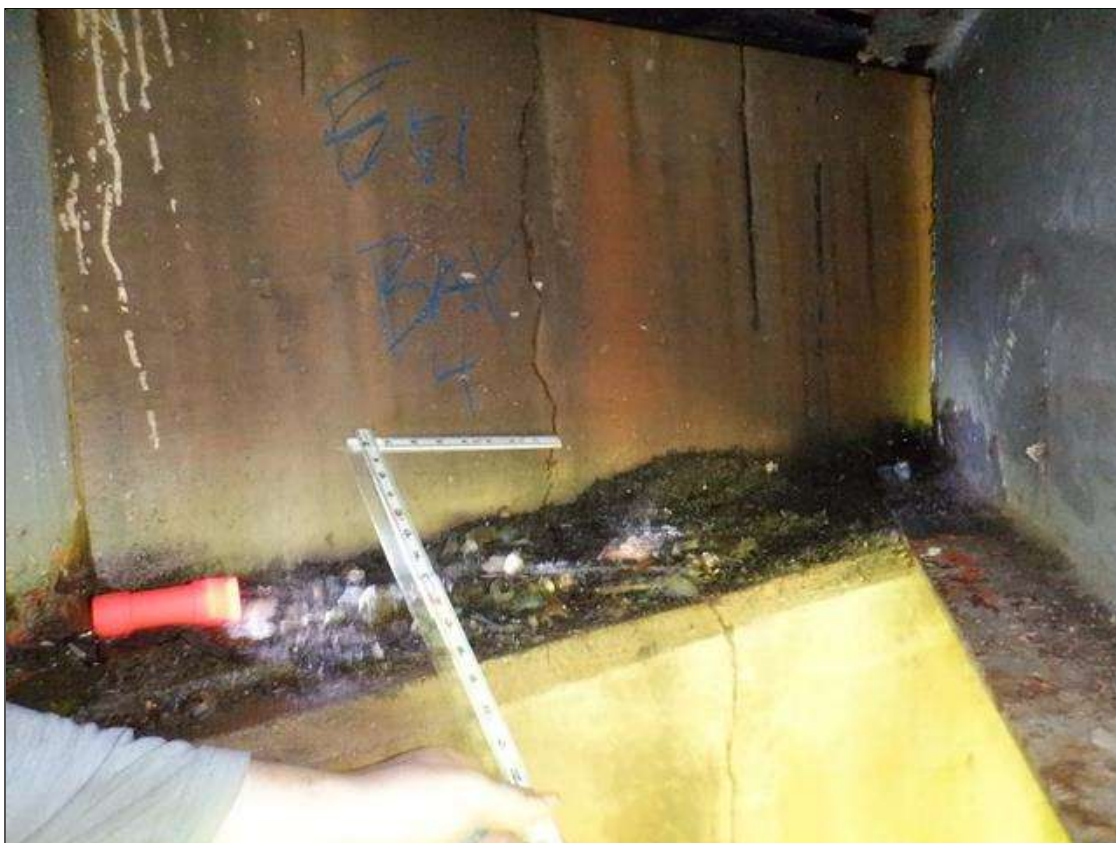
End Bent 1 Abutment/Backwall : at bay 4, vertical crack [full height x 3/16in]

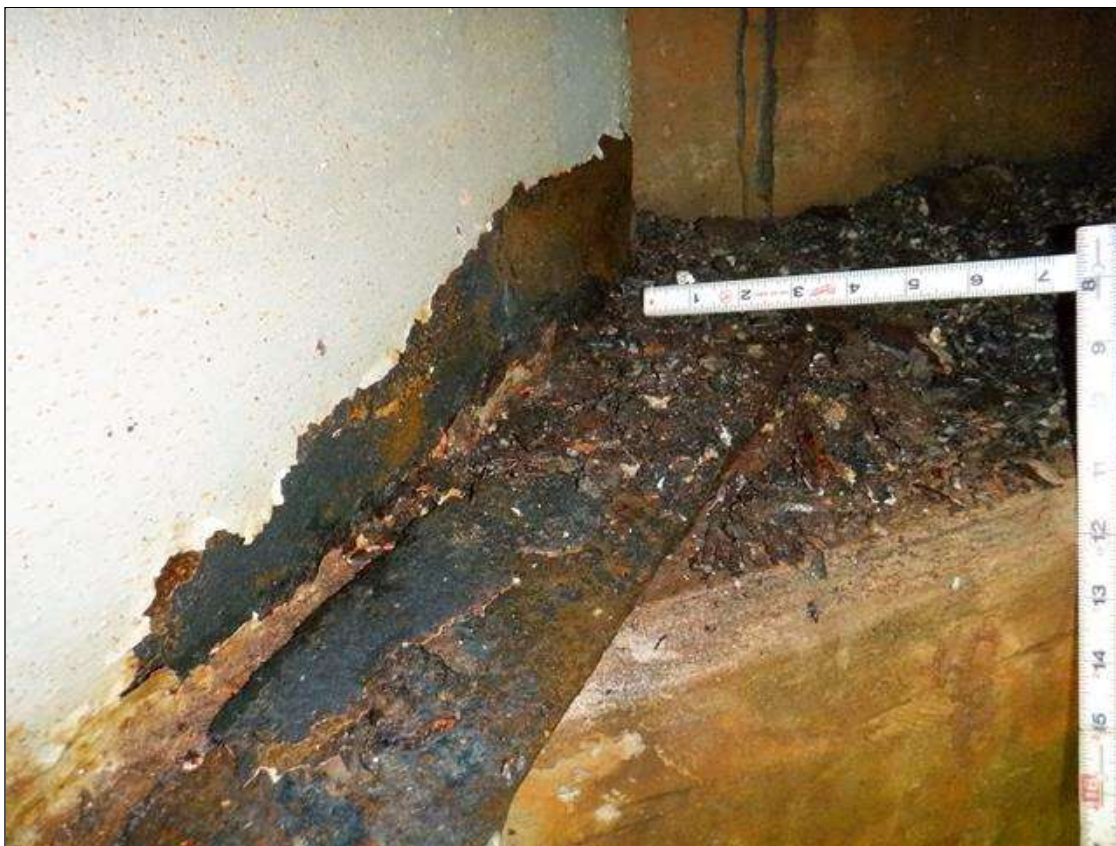
Span 1 Beam 4 Near Bearing: [PAR] North anchor bolt missing

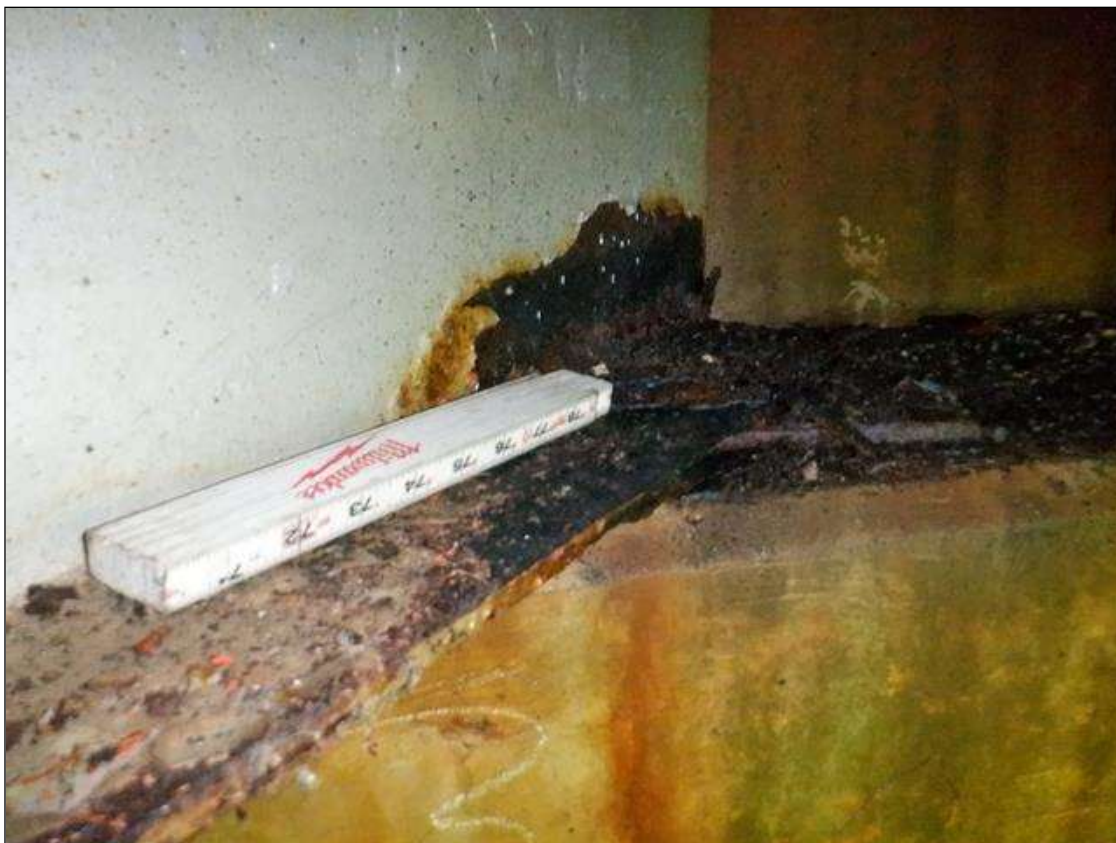
Span 1 Beam 3 Near Bearing: [PAR] North anchor bolt missing

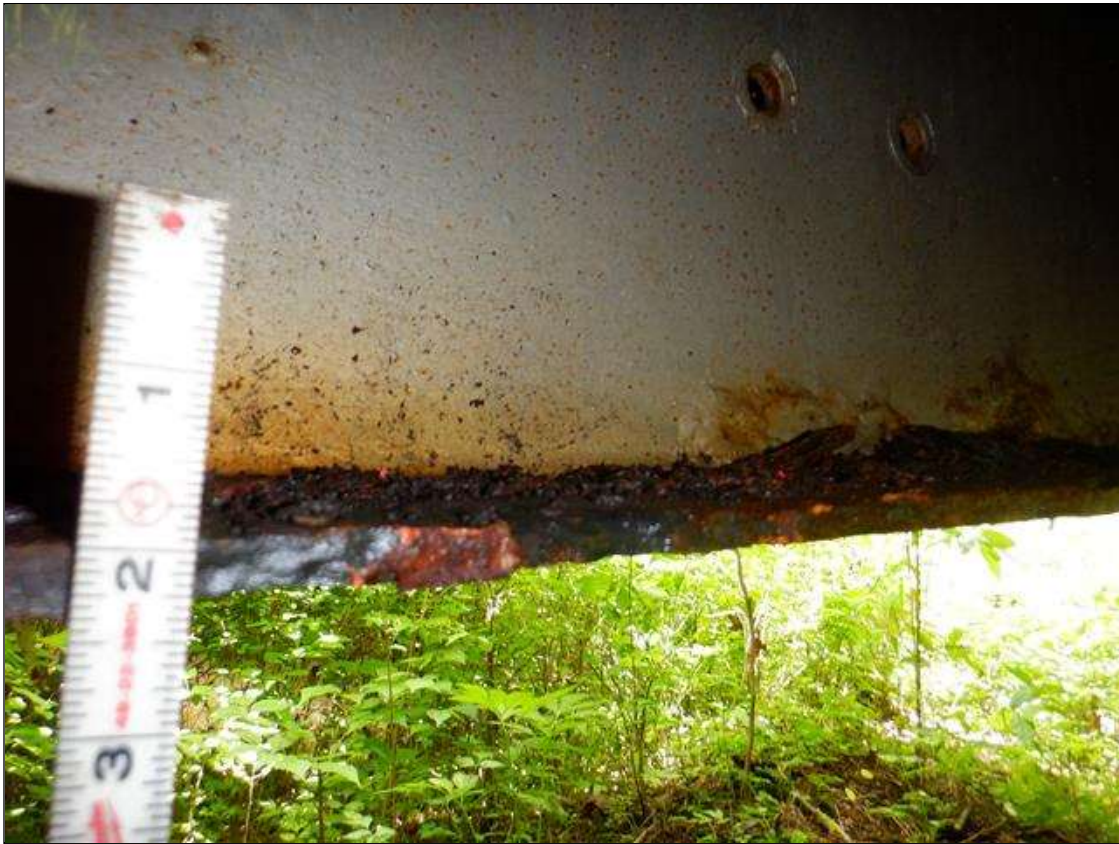
Span 1 Beam 2: [PAR] along length, active corrosion with section loss; top and bottom flange [full length x up to full width - avg rem 0.35in], lower web [up to 3ft x up to 6in - avg rem 5/16in]

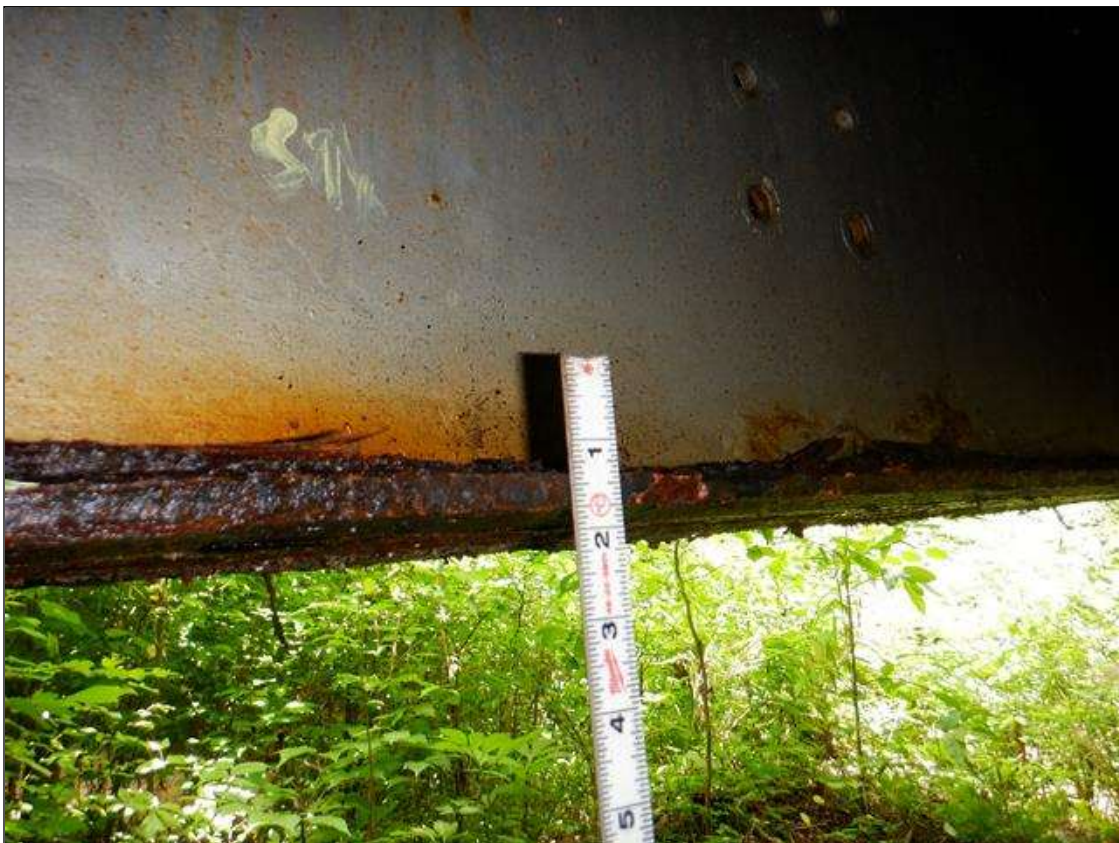
Span 1 Beam 2: [PAR] along length, active corrosion with section loss; top and bottom flange [full length x up to full width - avg rem 0.35in], lower web [up to 3ft x up to 6in - avg rem 5/16in]

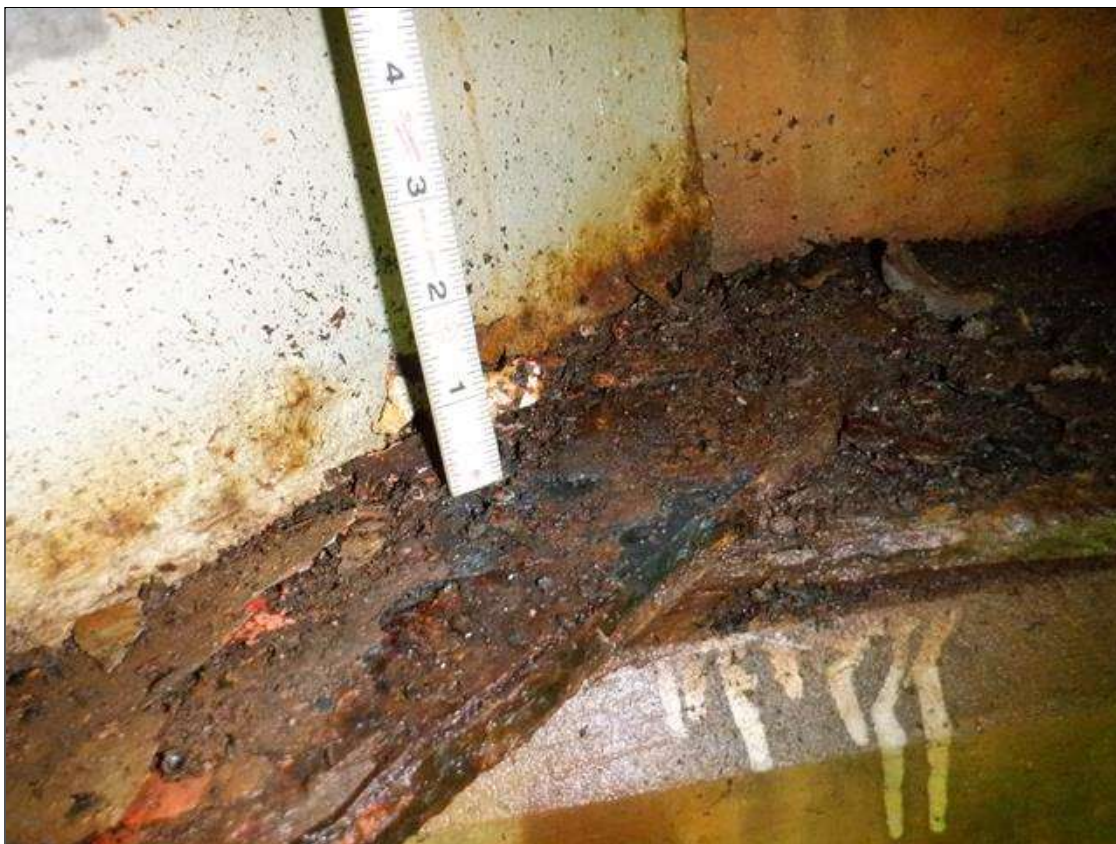
Span 1 Beam 2 Near Bearing: [PAR] North anchor bolt missing

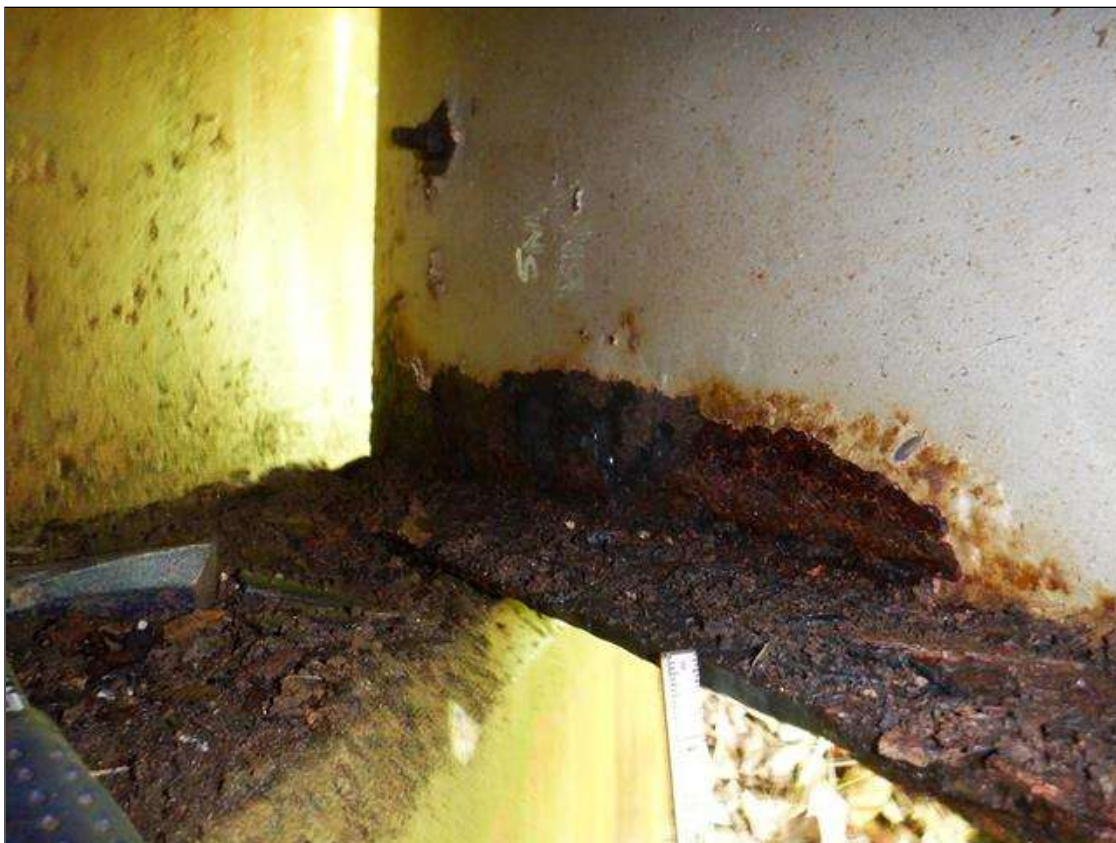
Span 1 Beam 1: [PAR] along length, active corrosion with section loss; top and bottom flange [full length x up to full width - avg rem 1/4in], lower web [full length x up to 3in - avg rem 5/16in]

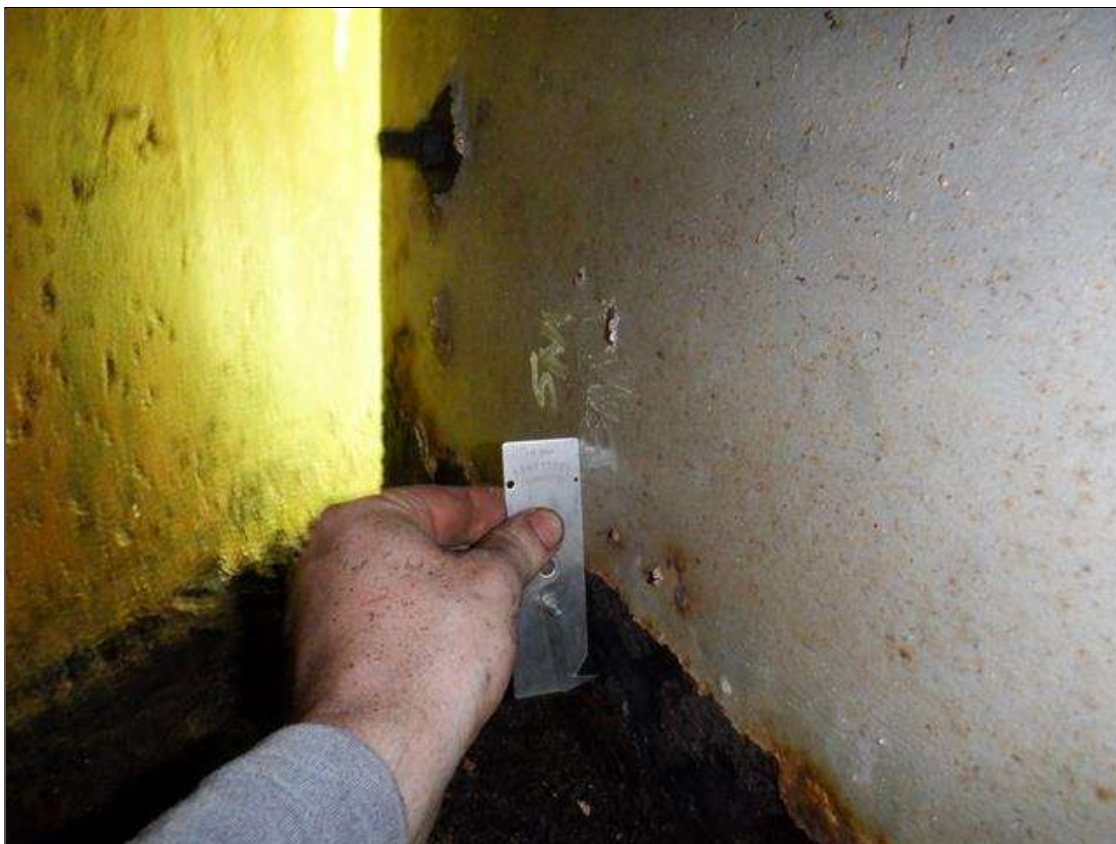
Span 1 Beam 1: [PAR] along length, active corrosion with section loss; top and bottom flange [full length x up to full width - avg rem 1/4in], lower web [full length x up to 3in - avg rem 5/16in]
