NC DEPARTMENT OF TRANSPORTATION
 DIVISION OF HIGHWAYS
 STRUCTURE MANAGEMENT UNIT

ATTENTION: PAR Submitted, Changes to Structure Data

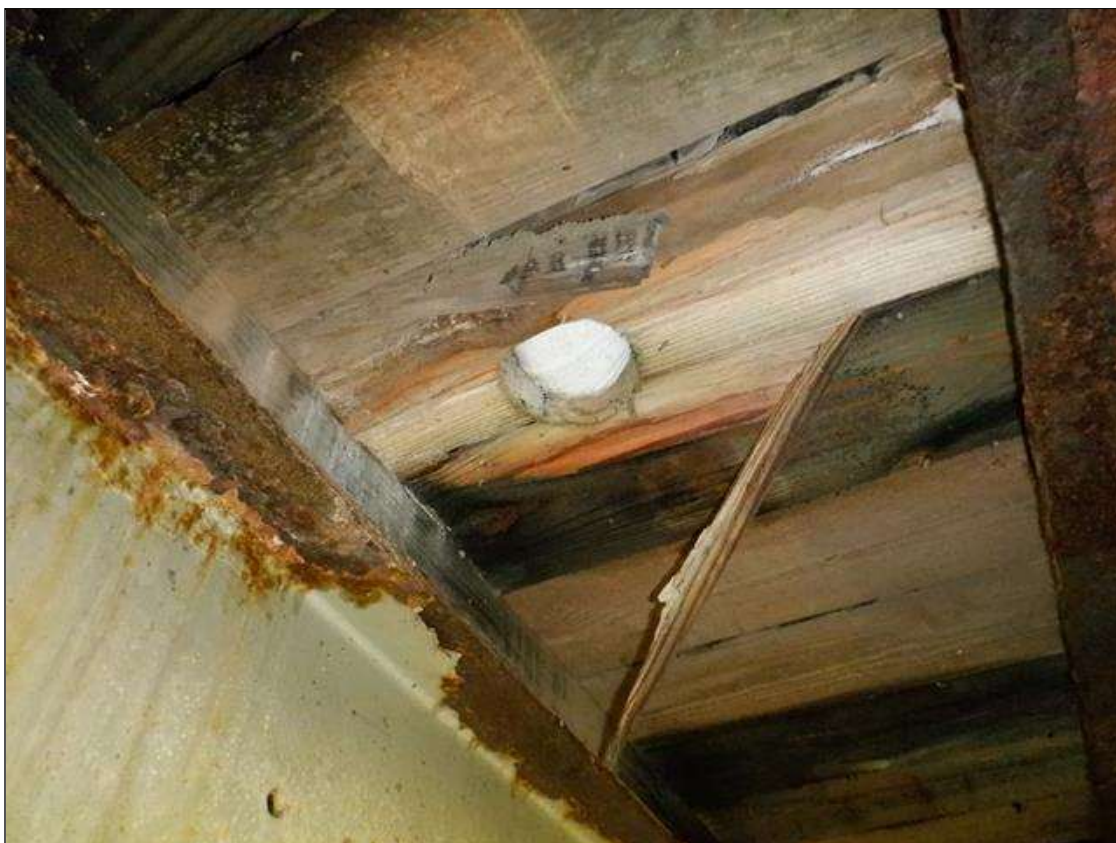
throughout underside of deck, multiple core holes [6in diameter]

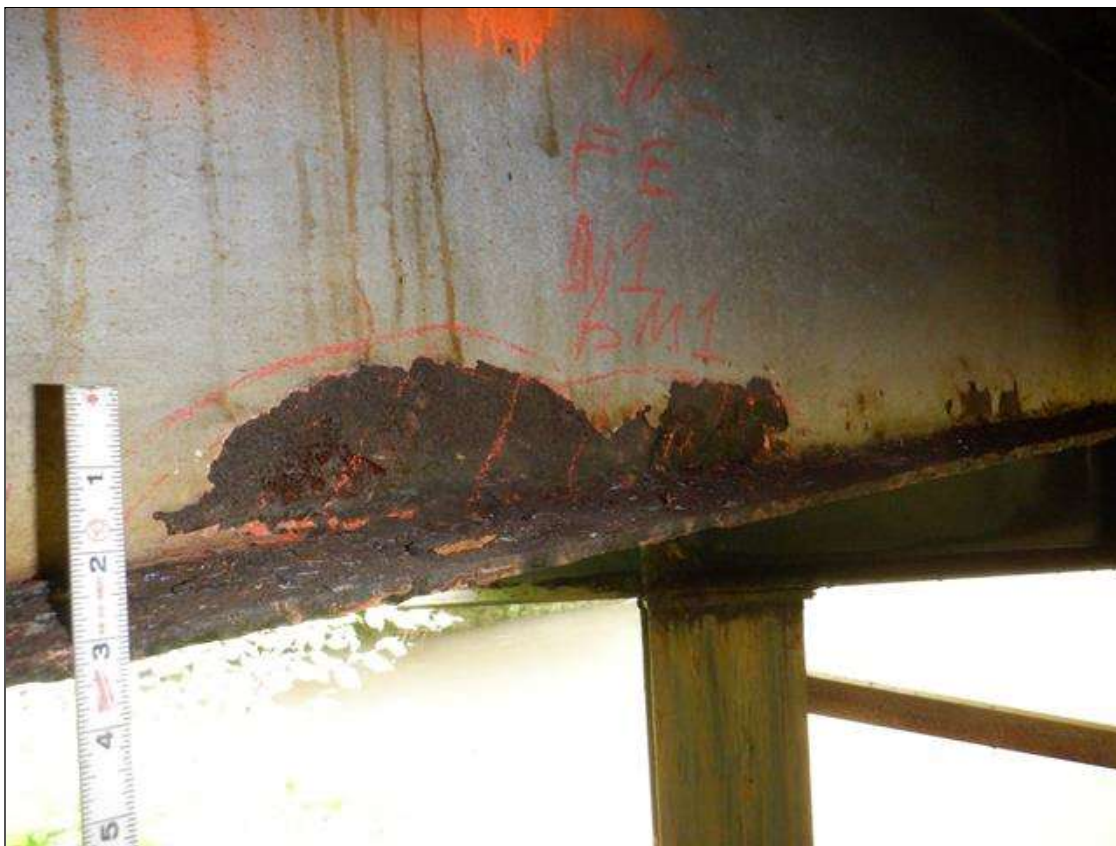
Span 1 Beam 1: [PAR] along length, active corrosion with section loss; top and bottom flange [full length x up to full width - avg rem 1/4in], lower web [full length x up to 3in - avg rem 5/16in]

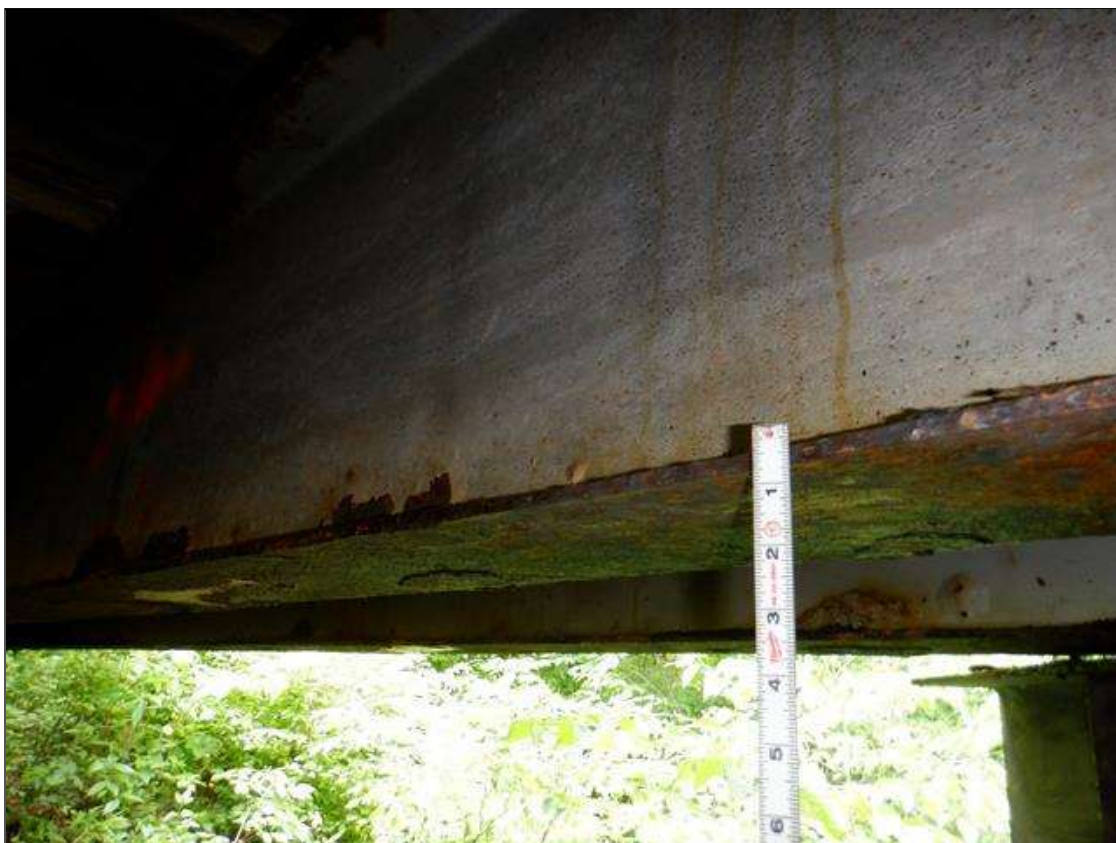
Span 1 Beam 2: [PAR] along length, active corrosion with section loss; top and bottom flange [full length x up to full width - avg rem 0.35in], lower web [up to 3ft x up to 6in - avg rem 5/16in]

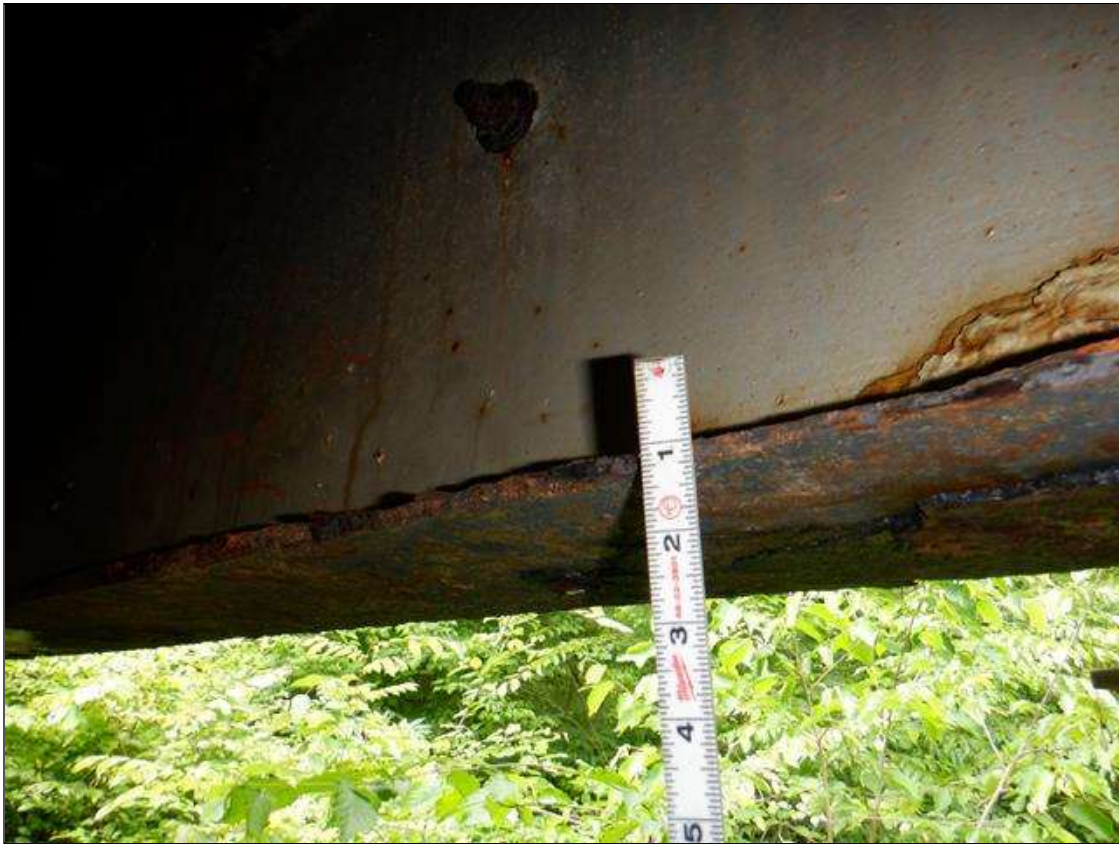
Span 1 Beam 1: [PAR] along length, active corrosion with section loss; top and bottom flange [full length x up to full width - avg rem 1/4in], lower web [full length x up to 3in - avg rem 5/16in]

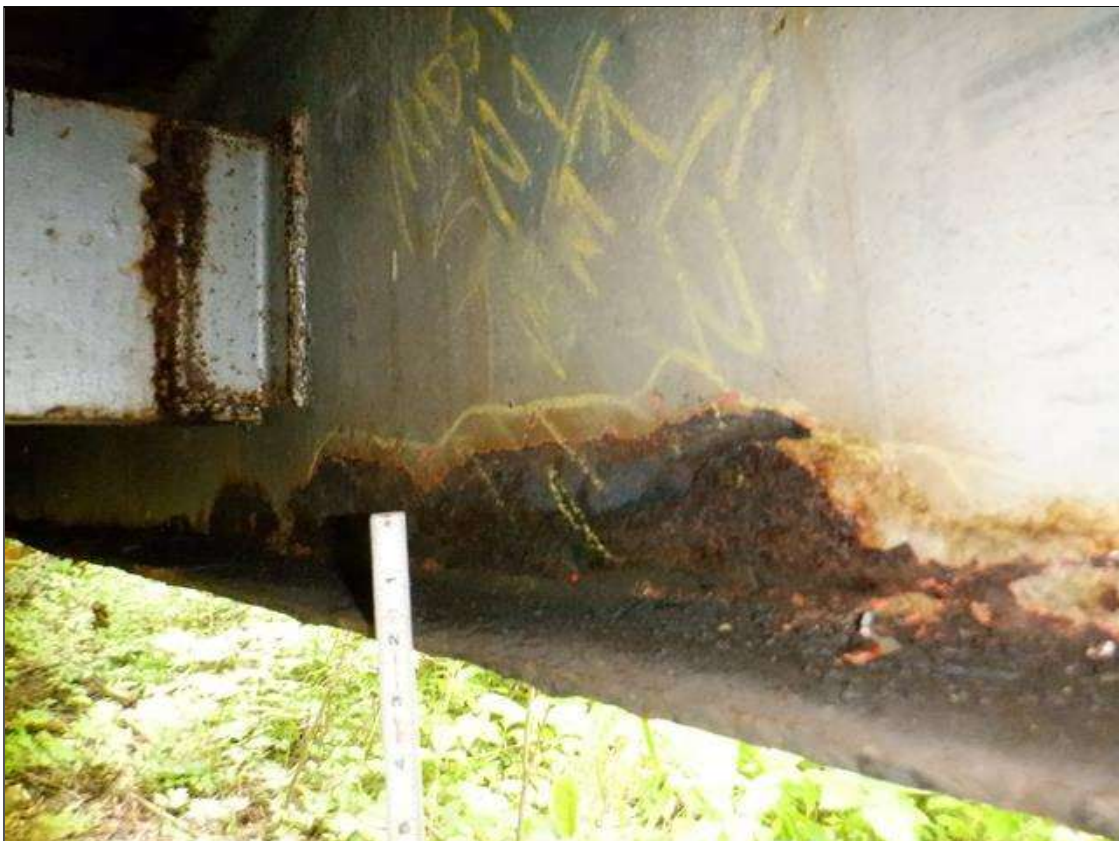
Span 1 Beam 1: [PAR] along length, active corrosion with section loss; top and bottom flange [full length x up to full width - avg rem 1/4in], lower web [full length x up to 3in - avg rem 5/16in]

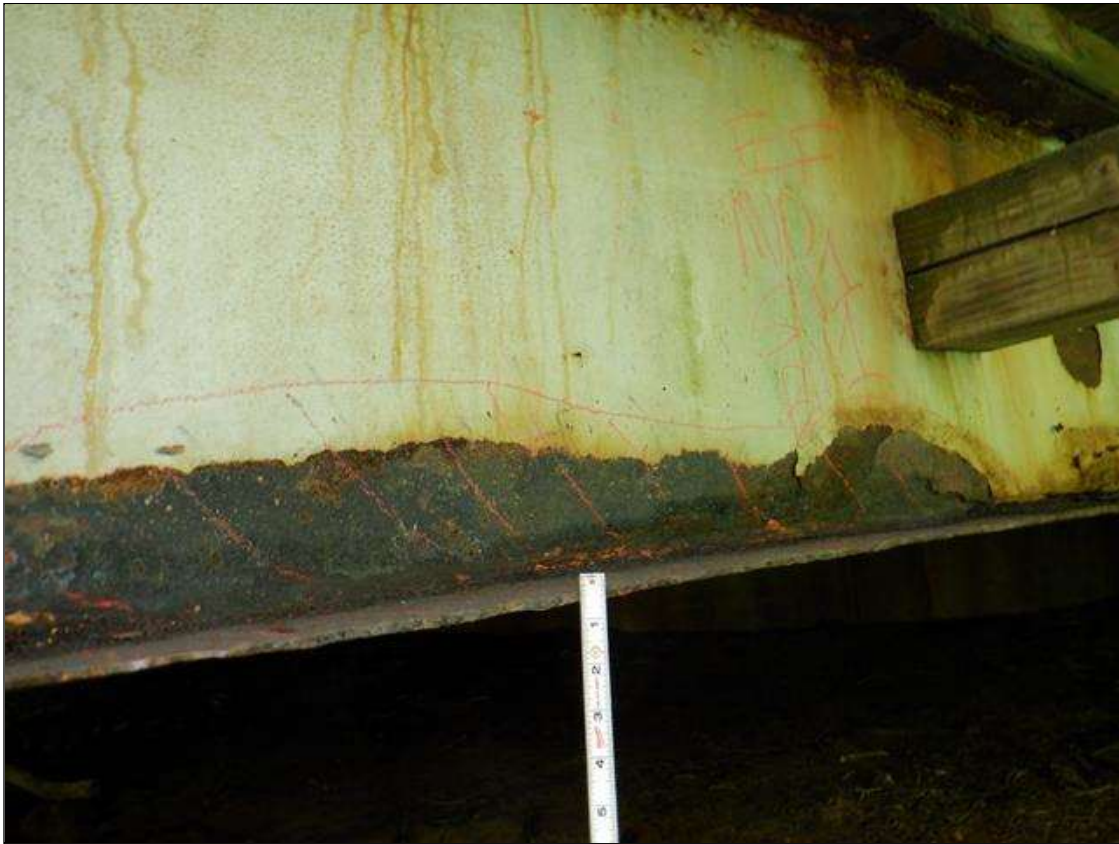
Span 1 Beam 1: [PAR] along length, active corrosion with section loss; top and bottom flange [full length x up to full width - avg rem 1/4in], lower web [full length x up to 3in - avg rem 5/16in]

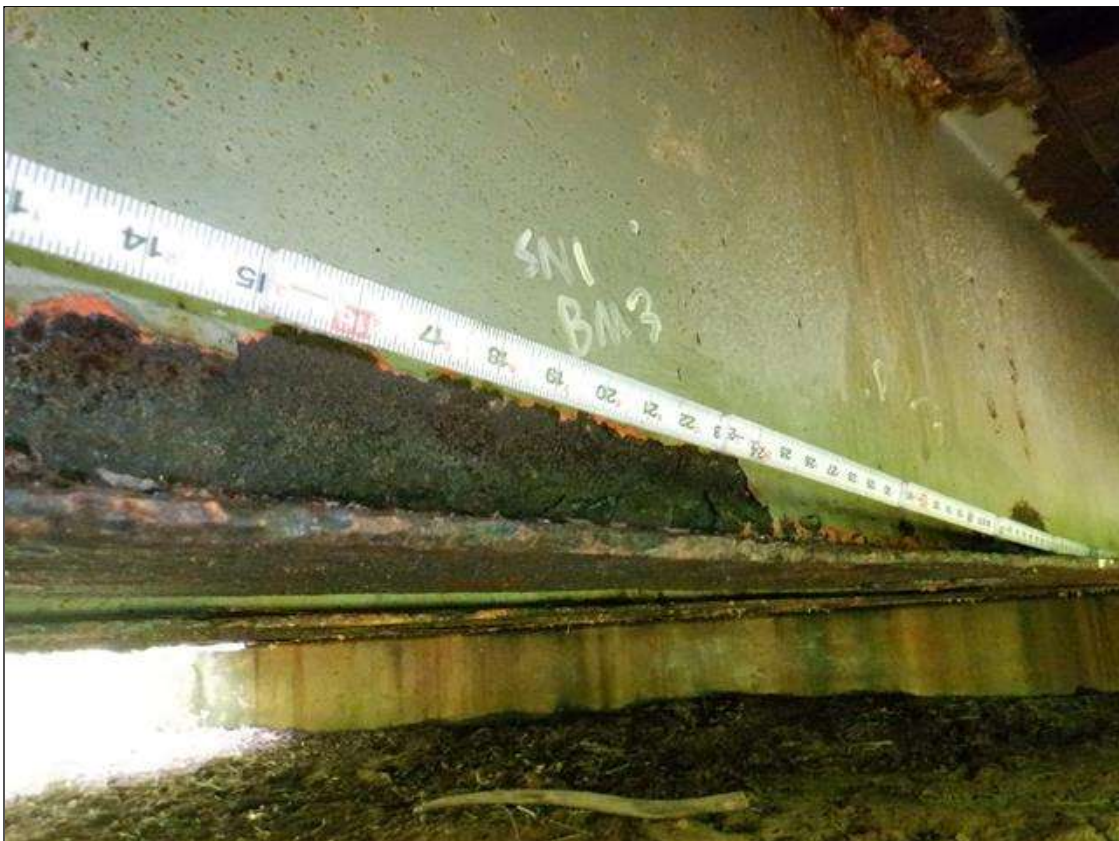
Span 1 Beam 3: [PAR] near midspan and at far third ,two [2] areas of active corrosion with section loss; bottom flange [up to 48in x full width - avg rem 3/8in], lower web [32in x 2-1/2in - avg rem 9/32in]

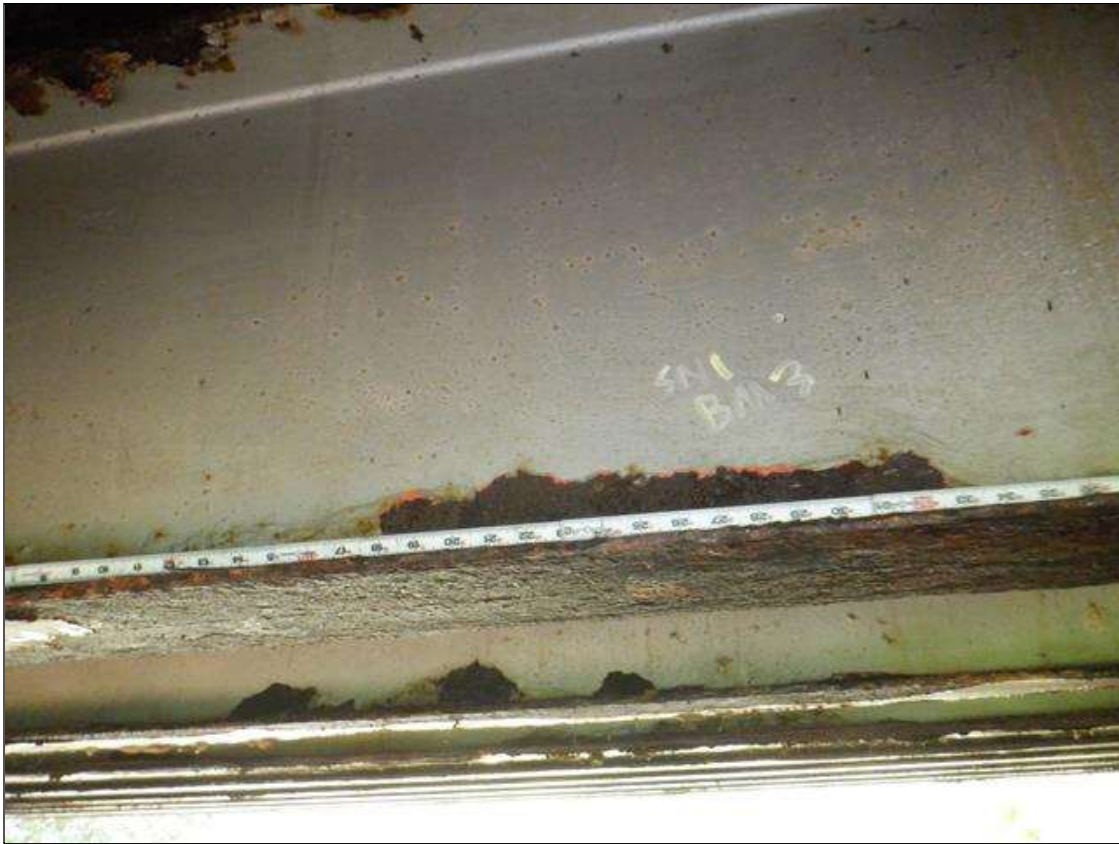
Span 1 Beam 3: [PAR] near midspan and at far third ,two [2] areas of active corrosion with section loss; bottom flange [up to 48in x full width - avg rem 3/8in], lower web [32in x 2-1/2in - avg rem 9/32in]

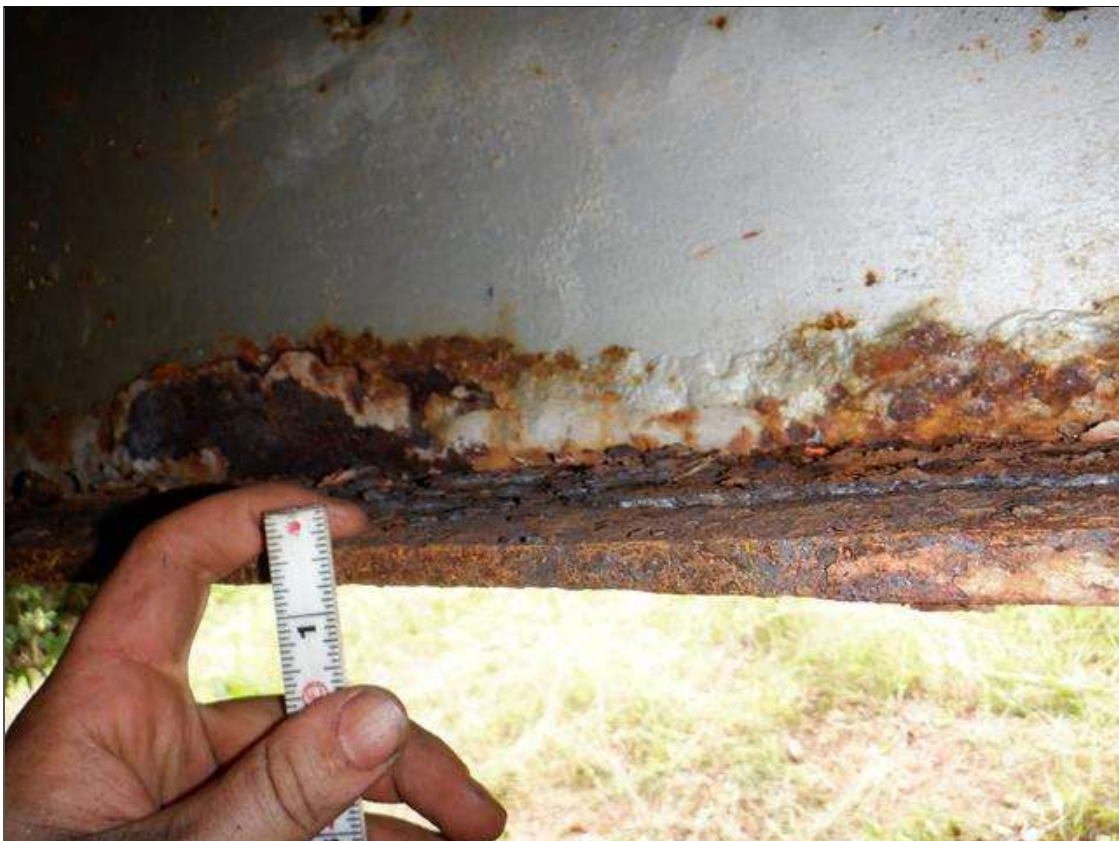
Span 1 Beam 8: 2ft from far end, active corrosion with section loss; top and bottom flange [9ft x up to full width - avg rem 7/16in], lower web [up to 3ft x up to 4in - avg rem 5/16in]

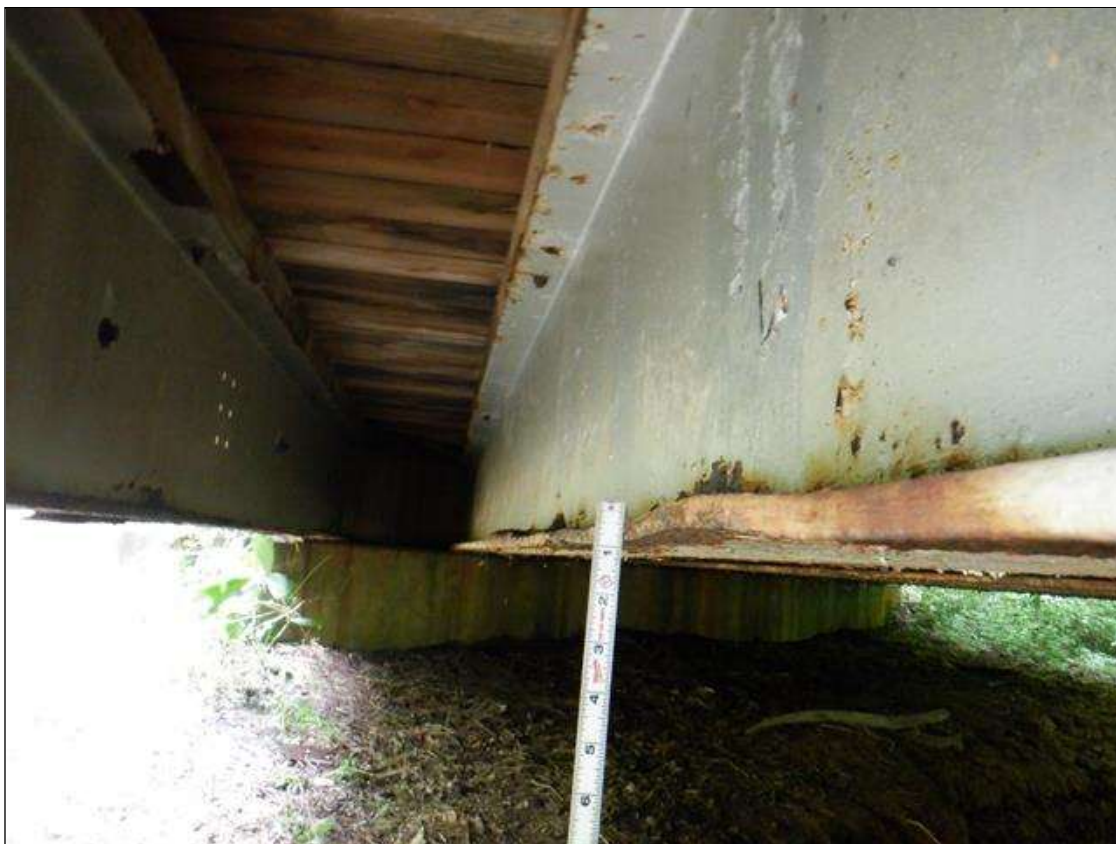
Span 1 Beam 9: South bottom flange at 2ft from interior diaphragm, distortion [6in x 1/4in]

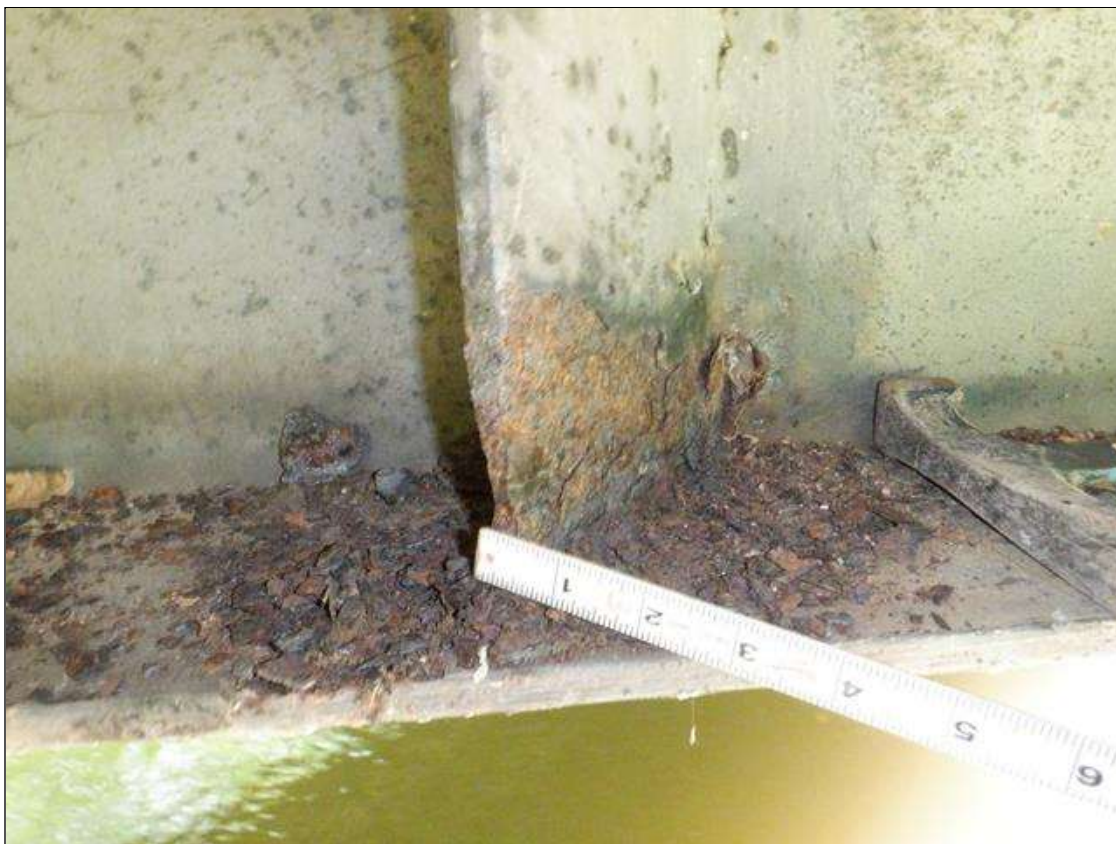
Bent 1 Cap 1: [PAR] along West face at stiffeners 2-6, 9, & 10, active corrosion with section loss [up to 6in x full width - avg rem 3/8in]; along East face at stiffeners 1-5, 9 & 10, active corrosion with section loss [8in x full width - avg rem 3/8in]

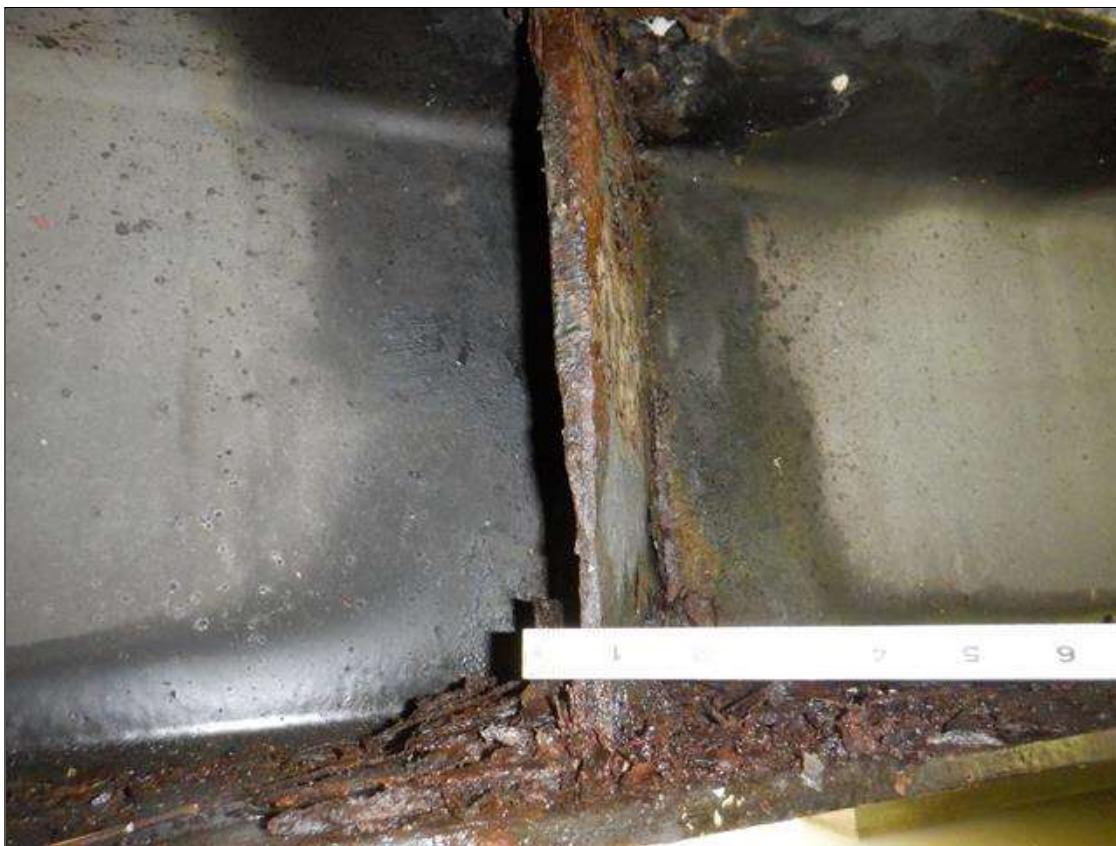
Bent 1 Cap 1: [PAR] along West face at stiffeners 2-6, 9, & 10, active corrosion with section loss [up to 6in x full width - avg rem 3/8in]; along East face at stiffeners 1-5, 9 & 10, active corrosion with section loss [8in x full width - avg rem 3/8in]

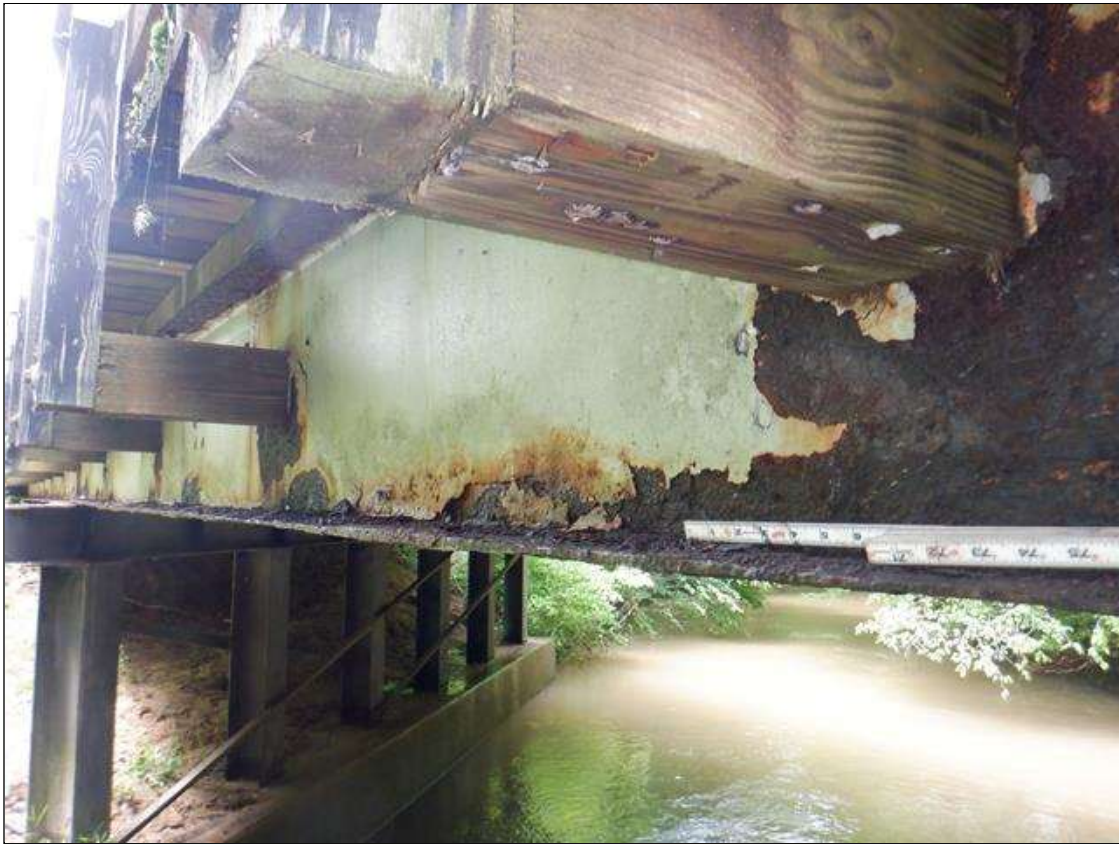
Span 2 Beam 10: [PAR] along length, active corrosion with section loss; top and bottom flange [full length x full width - avg rem 0.34, with areas down to 1/8in], lower web & web at rail connections [up to 3ft x up to 14in - avg rem 1/4in]

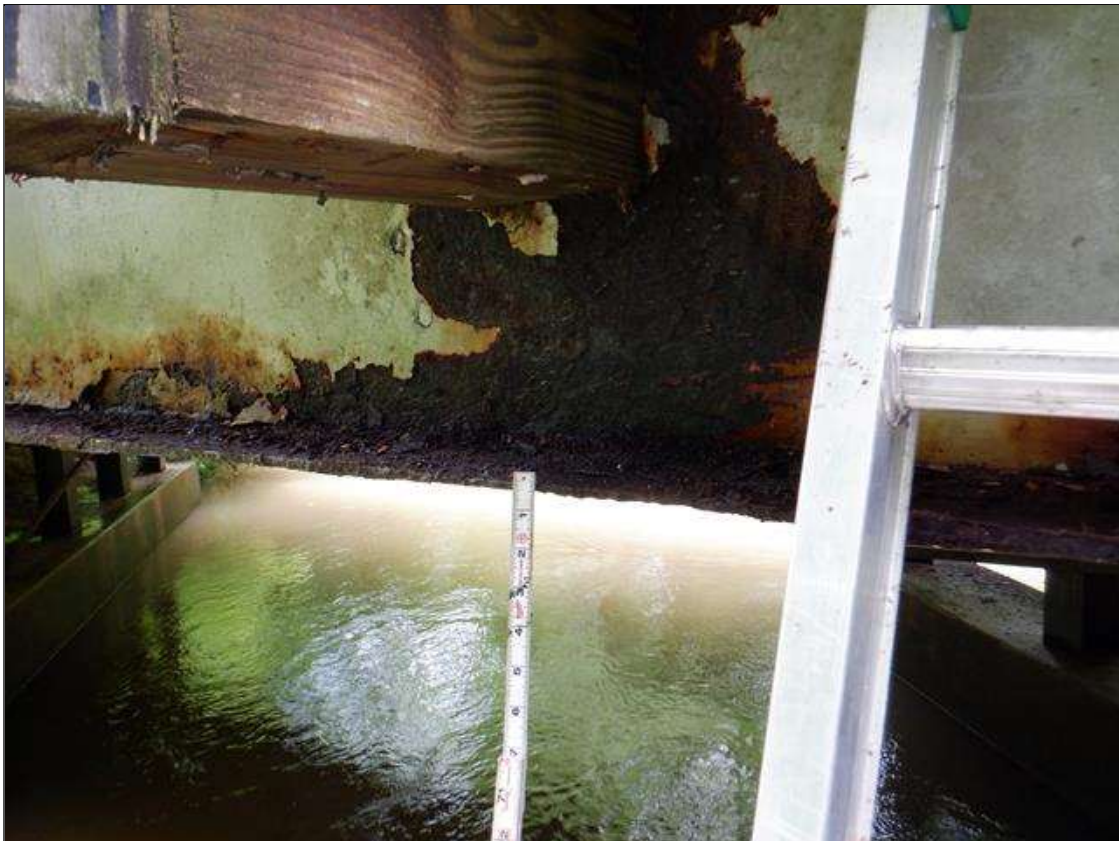
Span 2 Beam 10: [PAR] along length, active corrosion with section loss; top and bottom flange [full length x full width - avg rem 0.34, with areas down to 1/8in], lower web & web at rail connections [up to 3ft x up to 14in - avg rem 1/4in]

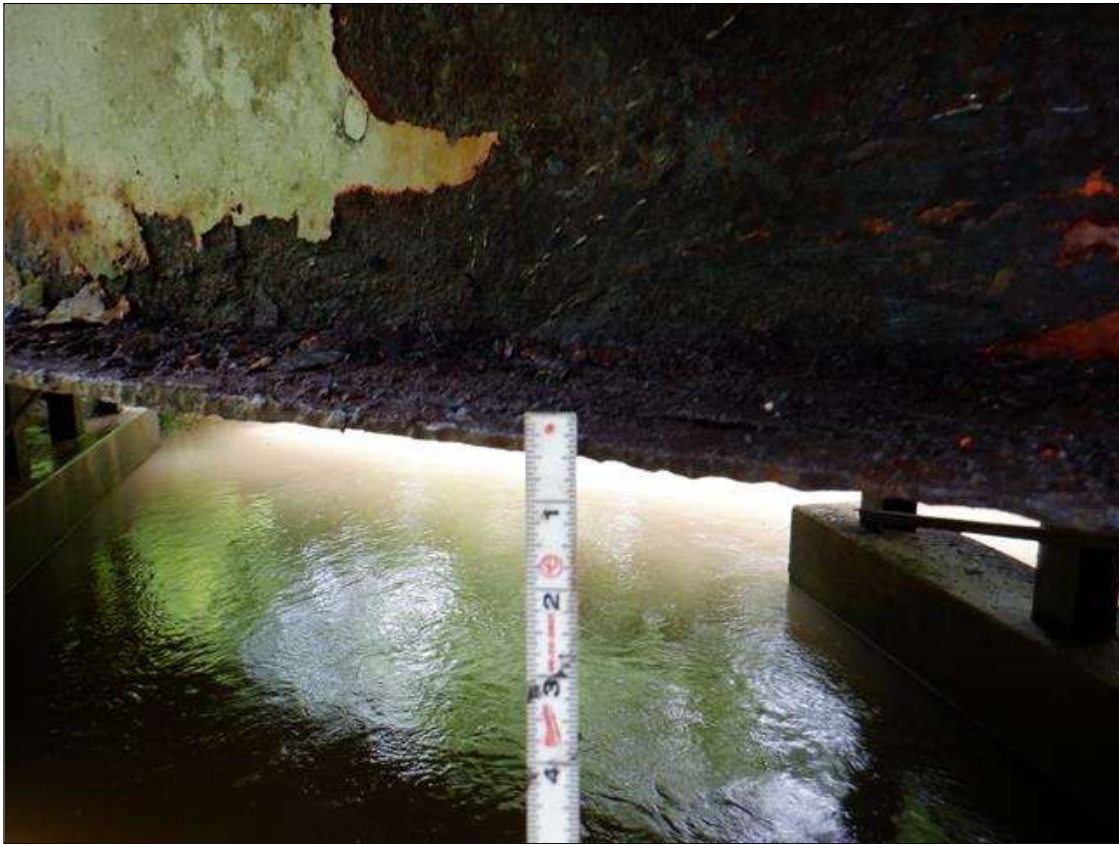
Span 2 Beam 10: [PAR] along length, active corrosion with section loss; top and bottom flange [full length x full width - avg rem 0.34, with areas down to 1/8in], lower web & web at rail connections [up to 3ft x up to 14in - avg rem 1/4in]

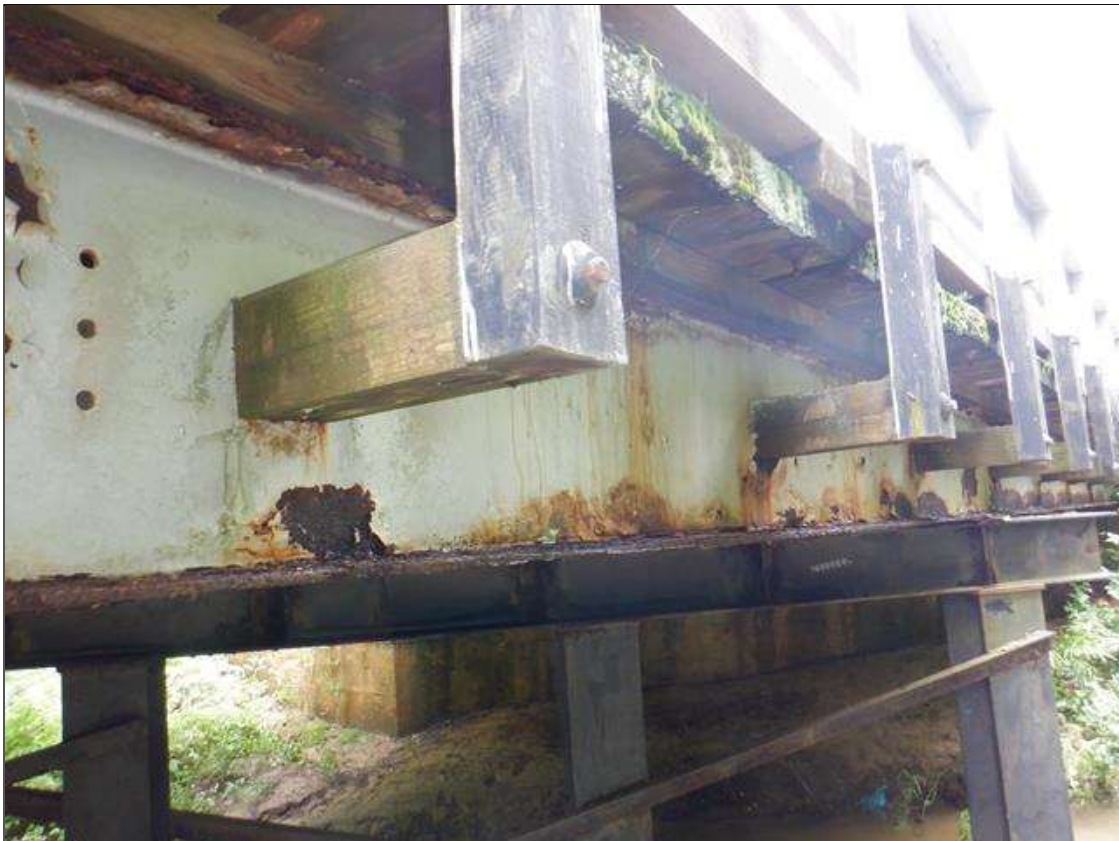
Span 2 Beam 10: [PAR] along length, active corrosion with section loss; top and bottom flange [full length x full width - avg rem 0.34, with areas down to 1/8in], lower web & web at rail connections [up to 3ft x up to 14in - avg rem 1/4in]

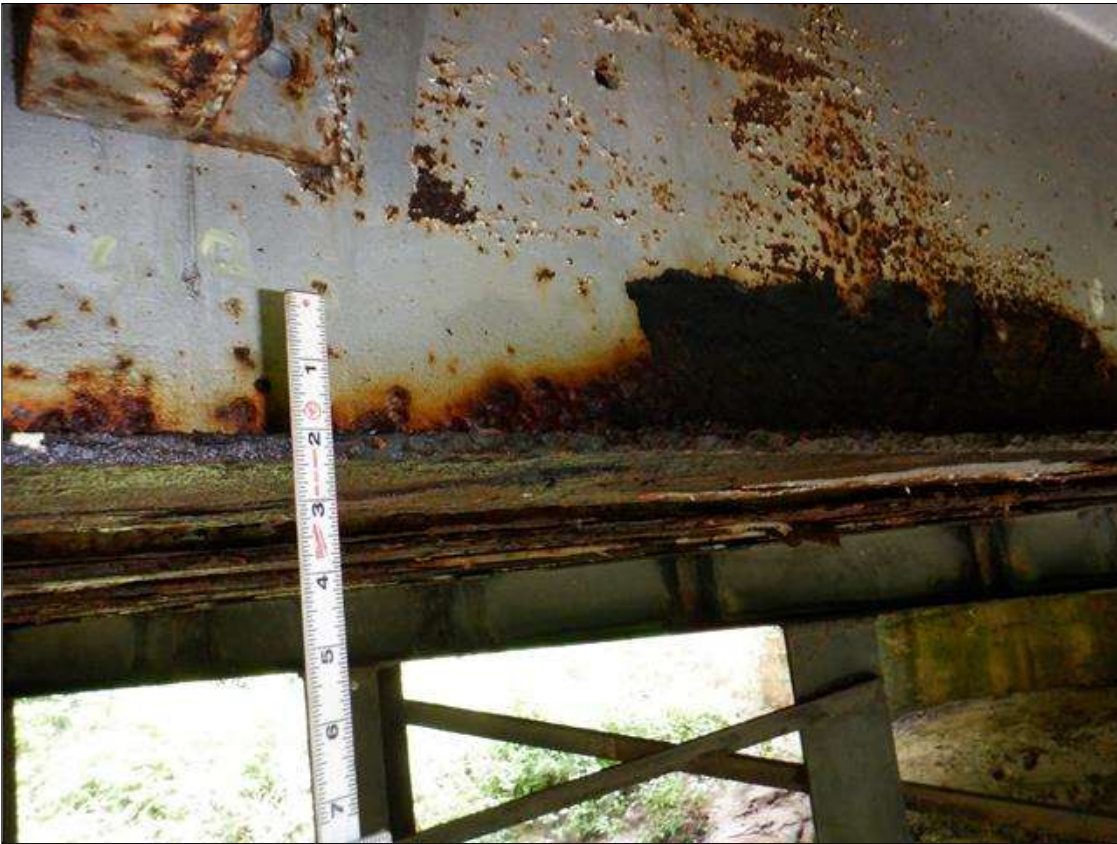
Span 2 Beam 9: [PAR] at midspan, active corrosion with section loss; bottom flange [2ft x full width - avg rem 3/8in], lower web [32in x 5in - avg rem 1/4in]

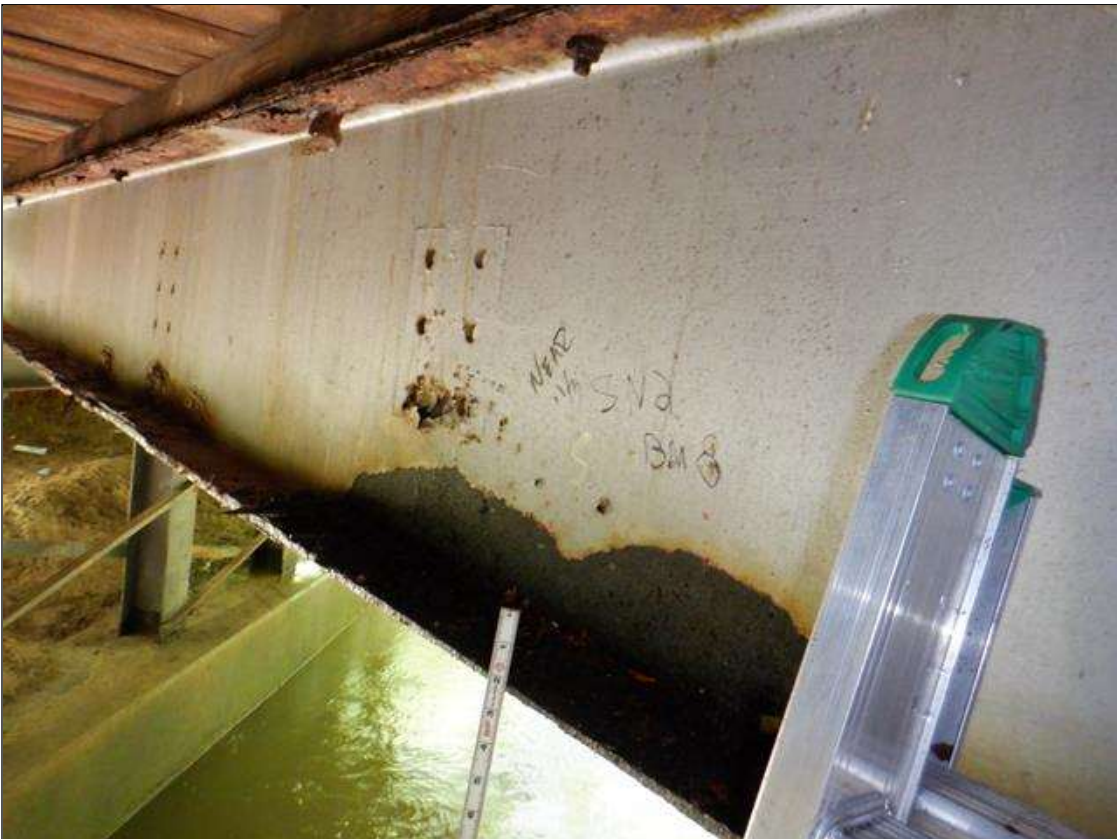
Span 2 Beam 8: [PAR] near midspan, active corrosion with section loss; top and bottom flange [63in x full width - avg rem 3/8in], lower web along length [up to 59in x up to 4in - avg rem 1/4in]

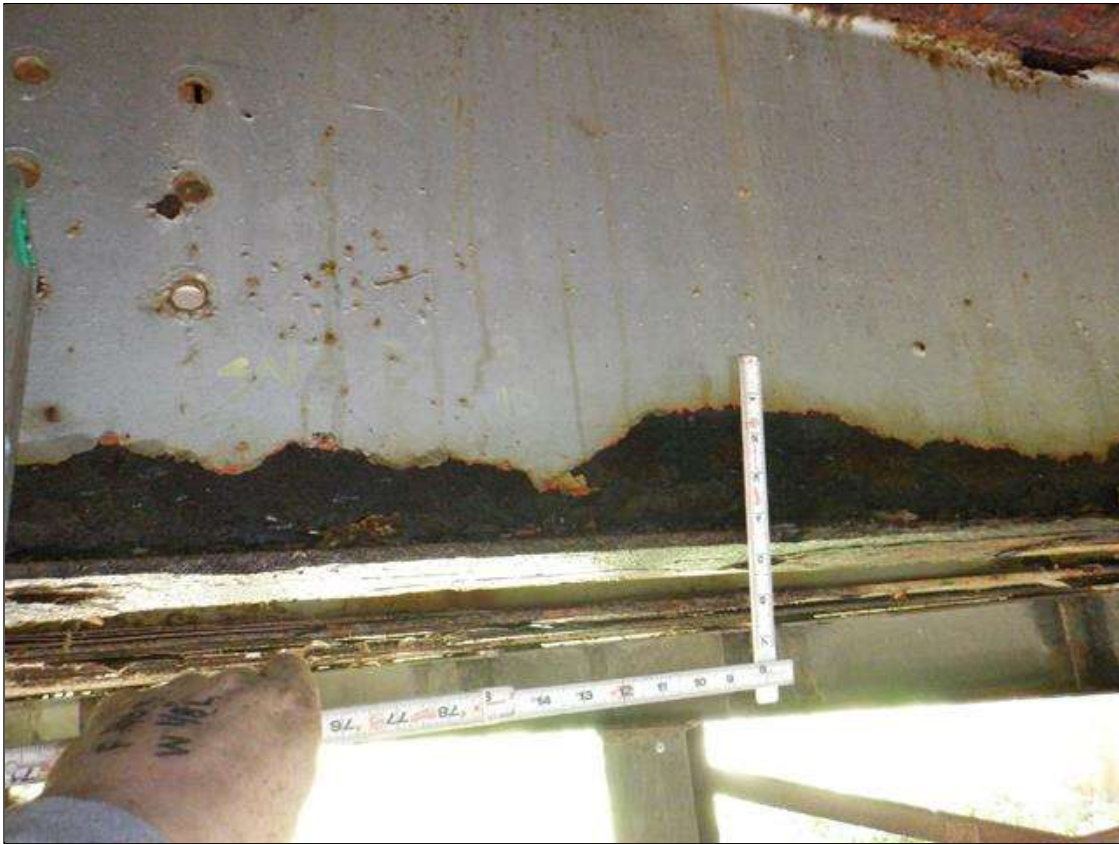
Span 2 Beam 8: [PAR] near midspan, active corrosion with section loss; top and bottom flange [63in x full width - avg rem 3/8in], lower web along length [up to 59in x up to 4in - avg rem 1/4in]

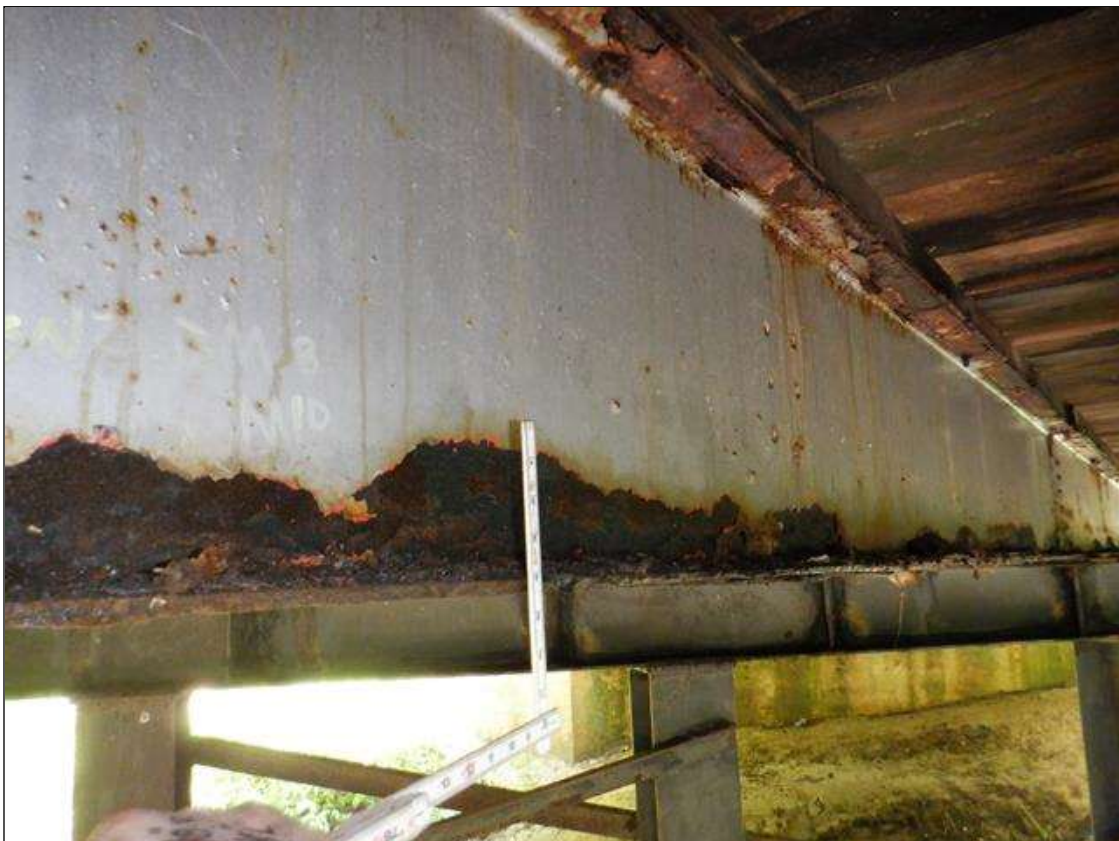
Span 2 Beam 8: [PAR] near midspan, active corrosion with section loss; top and bottom flange [63in x full width - avg rem 3/8in], lower web along length [up to 59in x up to 4in - avg rem 1/4in]

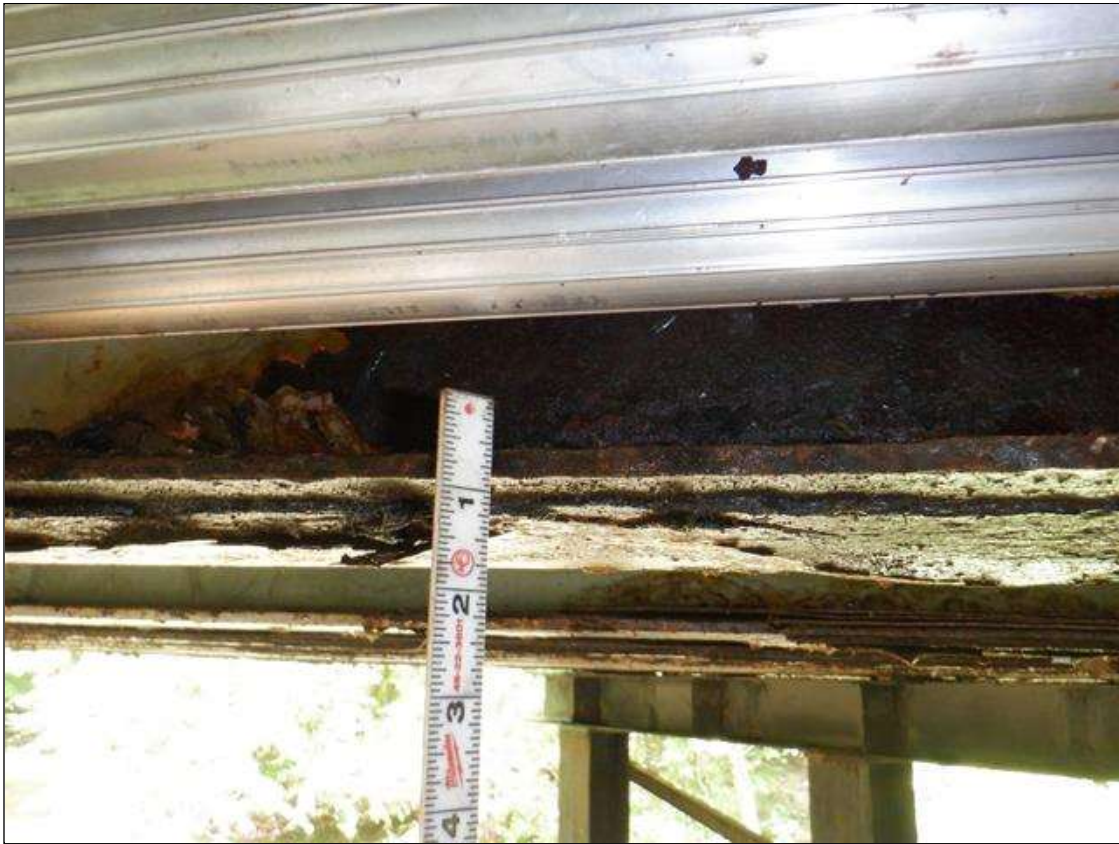
Span 2 Beam 8: [PAR] near midspan, active corrosion with section loss; top and bottom flange [63in x full width - avg rem 3/8in], lower web along length [up to 59in x up to 4in - avg rem 1/4in]

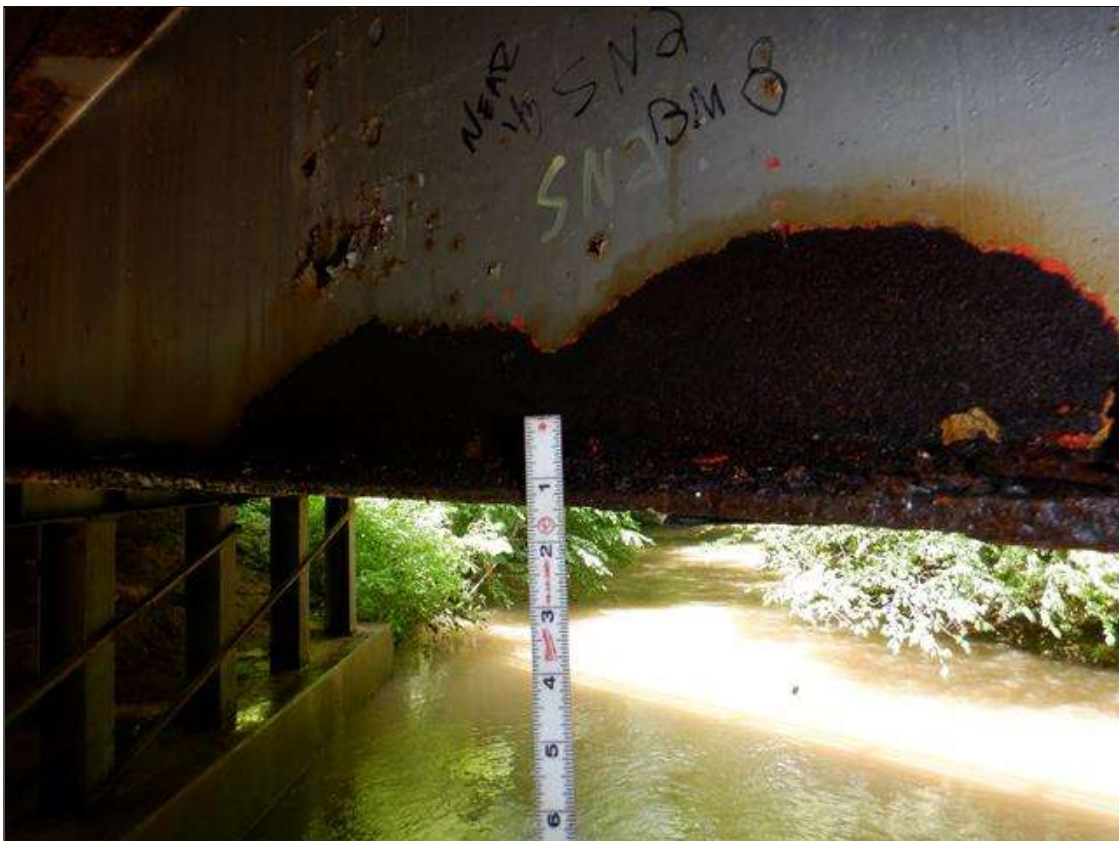
Span 2 Beam 8: [PAR] near midspan, active corrosion with section loss; top and bottom flange [63in x full width - avg rem 3/8in], lower web along length [up to 59in x up to 4in - avg rem 1/4in]

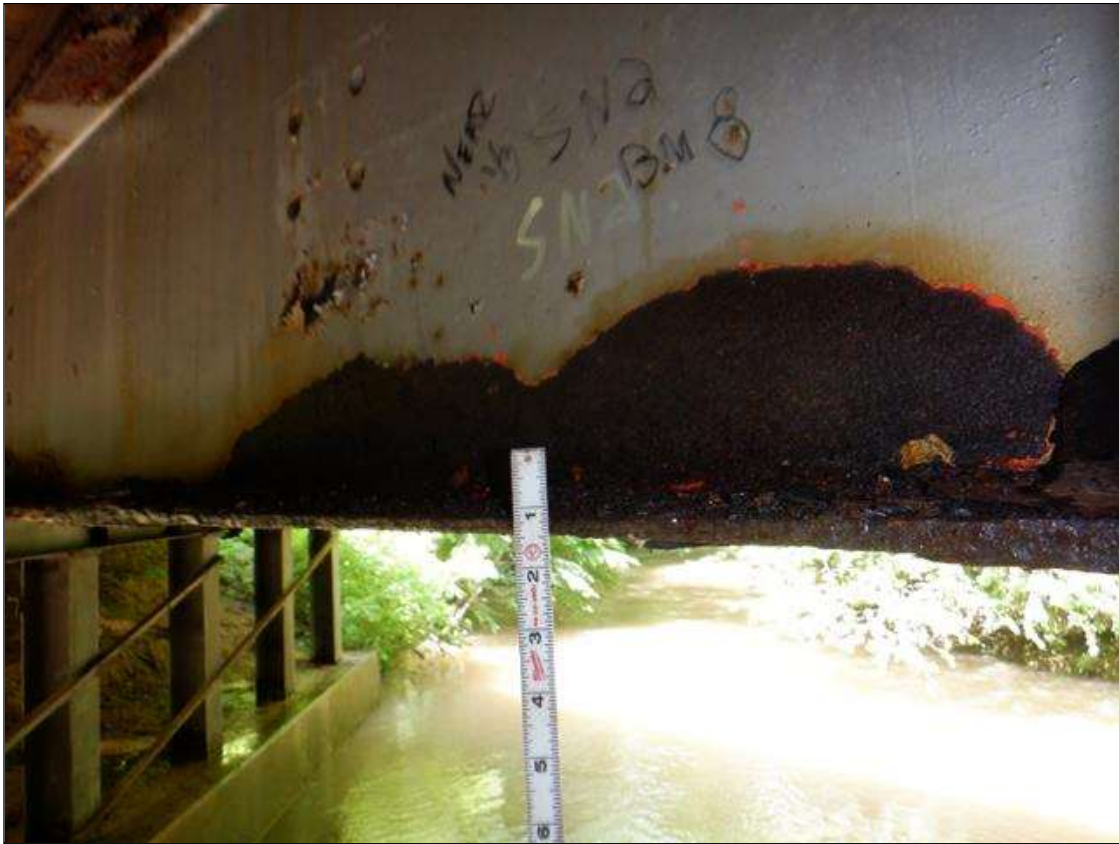
Span 2 Beam 8: [PAR] near midspan, active corrosion with section loss; top and bottom flange [63in x full width - avg rem 3/8in], lower web along length [up to 59in x up to 4in - avg rem 1/4in]
