NC DEPARTMENT OF TRANSPORTATION
 DIVISION OF HIGHWAYS
 STRUCTURE MANAGEMENT UNIT

ATTENTION: PAR Submitted, Changes to Structure Data

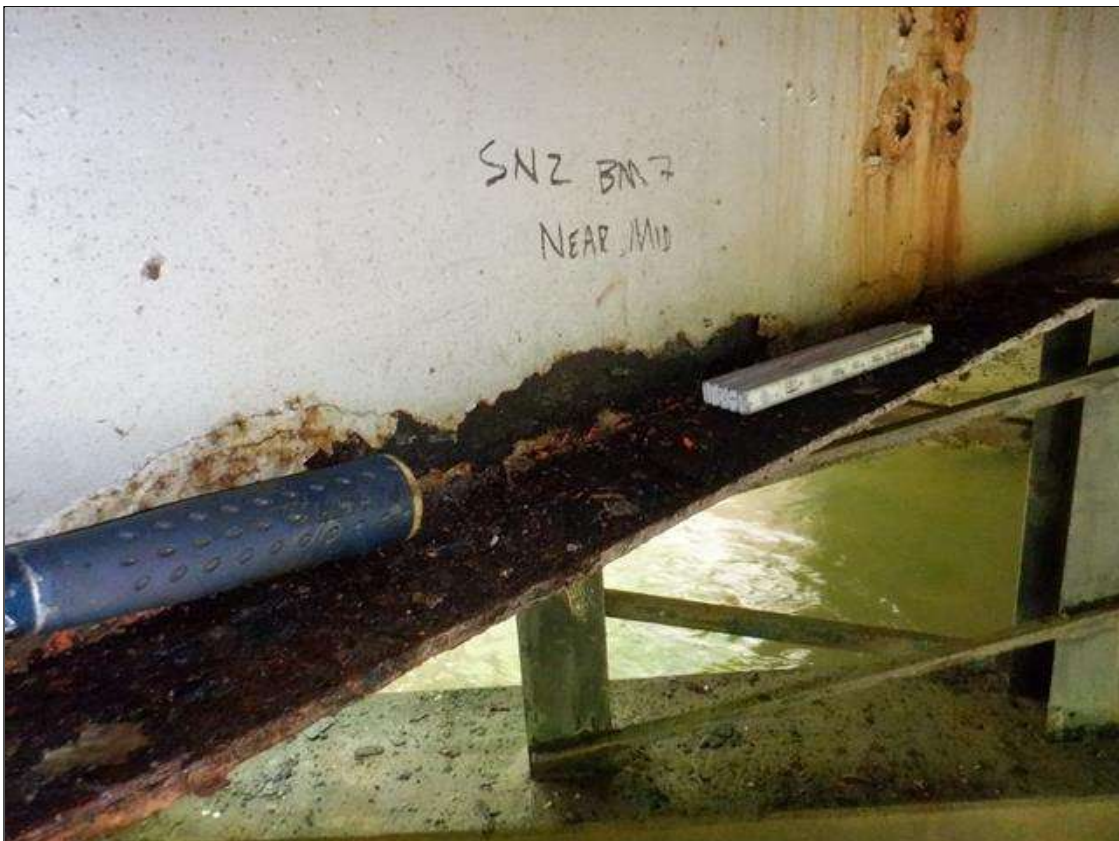
Span 2 Beam 7: [PAR] near midspan, active corrosion with section loss; bottom flange [up to 6ft x full width - avg rem 0.31in], lower web [up to 5ft x 2in - avg rem 5/16in]

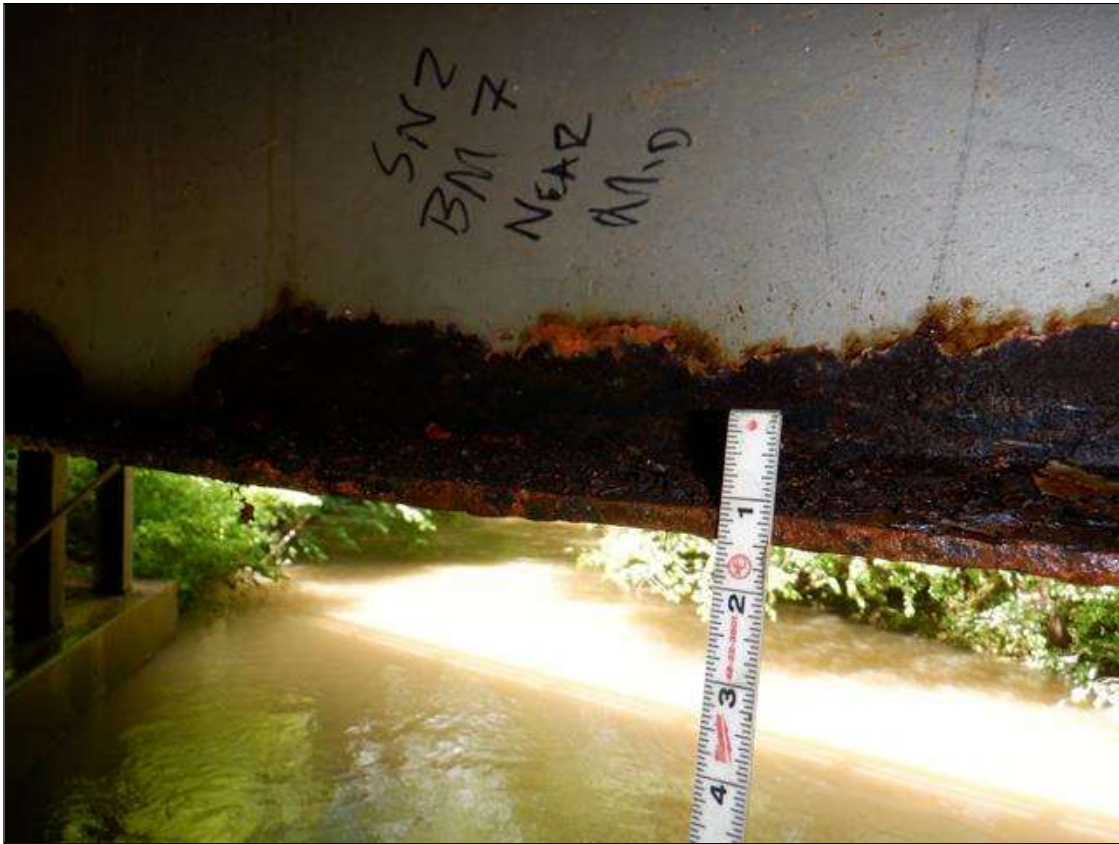
Span 2 Beam 7: [PAR] near midspan, active corrosion with section loss; bottom flange [up to 6ft x full width - avg rem 0.31in], lower web [up to 5ft x 2in - avg rem 5/16in]

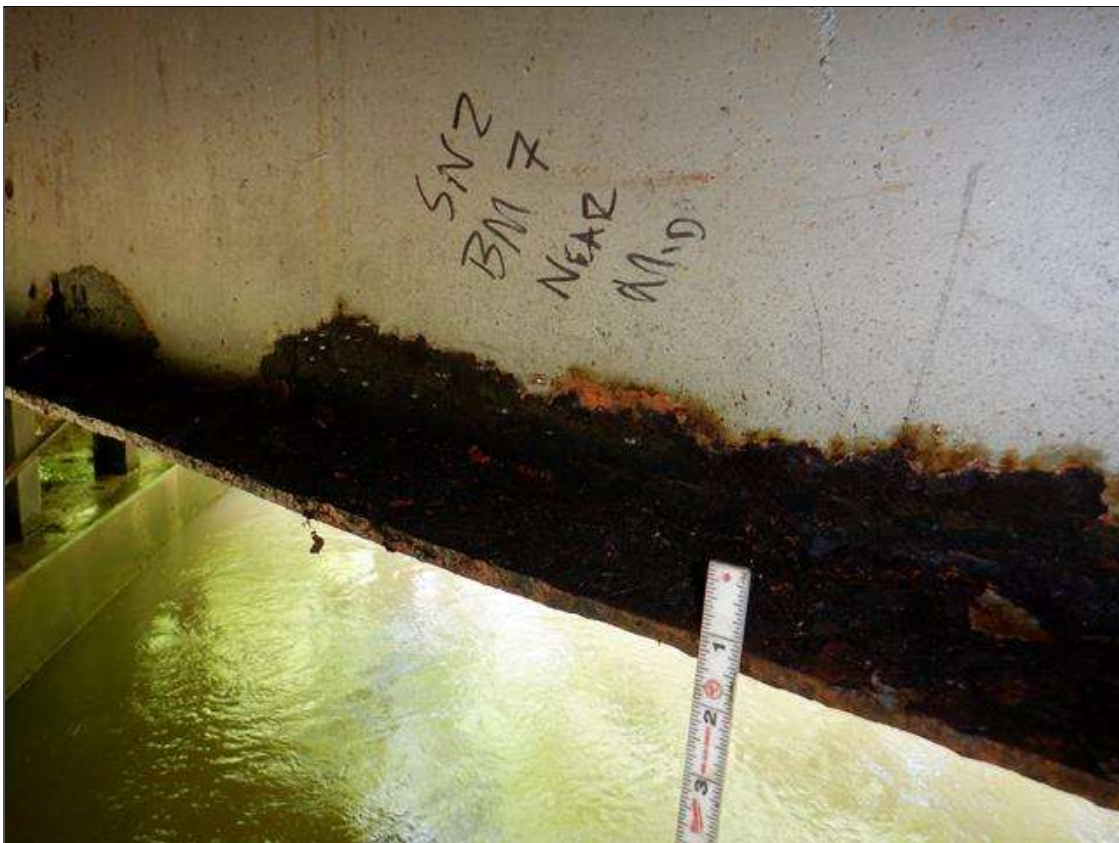
Span 2 Beam 7: [PAR] near midspan, active corrosion with section loss; bottom flange [up to 6ft x full width - avg rem 0.31in], lower web [up to 5ft x 2in - avg rem 5/16in]

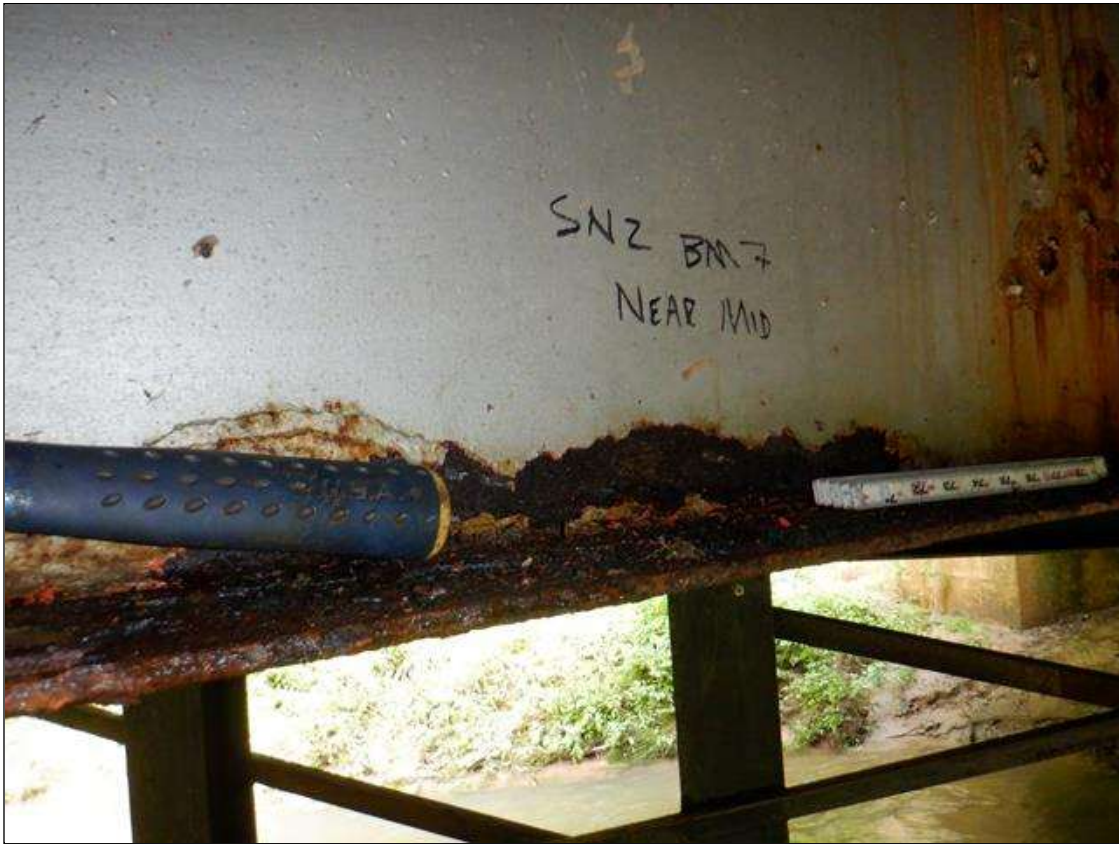
Span 2 Beam 7: [PAR] near midspan, active corrosion with section loss; bottom flange [up to 6ft x full width - avg rem 0.31in], lower web [up to 5ft x 2in - avg rem 5/16in]

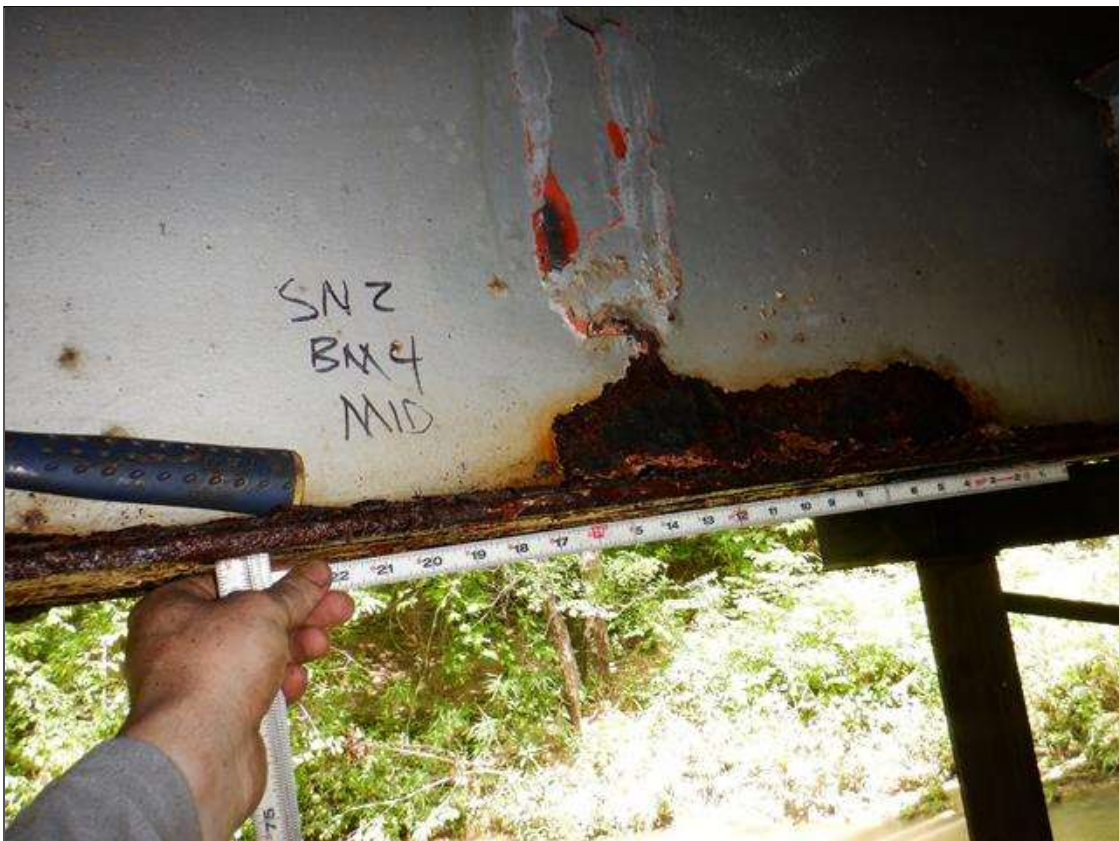
Span 2 Beam 4: [PAR] near midspan, active corrosion with section loss; bottom flange [up to 42in x up to full width - avg rem 3/8in], lower web [16in x 2in - avg rem 1/4in]

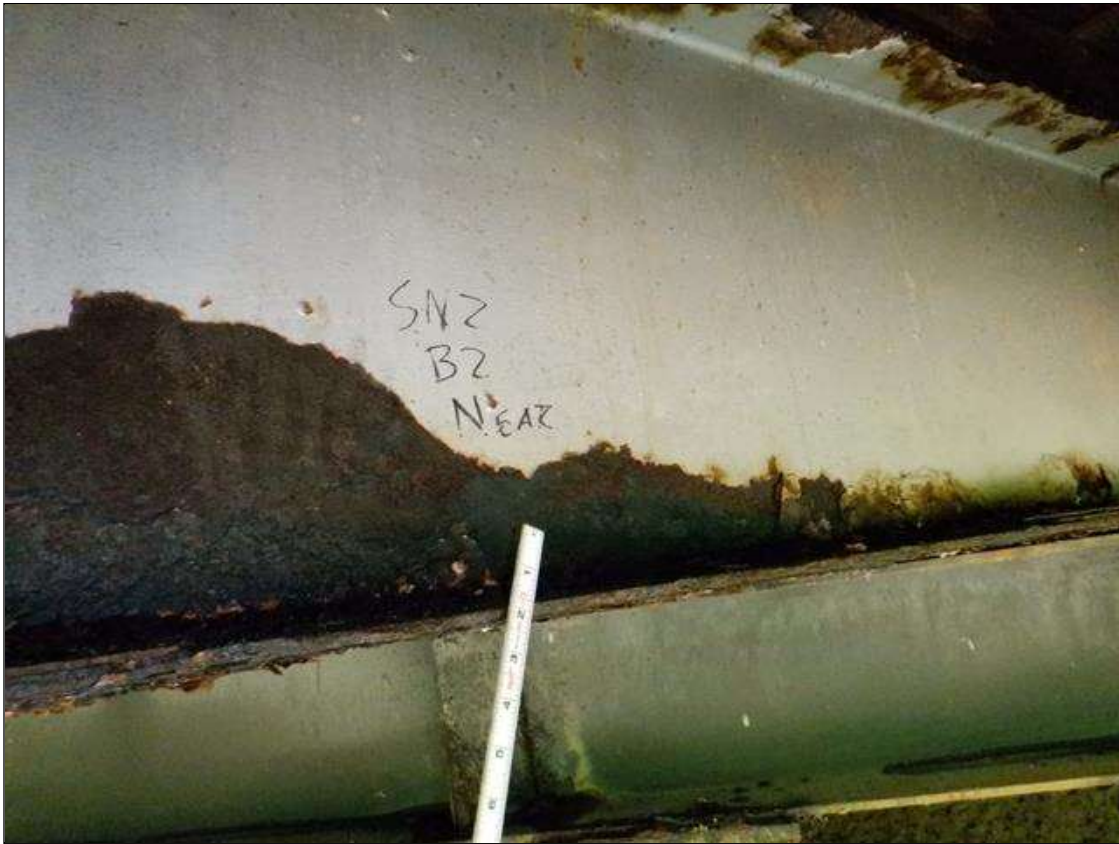
Span 2 Beam 2: [PAR] at near end, active corrosion with section loss; top and bottom flange [12ft x up to full width - avg rem 3/8in], lower web [up to 50in x up to 8in - avg rem 5/16in]

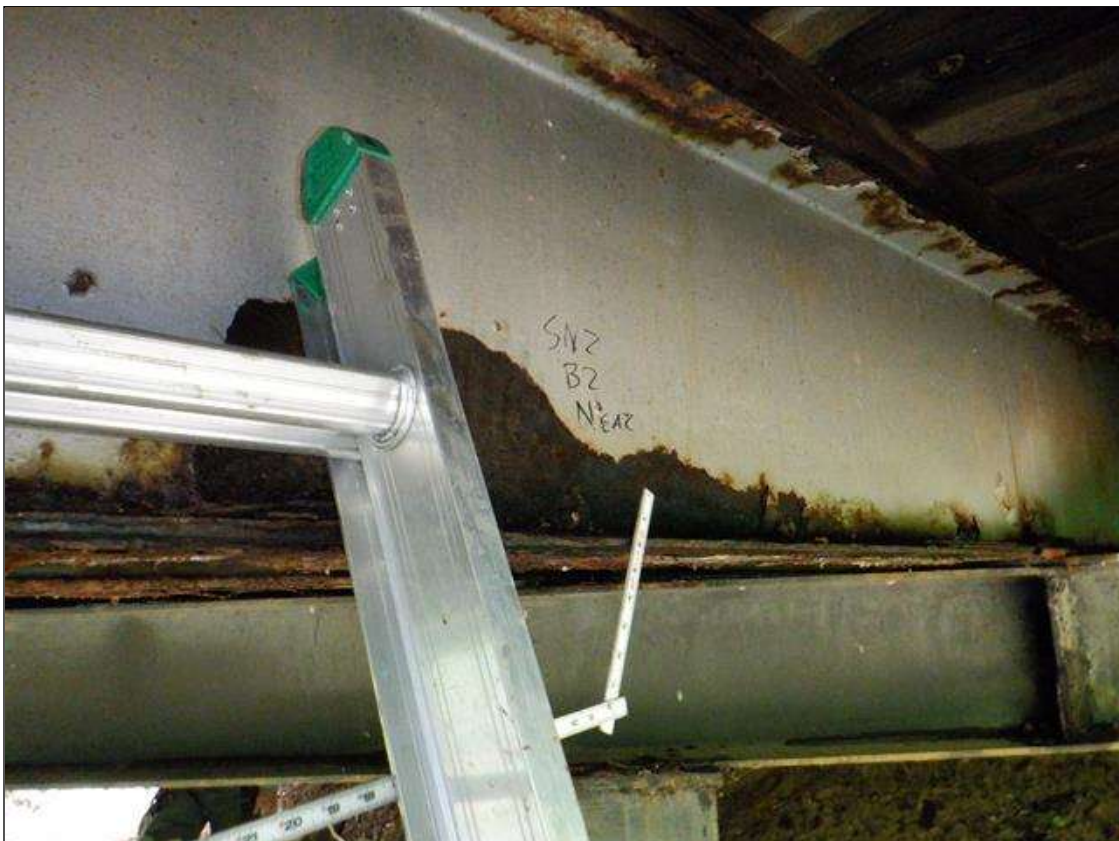
Span 2 Beam 2: [PAR] at near end, active corrosion with section loss; top and bottom flange [12ft x up to full width - avg rem 3/8in], lower web [up to 50in x up to 8in - avg rem 5/16in]

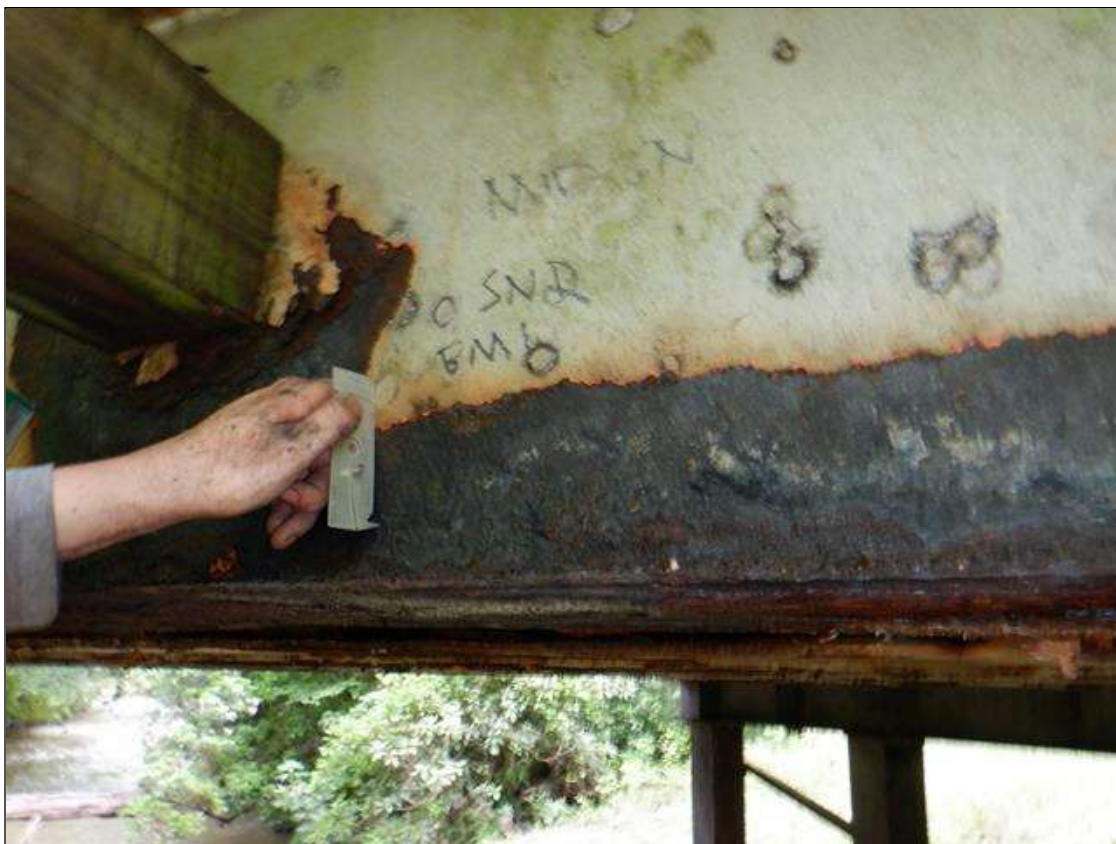
Span 2 Beam 1: [PAR] along length active corrosion with section loss; top and bottom flange [up to 15ft x full width - avg rem 3/8in], bottom flange at midspan [10ft x full width - avg rem 1/4in, with edges down to 1/8in], lower web along length [up to 15ft x up to 9in - avg rem 1/4in], lower web at midspan [10ft x 4in - avg rem 3/16in], web at rail connections [up to 12in diameter - avg rem 1/4in]

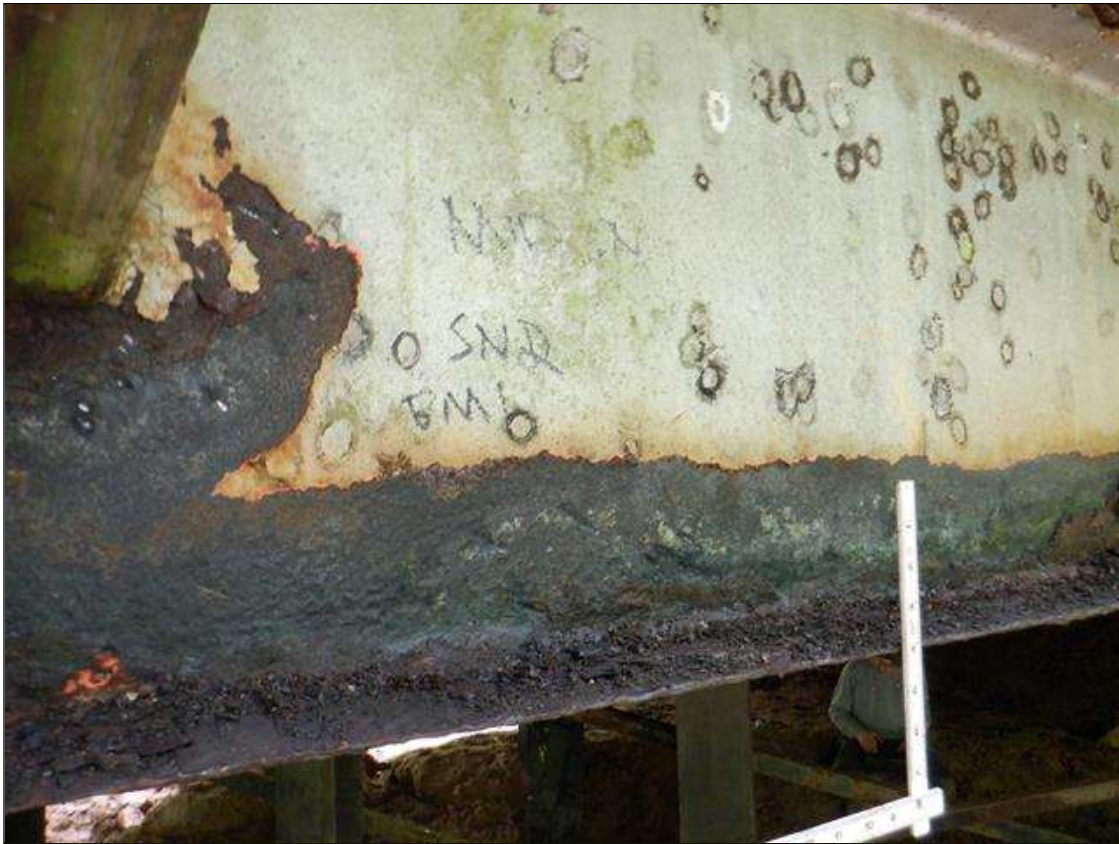
Span 2 Beam 1: [PAR] along length active corrosion with section loss; top and bottom flange [up to 15ft x full width - avg rem 3/8in], bottom flange at midspan [10ft x full width - avg rem 1/4in, with edges down to 1/8in], lower web along length [up to 15ft x up to 9in - avg rem 1/4in], lower web at midspan [10ft x 4in - avg rem 3/16in], web at rail connections [up to 12in diameter - avg rem 1/4in]

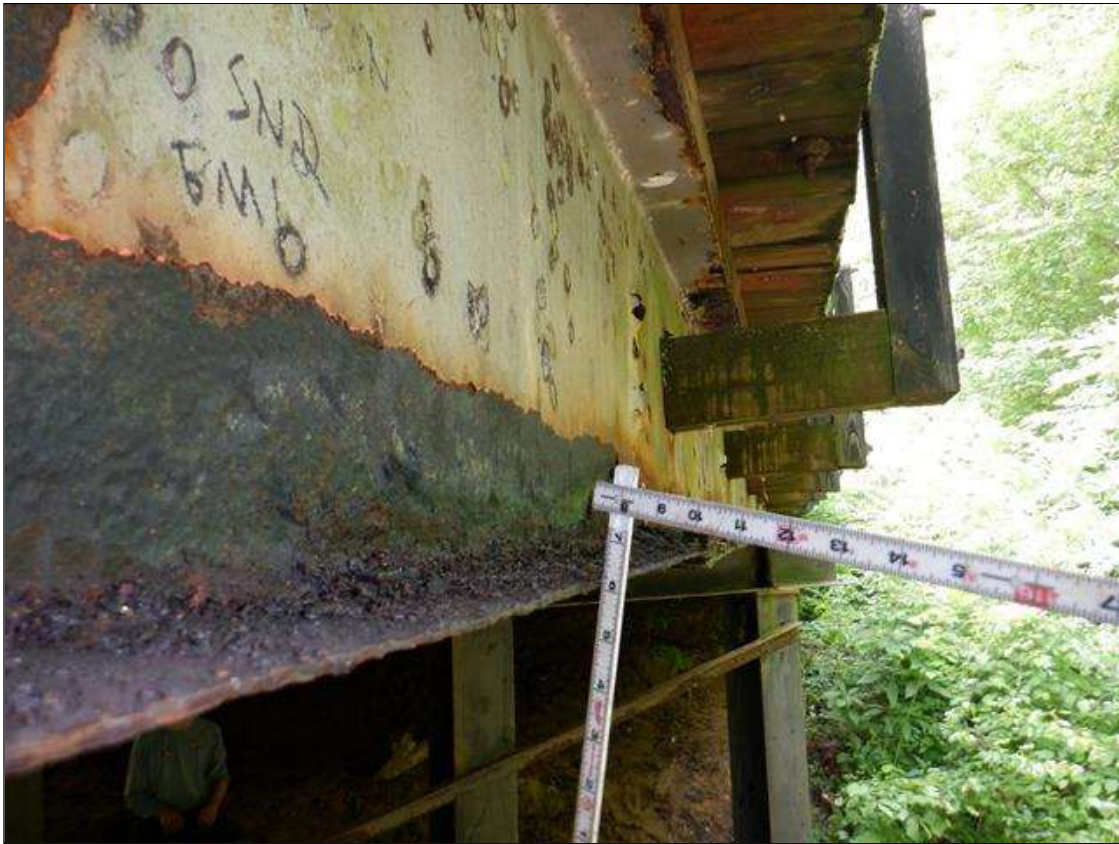
Span 2 Beam 1: [PAR] along length active corrosion with section loss; top and bottom flange [up to 15ft x full width - avg rem 3/8in], bottom flange at midspan [10ft x full width - avg rem 1/4in, with edges down to 1/8in], lower web along length [up to 15ft x up to 9in - avg rem 1/4in], lower web at midspan [10ft x 4in - avg rem 3/16in], web at rail connections [up to 12in diameter - avg rem 1/4in]

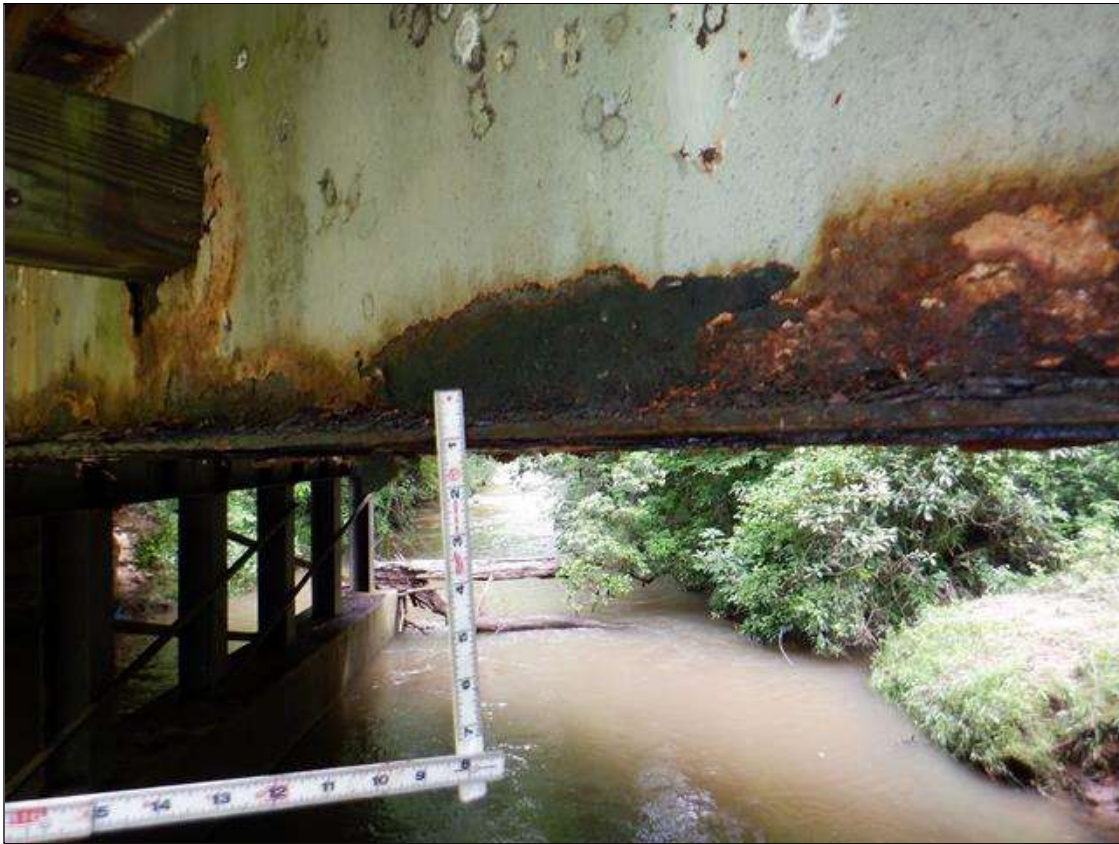
Span 2 Beam 1: [PAR] along length active corrosion with section loss; top and bottom flange [up to 15ft x full width - avg rem 3/8in], bottom flange at midspan [10ft x full width - avg rem 1/4in, with edges down to 1/8in], lower web along length [up to 15ft x up to 9in - avg rem 1/4in], lower web at midspan [10ft x 4in - avg rem 3/16in], web at rail connections [up to 12in diameter - avg rem 1/4in]

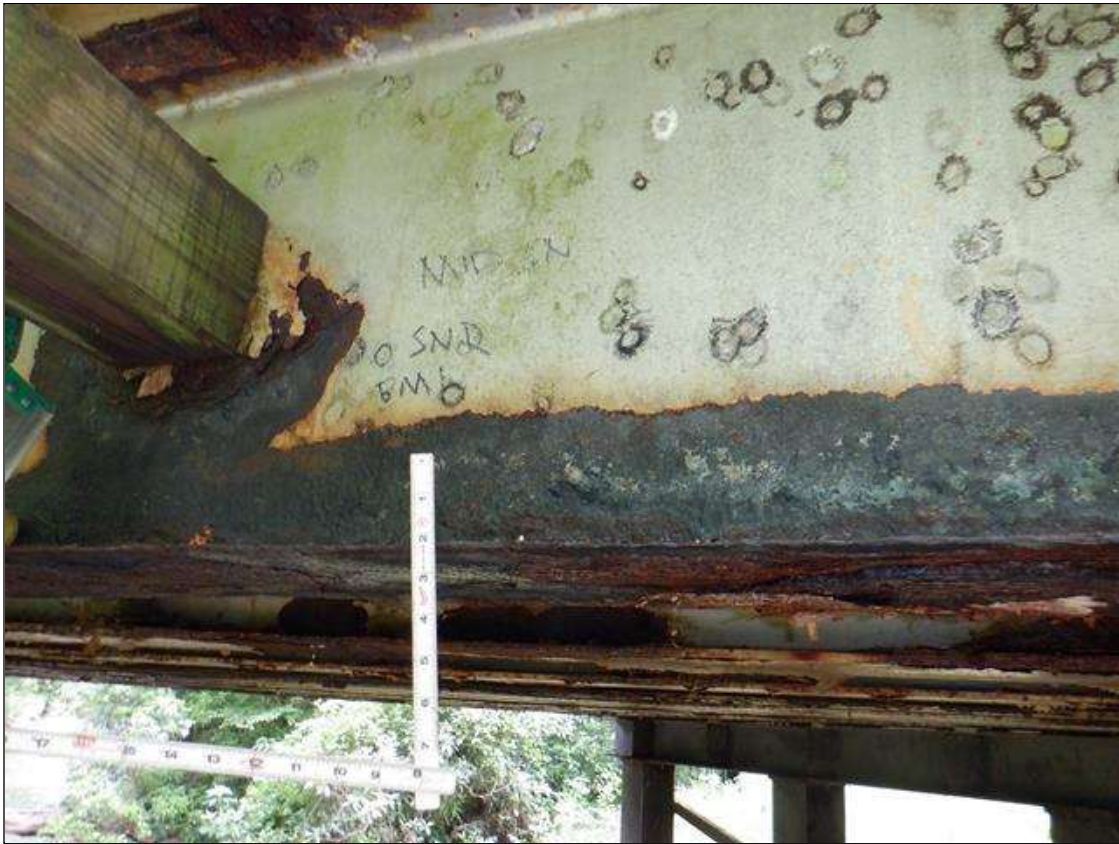
Span 2 Beam 1: [PAR] along length active corrosion with section loss; top and bottom flange [up to 15ft x full width - avg rem 3/8in], bottom flange at midspan [10ft x full width - avg rem 1/4in, with edges down to 1/8in], lower web along length [up to 15ft x up to 9in - avg rem 1/4in], lower web at midspan [10ft x 4in - avg rem 3/16in], web at rail connections [up to 12in diameter - avg rem 1/4in]

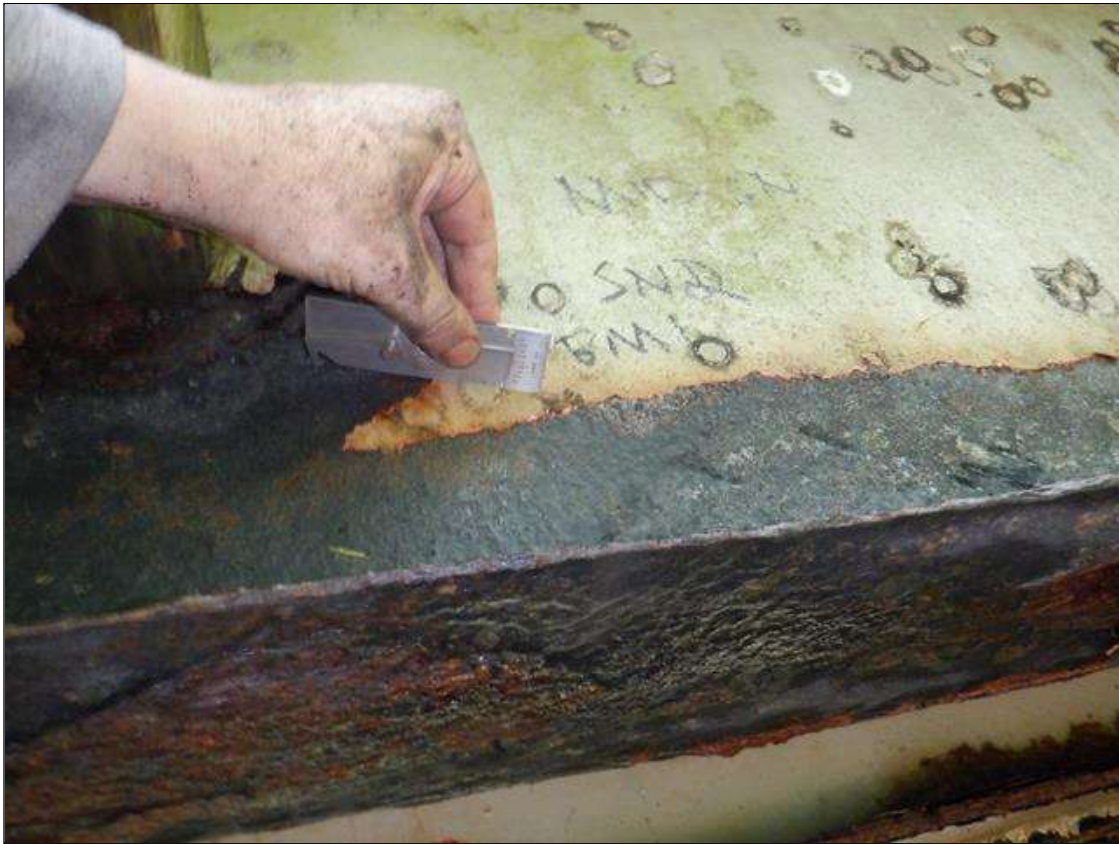
Span 2 Beam 1: [PAR] along length active corrosion with section loss; top and bottom flange [up to 15ft x full width - avg rem 3/8in], bottom flange at midspan [10ft x full width - avg rem 1/4in, with edges down to 1/8in], lower web along length [up to 15ft x up to 9in - avg rem 1/4in], lower web at midspan [10ft x 4in - avg rem 3/16in], web at rail connections [up to 12in diameter - avg rem 1/4in]

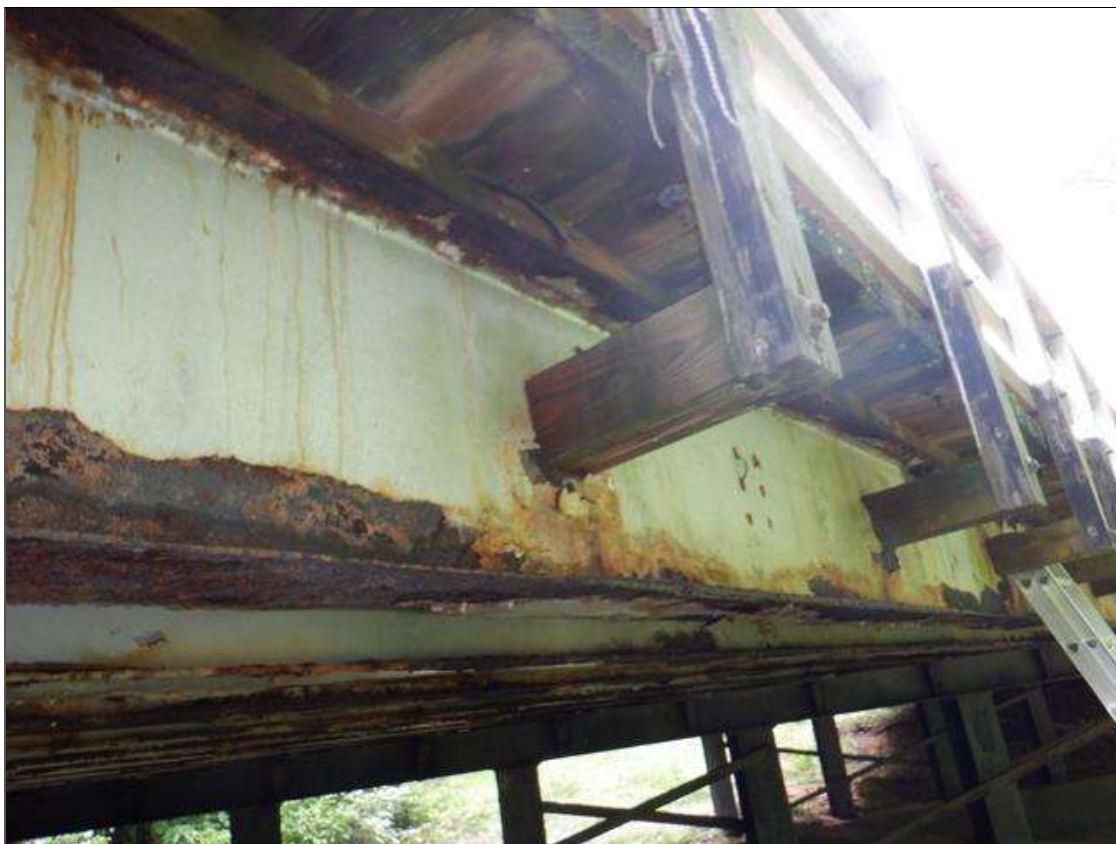
Span 3 Beam 1: [PAR] along length, active corrosion with section loss; top and bottom flange [full length x up to full width - avg rem 0.34in, edge down to 1/8in], lower and areas of upper web [16ft x up to 5in - avg rem 1/4in] , web at rail attachments [up to 12in diameter - avg rem 5/16in]

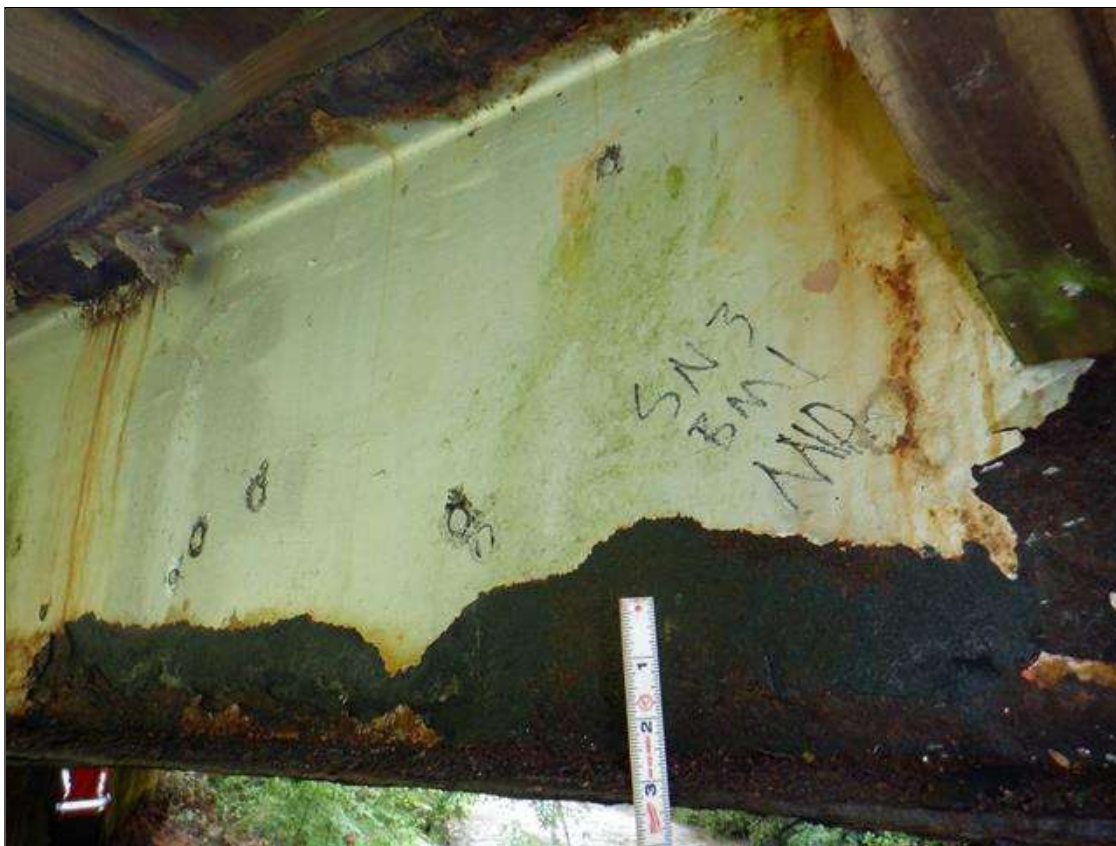
Span 3 Beam 1: [PAR] along length, active corrosion with section loss; top and bottom flange [full length x up to full width - avg rem 0.34in, edge down to 1/8in], lower and areas of upper web [16ft x up to 5in - avg rem 1/4in] , web at rail attachments [up to 12in diameter - avg rem 5/16in]

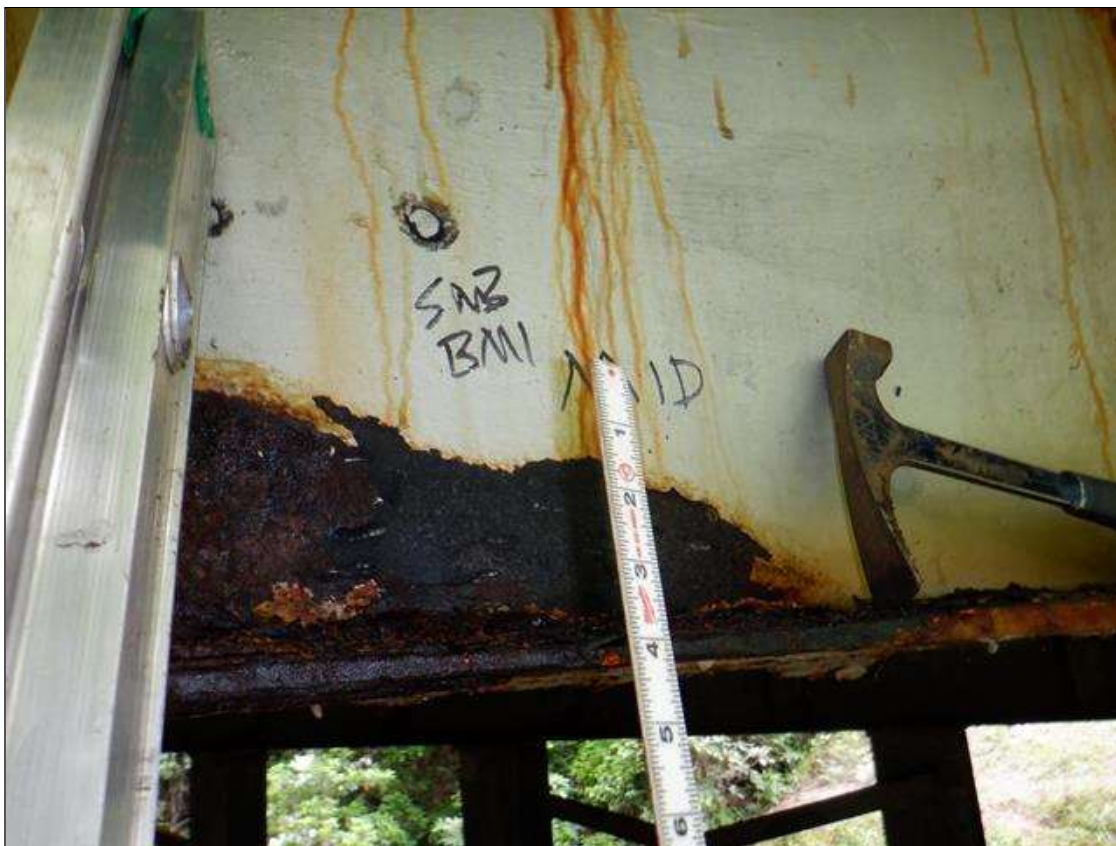
Span 3 Beam 1: [PAR] along length, active corrosion with section loss; top and bottom flange [full length x up to full width - avg rem 0.34in, edge down to 1/8in], lower and areas of upper web [16ft x up to 5in - avg rem 1/4in], web at rail attachments [up to 12in diameter - avg rem 5/16in]

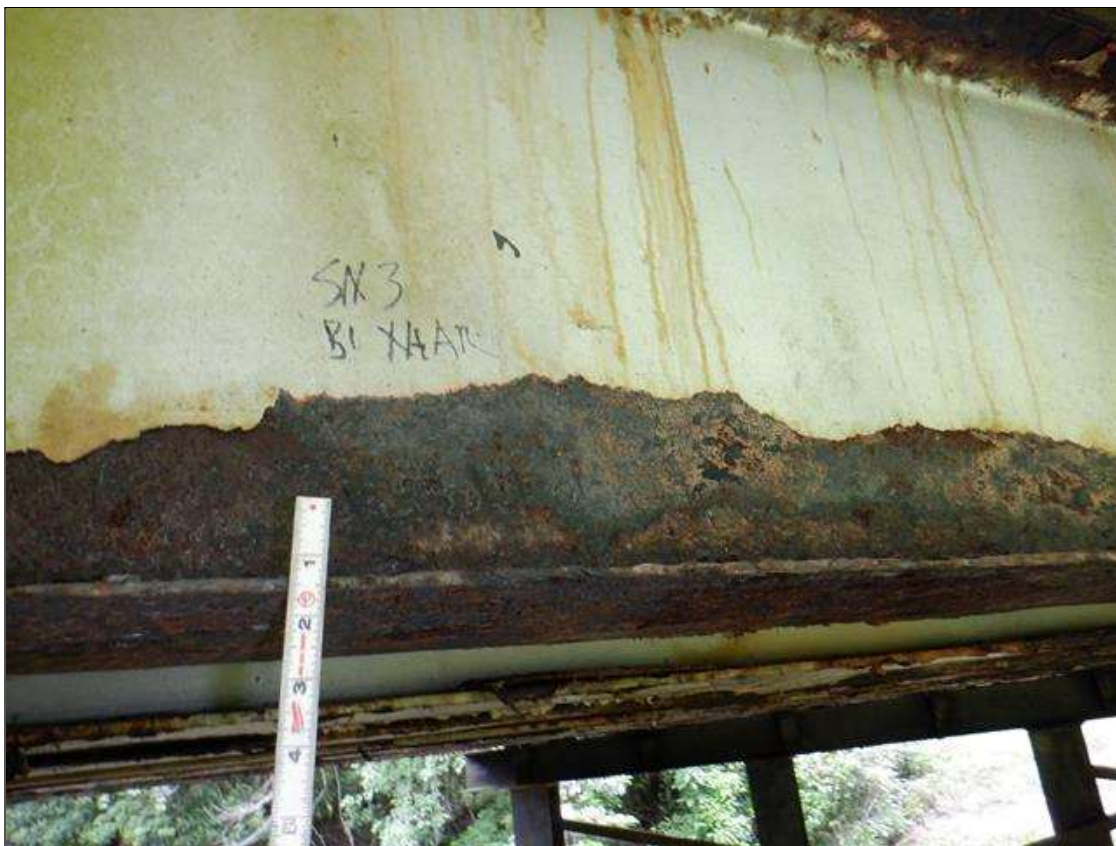
Span 3 Beam 1: [PAR] along length, active corrosion with section loss; top and bottom flange [full length x up to full width - avg rem 0.34in, edge down to 1/8in], lower and areas of upper web [16ft x up to 5in - avg rem 1/4in] , web at rail attachments [up to 12in diameter - avg rem 5/16in]

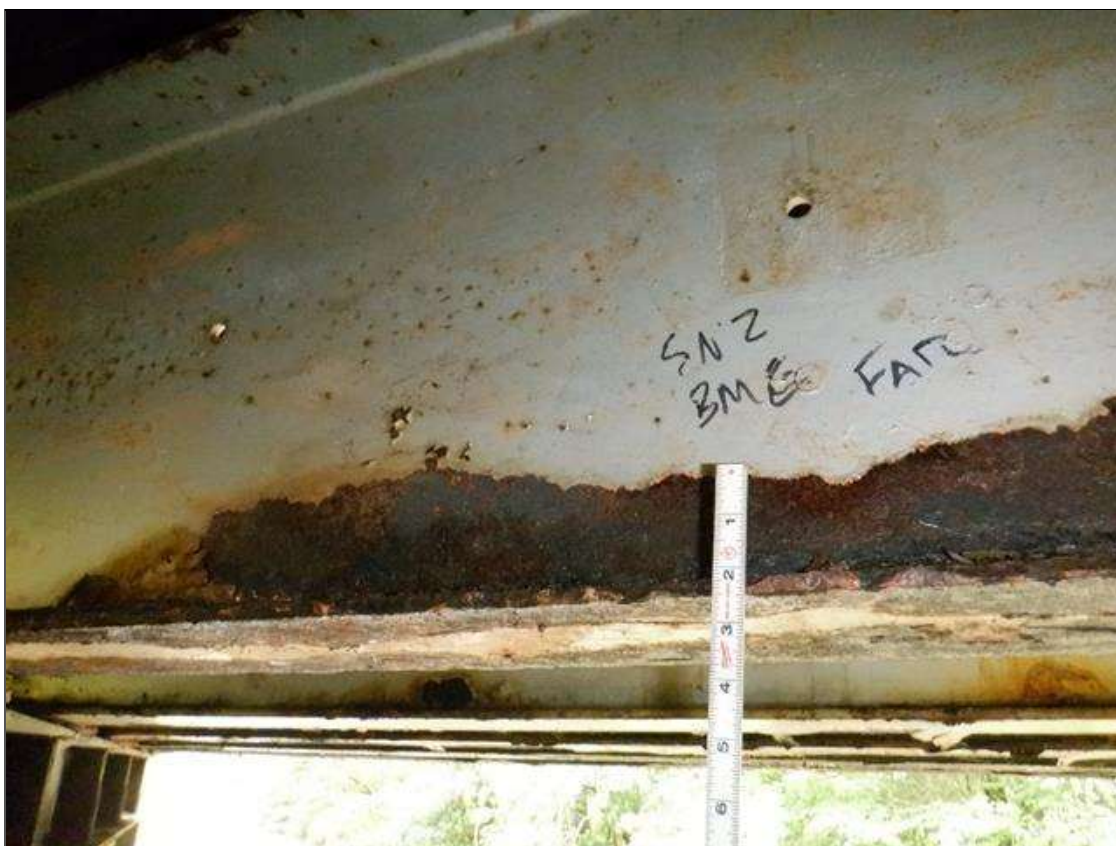
Span 2 Beam 6: [PAR] at far end, active corrosion with section loss; bottom flange [up to 8ft x full width - avg rem 3/8in], lower web [12ft x up to 2in - avg rem 1/4in]

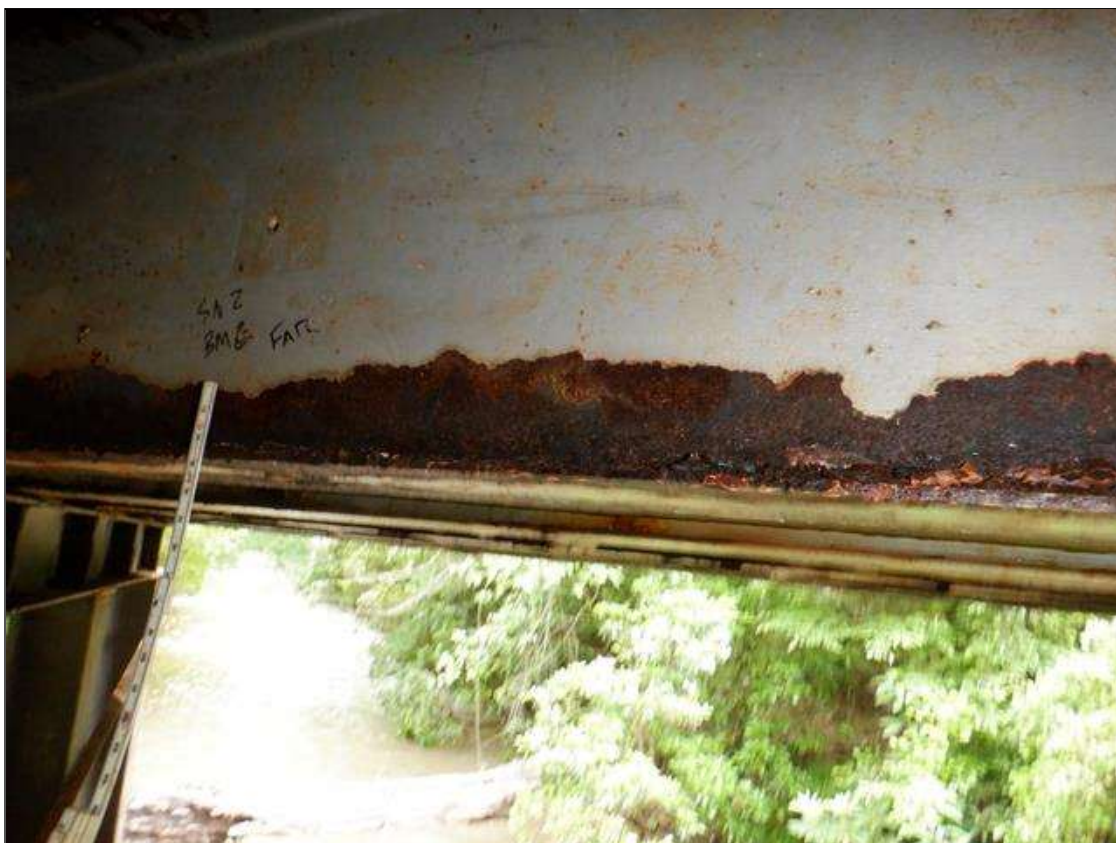
Span 2 Beam 6: [PAR] at far end, active corrosion with section loss; bottom flange [up to 8ft x full width - avg rem 3/8in], lower web [12ft x up to 2in - avg rem 1/4in]

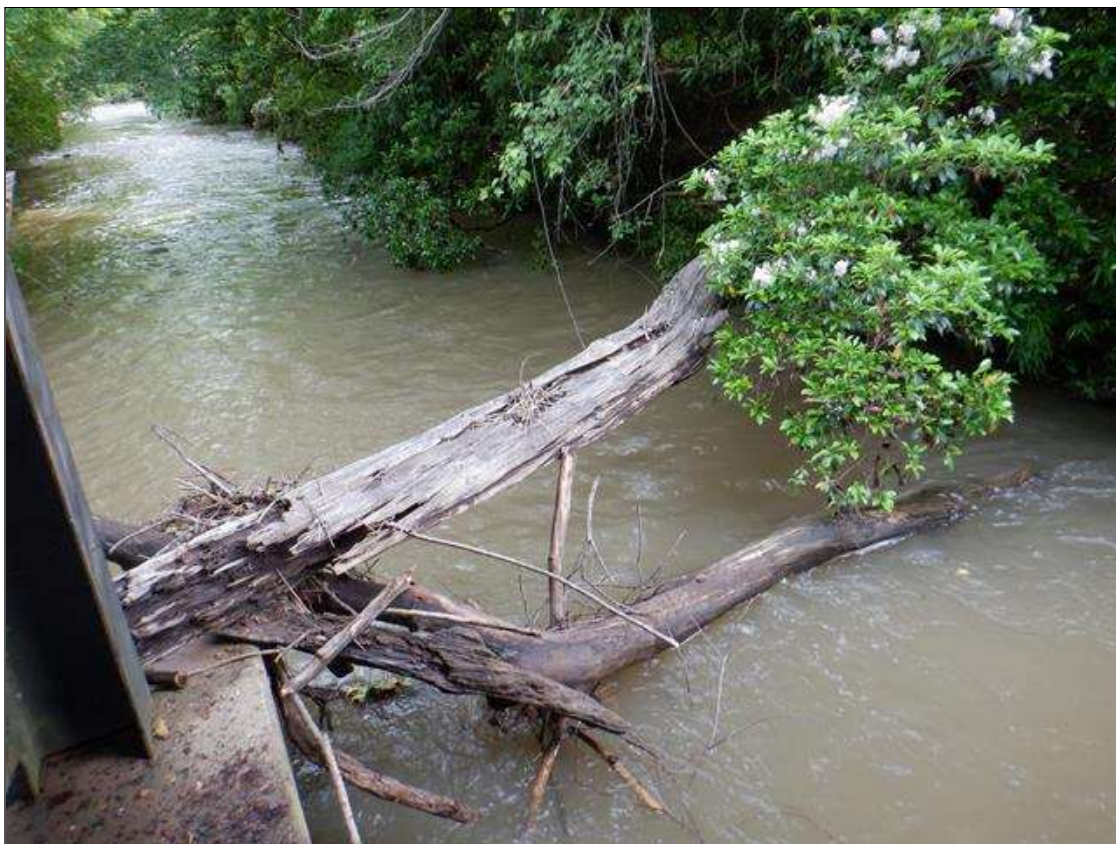
Drift: at bent 2 and West streambank, drift accumulation [up to 20in diameter]

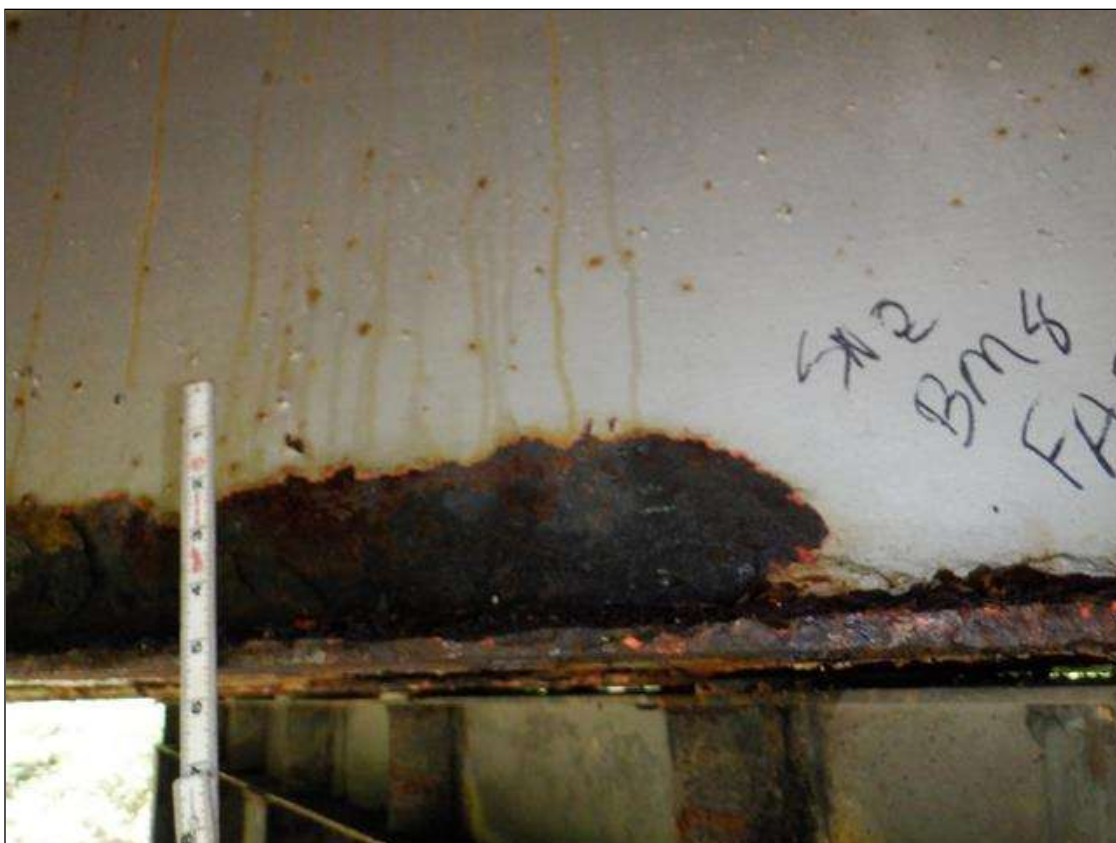
Span 2 Beam 8: [PAR] at 2ft from far end, active corrosion with section loss, South bottom flange [16in x 4in - avg rem 3/8in], lower web [28in x up to 2in - avg rem 1/4in]

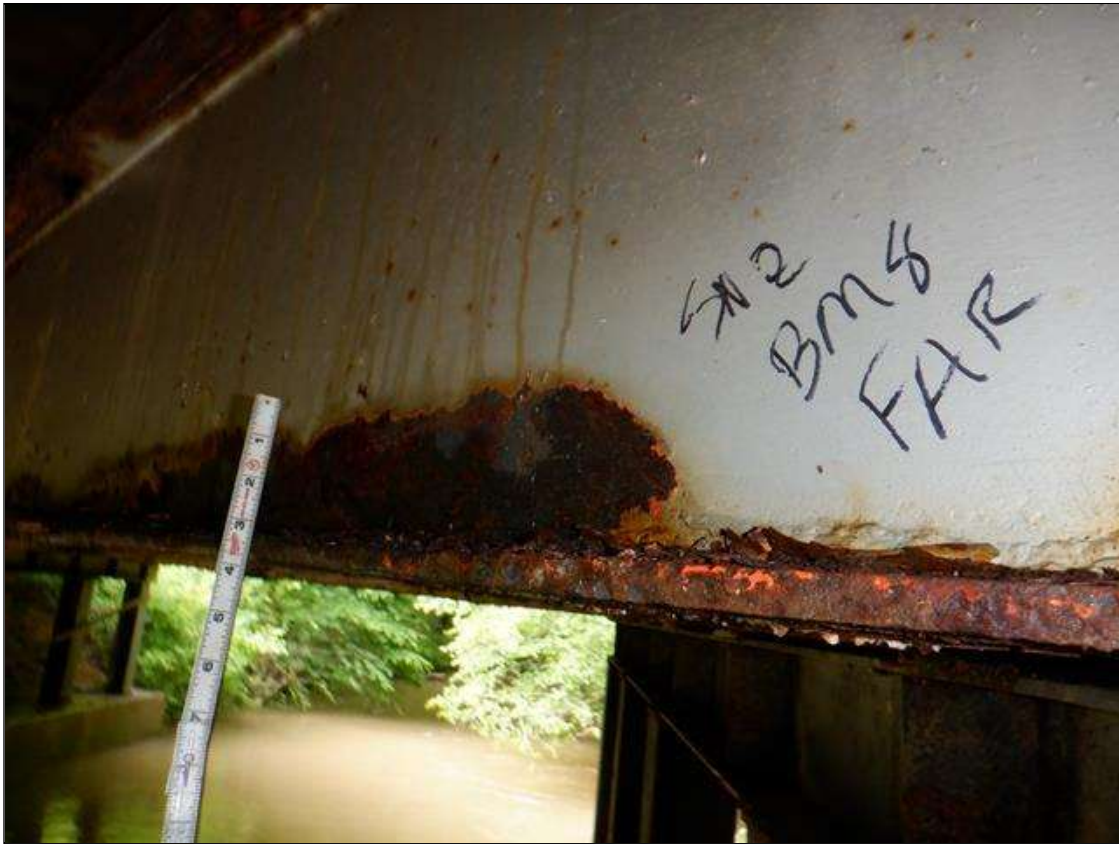
Span 2 Beam 8: [PAR] at 2ft from far end, active corrosion with section loss, South bottom flange [16in x 4in - avg rem 3/8in], lower web [28in x up to 2in - avg rem 1/4in]
