NC DEPARTMENT OF TRANSPORTATION
 DIVISION OF HIGHWAYS
 STRUCTURE MANAGEMENT UNIT

ATTENTION: PAR Submitted, Changes to Structure Data

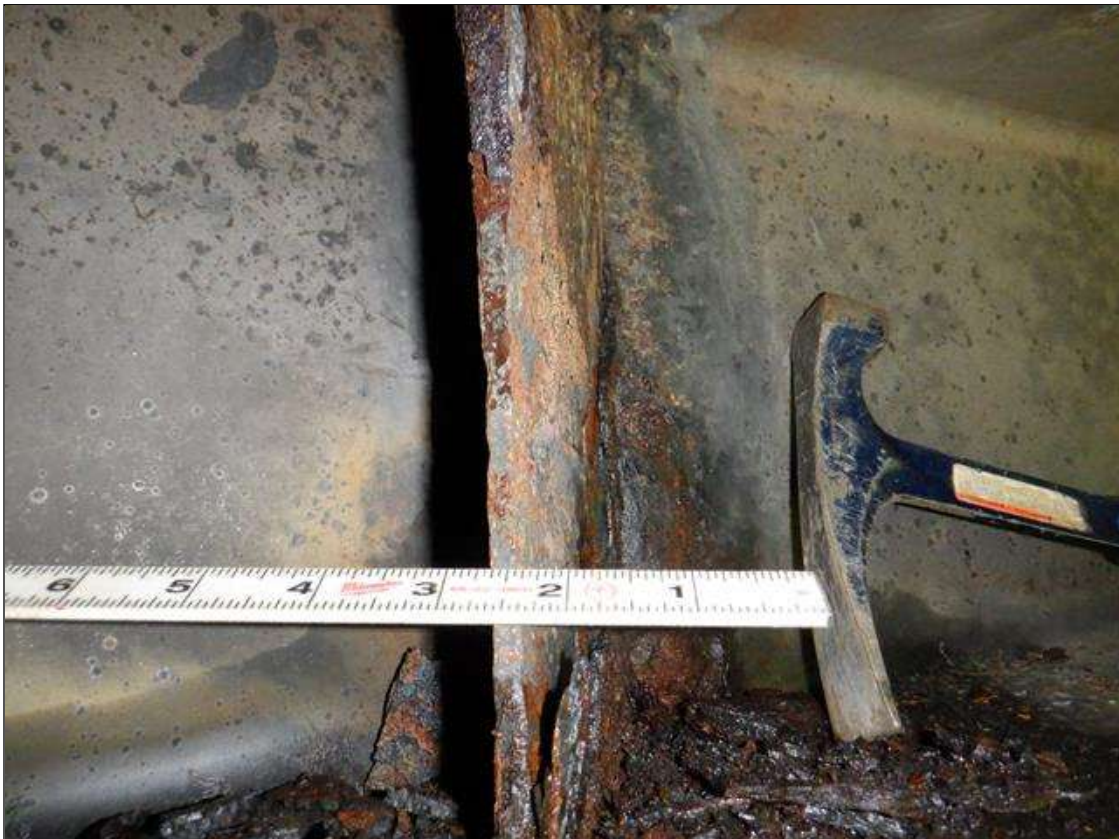
Bent 2 Cap 1: [PAR] along West face at stiffeners 2, 6, & 7, active corrosion with section loss [up to 6in x full width - avg rem 3/8in]; along East face at stiffeners 1, 2, & 7-9, active corrosion with section loss [8in x full width - avg rem 3/8in]

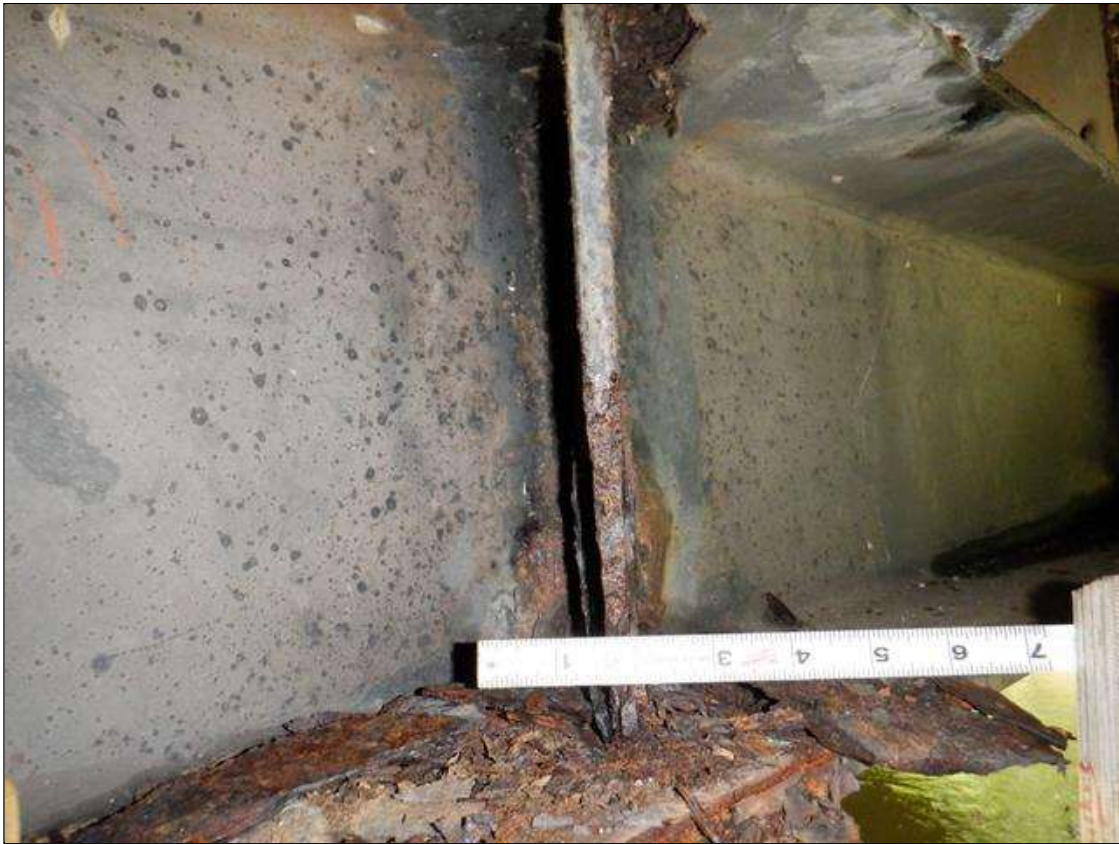
Bent 2 Cap 1: [PAR] along West face at stiffeners 2, 6, & 7, active corrosion with section loss [up to 6in x full width - avg rem 3/8in]; along East face at stiffeners 1, 2, & 7-9, active corrosion with section loss [8in x full width - avg rem 3/8in]

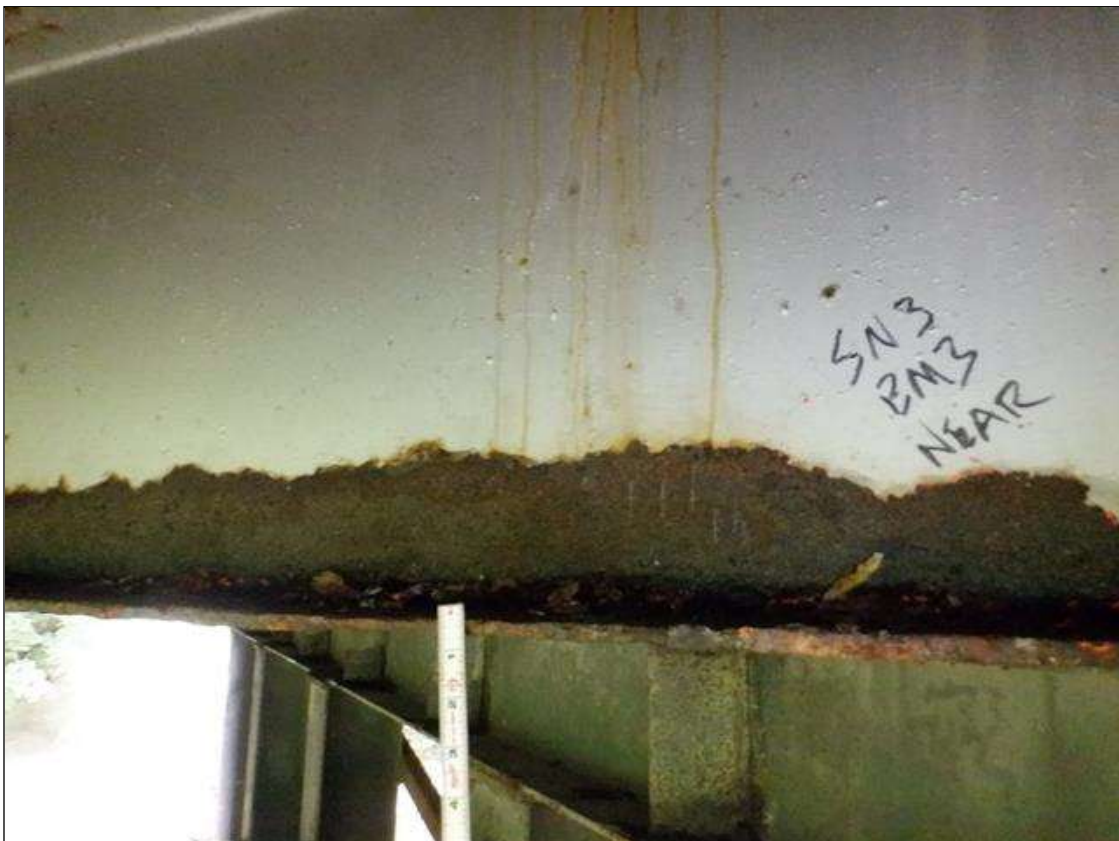
Span 3 Beam 3: [PAR] at 15in from near end, active corrosion with section loss; bottom flange [5ft x up to full width - avg rem 3/8in], lower web [52in x 3in - avg rem 5/16in]

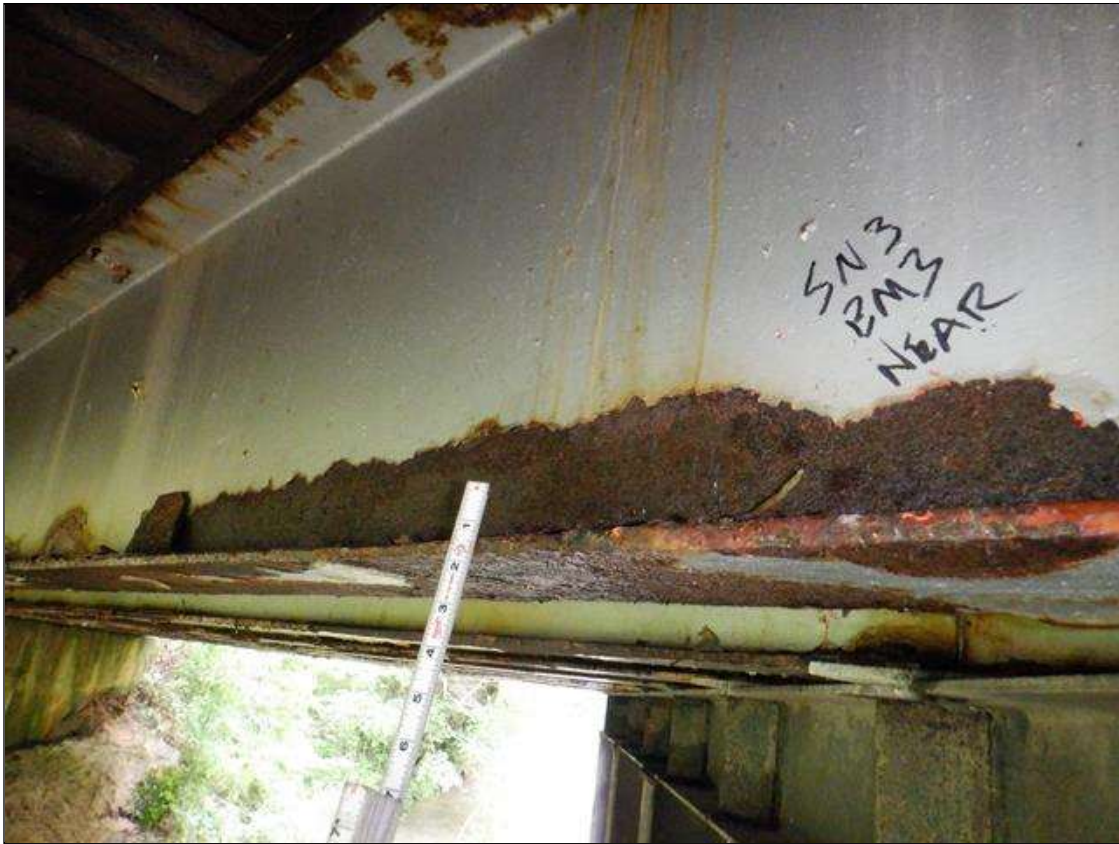
Span 3 Beam 3: [PAR] at 15in from near end, active corrosion with section loss; bottom flange [5ft x up to full width - avg rem 3/8in], lower web [52in x 3in - avg rem 5/16in]

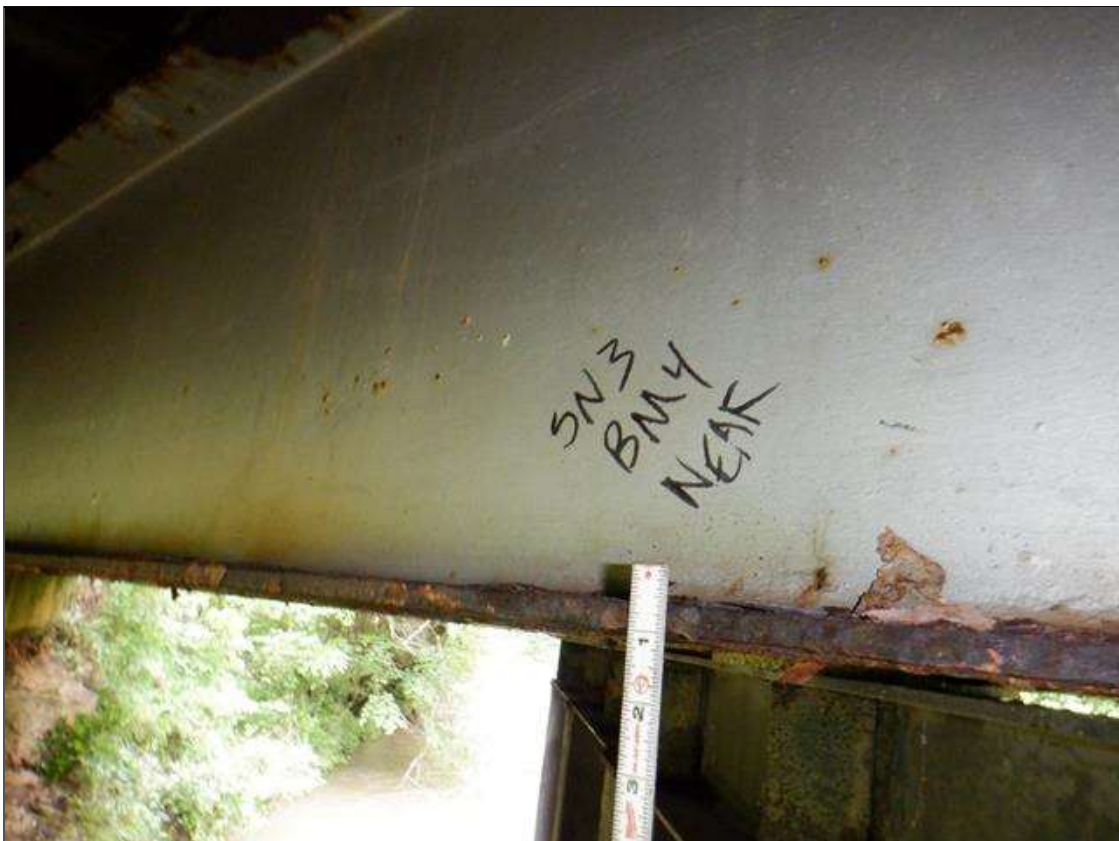
Span 3 Beam 4: [PAR] at near end, active corrosion with section loss; North bottom flange [4ft x 4in - avg rem 3/8in]

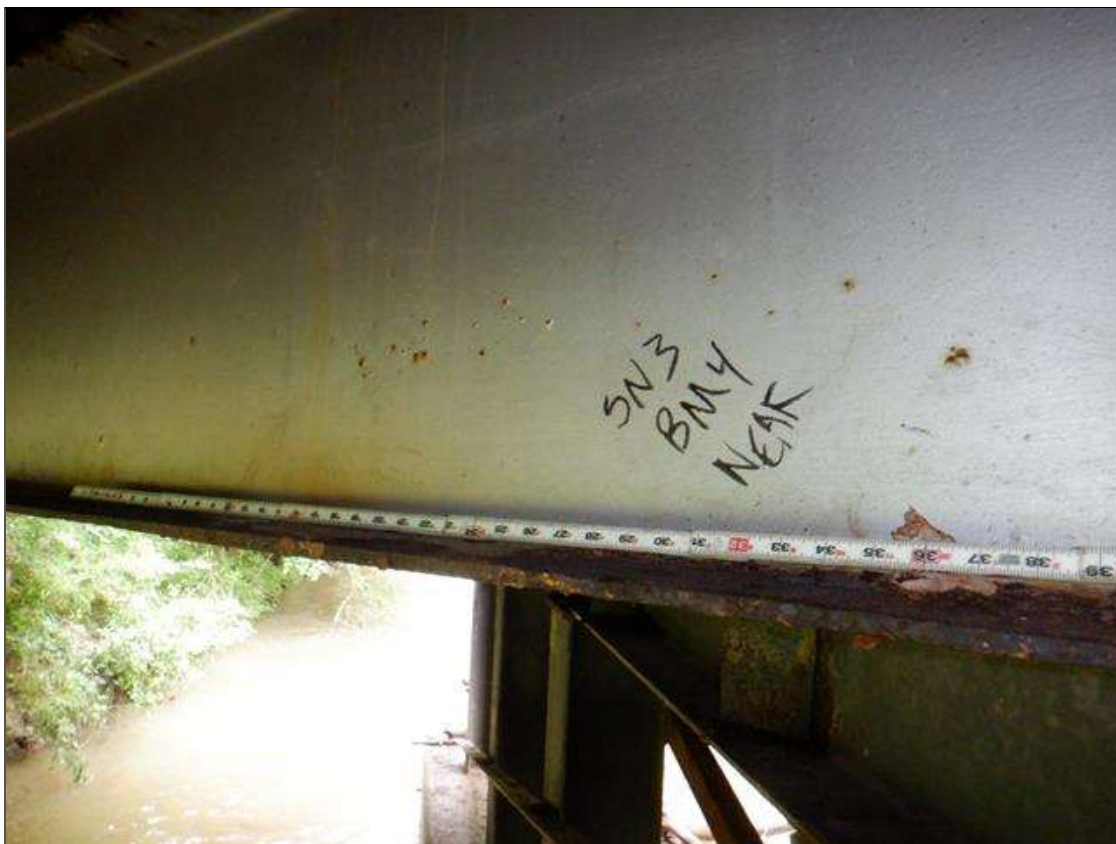
Span 3 Beam 4: [PAR] at near end, active corrosion with section loss; North bottom flange [4ft x 4in - avg rem 3/8in]

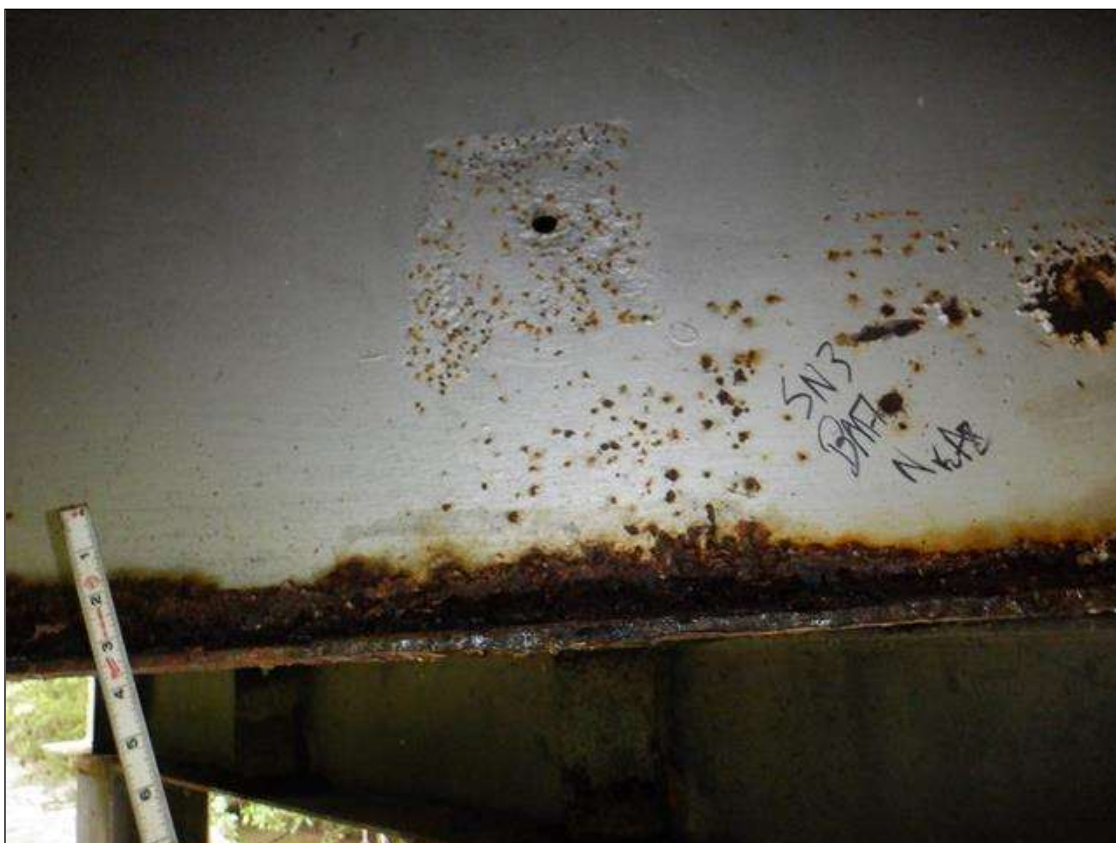
Span 3 Beam 7: [PAR] at 18in from near end, active corrosion with section loss; bottom flange [32in x up to full width - avg rem 3/8in]

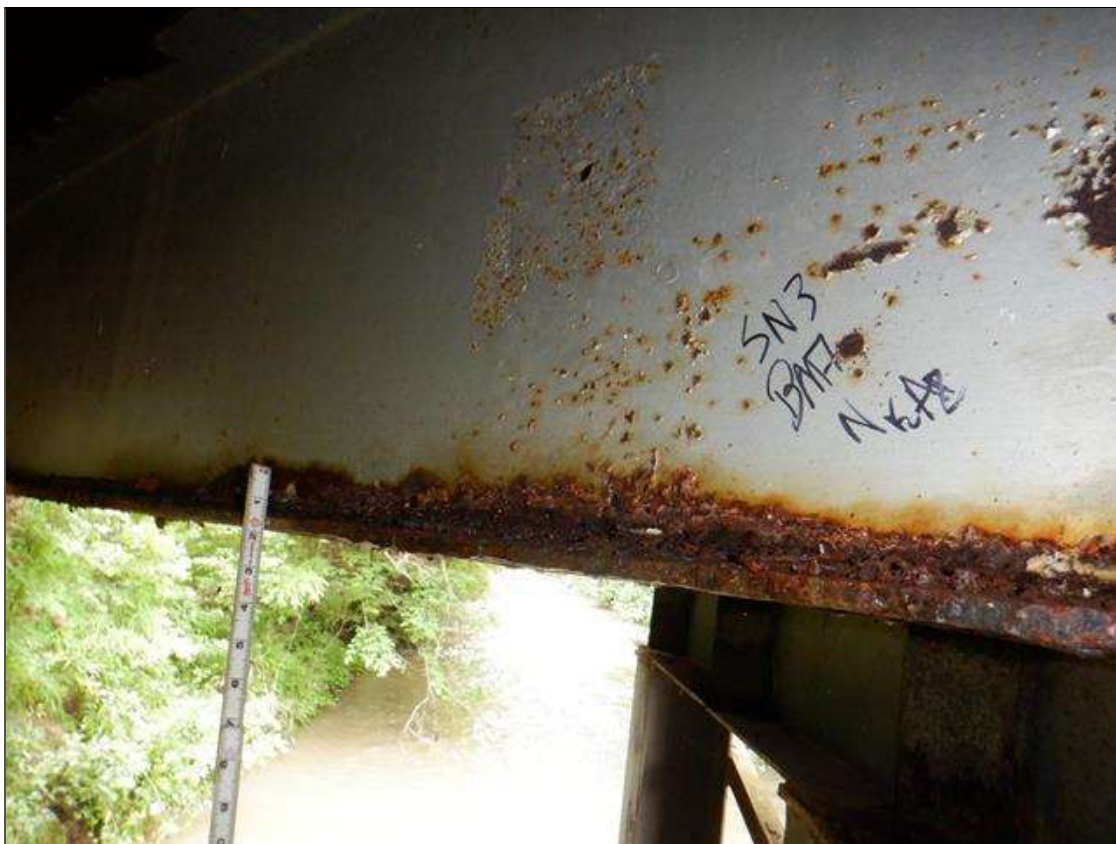
Span 3 Beam 7: [PAR] at 18in from near end, active corrosion with section loss; bottom flange [32in x up to full width - avg rem 3/8in]

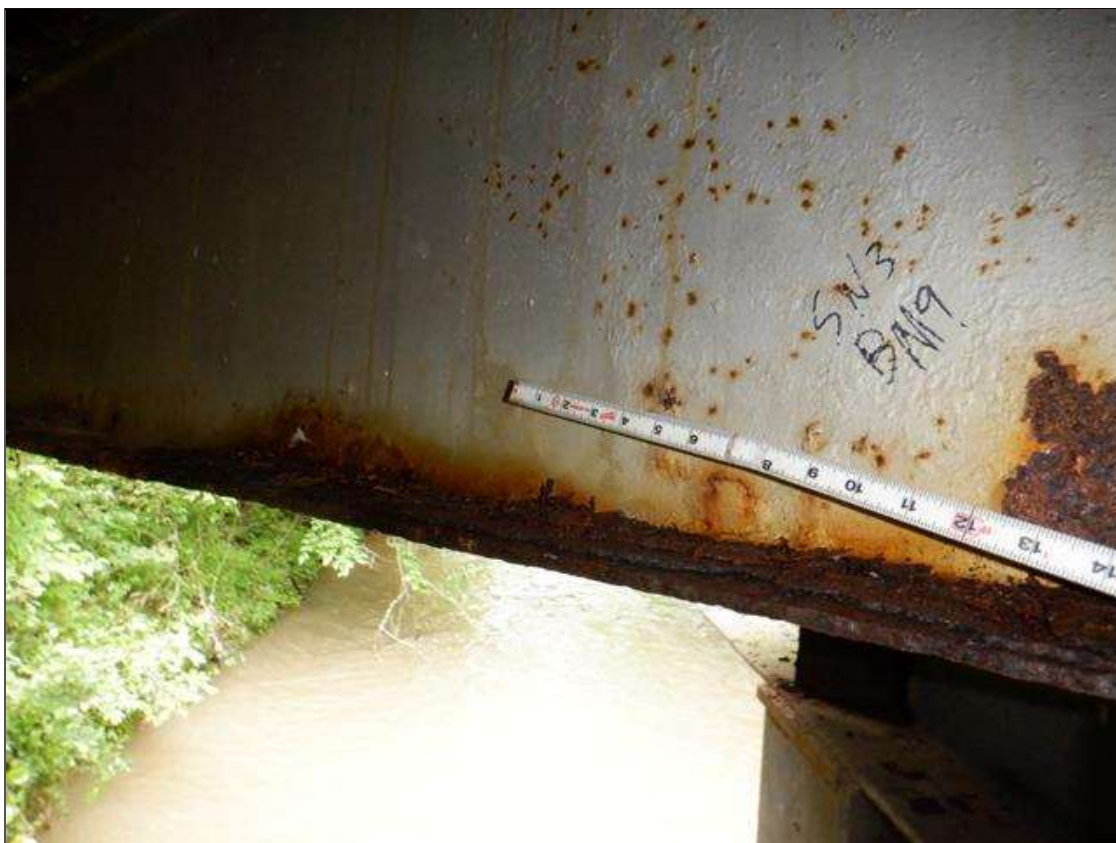
Span 3 Beam 9: [PAR] at near end, active corrosion with section loss; North bottom flange [41in x 4in - avg rem 3/8in]

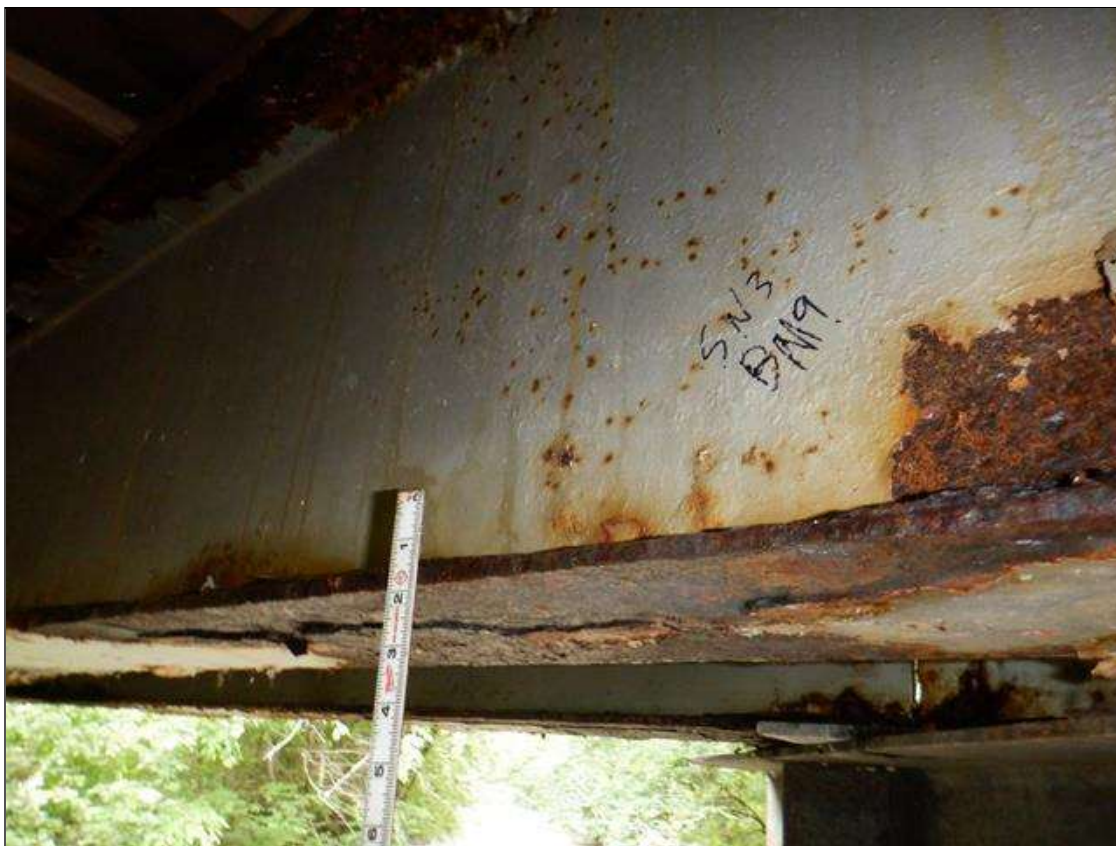
Span 3 Beam 9: [PAR] at near end, active corrosion with section loss; North bottom flange [41in x 4in - avg rem 3/8in]

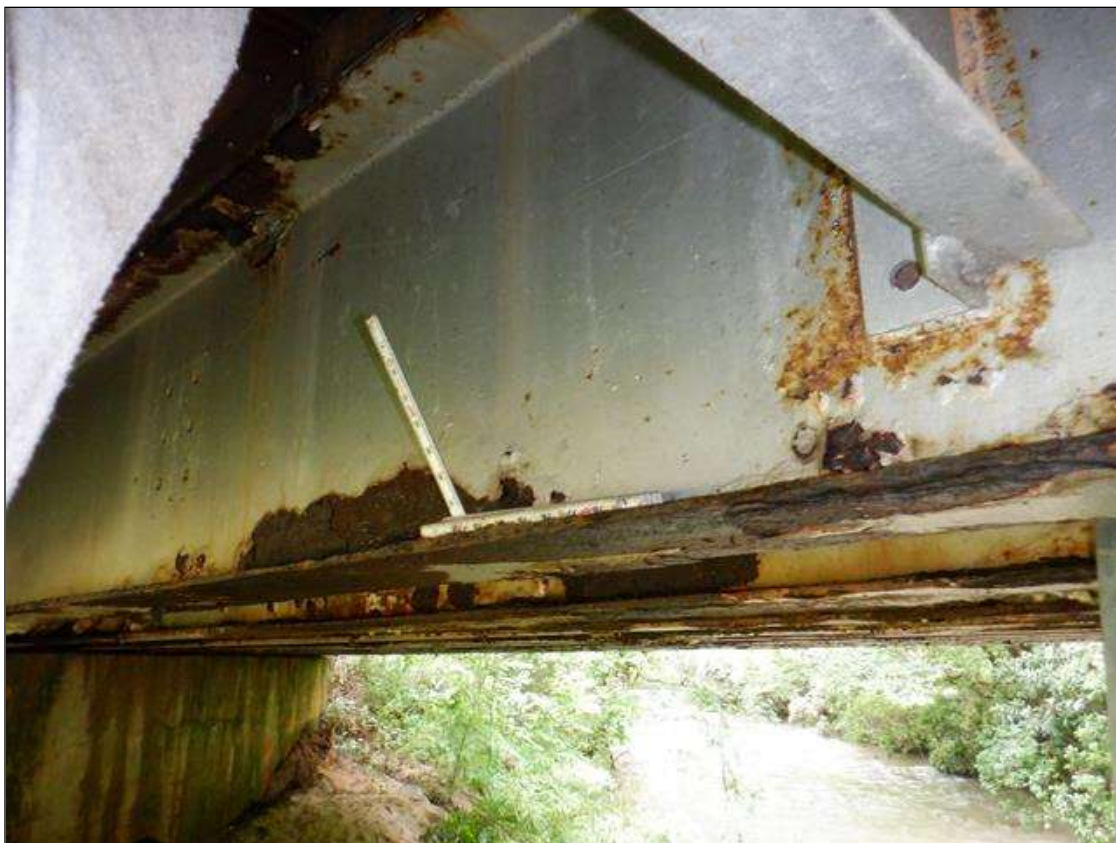
Span 3 Beam 2: [PAR] near midspan, active corrosion with section loss, bottom flange [10ft x full width - avg rem 0.35in], lower web [10ft x 4in - avg rem 5/16in]

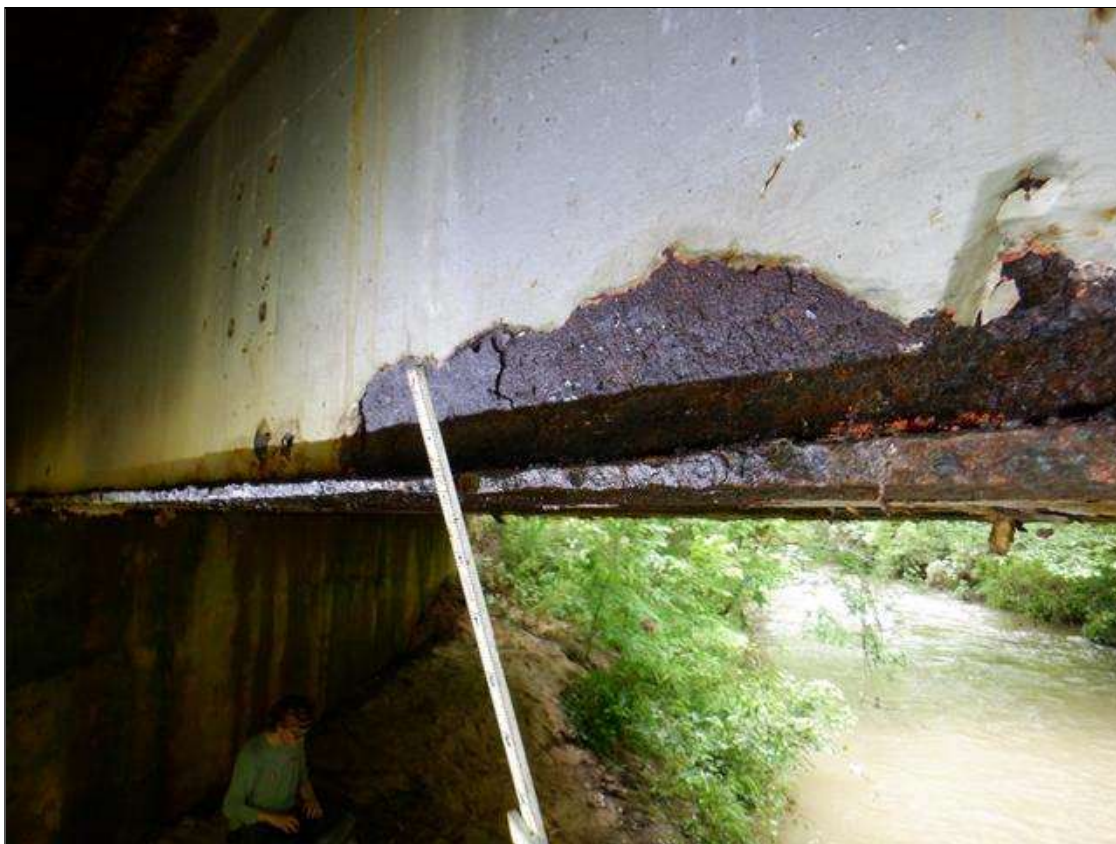
Span 3 Beam 2: [PAR] near midspan, active corrosion with section loss, bottom flange [10ft x full width - avg rem 0.35in], lower web [10ft x 4in - avg rem 5/16in]

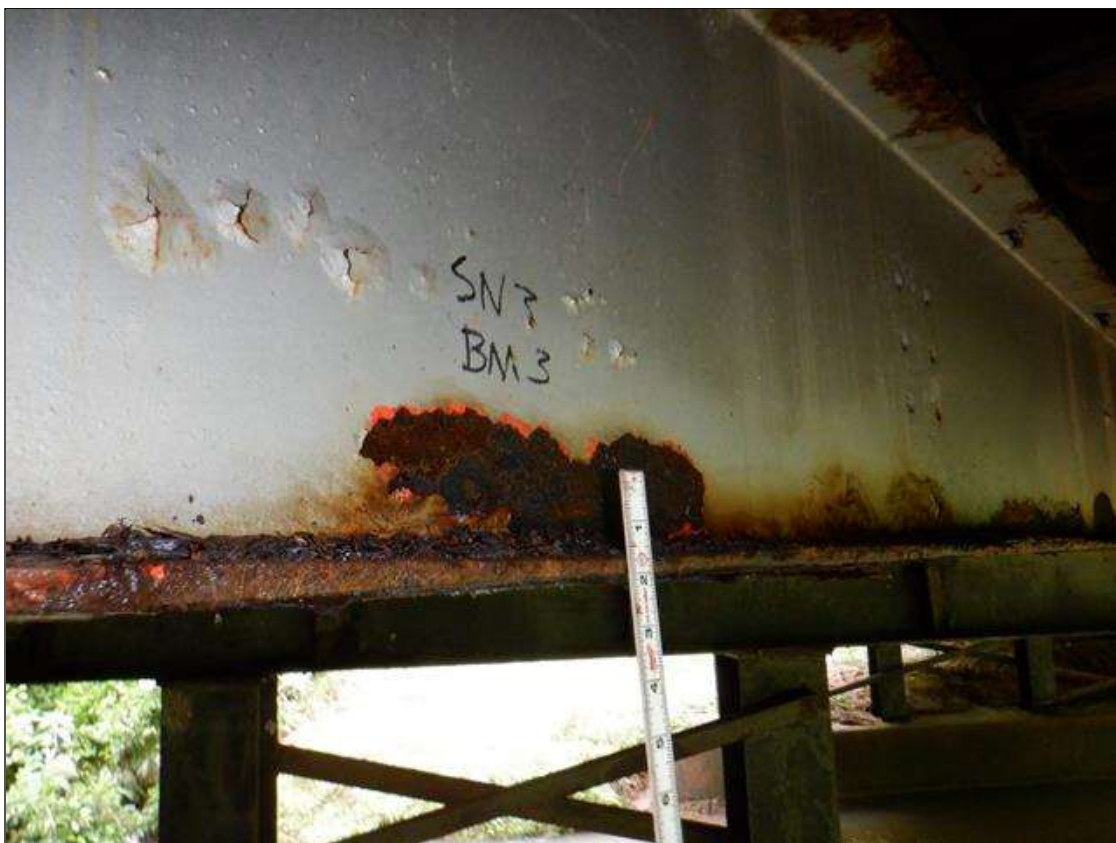
Span 3 Beam 3: [PAR] at midspan, active corrosion with section loss; bottom flange [up to 10ft x full width - avg rem 0.36in], lower web [up to 10ft x 4in - avg rem 5/16in]

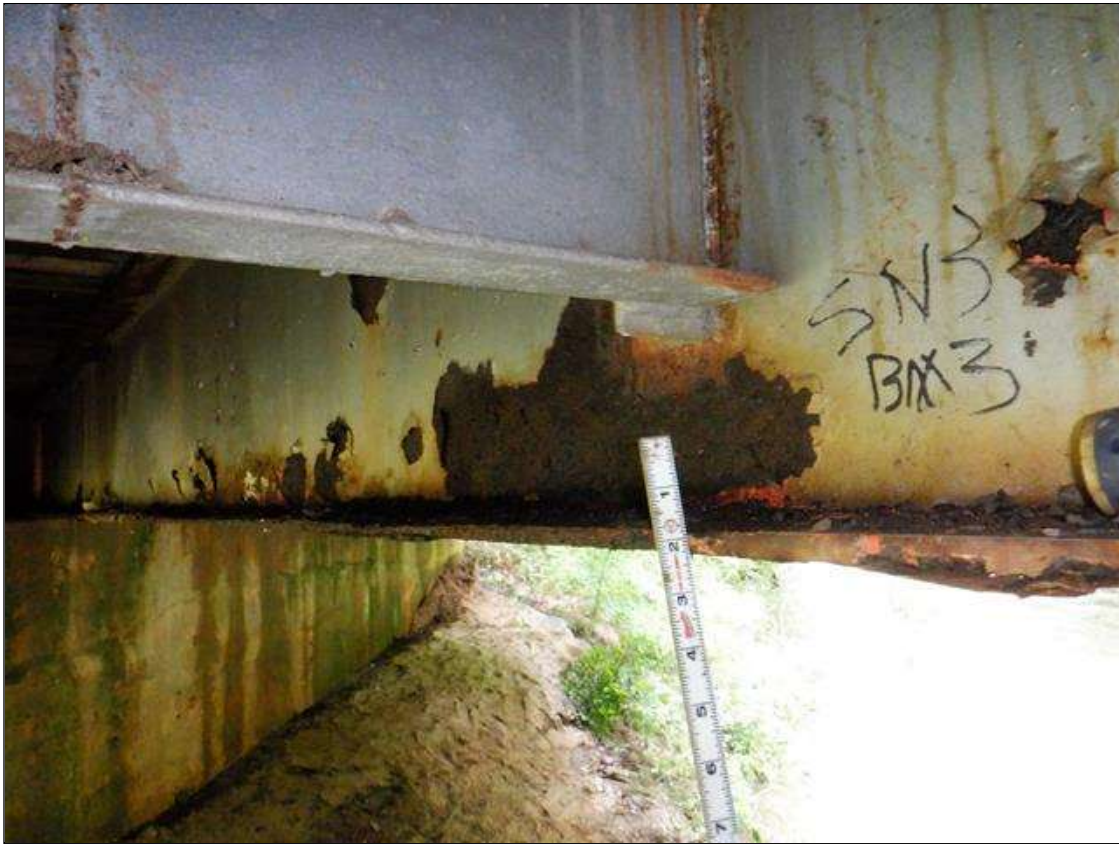
Span 3 Beam 3: [PAR] at midspan, active corrosion with section loss; bottom flange [up to 10ft x full width - avg rem 0.36in], lower web [up to 10ft x 4in - avg rem 5/16in]

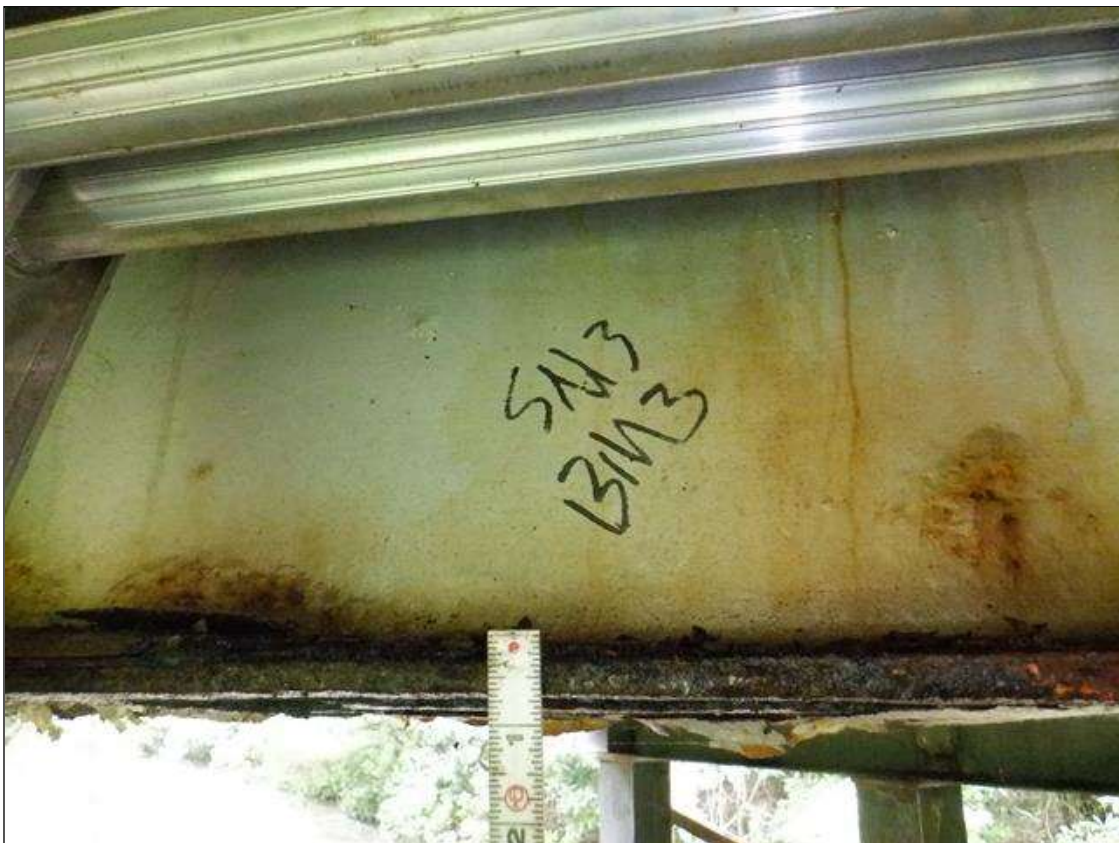
Span 3 Beam 3: [PAR] at midspan, active corrosion with section loss; bottom flange [up to 10ft x full width - avg rem 0.36in], lower web [up to 10ft x 4in - avg rem 5/16in]

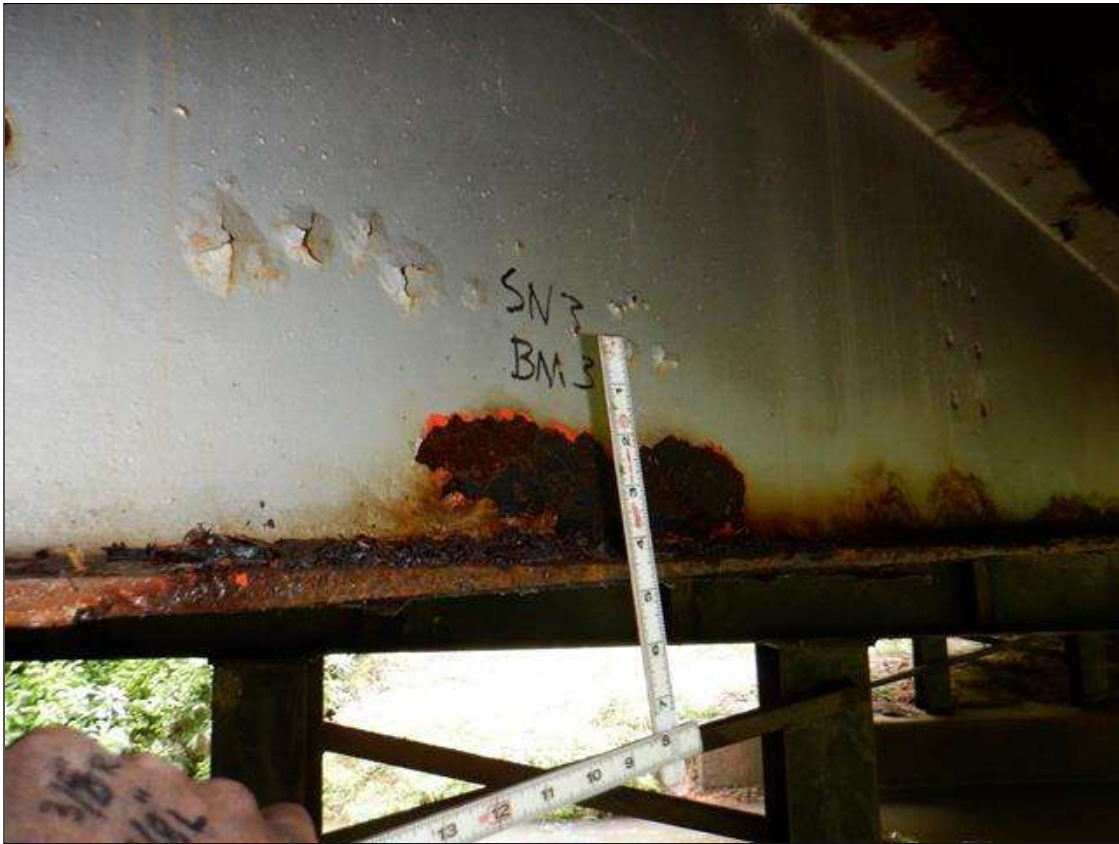
Span 3 Beam 3: [PAR] at midspan, active corrosion with section loss; bottom flange [up to 10ft x full width - avg rem 0.36in], lower web [up to 10ft x 4in - avg rem 5/16in]

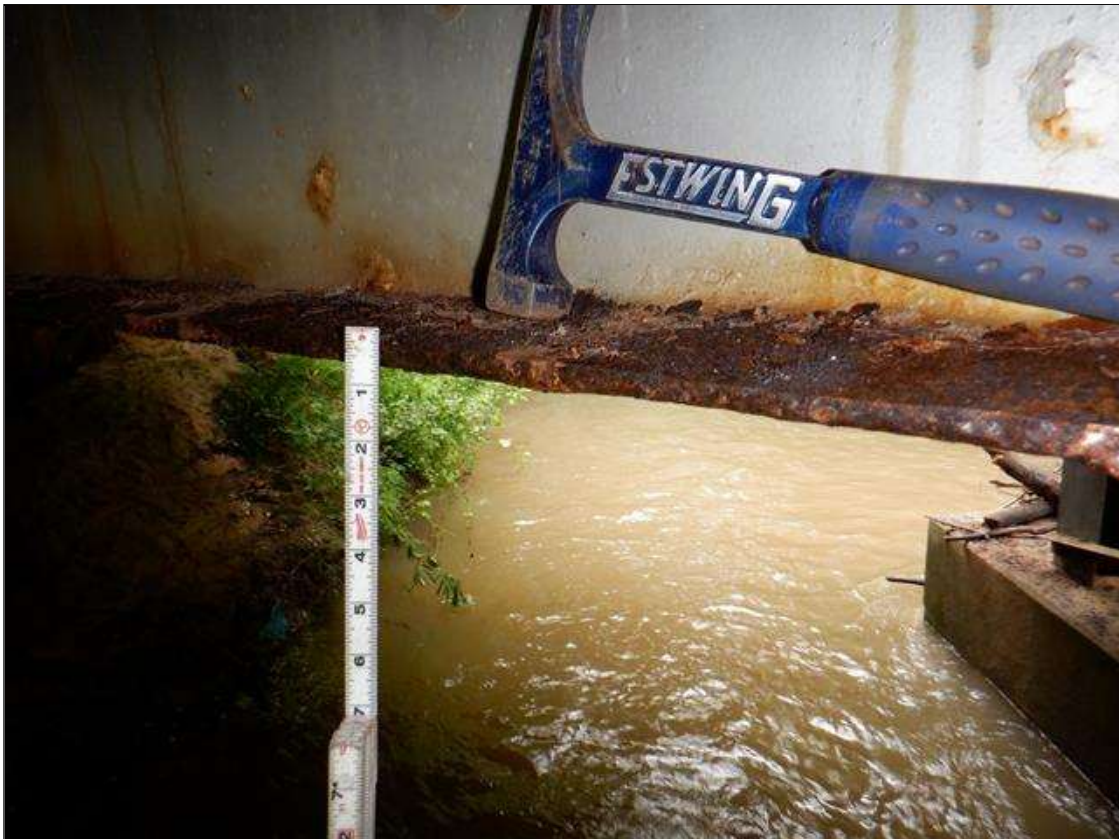
Span 3 Beam 4: [PAR] near midspan, active corrosion with section loss; top flange [up to 30in x up to full width - avg rem 5/16in], bottom flange [62in x up to full width - avg rem 7/16in]

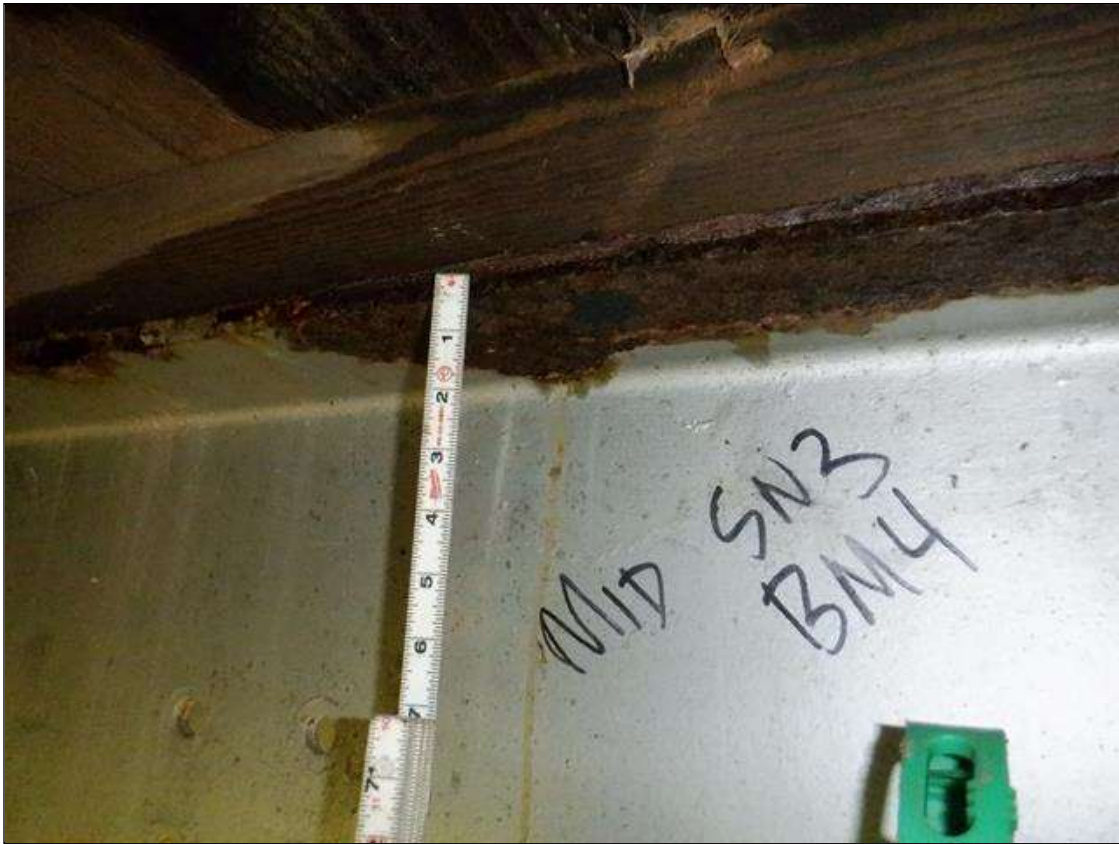
Span 3 Beam 4: [PAR] near midspan, active corrosion with section loss; top flange [up to 30in x up to full width - avg rem 5/16in], bottom flange [62in x up to full width - avg rem 7/16in]

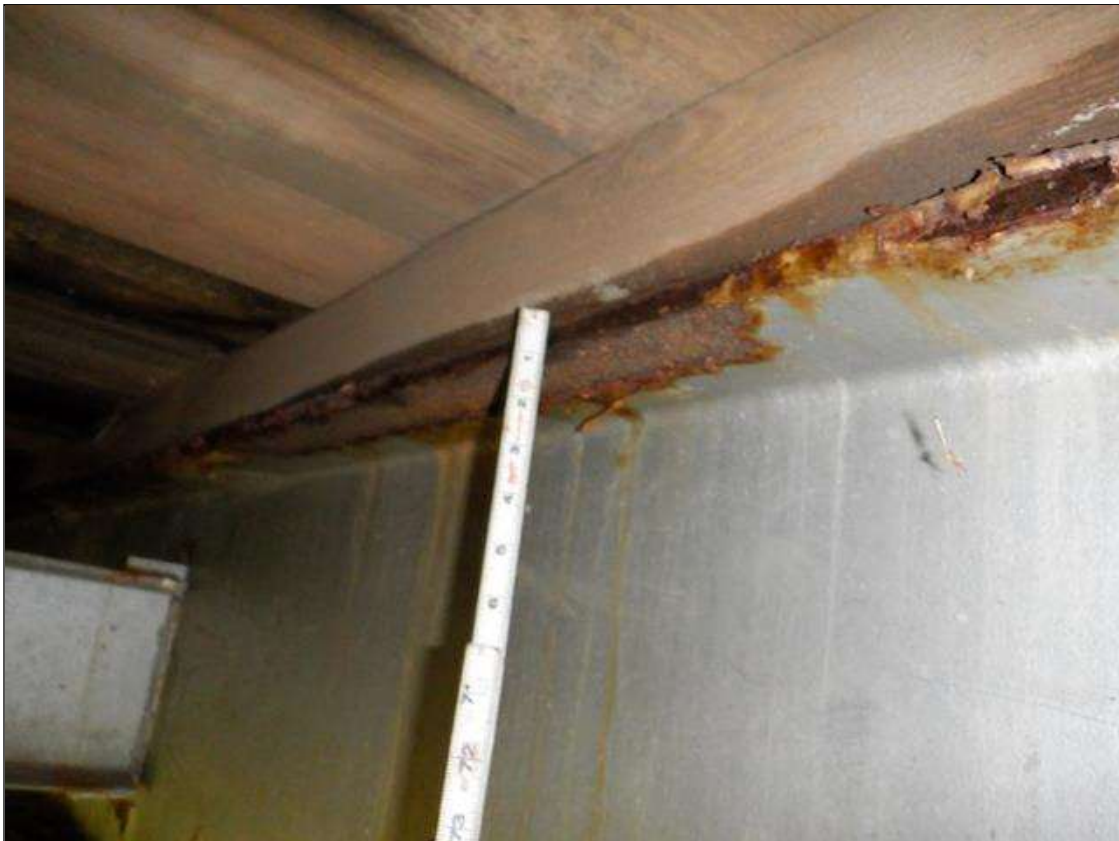
Span 3 Beam 4: [PAR] near midspan, active corrosion with section loss; top flange [up to 30in x up to full width - avg rem 5/16in], bottom flange [62in x up to full width - avg rem 7/16in]

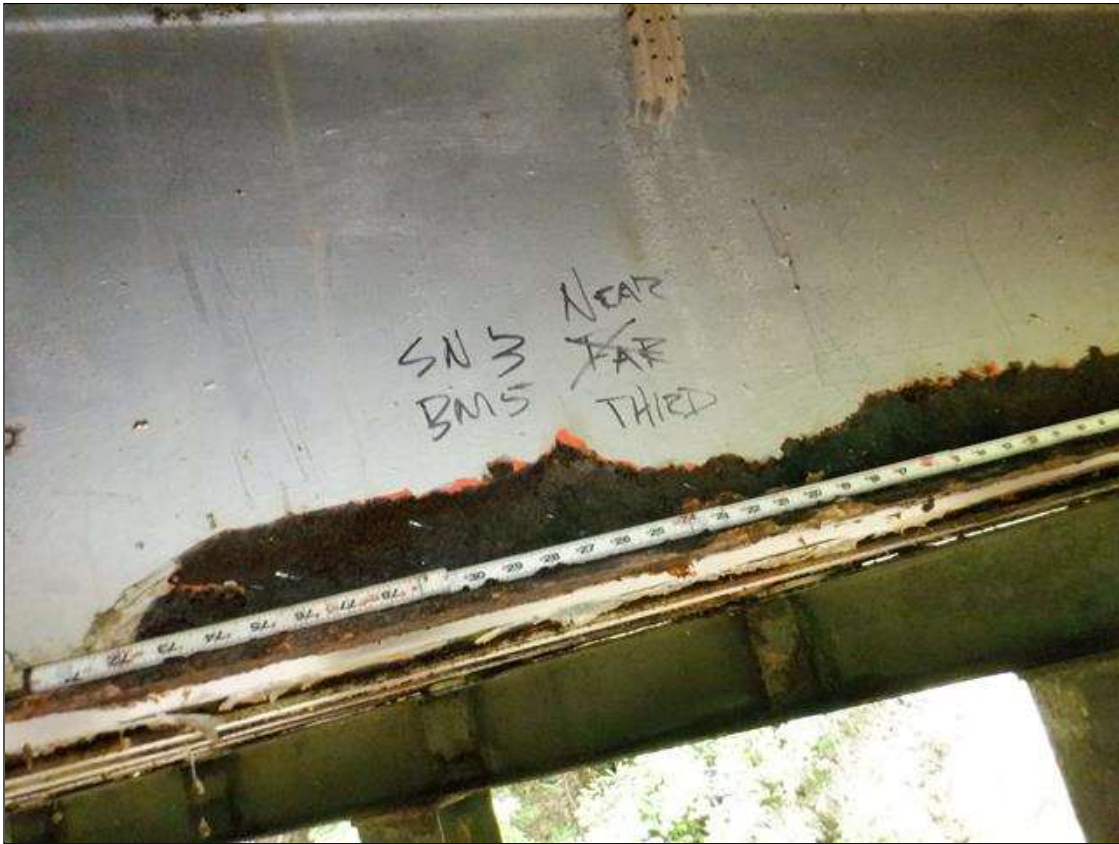
Span 3 Beam 5: [PAR] at near third, active corrosion with section loss; bottom flange [36in x up to full width - avg rem 3/8in], lower web [40in x up to 3in - avg rem 1/4in]

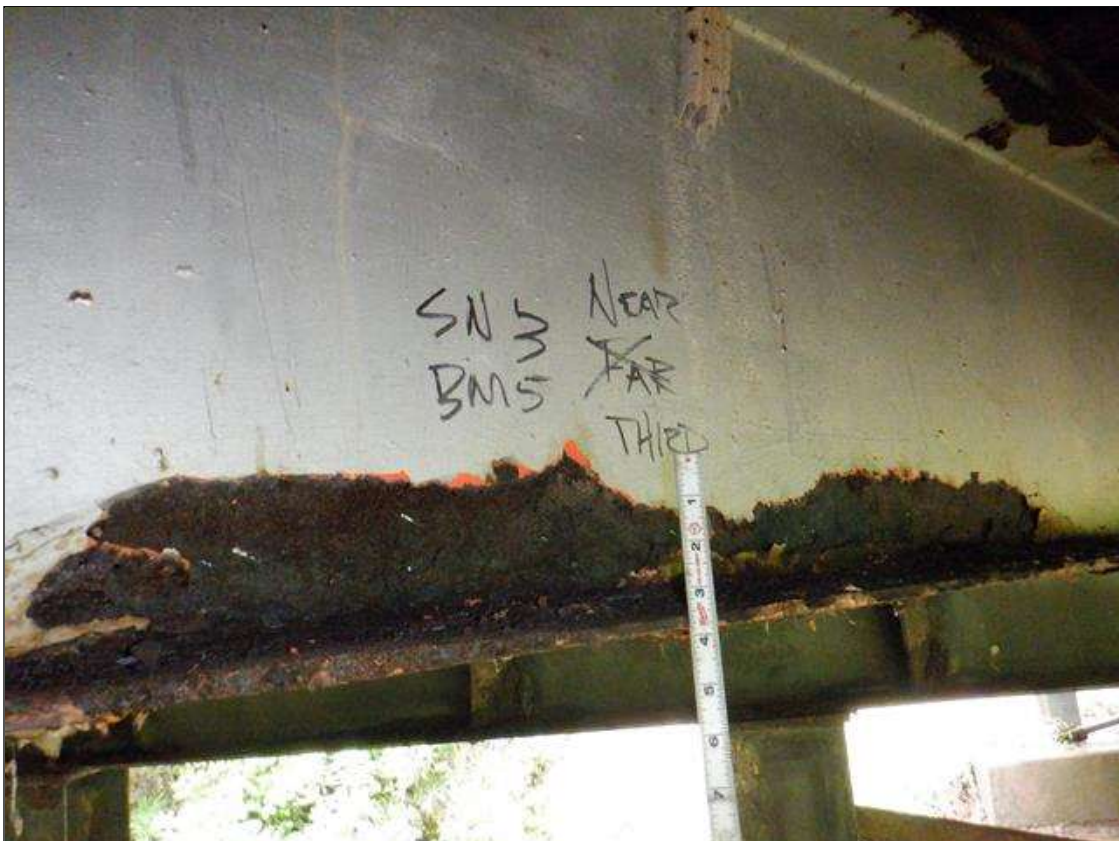
Span 3 Beam 5: [PAR] at near third, active corrosion with section loss; bottom flange [36in x up to full width - avg rem 3/8in], lower web [40in x up to 3in - avg rem 1/4in]

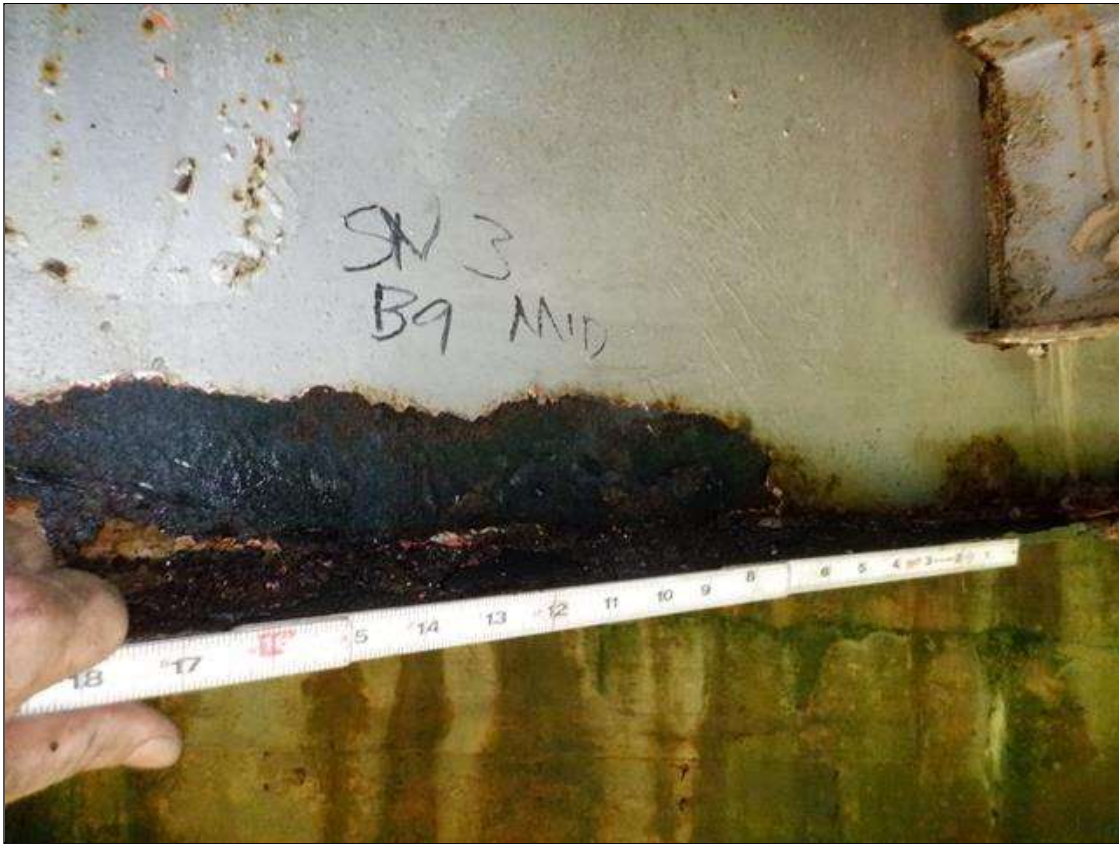
Span 3 Beam 9: [PAR] near midspan, active corrosion with section loss; bottom flange [24in x full width - avg rem 3/8in], lower web [20in x 2in - avg rem 1/4in]

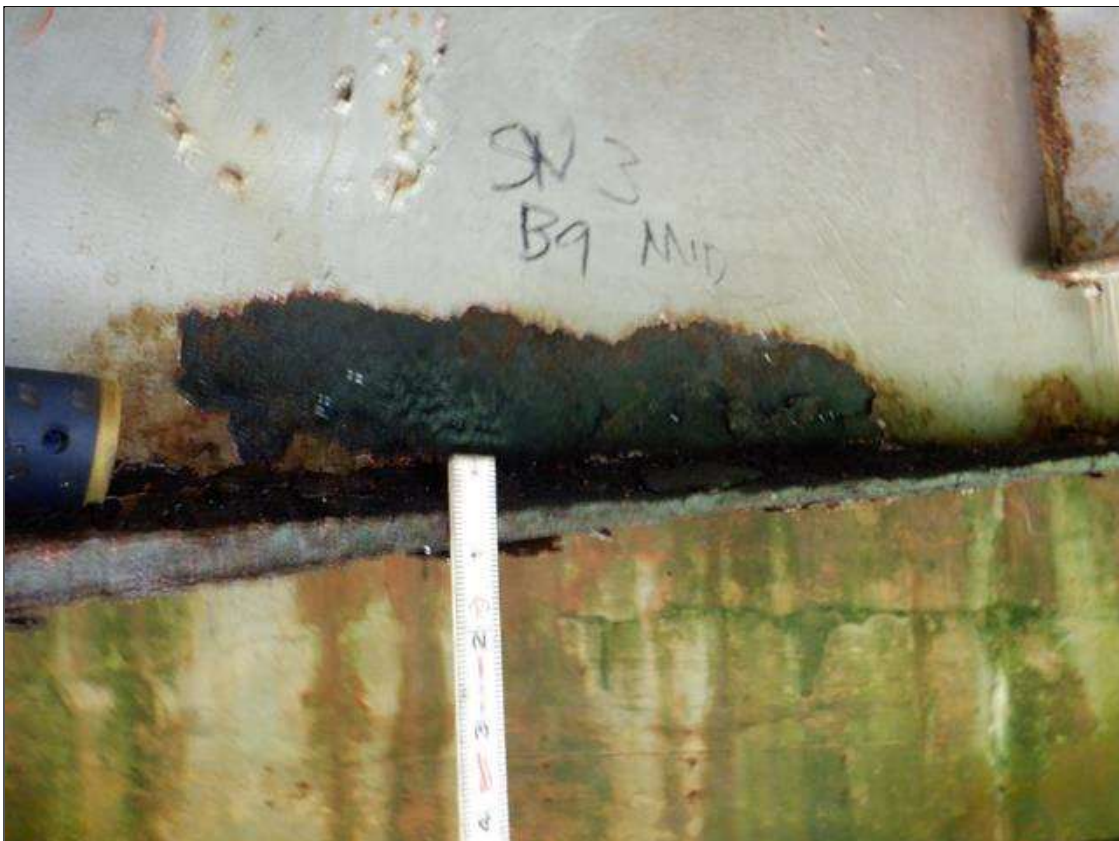
Span 3 Beam 9: [PAR] near midspan, active corrosion with section loss; bottom flange [24in x full width - avg rem 3/8in], lower web [20in x 2in - avg rem 1/4in]
