NC DEPARTMENT OF TRANSPORTATION
 DIVISION OF HIGHWAYS
 STRUCTURE MANAGEMENT UNIT

ATTENTION: PAR Submitted, Changes to Structure Data

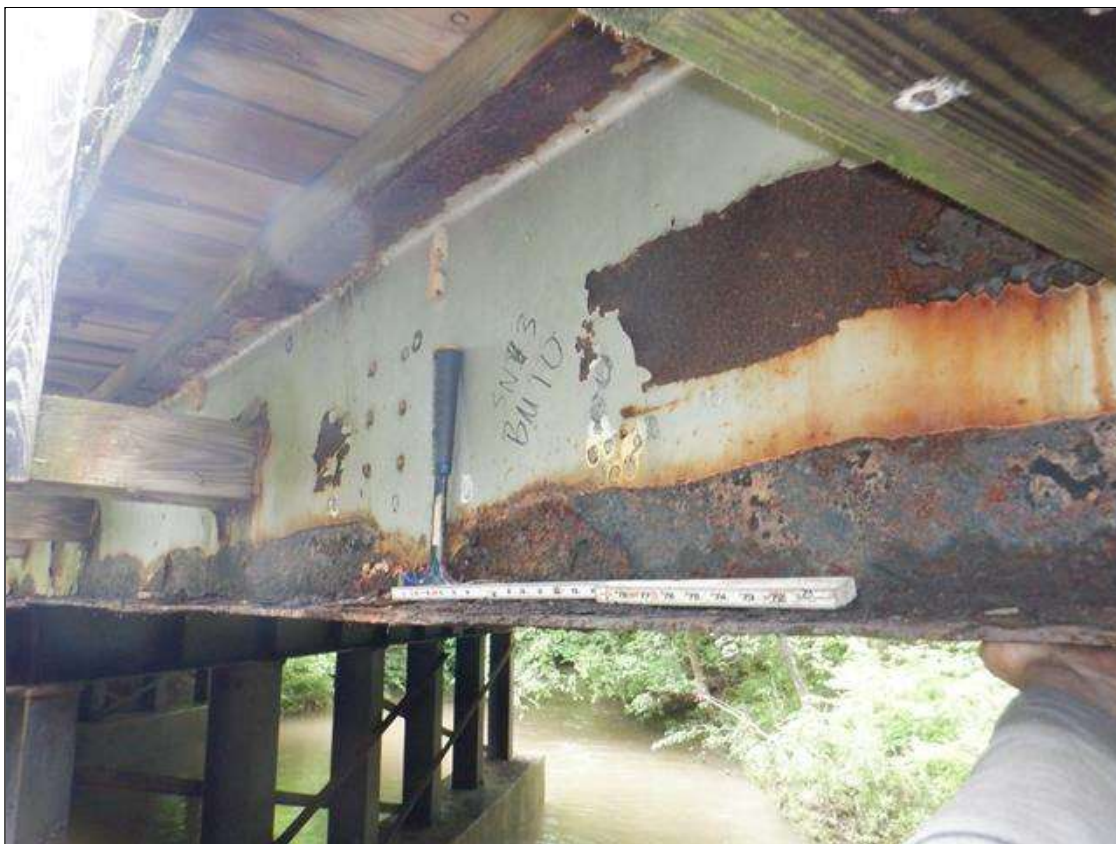
Span 3 Beam 10: [PAR] along length, active corrosion with section loss; top and bottom flange [full length x up to full width - avg rem 1/4in, with edges down to 1/16in], lower web [full length x up to 4in - avg rem 1/4in, with areas down to 3/16in], web at rail attachments [12in diameter - avg rem 1/4in]

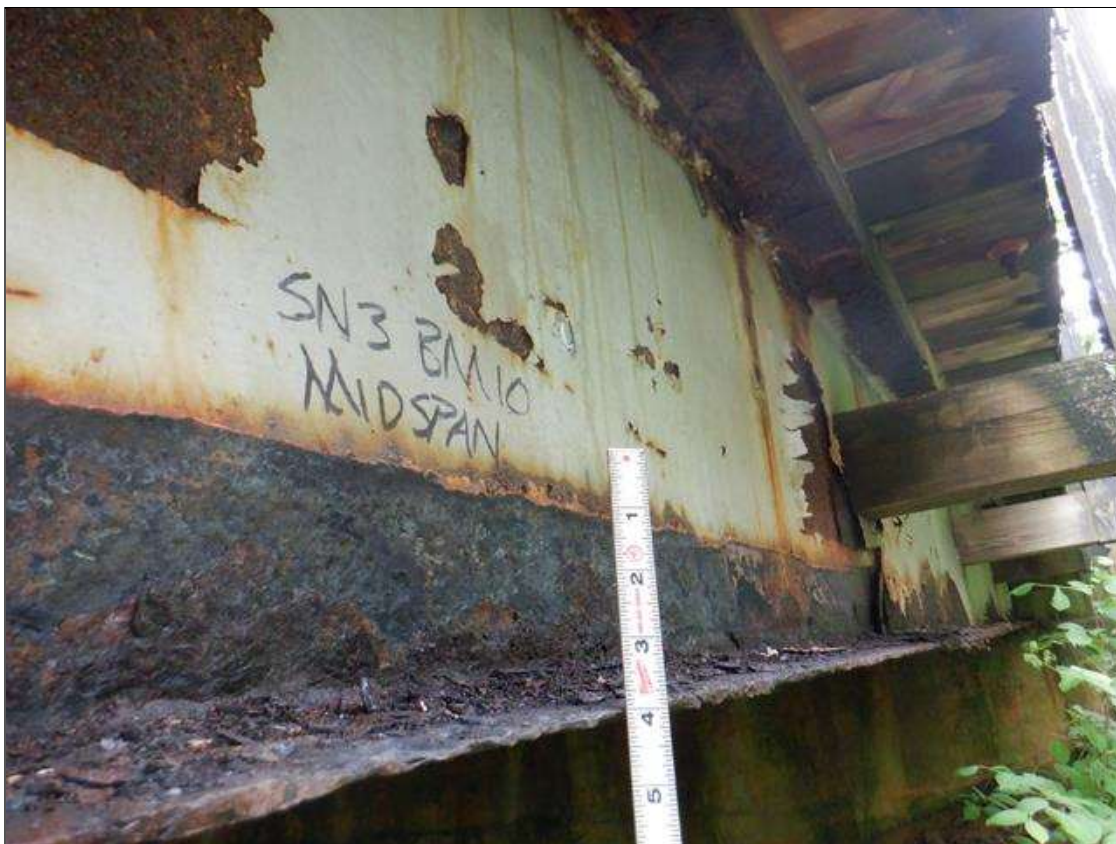
Span 3 Beam 10: [PAR] along length, active corrosion with section loss; top and bottom flange [full length x up to full width - avg rem 1/4in, with edges down to 1/16in], lower web [full length x up to 4in - avg rem 1/4in, with areas down to 3/16in], web at rail attachments [12in diameter - avg rem 1/4in]

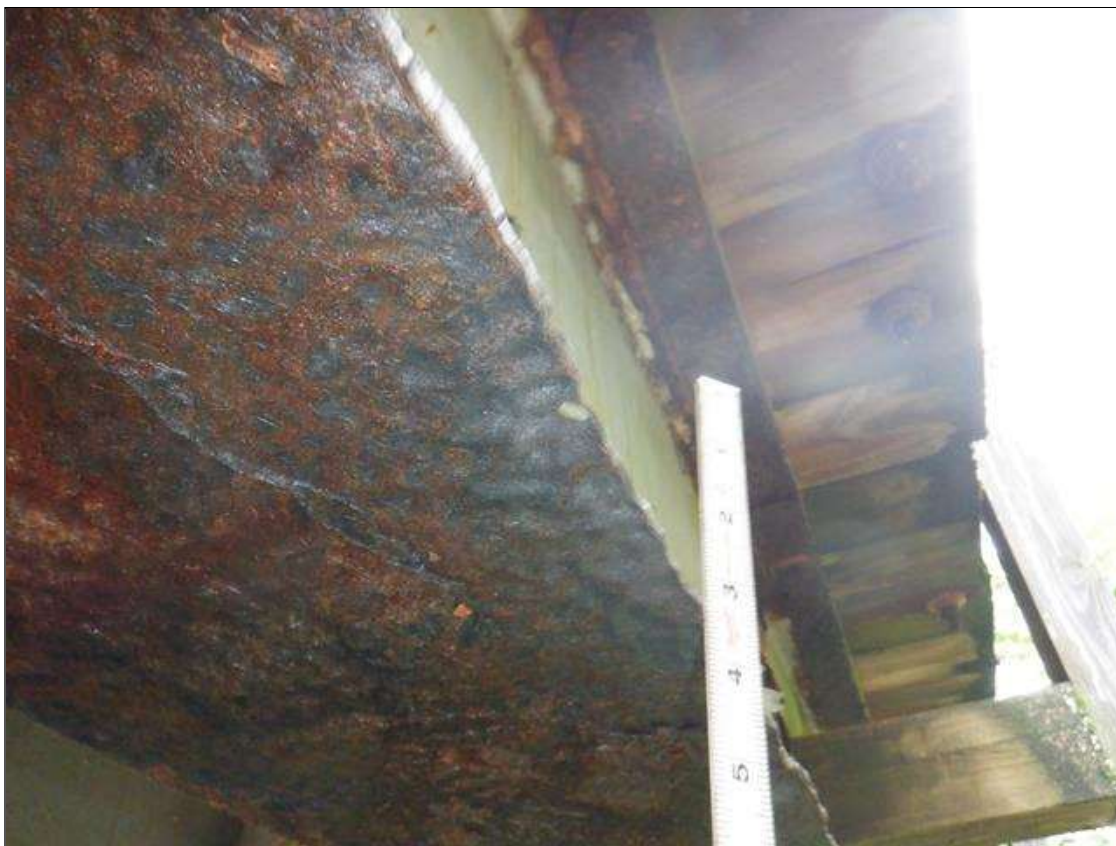
Span 3 Beam 10: [PAR] along length, active corrosion with section loss; top and bottom flange [full length x up to full width - avg rem 1/4in, with edges down to 1/16in], lower web [full length x up to 4in - avg rem 1/4in, with areas down to 3/16in], web at rail attachments [12in diameter - avg rem 1/4in]

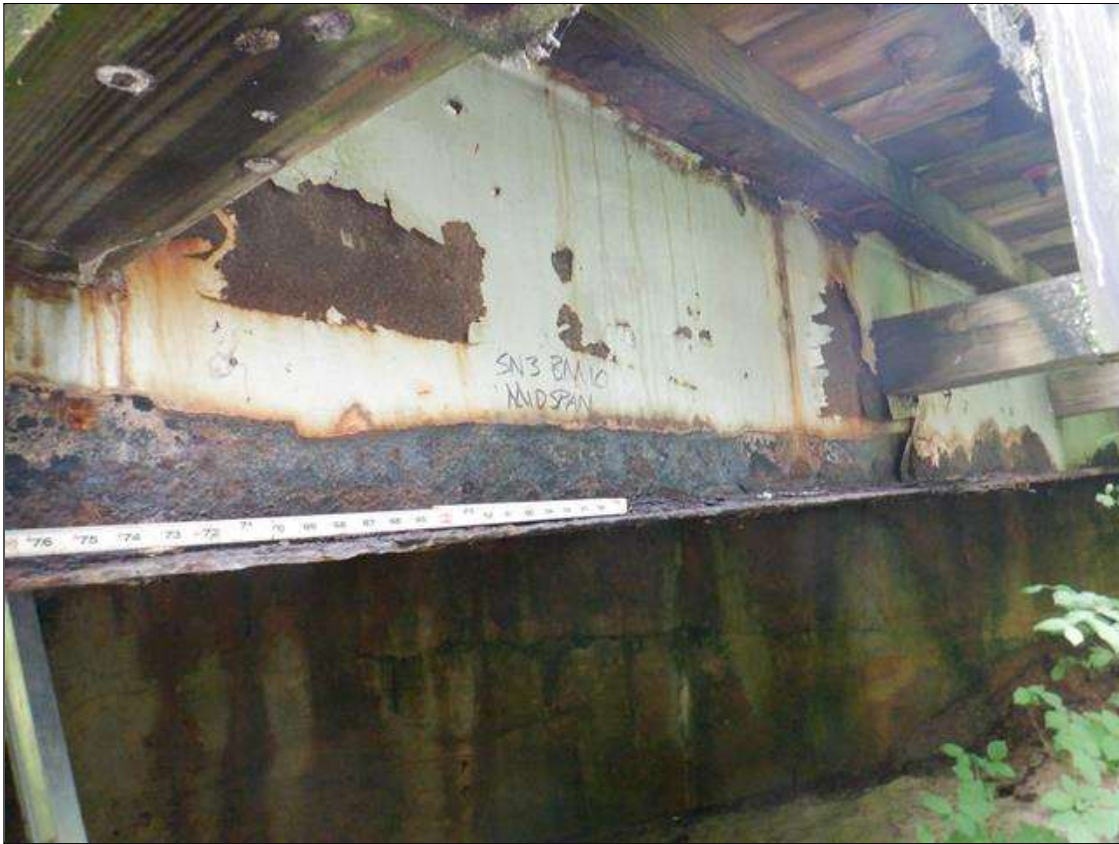
Span 3 Beam 10: [PAR] along length, active corrosion with section loss; top and bottom flange [full length x up to full width - avg rem 1/4in, with edges down to 1/16in], lower web [full length x up to 4in - avg rem 1/4in, with areas down to 3/16in], web at rail attachments [12in diameter - avg rem 1/4in]

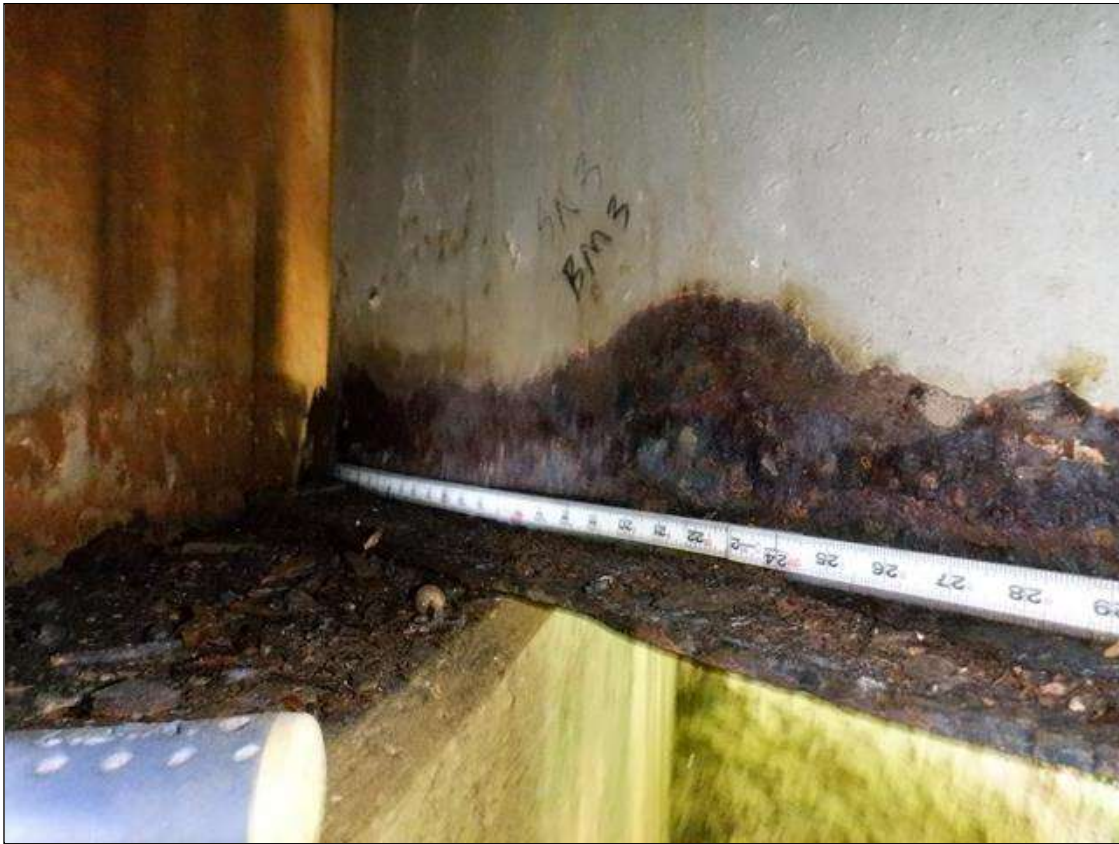
Span 3 Beam 3: [PAR] at far end, active corrosion with section loss; bottom flange [23in x up to full width - avg rem 3/8in], lower web [up to 32in x up to 5in - avg rem 5/16in]

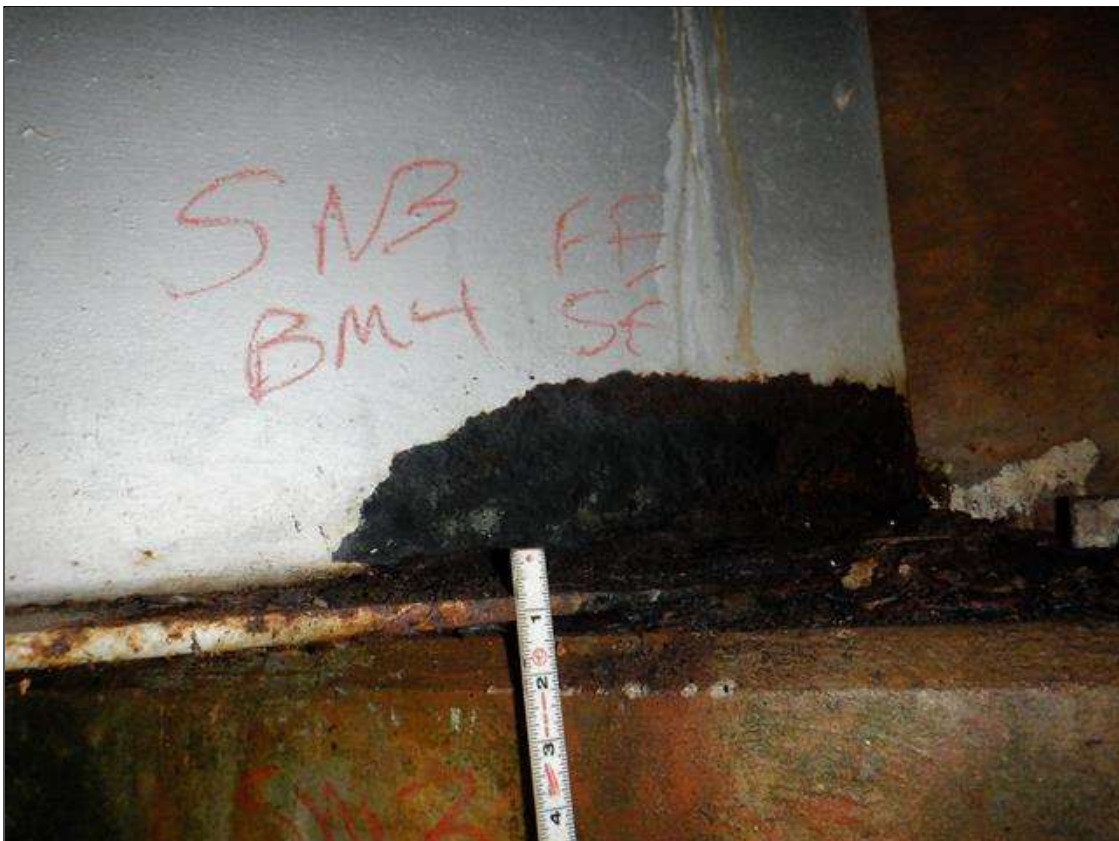
Span 3 Beam 4: [PAR] at far end, active corrosion with section loss, bottom flange [up to 24in x full width - avg rem 3/8in, with areas down to 3/16in], lower web [22in x up to 4in - avg rem 1/4in]

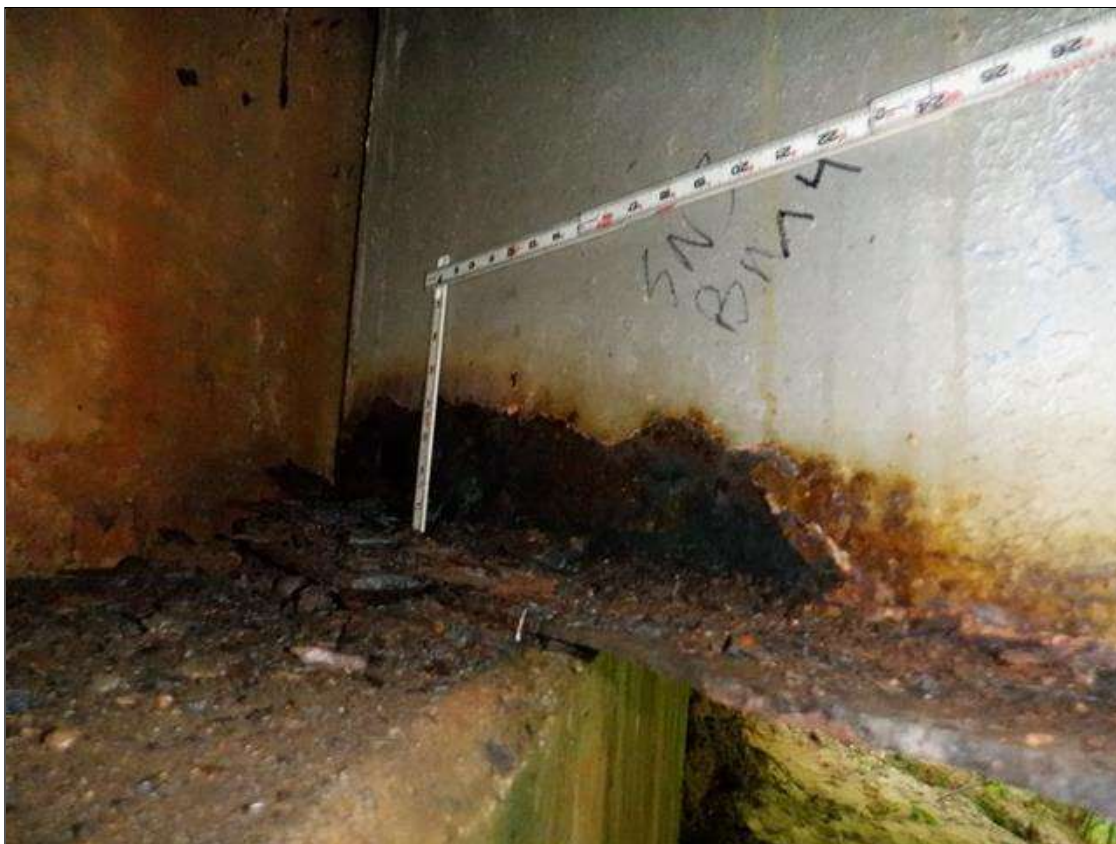
Span 3 Beam 4: [PAR] at far end, active corrosion with section loss, bottom flange [up to 24in x full width - avg rem 3/8in, with areas down to 3/16in], lower web [22in x up to 4in - avg rem 1/4in]

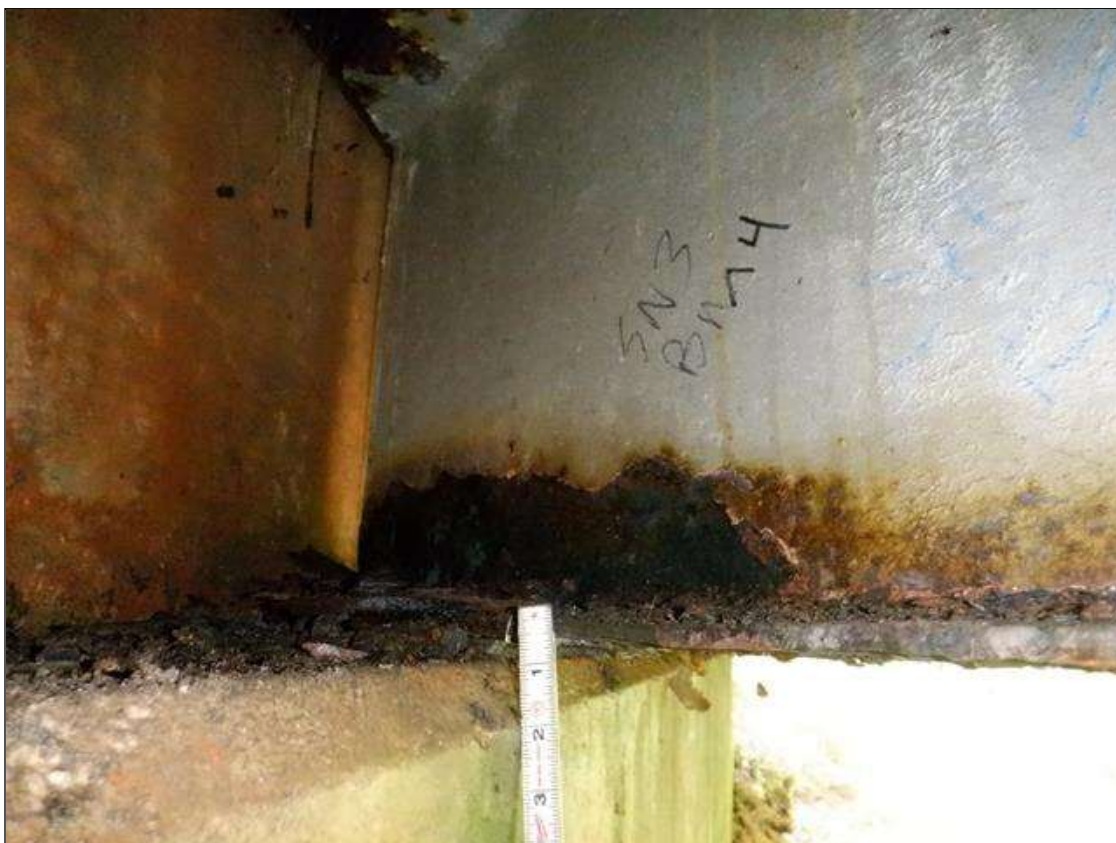
Span 3 Beam 4: [PAR] at far end, active corrosion with section loss, bottom flange [up to 24in x full width - avg rem 3/8in, with areas down to 3/16in], lower web [22in x up to 4in - avg rem 1/4in]

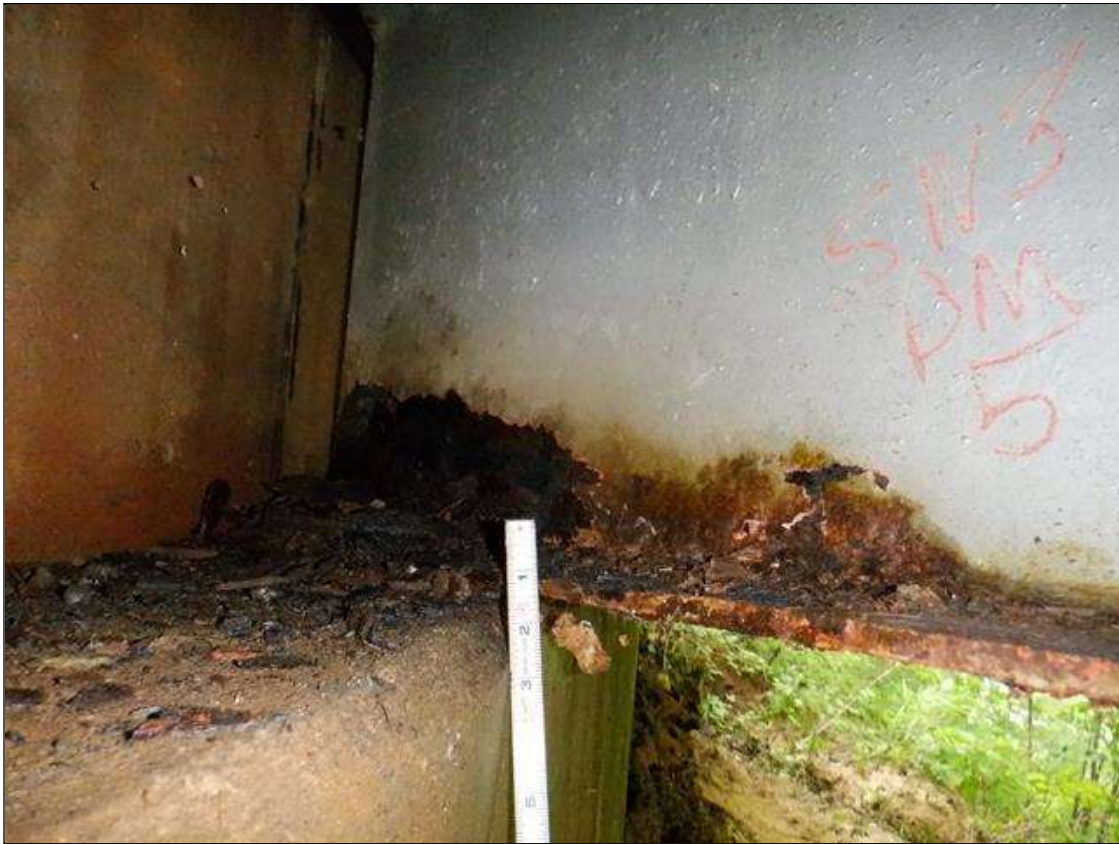
Span 3 Beam 5: [PAR] at far end, active corrosion with section loss, bottom flange [41in x full width - avg rem 3/8in], lower web [up to 24in x up to 4in - avg rem 5/16in]

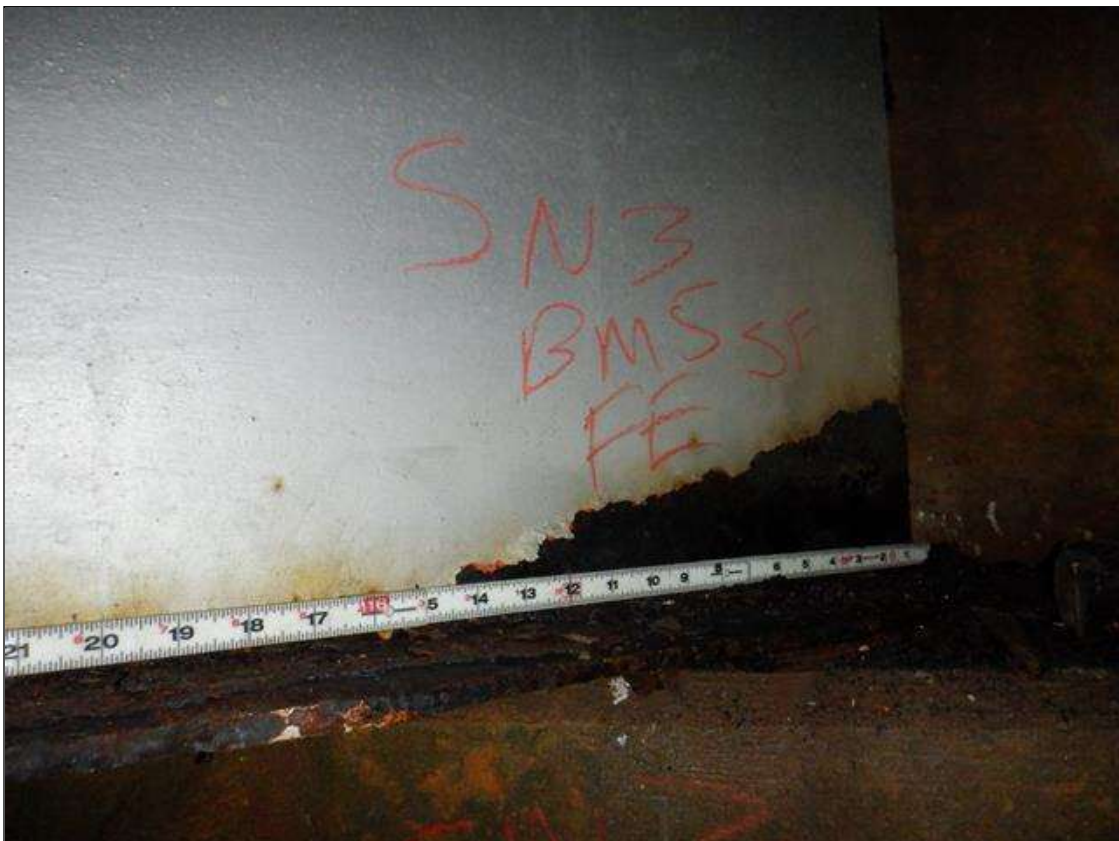
Span 3 Beam 5: [PAR] at far end, active corrosion with section loss, bottom flange [41in x full width - avg rem 3/8in], lower web [up to 24in x up to 4in - avg rem 5/16in]

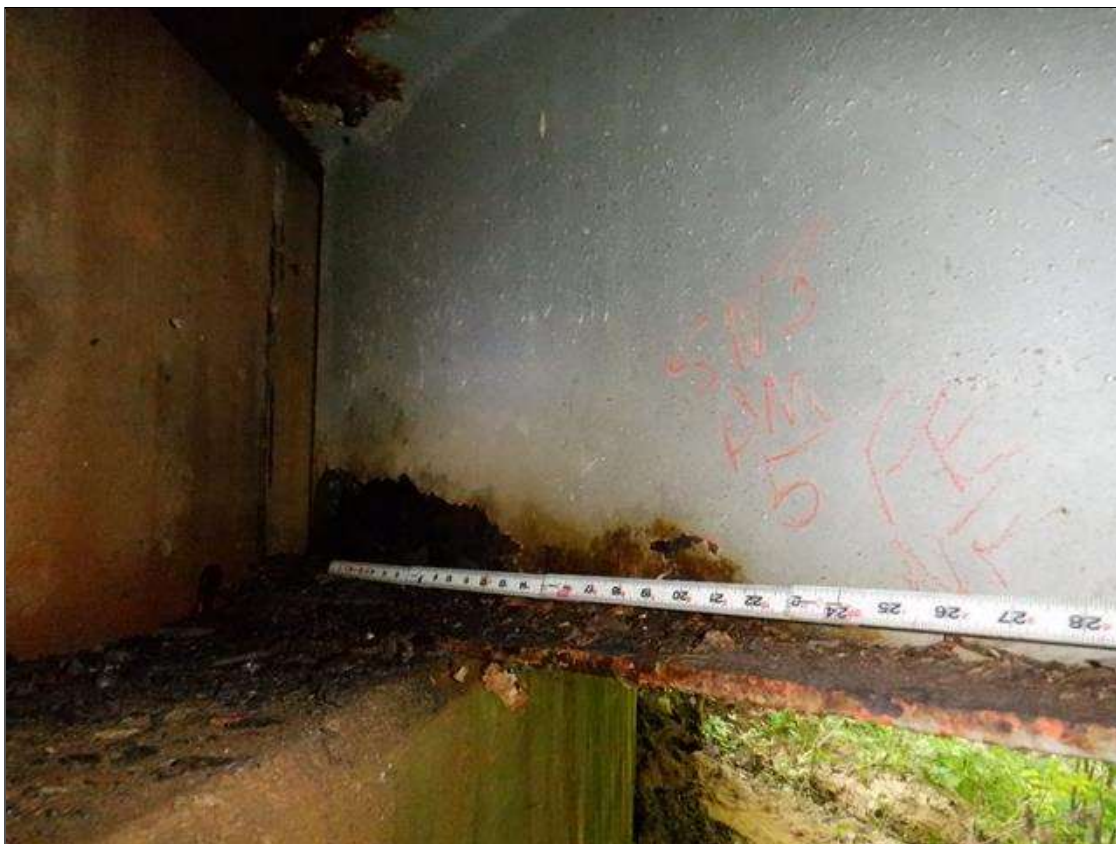
Span 3 Beam 5: [PAR] at far end, active corrosion with section loss, bottom flange [41in x full width - avg rem 3/8in], lower web [up to 24in x up to 4in - avg rem 5/16in]

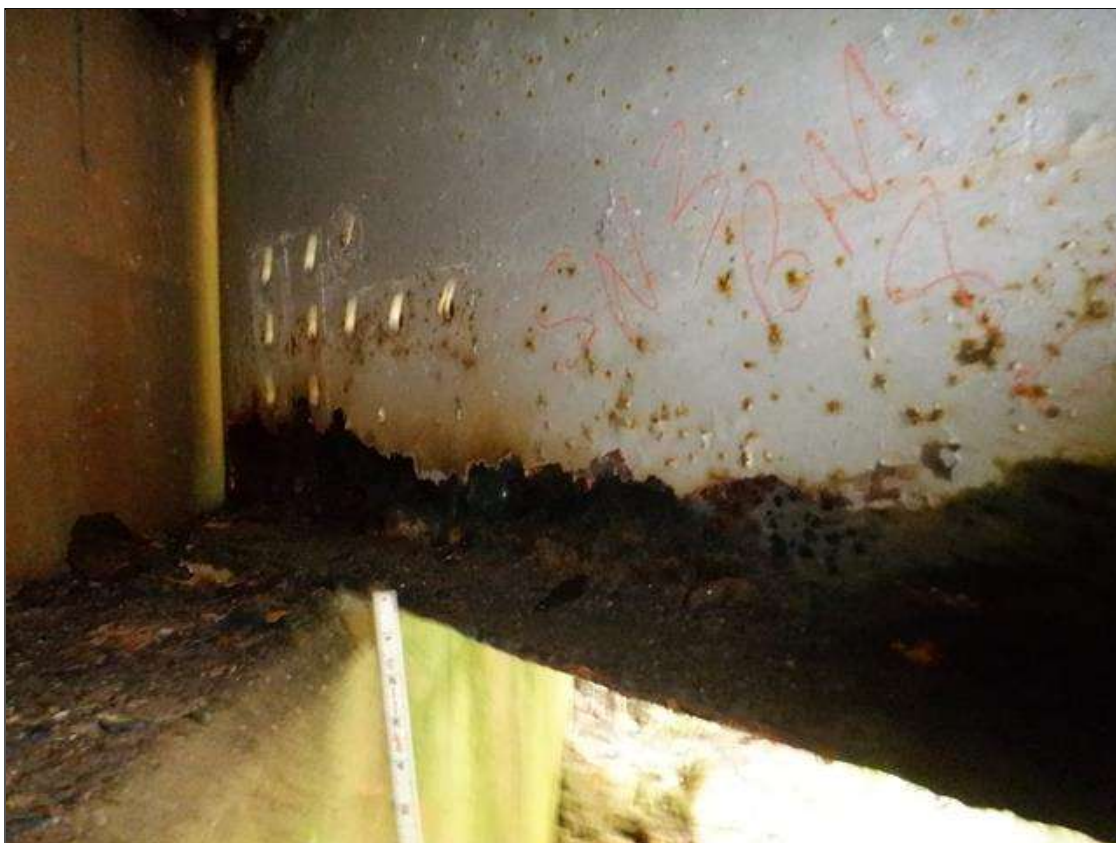
Span 3 Beam 8: [PAR] at far end, active corrosion with section loss; bottom flange [up to 27in x full width - avg rem 3/8in], lower web [up to 7ft x up to 3in - avg rem 5/16in]

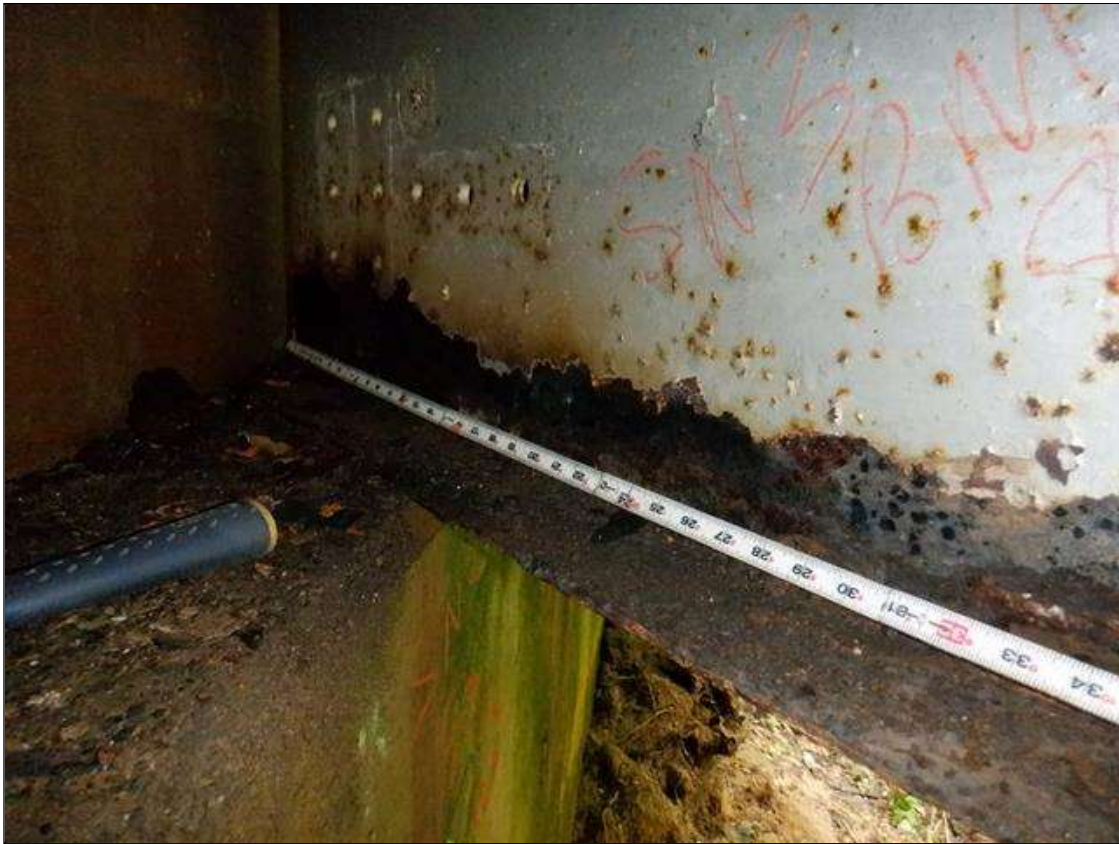
Span 3 Beam 8: [PAR] at far end, active corrosion with section loss; bottom flange [up to 27in x full width - avg rem 3/8in], lower web [up to 7ft x up to 3in - avg rem 5/16in]

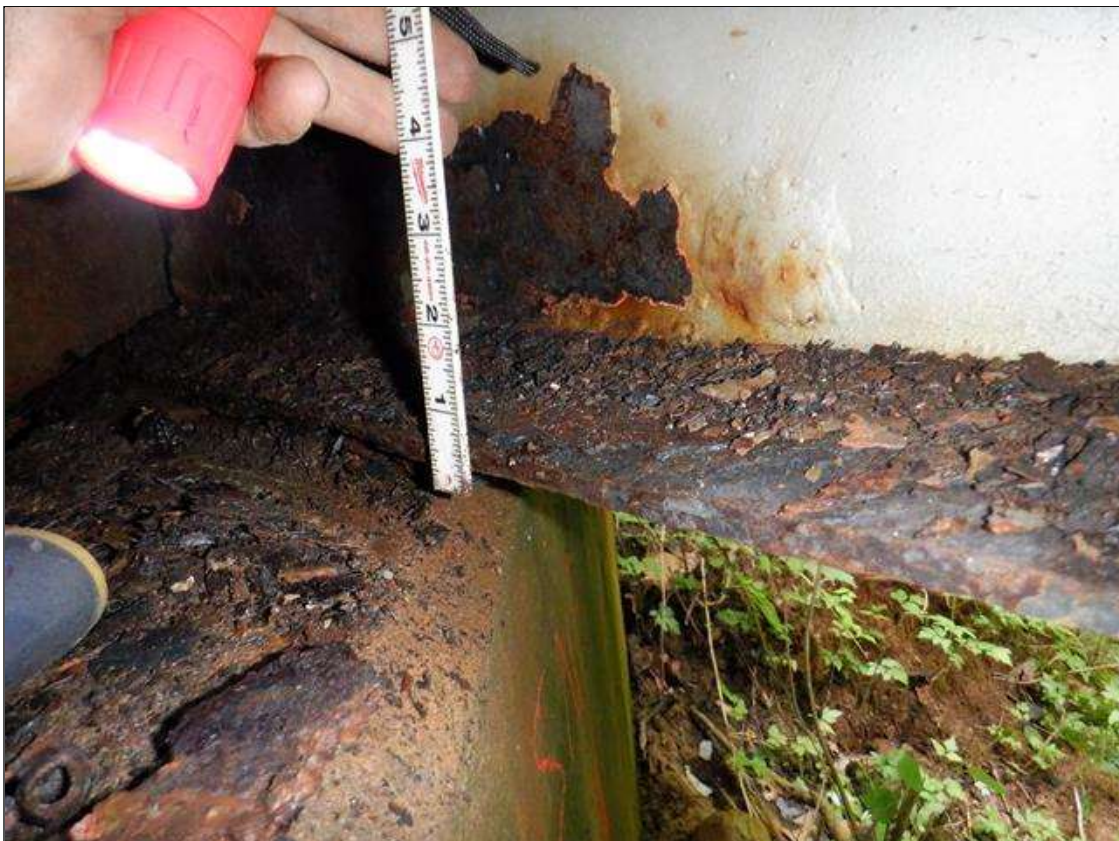
Span 3 Beam 9: [PAR] at far end, active corrosion with section loss; bottom flange [up to 38in x up to full width - avg rem 3/8in], lower web [up to 19in x up to 5in - avg rem 5/16in]

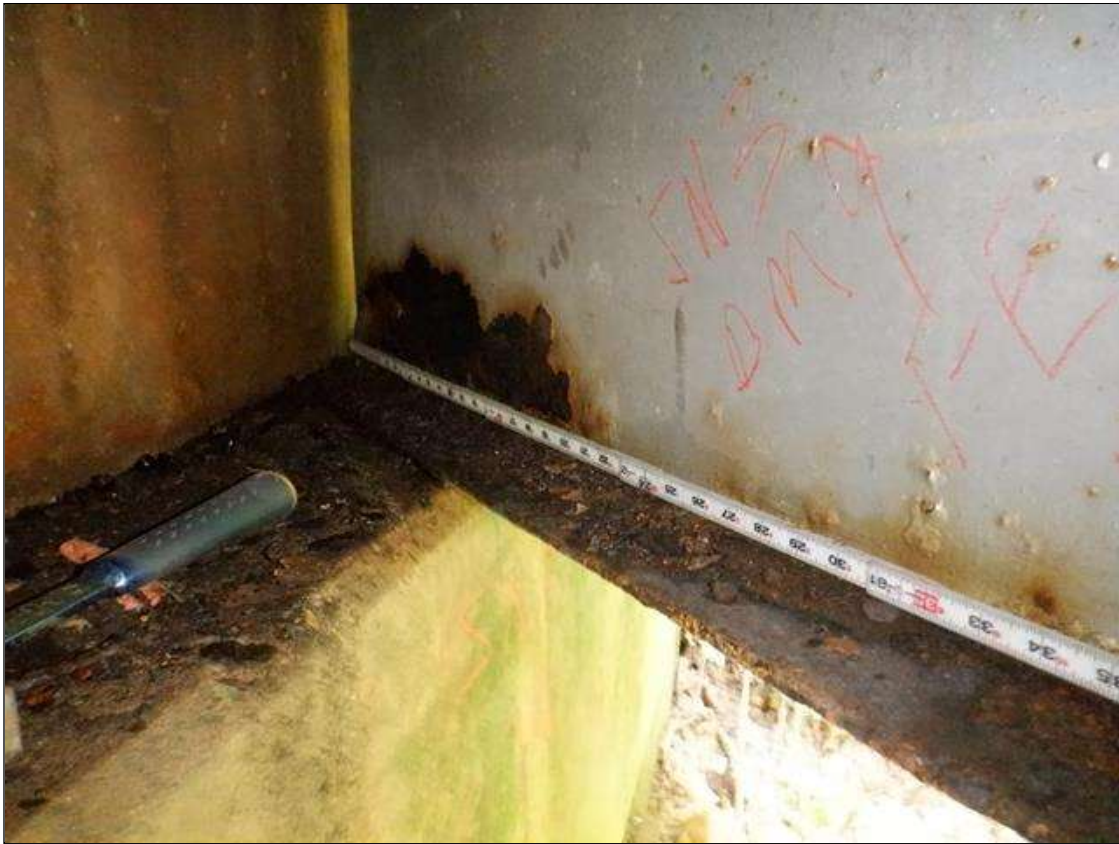
Span 3 Beam 9: [PAR] at far end, active corrosion with section loss; bottom flange [up to 38in x up to full width - avg rem 3/8in], lower web [up to 19in x up to 5in - avg rem 5/16in]

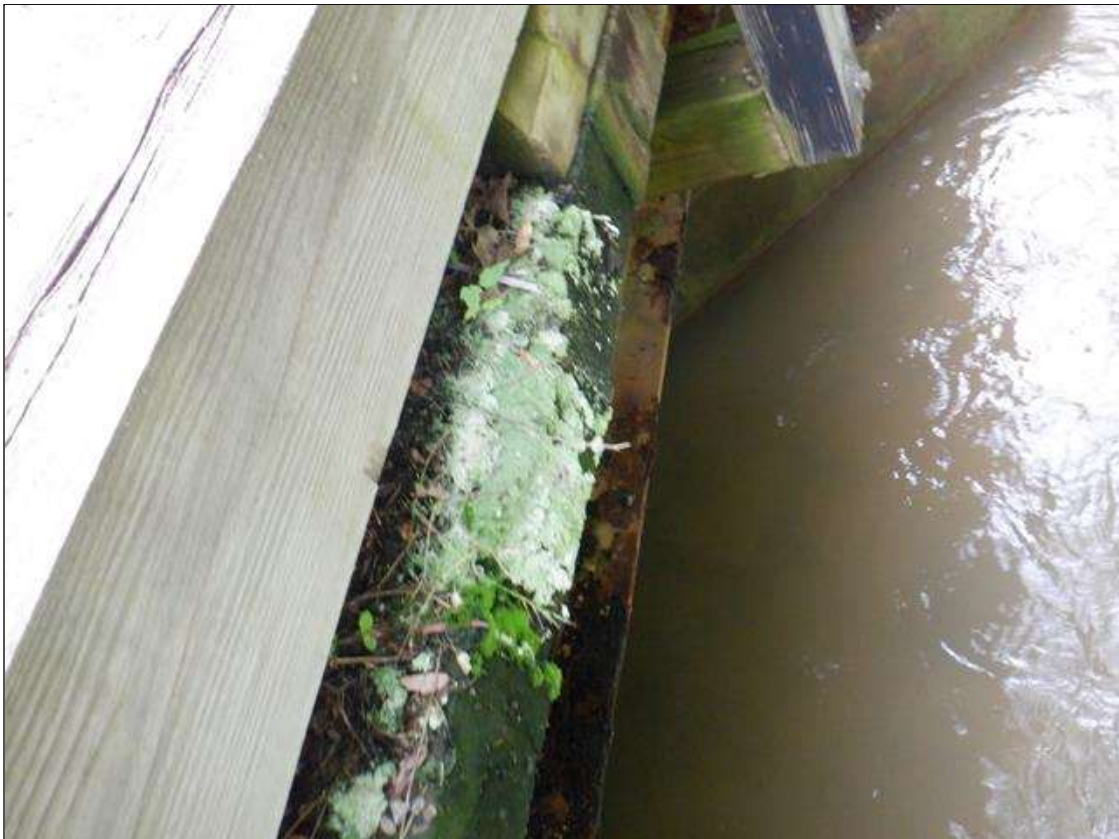
Span 3 Deck: throughout edge of deck at North and South ends, areas of decay/surface softness in end of deck boards [up to full width x full height x up to 1in deep probe] with vegetation/moss growth

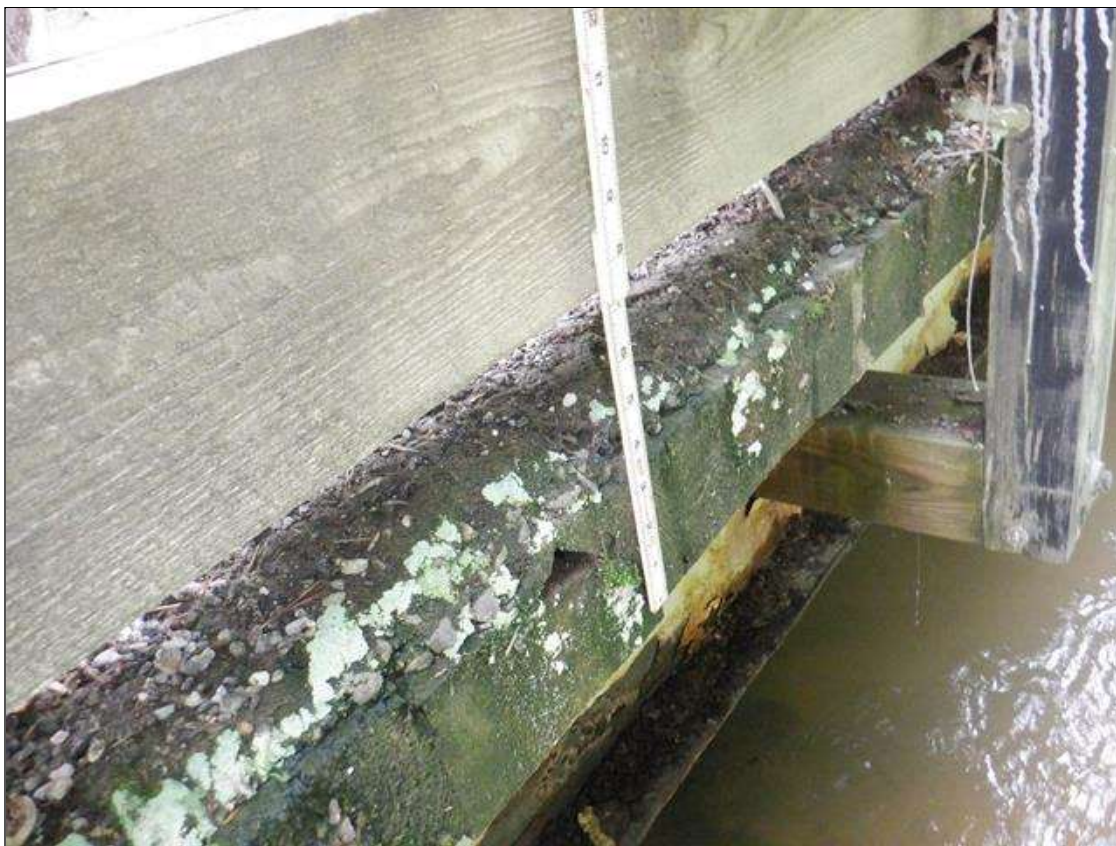
Span 3 Deck: throughout edge of deck at North and South ends, areas of decay/surface softness in end of deck boards [up to full width x full height x up to 1in deep probe] with vegetation/moss growth

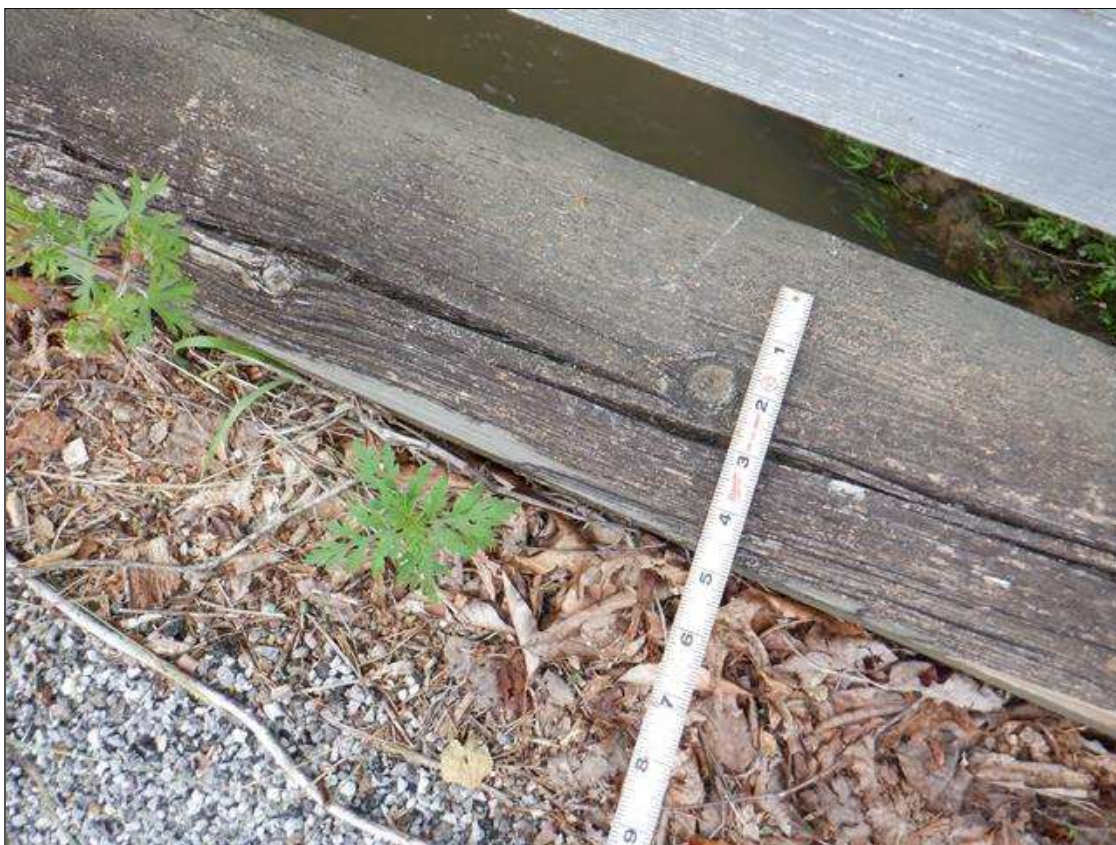
Span 3 Left Bridge Rail: top board and curb, checks (full length x up to 1/4in)

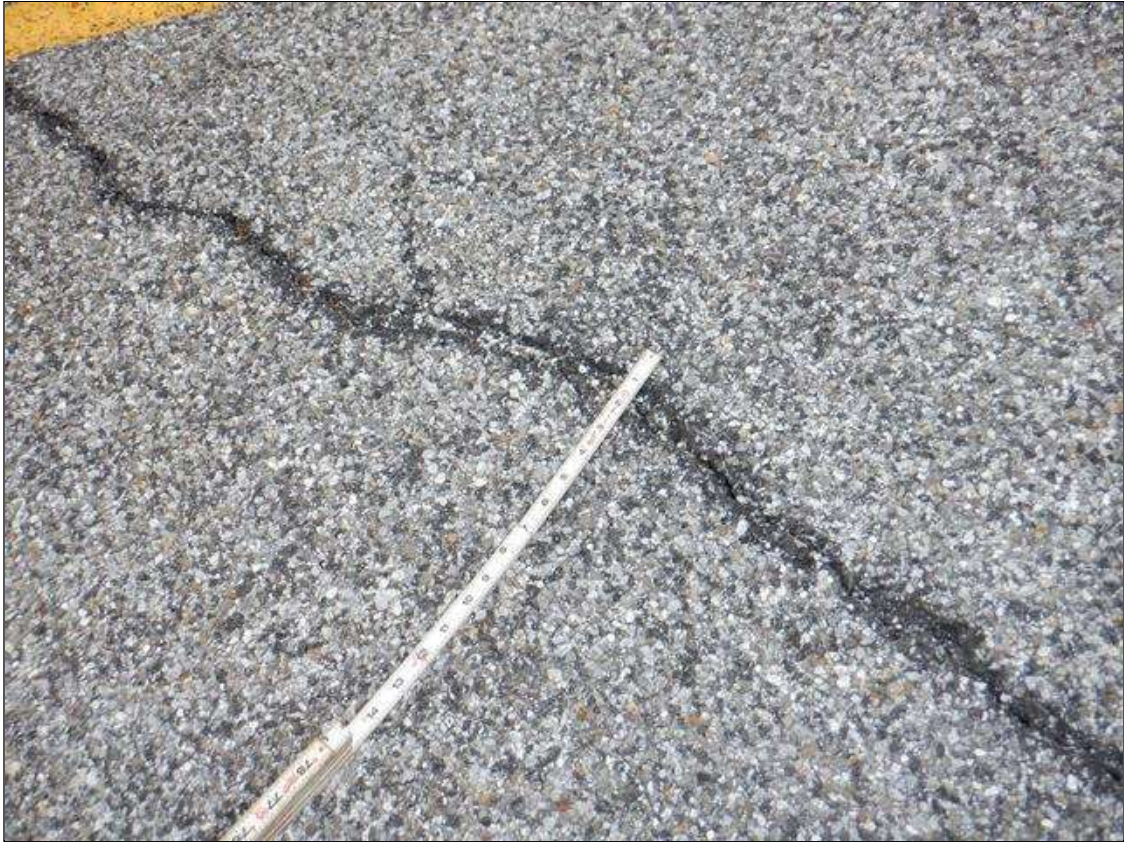
Span 1 Wearing Surface: both lanes and shoulders over end bent 1, transverse crack (full width x up to 1in)

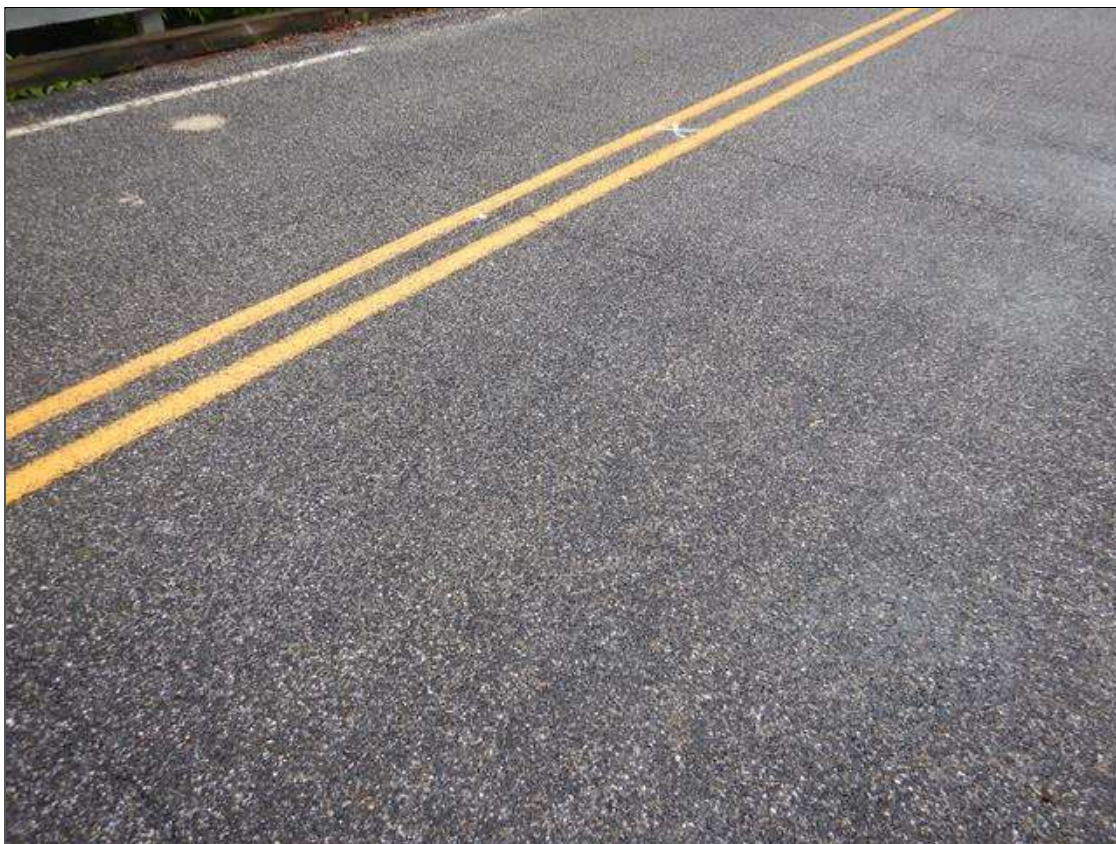
typical wearing surface

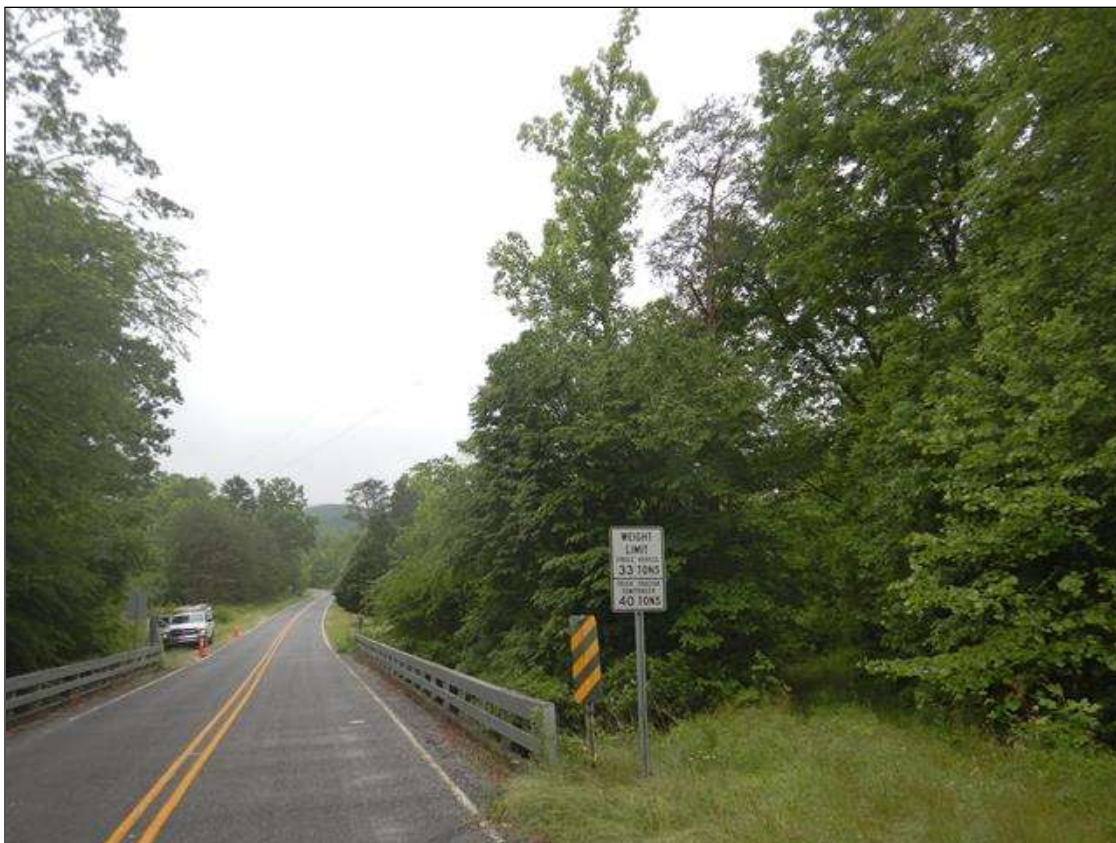
overhead utility across structure

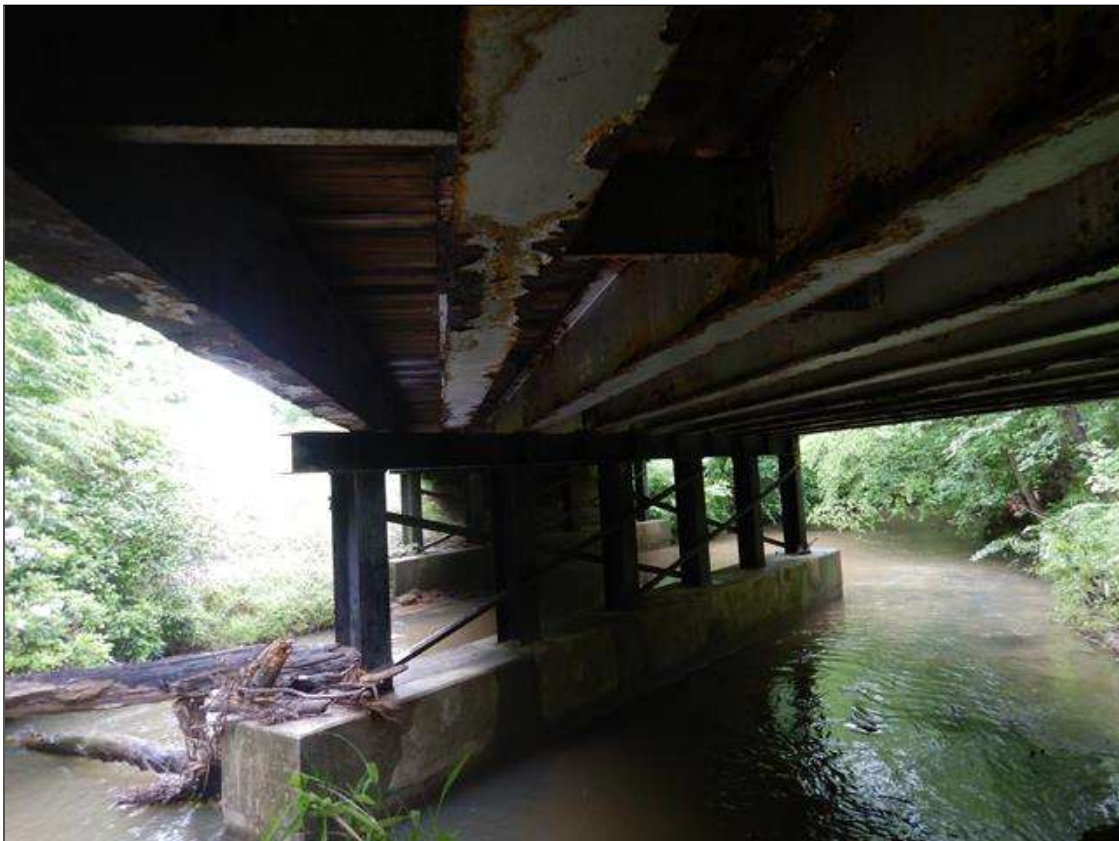
typical interior bent [bent 2 in view]

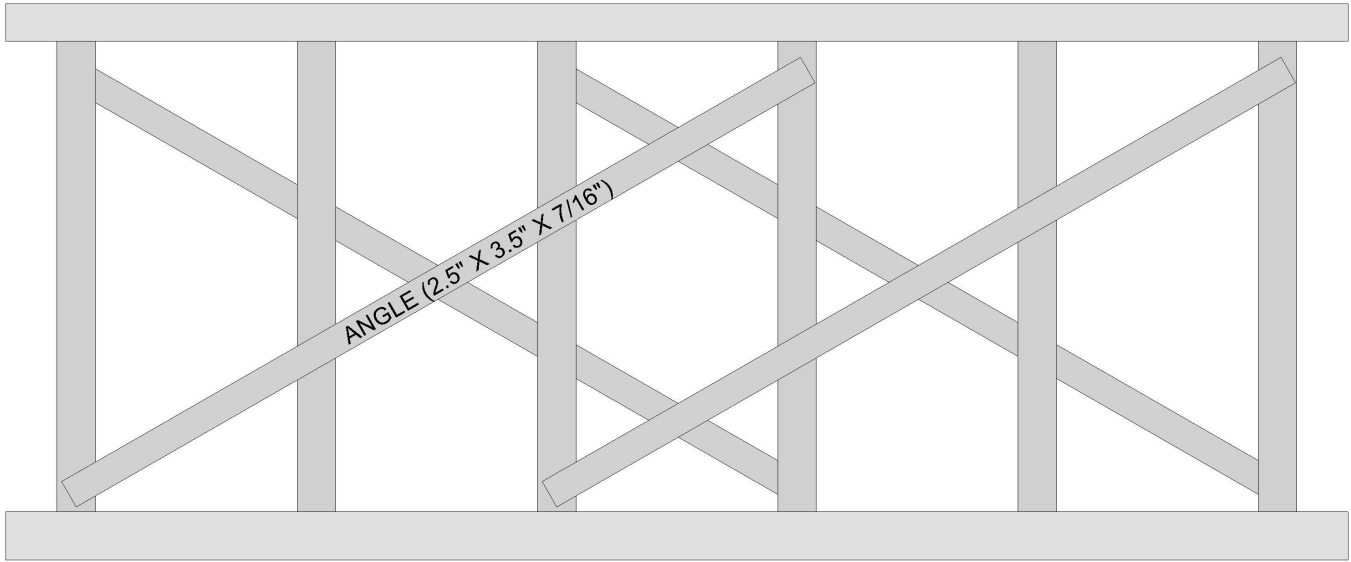
Cap Information			Material Steel							
Length	Width	Height	Left Overhang	Right Overhang	Left Beam to End of Cap.	Right Beam to End of Cap.				
*34.917 ft.	1.000 ft.	.979 ft.	1.833 ft.	1.833 ft.	1.667 ft.	1.500 ft.				
Subcap Information			Material							
Length	Width	Height	Left Overhang	Right Overhang	Left Pile to Splice.					
Sill Information			Material Cast-in-Place Concrete							
Length	Width	Height								
36.667 ft.	3.000 ft.	4.500 ft.								
Pile #	Material	Spacing	Width/Dia.	Height	Length	Orientation	Driven?	Replacement?	Removed?	Collar?
1	Steel	6.25 ft.	1 ft.			Vertical	Yes	No	No	No
2	Steel	6.25 ft.	1 ft.			Vertical	Yes	No	No	No
3	Steel	6.25 ft.	1 ft.			Vertical	Yes	No	No	No
4	Steel	6.25 ft.	1 ft.			Vertical	Yes	No	No	No
5	Steel	6.25 ft.	1 ft.			Vertical	Yes	No	No	No
6	Steel		1 ft.			Vertical	Yes	No	No	No
Bent #: 1			Bent 2 similar

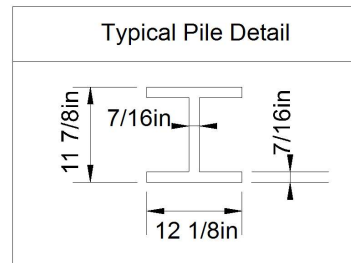
All Measurements Verified: D. Winters 5/27/2020

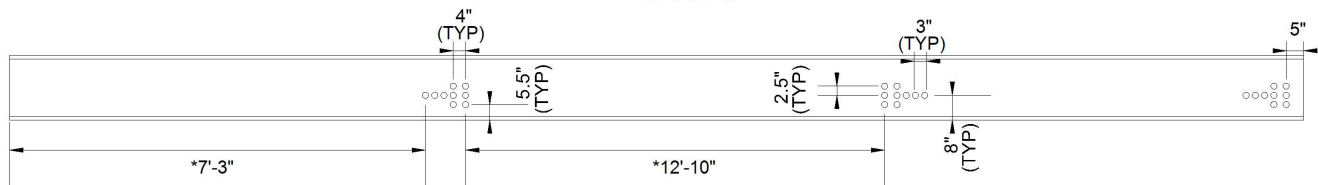
HOLES ARE 3/4" DIA.
UNLESS NOTED OTHERWISE
Measurements Verified: D. Winters 05/29/2020
