NC DEPARTMENT OF TRANSPORTATION
 DIVISION OF HIGHWAYS
 STRUCTURE MANAGEMENT UNIT

ATTENTION: PAR Submitted, Changes to Structure Data

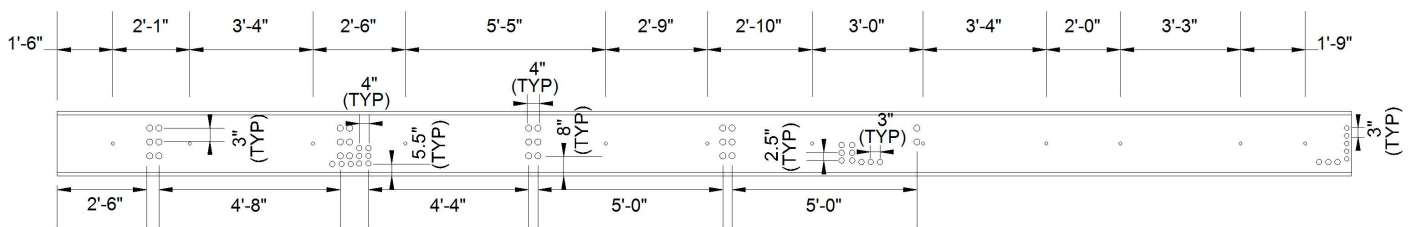
HOLES ARE 3/4" DIA.
UNLESS NOTED OTHERWISE

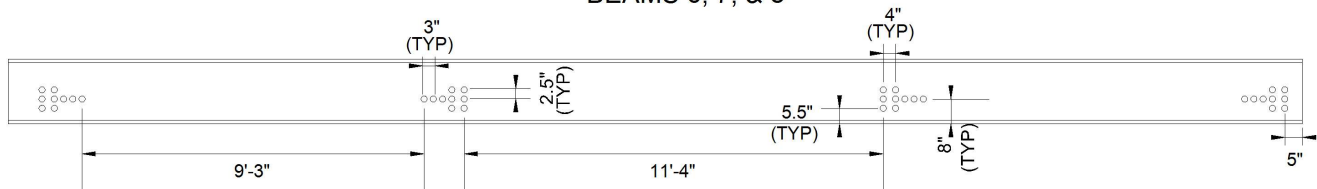
HOLES ARE 3/4" DIA.
UNLESS NOTED OTHERWISE
