NC DEPARTMENT OF TRANSPORTATION ATTENTION:
 DIVISION OF HIGHWAYS
 STRUCTURE MANAGEMENT UNIT

Structure Safety Report

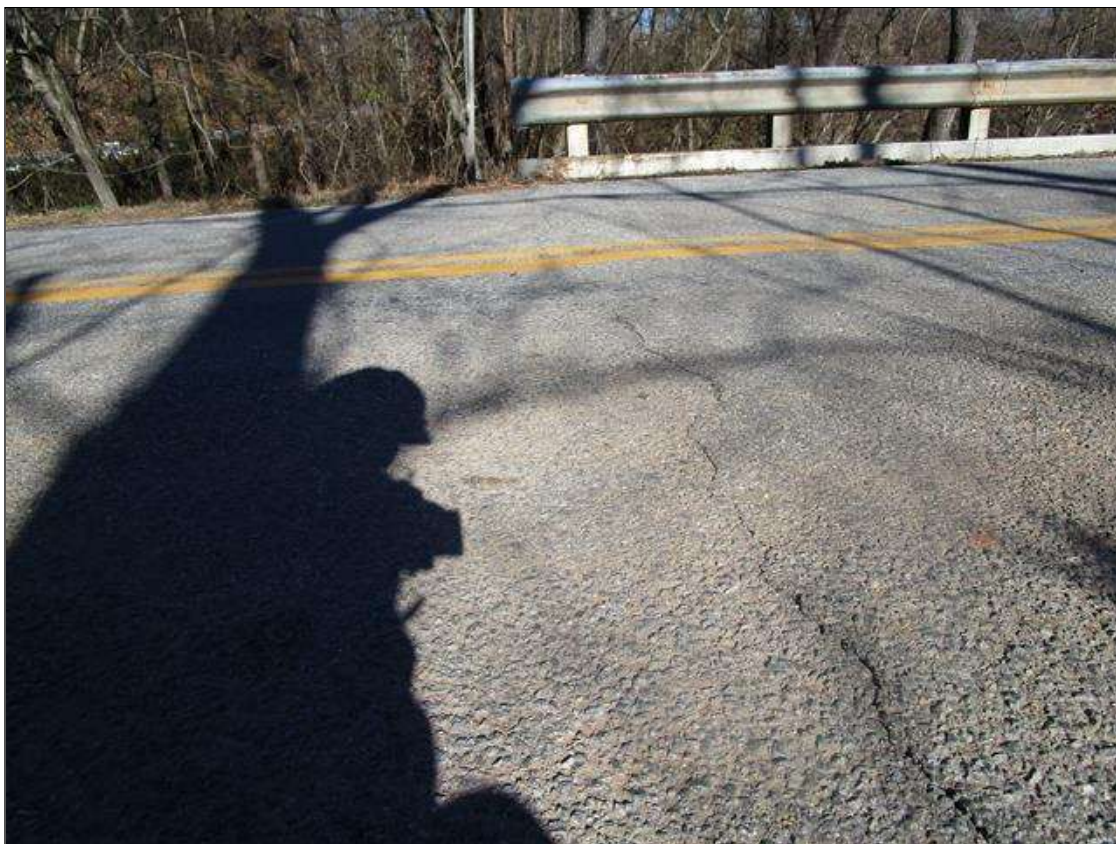
UP TO 1/4" CRACKING AND 1.5" SETTLEMENT IN WEST APPROACH (SIMILAR CONDITIONS AT EAST APPROACH)

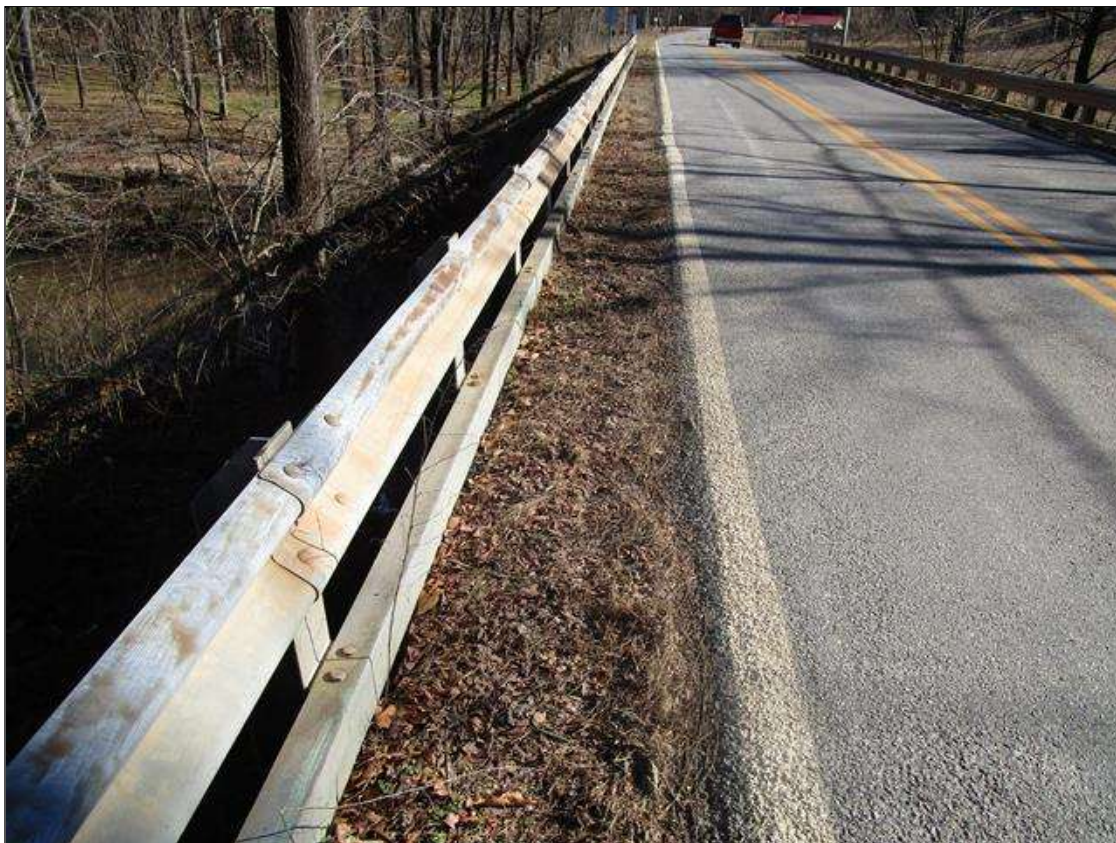
DEBRIS ALONG BOTH GUTTERLINES

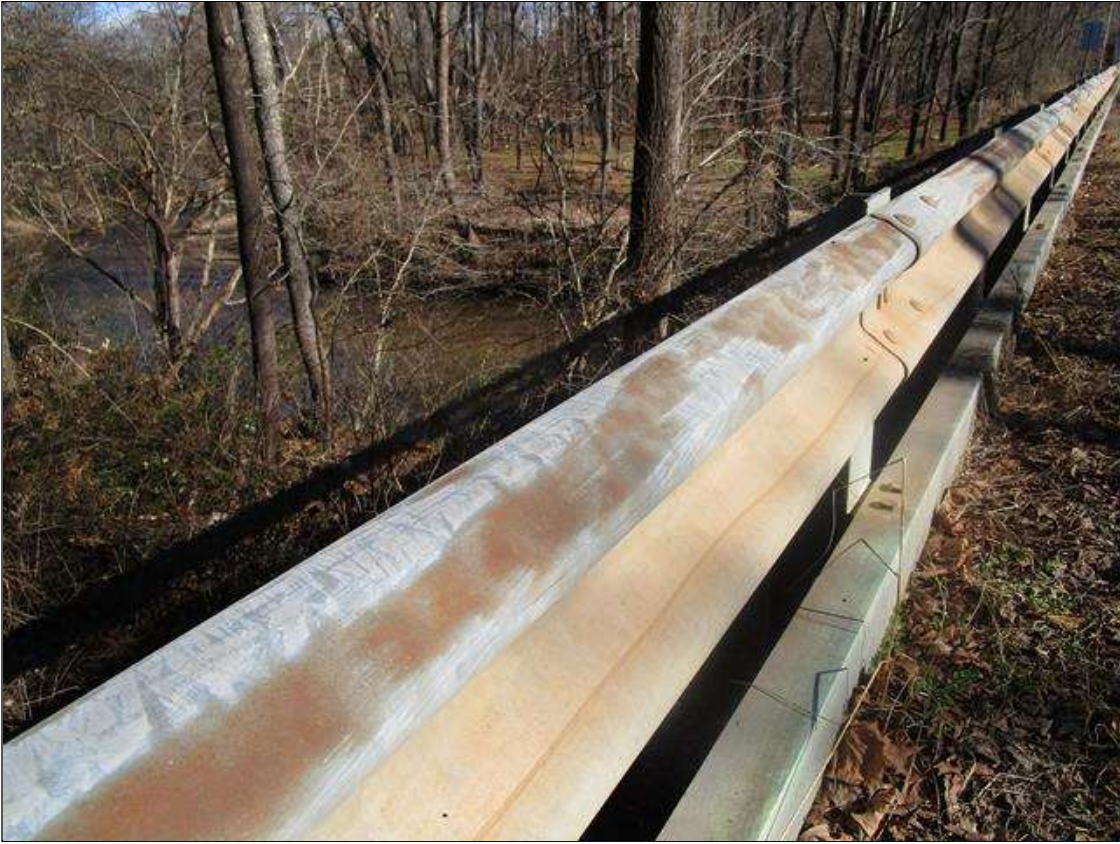
SURFACE RUST ON BOTH RAILS

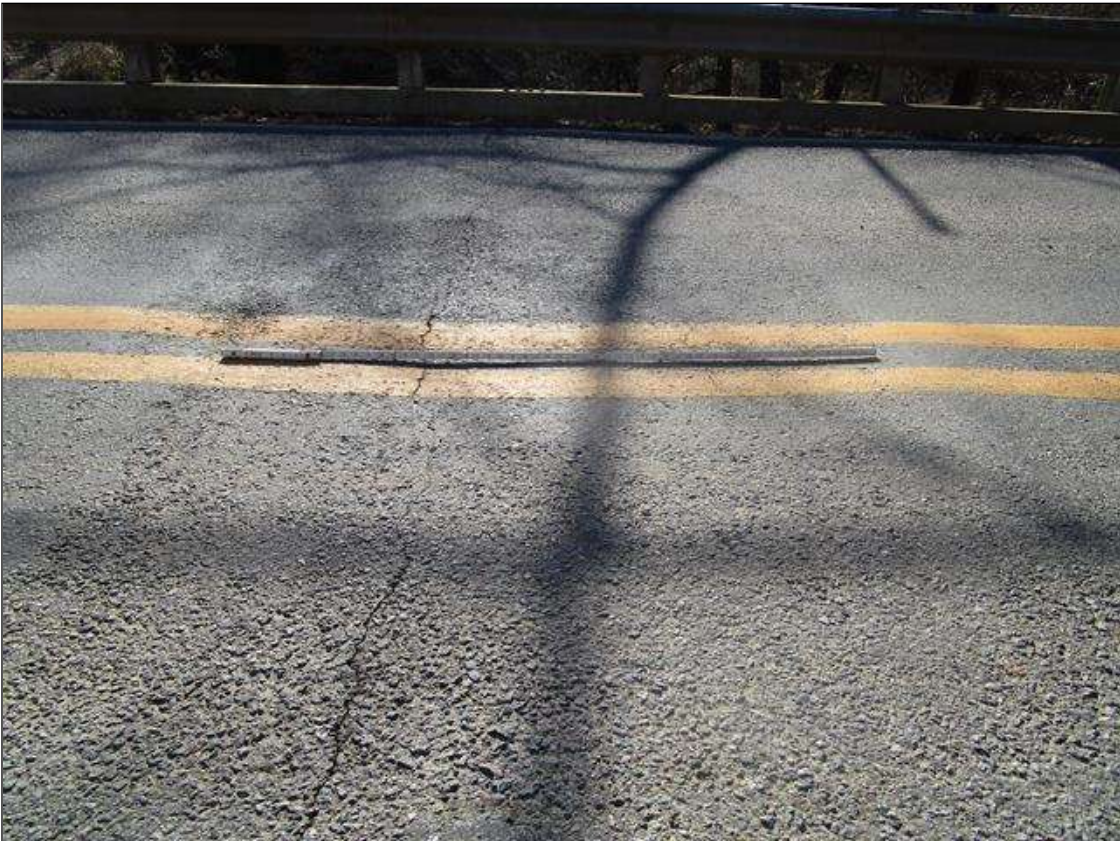
Span 1 Wearing Surface: 6' X 4' AREA OF SUNKEN ASPHALT WEARING SURFACE OVER BENT 1

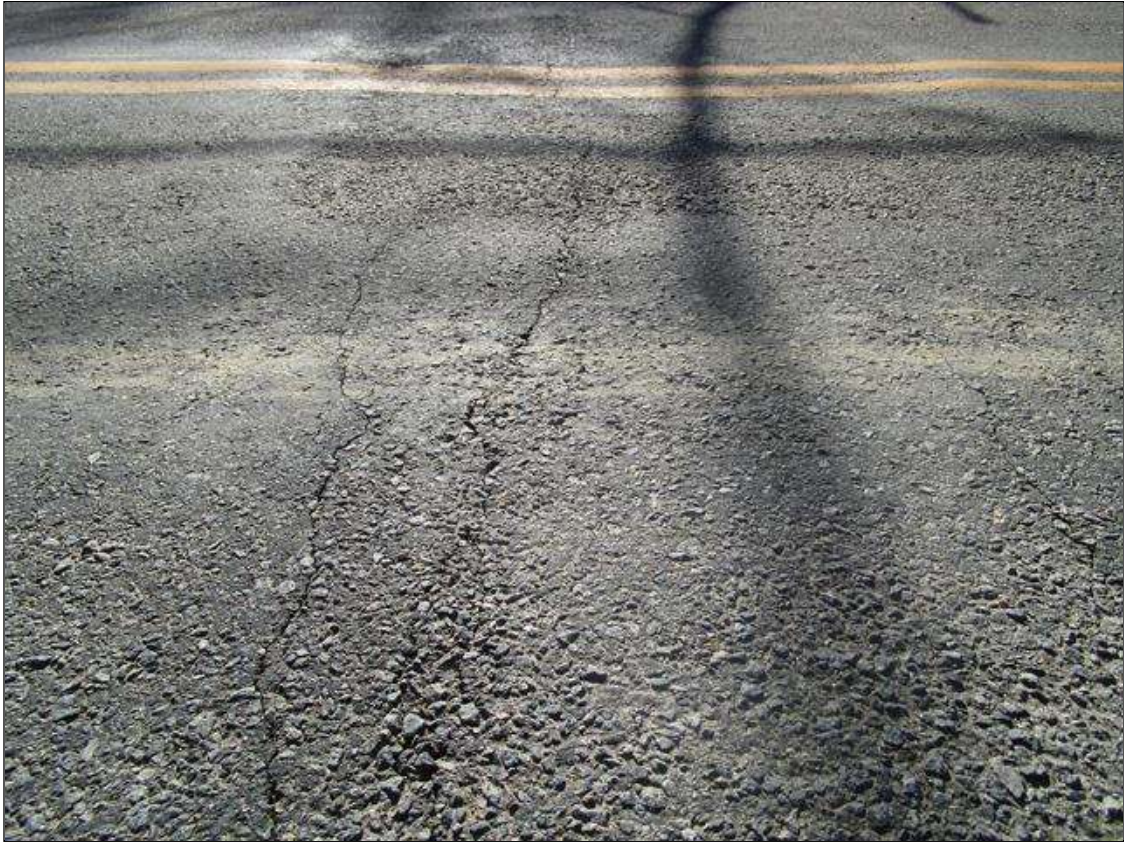
UP TO 1/8" TRANSVERSE CRACKING IN ASPHALT WEARING SURFACE OVER BOTH INTERIOR BENTS

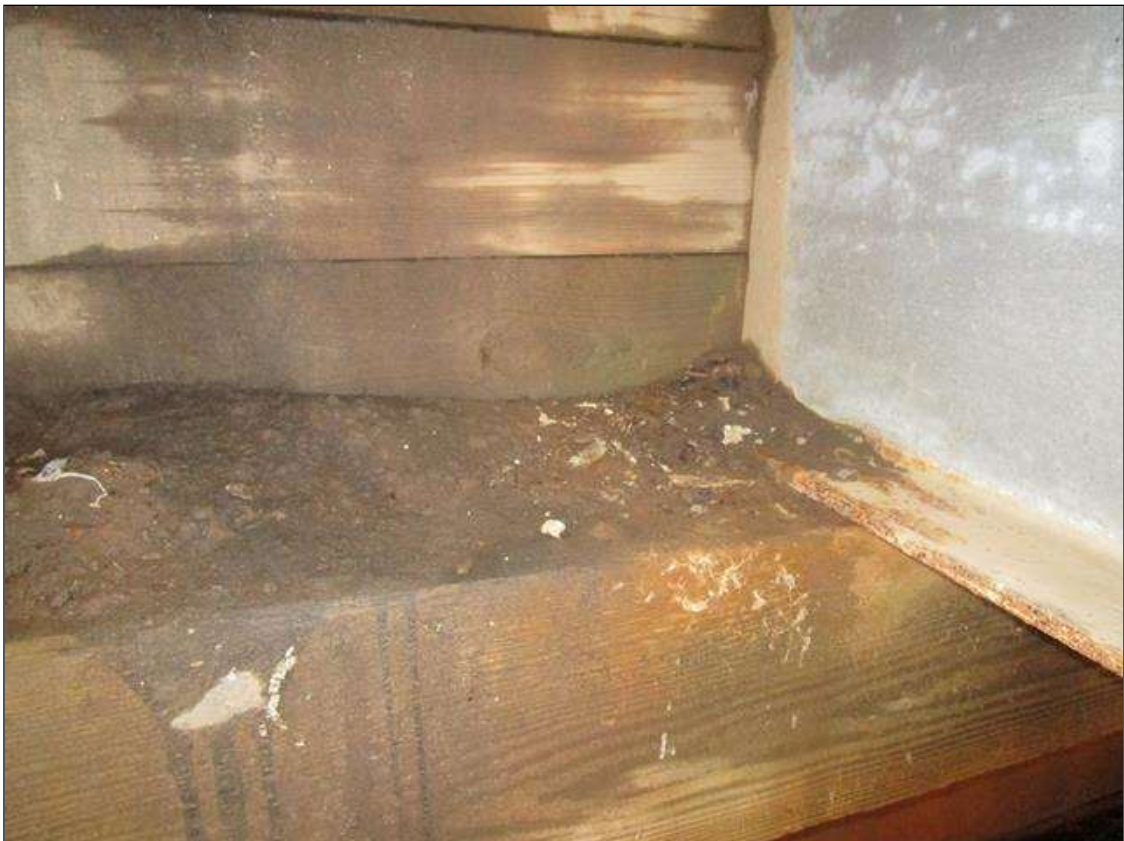
TYPICAL DEBRIS BUILDUP ON END BENT 2 CAP

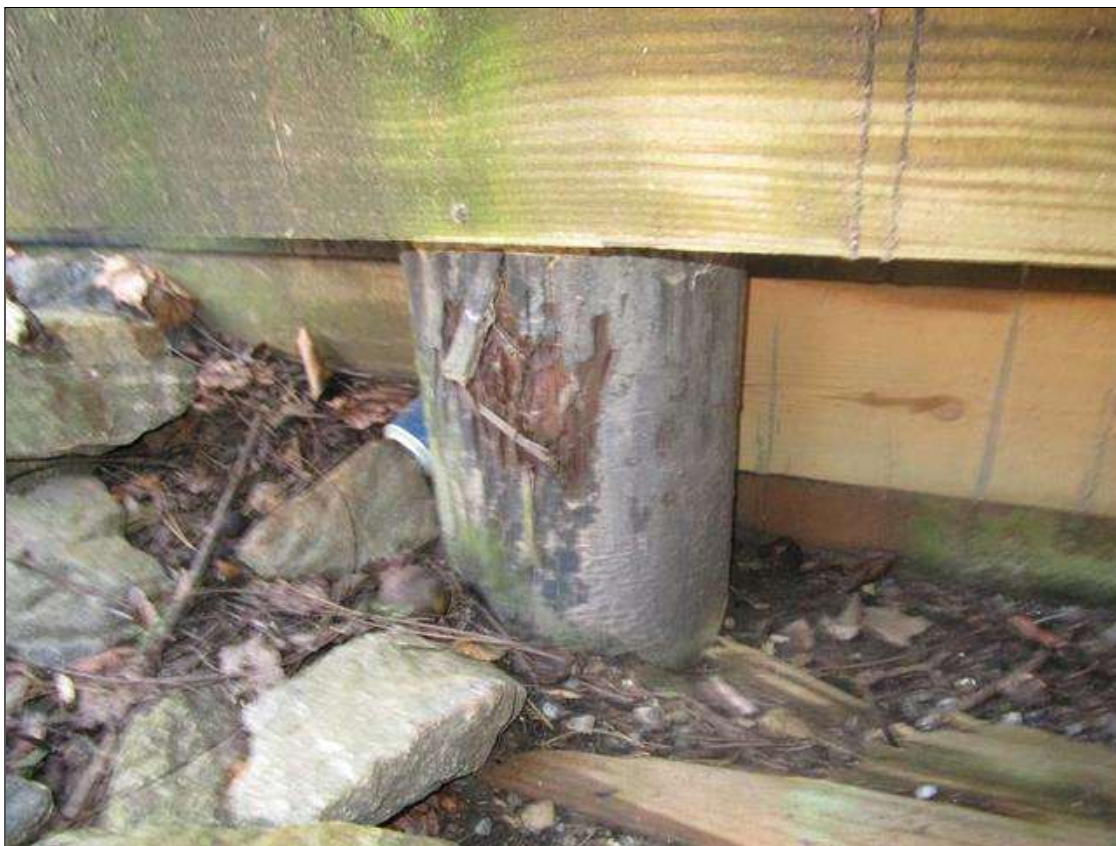
End Bent 2 Pile 1: 5" DIAMETER X 1" DEEP DECAY

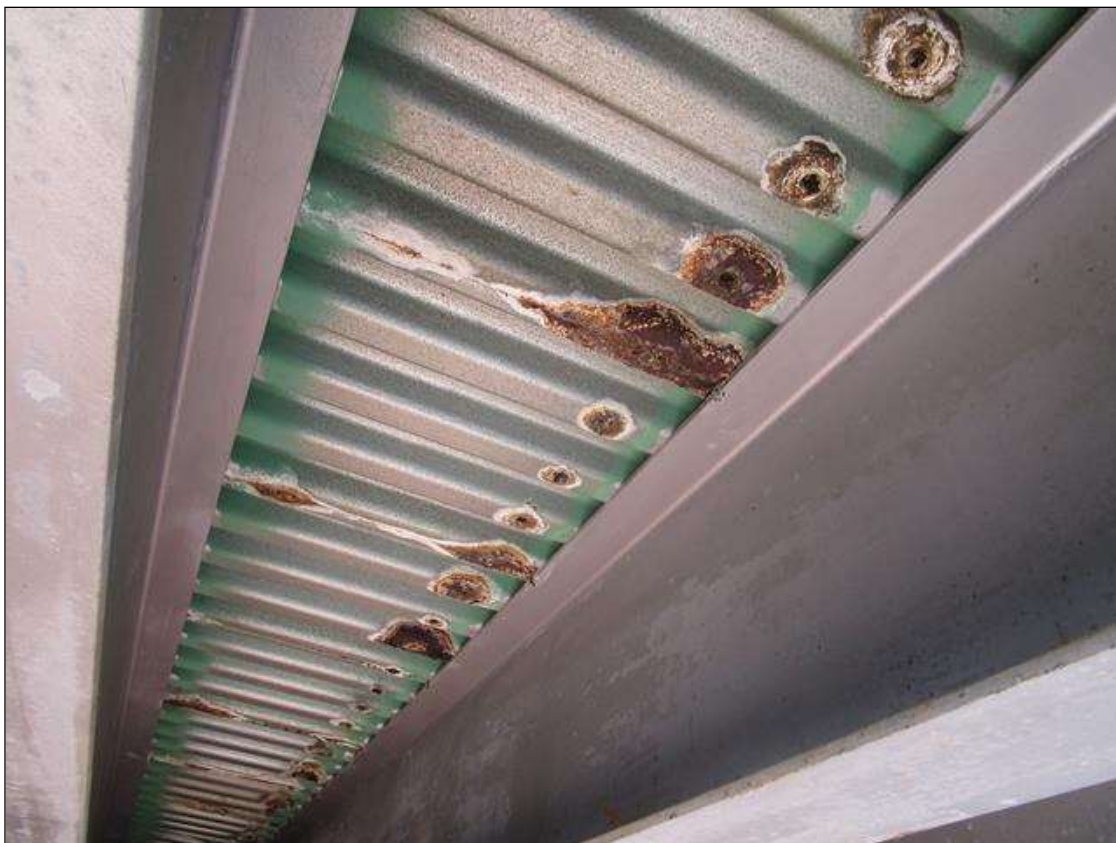
APPROXIMATELY 10% OF UNDERSIDE OF DECK IN ALL SPANS HAS CORROSION

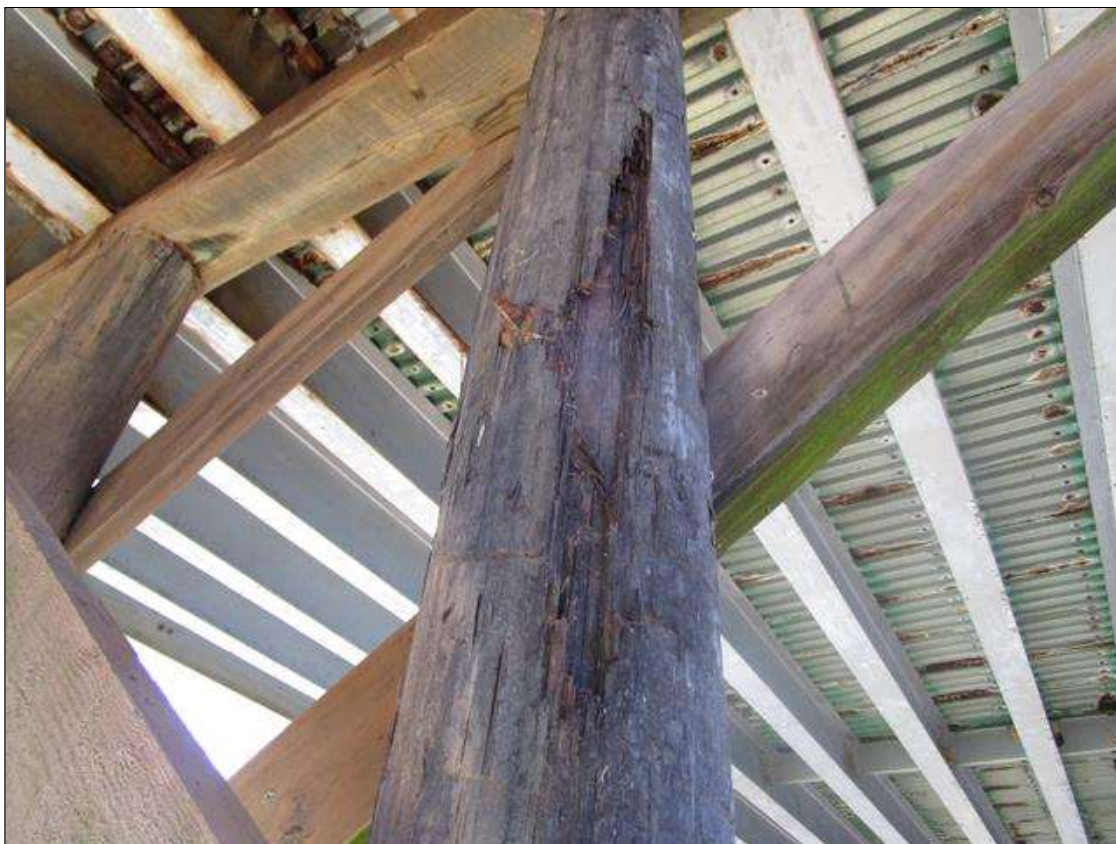
Bent 2 Pile 2: 2' HIGH X 3" WIDE X 0.5" DEEP DECAY IN NORTHEAST FACE

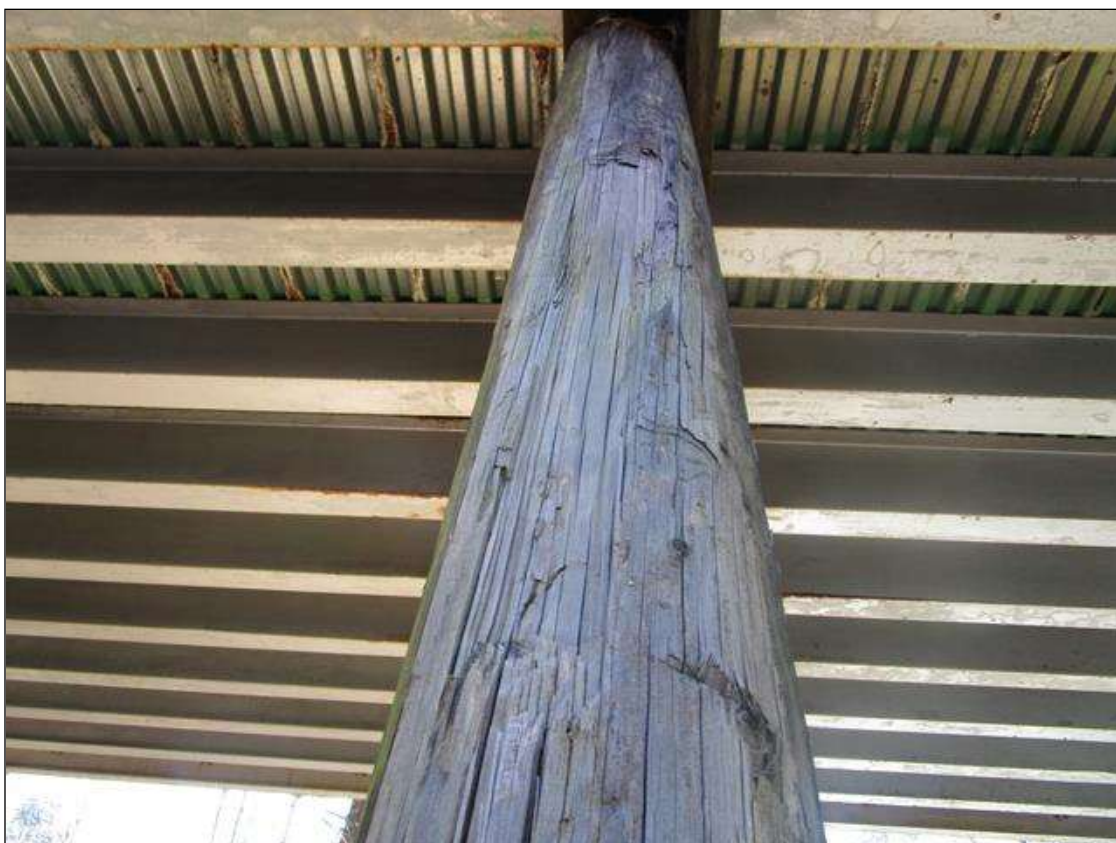
Bent 2 Pile 1: 3 FT HIGH X 6 IN WIDE DELAMINATION, NORTH FACE OF PILE NEAR BASE.

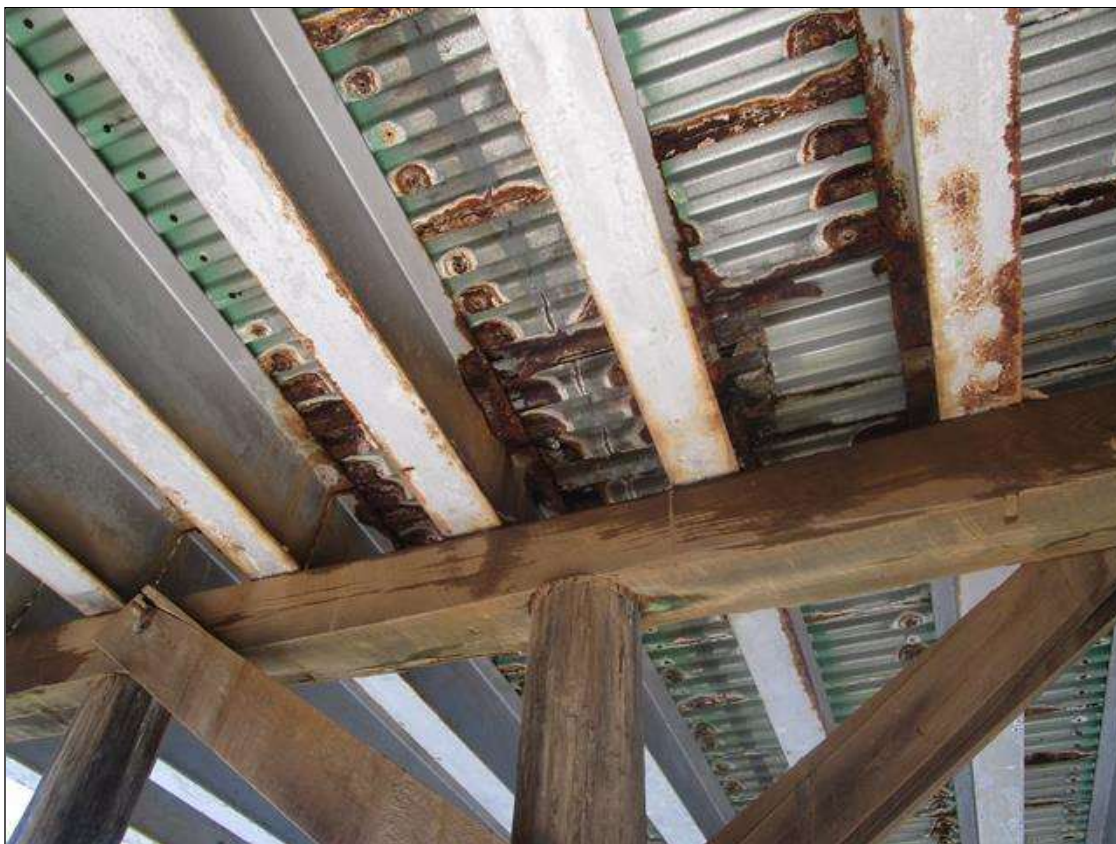
OVERVIEW OF CORROSION TO TOP FLANGES OF BEAMS 4-8 OVER BENT 2

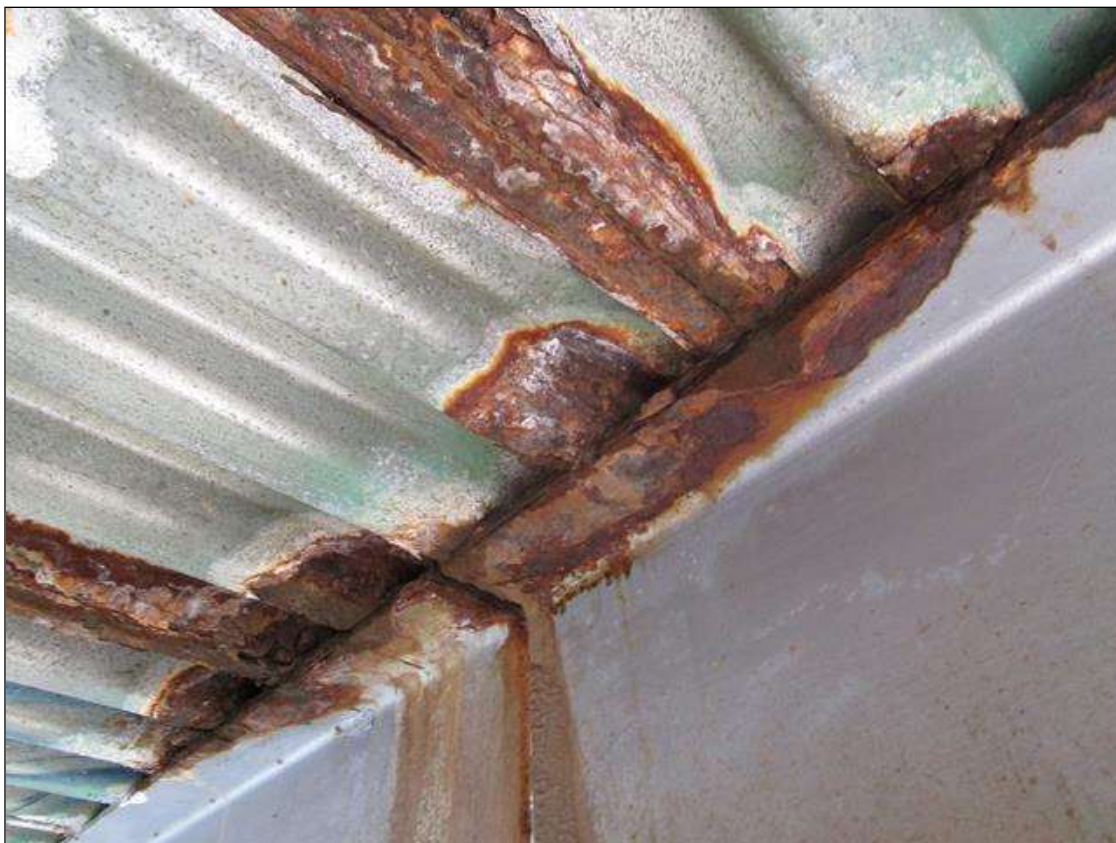
BEAMS 4-8 OVER BENT 2 HAVE CORROSION IN THE TOP FLANGES. SECTION LOSS IS NEGLIGIBLE AT THIS TIME

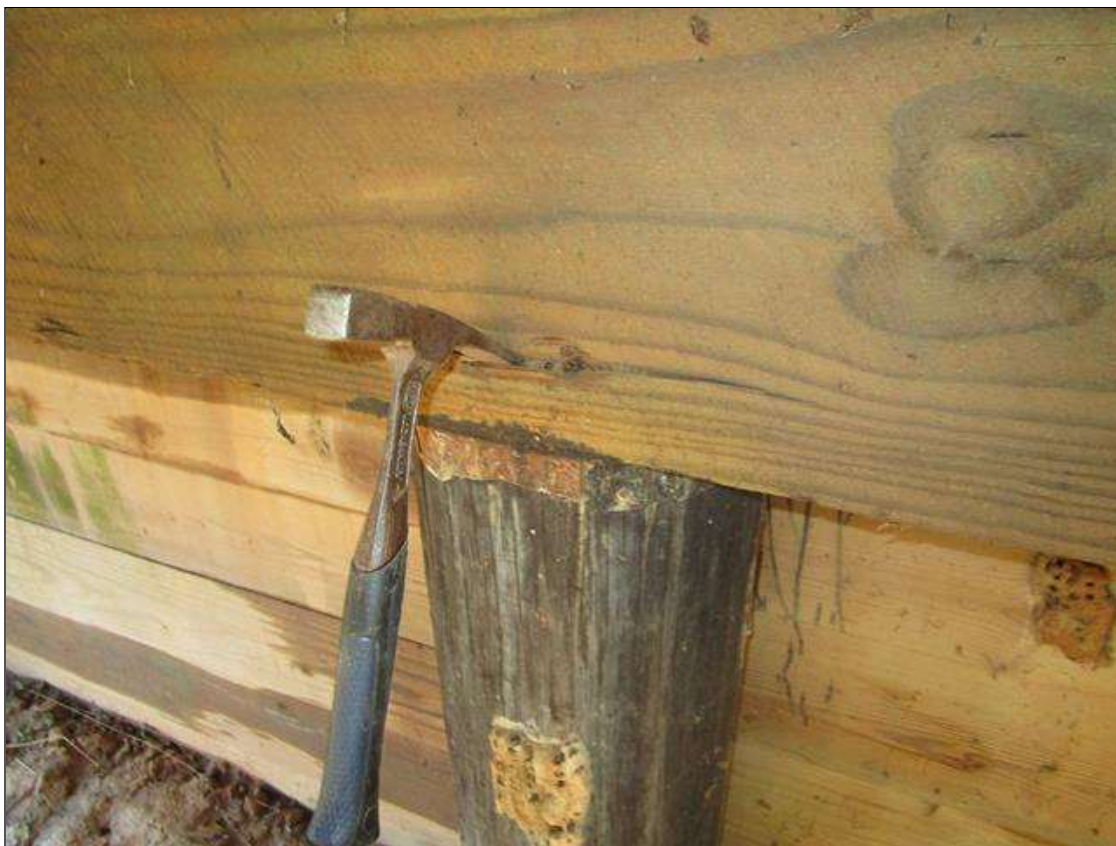
End Bent 1 Cap 1: 1 FT HORIZONTAL SPLIT UP TO 1/8 IN, EAST FACE OF PILE CAP ABOVE PILE 4.

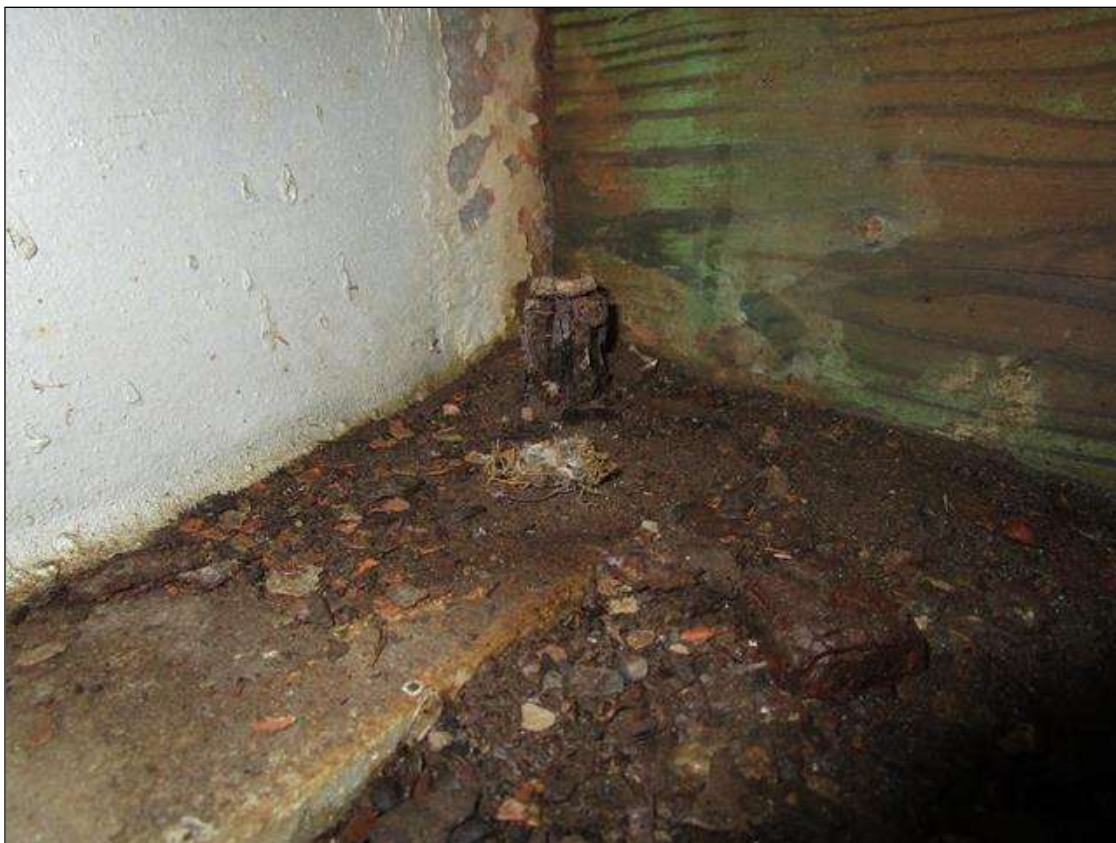
Span 1 Beam 4 Near Bearing: CORROSION OF ANCHOR BOLTS AT END BENT 1, ANCHOR BOLTS MISSING NUTS.

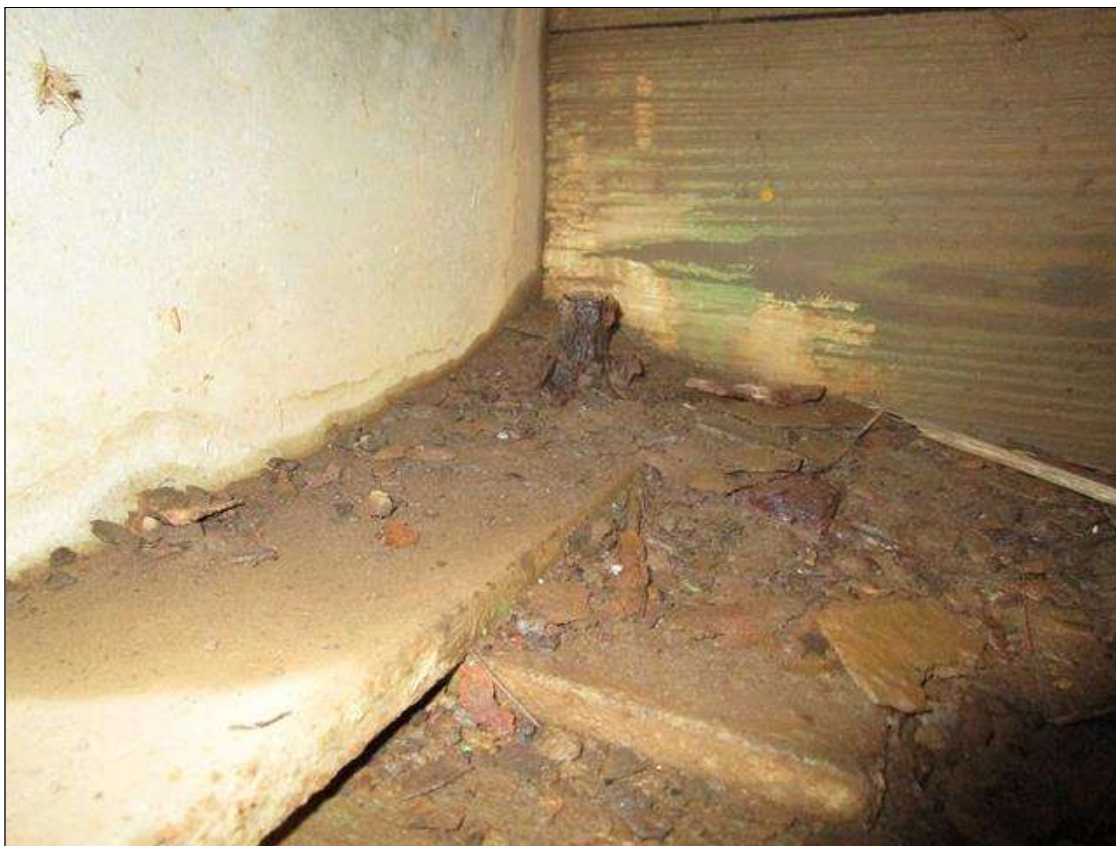
CORROSION TO VARIOUS ANCHOR BOLTS AT BOTH END BENTS

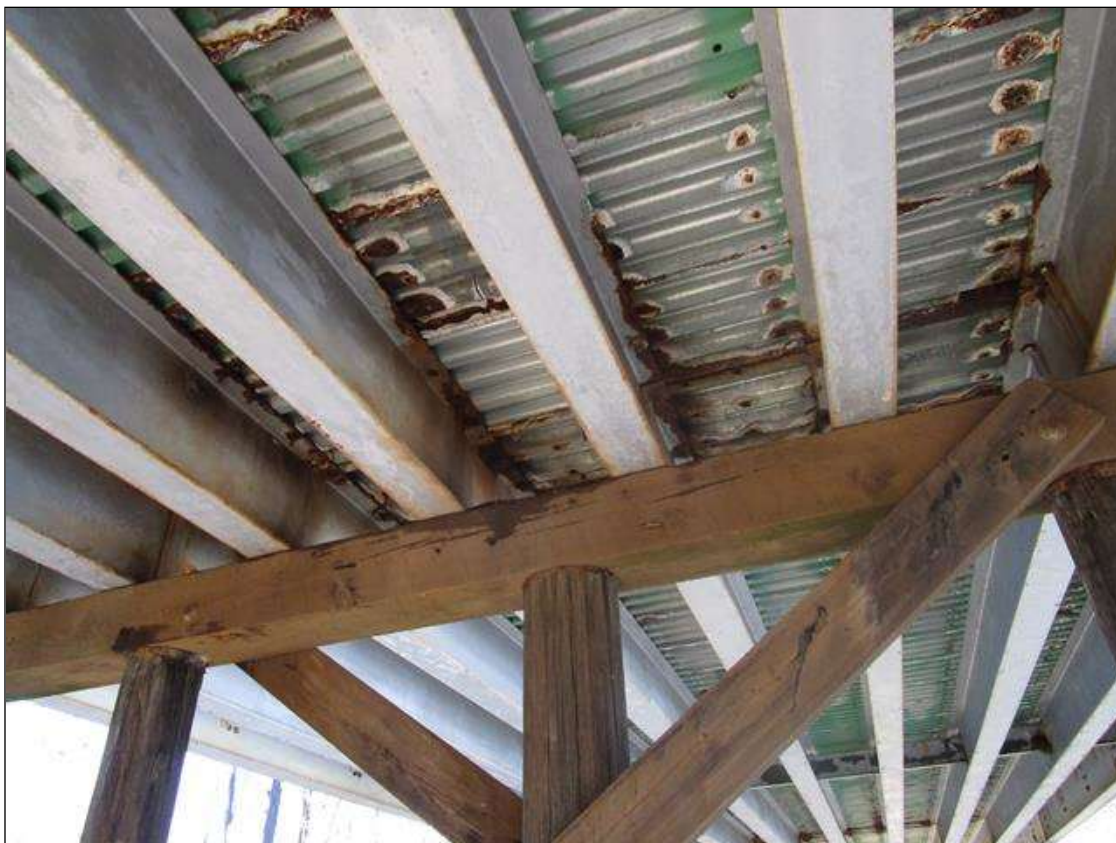
OVERVIEW OF CORROSION TO TOP FLANGES OF BEAMS 2-7 OVER BENT 1

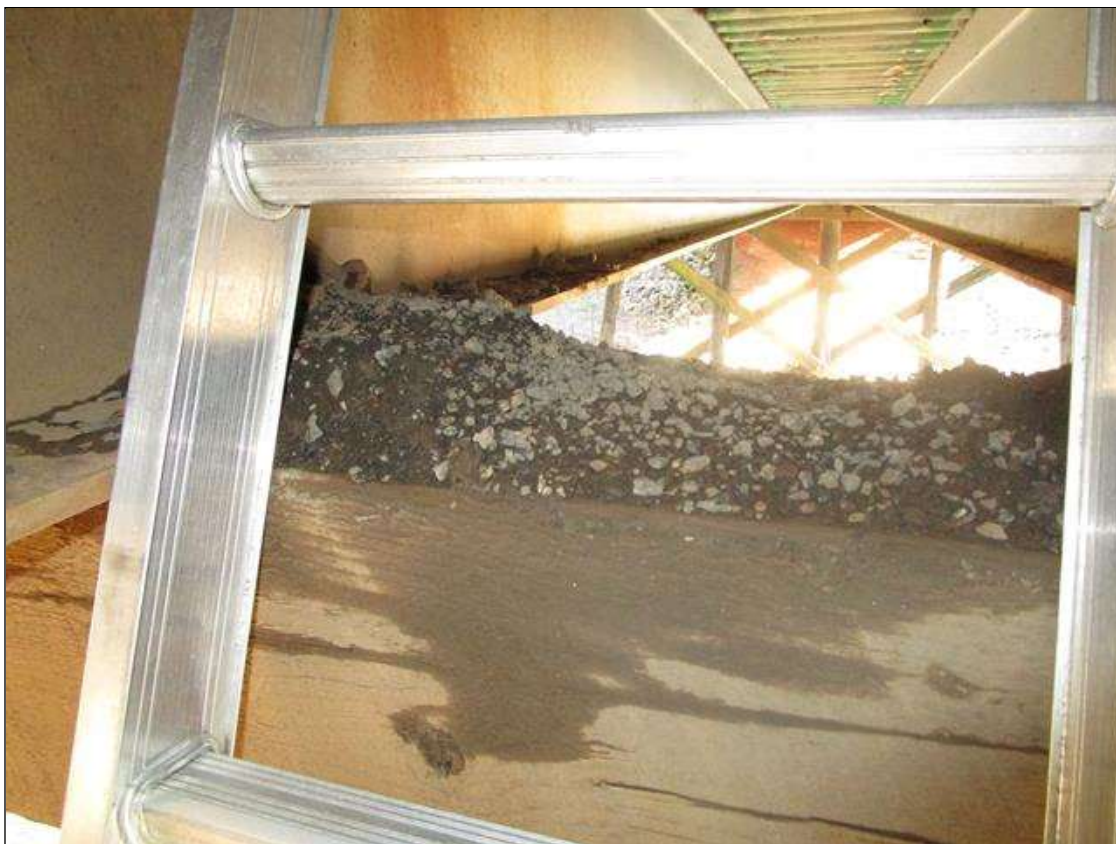
DEBRIS BUILDUP ON BENT 1 CAP

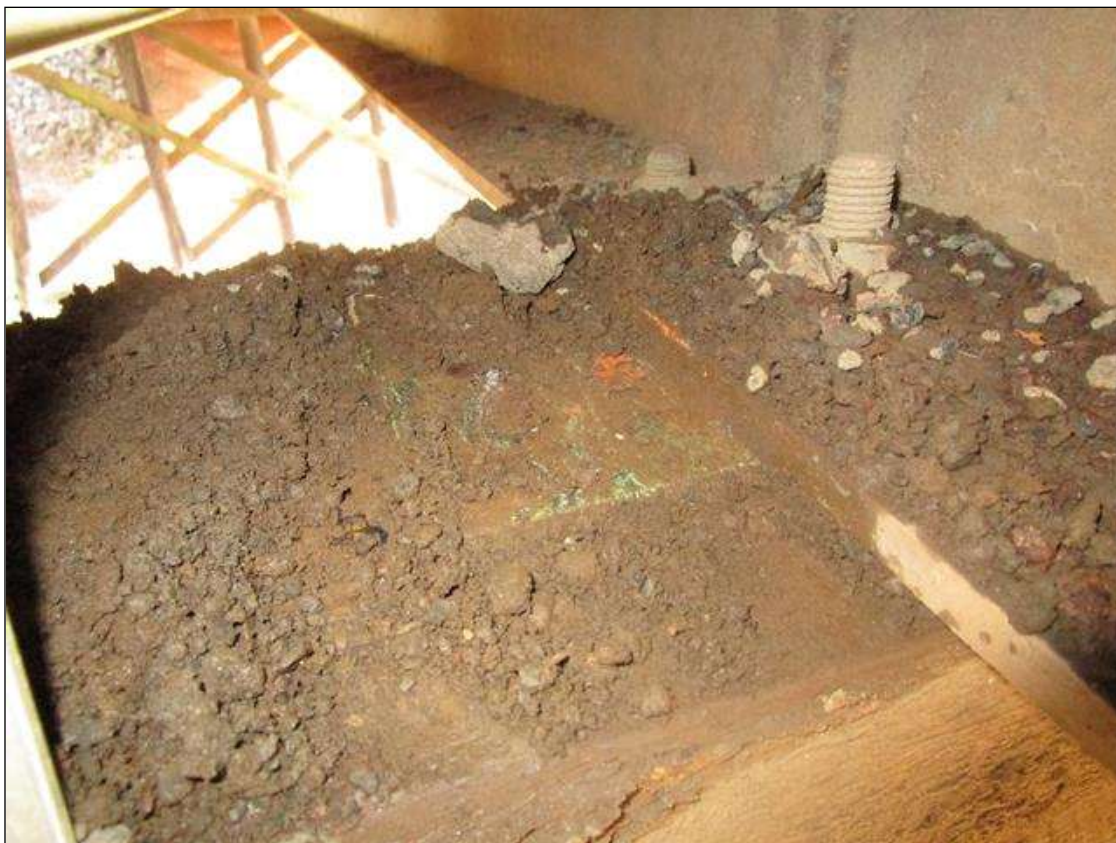
SURFACE CORROSION ON INTERIOR BENT BEARINGS FOR BEAMS WITH CORROSION AT ENDS

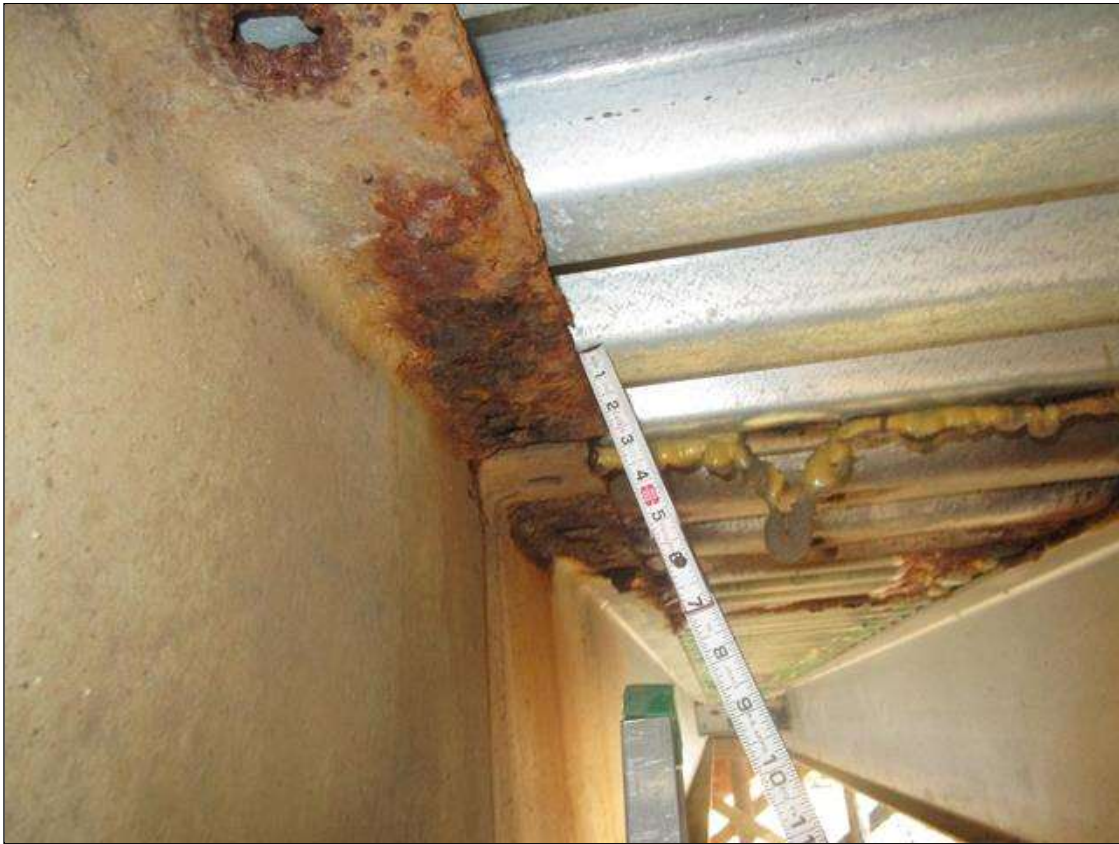
BEAMS 2-7 OVER BENT 1 HAVE CORROSION IN TOP FLANGES. SECTION LOSS IS NEGLIGIBLE AT THIS TIME

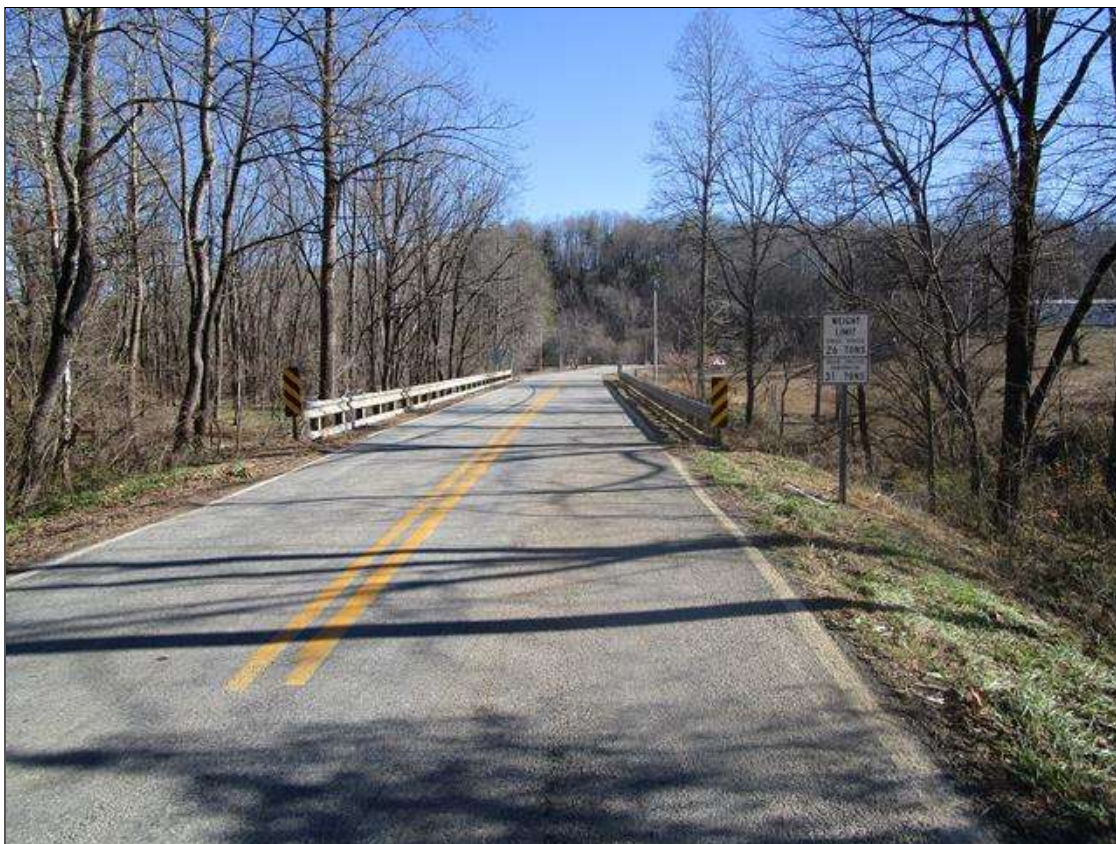
WEST APPROACH LOOKING EAST
