NC DEPARTMENT OF TRANSPORTATION  
 DIVISION OF HIGHWAYS  
 STRUCTURE MANAGEMENT UNIT

ATTENTION: **prompt action request, sketches revised**

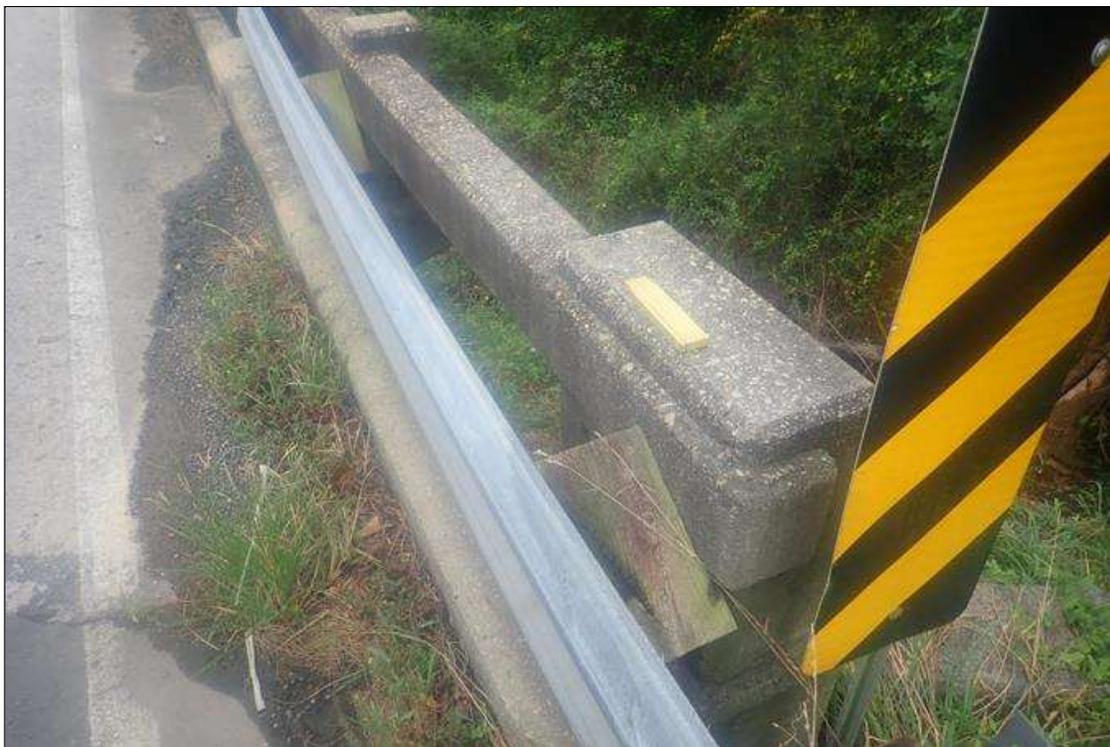
(PAR) northwest guardrail attachment, (2) twisted spacer blocks

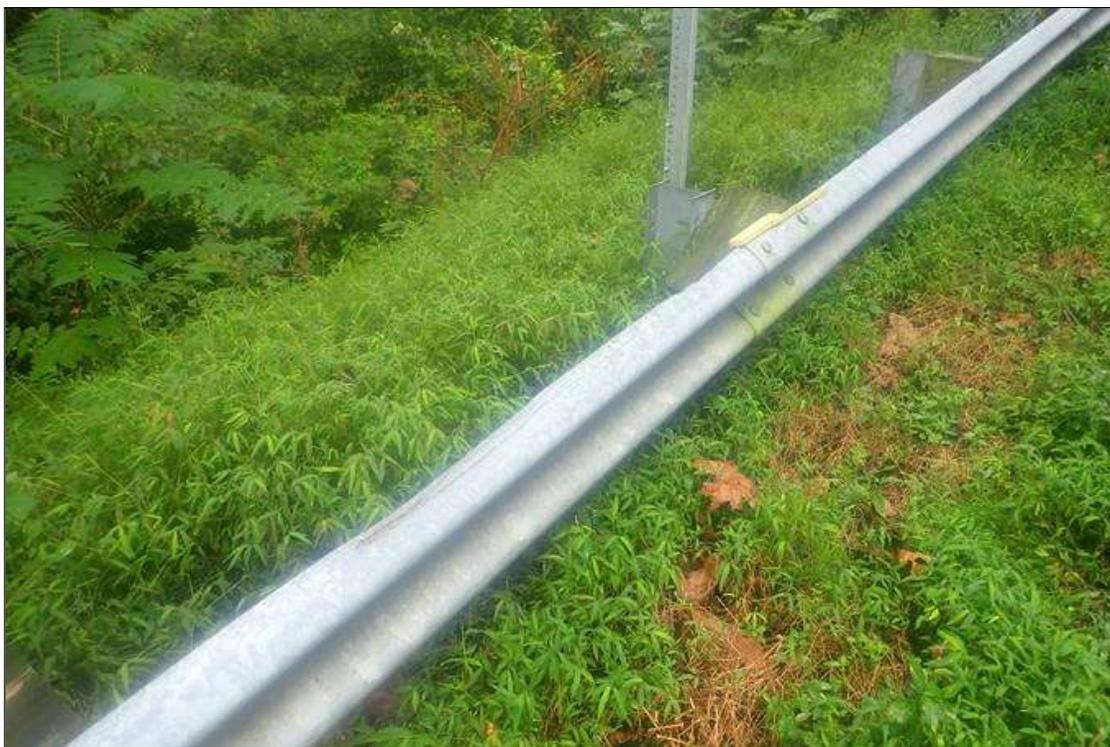
(PAR) southeast guardrail, 60' from bridge, impact damage (12')

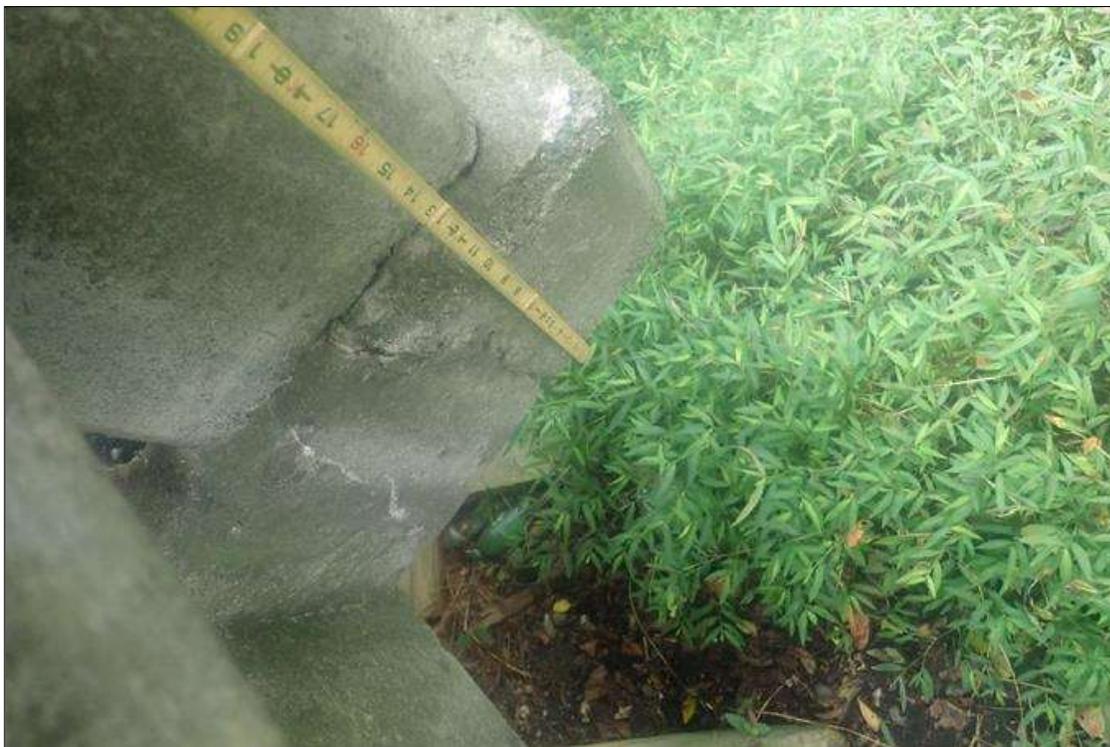
Span 1 Right Bridge Rail: 2nd post from end bent 1, vertical cracks (up to 1/16" x 9"), some with efflorescence

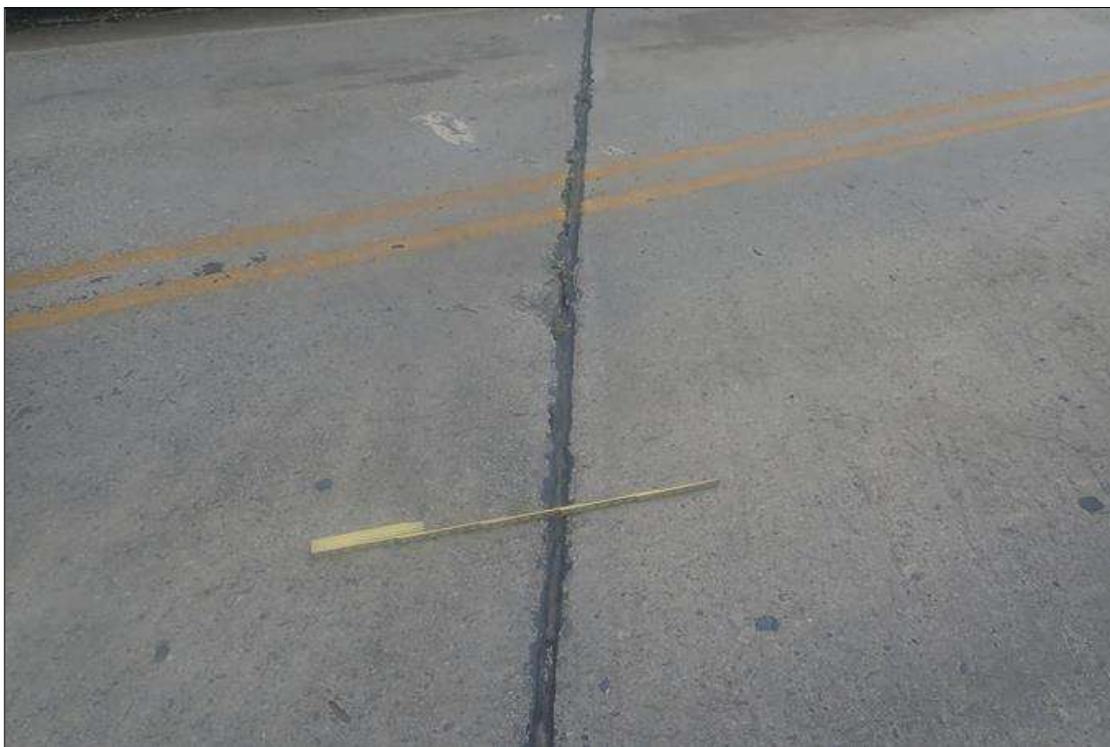
Span 2 Expansion Joint: along the joint, adhesion loss (up to full depth) at locations of edge spalls (up to 4.5' x 6" x 1" deep)

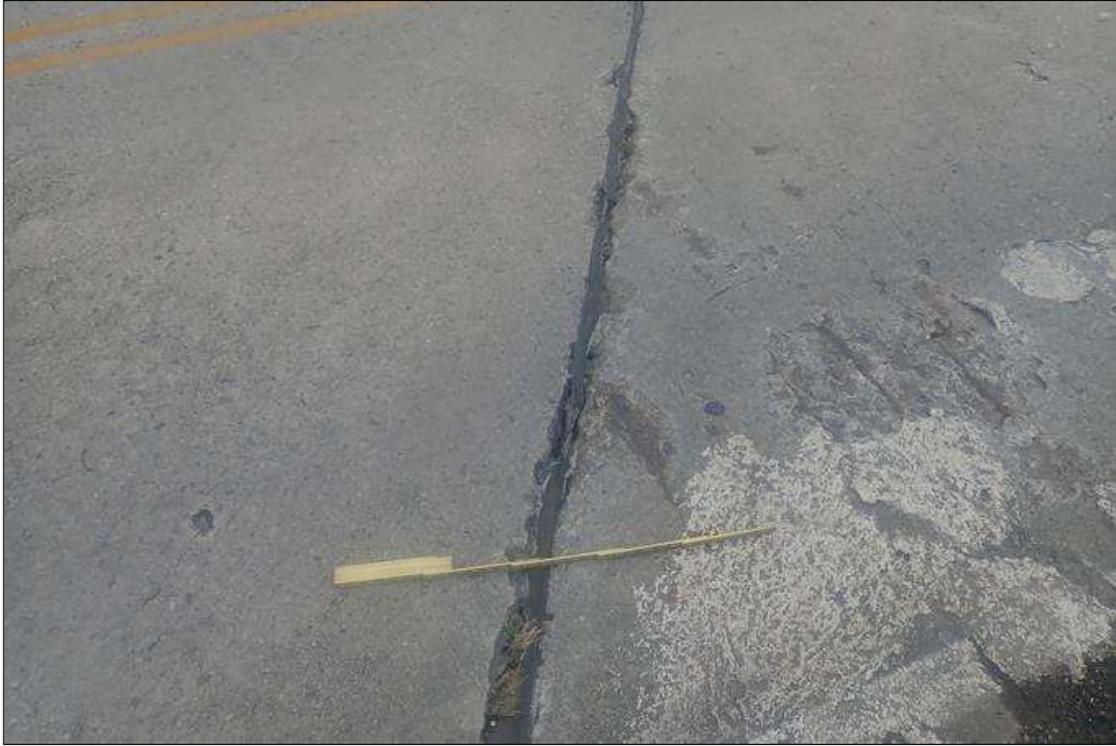
Span 3 Bent 2 Joint: along the joint, adhesion loss (up to full depth) at locations of edge spalls (up to 7' x 5" x 1.5" deep)

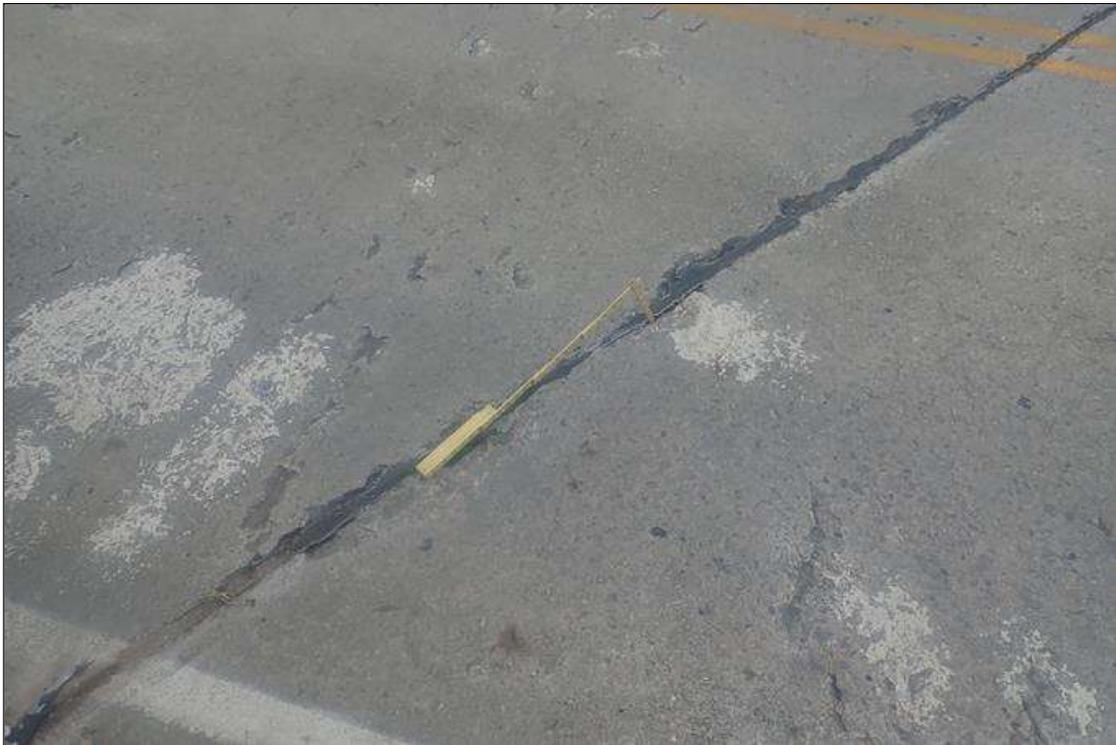
Span 4 Bent 3 Joint: along the joint, adhesion loss (up to full depth) at locations of edge spalls (up to 2.5' x 6" x 1.5" deep)

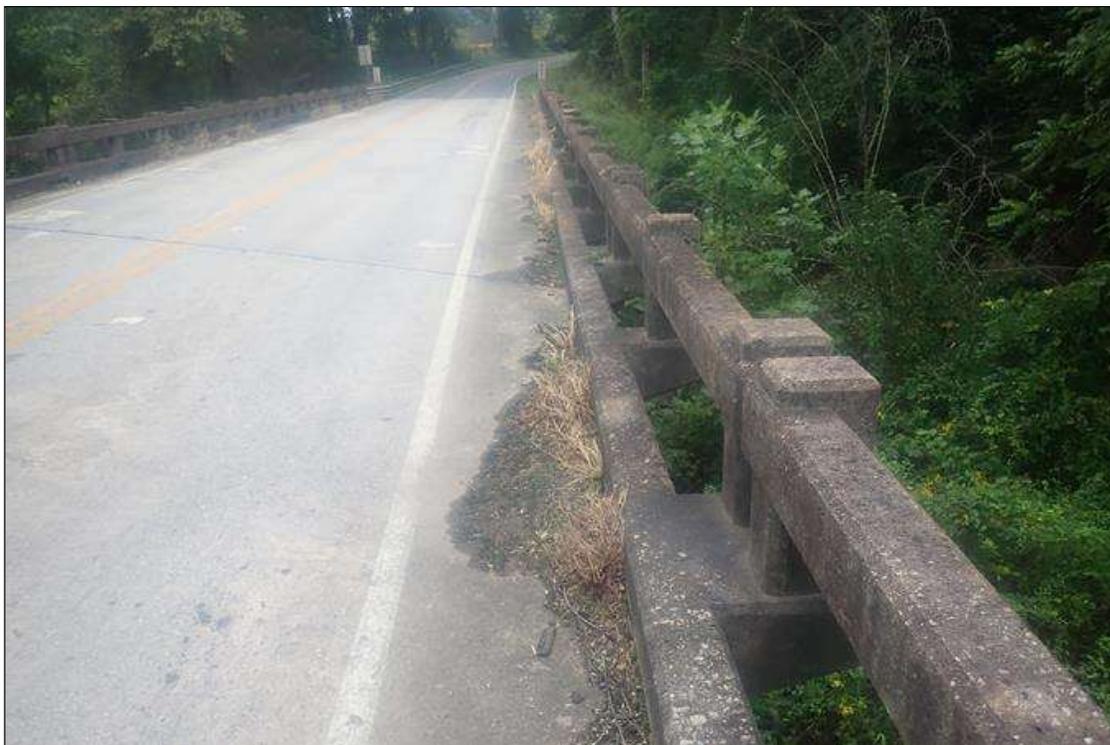
along the curblines, debris accumulation (up to 2' wide x 3" high) with vegetation

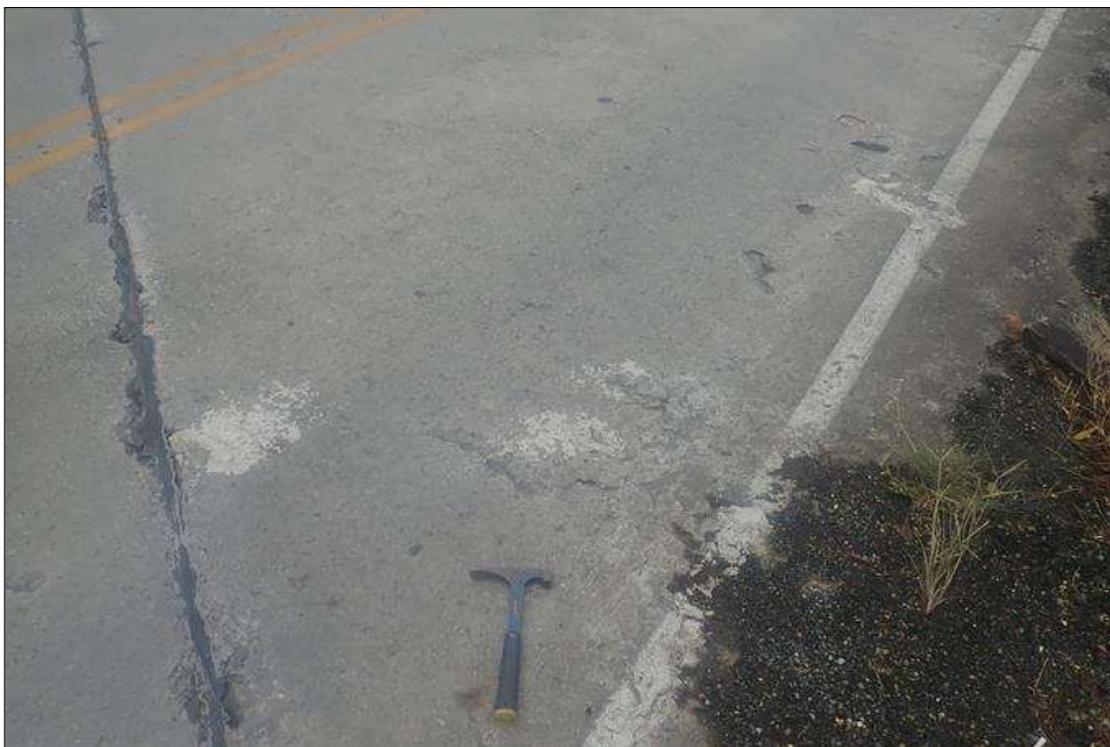
Span 4 Deck: (PAR) throughout top of deck, spalls/delaminations/unsound patches (up to 3' x 1.5' x up to 1.5" deep), some with exposed rusted rebar

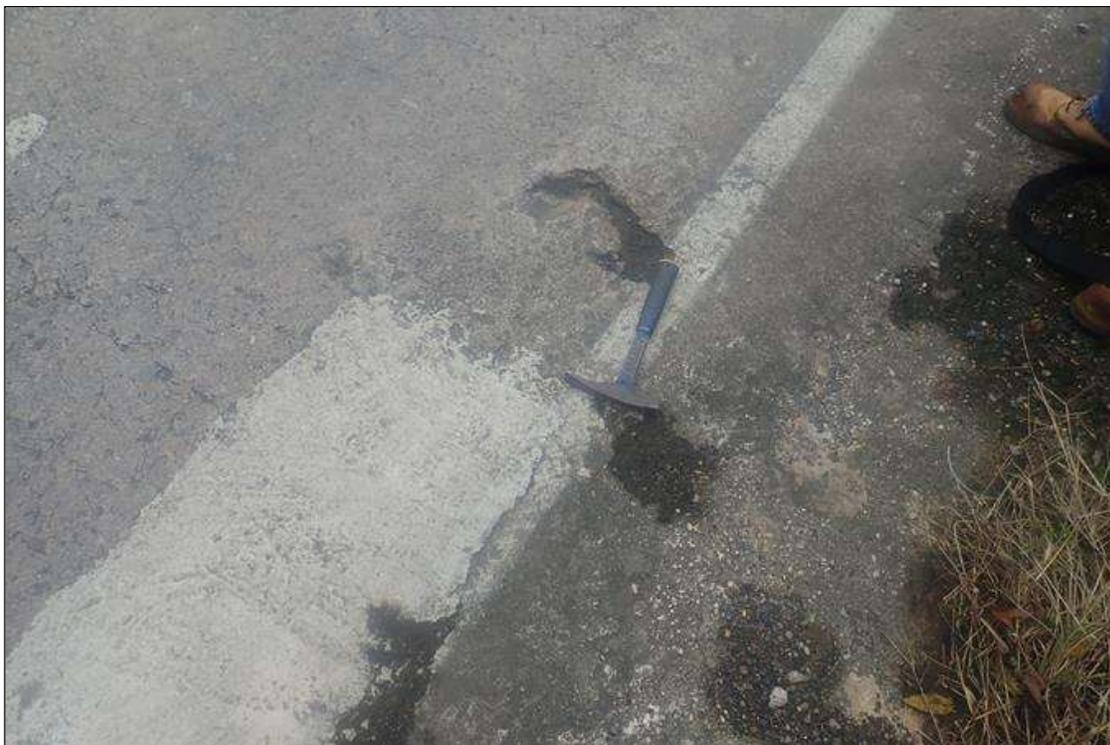
Span 4 Deck: (PAR) throughout top of deck, spalls/delaminations/unsound patches (up to 3' x 1.5' x up to 1.5" deep), some with exposed rusted rebar

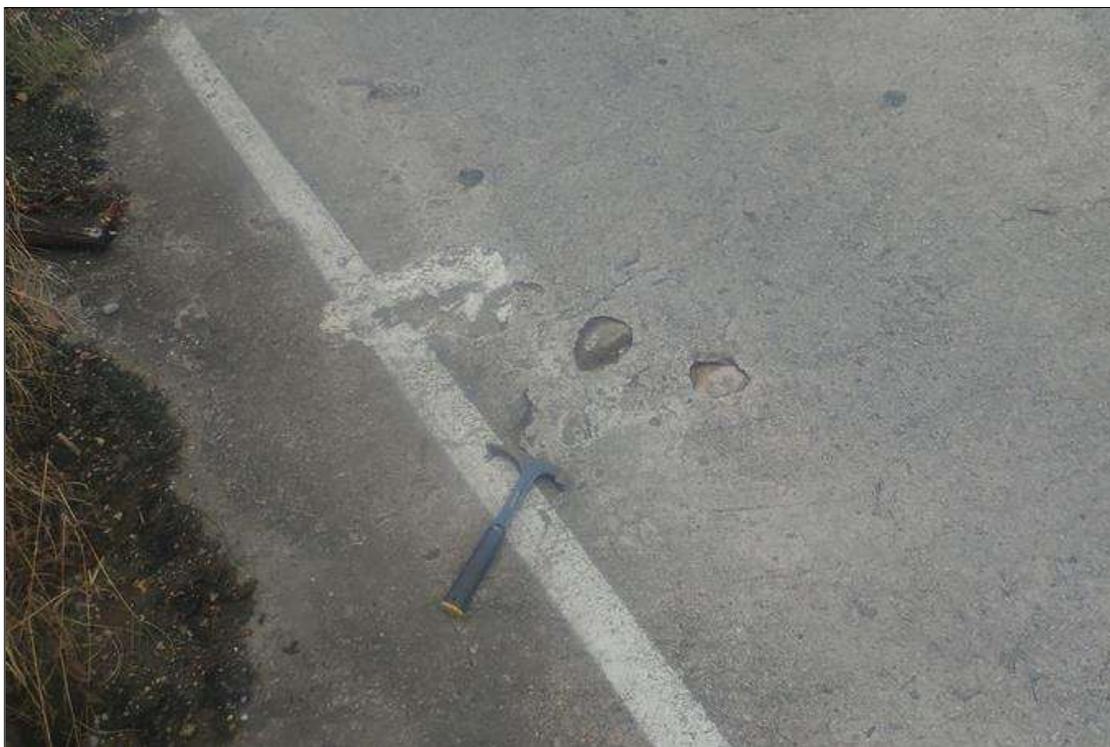
Span 4 Deck: (PAR) throughout top of deck, spalls/delaminations/unsound patches (up to 3' x 1.5' x up to 1.5" deep), some with exposed rusted rebar

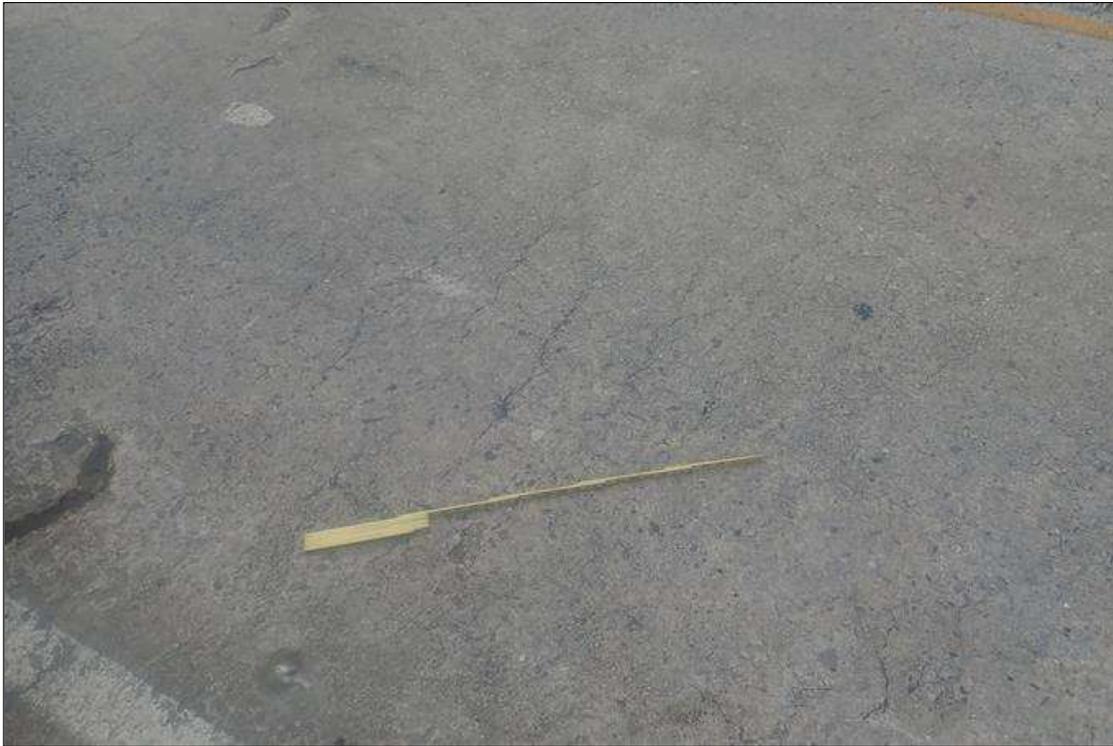
Span 4 Deck: transverse and map cracks (up to 1/16") throughout

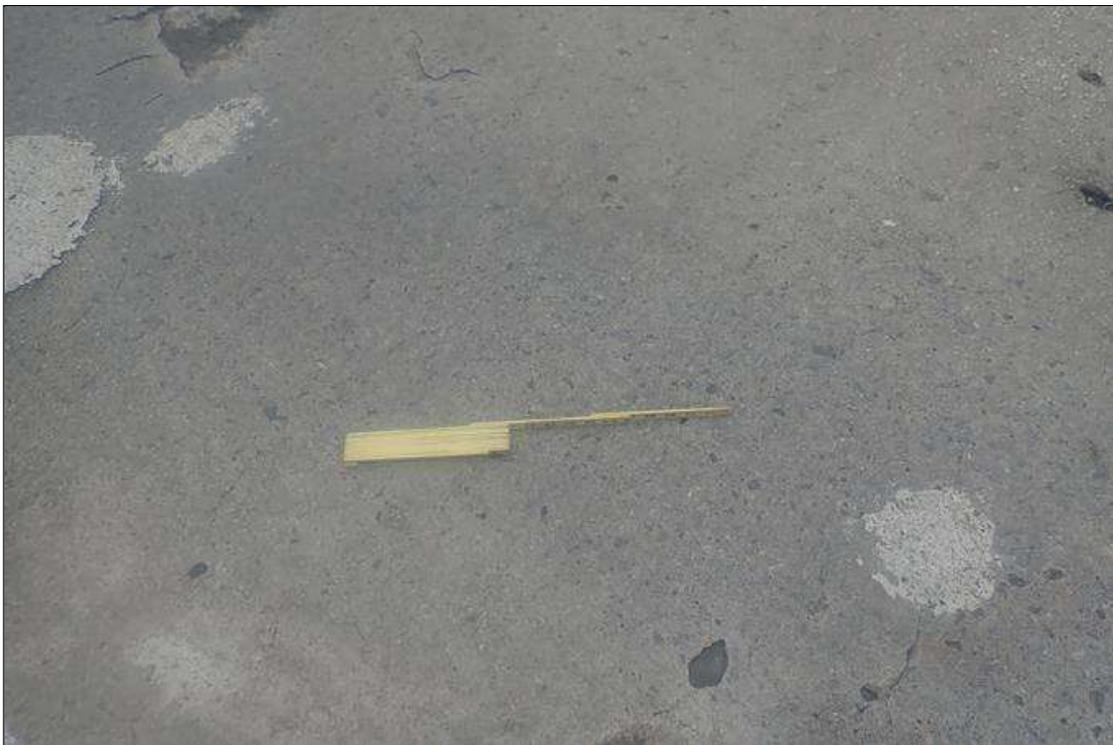
Span 3 Deck: wear with secure aggregate throughout

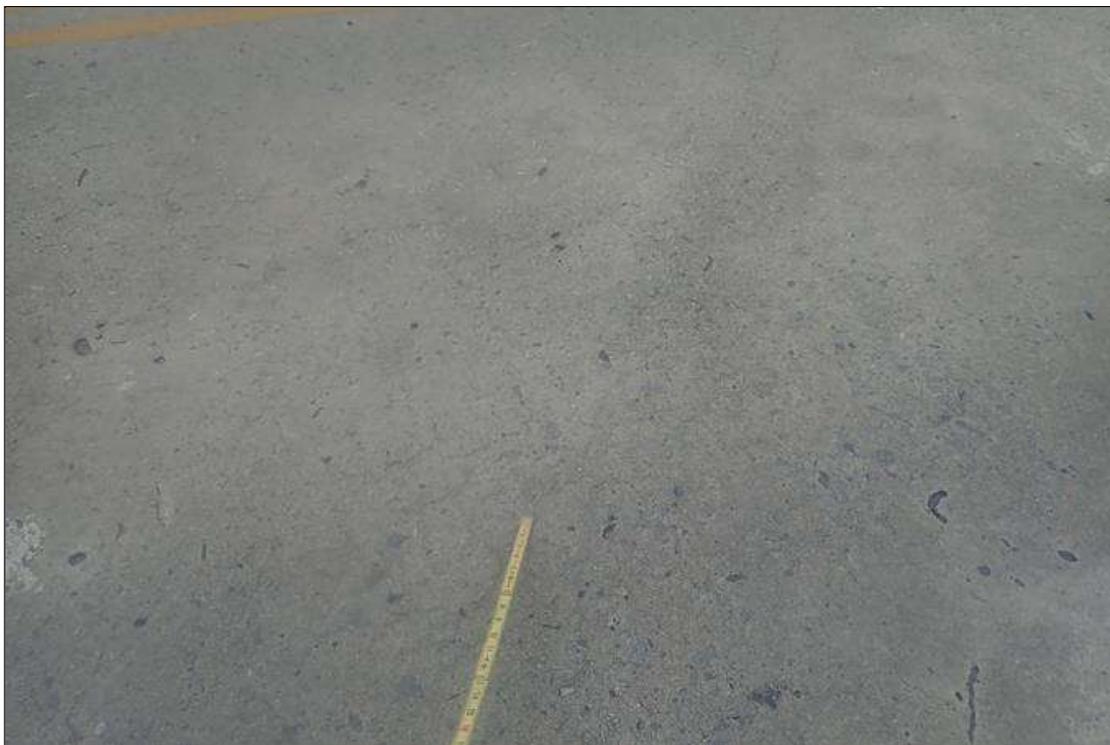
Span 3 Deck: transverse and map cracks (up to 1/8") throughout, some with rust stains

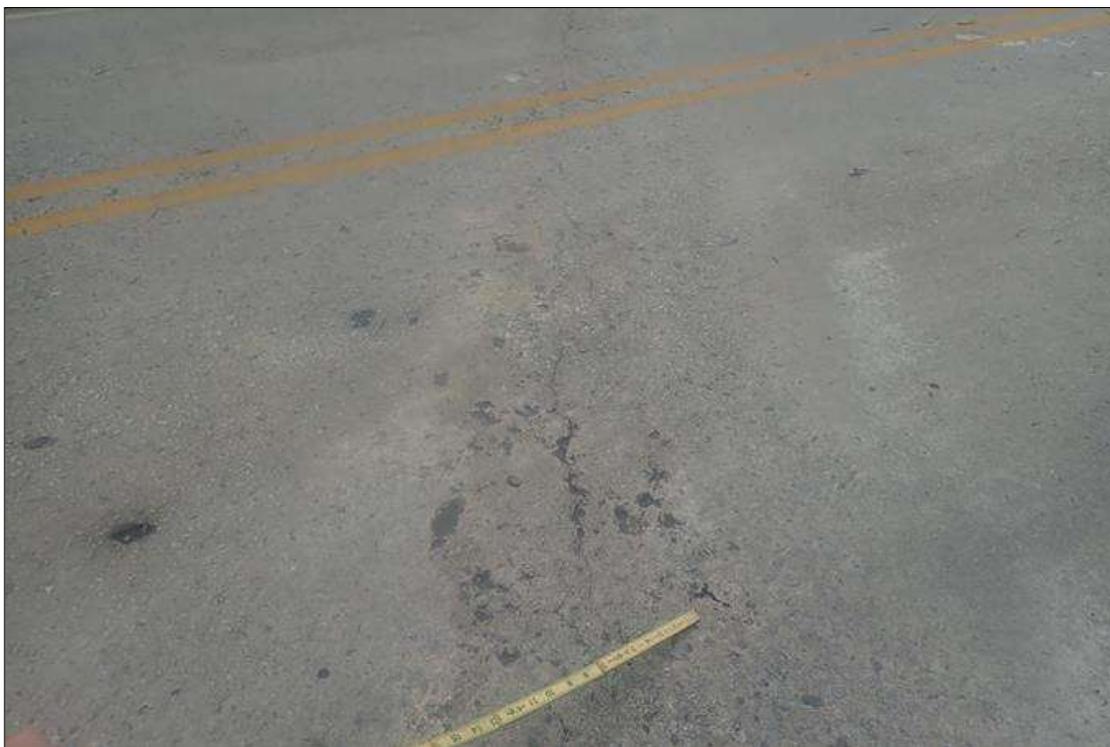
Span 3 Deck: transverse and map cracks (up to 1/8") throughout, some with rust stains

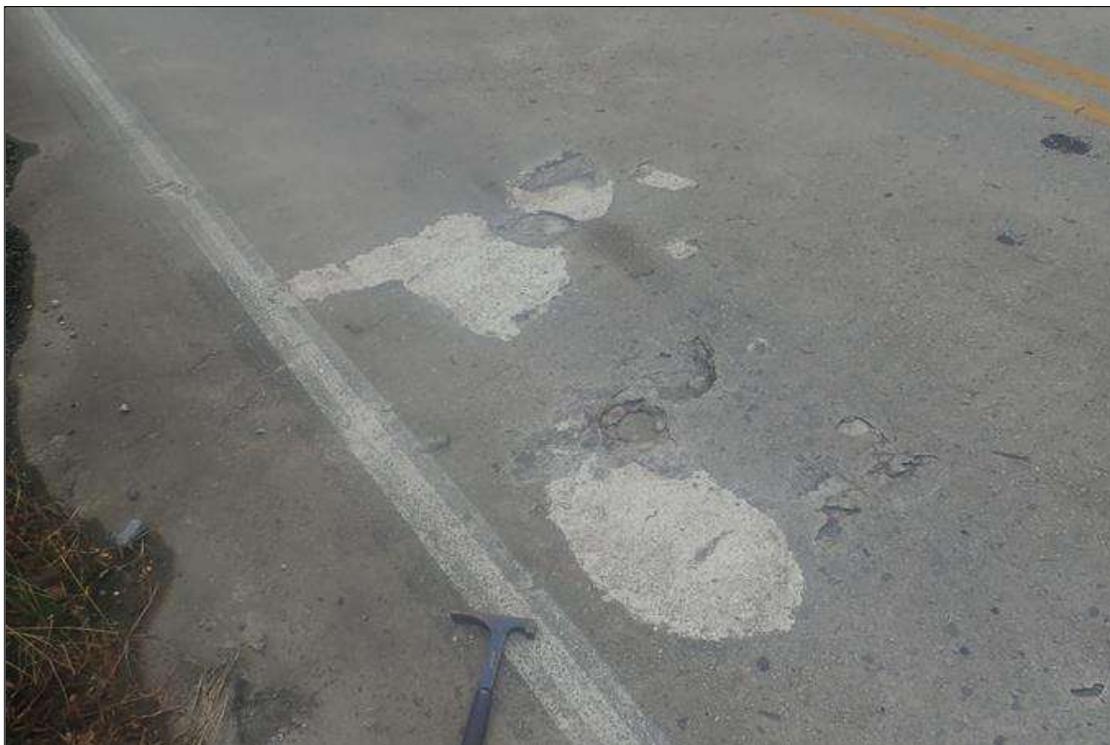
Span 3 Deck: (PAR) throughout top of deck, spalls/delaminations/unsound patches (up to 8' x 6' x up to 1.5" deep), some with exposed rusted rebar

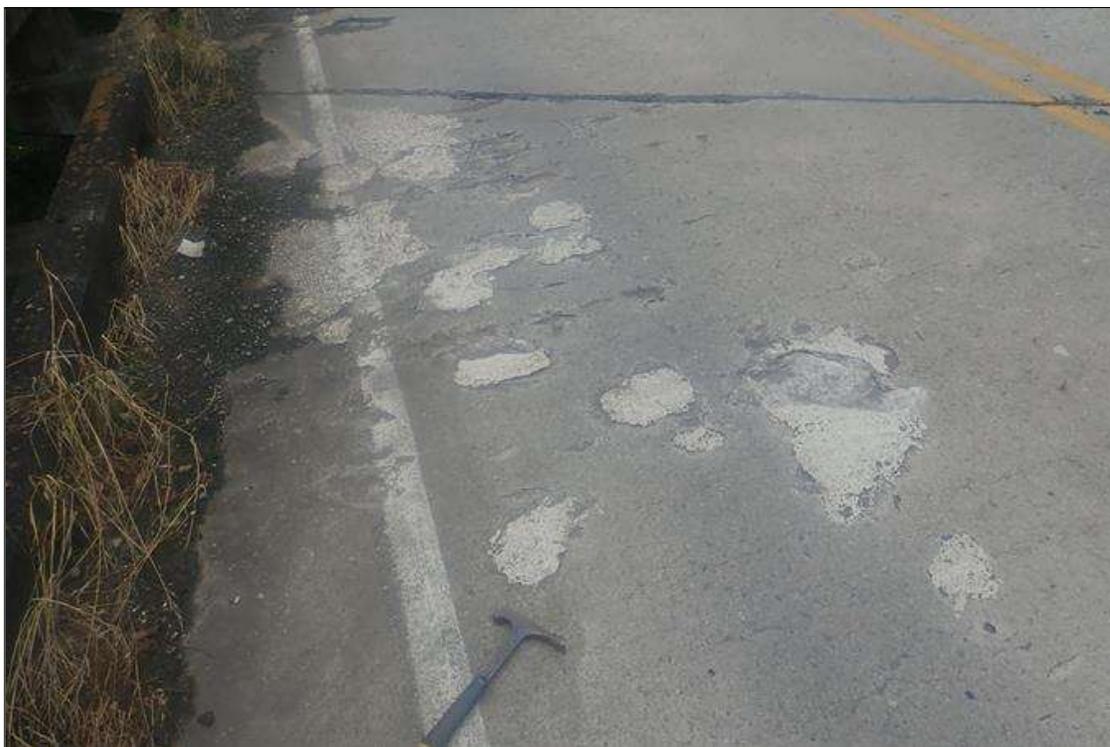
Span 3 Deck: (PAR) throughout top of deck, spalls/delaminations/unsound patches (up to 8' x 6' x up to 1.5" deep), some with exposed rusted rebar

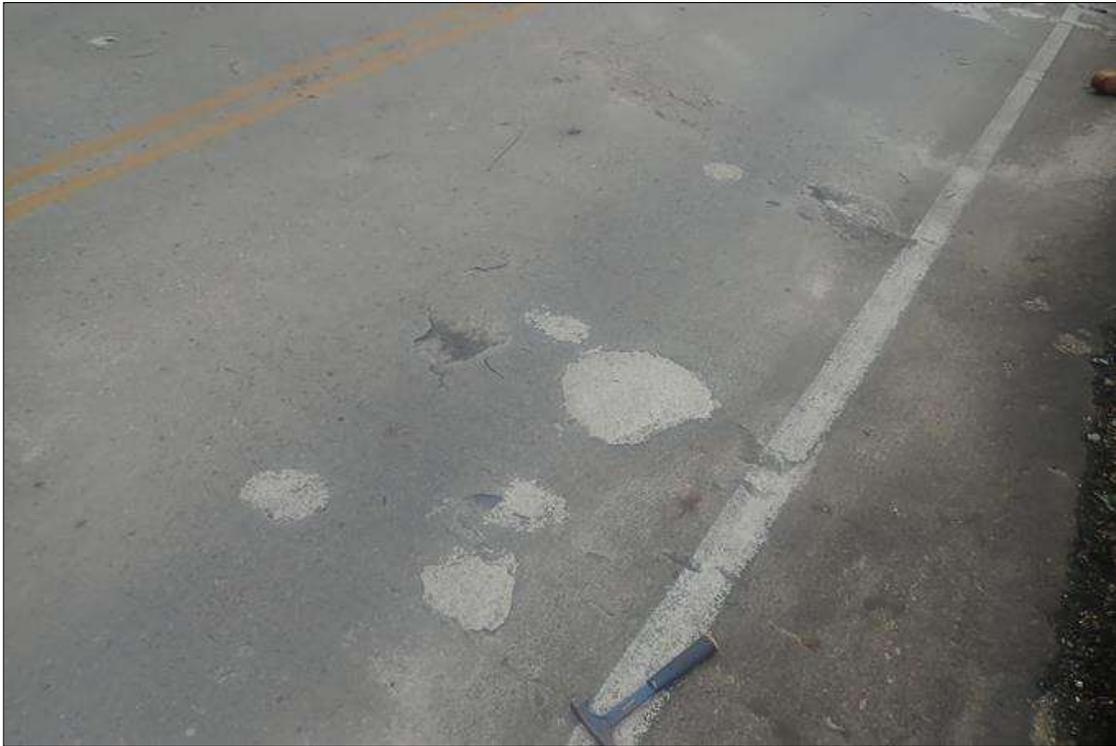
Span 3 Deck: (PAR) throughout top of deck, spalls/delaminations/unsound patches (up to 8' x 6' x up to 1.5" deep), some with exposed rusted rebar

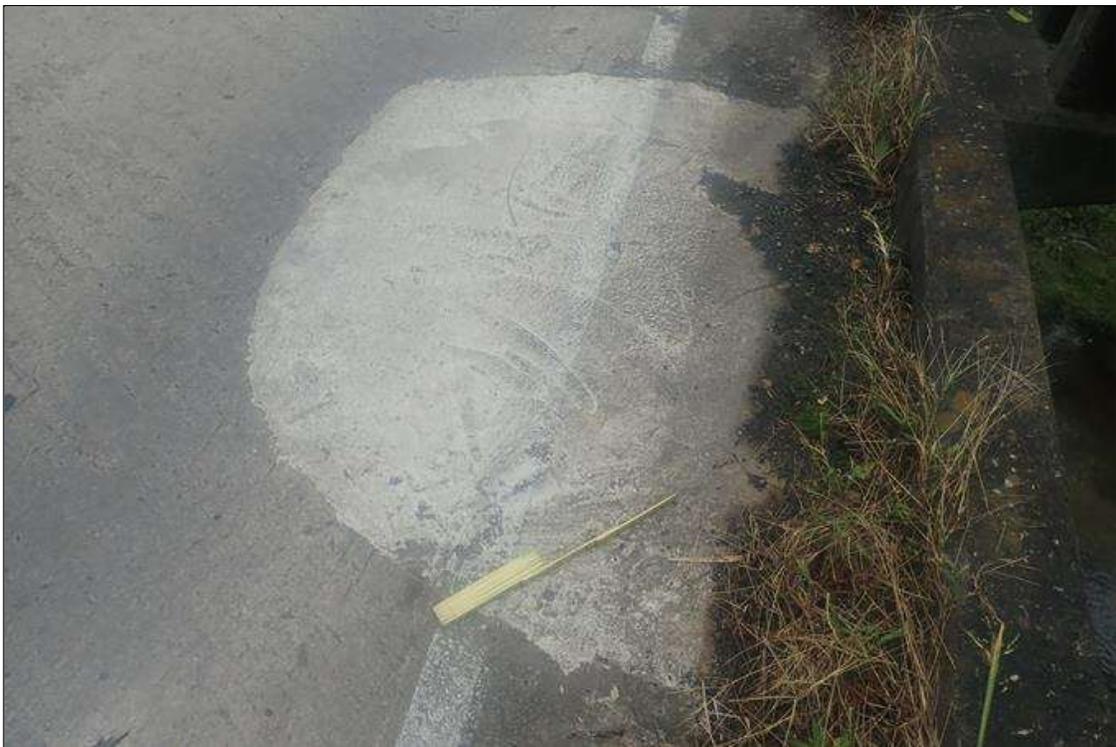
Span 2 Deck: northbound lane and shoulder, at 5' from bent 1, patched area (6' x 4.5') with map cracks (up to 1/32")

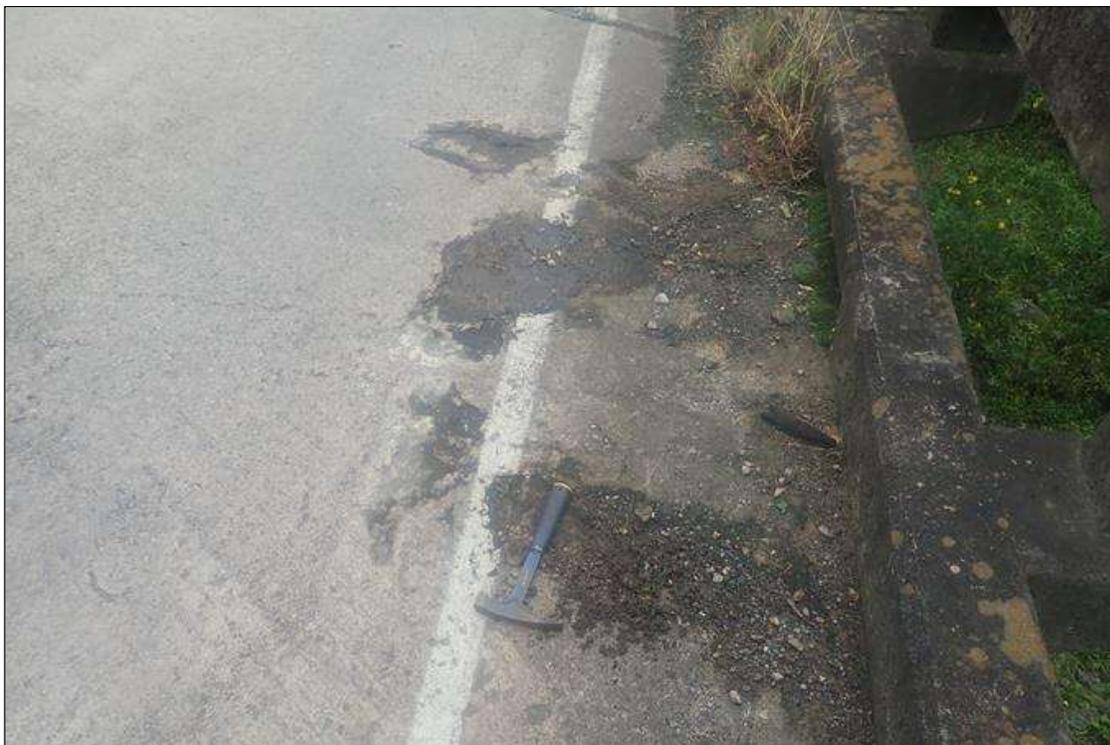
Span 2 Deck: (PAR) in northbound lane and shoulder, at 3' from bent 2, area spalls/delaminations (up to 5.5' x 4' x 1.5" deep)

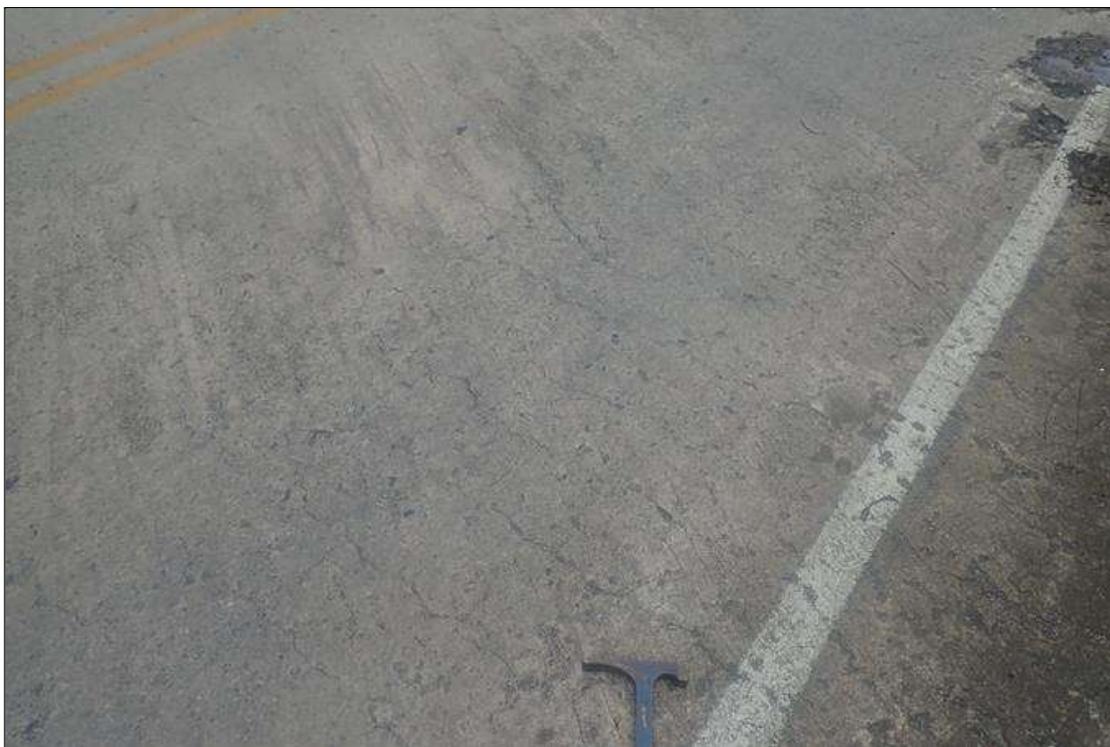
Span 2 Deck: transverse and map cracks (up to 1/8") throughout, some with rust stains

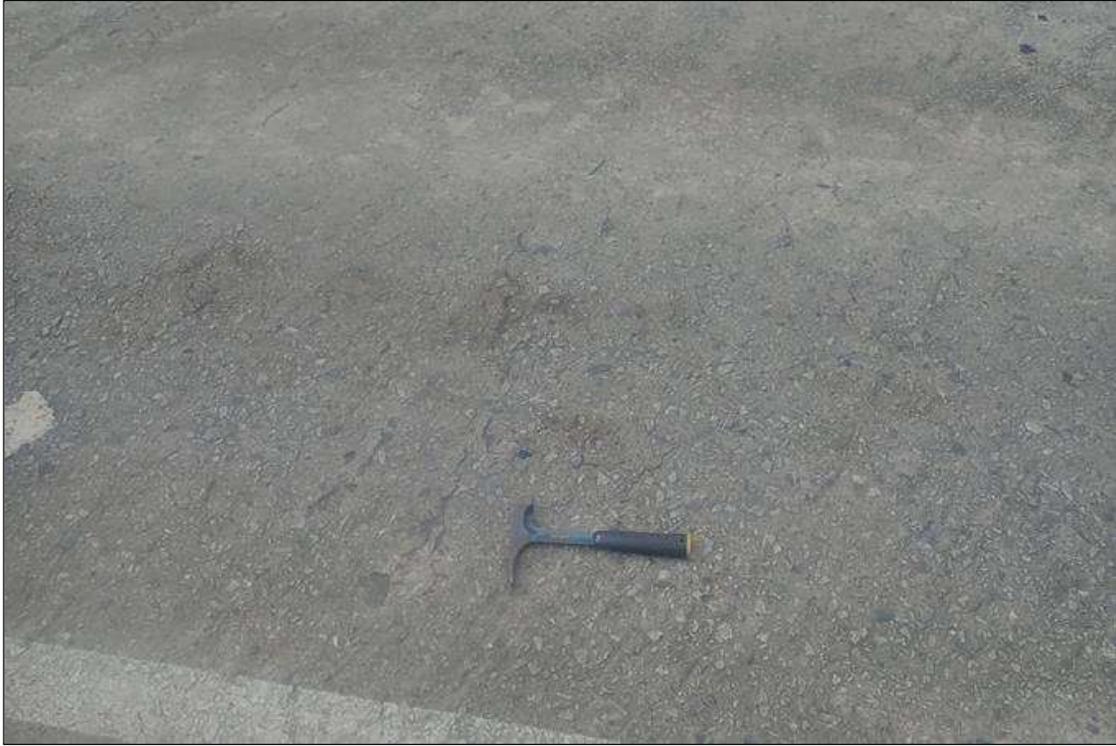
Span 1 Deck: transverse crack and map cracks (up to 1/8") throughout

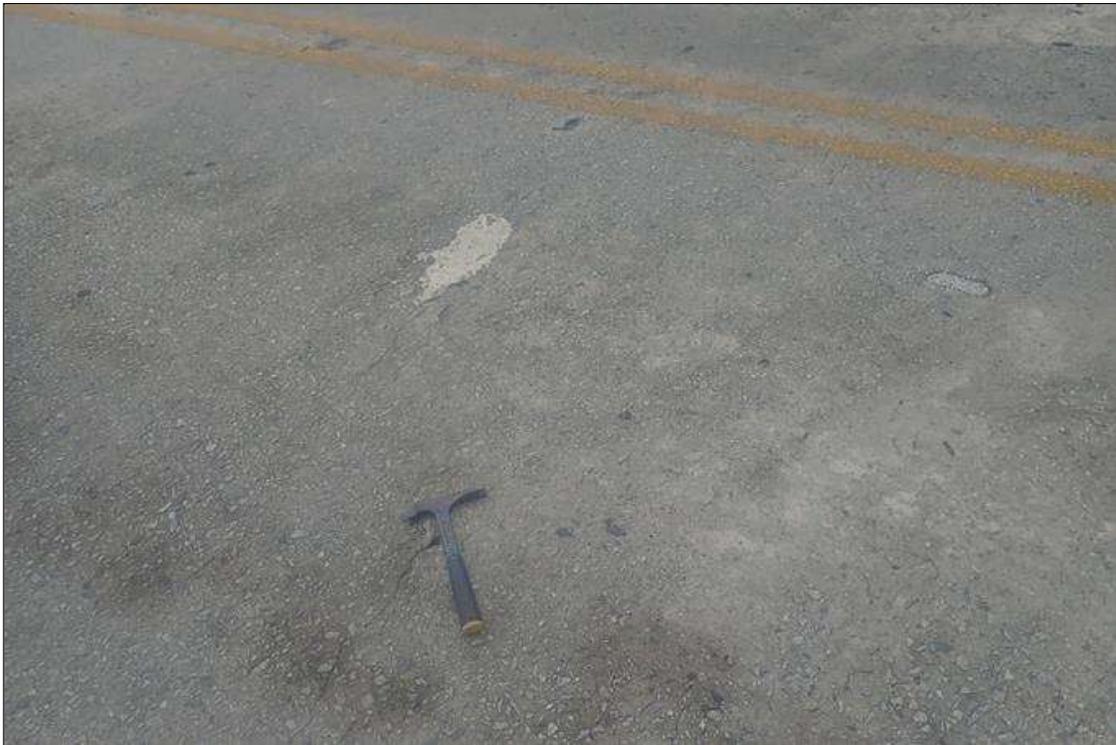
Span 1 Deck: (PAR) throughout top of deck, spalls/delaminations/unsound patches (up to 16" x 6" x 1" deep), some with exposed rusted rebar

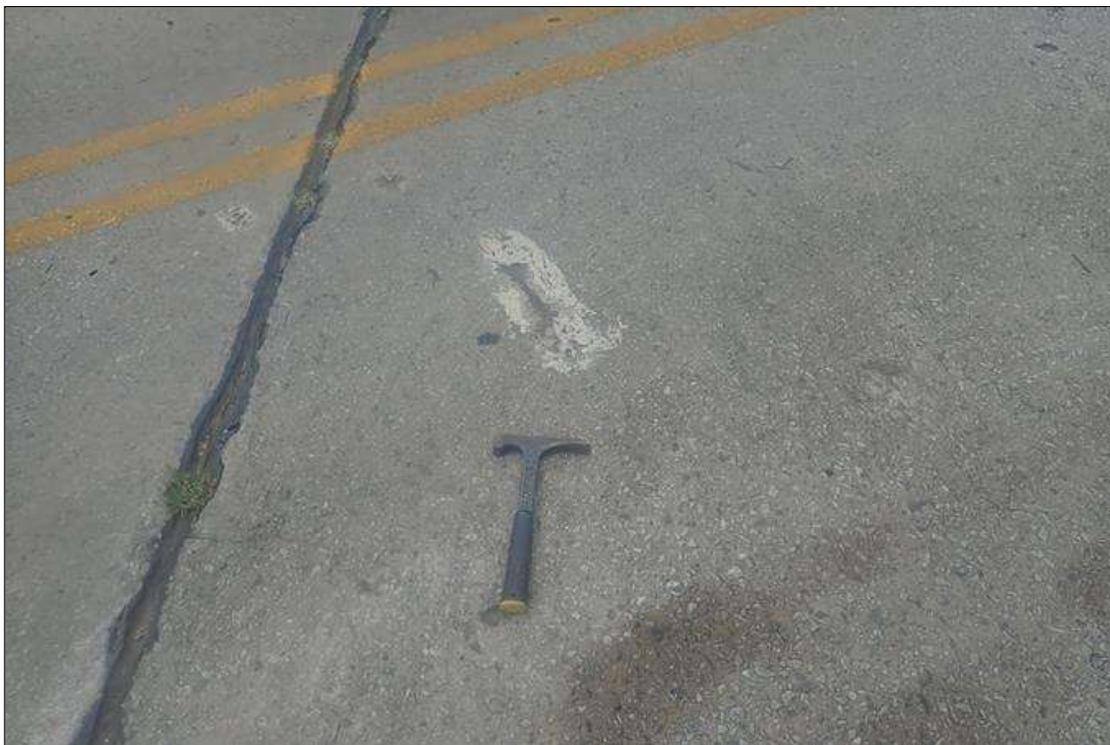
Span 1 Deck: (PAR) throughout top of deck, spalls/delaminations/unsound patches (up to 16" x 6" x 1" deep), some with exposed rusted rebar

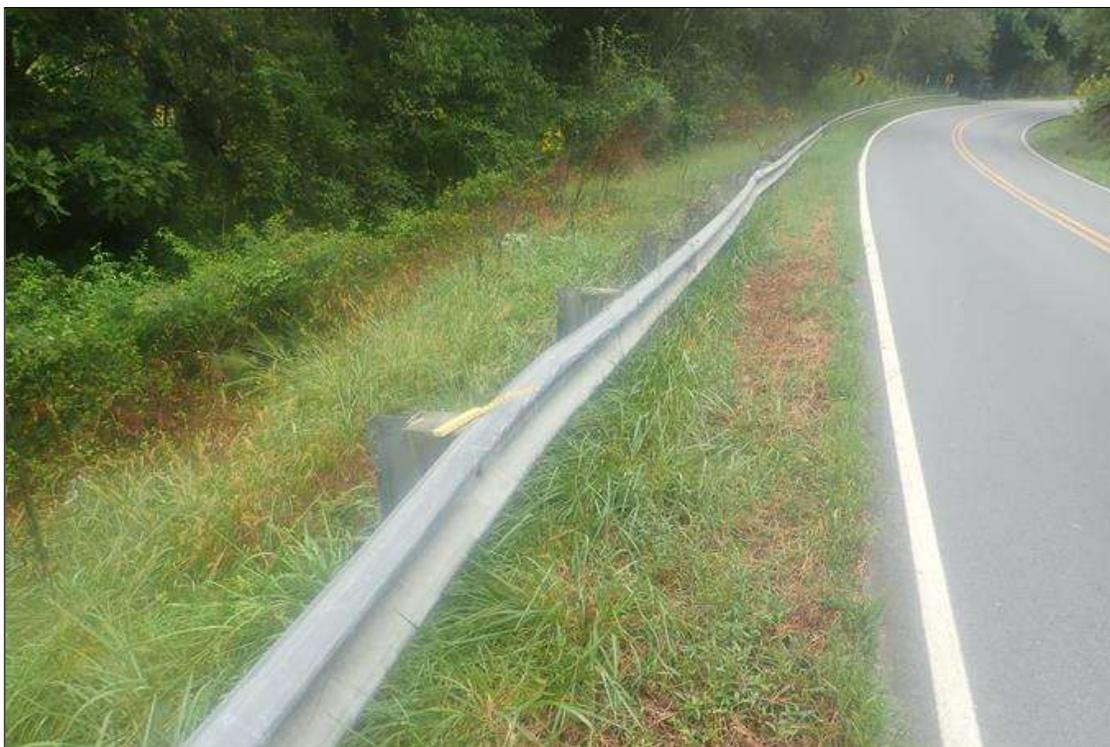
(PAR) northwest guardrail, areas of impact damage (up to 12' long; 30' total)

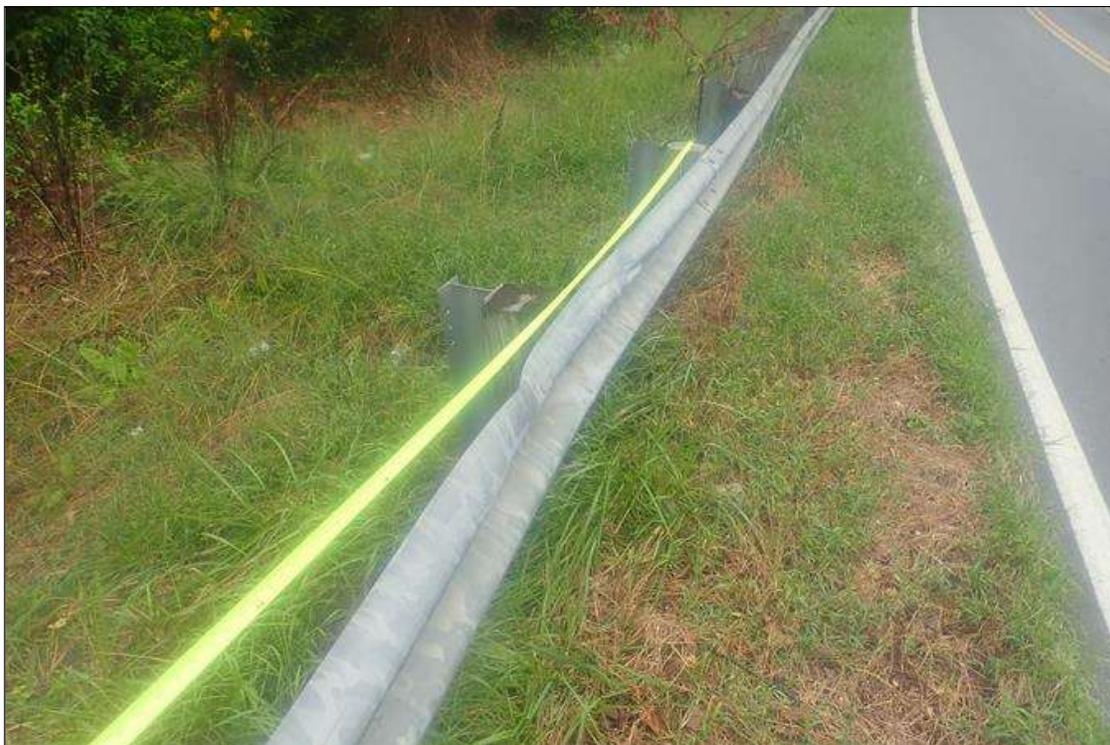
(PAR) northwest guardrail, areas of impact damage (up to 12' long; 30' total)

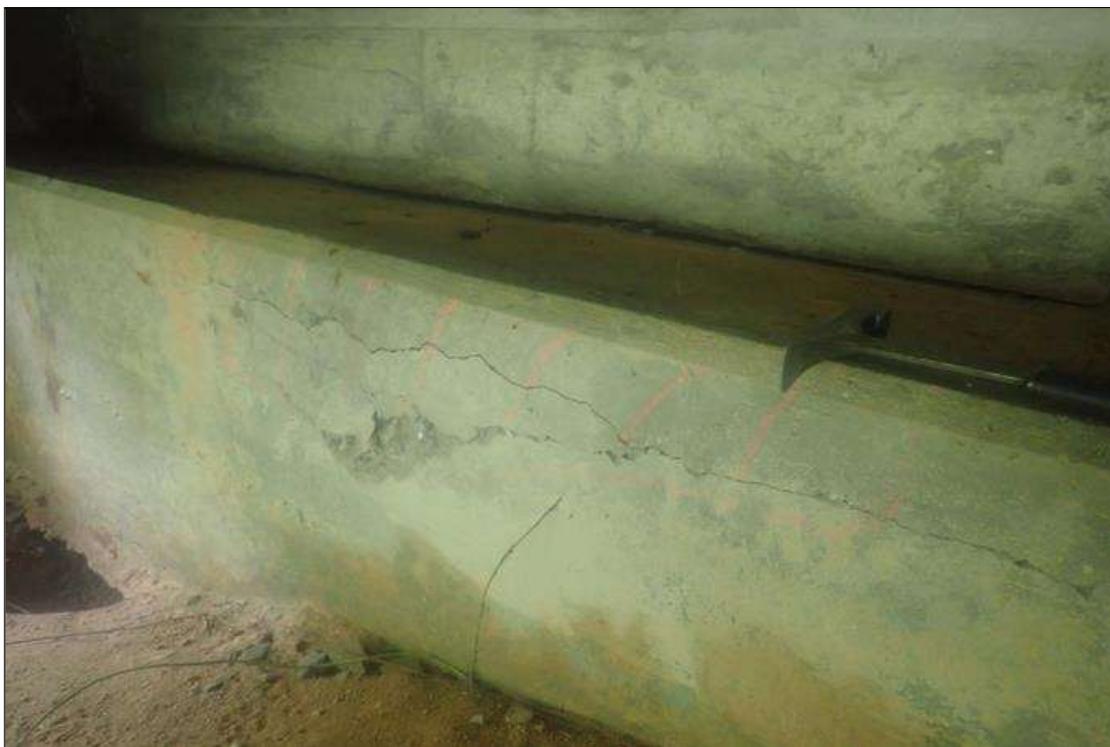
End Bent 2 Cap 1: bay 1, spall/delamination (3.5' x 1' x 0.5" deep)

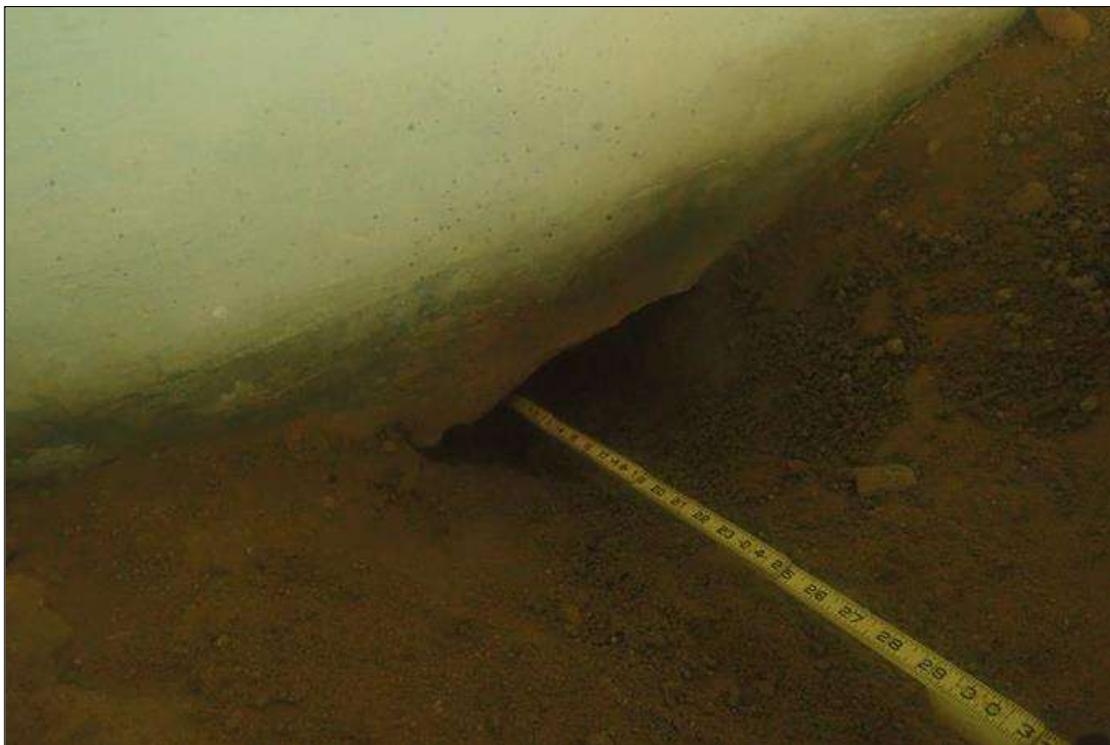
End Bent 2 Cap 1: (PAR) below beams 1 and 3, undermining of cap (up to 16" x 6" x 13" deep), no exposed piles
