NC DEPARTMENT OF TRANSPORTATION  
 DIVISION OF HIGHWAYS  
 STRUCTURE MANAGEMENT UNIT

ATTENTION: **prompt action request, sketches revised**

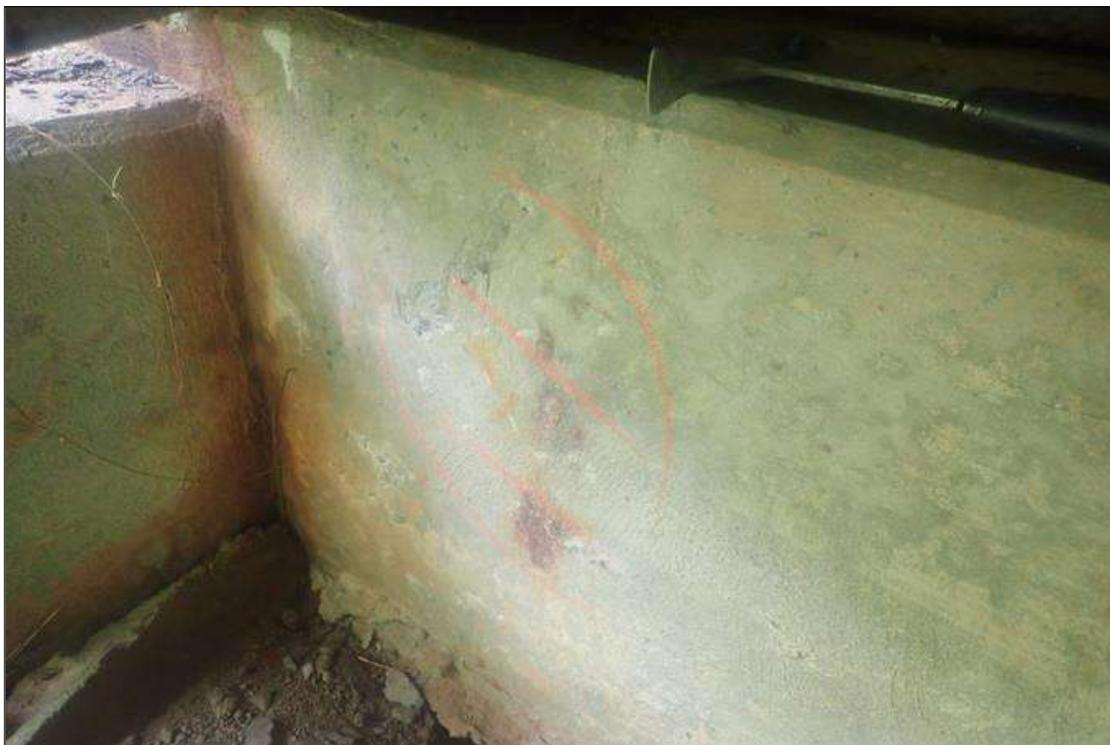
End Bent 2 Cap 1: below beam 1, spall/delamination (11' x 12" x 1/2" deep) with rust stains

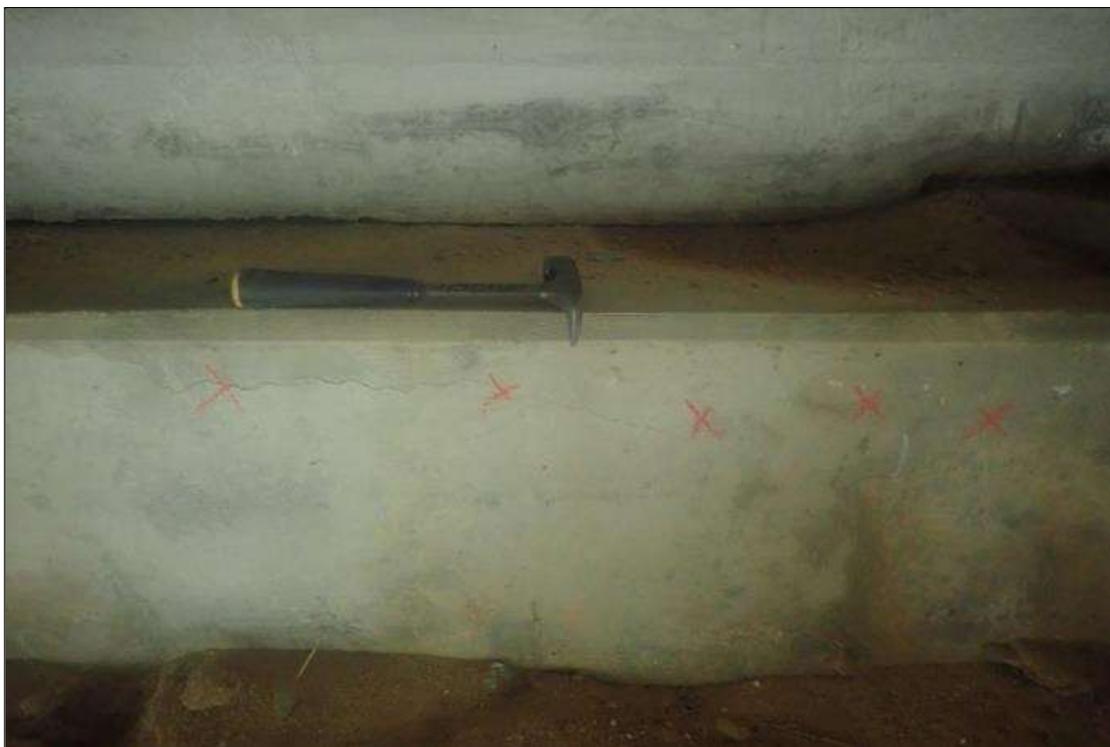
End Bent 2 Cap 1: below bay 3, horizontal crack (1/32" x 3')

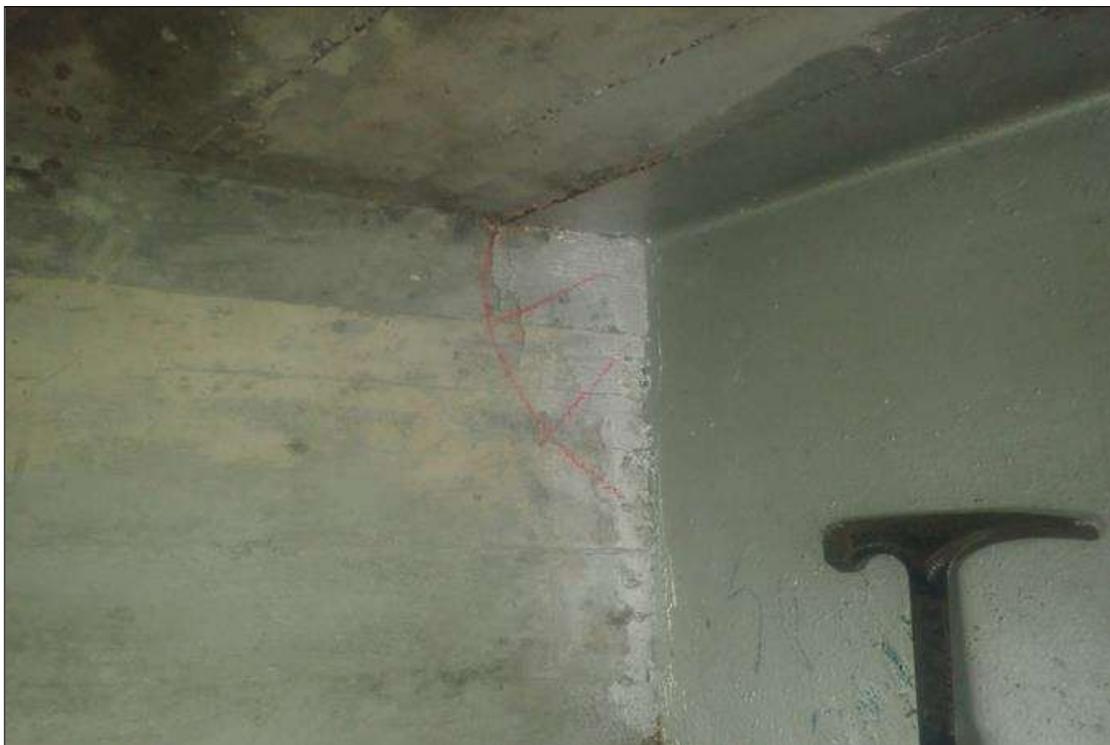
End Bent 2 Abutment: adjacent to west face of beam 4, delamination (6" x 10")

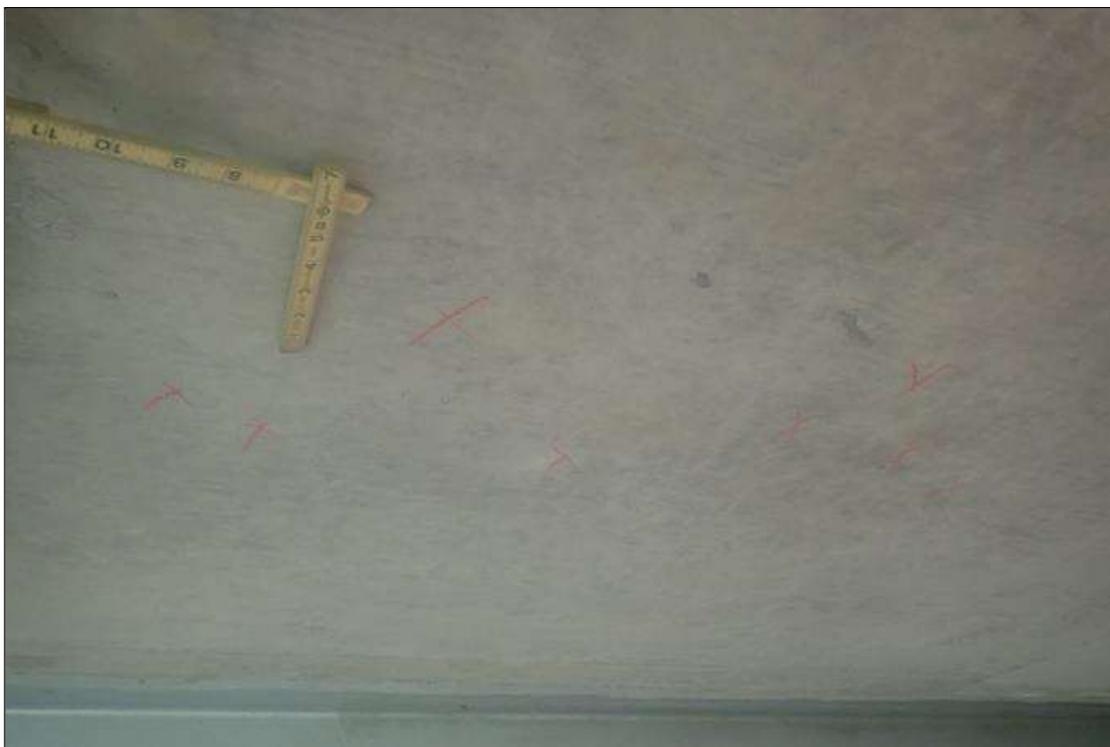
Span 4 Deck: throughout underside of deck, areas of map cracks (up to 1/32") at random; some cracks with dampness

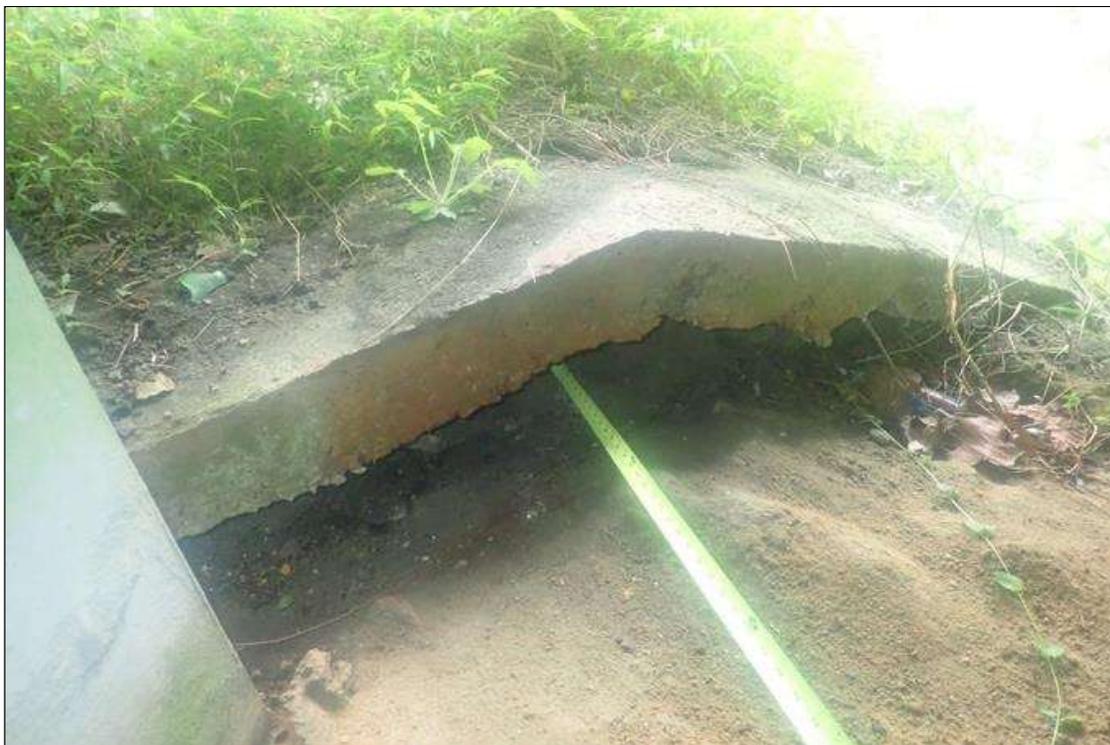
(PAR) end bent 2 slope protection, at east end, undermining (6' x up to 6" x up to 4.5" deep); concrete slope with cracks (up to 1/4")

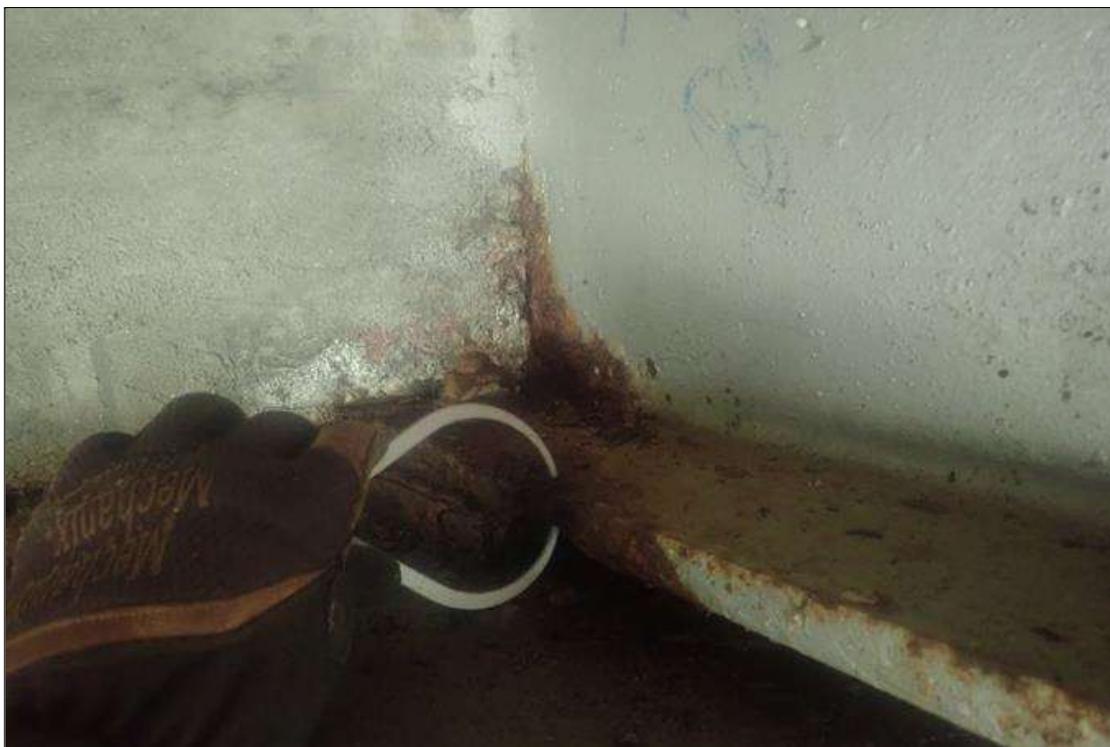
Span 4 Beam 4: at end bent 2, corrosion with section loss to bottom flange (0.75" average remaining x 10"); lower web, rust scale (5" x 5")

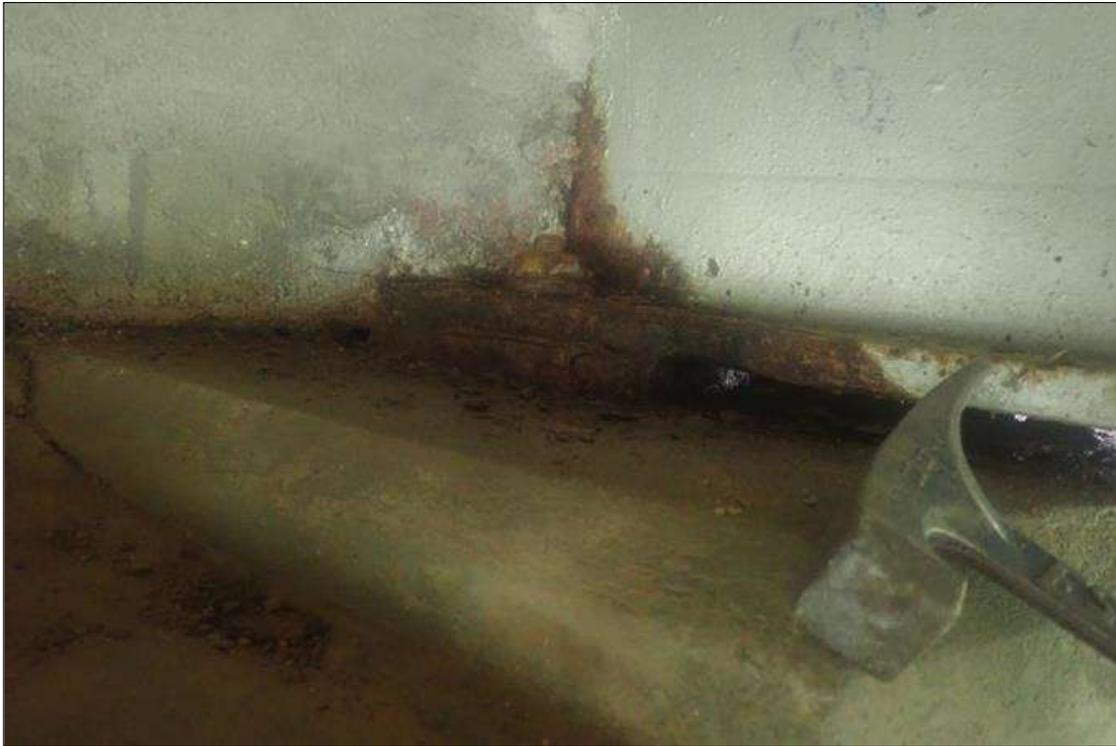
Span 4 Beam 4 - Far Bearing 4: rust scale

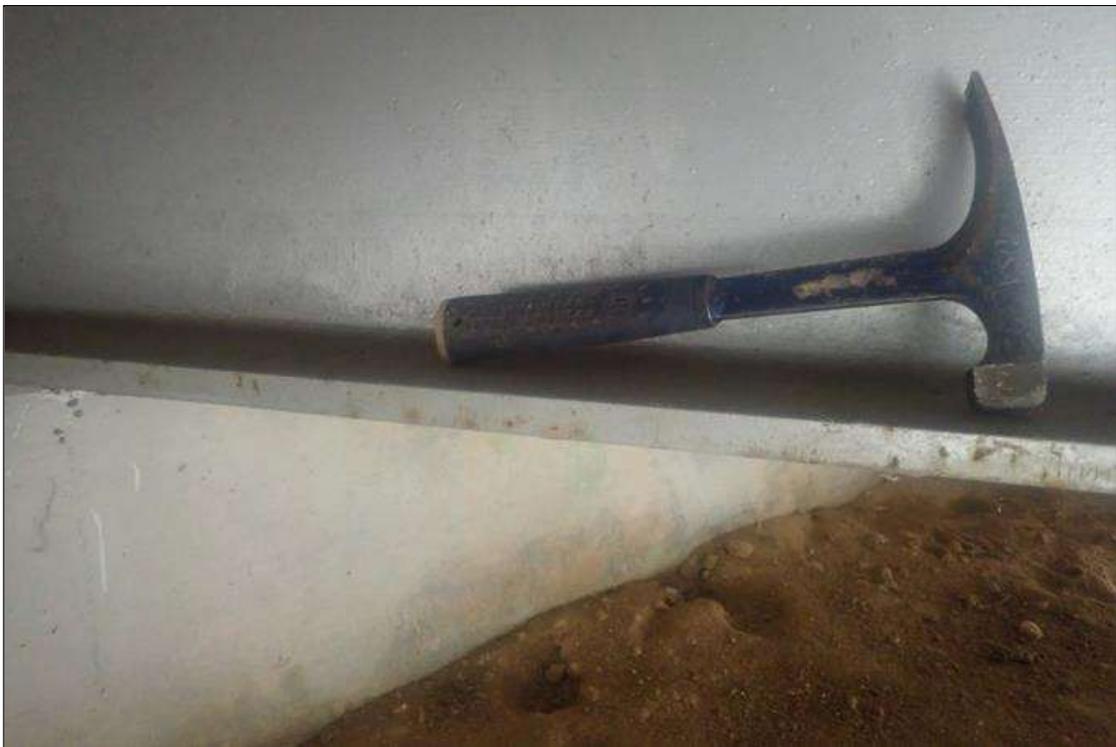
Span 4 Beam 3: along the length of the beam, freckled rust at random

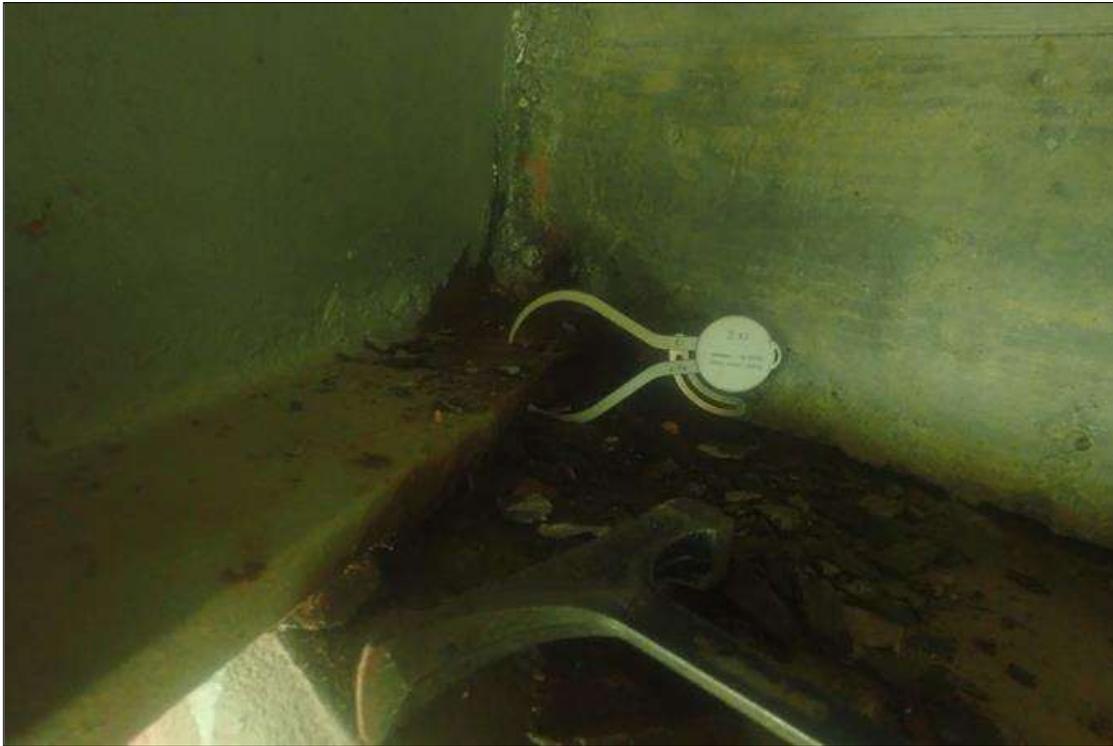
Span 4 Beam 1: (PAR) at end bent 2, corrosion with section loss to bottom flange (0.35" average remaining x 15"); lower web (3/8" average remaining x 7" x up to 4")

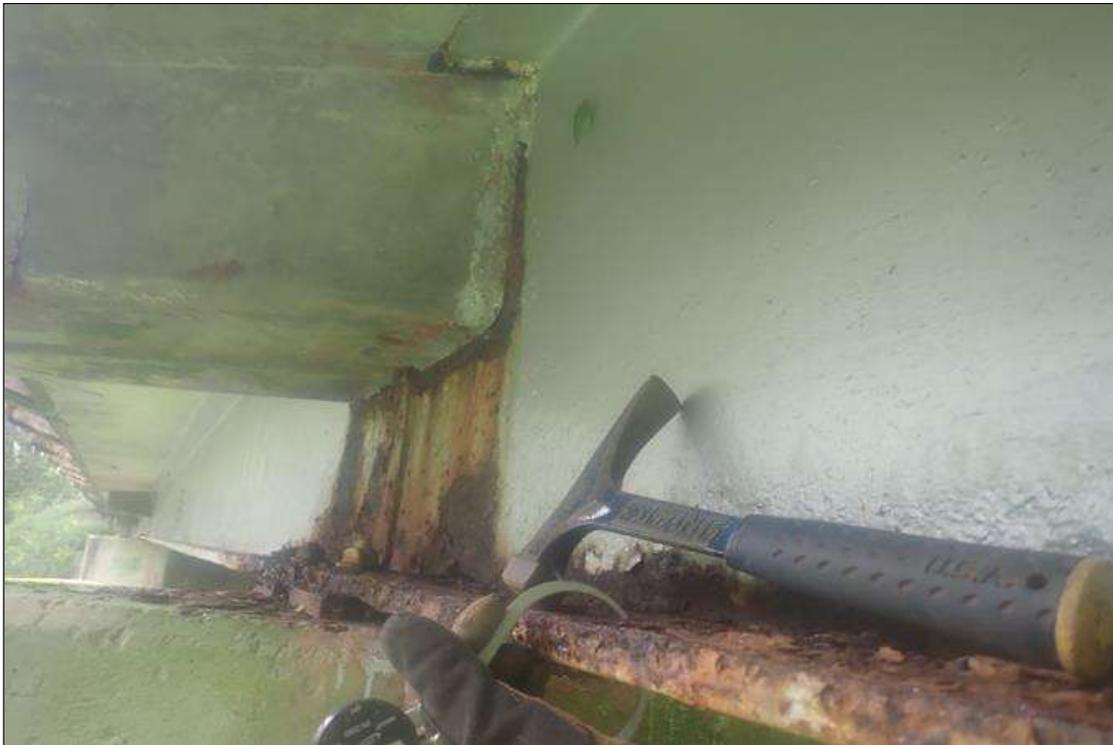
Span 4 Beam 4: (PAR) at bent 3, corrosion with section loss to bottom flange (0.7" average remaining x 1.5') with rust scale for an additional (4'); lower web, corrosion with partially painted over section loss (5/16" average remaining x 5')

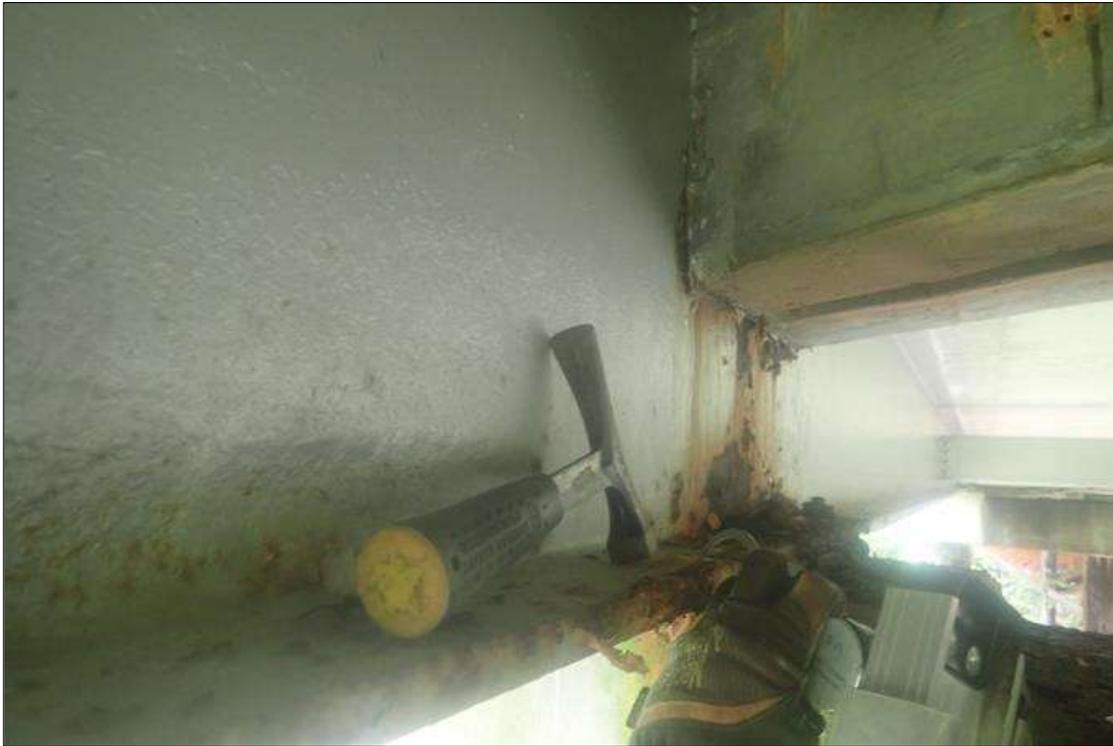
Span 4 Beam 4: (PAR) at bent 3, corrosion with section loss to bottom flange (0.7" average remaining x 1.5') with rust scale for an additional (4'); lower web, corrosion with partially painted over section loss (5/16" average remaining x 5')

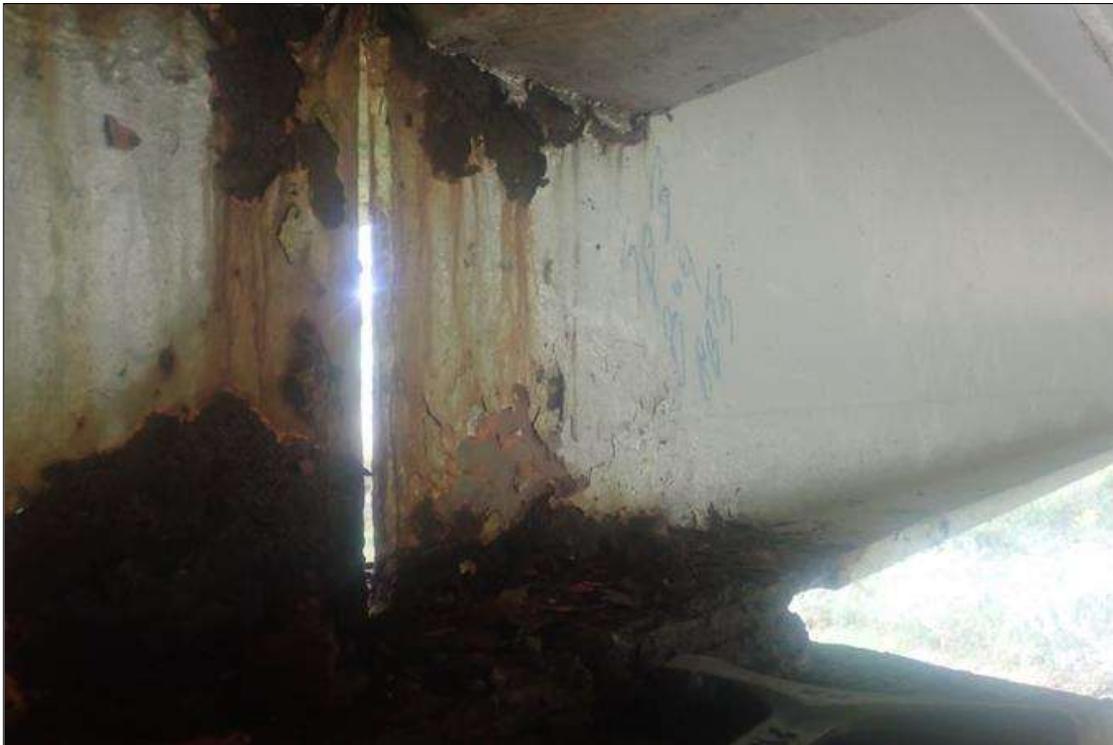
Span 3 Beam 4: (PAR) at bent 3, corrosion with section loss to bottom flange (0.57" average remaining x 1') and web (3/8" average remaining x 2' x 10" high)

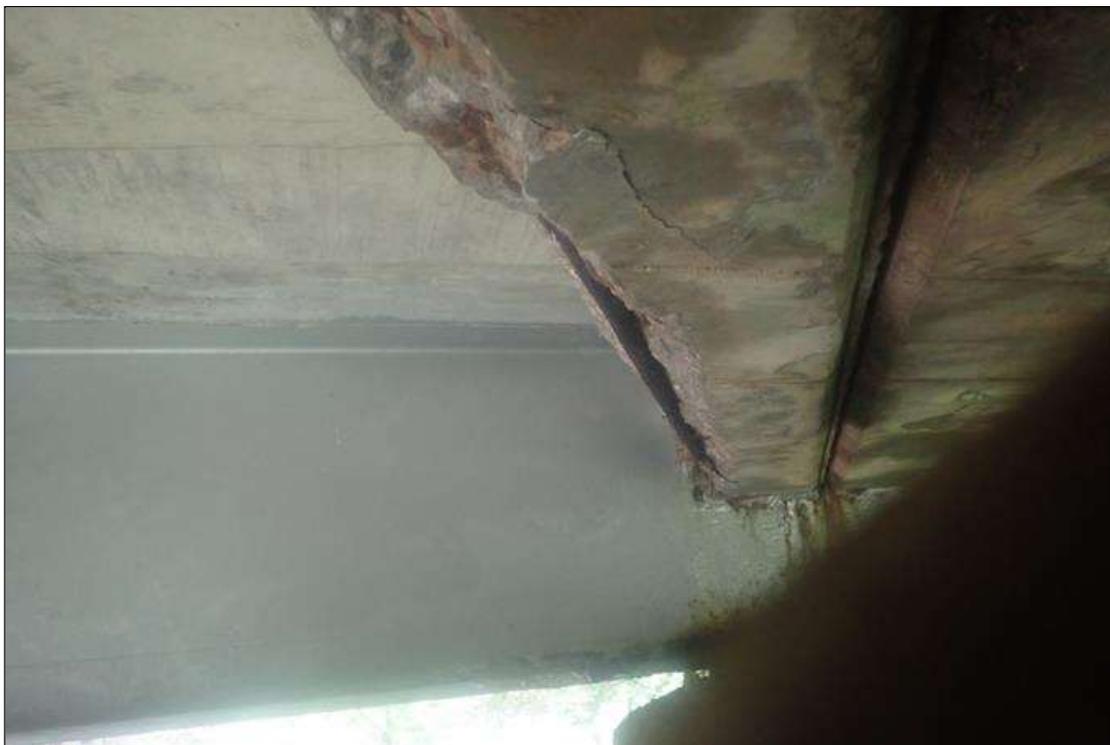
Span 3 Deck: at bent 3 bay 3 end diaphragm, spall (5' x 6" x 4" deep) with exposed rusted rebar

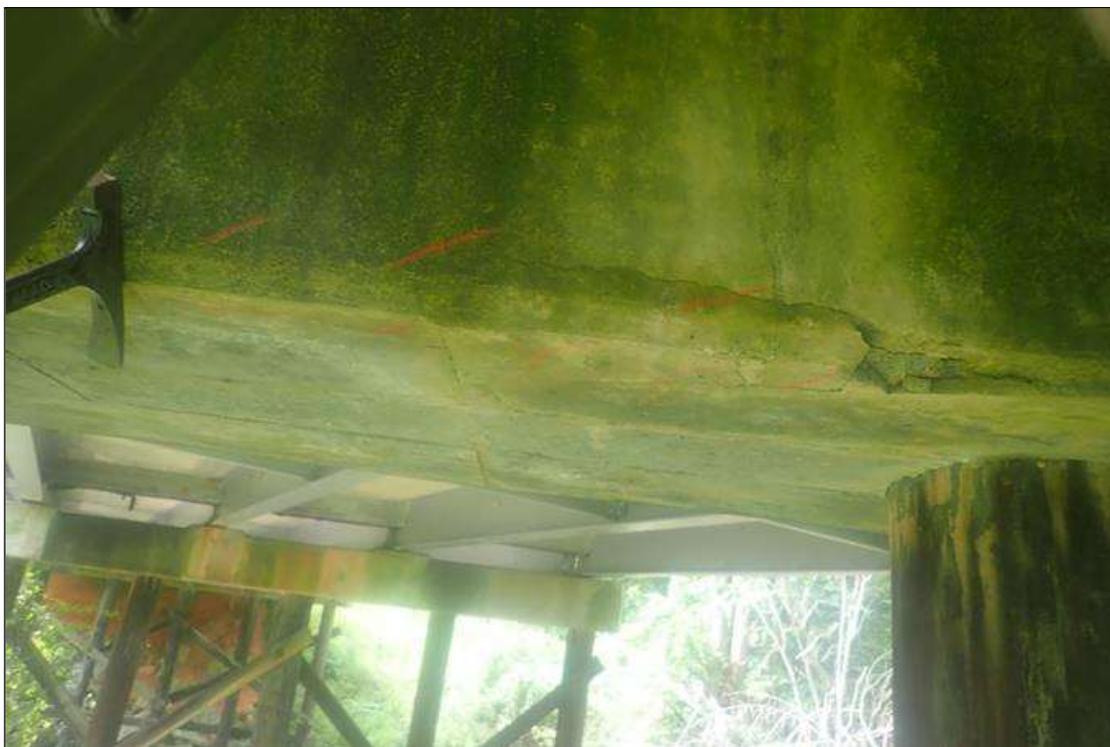
Bent 3 Cap 1: spans 3 and 4 face, between piles 4 and 5, spall/delamination (up to 5' x 6" x 1" deep)

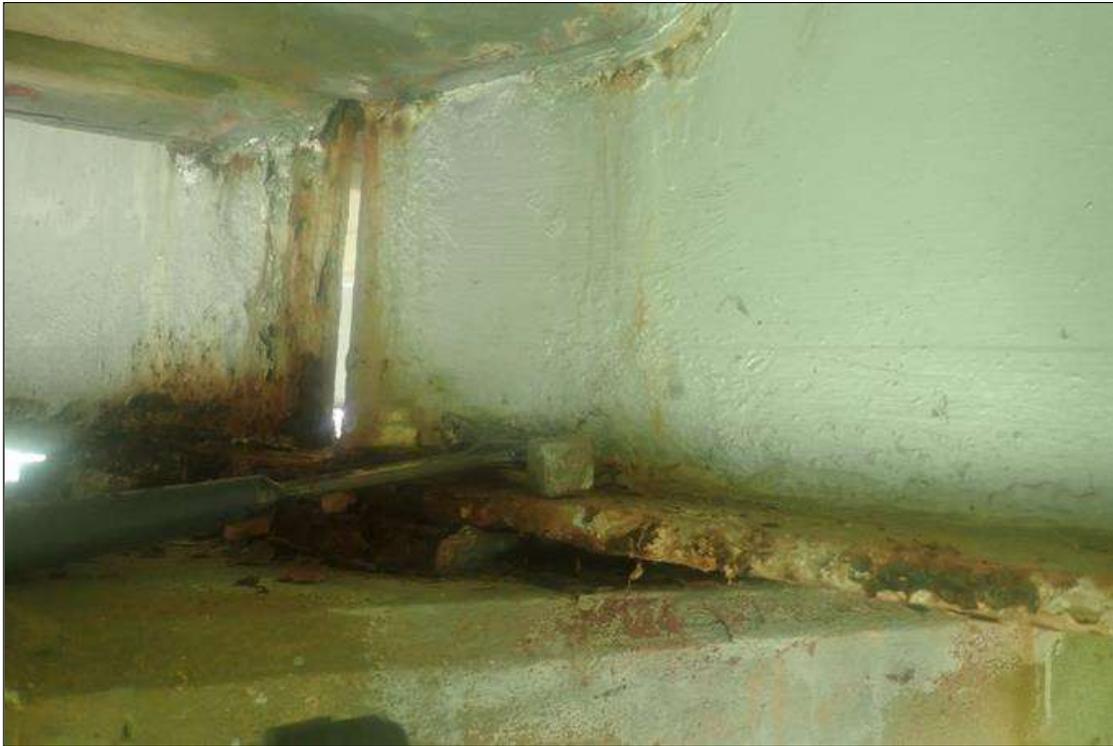
Span 4 Beam 3: (PAR) at bent 3, corrosion with section loss: bottom flange (0.50" average remaining x 8"); web painted over pitting (1/16" deep x 11" x up to 10")

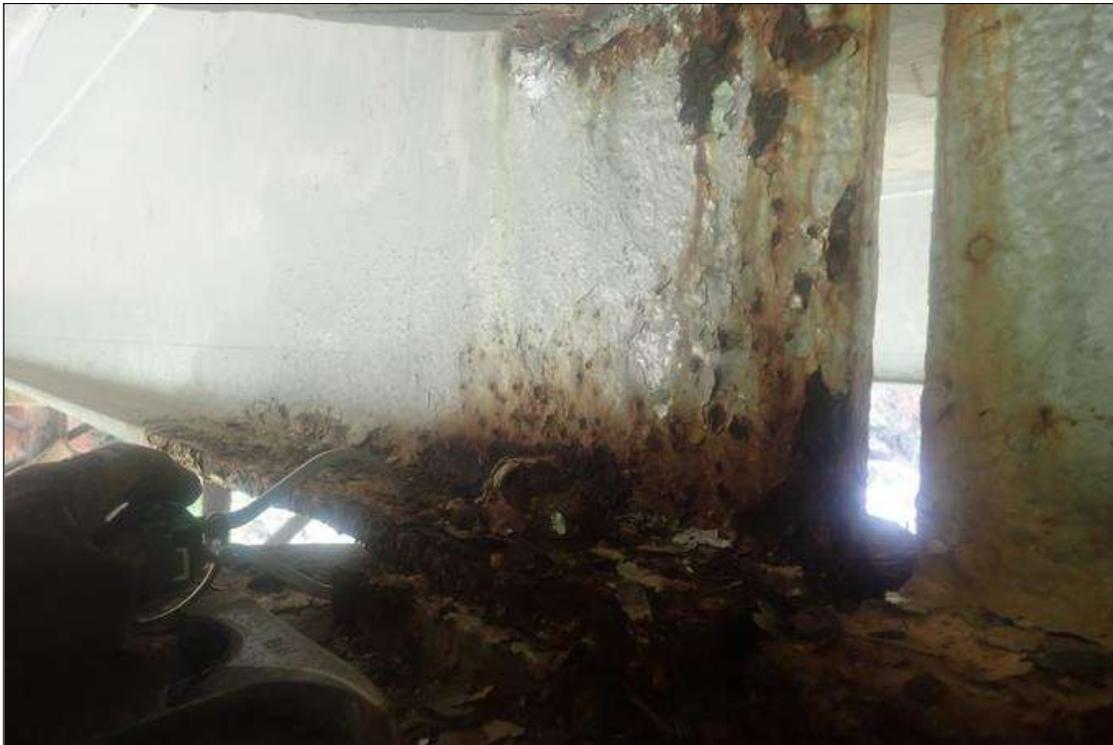
Span 3 Beam 3: (PAR) at bent 3, corrosion with section loss to bottom flange (0.58" average remaining x 1.5') and web (7/16" average remaining x 1.5' x up to 10")

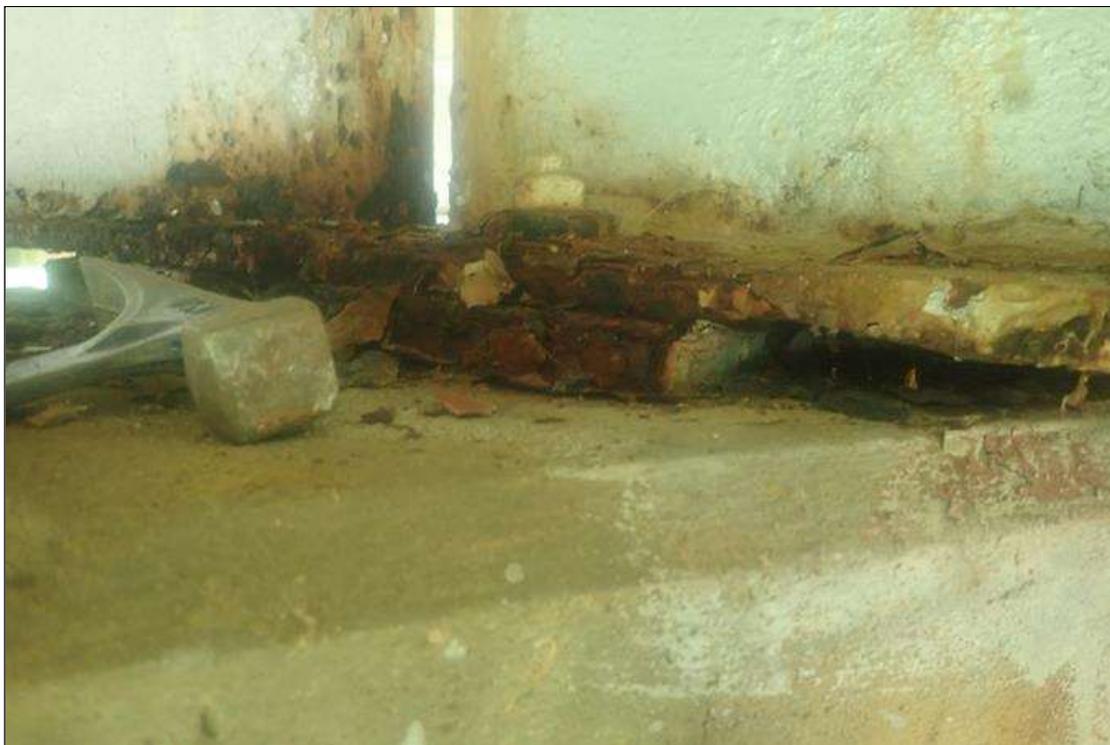
Span 4 Beam 3 - Near Bearing 3: rust scale

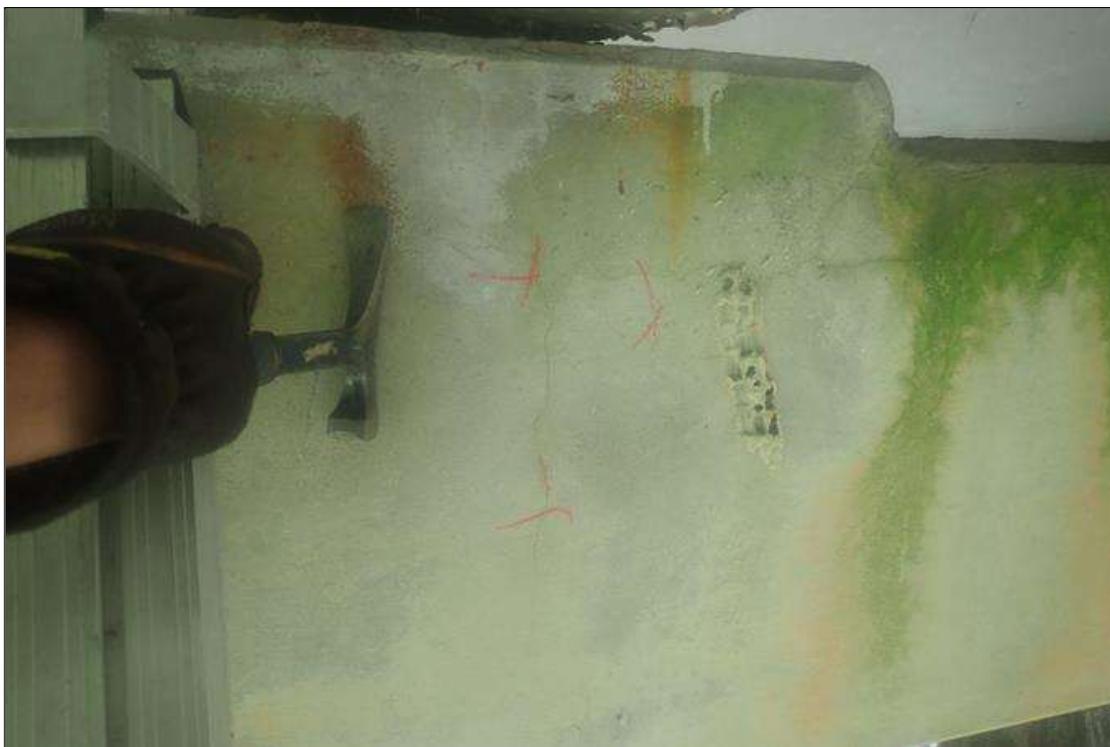
Bent 3 Cap 1: along the length of the cap, vertical and horizontal cracks (up to 1/32" x 2.5') at random

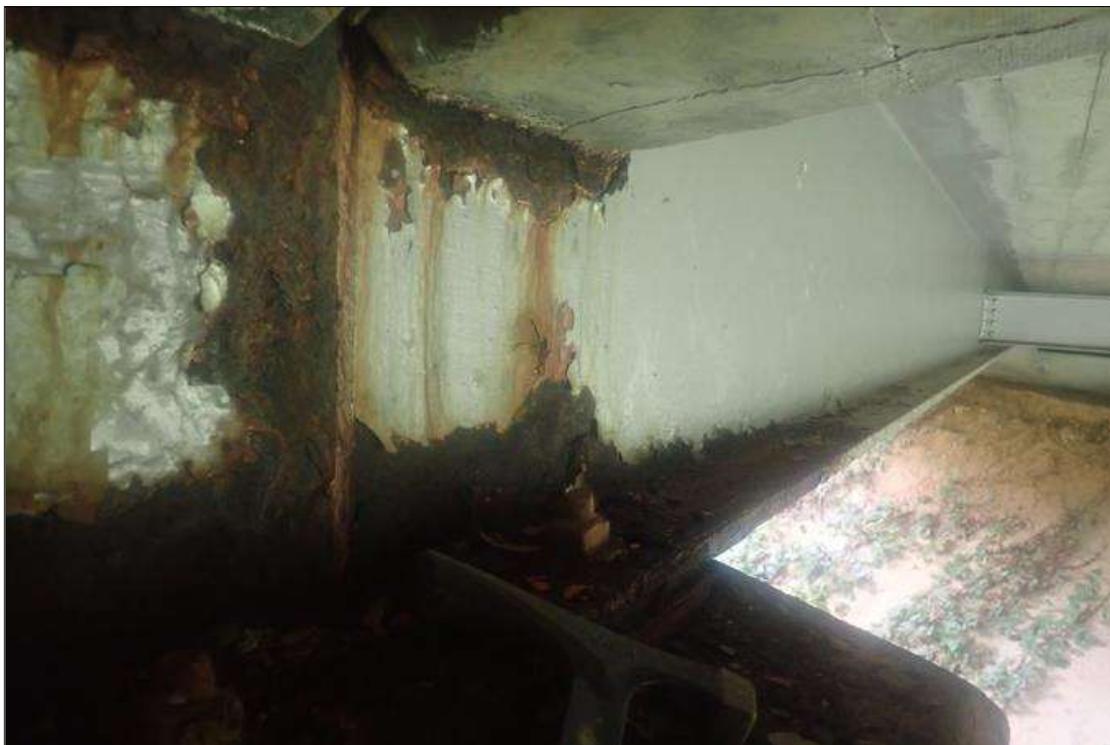
Span 4 Beam 2: at bent 3, corrosion with section loss: bottom flange (0.75" average remaining x 2'); lower web (7/16" x 1' x 10")

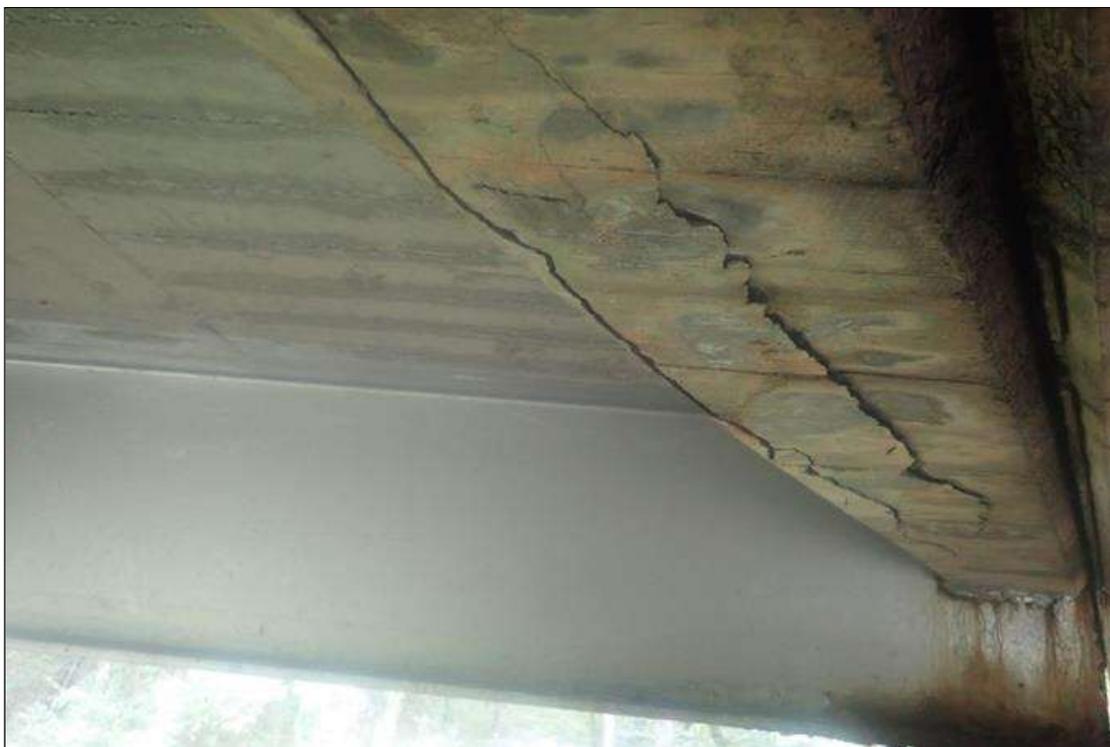
Span 4 Deck: at bent 3 bay 2 end diaphragm, spall/delamination (7.5' x 6" x 1" deep)

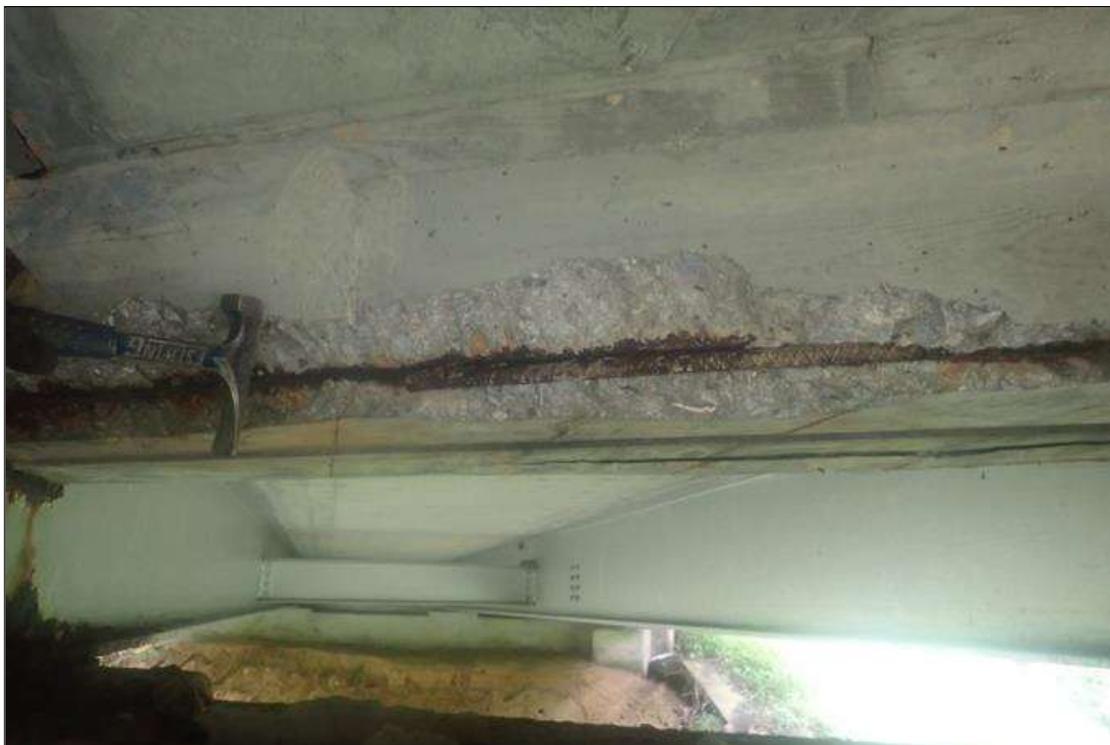
Span 3 Deck: at bent 3 bay 2 end diaphragm, spall (4' x 7" x 4" deep) with exposed rusted rebar

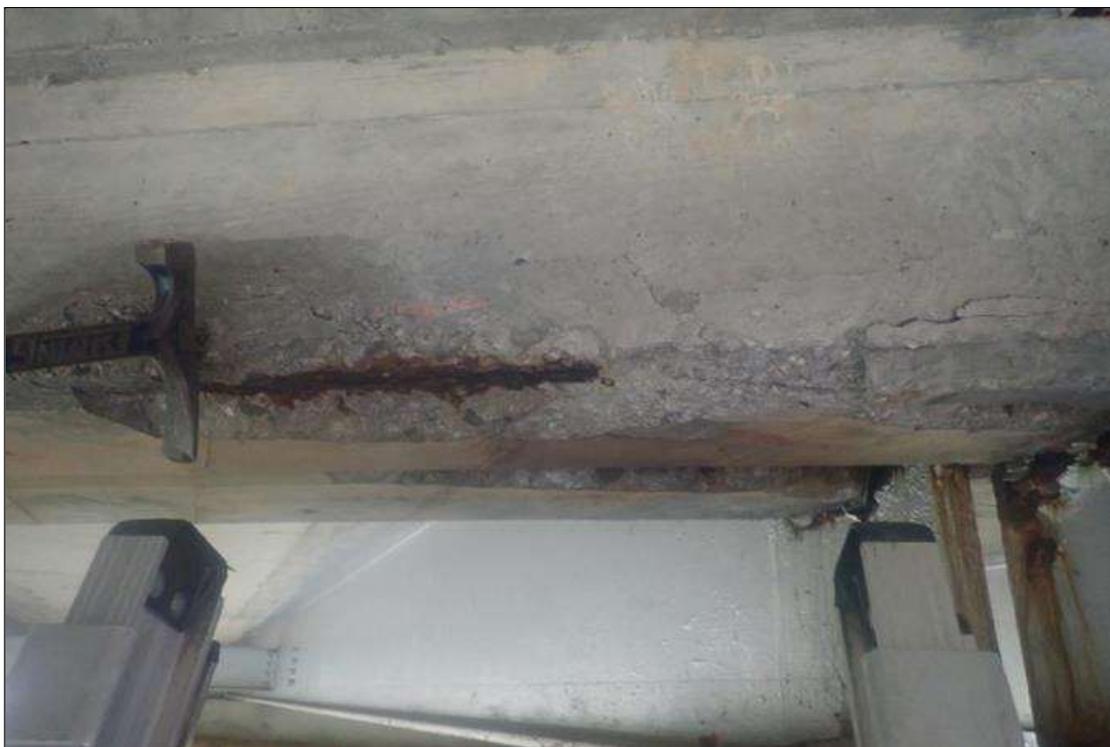
Span 3 Deck: at bent 3 bay 1 end diaphragm, spall (3' x 6" x 1.5" deep) with exposed rusted rebar

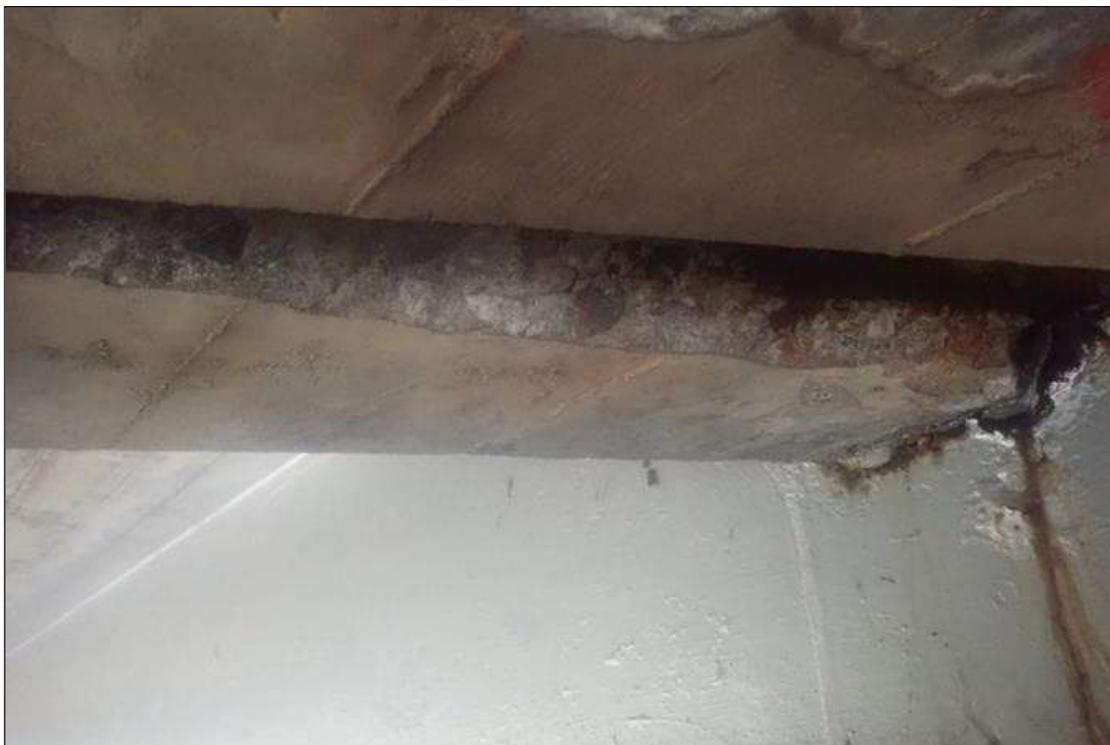
Span 4 Deck: at bent 3 bay 1 end diaphragm, (2) spalls (up to 3' x 7" x 2" deep) with exposed rusted rebar

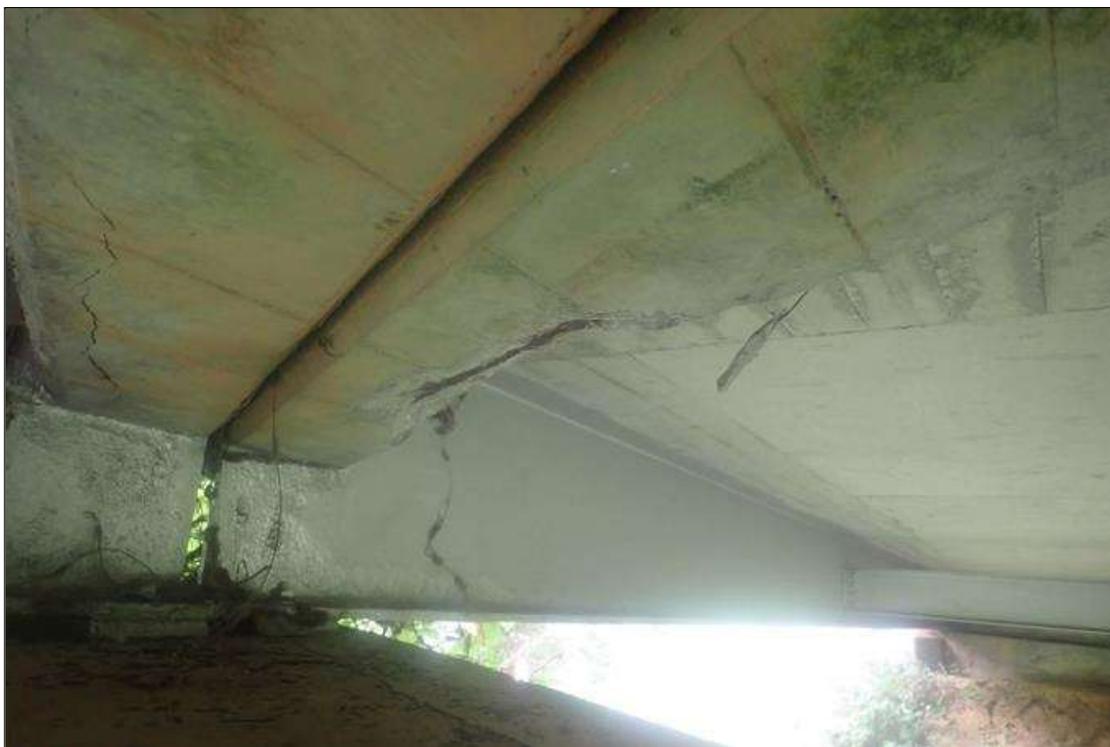
Span 4 Deck: at bent 3 bay 1 end diaphragm, (2) spalls (up to 3' x 7" x 2" deep) with exposed rusted rebar

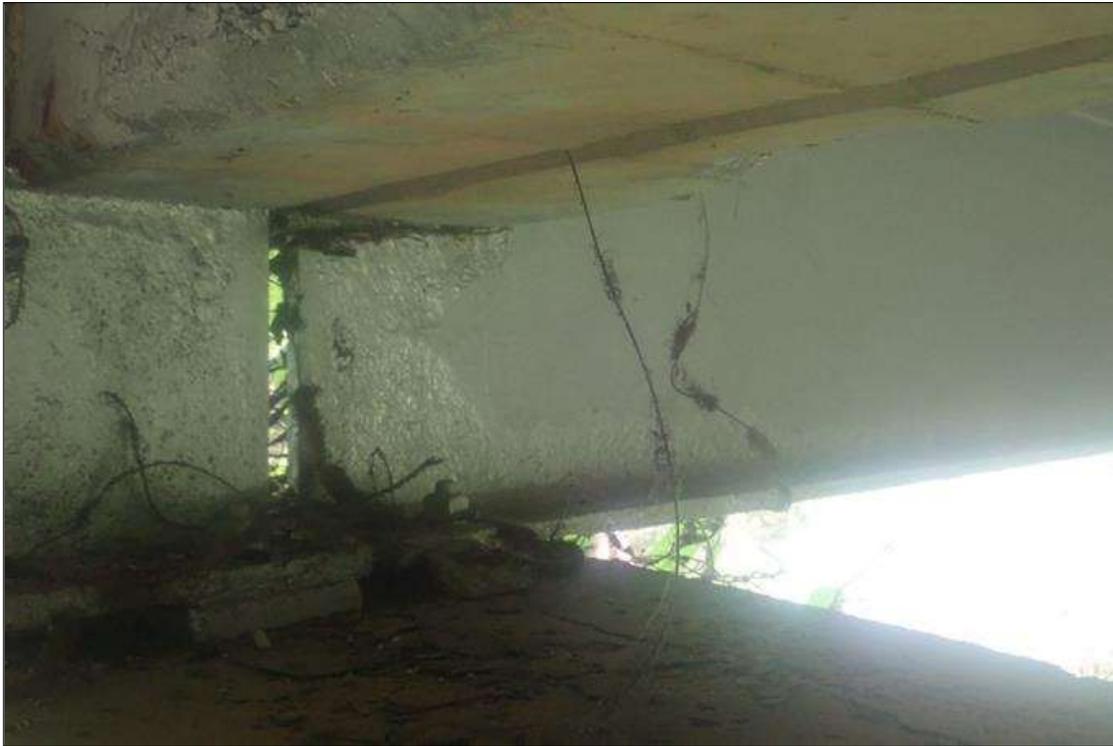
Span 4 Beam 1: at bent 3, previously painted over section loss to bottom flange (0.75" average remaining x 5'); pitting in web (up to 1/8" deep x 5' x up to 10")

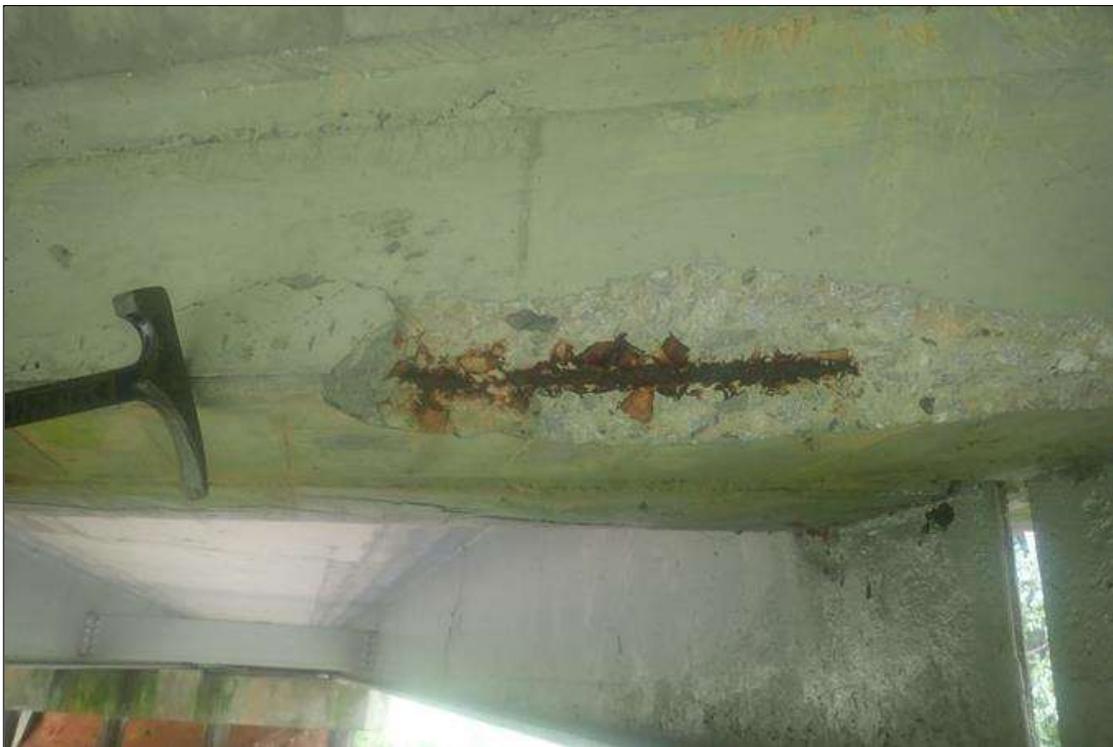
Span 3 Deck: bay 1, end diaphragm at bent 2, spall/delamination (3' x 6" x 2" deep) with exposed rusted rebar

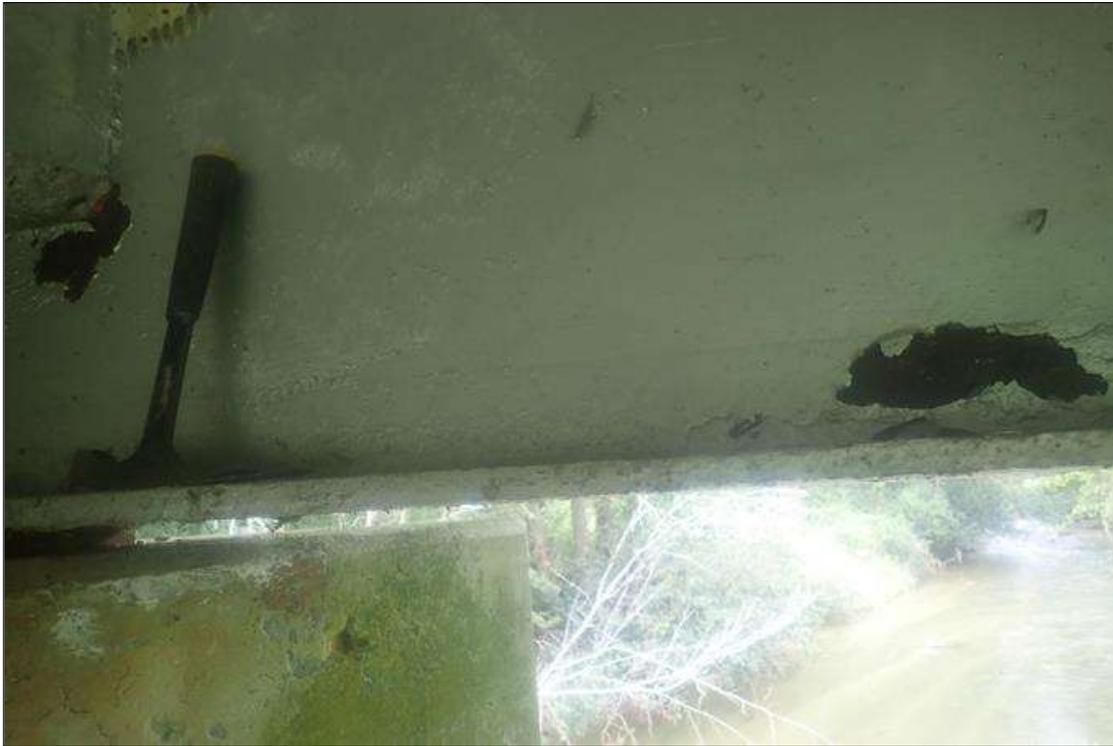
Span 3 Beam 1: at bent 2, surface rust to bottom flange and web with no measurable loss (4')
